Wiss, Janney, Elstner Associates, Inc.

August 4, 2022

P6: 2 Harbor Point South, Stamford, CT Visual Survey

WJE No. 2022.0759

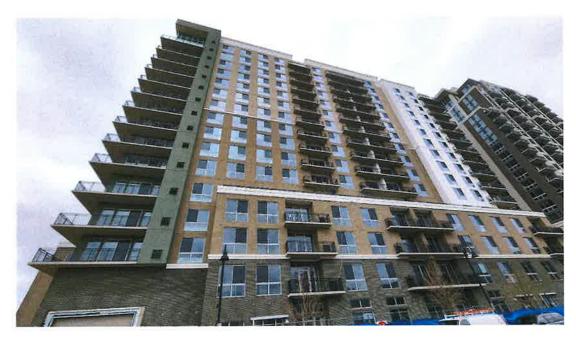
The building is clad with an exterior insulation and finishing system (EIFS) and the building has a flat roof (Figures 1-4). The building was designed by EDI International (EDI) and the structural engineer of record is Cary Kopczynski & Company (CKC). The State of Connecticut threshold structural peer review was completed by Pelliccione & Associates, LLC.

Figure 1- P6: East Elevation

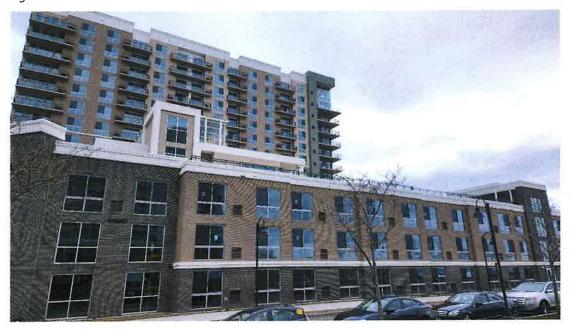
P6-West Elevation

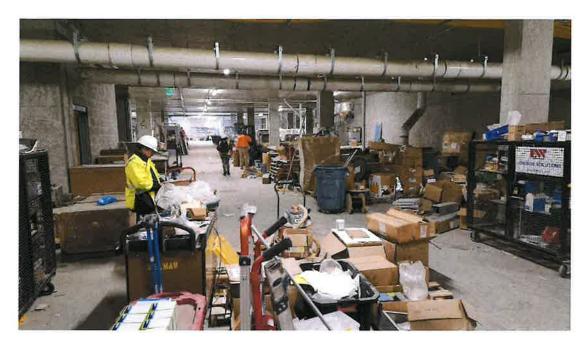
- Basement Level of garage appears in good condition no deleterious conditions were noted (Figure 5).
- First level of garage appears in good condition a few hairline shrinkage cracks were noted at the underside of the 2<sup>nd</sup> floor slab (Figures 6-8).

Figure 5- Basement Level of Parking Garage

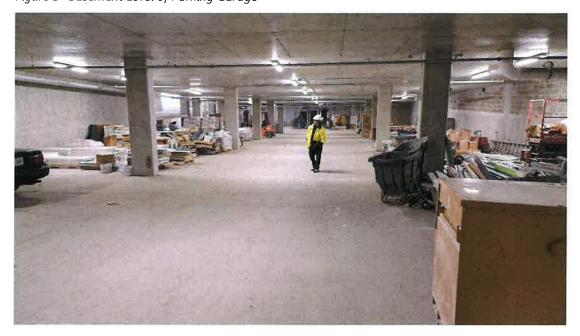
Figure 6- 1st Level of Parking Garage

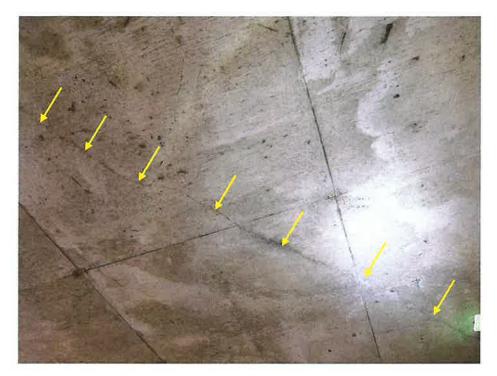
Figure 7- Hairline Shrinkage Cracks

- WJE would recommend routing and sealing the shrinkage cracks to prevent the ingress of air and water which could result in corrosion of the underlying steel and/or post tensioning.
- WJE recommends that an adequate soft joint should be provided between the CMU walls and concrete slabs at the garage to prevent further cracking from frame shortening and concrete creep.

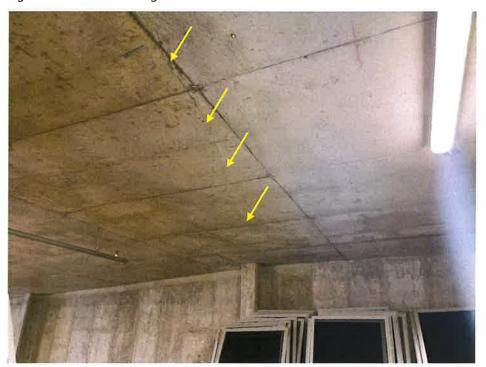
Figure 8- Hairline Shrinkage Cracks

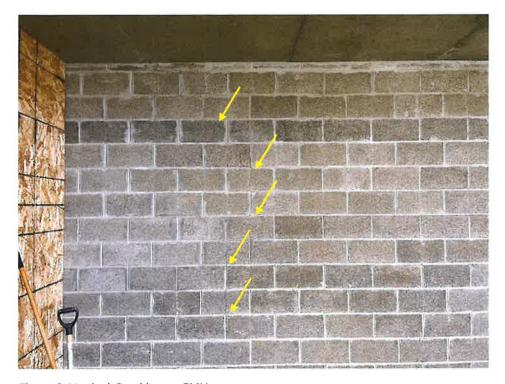
- Minor step cracking was noted at the southeast corner of the 1<sup>st</sup> level CMU wall between the garage and residential space (Figure 9).
- Cracking and delaminated concrete were noted at a beam to column connection at the southwest corner of the 1st floor level (Figures 10-11).

Figure 9-Vertical Cracking at CMU

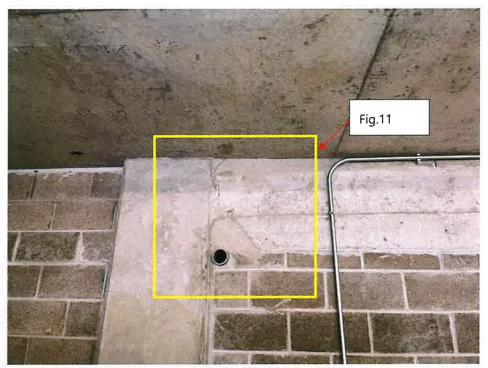
Figure 10- Cracking/Delamination at Beam to Column Connection

- WJE recommends that the spalled concrete at the beam to column connection be repaired to prevent further deterioration.
- The owner should consider applying a penetrating sealer to the parking levels or installing a traffic coating to protect the mild reinforcement from chloride laden water that gets tracked into the garage from vehicles
- Repairs to the exposed grout pockets at the live end anchorages should be made, if necessary, at the cantilever balconies.

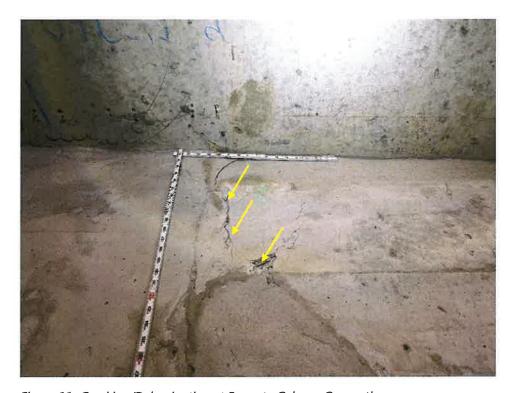
Figure 11- Cracking/Delamination at Beam to Column Connection

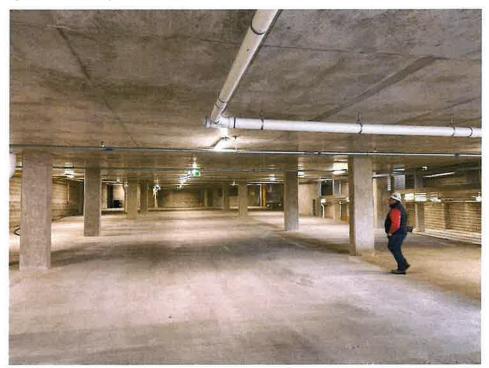
- Second Level of garage appears in good condition. A shrinkage crack with efflorescence staining emanating from it was noted at the ceiling at the northwest corner (Figures 12-13).

Figure 12- 2<sup>nd</sup> Floor of Parking Garage

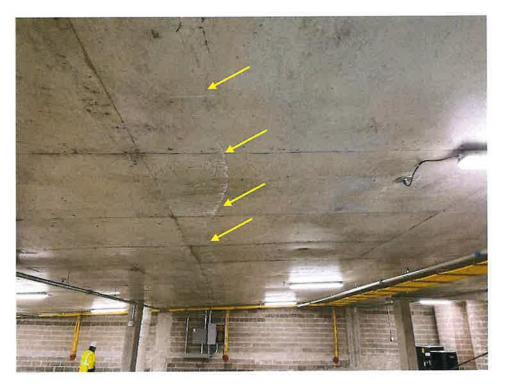
Figure 13- Shrinkage Crack with Efflorescence

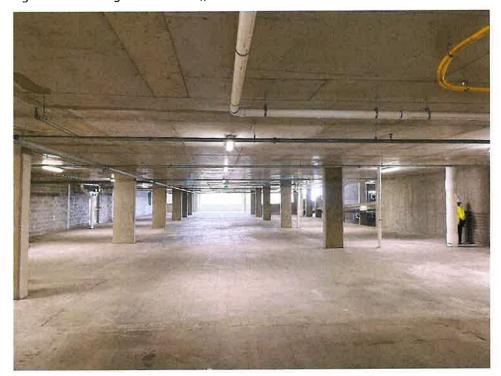
- Third Level of garage appears in good condition. A couple of shrinkage cracks with efflorescence staining emanating from them were noted at the ceiling of the northwest corner beneath the terrace (Figures 14-16).

Figure 14- 3<sup>rd</sup> Floor of Parking Garage

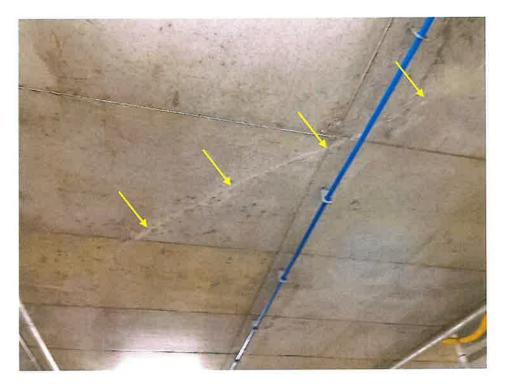
Figure 15- Shrinkage Crack with Efflorescence

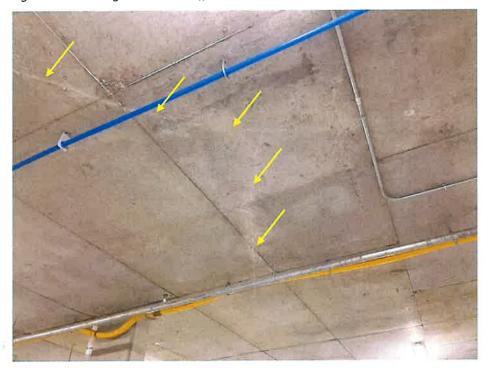
Figure 16- Shrinkage Crack with Efflorescence

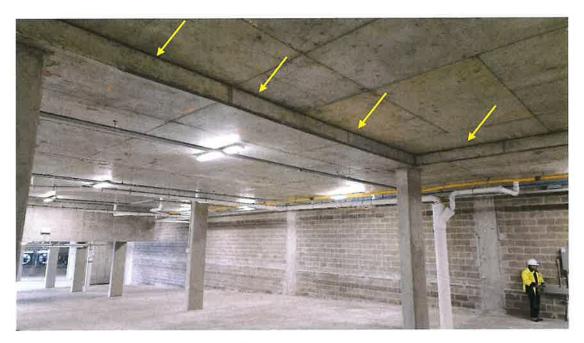
- WJE reviewed areas beneath the 4<sup>th</sup> floor terrace where the slab steps up or down changing elevation and found no deleterious conditions (Figures 17-18).

Figure 17- Step in 4th Floor Terrace Level Slab

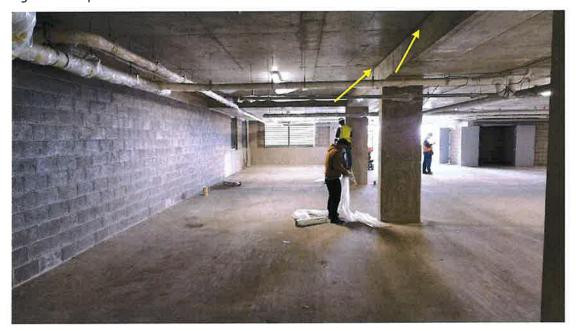
Figure 18- Step in 4th Floor Terrace Level Slab

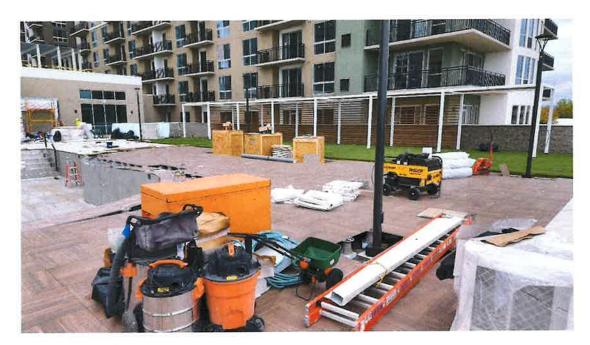
WJE visually reviewed the amenity terrace at the 4<sup>th</sup> floor level which was under construction at the time of our visit, WJE did not observe any cracking in finishes or excessive deflections that could be an indication of an underlying structural issue (Figures 19-22).

Figure 19- Amenity Terrace

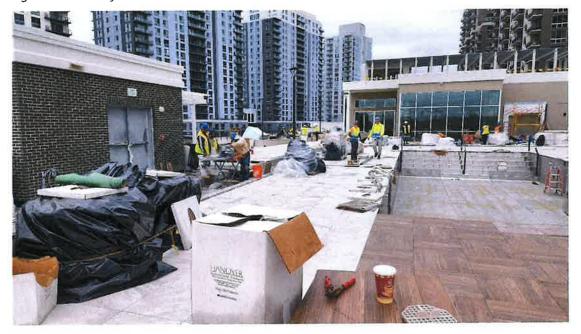
Figure 20- Amenity Terrace

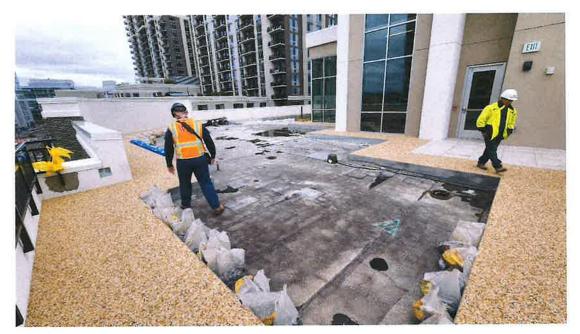
Figure 21- Amenity Terrace

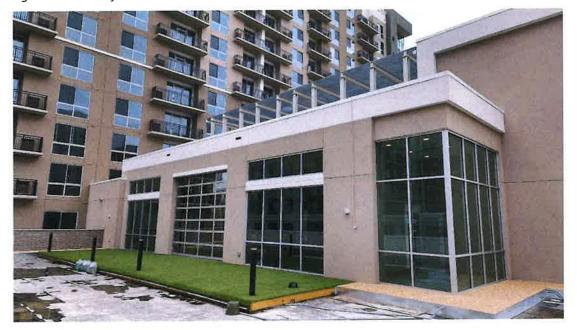
Figure 22- Amenity Terrace

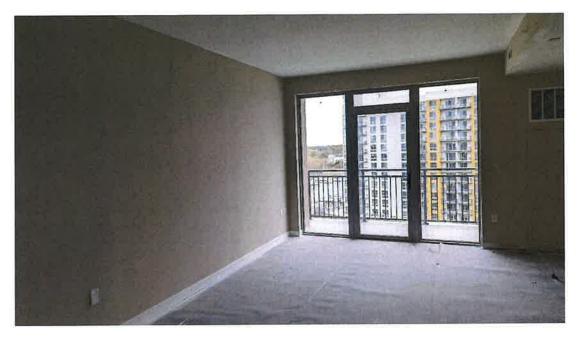
- At the time of our visit, the building was still under construction, WJE visually reviewed 40 apartments and all accessible public and amenities spaces. As part of our review, WJE was looking for cracks in the drywall finishes especially at doorways and floor to ceiling transitions that may be an indication of recent movement. Additionally, WJE was looking for separations in the trim or gaps in the trim that may indicate the presence of slab deflections. No deleterious conditions were noted at the reviewed areas (Figures 23-26).

Figure 23- Typical Apartment

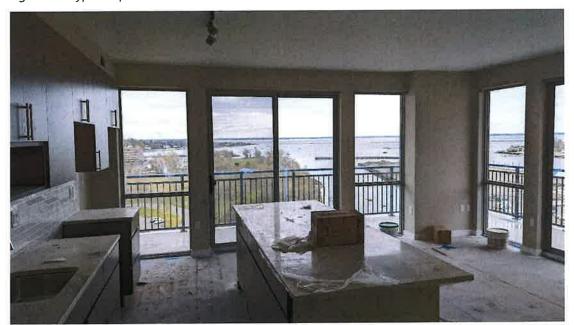
Figure 24- Typical Apartment

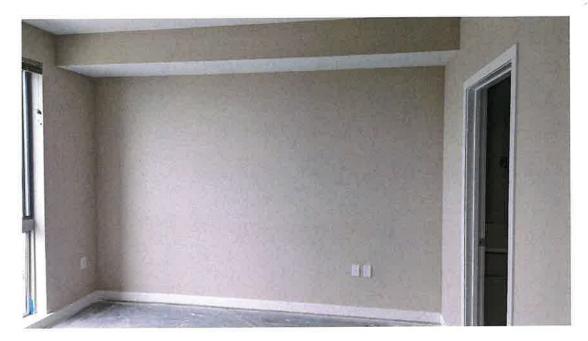
Figure 25- Typical Apartment

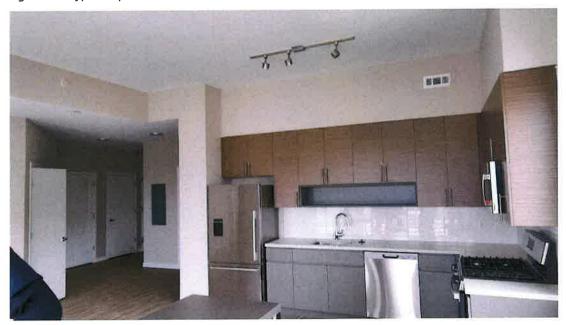
Figure 26- Typical Apartment

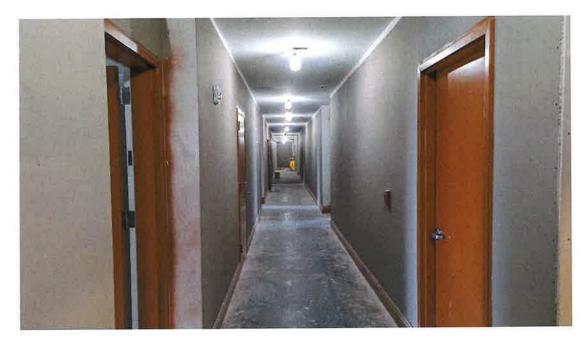
- Elevator lobbies and corridors were visually inspected for similar cracks and separations. In some instances, the slab was exposed at the corridor. No deleterious conditions were noted at the reviewed areas (Figures 27-28).

Figure 27- Typical Corridor

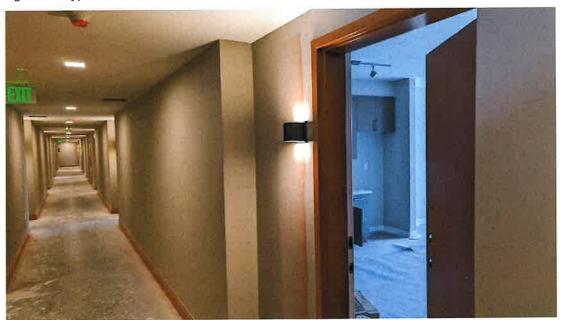
Figure 28- Typical Corridor

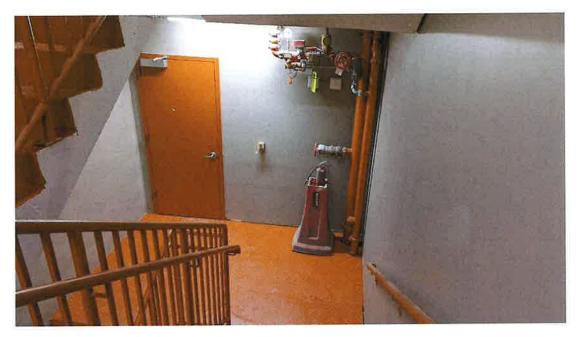
- The north and south stair towers were partially reviewed. At these locations, painted concrete shear wall are exposed. No cracking or deleterious conditions were noted at the reviewed areas (Figures 29).

Figure 29- Typical Stairwell

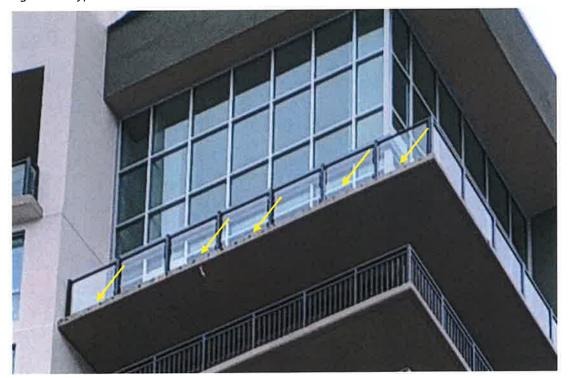
- WJE visually reviewed the exterior elevations of the building from grade, select apartments terraces and from the 4<sup>th</sup> floor terrace. In general, WJE did not observe any cracking in the EIFS or exposed concrete that would be indicative of an underlying structural issue.
- At one location at the top level (i.e. 15<sup>th</sup> floor) and at a location at the southeast corner, there appears to be grout missing at the live end anchorages at the face of the cantilevered balconies (Figure 30).

Figure 30- Possible Missing Grout at End Anchorages
