Wiss, Janney, Elstner Associates, Inc.

August 4, 2022

P1 & P2: The Escape, 880 Pacific Street, Stamford, CT: Visual Survey

WJE No. 2022.0759

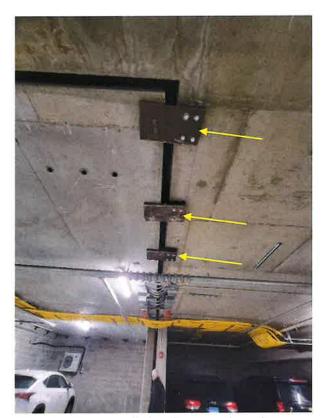
Following the partial collapse at the Allure, a resident of The Escape asked the Stamford building department about the installed steel plates at the underside of the expansion joint at the building (Figure 6). WJE reviewed a March 15, 2022 letter issued by HRSE titled: "Harbor Points- The Escape: Steel Plates on Underside of Level 1" which includes the following:

- After the level 1 shores were removed following the concrete placement, a ¾ in. vertical deflection was noted at the expansion joint.
- Upon review it was determined that the profiles of the uniform tendons at the cantilevered end adjacent to the expansion joint were reversed.
- Structural analysis indicated that the reversed tendon condition is structurally ok, however, steel plates will be required to control deflection.
- The layout was corrected at the upper-level floors, therefore the plates were not required.

Review of the original structural drawings issued by HRSE compared to the post tensioning shop drawings issued by Suncoast, indicates that the approved shop drawings for level 1 show the post tensioning near the expansion joints to be lower in the slab than shown in the structural design drawings at level 1. This appears to be corrected in the upper-level shop drawings which were issued at a later date.

Figure 6- Plates Installed under Expansion Joint

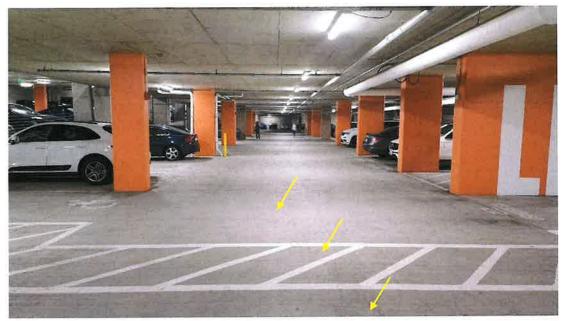
- The lower level of the parking garage was observed to be in good condition at isolated locations, shrinkage cracks were noted in the slab-on-grade as well as at the underside of the 1st floor slab level. In some instances, efflorescence was observed emanating from the shrinkage cracks (Figures 7 & 8).

Figure 7- Lower Level of Garage, Note Shrinkage Cracks at Slab-on-Grade

- WJE would recommend routing and sealing the shrinkage cracks to prevent the ingress of air and water which could result in corrosion of the underlying steel and/or post tensioning.

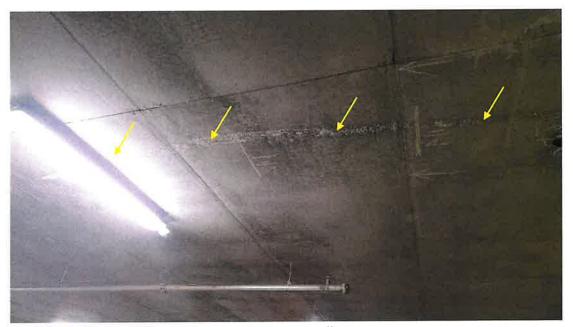
Figure 8- Shrinkage Cracks at Underside of Level 1 with Efflorescence

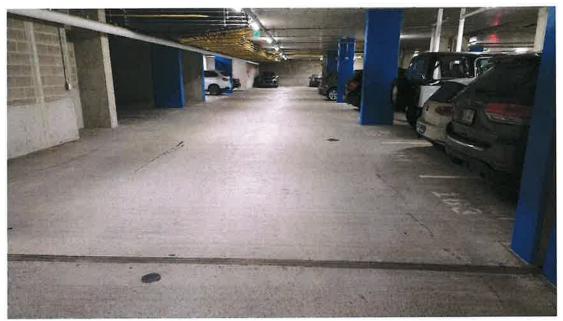
- Levels 1 through 3 of garage appear in good condition a few shrinkage cracks noted at isolated locations (Figures 9-11).
- The 4<sup>th</sup> floor of the garage beneath the amenities terrace appears in good condition. A few hairline shrinkage cracks were noted at the underside of the 5th floor terrace slab (Figure 12).

Figure 9- Garage Level 1 Overall

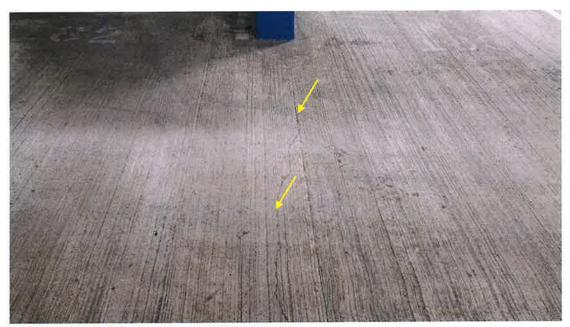
Figure 10- Shrinkage Cracks at Garage Level 1

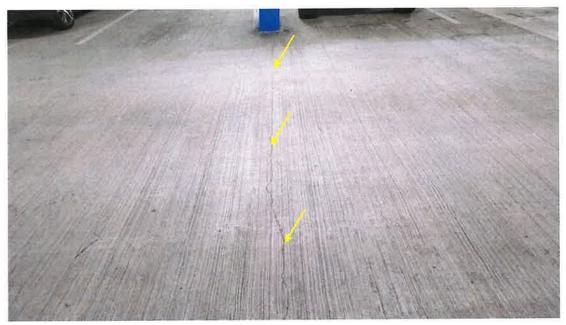
Figure 11- Shrinkage Cracks at Level 2

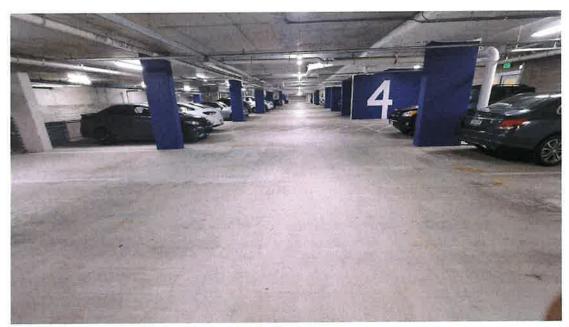
Figure 12-Garage 4<sup>th</sup> Floor Level Overall

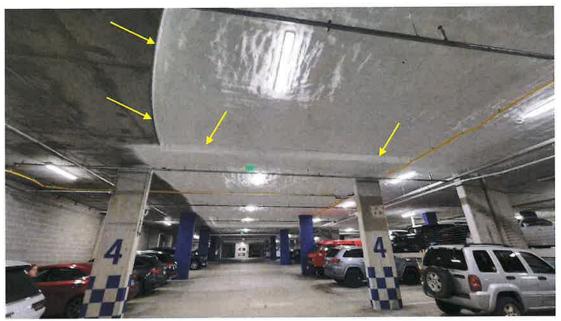
- WJE reviewed areas beneath the 5<sup>h</sup> floor terrace where the slab steps up or down and found no cracks or offsets in the spray foam insulation (Figures 13). Any significant disruption of the underlying concrete would be expected to manifest as cracks and offsets in the spray foam insulation bonded to it

Figure 13- Steps in Slab Beneath Terrace

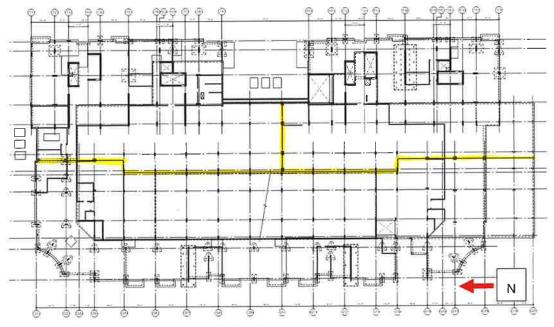
- On Levels 1 to 4, there are three locations on each floor where the 3 in. wide building expansion joint crosses the drive lanes in the garage (Figure 14). At the north and south end of the garage, the slab cantilevers to create the expansion joint which is due to the column layout at the location of the expansion joint (Figure 15). At these expansion joints, rather large deflections were noted, in some instances greater than 1 inch. This results in an vertical offset between the two edges of the joint which then creates lip in the slab that is impacted as car tires roll over the joint (Figure 16- 18).

Figure 14- Expansion Joint Locations (Yellow Lines)

- The owner should consider having an engineer review the condition of the expansion joints and propose a repair solution to improve the serviceability of the joints. Overtime, the joints will continue to displace downward because of concrete creep. The impacts of the tires on the edges of the joints will likely result in premature deterioration of the concrete, the expansion joint material and potentially damage embedded anchorages. In their current installation, the expansion joints are forced to accommodate movement in 6 directions (two each vertically, longitudinally, and transversely) which the rubber seals cannot accommodate.

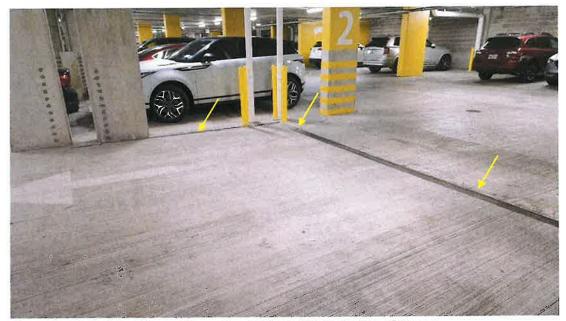
Figure 15- Typical Cantilevered Expansion Joint at North and South of Garage

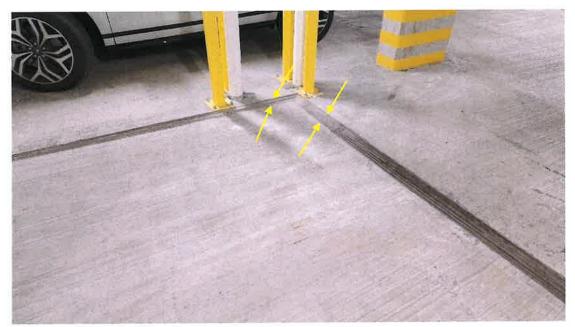
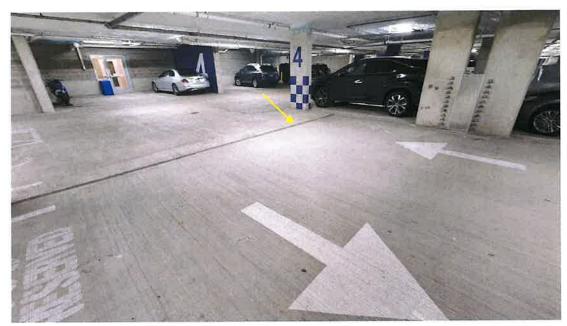
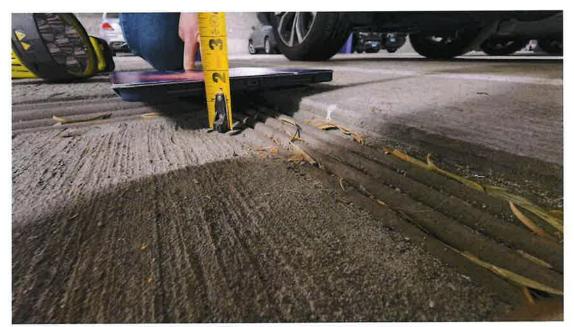
Figure 16- Deflection at Cantilevered End of Joint

Figure 17- Deflection at Cantilevered End of Joint

Figure 18- Deflection at Cantilevered End of Joint

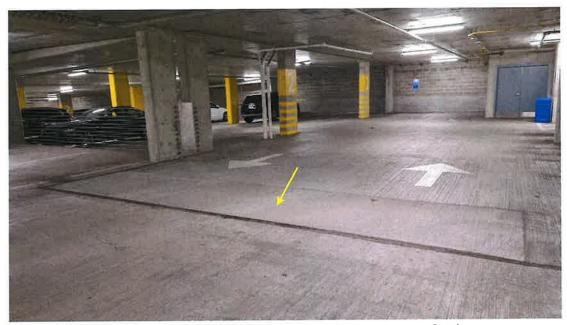
- The expansion joint at the first-floor joint has been repaired with steel plates and a concrete patch has been installed at the deflected joint as well (Figure 19)

Figure 19- Repaired Expansion Joint with Plates at Underside. Note Concrete Patch.

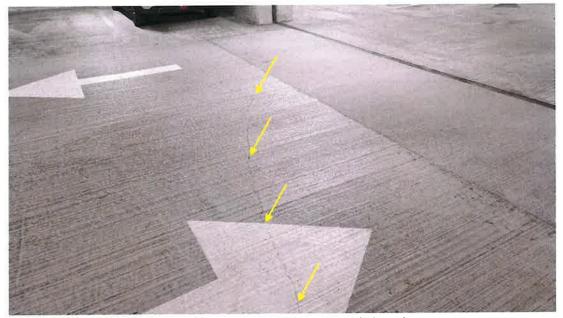
- Additionally, cracking following the banded tendon layout was noted in the cantilevered slab (Figure 20).

Figure 20- Cracking at Repaired Expansion Joint Following Banded Tendons

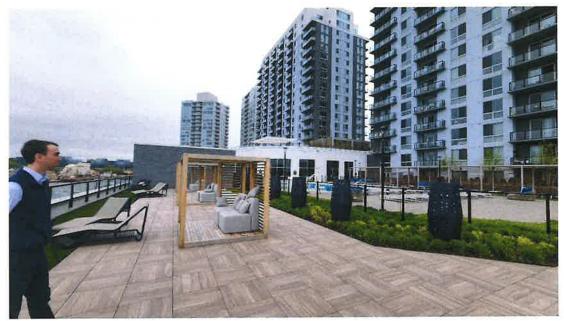
■ WJE visually reviewed the amenity terrace at the 5<sup>th</sup> Floor. WJE did not observe any cracking in finishes or excessive deflections that could be an indication of an underlying structural issue (Figures 21-22).

Figure 21- Terrace South Side

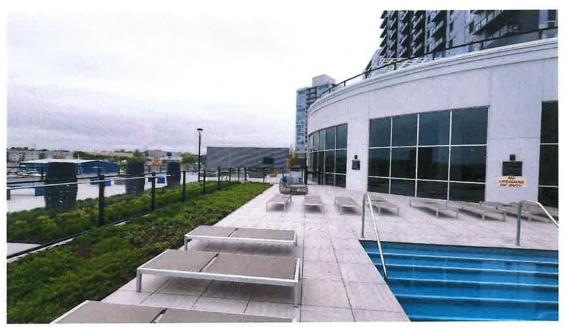
Figure 22- Terrace Looking North

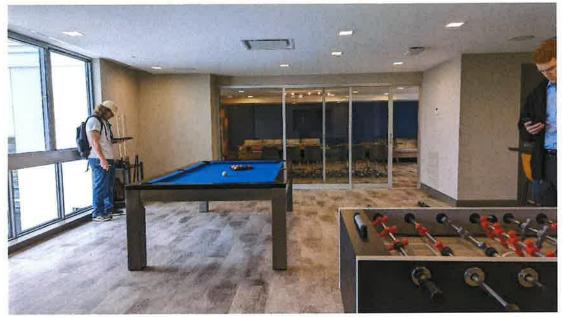
- At the time of our visit, WJE was provided access to 18 units within the two towers. WJE visually reviewed the 18 apartments and all accessible public and amenities spaces. As part of our review, WJE looked for cracks in the drywall finishes especially at doorways and floor to ceiling transitions that may be an indication of differential movement. Additionally, WJE also looked for separations in the trim or gaps in the trim that may indicate the presence of slab deflections. No distressed conditions were noted at the reviewed areas (Figures 23-26).

Figure 23- Amenity Space

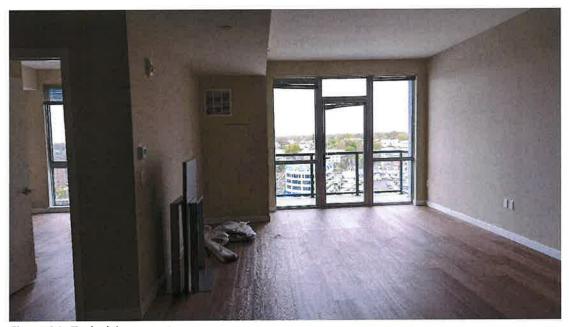
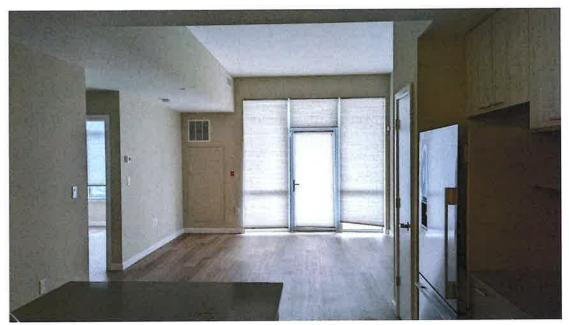
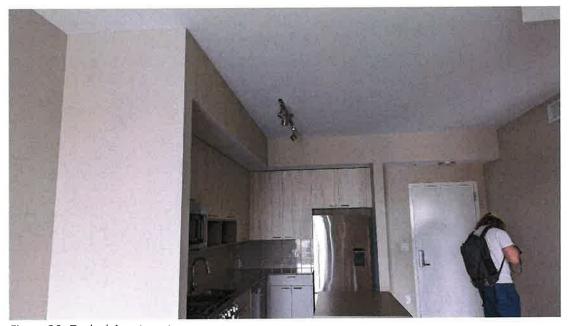
Figure 24- Typical Apartment

Figure 25- Typical Apartment

Figure 26- Typical Apartment
