PLAYGROUND SAFETY INSPECTION REPORT

SITE: Davenport Ridge Elementary School
1300 Newfield Avenue
Stamford, CT 06905

DATE OF INSPECTION: April 24, 2019

INSPECTOR: Natale Chionchio
CPSI Certification # 41619-0521
Expiration: 5/1/2021

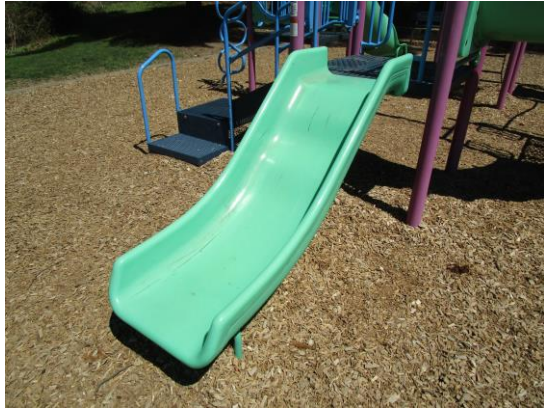
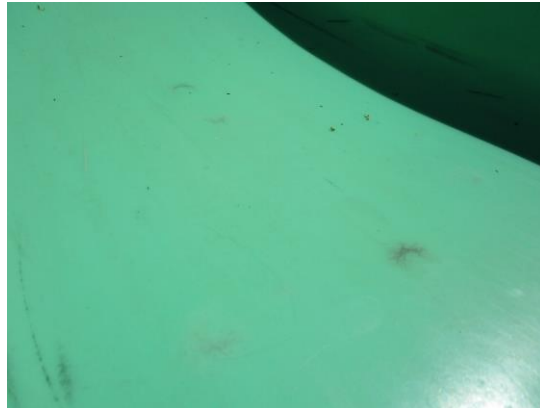
**Metal Composite Structure (GameTime)
Swift Rider Slide - Small cracks in bed way - MAINTENANCE**

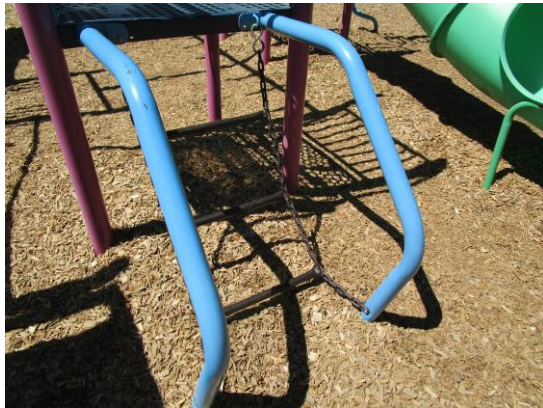
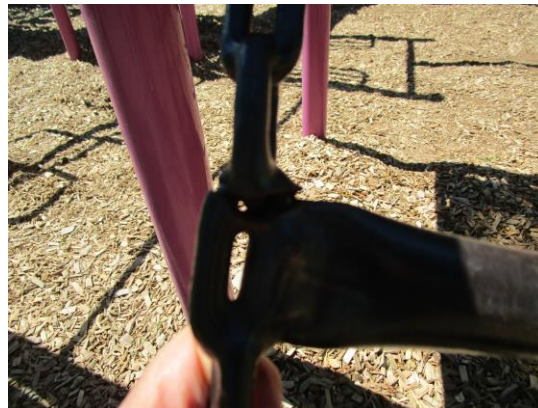
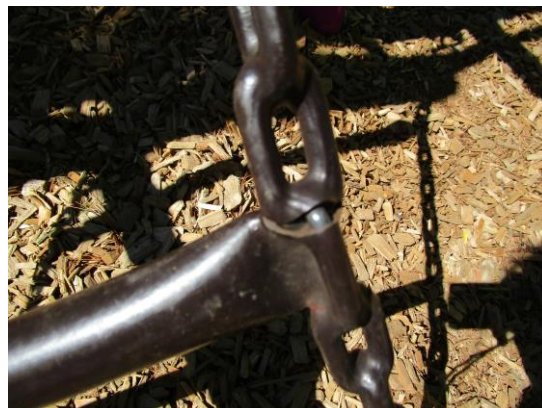
Chain Net Climber - Plastisol cracked - MAINTENANCE

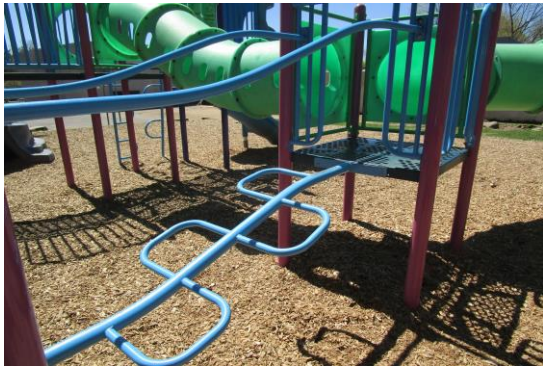
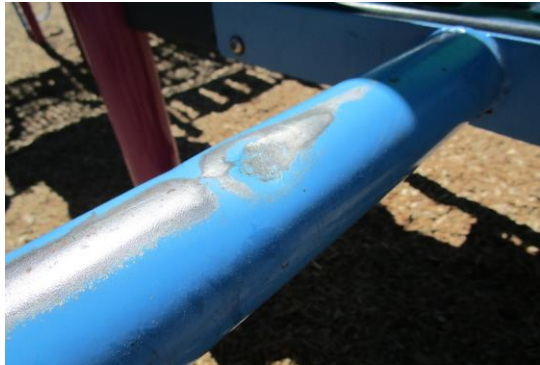
Tree Climber Link - Dent in pipe - MAINTENANCE

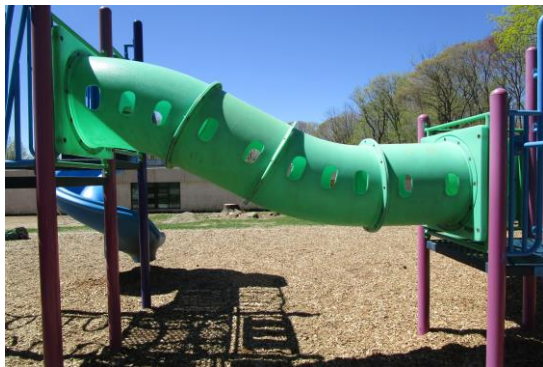
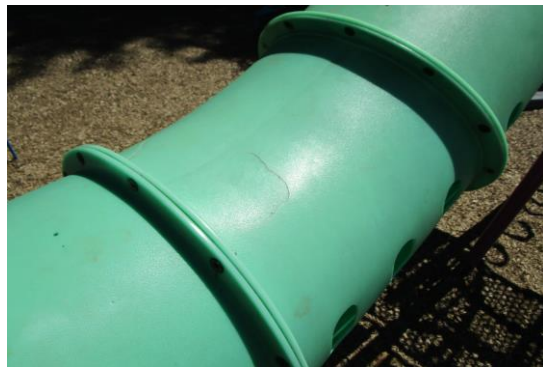
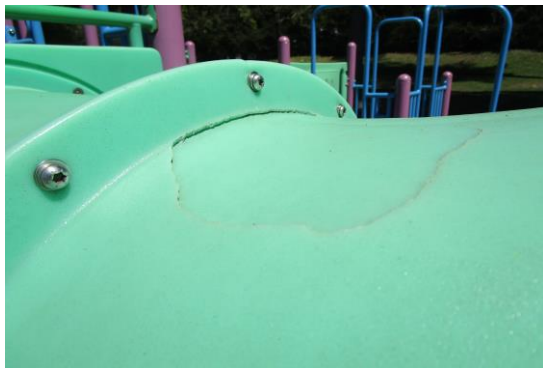
Tunnel Up Crawl Tube - Large cracks at top of one section - CLASS B HAZARD

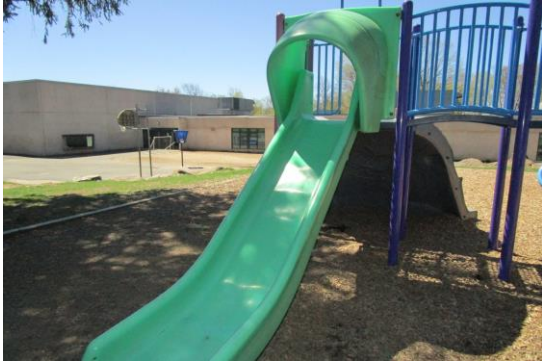
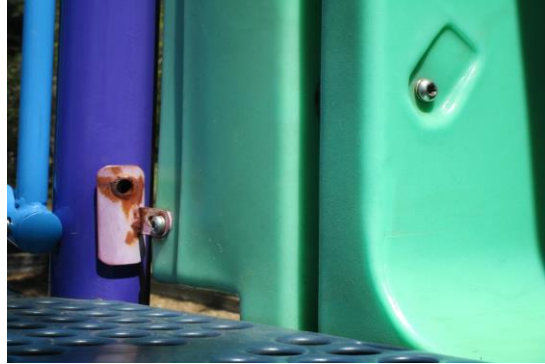
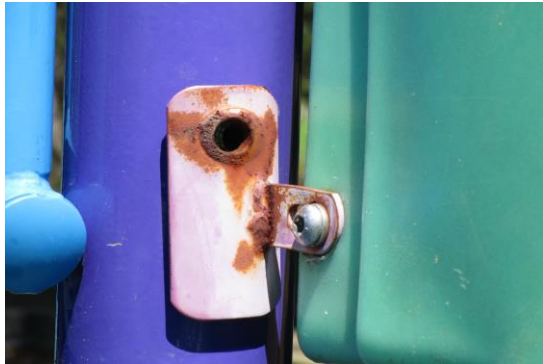
Slide with Tunnel - One bolt missing at bracket - MAINTENANCE

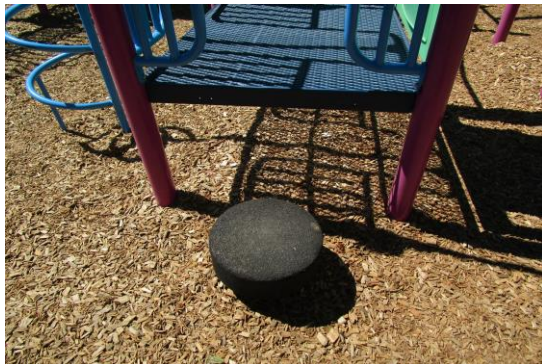
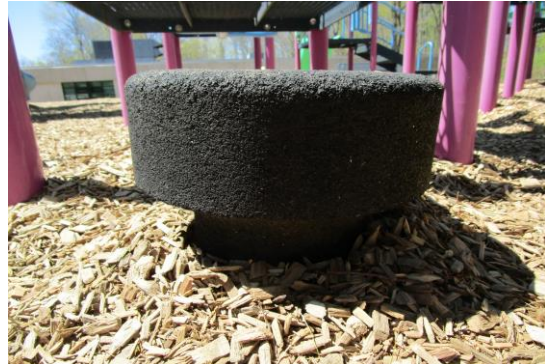
Toad Stool Climber (1) - Loose in footing - MAINTENANCE

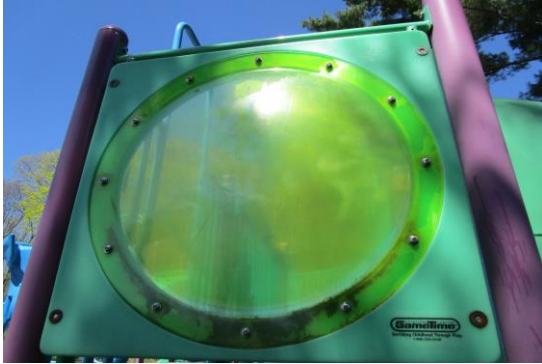
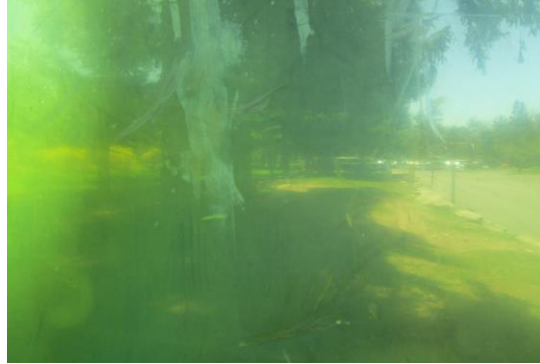
Bubble Panel - Small gauges - MAINTENANCE

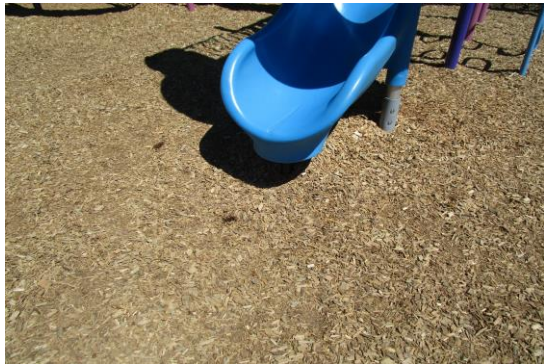
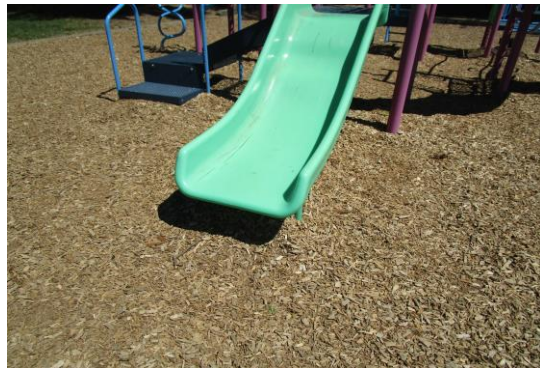
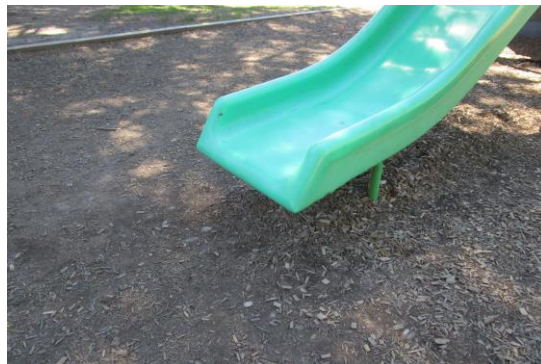
There are no wear mats at the slide exits. ADA requires wear mats for accessibility and the prevention of holes at the slide exits.

Surfacing - No wear mats at slide exits - CLASS C HAZARD

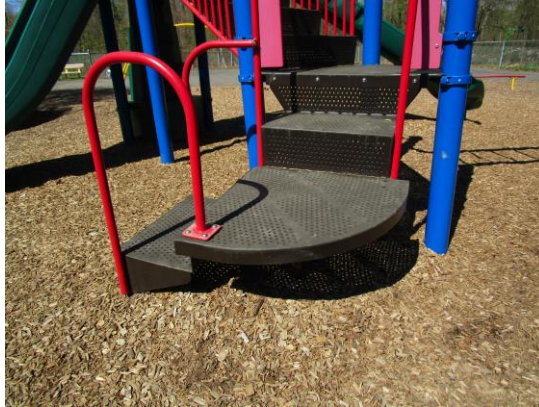
**Metal Composite Structure (Landscape Structures)
Transfer Platform - Deck not level - MAINTENANCE**

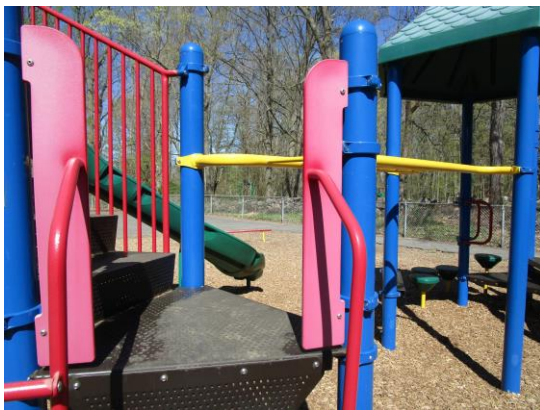
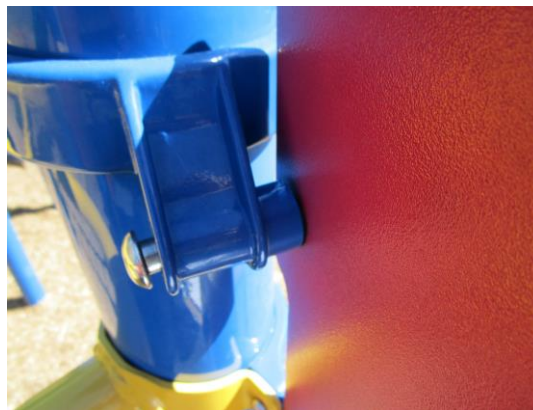
Transfer Platform - Handhold plate loose - MAINTENANCE

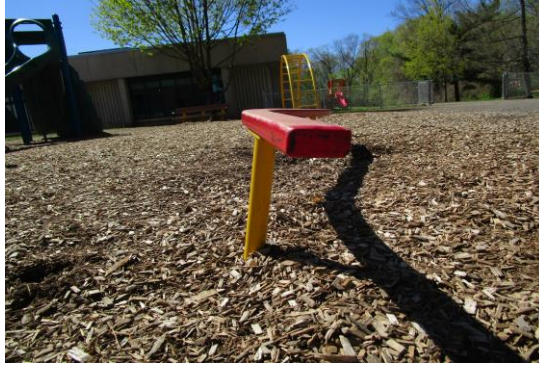
Curved Balance Beam (Landscape) - Post is bent - MAINTENANCE

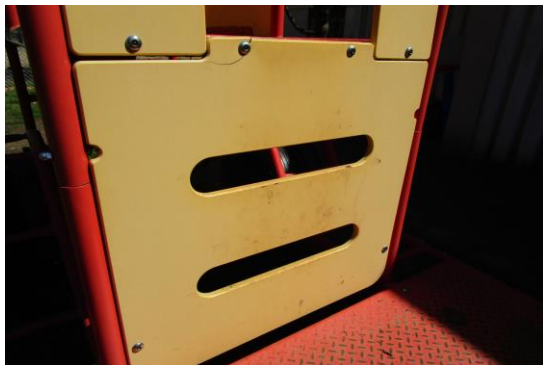
Fire Truck Climber (Unknown) - Crack at bolt of rung access panel - MAINTENANCE

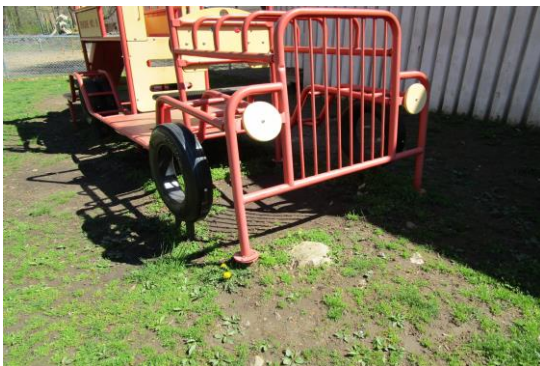
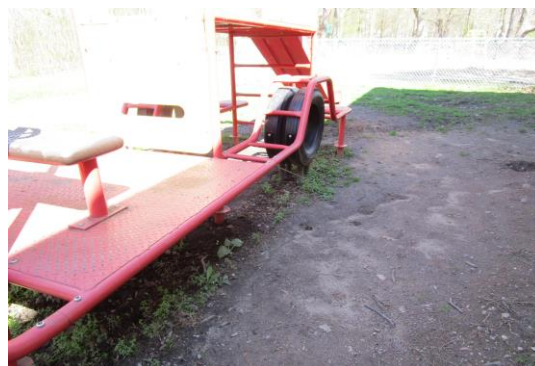
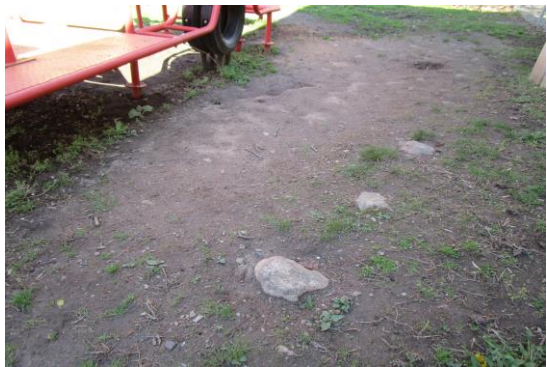
Surfacing - Insufficient, & rocks in surfacing - CLASS A HAZARD

*** This climber should not be used until surfacing installed ***

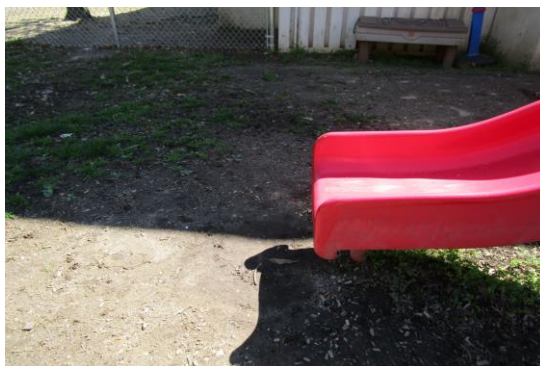
There are no wear mats at the slide exits. ADA requires wear mats for accessibility and the prevention of holes at the slide exits.

Surfacing - No wear mat at slide exit - CLASS C HAZARD

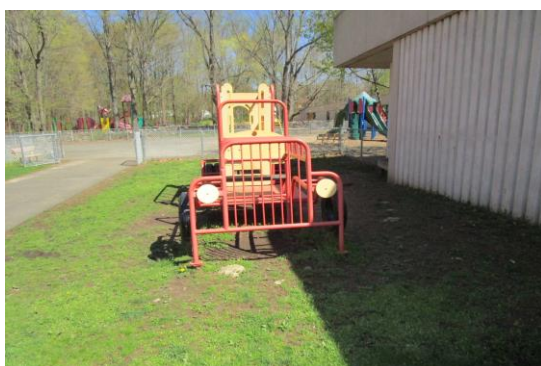
Use Zone - Inadequate, no clear use zone - CLASS A HAZARD

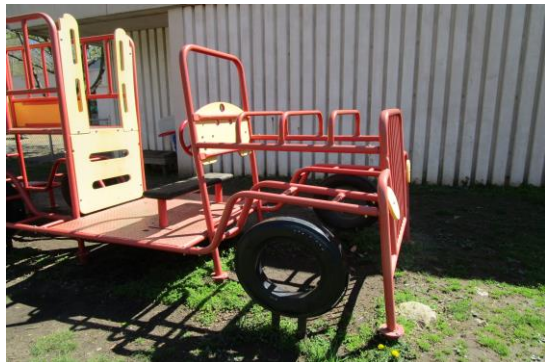
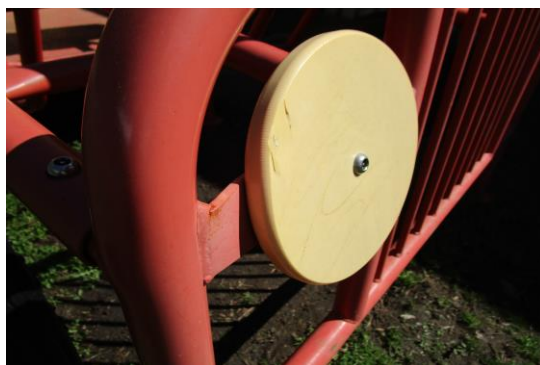
**Structure Stability - Unit leaning slightly & one headlight & support bent -
MAINTENANCE**

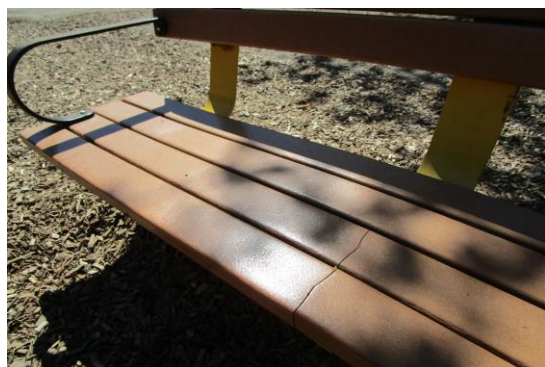
Site Amenities - Cracks in bench seats - MAINTENANCE

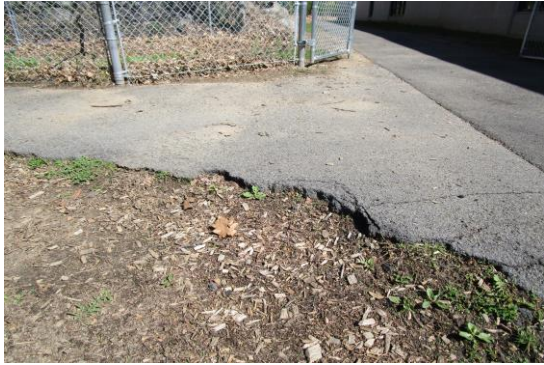
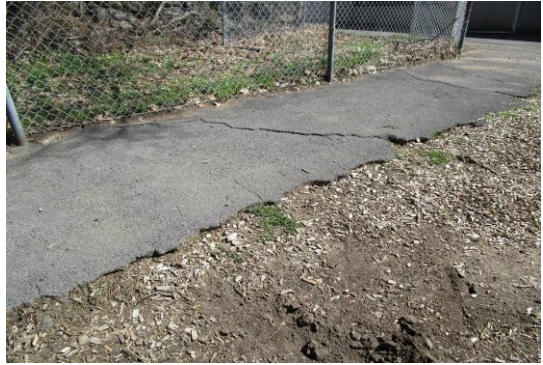
Border/Edging - Asphalt cracked & uneven - MAINTENANCE

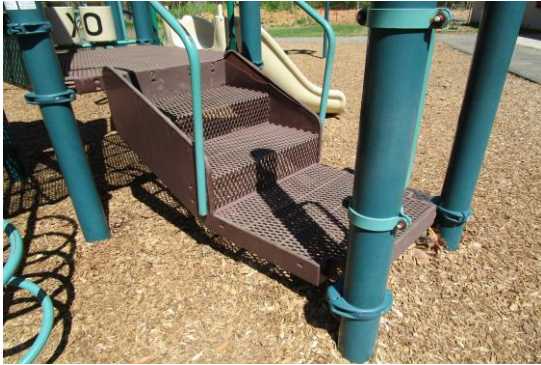
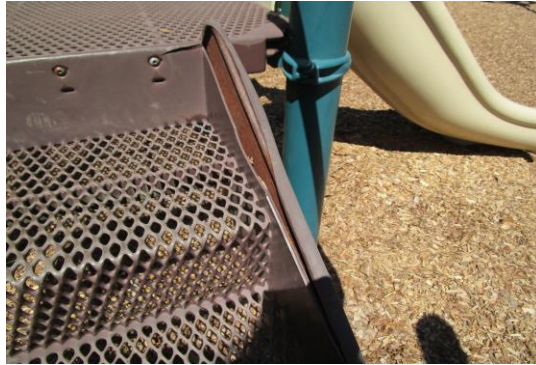
**Small Composite Structure (Playworld Systems)
Transfer Platform - Plastisol torn off at stairs - MAINTENANCE**

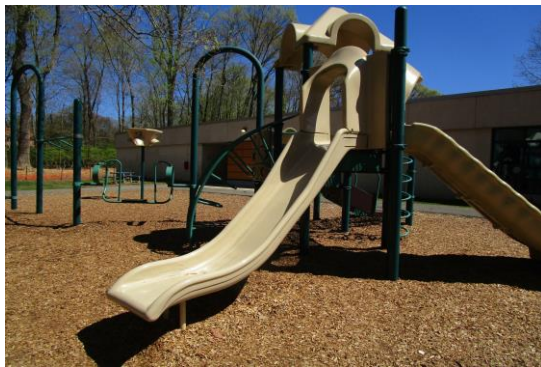
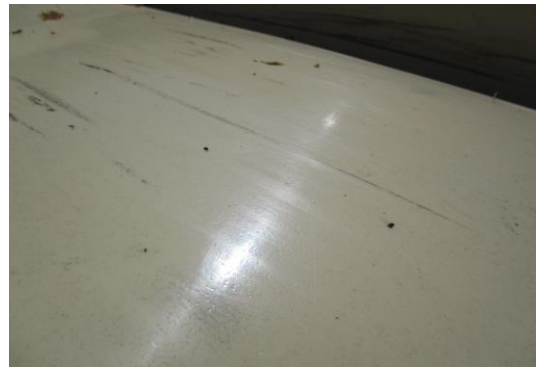
Long Glide Slide - Small cracks in bed way - MAINTENANCE

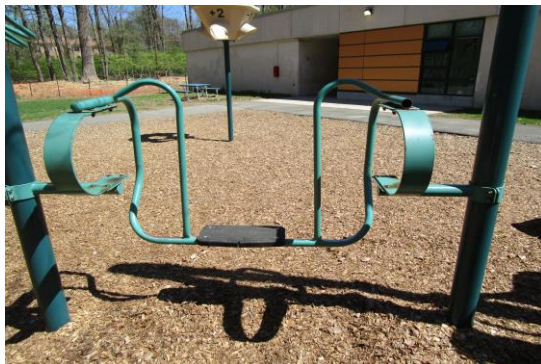
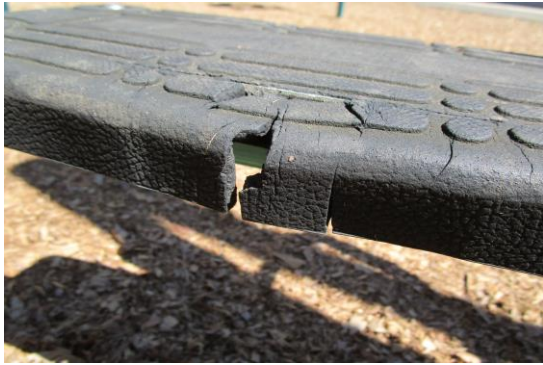
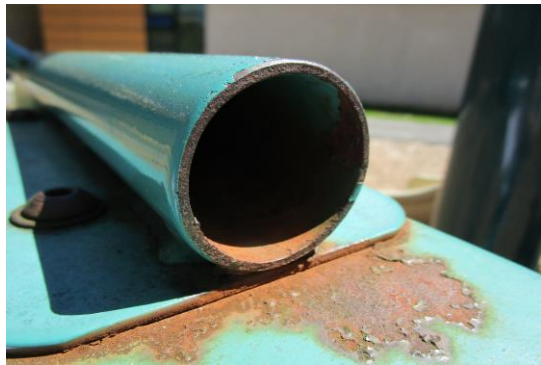
U Bounce - Rubber step worn & one pipe cap missing - MAINTENANCE

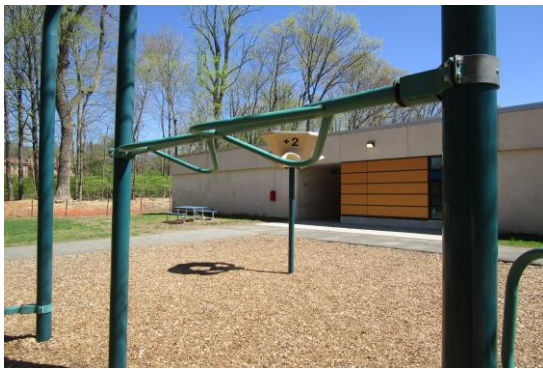
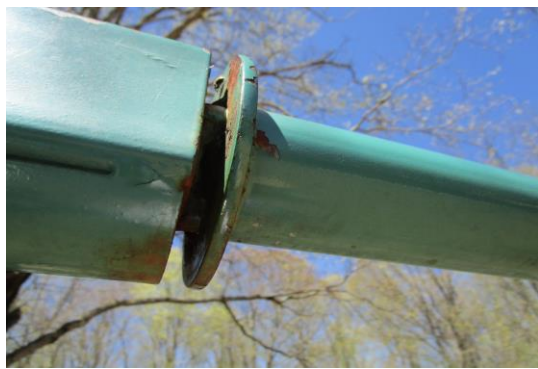
Sky Rocker - Very tight - MAINTENANCE

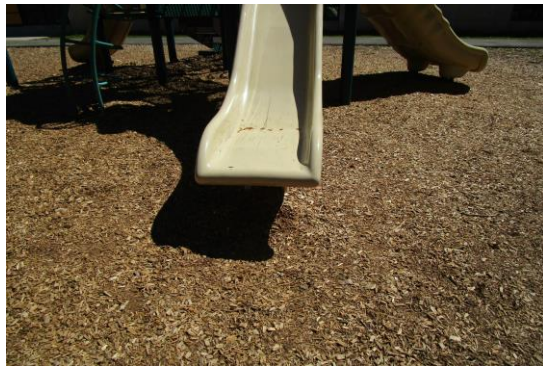
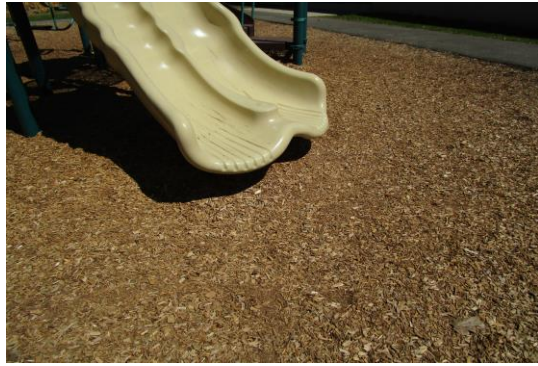
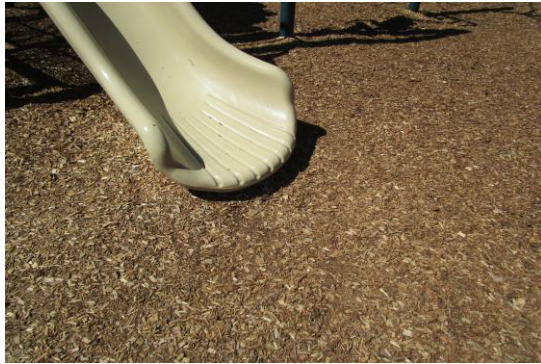
Surfacing - No wear mats at slide exits - CLASS C HAZARD

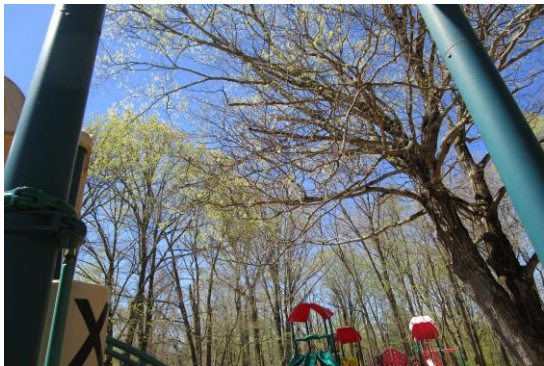
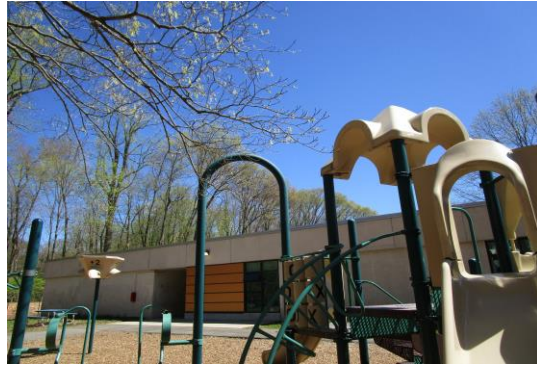
Use Zone - Overhanging branches - MAINTENANCE

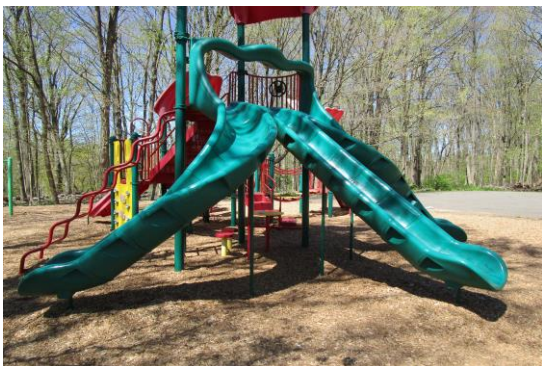
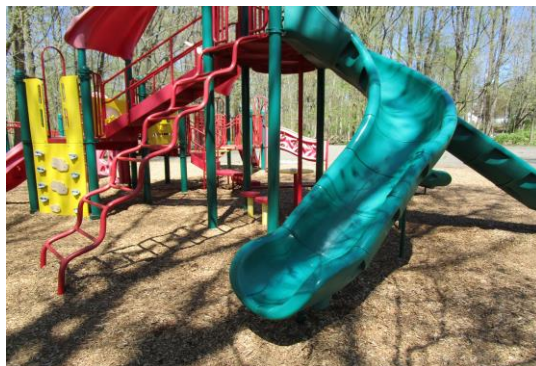
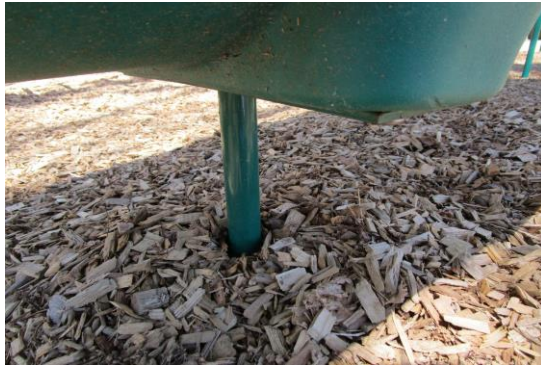
Triple Avalanche Slide - One slide loose at bottom footing - MAINTENANCE

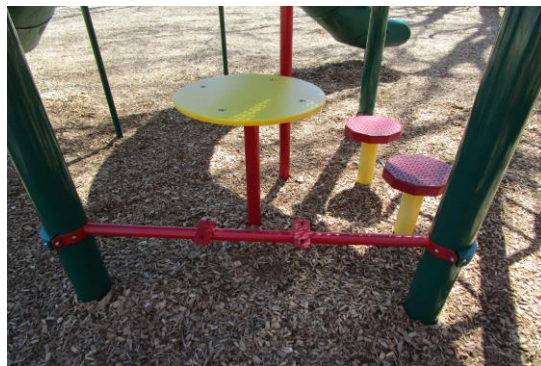
Table w/ Two Seats & One Bench - One missing bench - MAINTENANCE

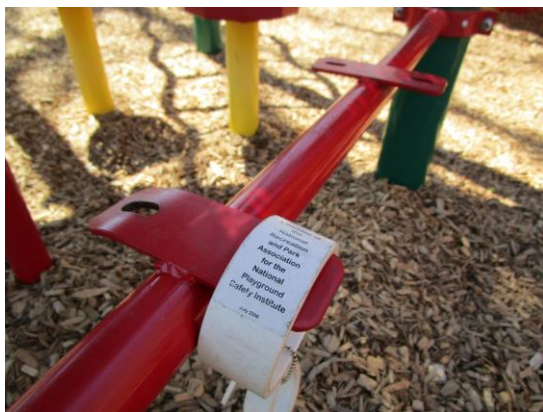
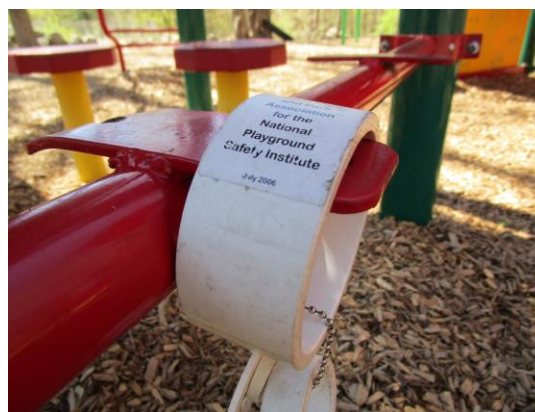
**Table w/ Two Seats & One Bench - Four protrusions at missing bench brackets -
CLASS A HAZARD**

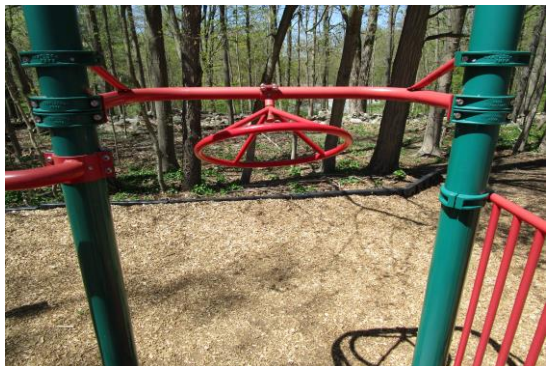
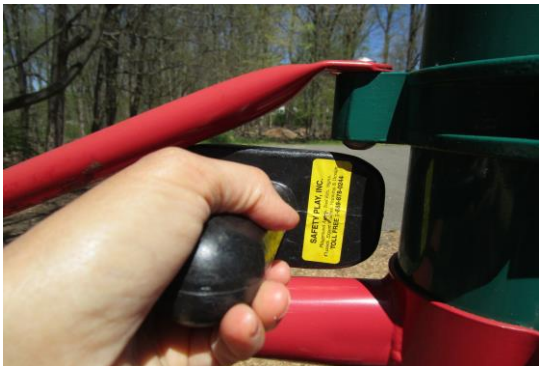
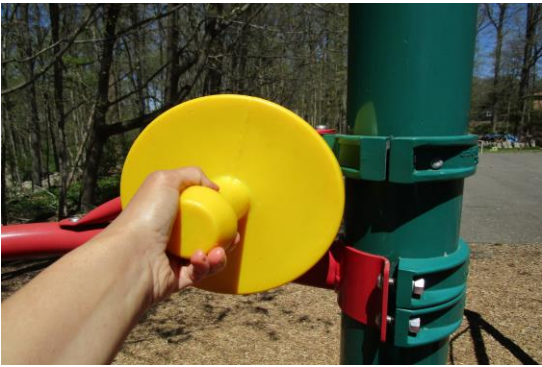
Wild Swinger - Head entrapment at side brackets - CLASS A HAZARD

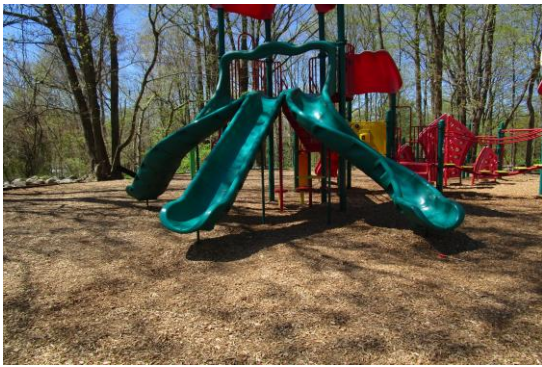
Surfacing - No wear mats at slide exits - CLASS C HAZARD

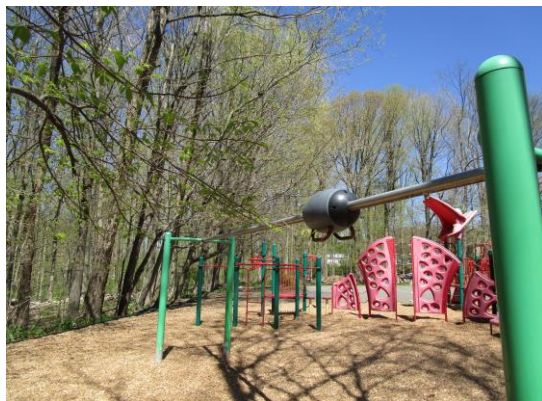
Space Shuttle (GameTime) - Overhanging branches - MAINTENANCE

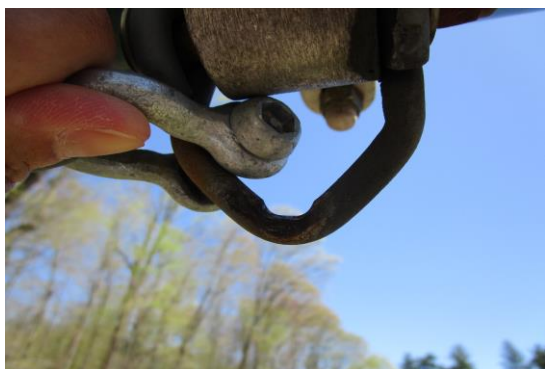
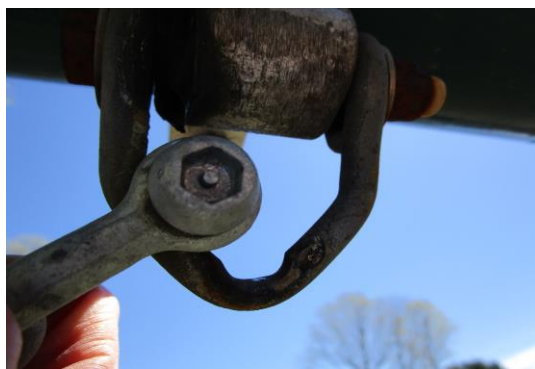
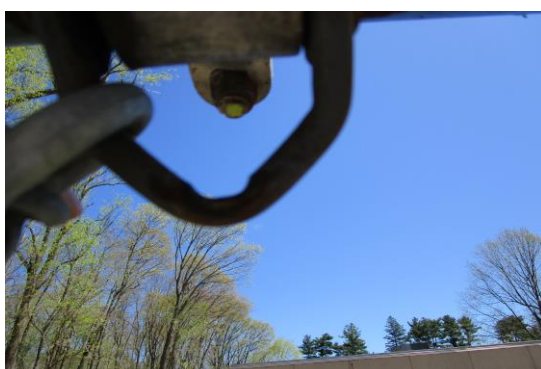
8ft. Swing Set (2Bay/4Belt)(Playworld)- Eight swing hangers worn - CLASS A HAZARD

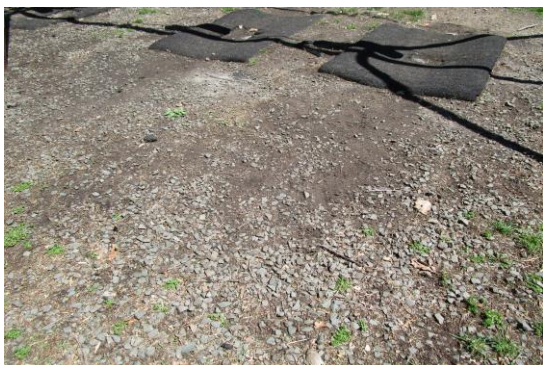
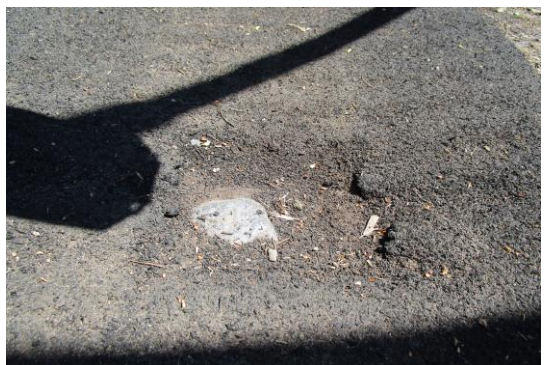
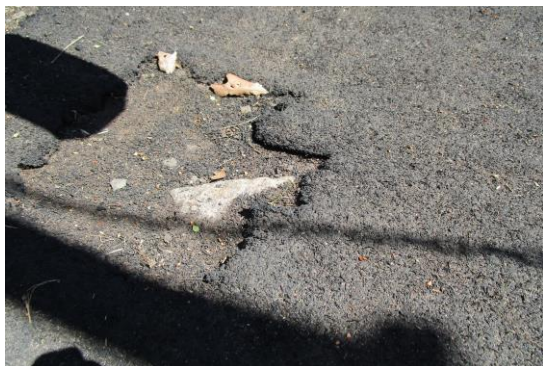
Surfacing - None, gravel & rocks below swings- CLASS A HAZARD

Swings should not be used until surfacing is installed

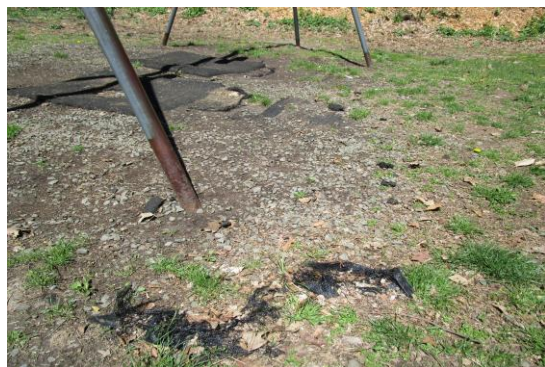
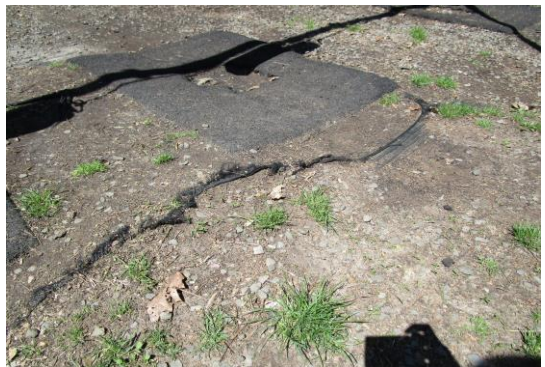
Surfacing - Fabric exposed, tripping hazard - CLASS B HAZARD

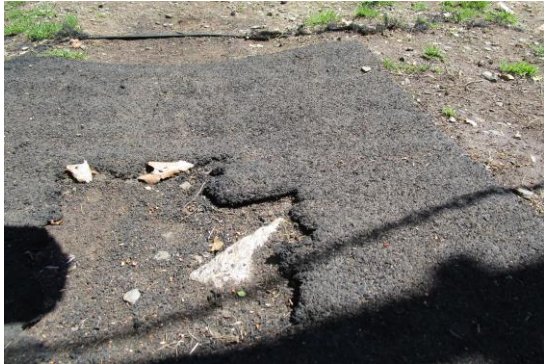
Surfacing - Four wear mats broken, tripping hazard - CLASS B HAZARD

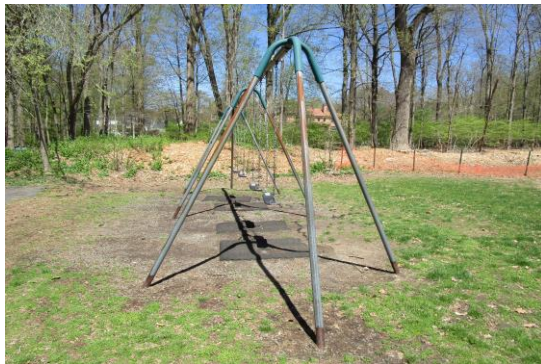
Use Zone - Inadequate, no clear use zone - CLASS A HAZARD
