PLAYGROUND SAFETY INSPECTION REPORT

DATE: September 27, 2019

SITE: Kosciuzko Park (Elmcroft/Westover)
1 Elmcroft Road
Stamford, CT 06902

DATE OF INSPECTION: September 20, 2019

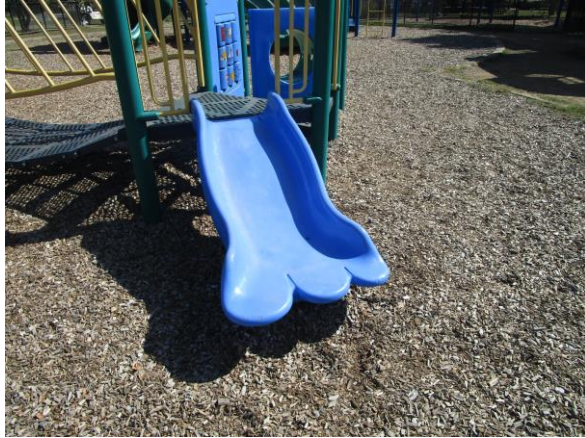
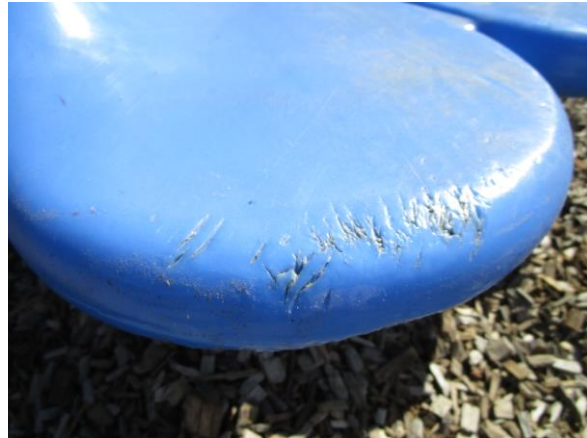
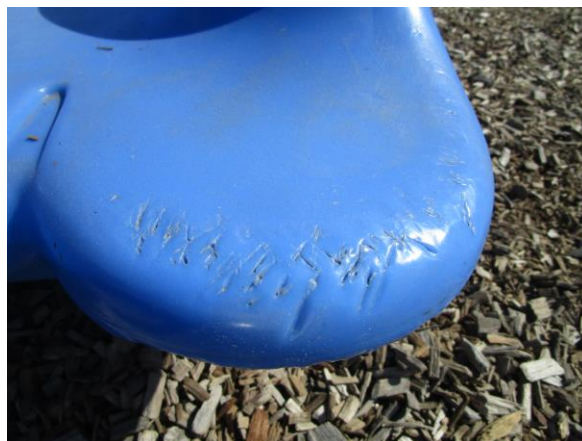
Condition	Hazard Priority	Recommendation
Small Metal Composite Structure #1(GameTime)				
Components				
Accessible Stairs (1)		Good		
Decks (9)		Good		
Roof (1)		Good		
Pipe Barriers		Good		
Zoo Panel		Good		
Suspension Bridge		Good		
Little Foot Slide		Bed way has gouges from animal bites	Maint	Monitor
Shapes Panel		Good		
Crawl Tube		Cracked at two bolts	Maint.	Monitor
Curved Slide		Good		
Rung Ladder		Good		
Clover Climber		Good		
Slide & Glide Slide		Good		
Storefront (below)		Good		
Surfacing	EWF 9-12"	Good		
		Wear mats at Little Foot Slide buried too deep	Maint.	Raise & level mats
Use Zone		Good		
Structural Stability		Good		
Large Metal Composite Structure #2(GameTime)				
Components				
Transfer Platform		Good		
Decks (5)		Good		
Stairs (1)		Good		
Roofs (1)		Good		
Pipe Barriers		Good		
Trapeze Rings (4)		Good		
Rung Ladder (3)		Good		
Arch Bridge w/ Barriers		Good		
Toad Stool (1)		Good		
"S" Horizontal Loop		Good

Little Foot Slide - Bed way has gouges from animal bites - MAINTENANCE

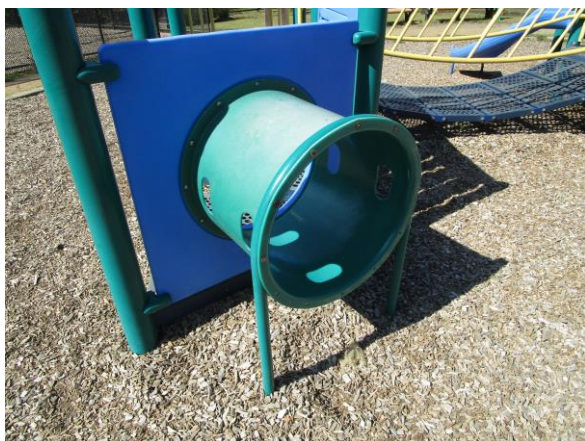
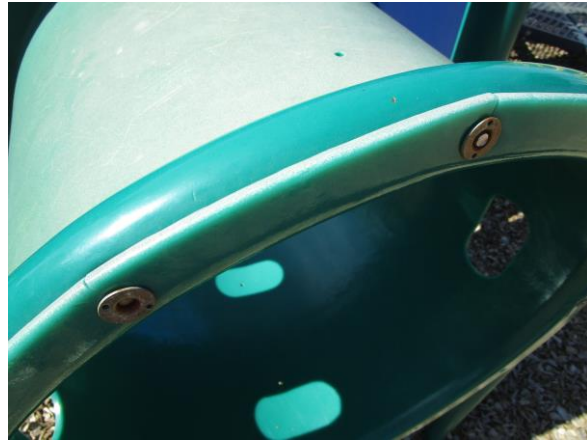
Crawl Tube - Cracked at two bolts - MAINTENANCE

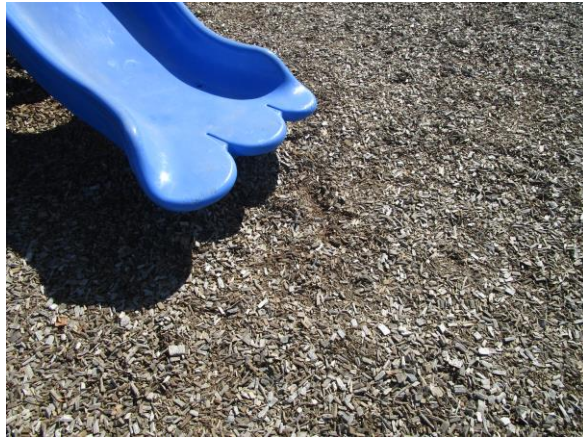
Surfacing - Wear mats at Little Foot Slide buried too deep - MAINTENANCE

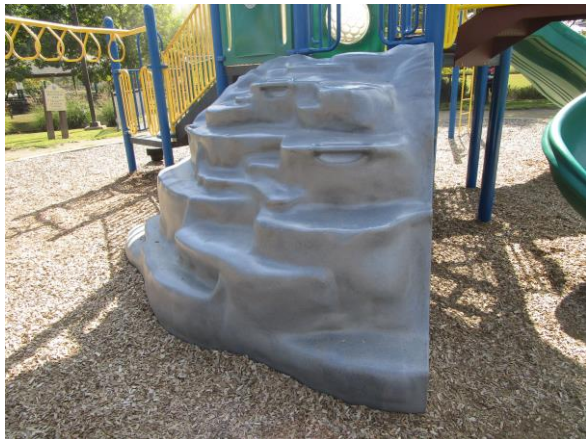
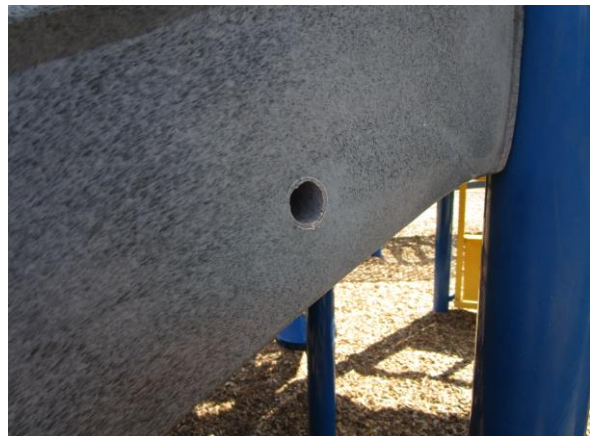
**Large Metal Composite Structure #2 (GameTime)
Mega Rock Climber - One bolt cap missing - MAINTENANCE**

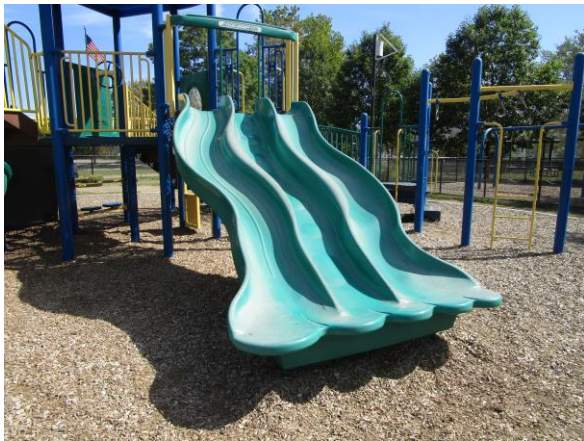
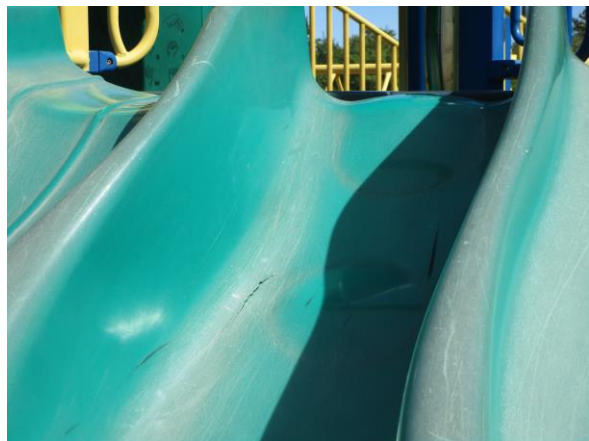
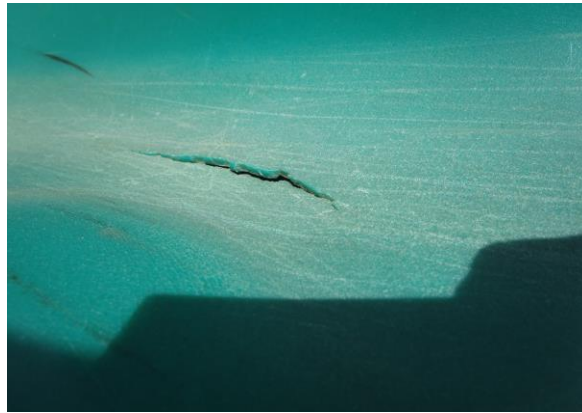
Big Foot Slide - Large crack in center of bed way - MAINTENANCE

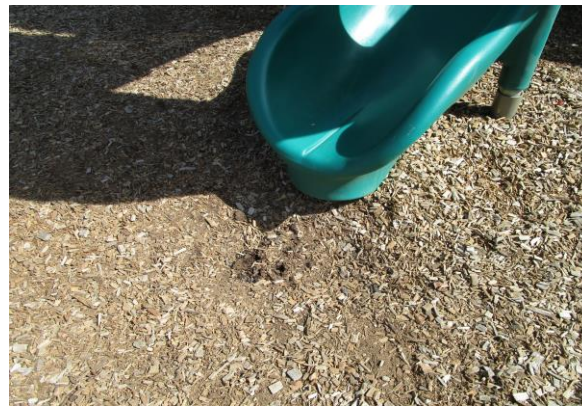
There are no wear mats at the slide exits. ADA requires wear mats for accessibility and the prevention of holes at the slide exits.

Surfacing - No wear mat at Spiral Slide exit - CLASS C HAZARD

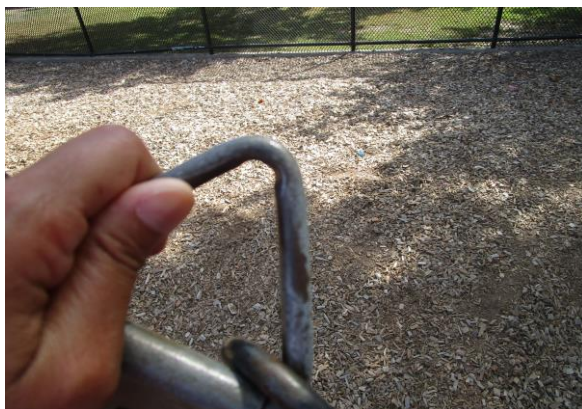
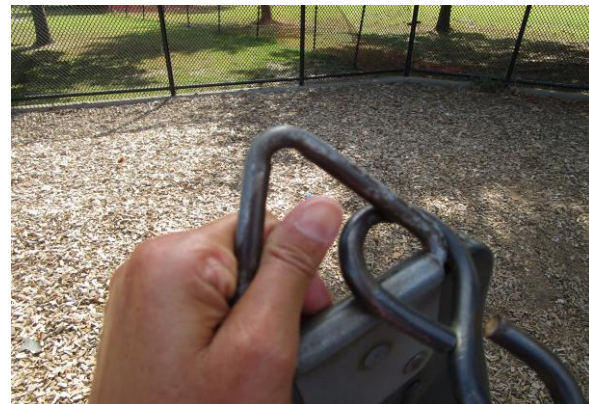
8ft. Swing Set #2 (2Bay/4Belts) (GameTime) - Four belt seats starting to show wear - MAINTENANCE

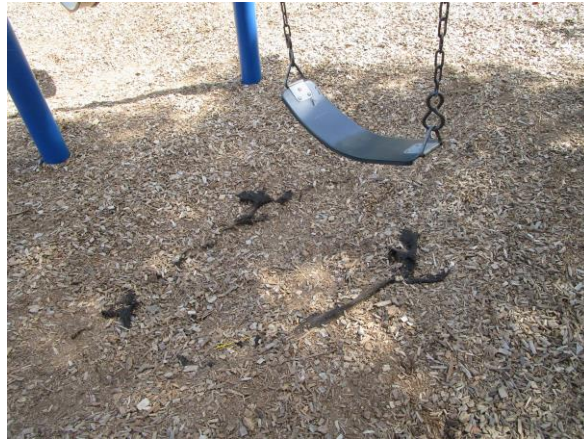
There are no wear mats under the swing seats. ADA requires wear mats for accessibility and the prevention of "holes" under the swings.

Surfacing - One wear mat missing - CLASS C HAZARD

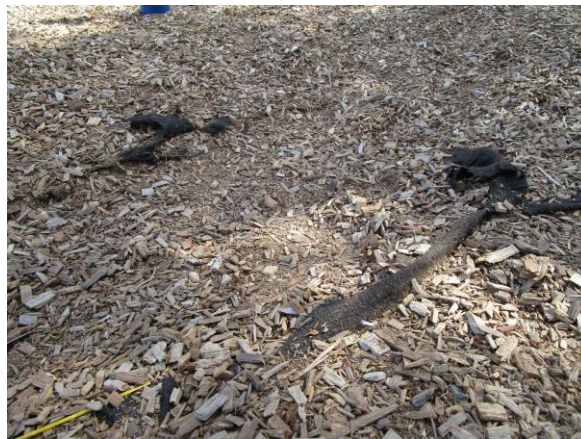
Surfacing - Exposed fabric, tripping hazard - CLASS B HAZARD

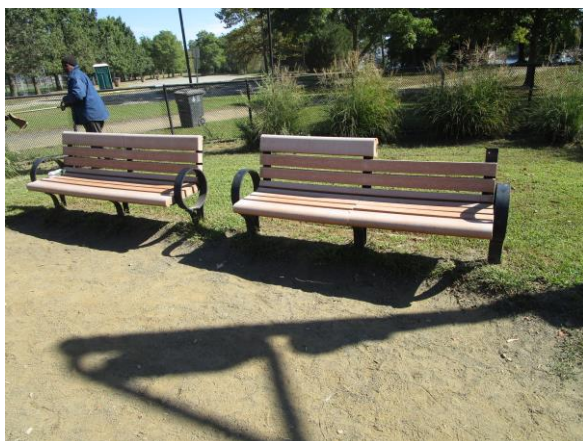
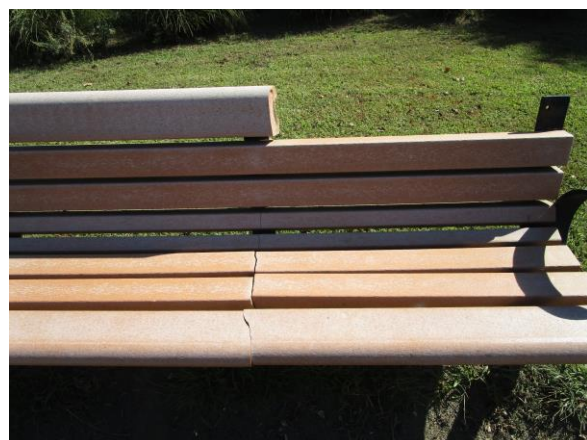
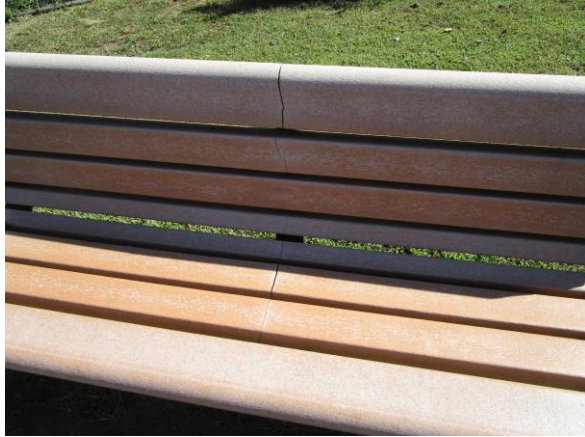
Site Amenities - Two benches damaged - MAINTENANCE

Site Amenities	Two benches damaged	Maint.	Repair or replace two benches
-----------------------	---------------------	--------	-------------------------------
