PLAYGROUND SAFETY INSPECTION REPORT

DATE: May 16, 2019

SITE: Northeast Elementary School
82 Scofieldtown Road
Stamford, CT

DATE OF INSPECTION: May 1, 2019

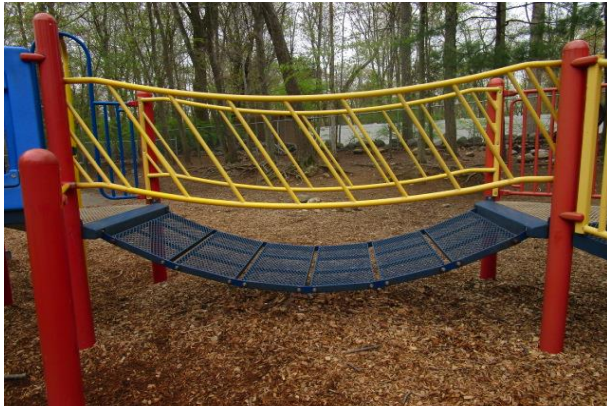
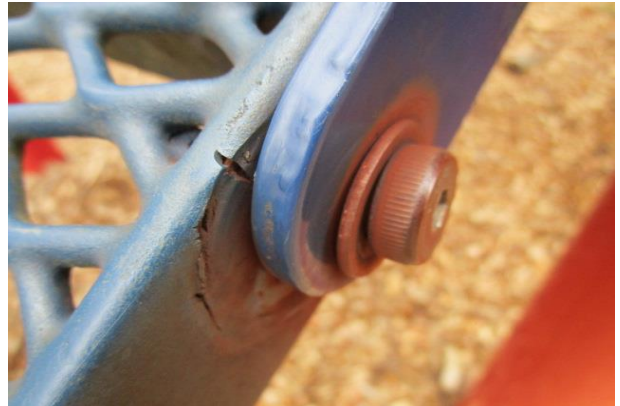
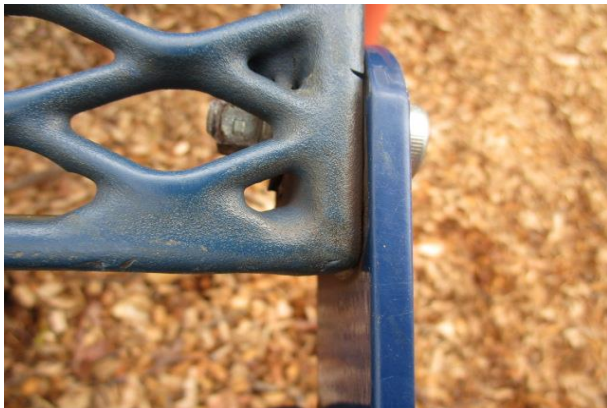
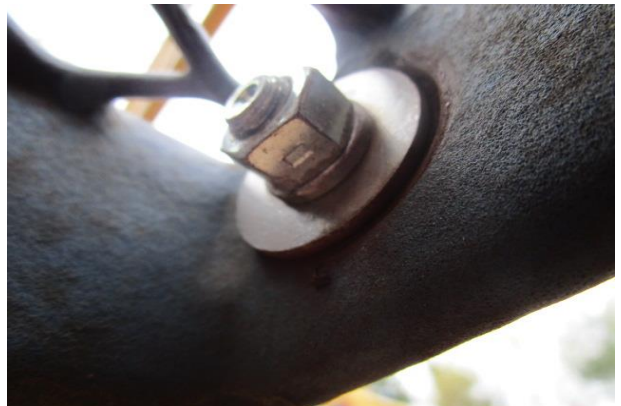
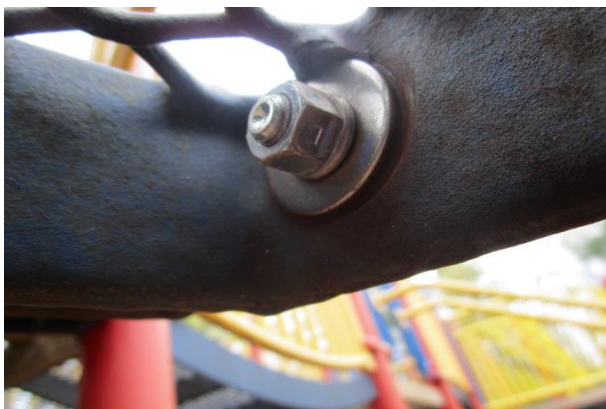
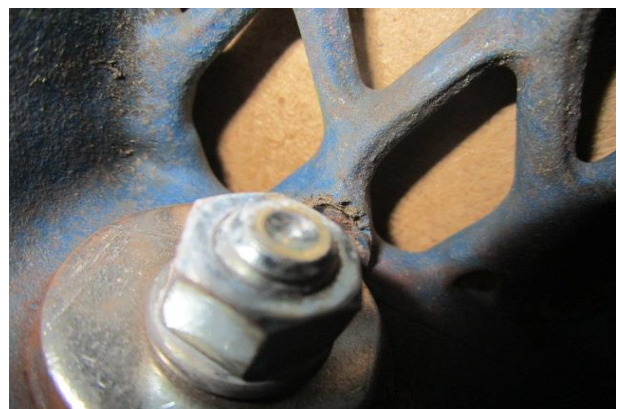
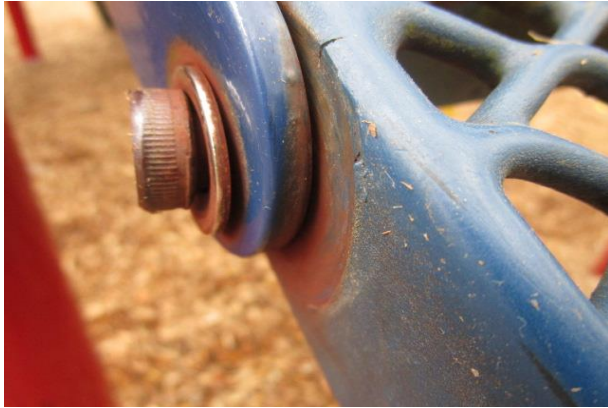
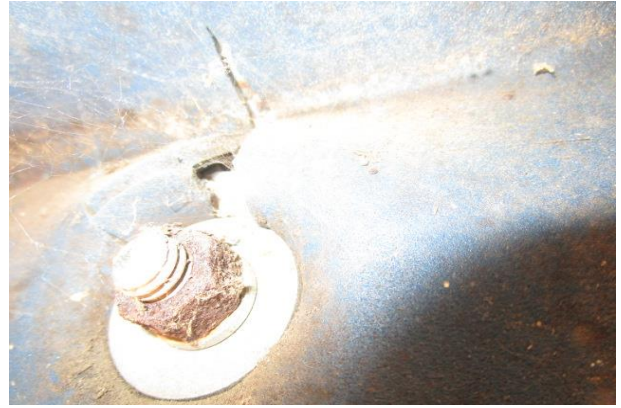
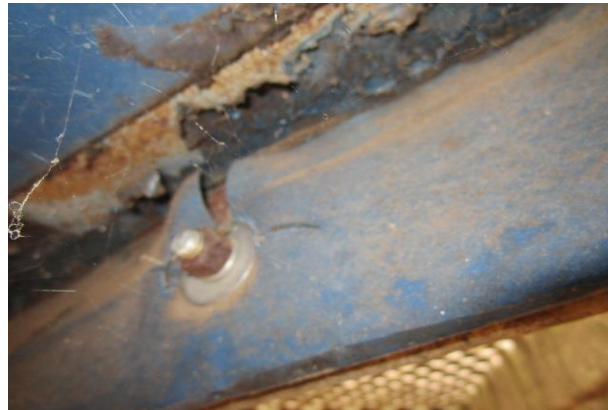
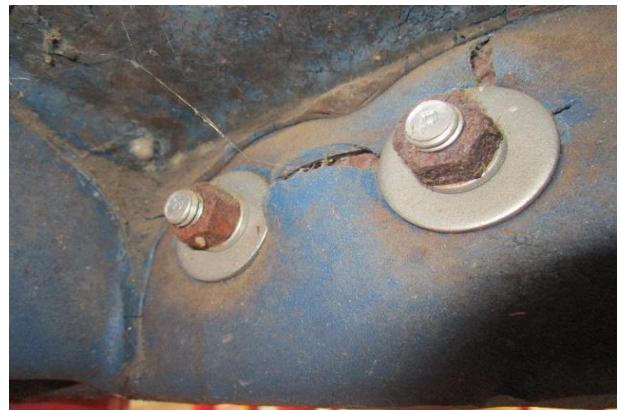
Large Composite Structure (GameTime)
Suspension Bridge - Bolts at boards bending/stretching steel & attachment plates -
CLASS B HAZARD

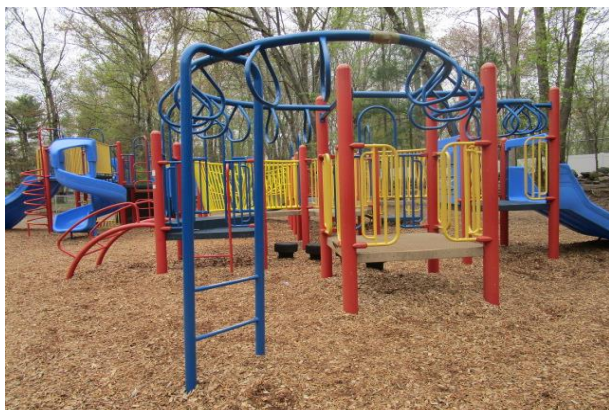
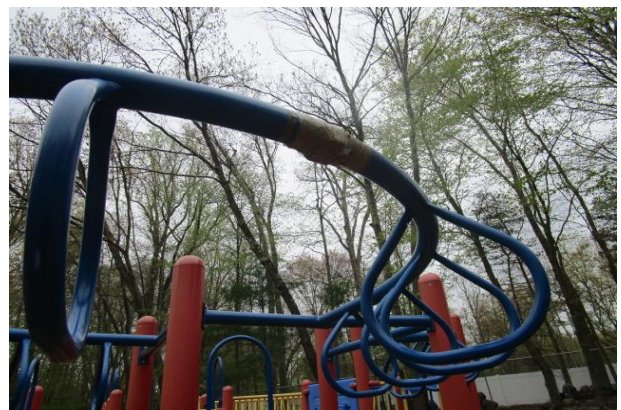
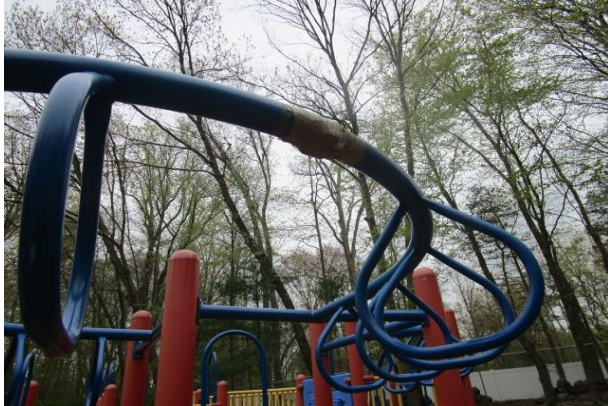
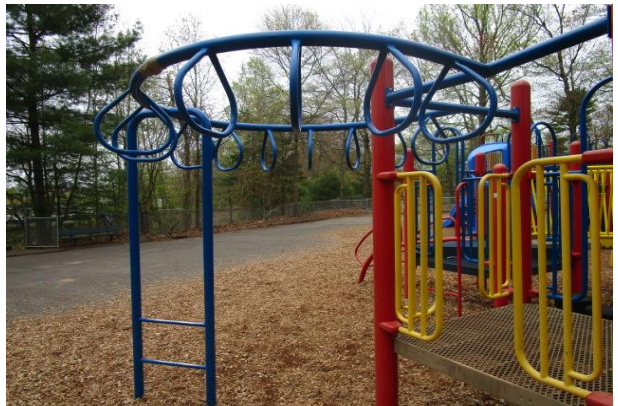
**270° Overhead Loop Ladder - Missing one loop, four handholds loose at deck -
CLASS B HAZARD**

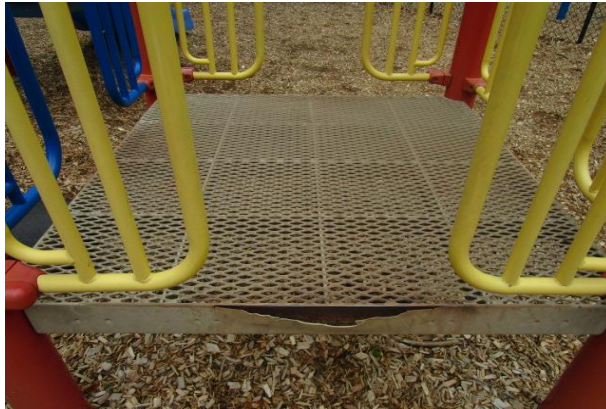
Decks (13) - Plastisol wearing at one deck - MAINTENANCE

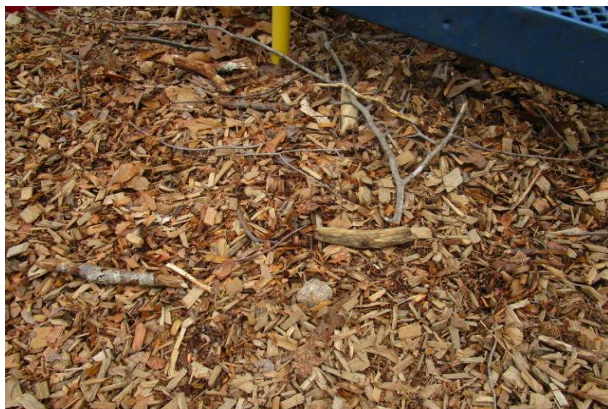
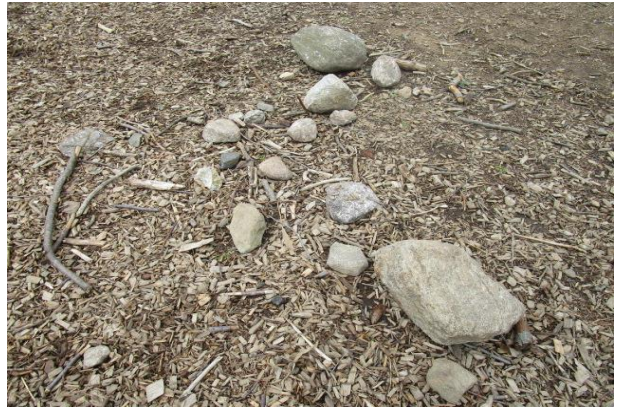
Surfacing - Rocks & debris in use zone - MAINTENANCE

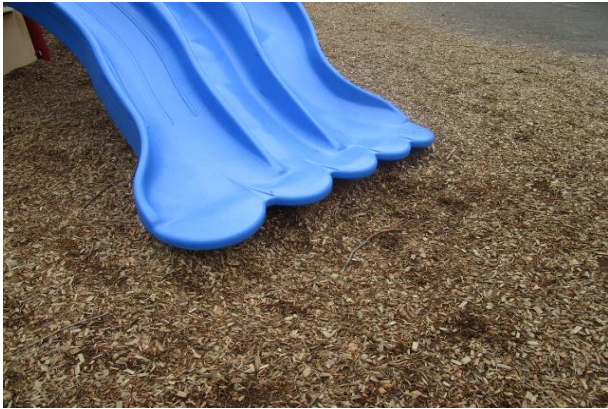
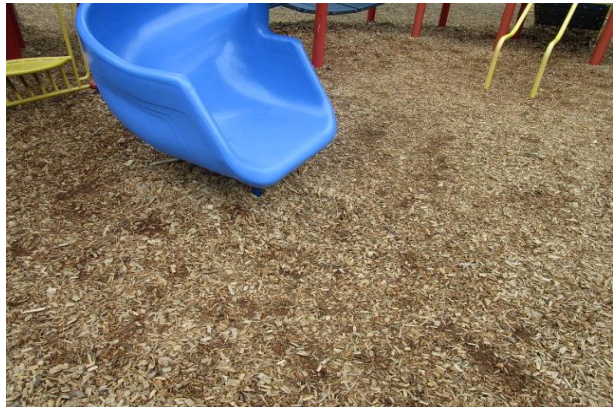
There are no wear mats at the slide exits. ADA requires wear mats for accessibility and the prevention of "holes".

Surfacing - No wear mats at slide exits - CLASS C HAZARD

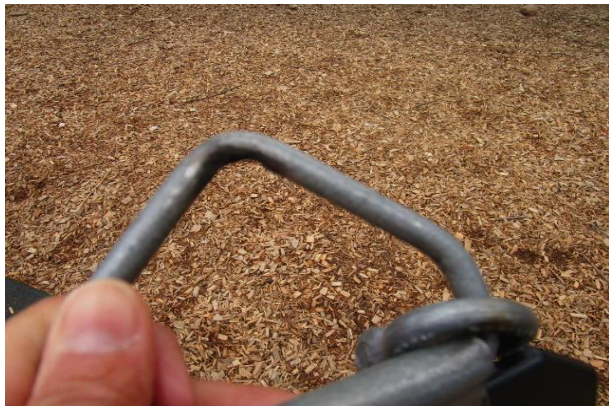
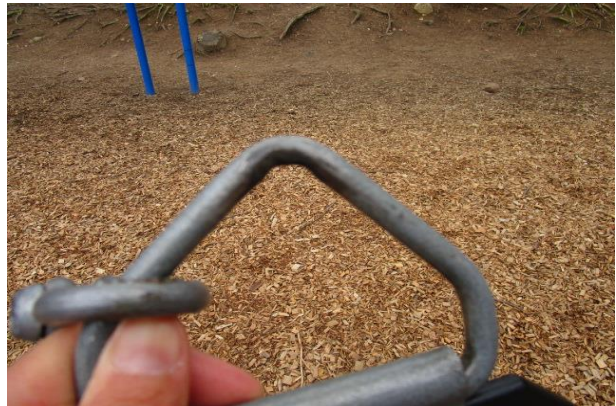
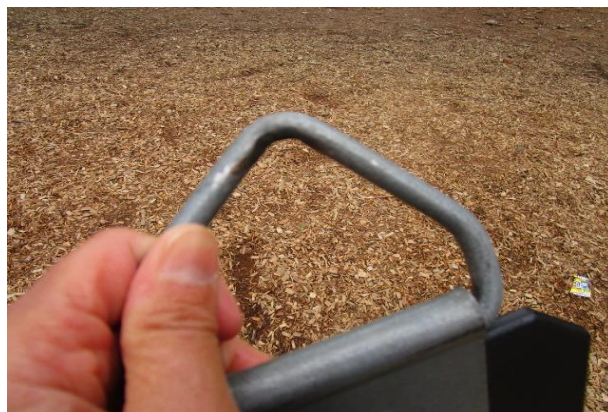
8ft. Swing Set (2Bay/4Belt) Four belt seats starting to show wear - MAINTENANCE

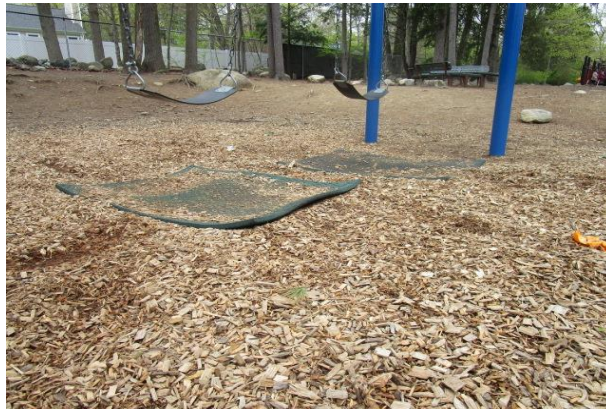
Surfacing - Exposed wear mats, tripping hazard - CLASS B HAZARD

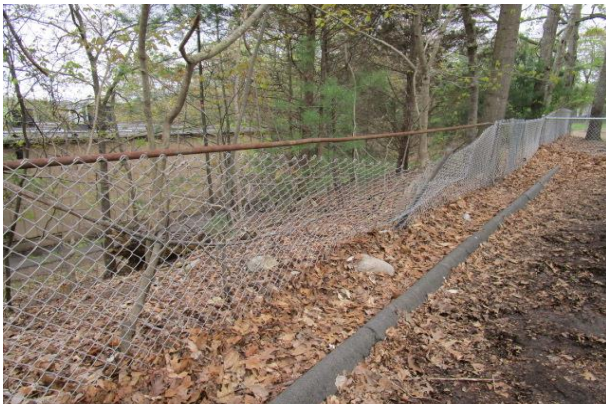
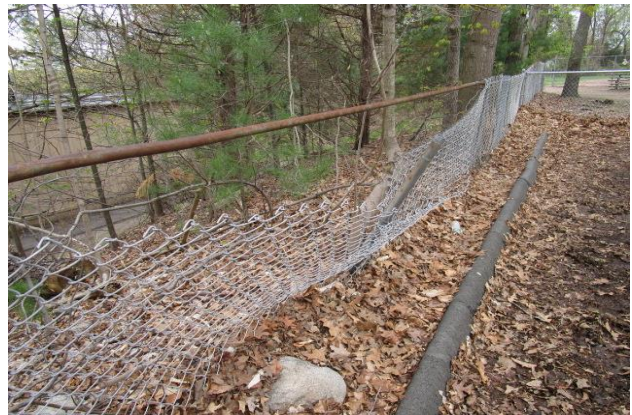
Fencing - One section of fence damaged - MAINTENANCE

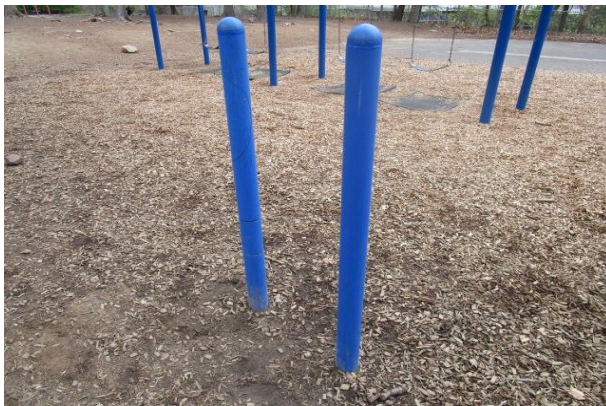
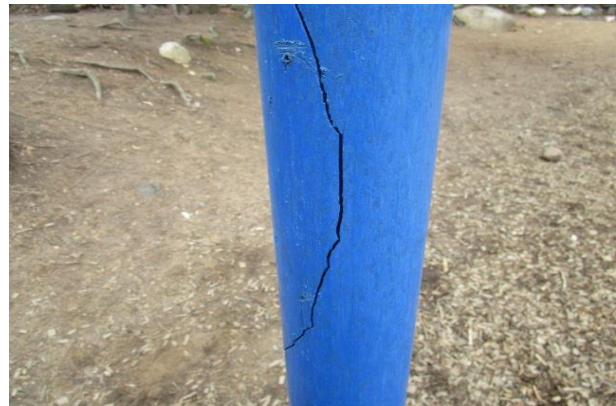
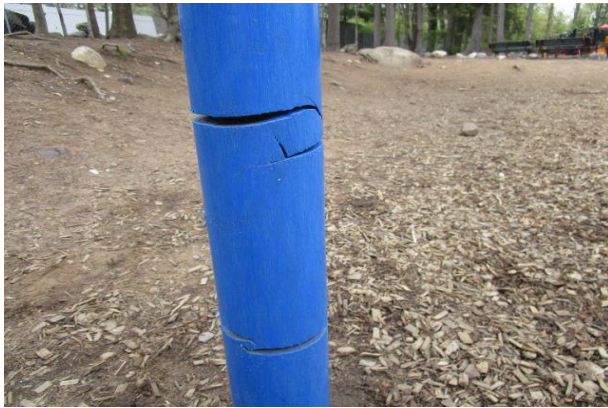
Playground Signs - Two old posts cracking - MAINTENANCE

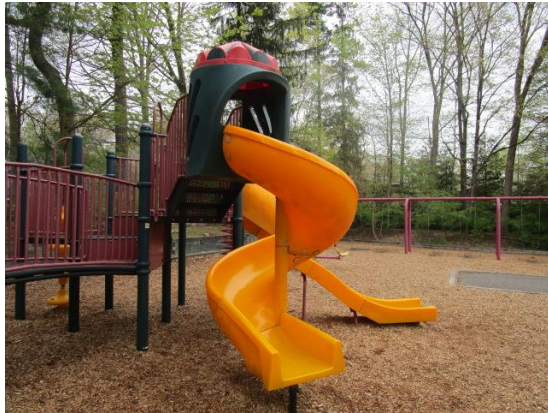
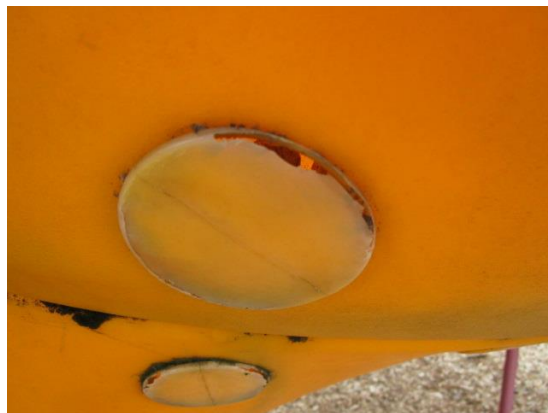
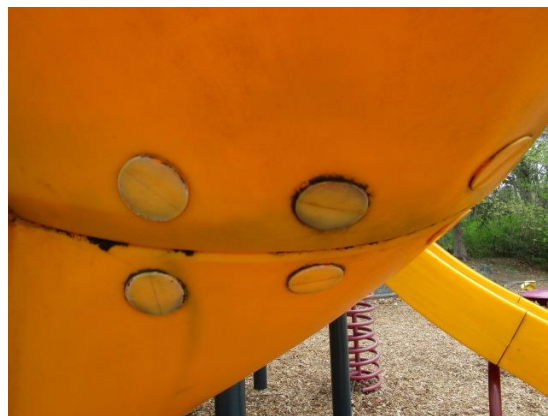
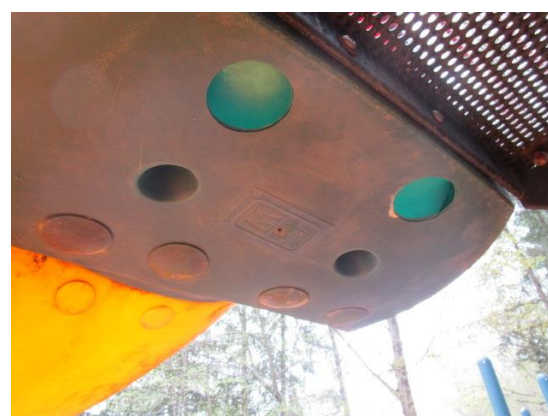
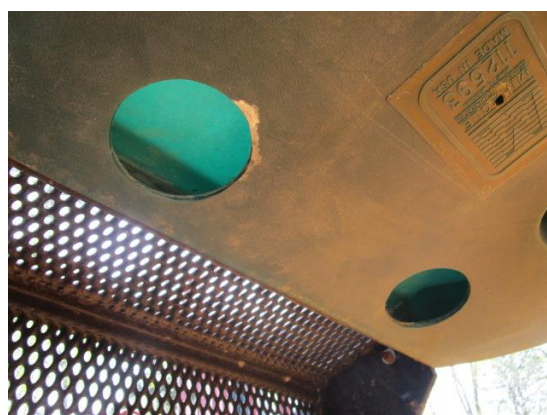
**Spiral Slide - Three cracked caps below bed way & two missing caps below hood -
MAINTENANCE**

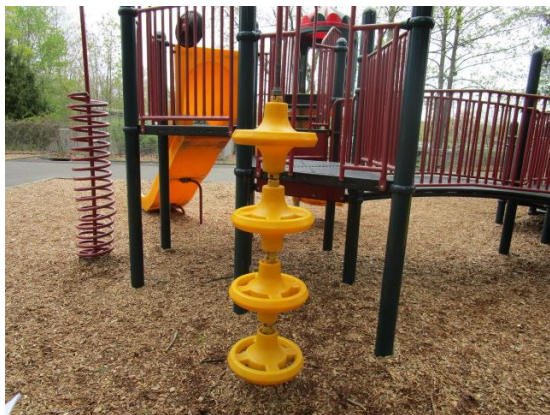
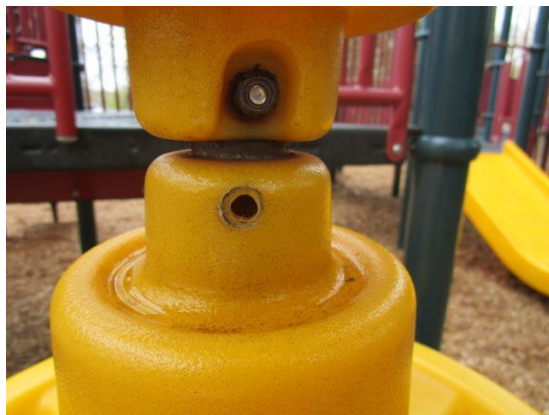
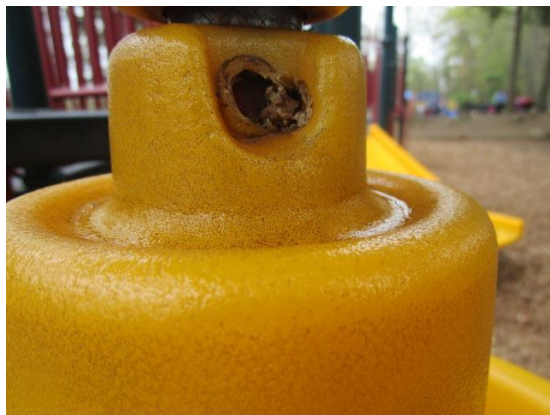
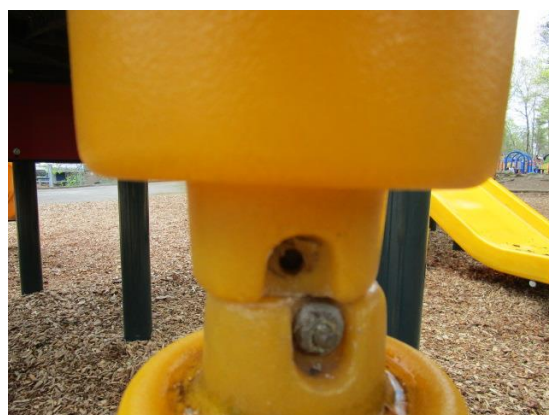
Bumper Ladder - Two bolts missing - MAINTENANCE

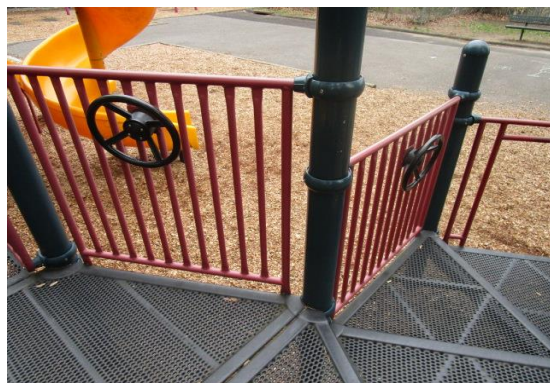
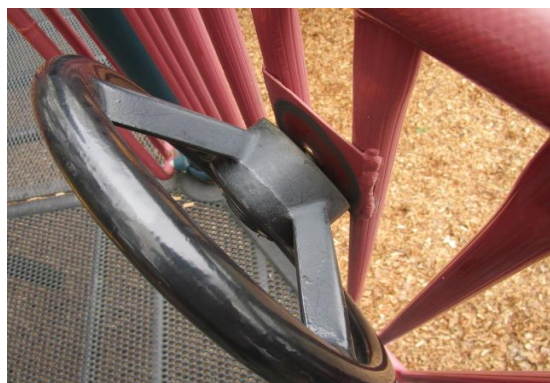
Steering Wheels - (3) - Three steering wheels loose - MAINTENANCE

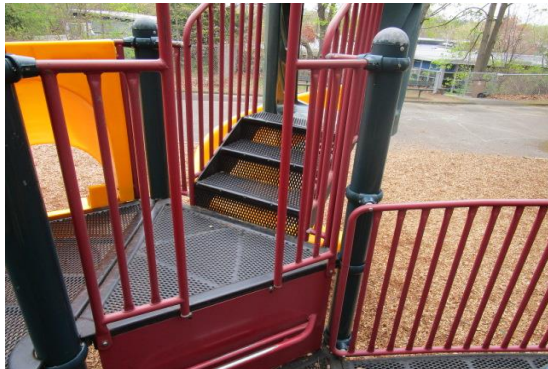
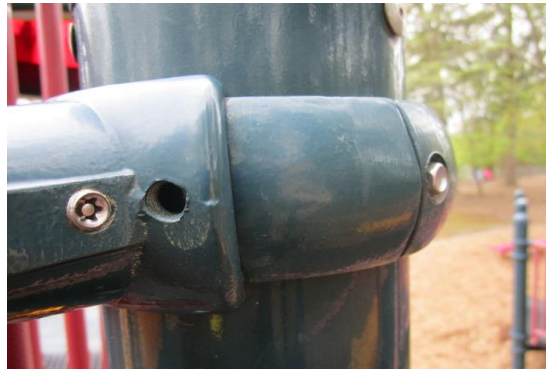
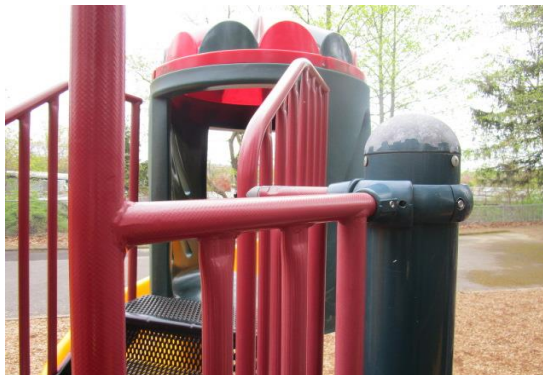
**Barrier Rails - One set screw missing at handhold near Spiral Slide Access step -
MAINTENANCE**

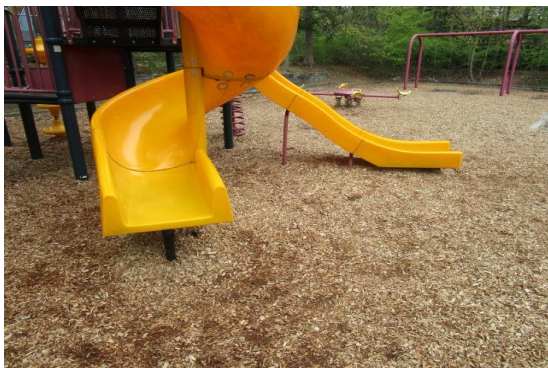
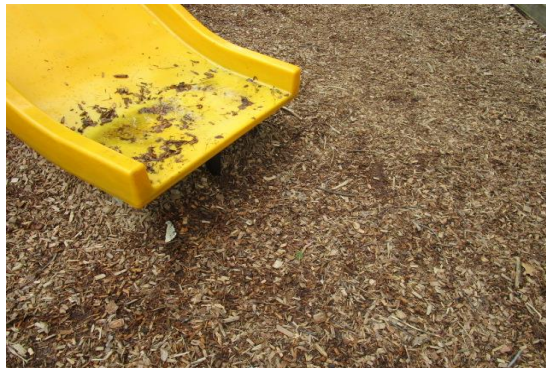
There are no wear mats at the slide exits. ADA requires wear mats for accessibility and the prevention of "holes".

Surfacing - No wear mats at slide exits - CLASS C HAZARD

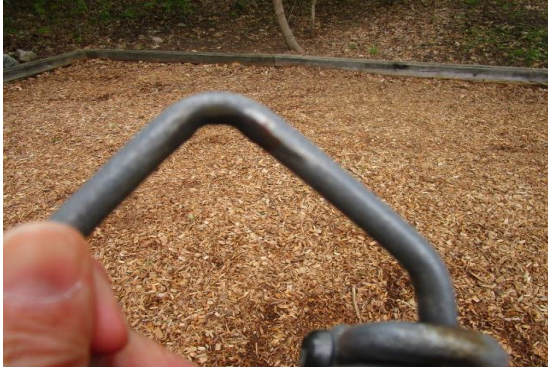
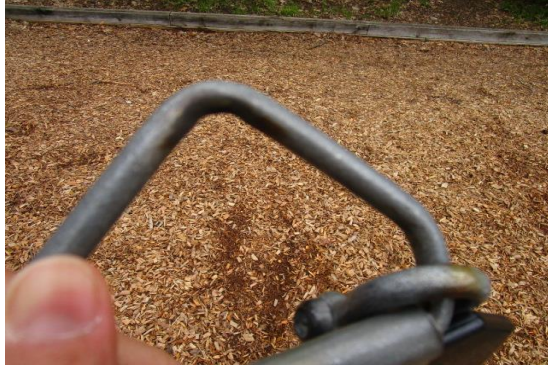
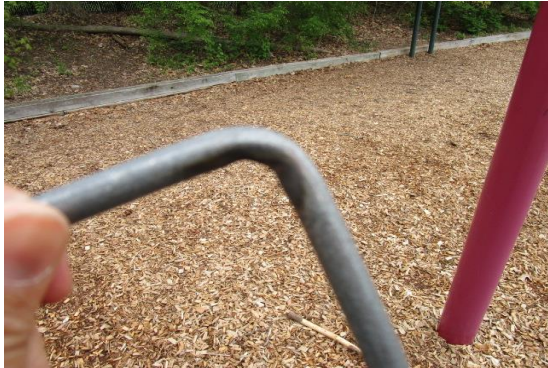
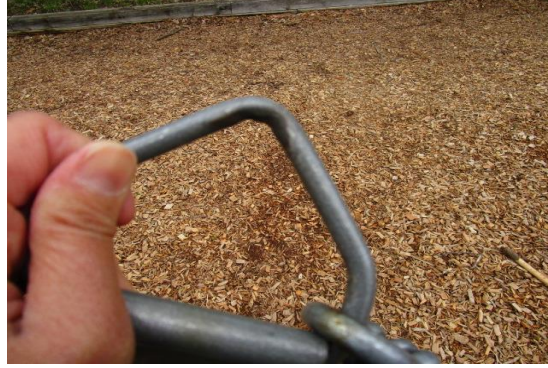
8ft. Swing Set (3Bay/6Belt)(GT) - Six belt seats starting to wear - MAINTENANCE

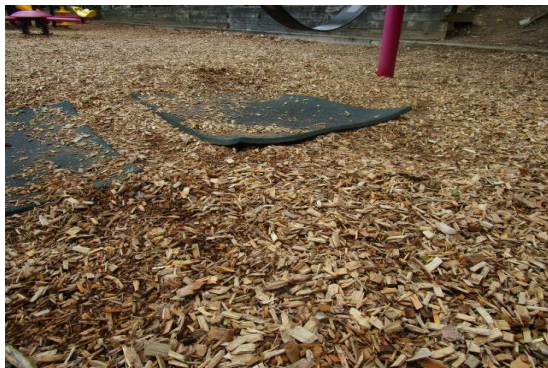
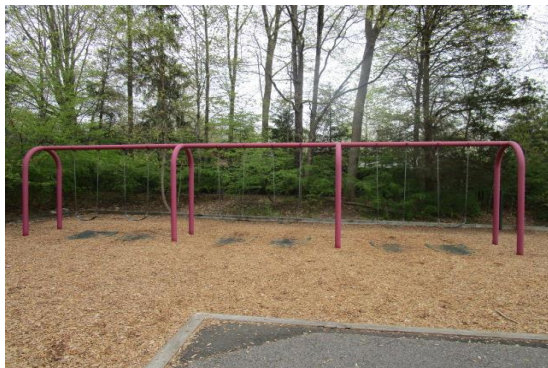
8ft. Swing Set (3Bay/Belts) - Exposed wear mats tripping hazard - CLASS B HAZARD

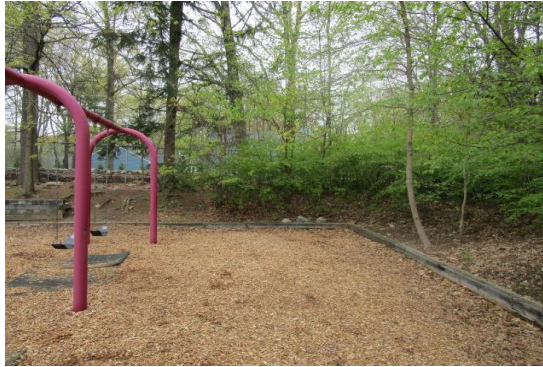
Use Zone - Overhanging branches in rear use zone - MAINTENANCE

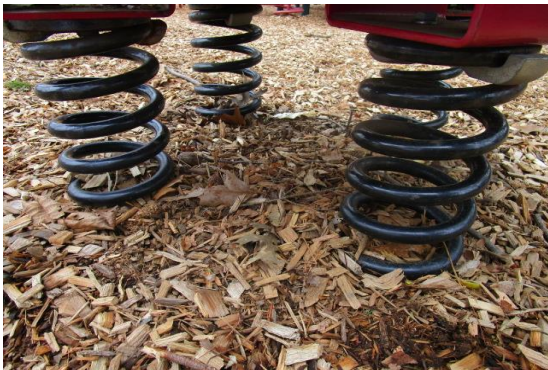
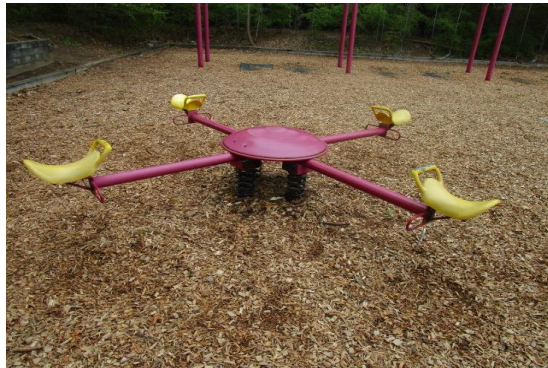
4 Seat Buck-a-Bout (GameTime) - Springs slightly loose at footing - MAINTENANCE

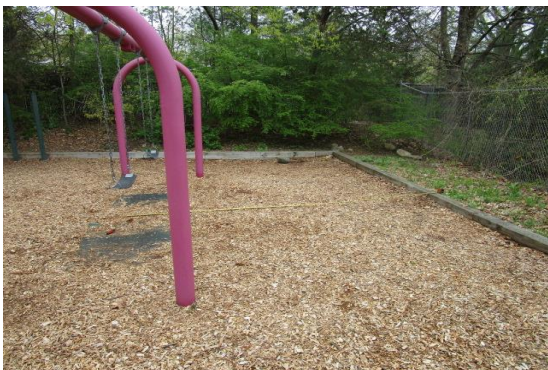
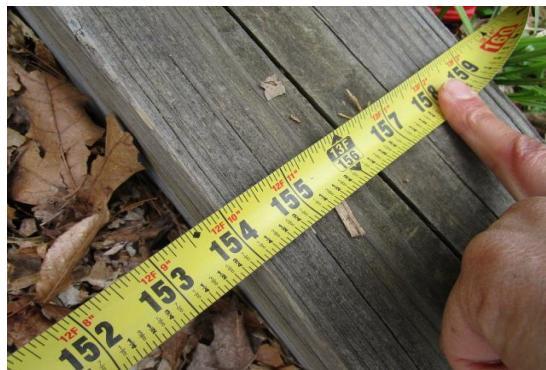
7ft. Swing Set (1Bay/2Belts)(GT) - Inadequate use zone at 13ft. In back - CLASS C HAZARD
