PLAYGROUND SAFETY INSPECTION REPORT

DATE: May 8, 2019

SITE: Stillmeadow Elementary School
800 Stillwater Road
Stamford, CT 06907

DATE OF INSPECTION: April 30, 2019

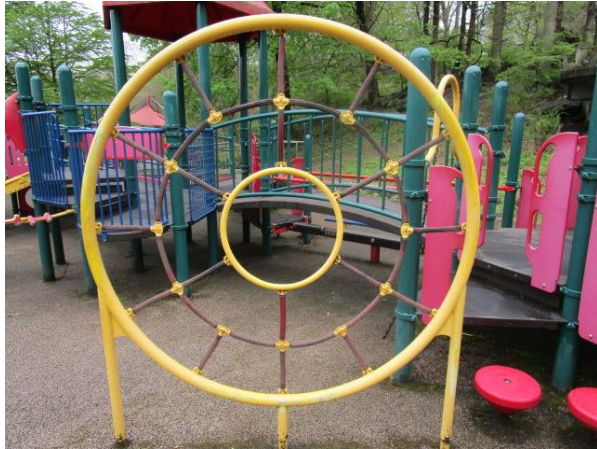
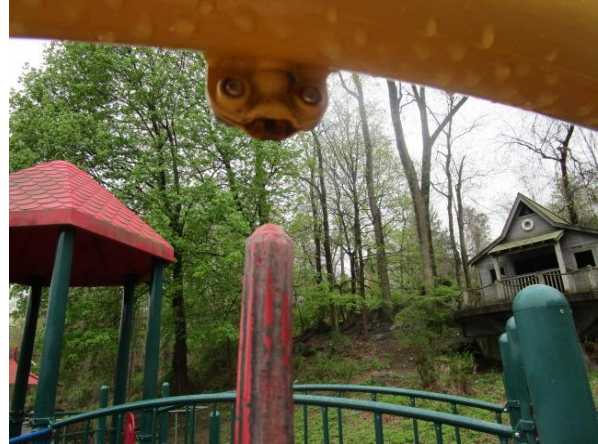
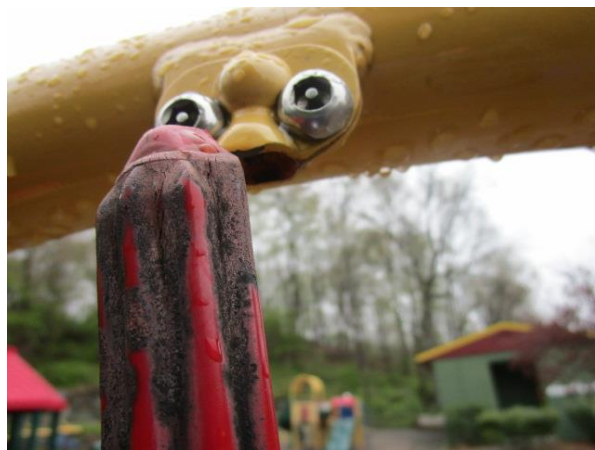
| | Condition | Hazard Priority | Recommendation |
|---|---|---|--|
| Spider Web Climbers (2) | One handhold not attached | Maint. | Replace one handhold & reattach |

Large Composite Structure (Landscape Structures)
Spider Web Climbers (2) - One handhold not attached - MAINTENANCE

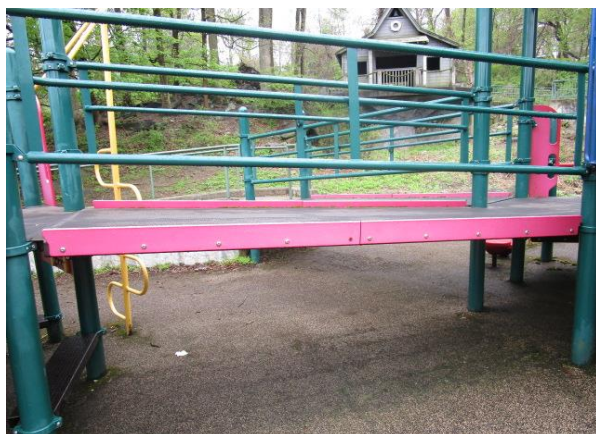
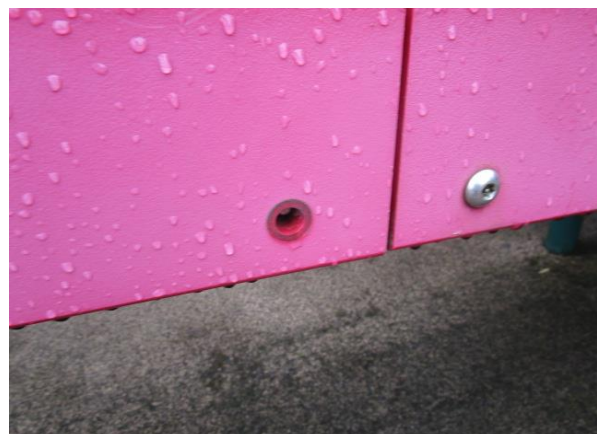
| | Condition | Hazard Priority | Recommendation |
|---|---|---|--|
| Ramps (3) | Missing nine bolts at side rails/lip | Maint. | Replace nine bolts at side rail/lip |

Ramps (3) - Nine bolts missing at side rail/lip - MAINTENANCE

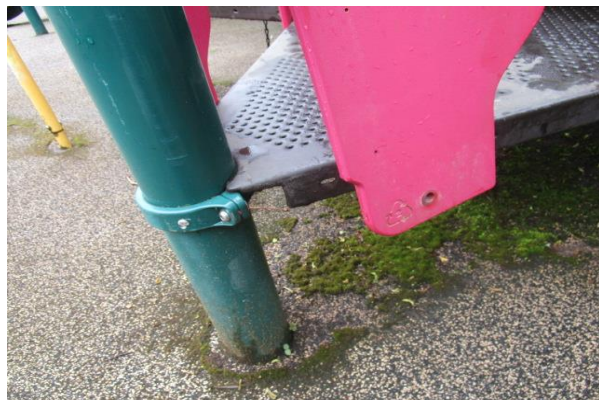
| | Condition | Hazard Priority | Recommendation |
|---|---|---|--|
| Disc Challenge | One handhold at panel not attached | Maint. | Replace two bolts, reattach & tighten |

Disc Challenge - One handhold panel not attached - MAINTENANCE

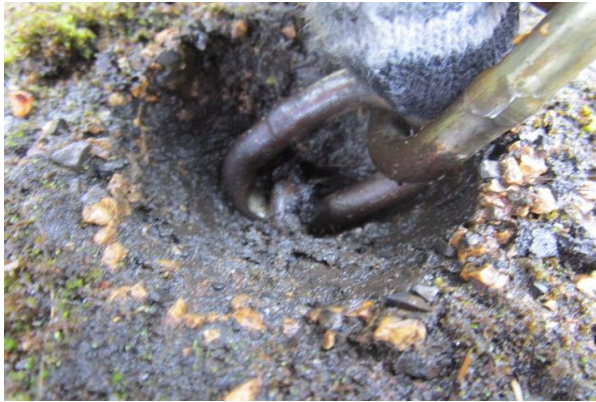
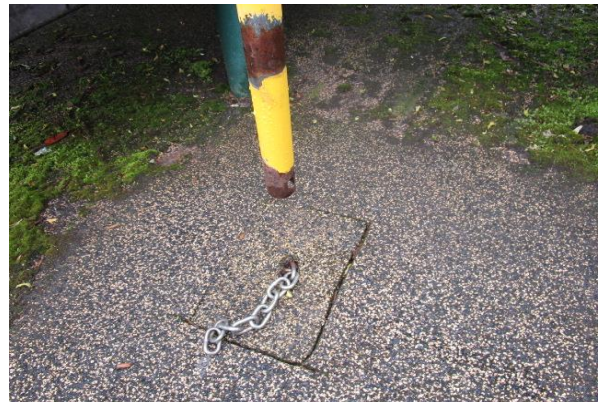
| | Condition | Hazard Priority | Recommendation |
|---|---|---|--|
| | Three bottom chains worn & one pod missing | B | Replace all bottom chain & one pod with hardware |

Disc Challenge - Three bottom chains worn - CLASS B HAZARD
One pod missing - CLASS B HAZARD

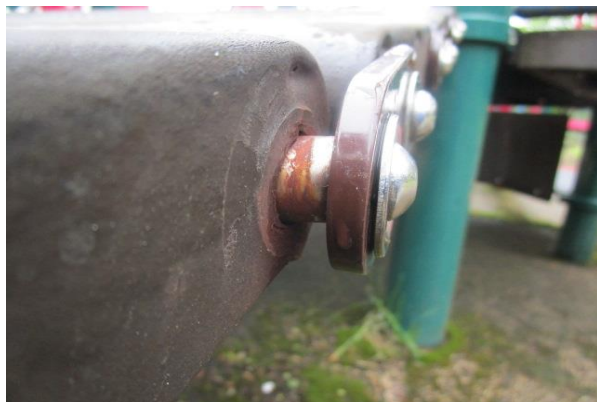
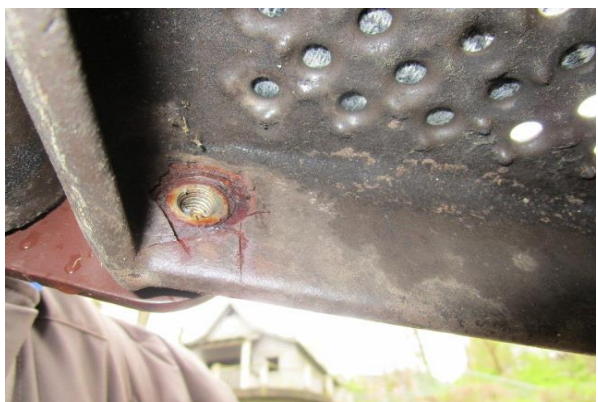
| | Condition | Hazard Priority | Recommendation |
|---|---|---|--|
| Suspension Bridge | One bolt out of one board | B | Repair one board attachment & replace one bolt. Consult Mfr. |

Suspension Bridge - One bolt out of one board - CLASS B HAZARD

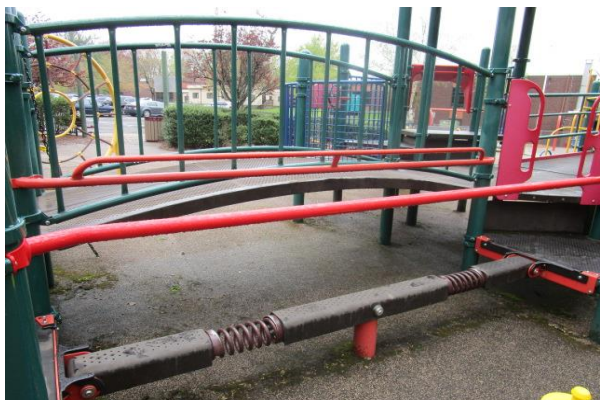
| | Condition | Hazard Priority | Recommendation |
|---|---|---|--|
| Spring Across Bridge | Head entrapment between rail & Arch Bridge | A | Consult Manufacturer, close gaps |

Spring Across Bridge - Head Entrapment between rail & Arch Bridge - CLASS A HAZARD

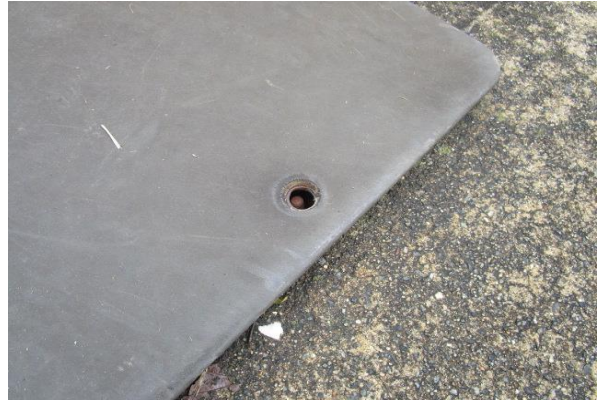
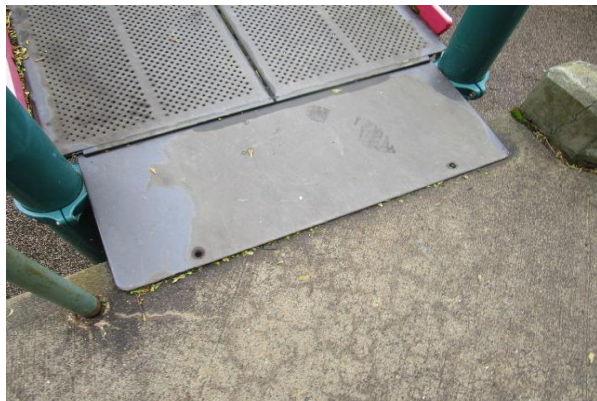
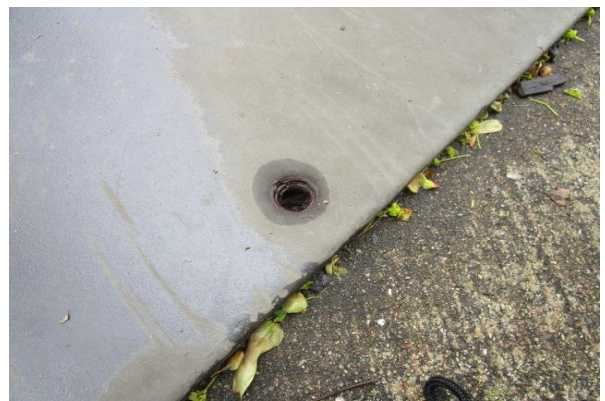
| | Condition | Hazard Priority | Recommendation |
|---|--|---|---|
| Entrance Ramp (2) | Trip hazard at three bolts missing at sidewalk | B | Replace three bolts & reattach to sidewalk |

Entrance Ramp (2) - Trip hazard at three bolts missing at sidewalk - CLASS B HAZARD

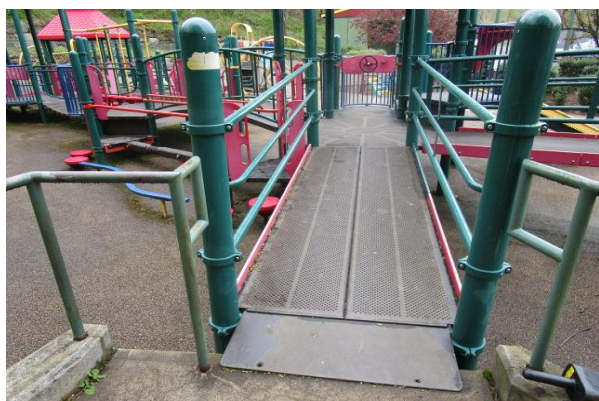
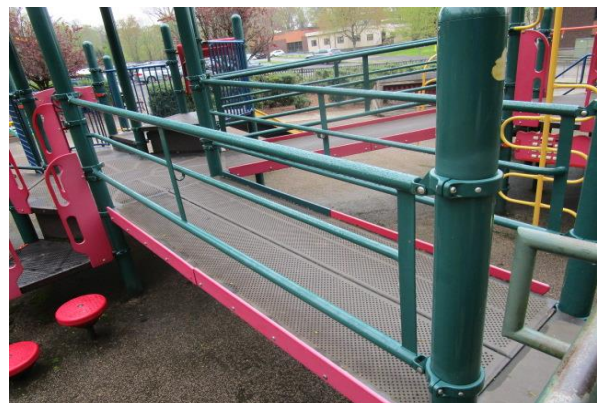
| | Condition | Hazard Priority | Recommendation |
|---|--|---|---|
| | Four bolts missing at side rails | Maint. | Replace four bolts at side rails/lip |

Entrance Ramp (2) - Four bolts missing at side rails - MAINTENANCE

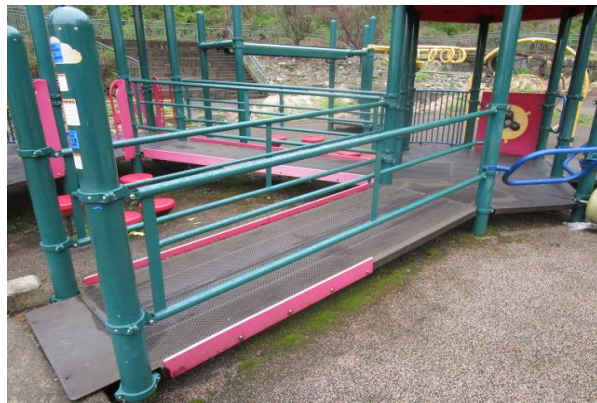
| | Condition | Hazard Priority | Recommendation |
|---|--|---|---|
| | One section of 5" high side rail missing | C | Replace one section of side rail/lip |

Entrance Ramp (2) - One section of 5" high rail missing - CLASS C HAZARD

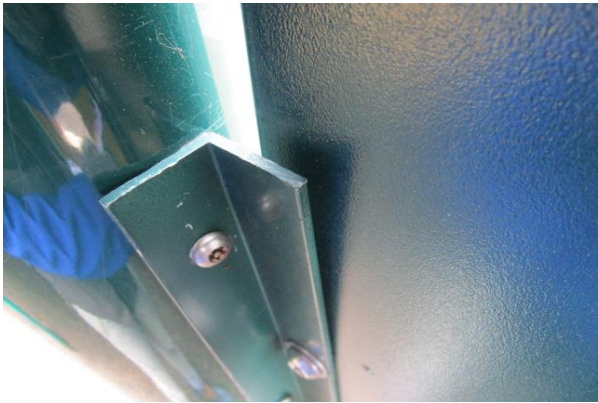
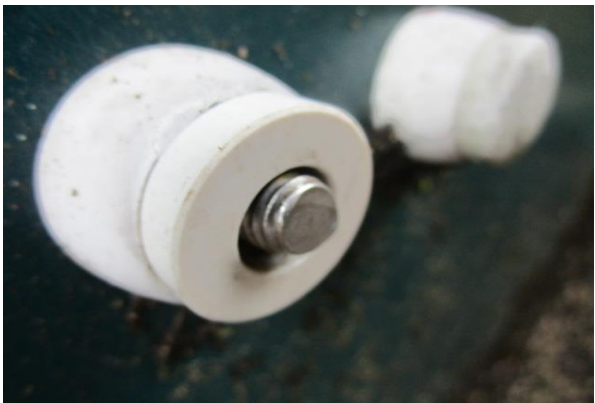
| | Condition | Hazard Priority | Recommendation |
|---|--|---|---|
| | Two protruding bolts | B | Cut down two bolts and cap |

Rockwall (2) - Two protruding bolts - CLASS B HAZARD

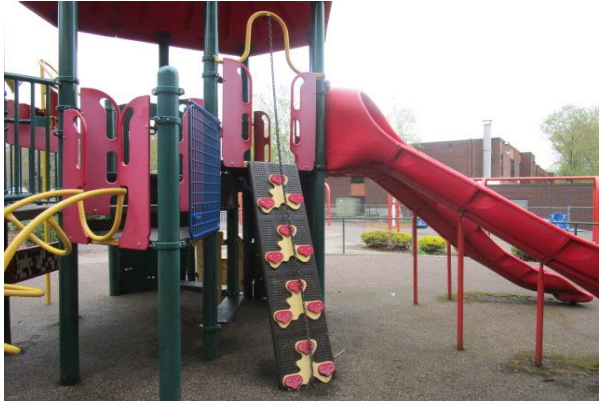
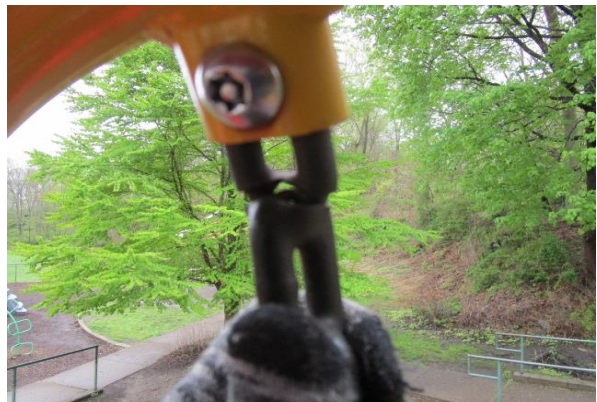
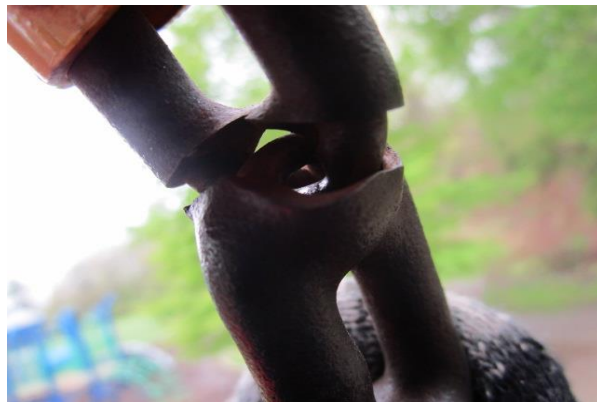
| | Condition | Hazard Priority | Recommendation |
|---|--|---|---|
| Incline Cliff Climber | Chain worn | A | Replace chain |

Incline Cliff Climber - Chain worn - CLASS A HAZARD

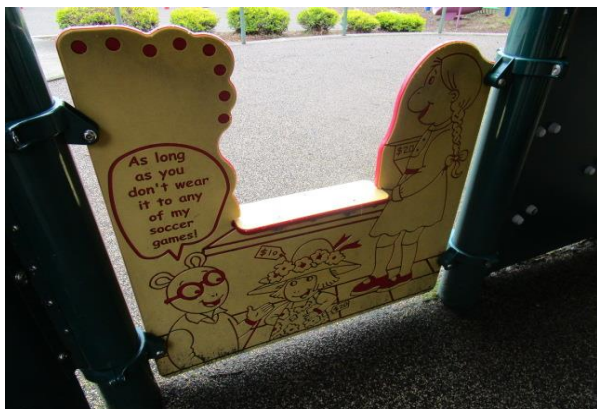
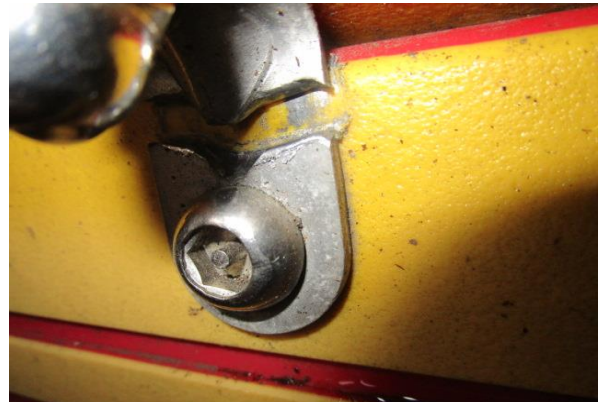
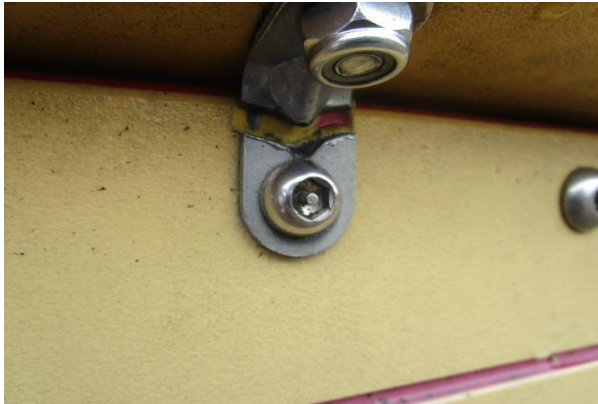
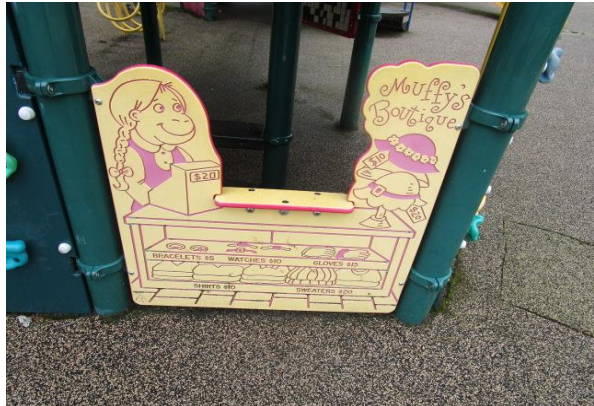
| | Condition | Hazard Priority | Recommendation |
|---|--|---|---|
| Storefront Panel | Three broken brackets at counter | Maint. | Replace three metal brackets & reattach |

Storefront Panel - Three broken brackets at counter - MAINTENANCE

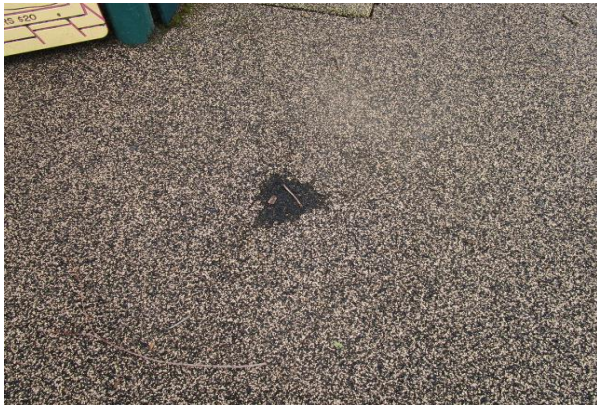
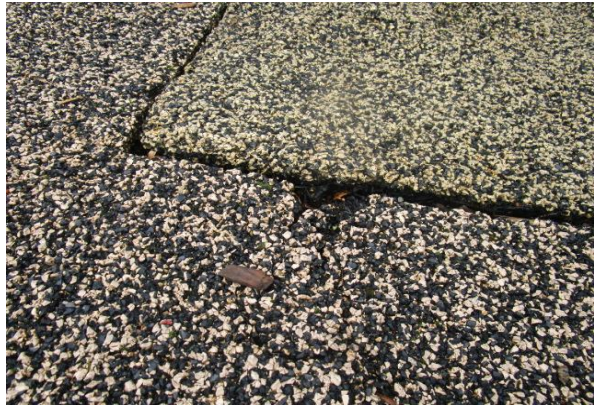
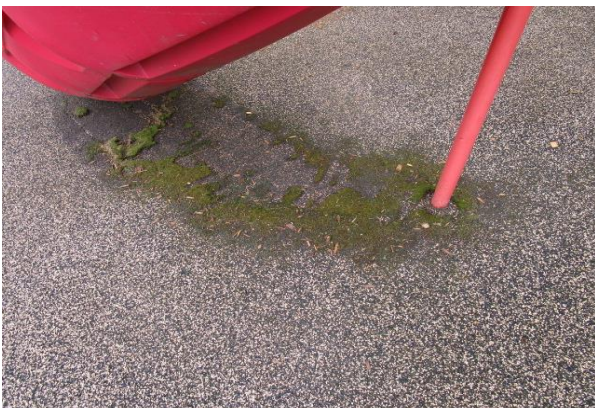
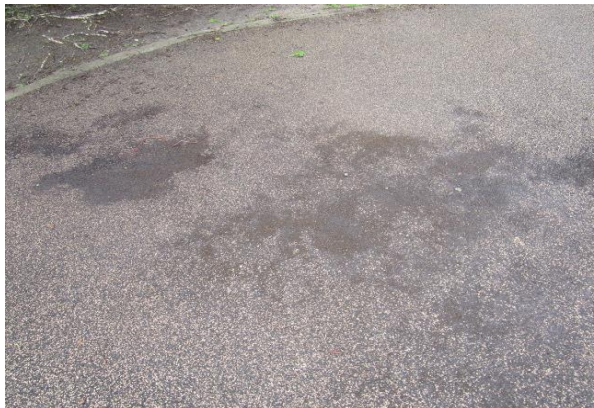
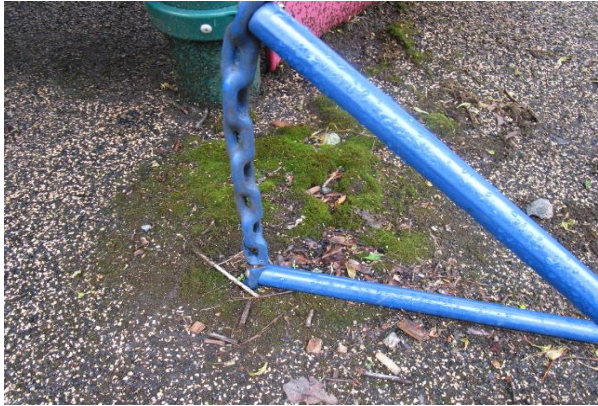
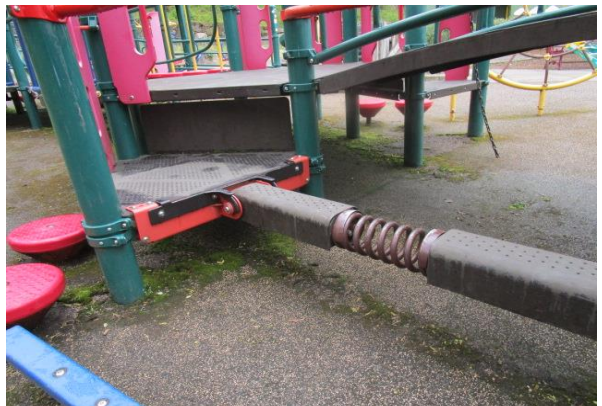
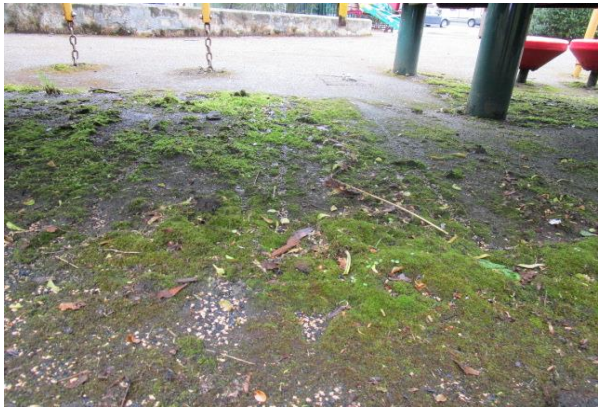
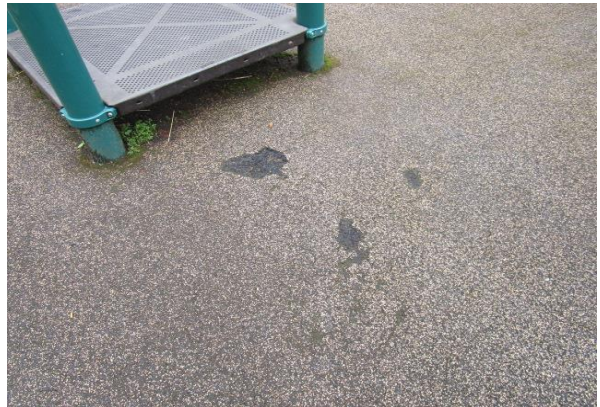
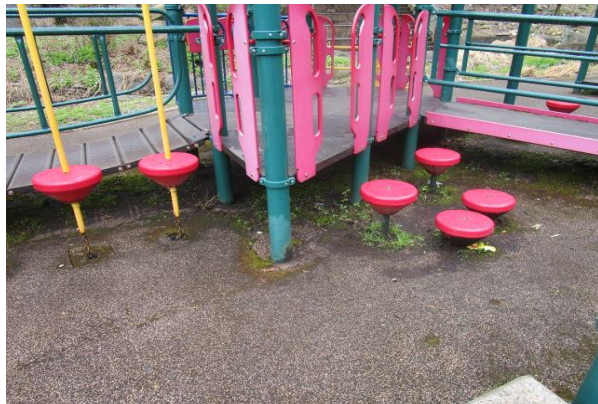
| | Condition | Hazard Priority | Recommendation |
|---|--|---|---|
| Surfacing PIP 2½ - 3" | PIP dirty, cracked & small holes | Maint. | Clean, repair approx. 25 sq. ft. |
| | Moss covering PIP | Maint. | Clean to remove moss |

Surfacing - PIP is dirty, cracked, small holes & moss - MAINTENANCE

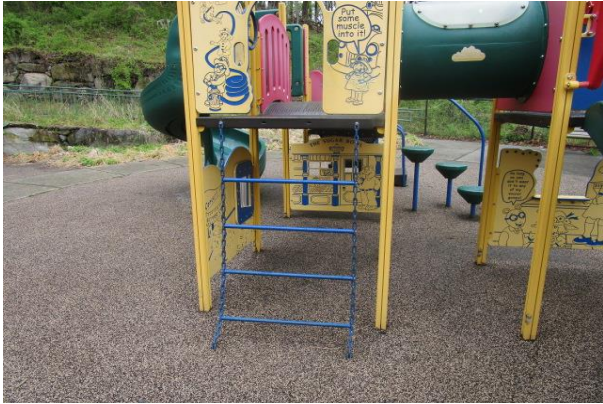
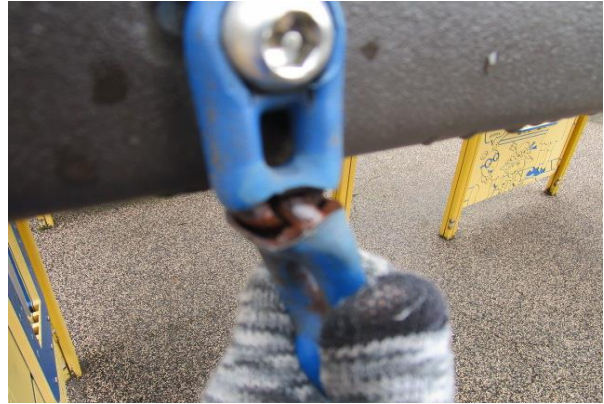
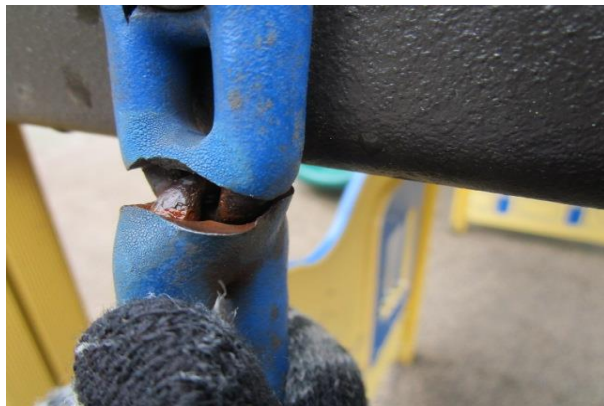
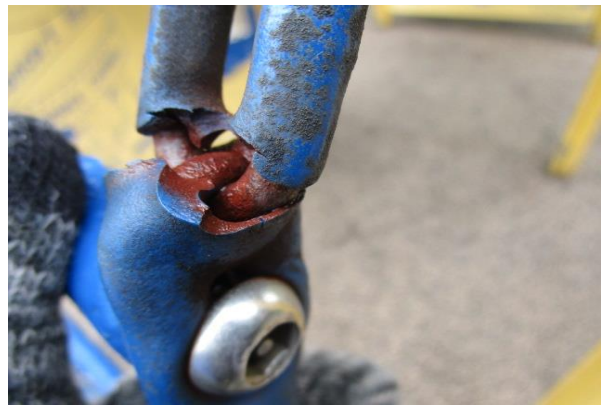
| | | Condition | Hazard Priority | Recommendation |
|---|---|--|---|--|
| Wiggle Ladder | | Chain worn | B | Replace ladder |

**Tot Composite Structure (Landscape Structures)
Wiggle Ladder - Chain worn - CLASS B HAZARD**

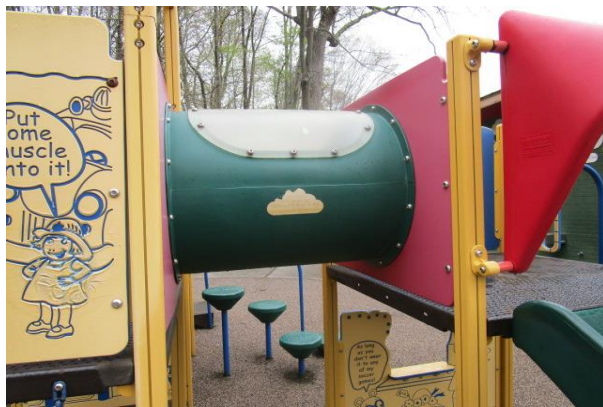
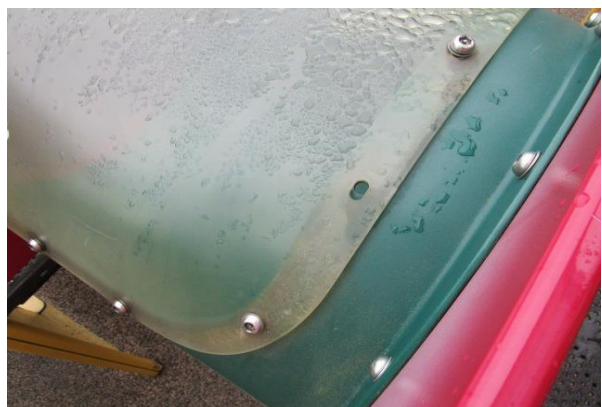
| | | Condition | Hazard Priority | Recommendation |
|---|---|--|---|--|
| View Crawl Tube | | Bolt missing | Maint. | Replace bolt |

View Crawl Tube - Bolt missing - MAINTENANCE

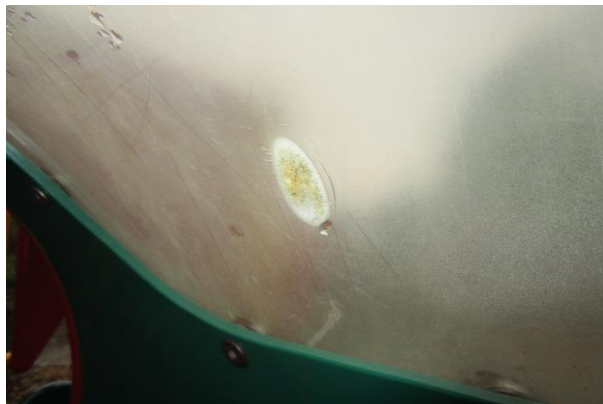
| | | Condition | Hazard Priority | Recommendation |
|---|---|--|---|--|
| | | One burn mark | Maint. | Monitor |

View Crawl Tube - One burn mark - MAINTENANCE

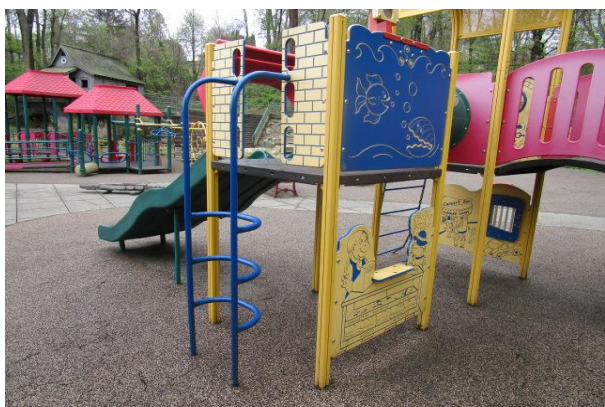
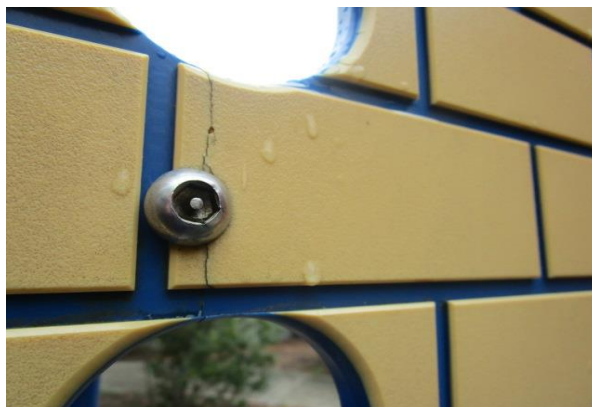
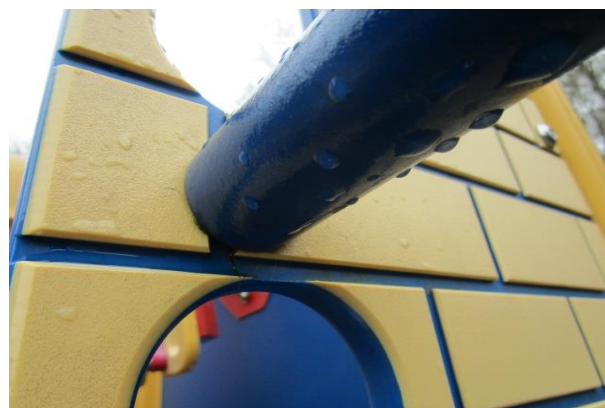
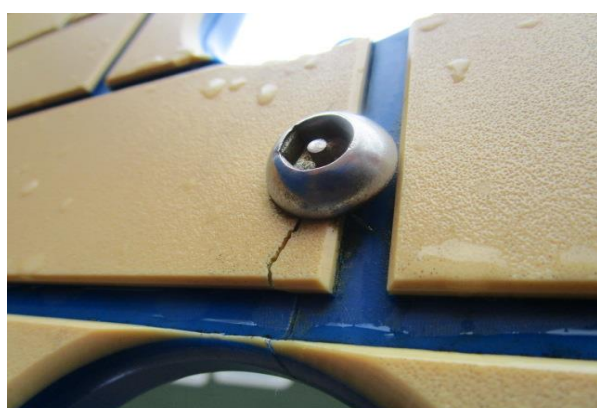
| | | Condition | Hazard Priority | Recommendation |
|---|---|--|---|--|
| Curved Rung Ladder | | Handhold panel cracked at bolts | Maint. | Replace "Brick" handhold panel |

Curved Rung Ladder - Handhold panel cracked at bolts - MAINTENANCE

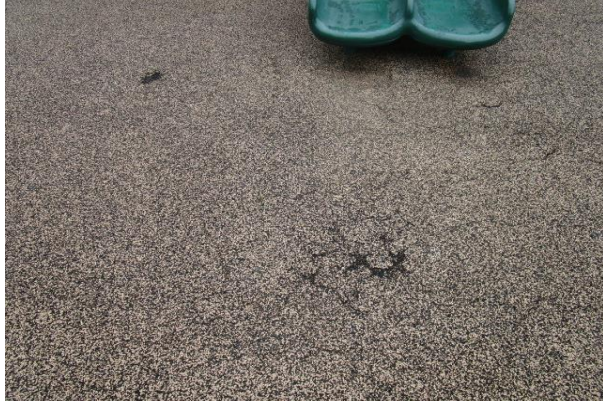
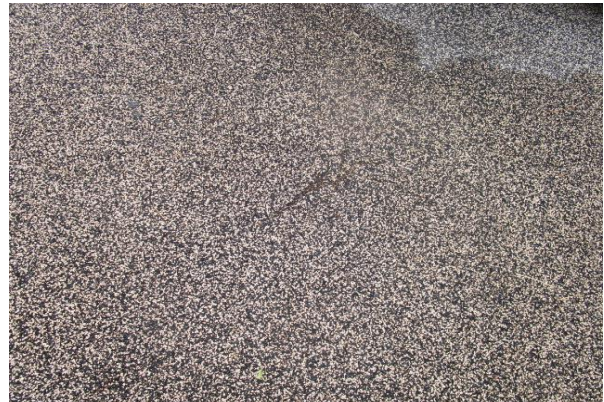
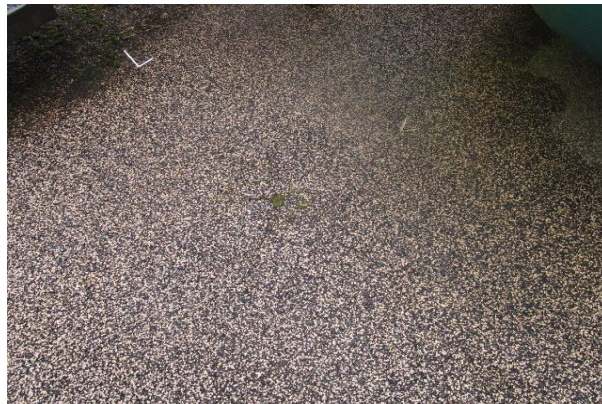
| | | Condition | Hazard Priority | Recommendation |
|---|---|--|---|--|
| Surfacing | PIP 2½ - 3" | Cracks & holes in rubber | Maint. | Clean, repair approx. 15 sq. ft. |

Surfacing - Cracks & holes in rubber - MAINTENANCE

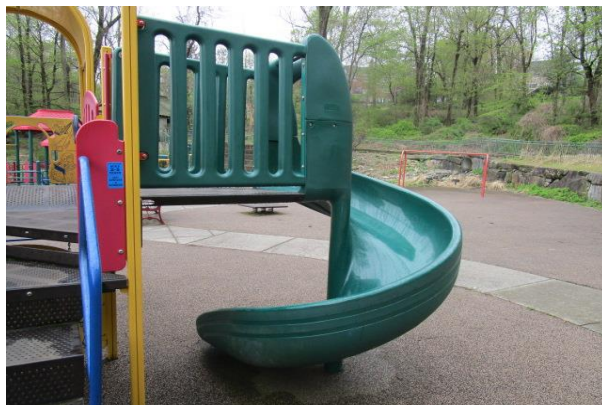
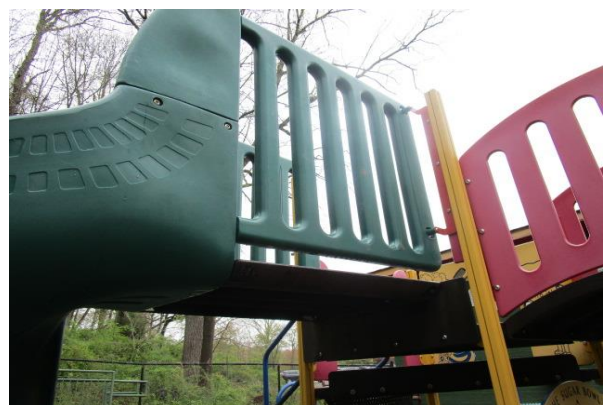
| | | Condition | Hazard Priority | Recommendation |
|---|---|--|---|--|
| Structural Stability | | Spyro Slide loose | Maint. | Tighten all hardware |

Structural Stability - Spyro Slide loose - MAINTENANCE

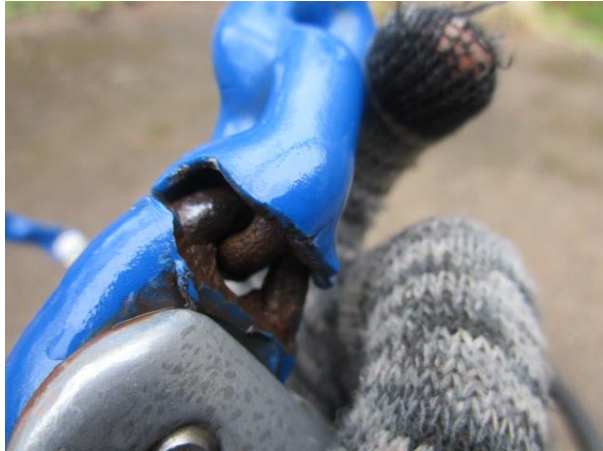
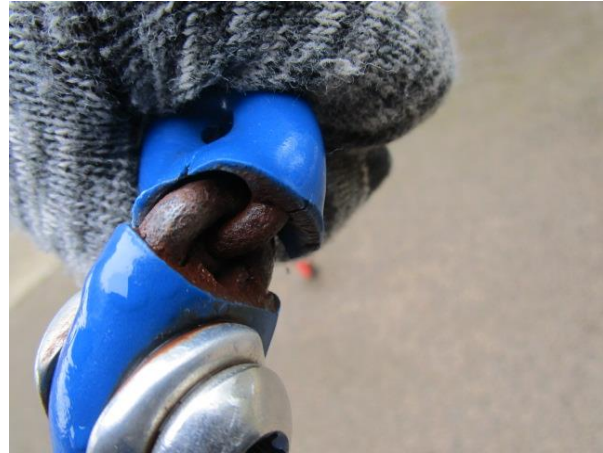
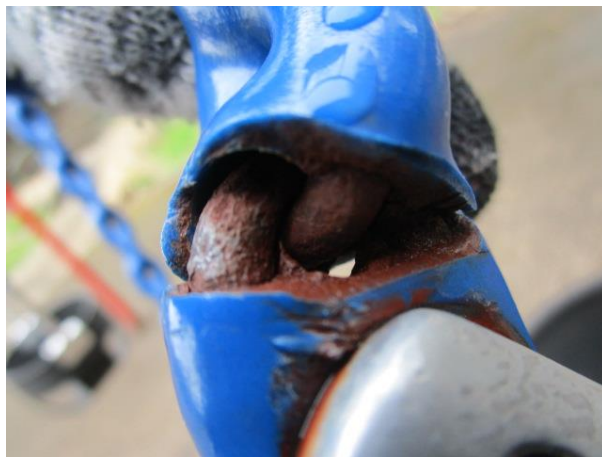
| | | Condition | Hazard Priority | Recommendation |
|---|---|--|---|--|
| 7ft. Swing Set (1Bay) (Landscape) | | Chains worn at two enclosed tot seats | A | Replace chains at two enclosed tot seats |

7ft. Swing Set (1Bay)(Landscape) - Chains worn at two enclosed tot seats -

CLASS A HAZARD

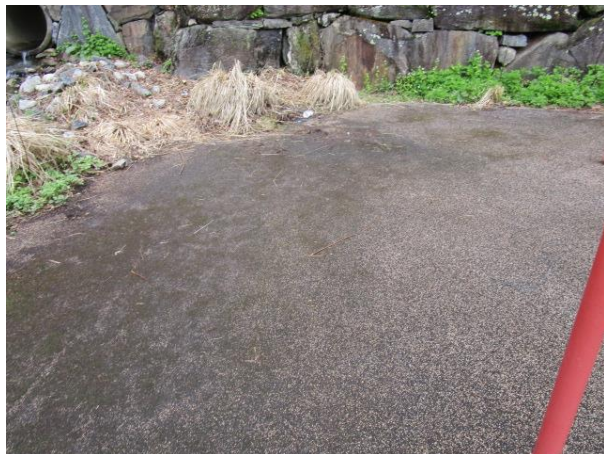
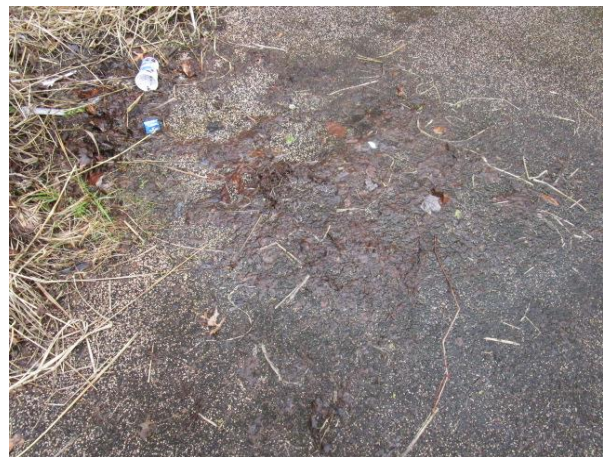
| | | Condition | Hazard Priority | Recommendation |
|---|---|--|---|--|
| Surfacing | PIP 2½ - 3" | Dirty | Maint. | Clean PIP |

Surfacing - Dirty - MAINTENANCE

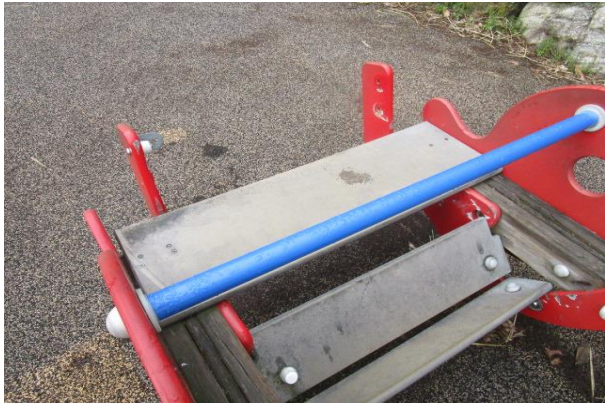
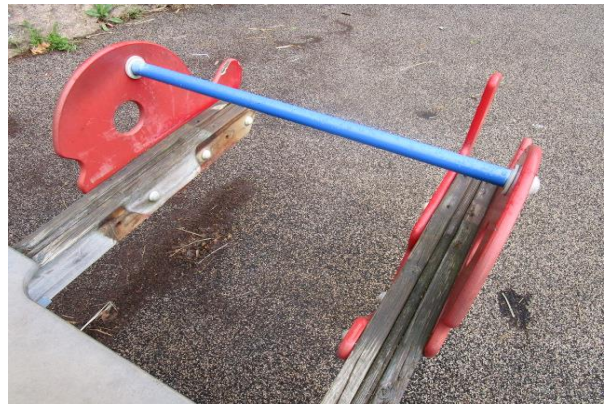
| | | | Condition | Hazard Priority | Recommendation |
|---|---|--|--|---|---|
| Multi-Spring See-Saw (Kompan) | | | One seat missing & two back supports missing | Maint. | Close unit Remove if no repairs made |

Multi-Spring See-Saw (Kompan) - One seat missing & two back supports missing - MAINTENANCE

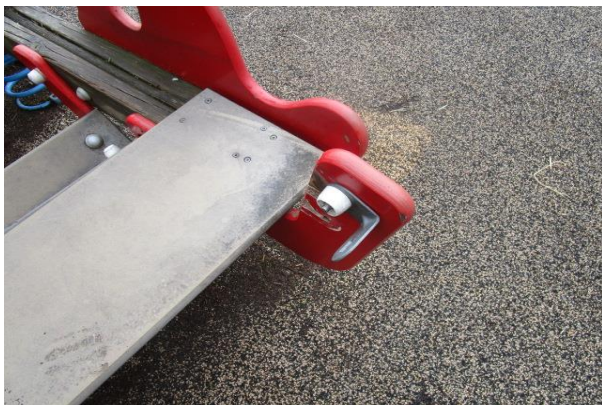
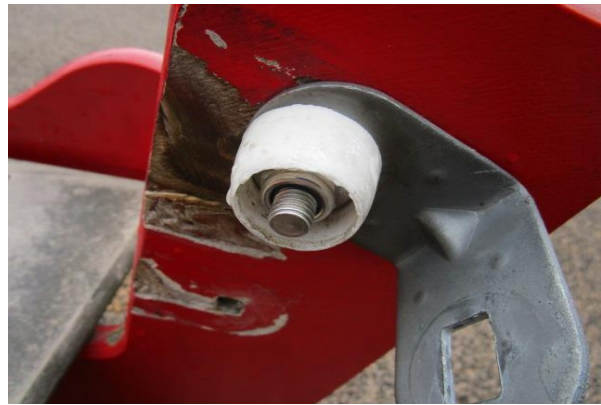
| | | | Condition | Hazard Priority | Recommendation |
|---|---|--|--|---|---|
| | | | One bolt cap cracked | Maint. | |

Multi-Spring see-Saw (Kompan) - One bolt cap cracked - MAINTENANCE

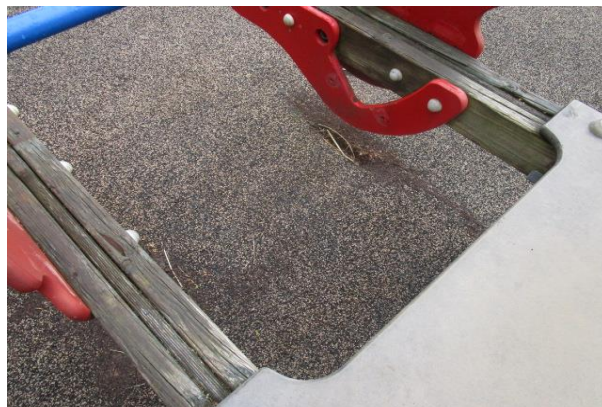
Multi-Spring See-Saw - One foot rest missing - MAINTENANCE

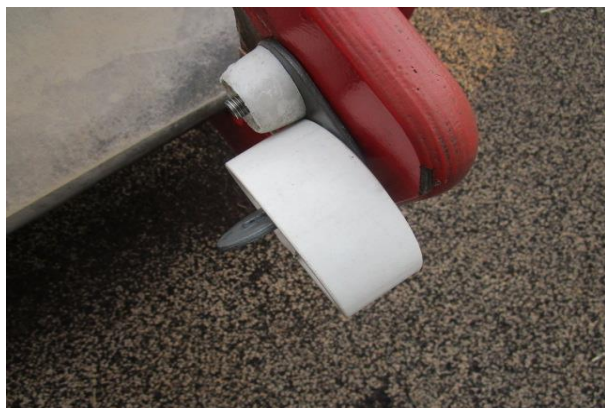
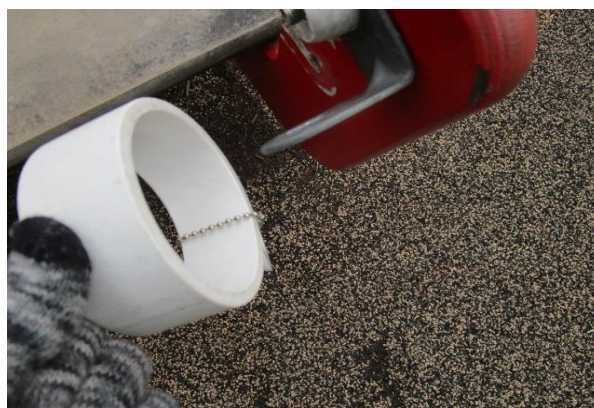
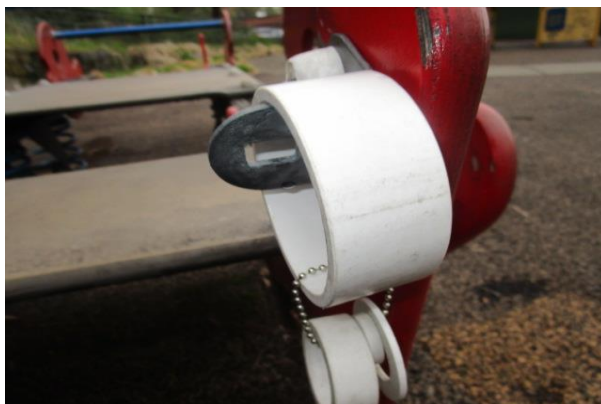
| | | | Condition | Hazard Priority | Recommendation |
|---|---|--|--|---|---|
| | | | One foot rest missing One protrusion at bracket | Maint. A | |

Multi-Spring See-Saw - One protrusion at bracket - CLASS A HAZARD

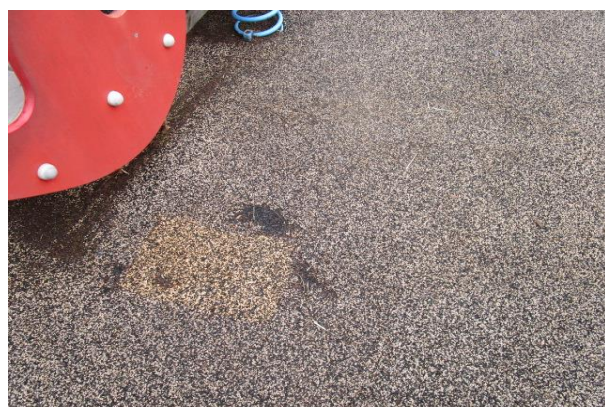
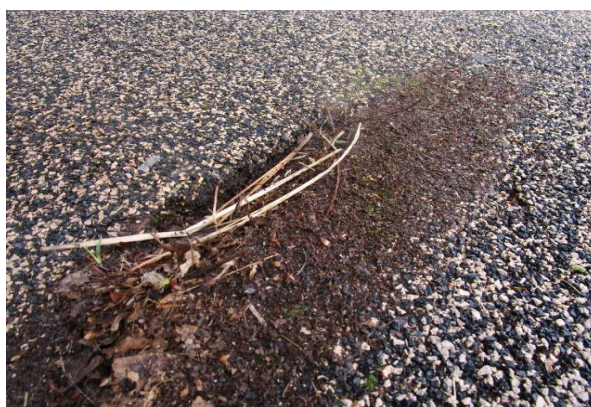
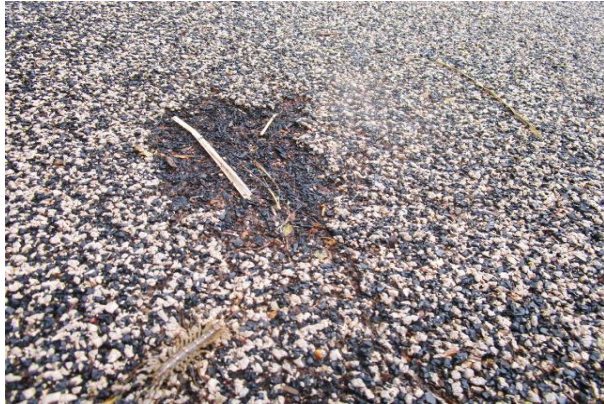
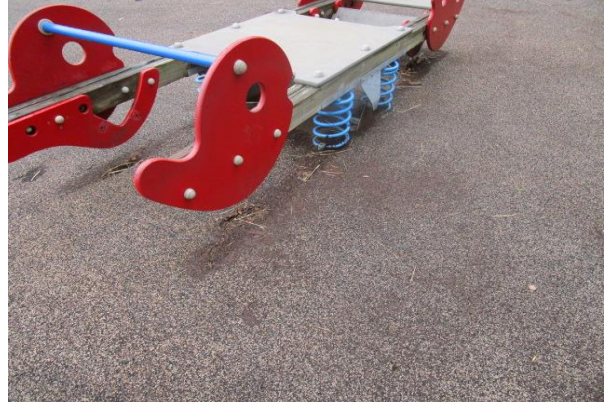
| | | | Condition | Hazard Priority | Recommendation |
|---|---|--|--|---|---|
| Surfacing | PIP 2½ - 3" | | Small holes in rubber | Maint. | Repair approx. 3 sq. ft. |

Surfacing - Small holes in rubber - MAINTENANCE

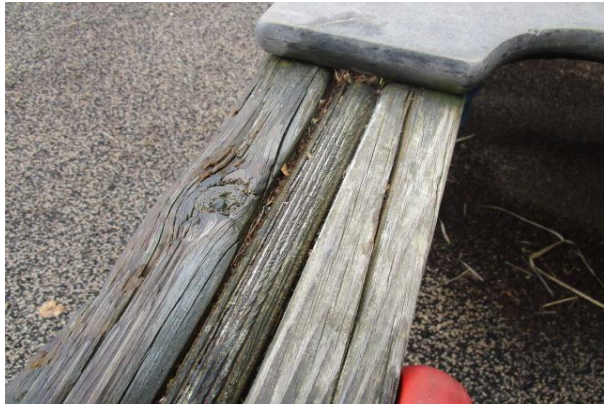
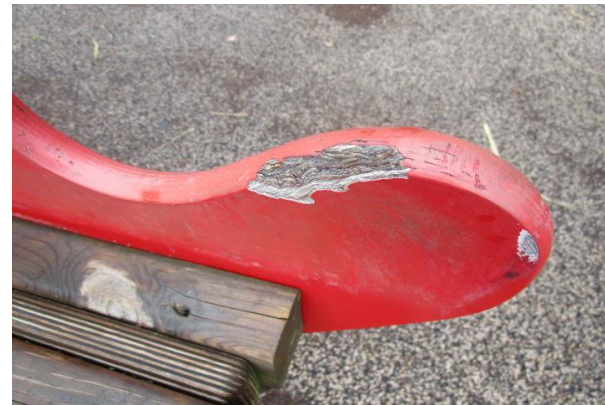
| | | | Condition | Hazard Priority | Recommendation |
|---|---|--|--|---|---|
| Structural Stability | | | Wood cracked | Maint. | Close until repaired |

Structural Stability - Wood cracking - MAINTENANCE

If no repairs are made we recommend removing unit & patch rubber
