**STILLMEADOW ELEMENTARY SCHOOL  
Area #3**

**AREA #3 CONDITION REPORT**

**STILLMEADOW ELEMENTARY SCHOOL  
Area #4**

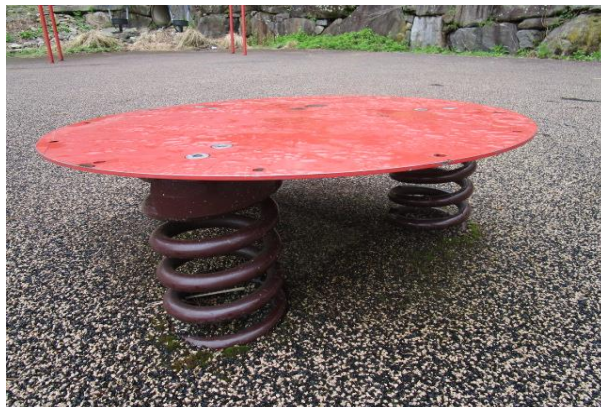
**Bounce Saucer Pad - Top component missing - CLASS B HAZARD**

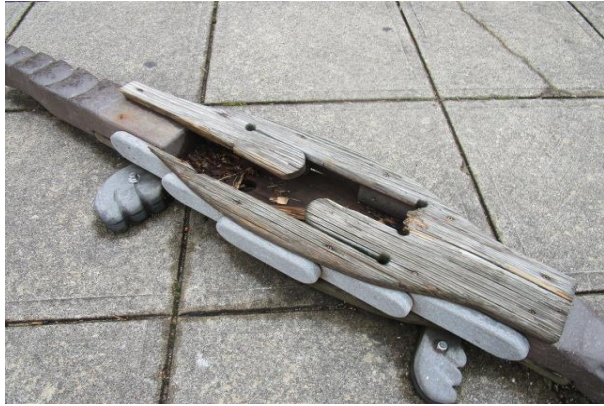
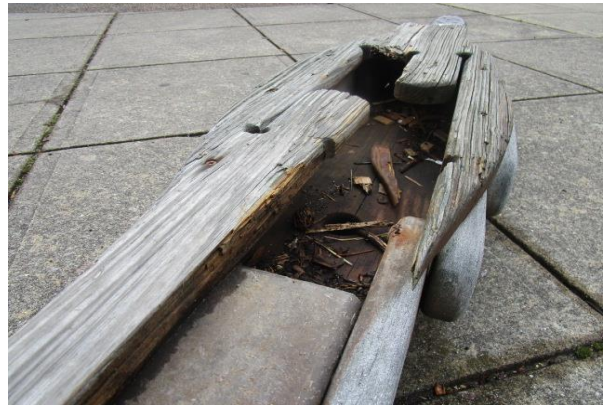
**Alligator (SoundPlay) - Wood broken, cracked & splintered - CLASS B HAZARDS**

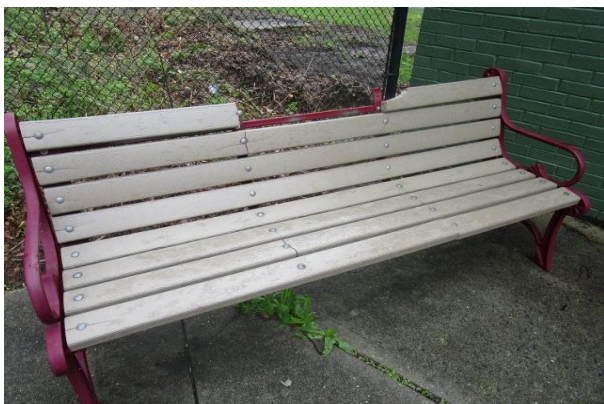
**Site Amenities - One bench damaged - MAINTENANCE**

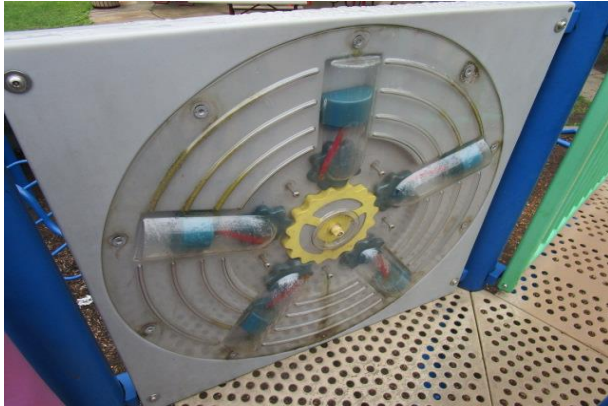
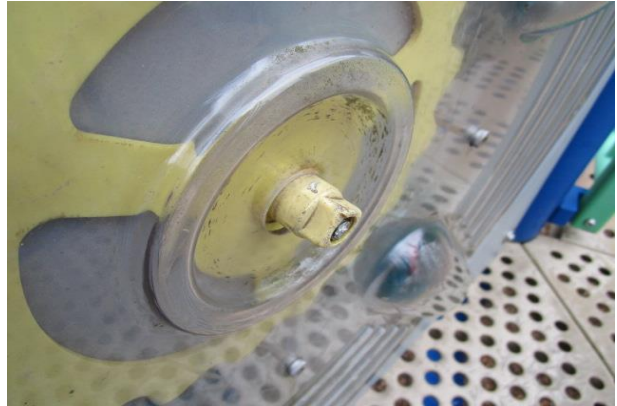
**Medium Composite Structure - GameTime  
Piston Panel - Missing handle - MAINTENANCE**

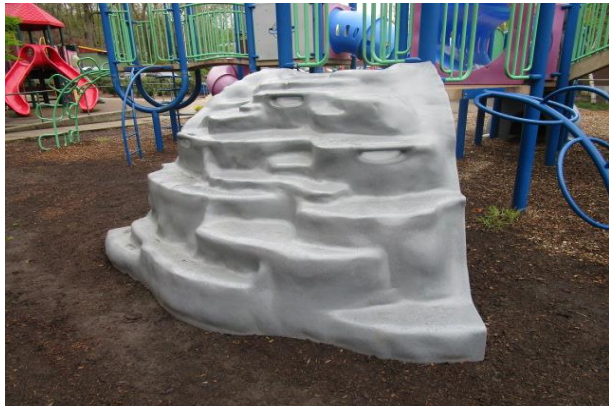
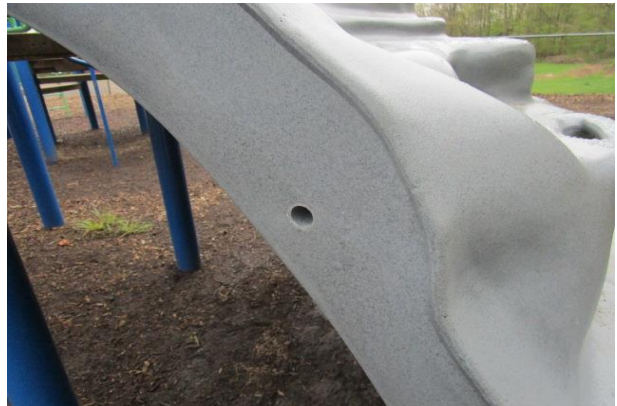
**Mega Rock Climber - One bolt cap missing - MAINTENANCE**

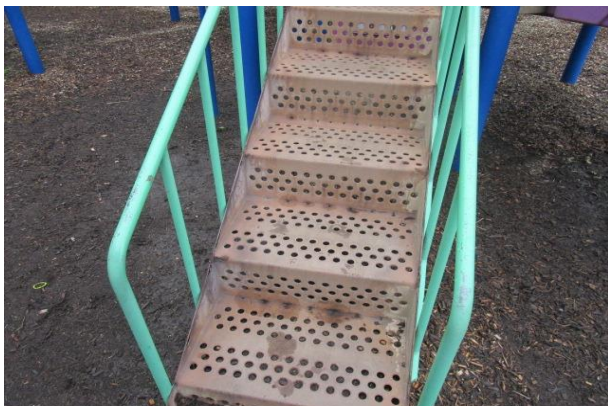
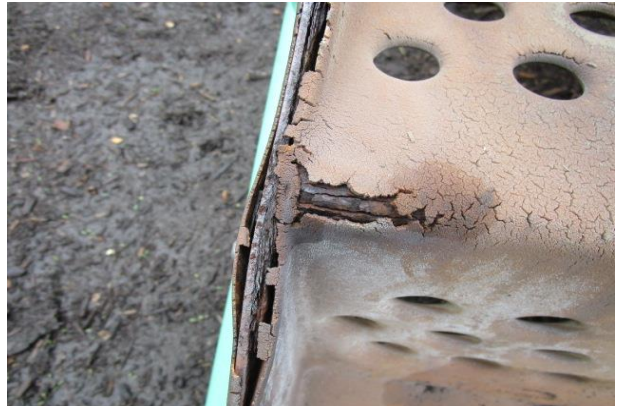
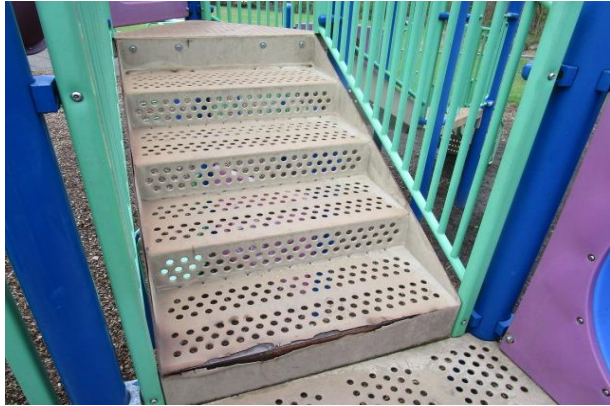
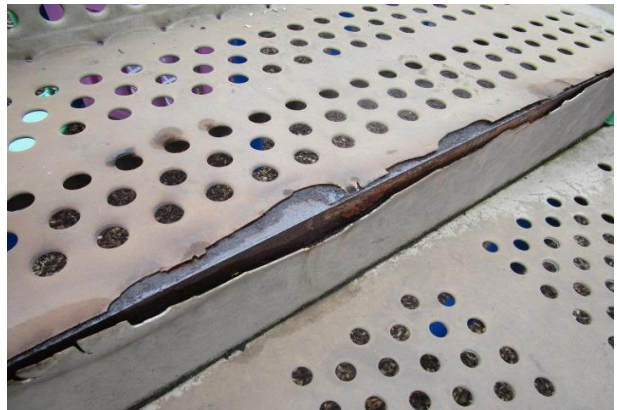
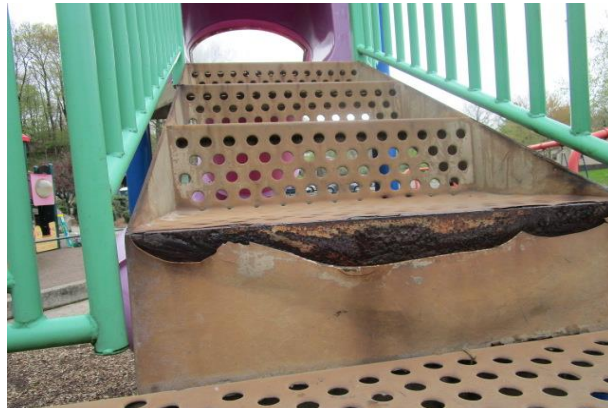
**Stairs (3) - Plastisol worn & missing at three stairs - MAINTENANCE**

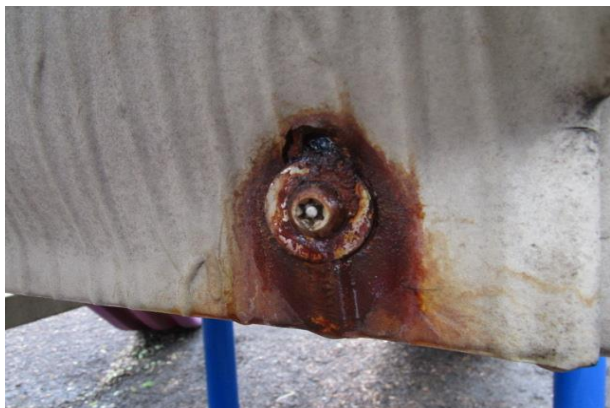
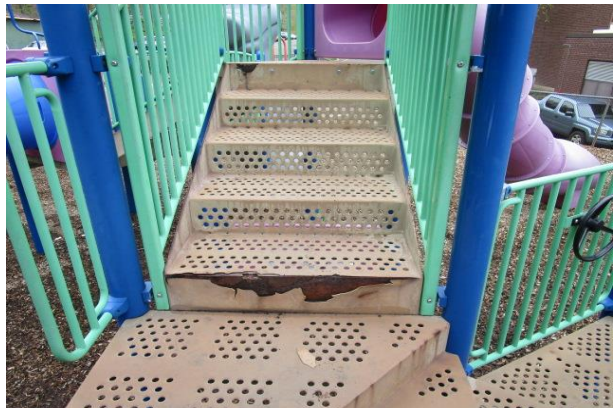
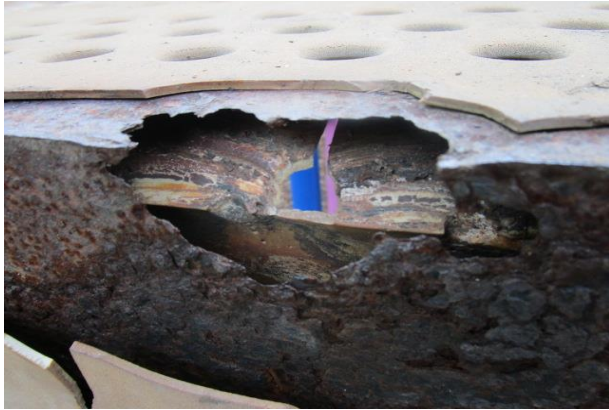
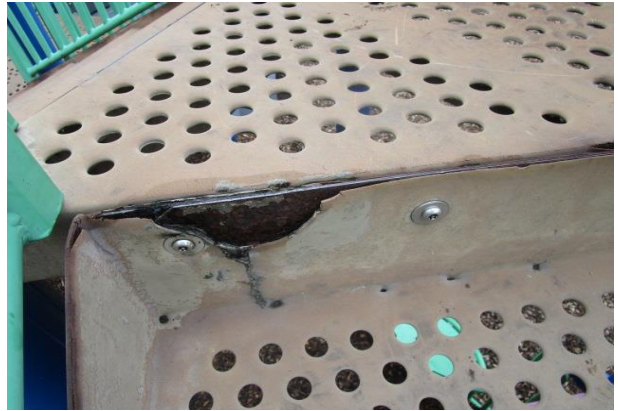
**Stairs - One stair exposed holes in steel - CLASS B HAZARD**

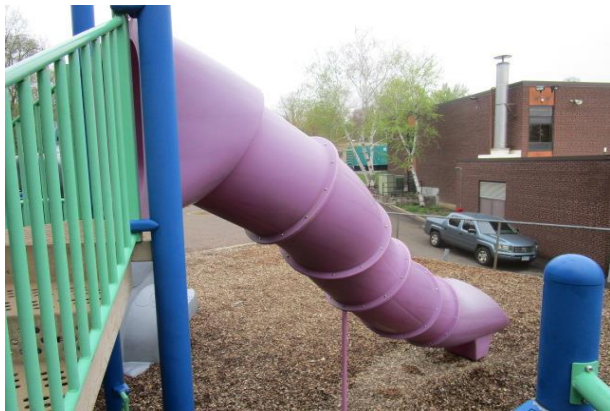
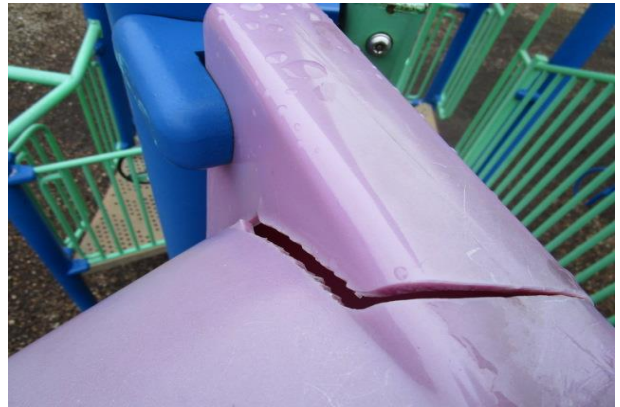
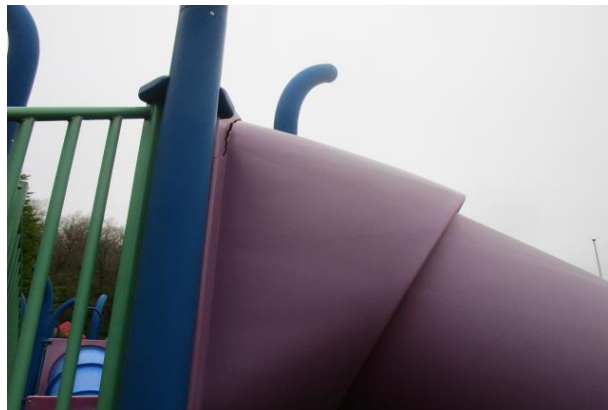
**Wiggle Tube Slide - Cracked at top hood section - CLASS B HAZARD**

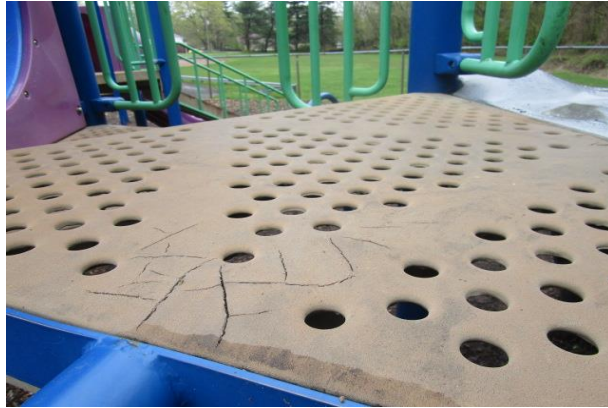
**Decks (9) - Plastisol wearing - MAINTENANCE**

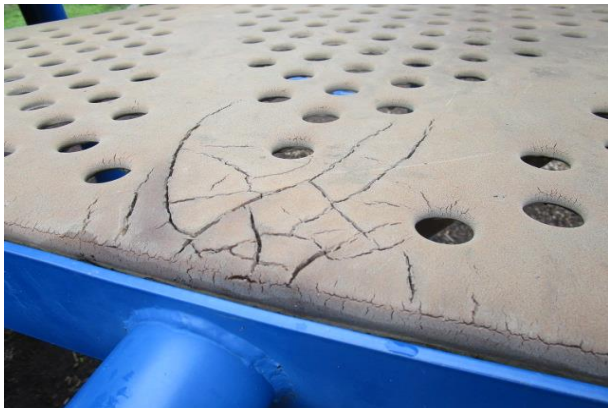
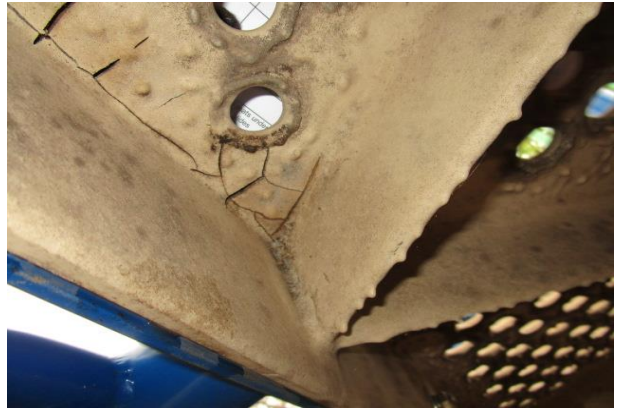
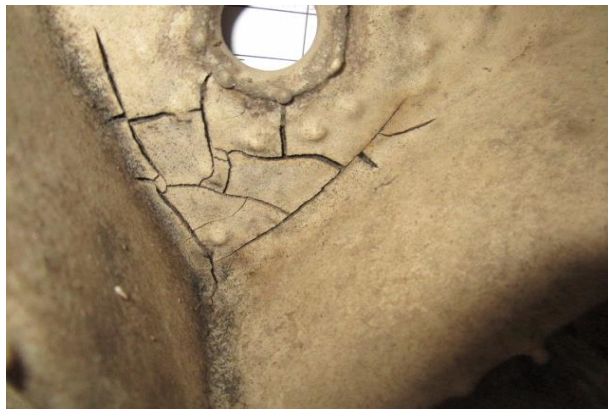
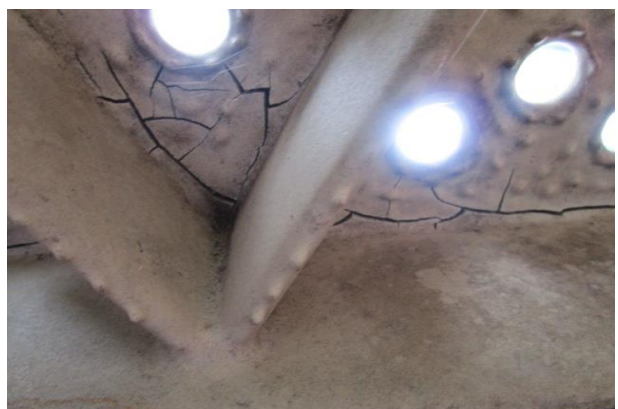
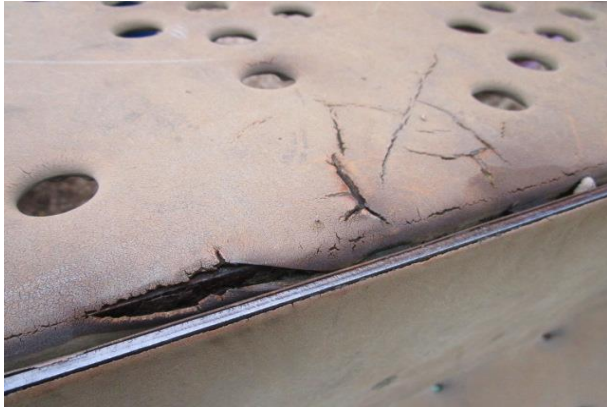
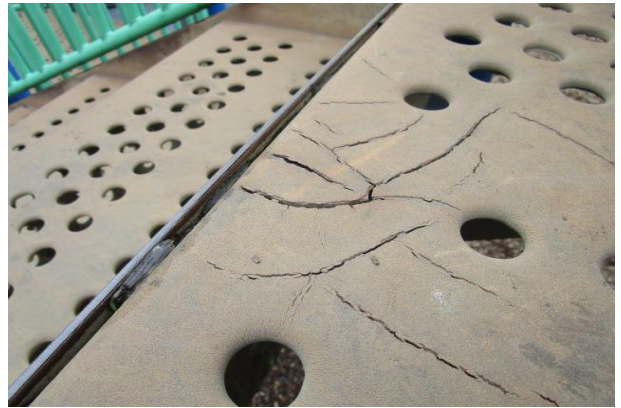
**Decks (9) - Three triangle decks cracked - CLASS B HAZARD**

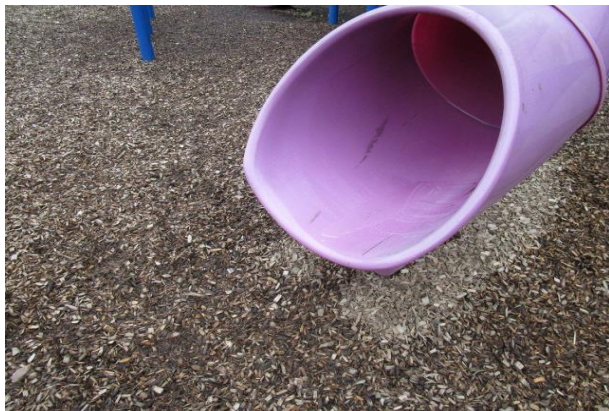
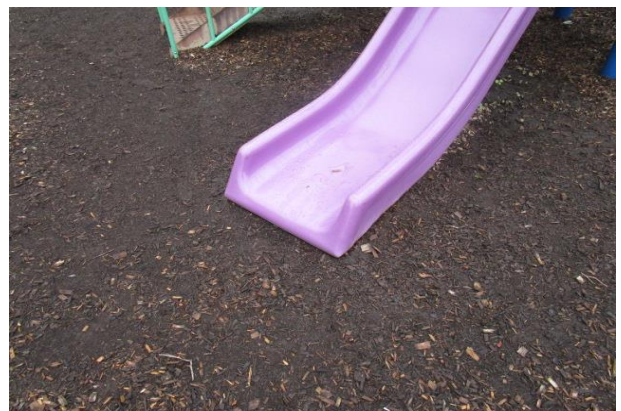
**There are no wear mats at the slide exits of the medium composite. ADA requires wear mats for accessibility and the prevention of holes at the slide exits.**

**Surfacing - No wear mats at slide exits - CLASS C HAZARD**

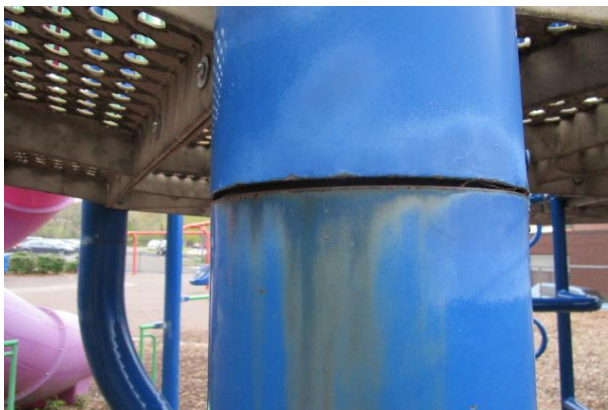
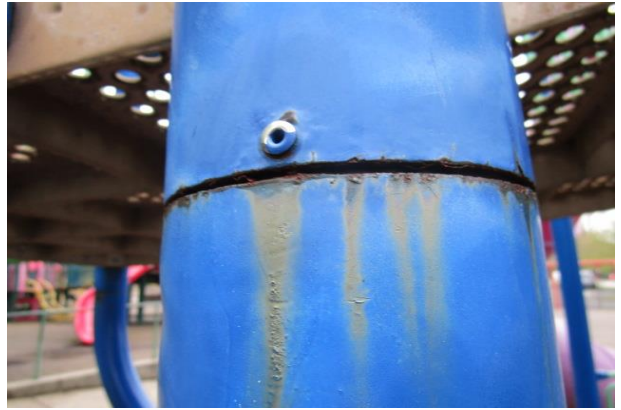
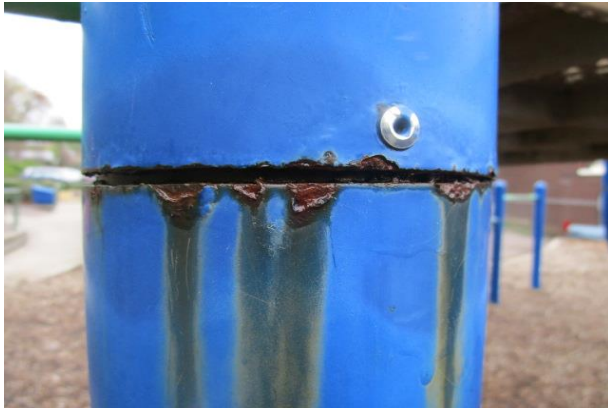
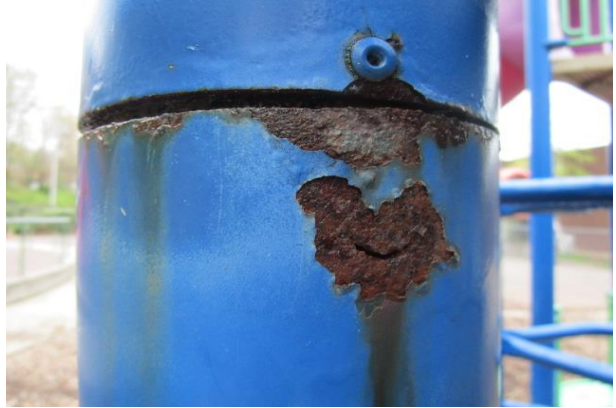
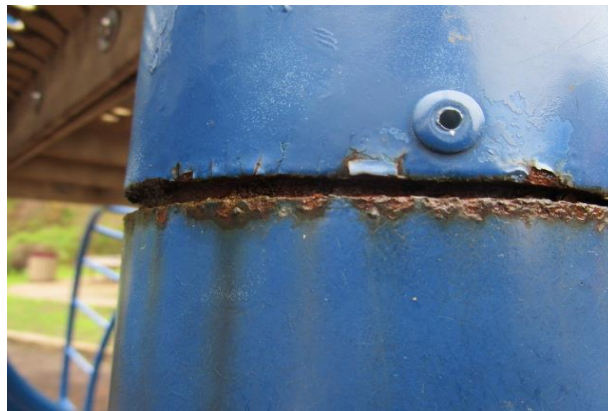
**Structural Stability - Structure rusting & showing gaps at support post joints - MAINTENANCE**

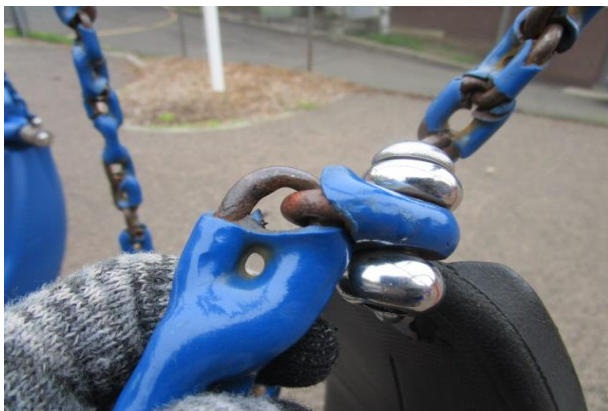
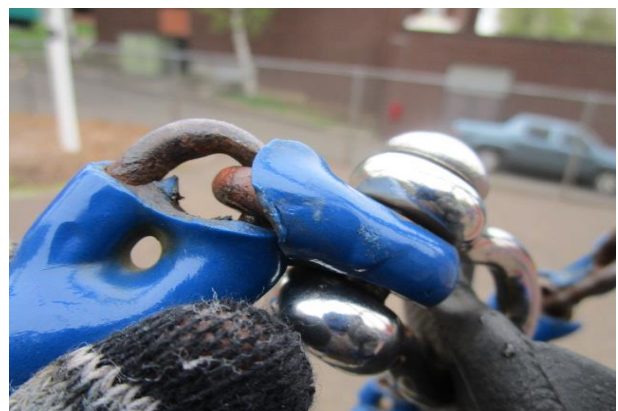
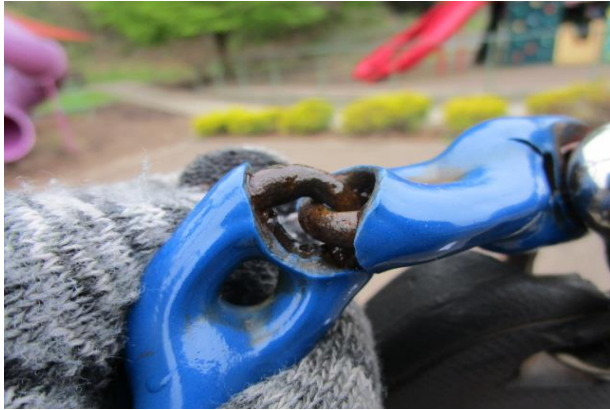
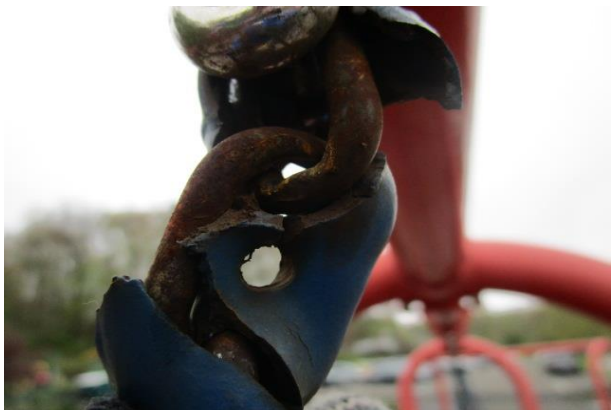
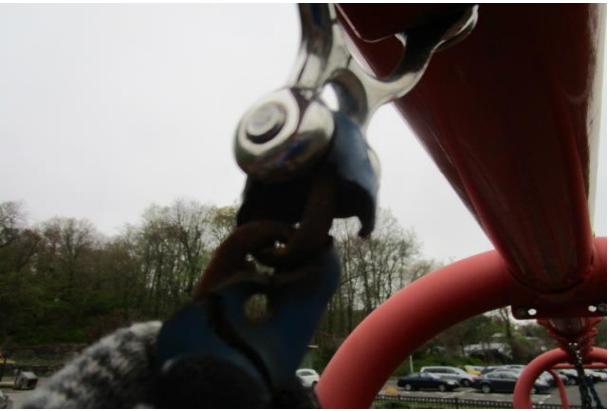
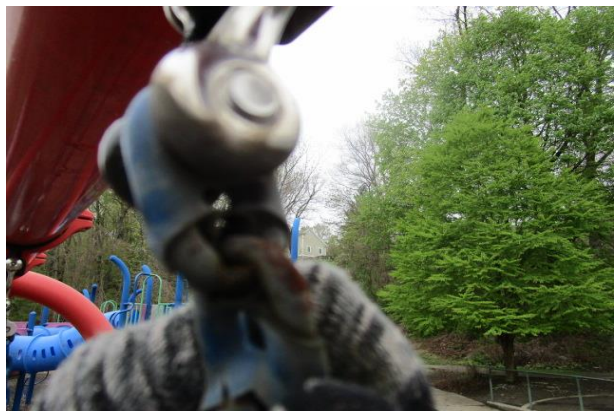
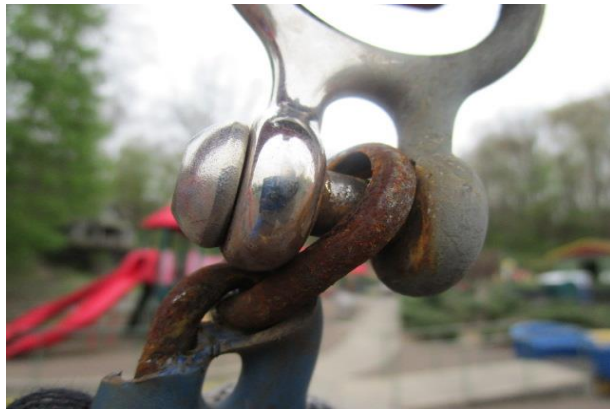
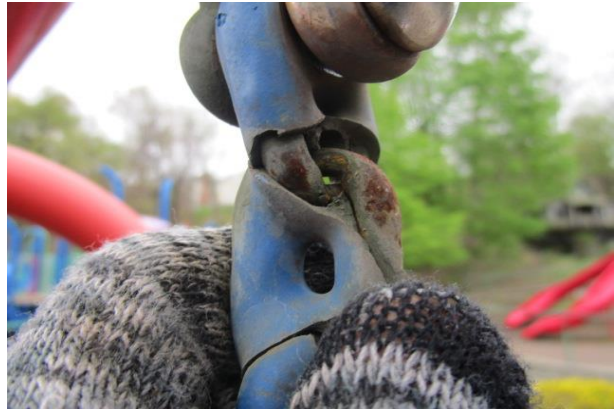
**Freestanding Equipment**  
**8ft. Swing Set (2Bays)(Landscape) - Chains worn at two belt seats - CLASS A HAZARD**

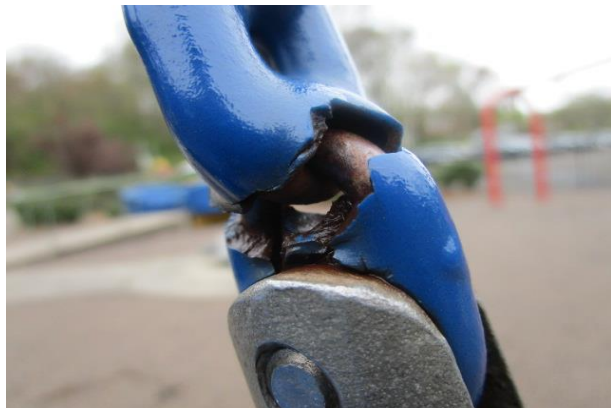
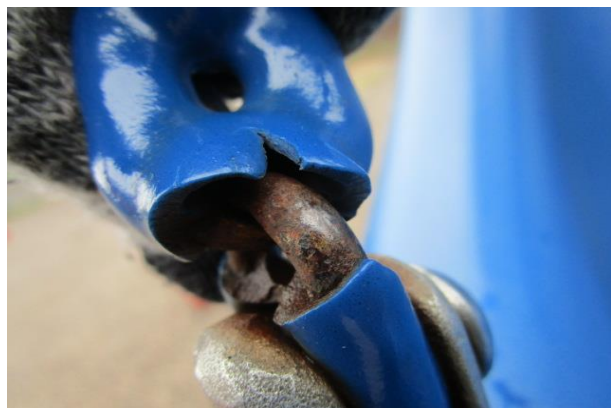
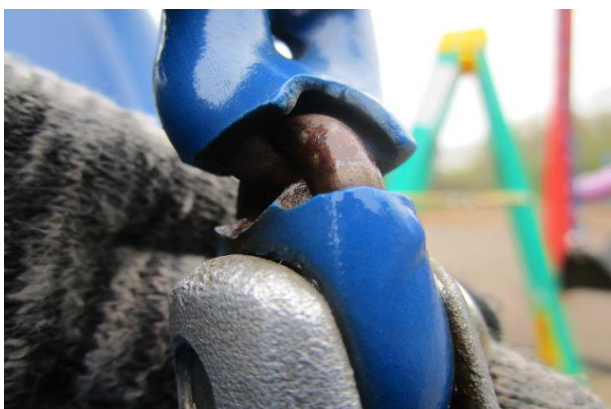
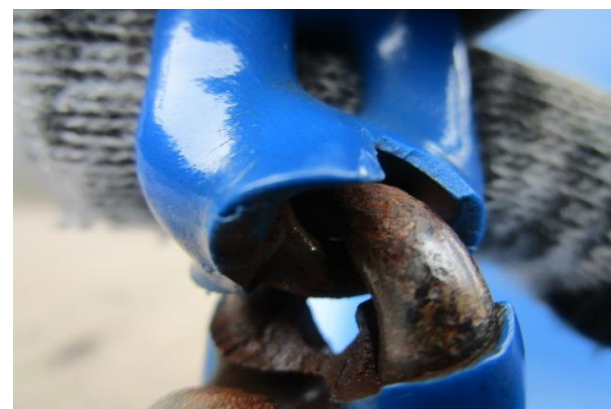
**8ft. Swing Set (2Bay)(Landscape) - Chains worn at Inclusion seats - CLASS A HAZARD**

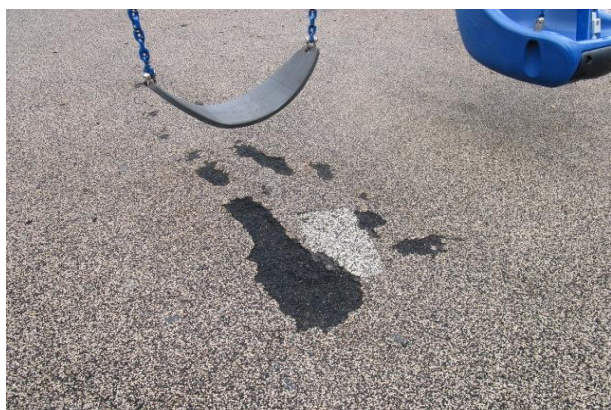
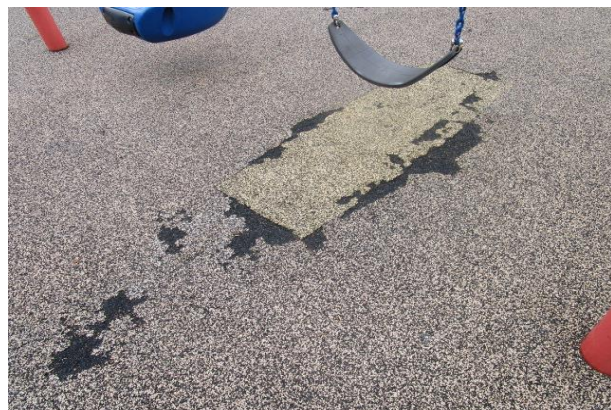
**8ft. Swing Set - Surfacing has large holes - MAINTENANCE**

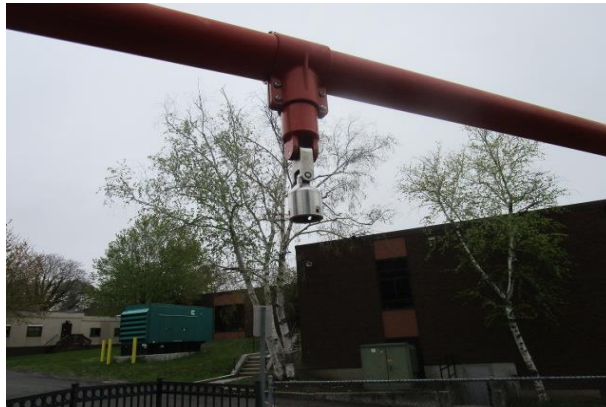
**7ft. Tire Swing (Landscape) - Tire Swing seat is missing - MAINTENANCE**

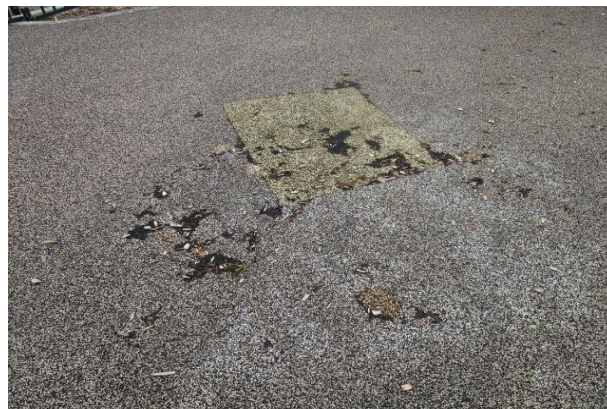
**Tire Swing - Holes in the PIP surfacing - MAINTENANCE**

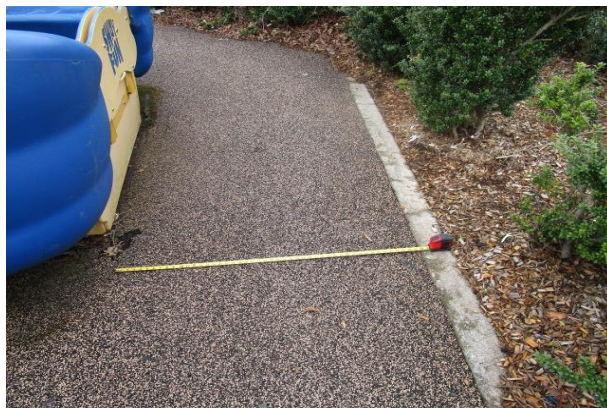
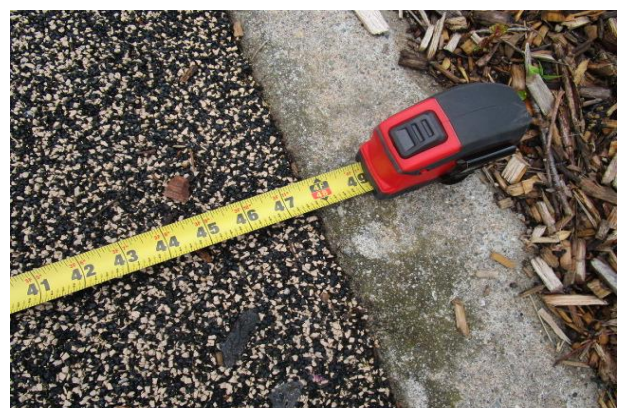
**Sway Fun Glider - Use zone inadequate at 48" at rear - CLASS C HAZARD**

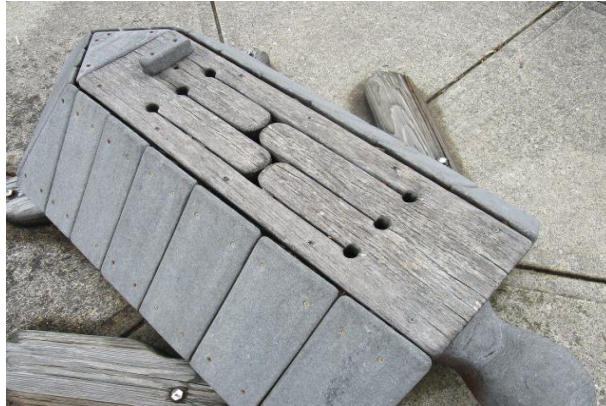
**Turtle (SoundPlay) - Music component missing - MAINTENANCE**

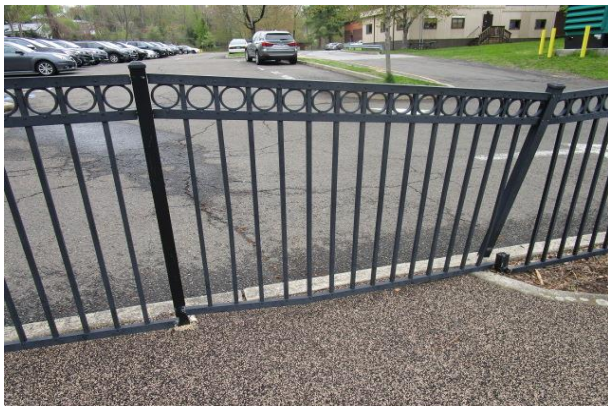
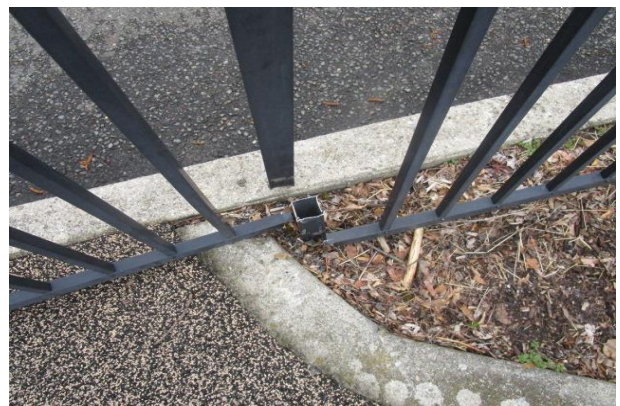
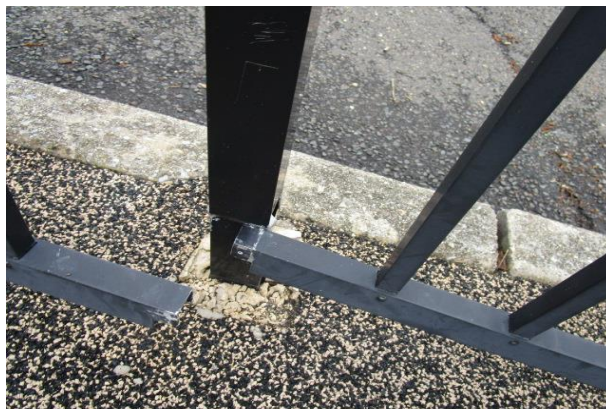
**Fence - Three sections of 4ft. metal fence damaged - MAINTENANCE**

<b>Condition</b>	<b>Hazard Priority</b>	<b>Recommendation</b>
Structural Stability	Good		
<b>Environment</b>			
Traffic or Fence hazard	Three sections of 4ft. metal fence damaged	Maint.	Repair three sections of fence

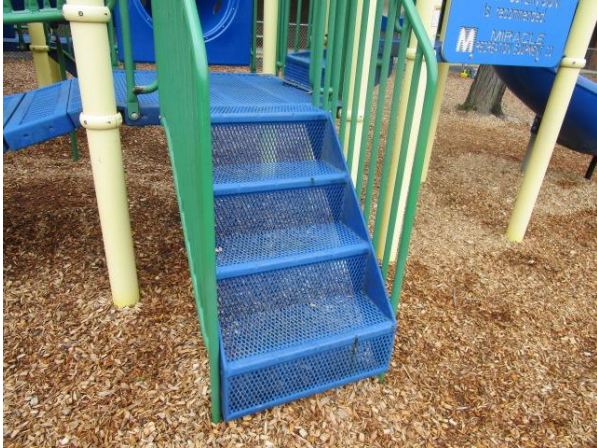
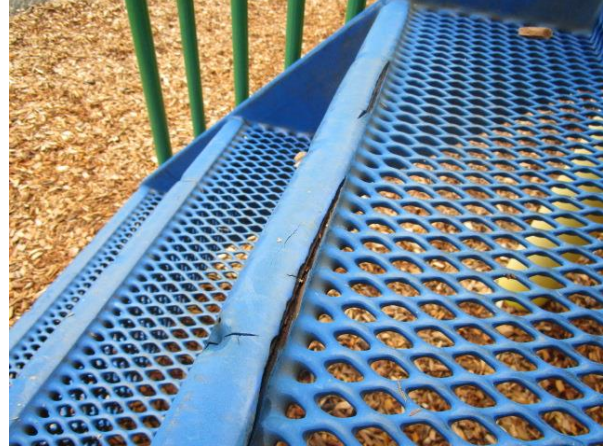
**Small Composite Structure (Miracle Recreation)**  
**Stairs (2) - Plastisol cracked & worn at one - MAINTENANCE**

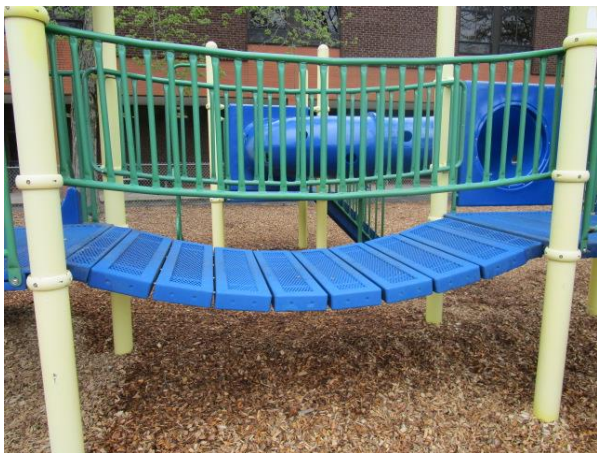
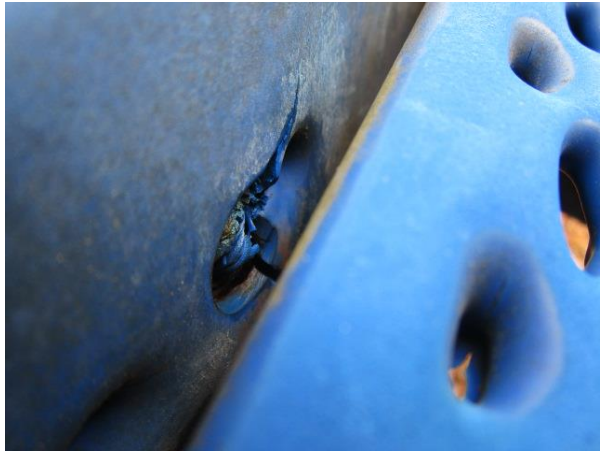
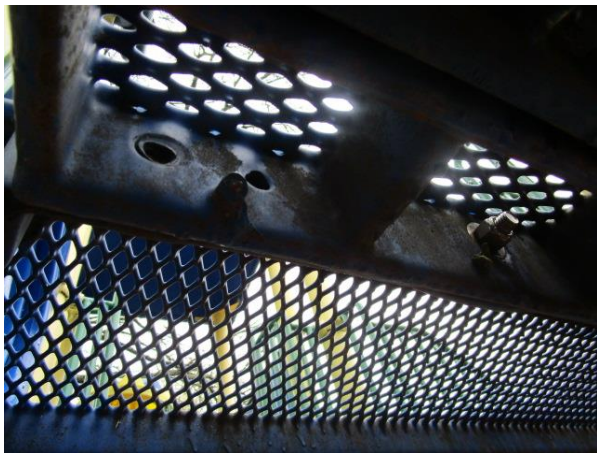
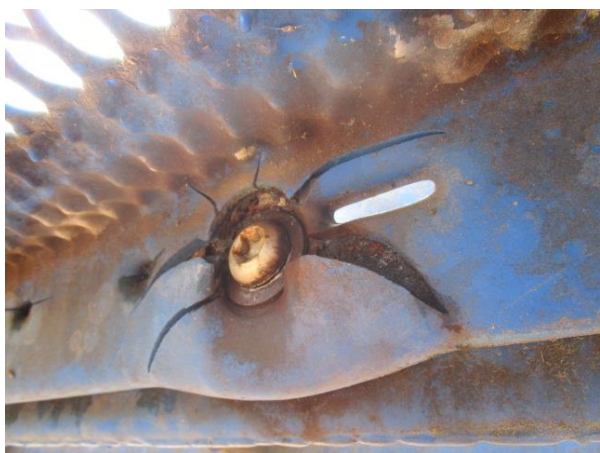
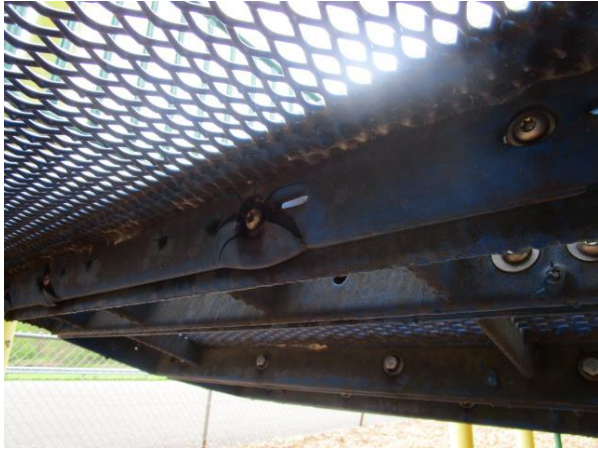
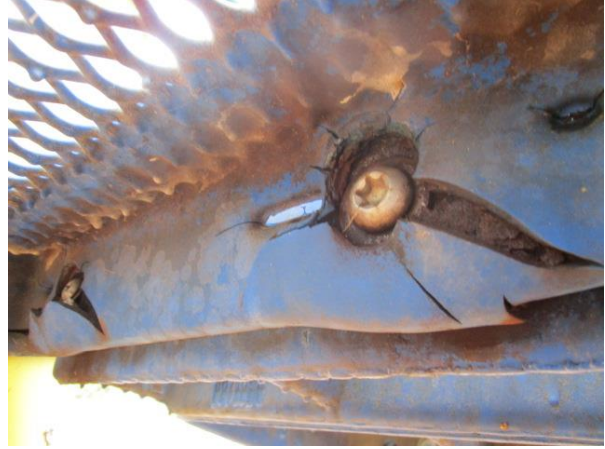
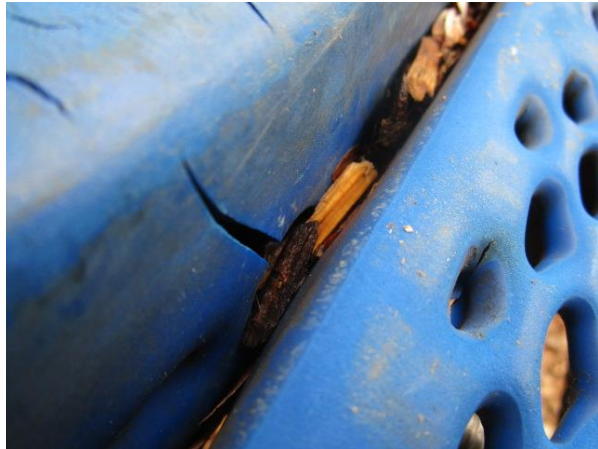
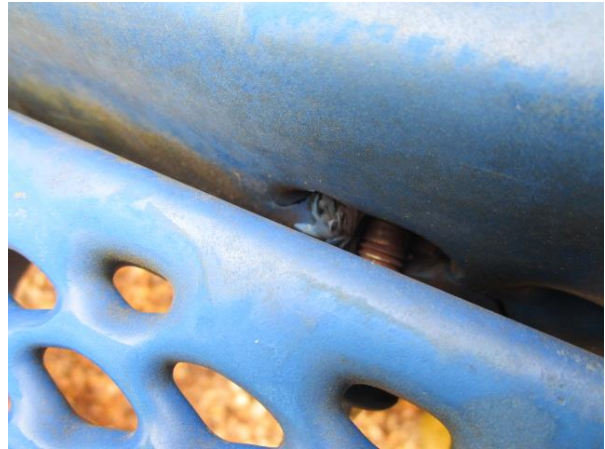
**Suspension Bridge - One bolt at deck attachment, worn at deck attachment - CLASS A HAZARD**

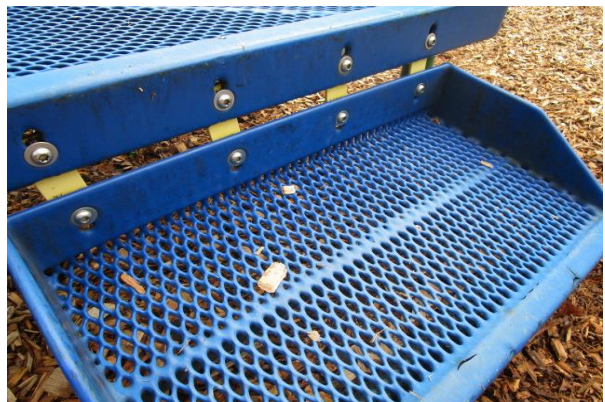
**Transfer Platform - Step loose & plastisol worn - MAINTENANCE**

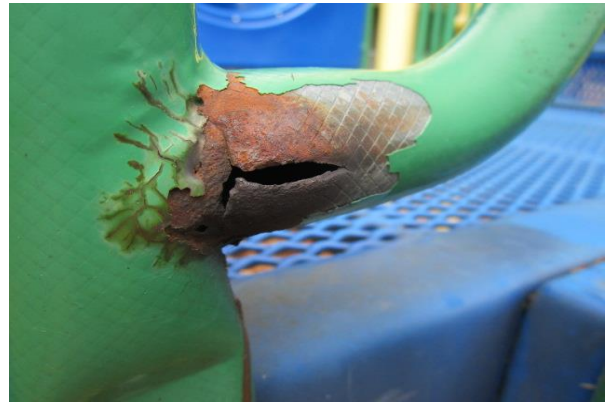
**Pipe Barriers - One handhold cracked - CLASS B HAZARD**

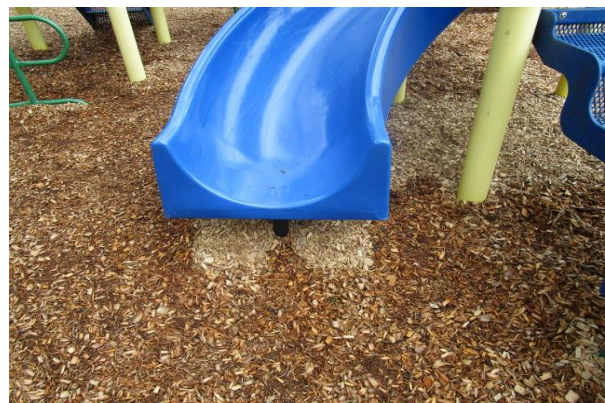
**There are no wear mats at the slide exits of the medium composite. ADA requires wear mats for accessibility and the prevention of holes at the slide exits.**

**Surfacing - No wear mats at slide exits - CLASS C HAZARD**
