Infrared Thermographic Roof Moisture Analysis

LOCATION: Davenport Ridge Elementary
Stamford, CT

CONDUCTED ON: April 24 & 25, 2019

PERFORMED BY: Tim Moughty, Certified Thermographer

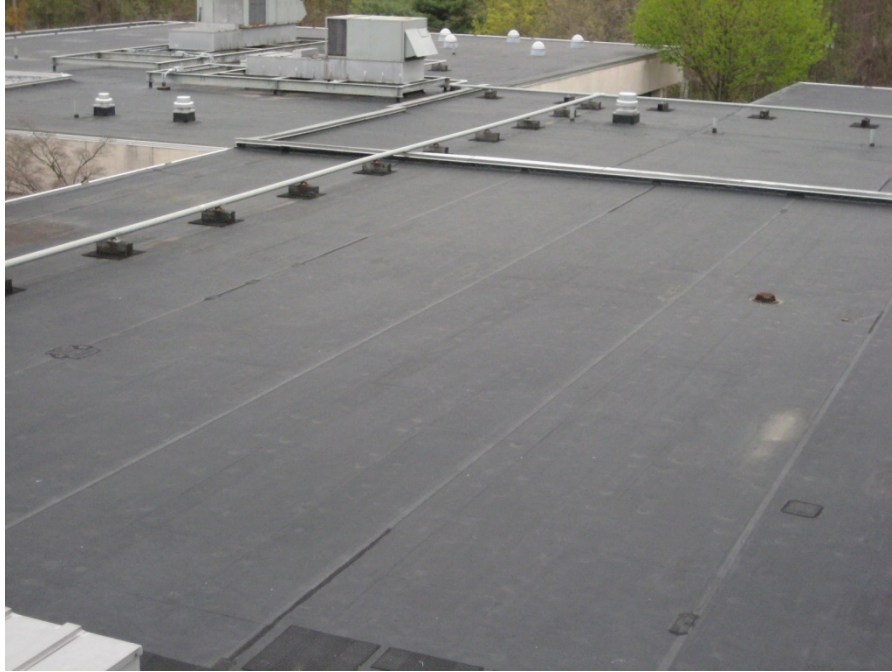
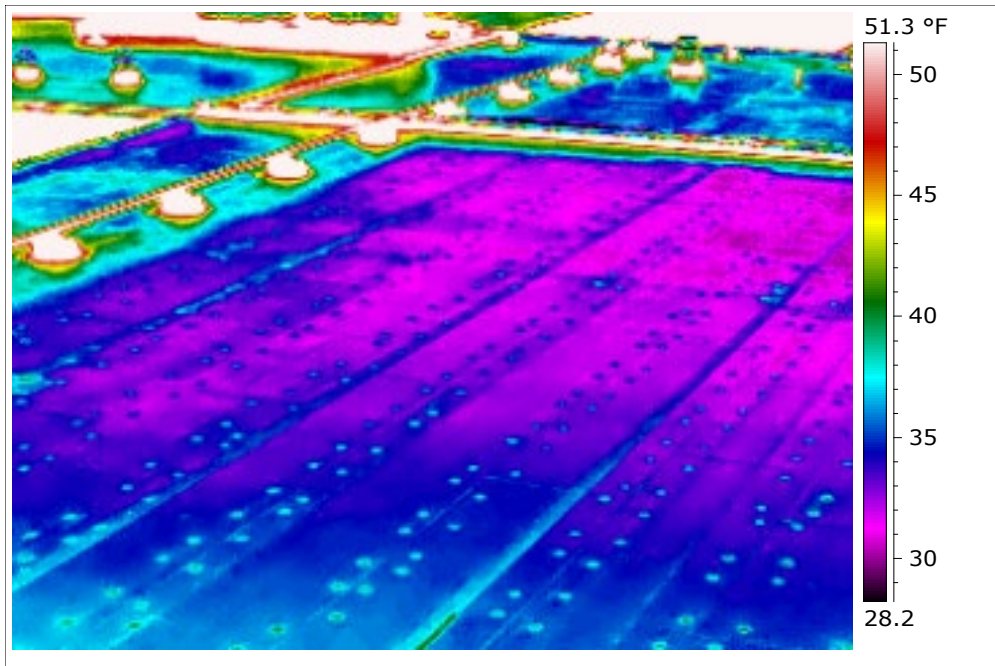
Thermogram # 1

Dry area of roofing

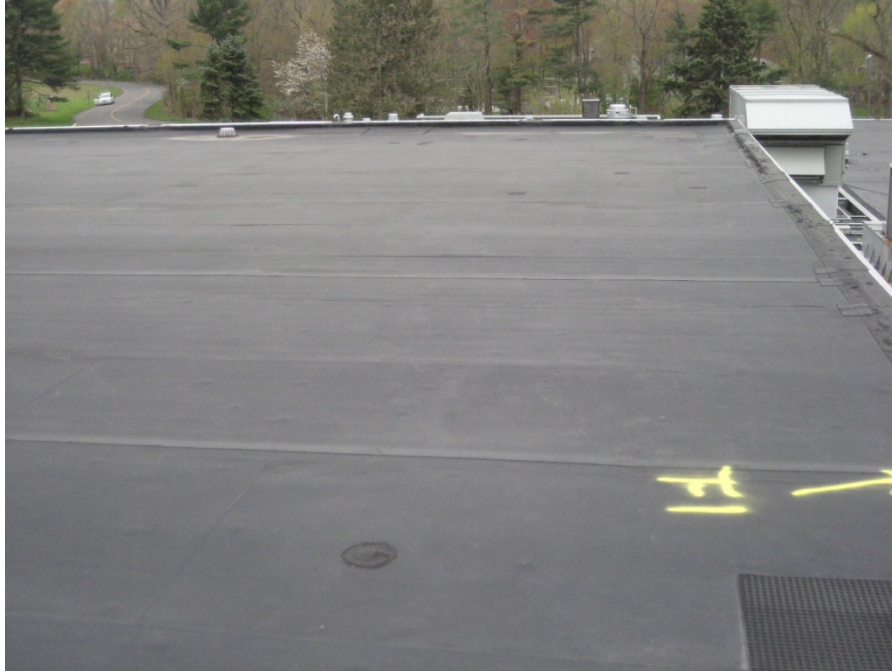
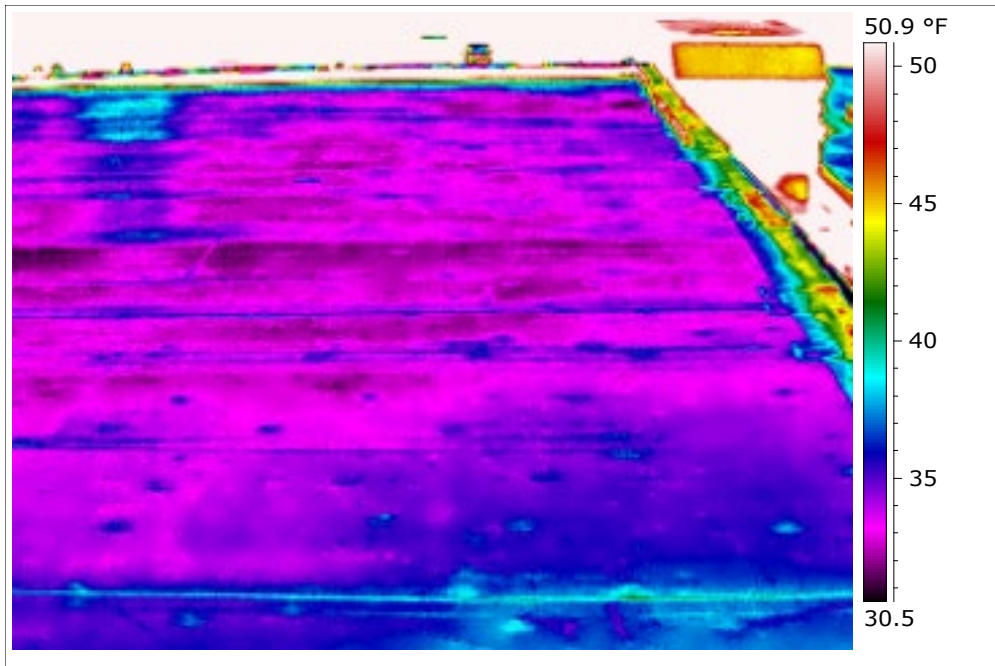
Thermogram # 2

Dry area of roofing

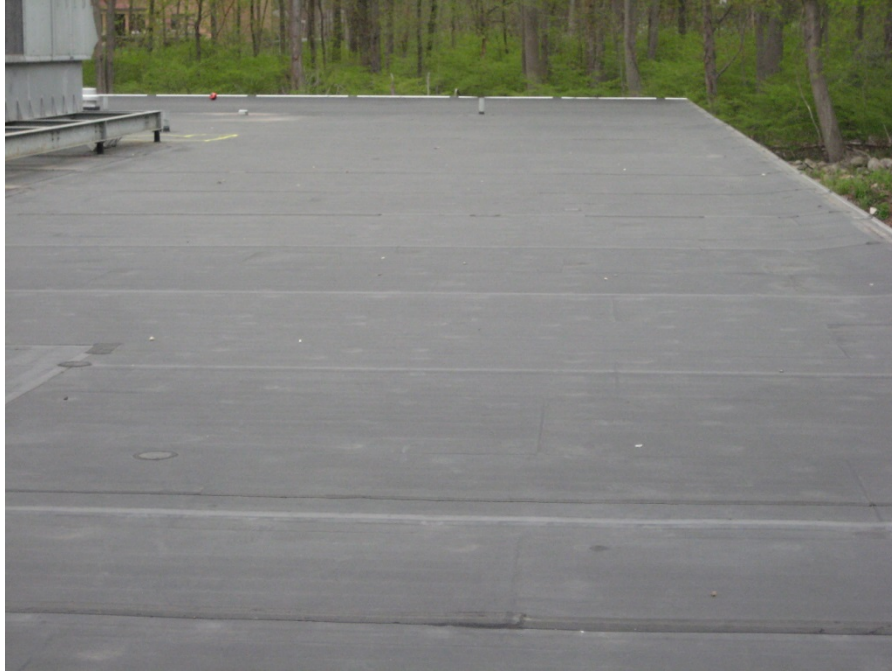
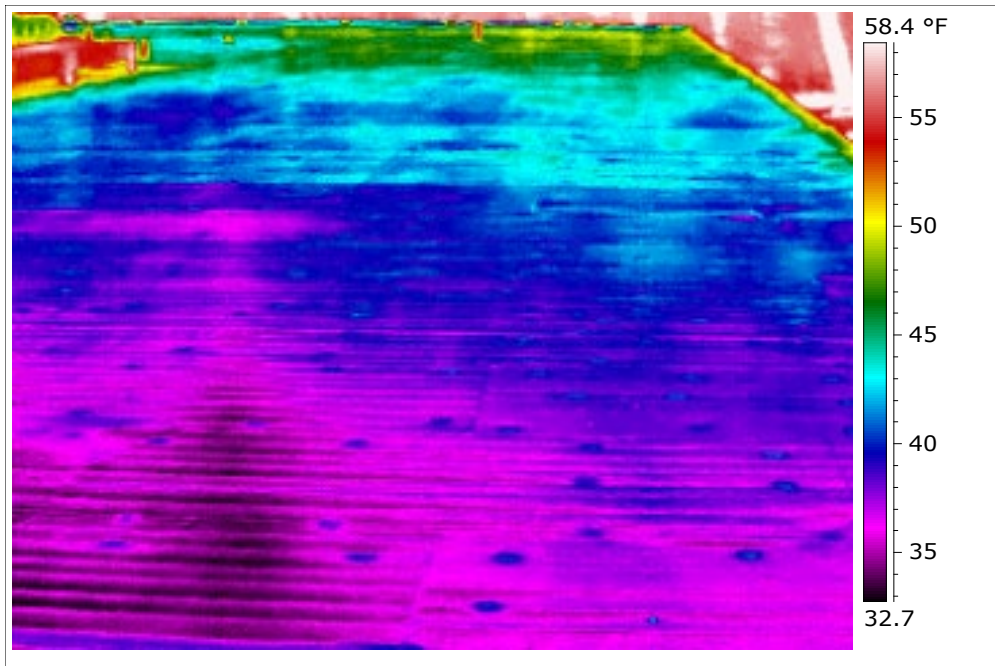
Thermogram # 3

Dry area of roofing

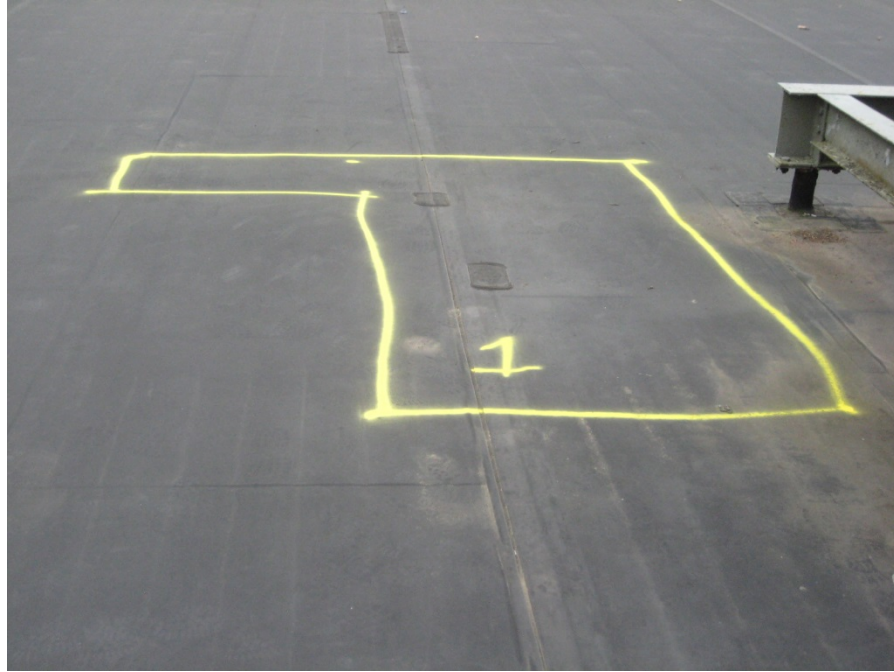
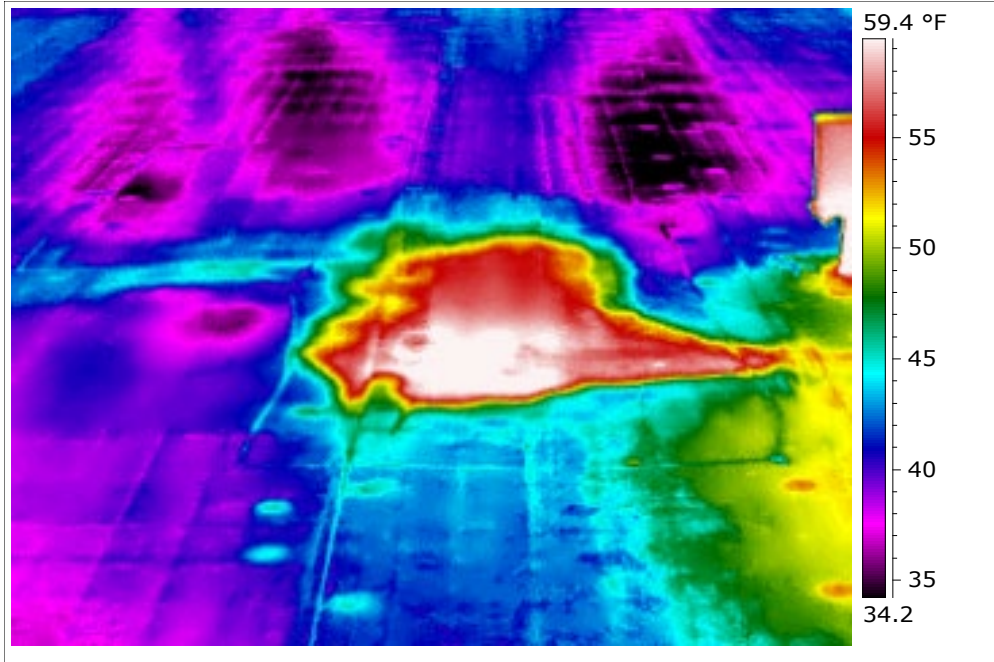
Thermogram # 4

Wet Area # 1

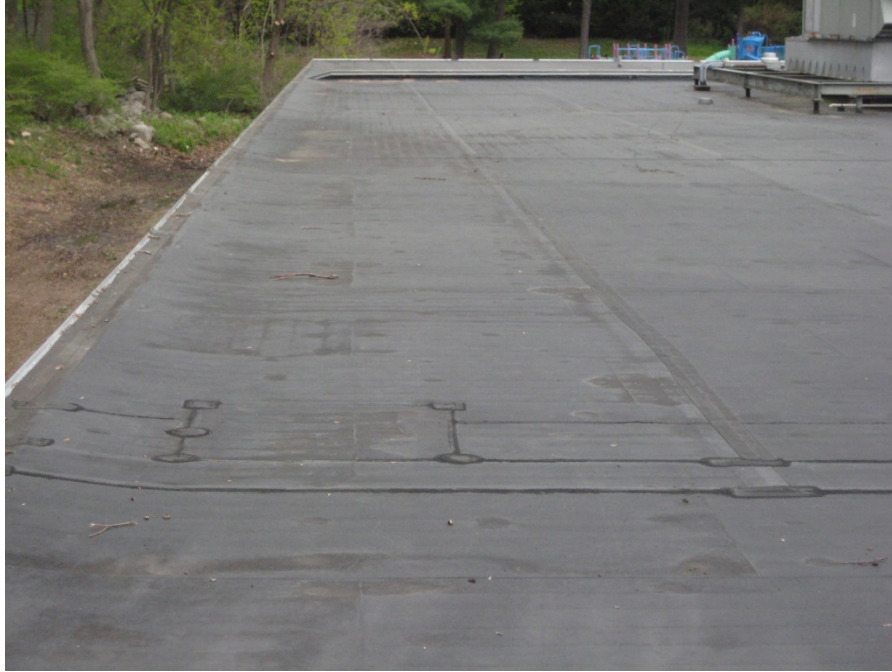
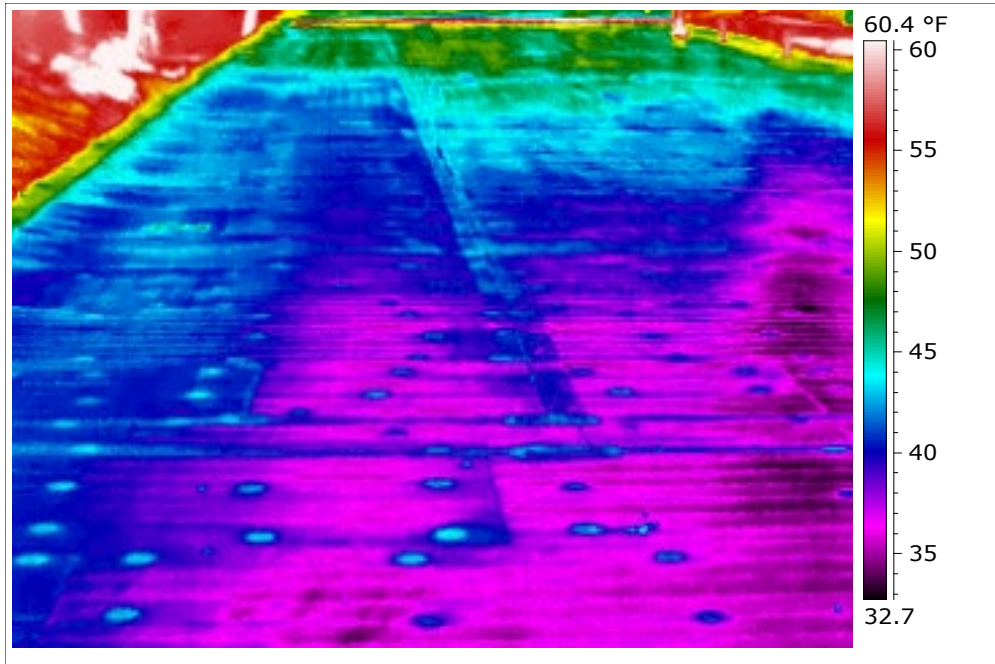
Thermogram # 5

Dry area of roofing

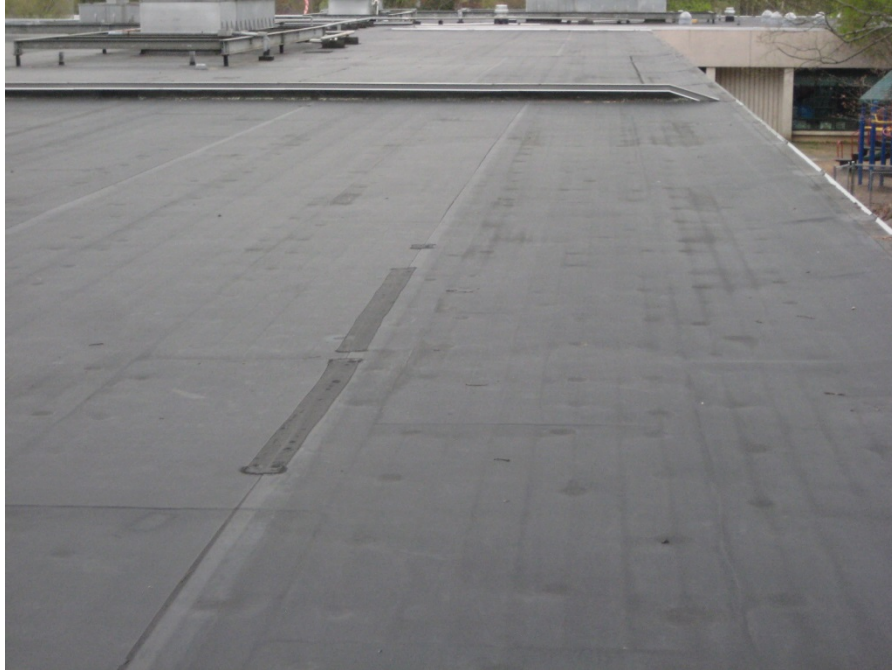
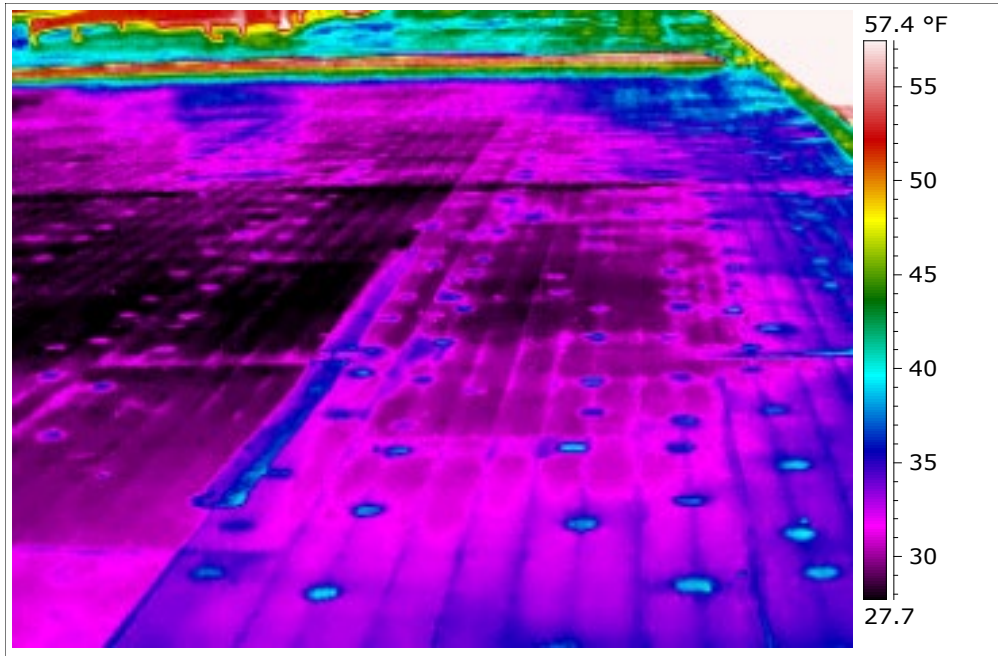
Thermogram # 6

Dry area of roofing

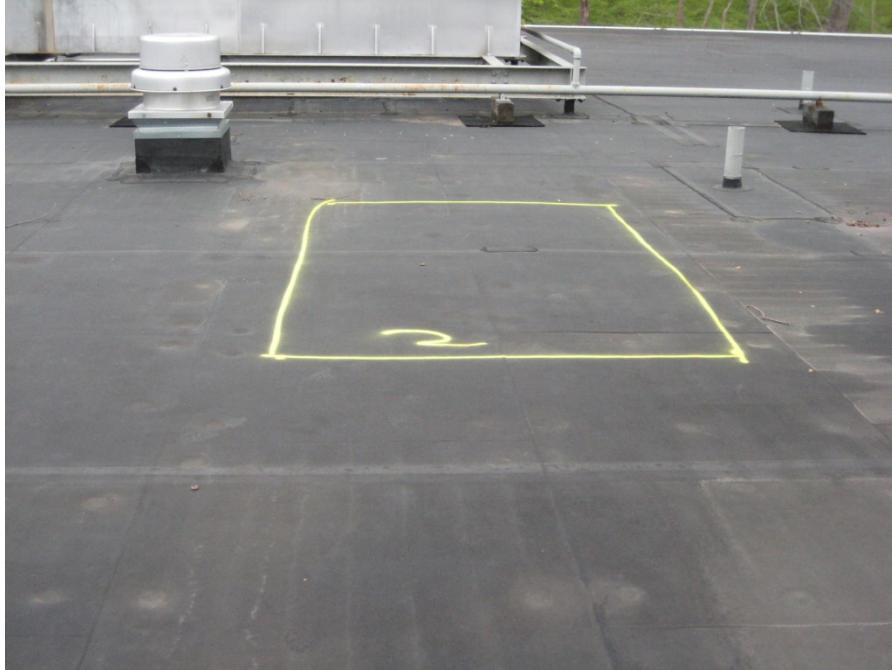
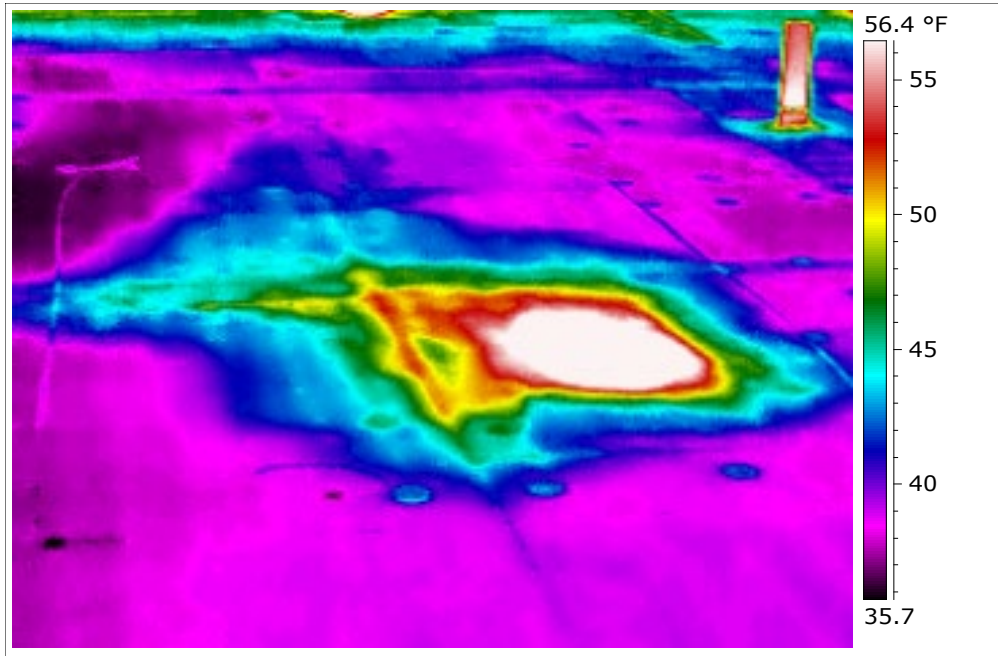
Thermogram # 7

Wet Area #2

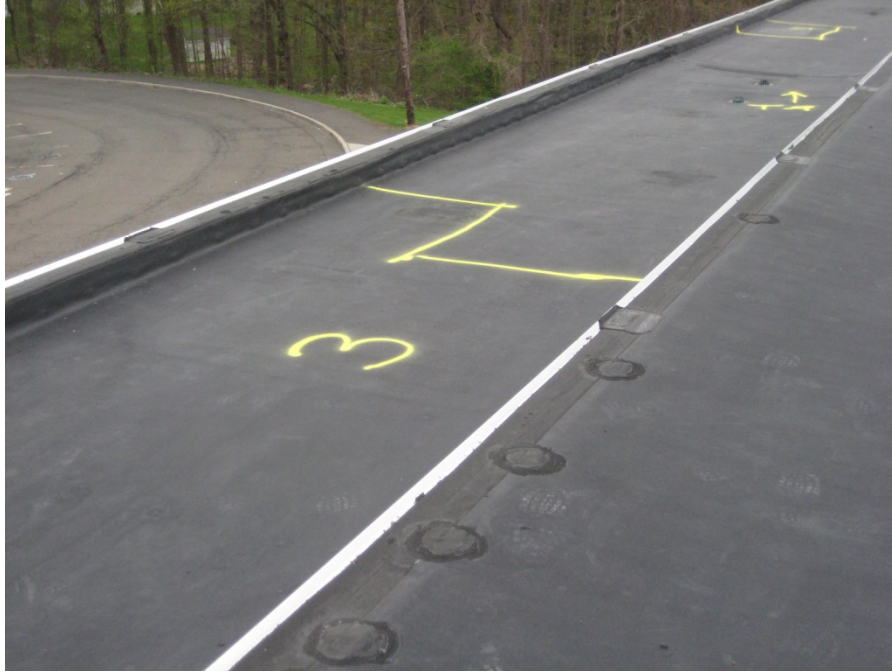
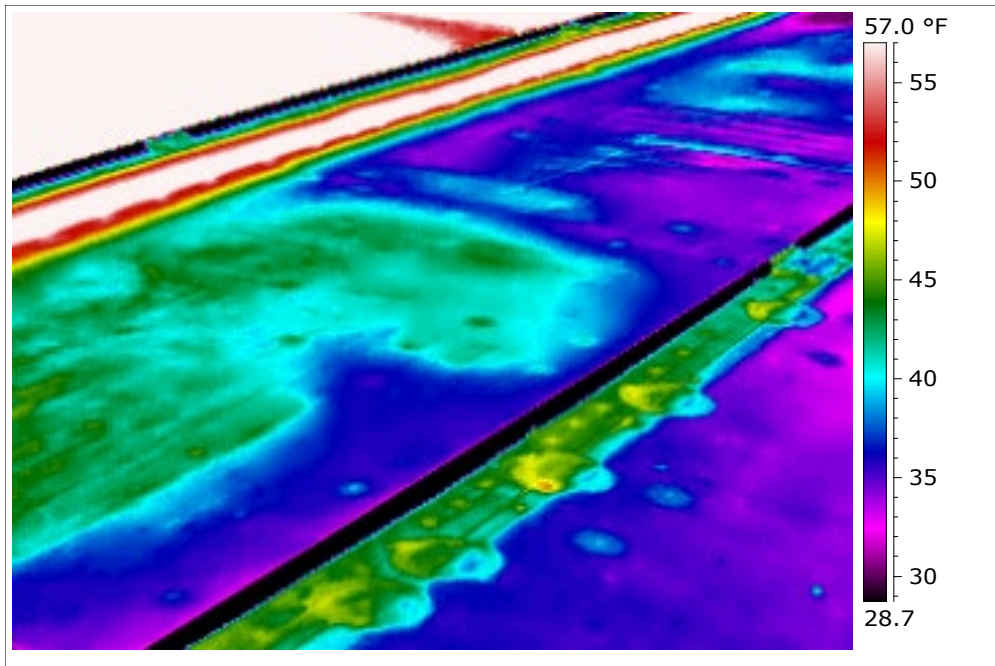
Thermogram # 8

Wet Area #3

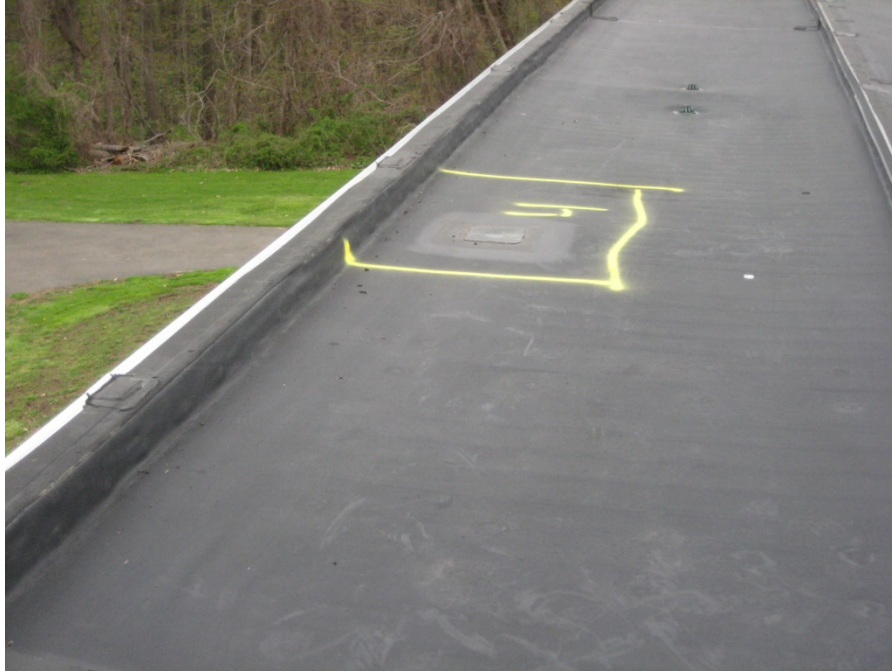
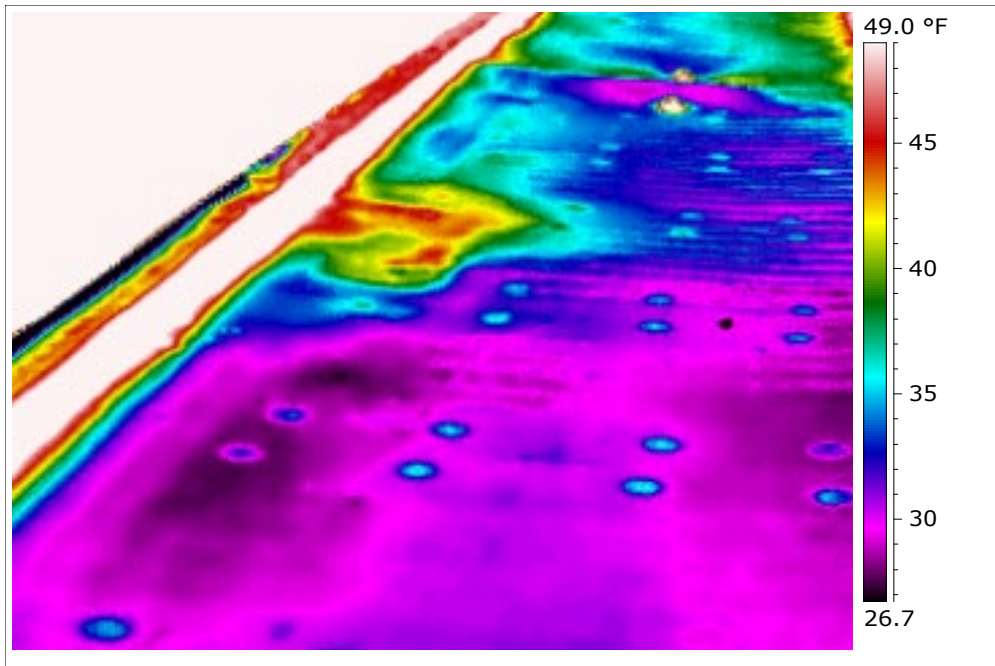
Thermogram # 9

Wet Area #4

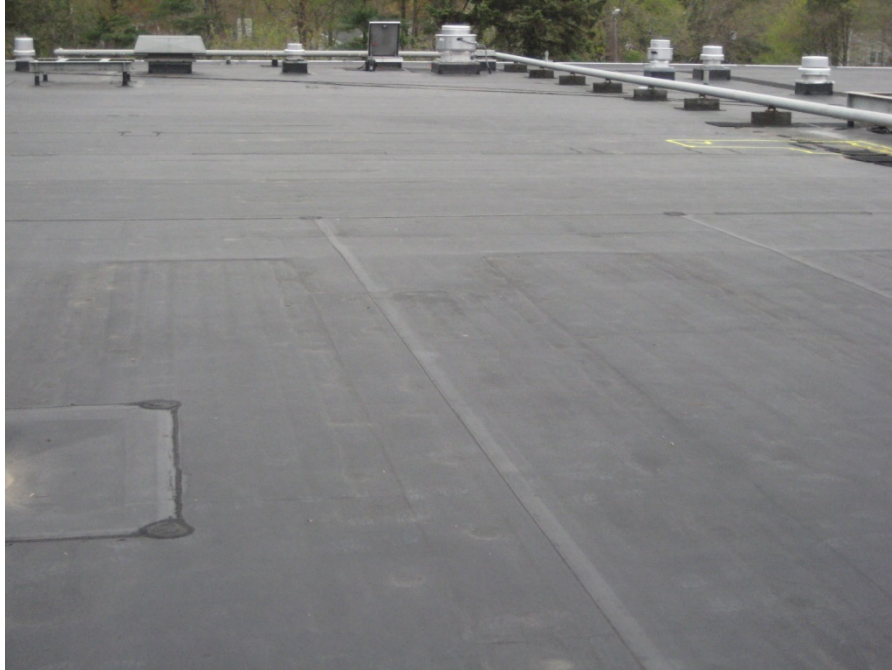
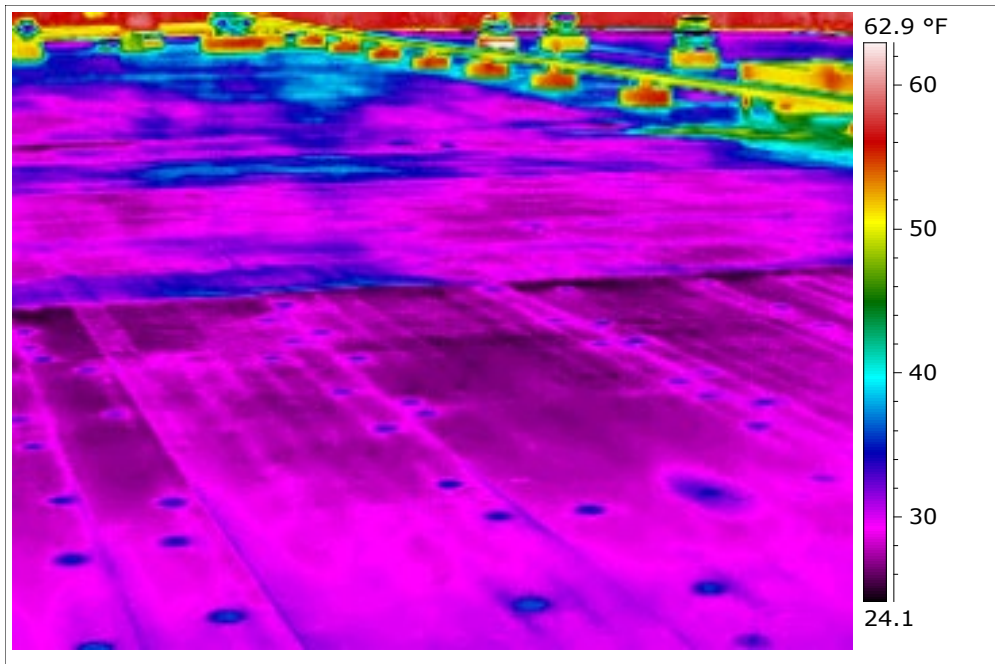
Thermogram # 10

Wet Area #7
