Infrared Thermographic Roof Moisture Analysis

PERFORMED FOR: Viking Construction
1387 Seaview Ave.
Bridgeport, CT 06607

LOCATION: Hart Magnet Elementary
Stamford, CT

CONDUCTED ON: May 16 & June 4, 2019

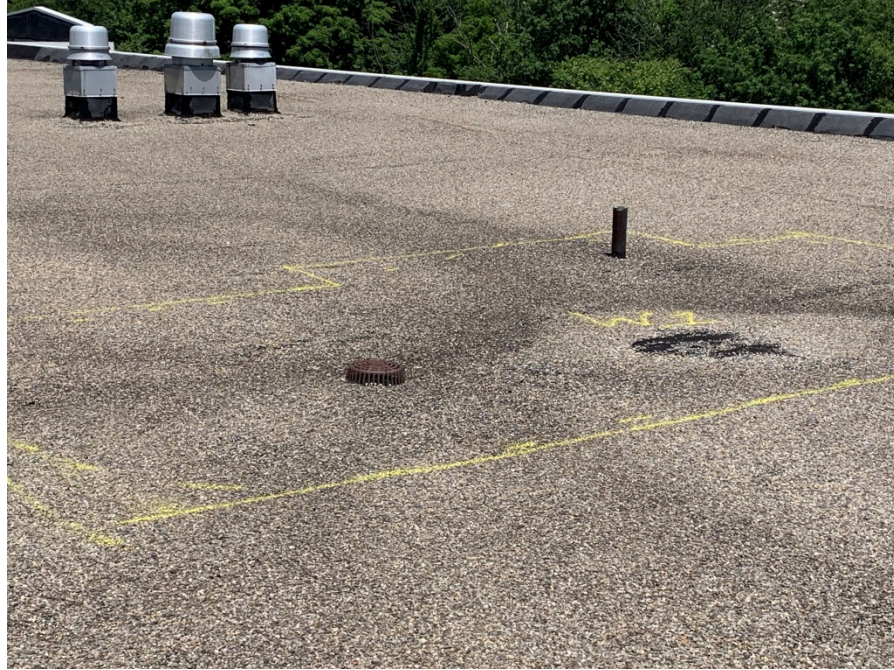
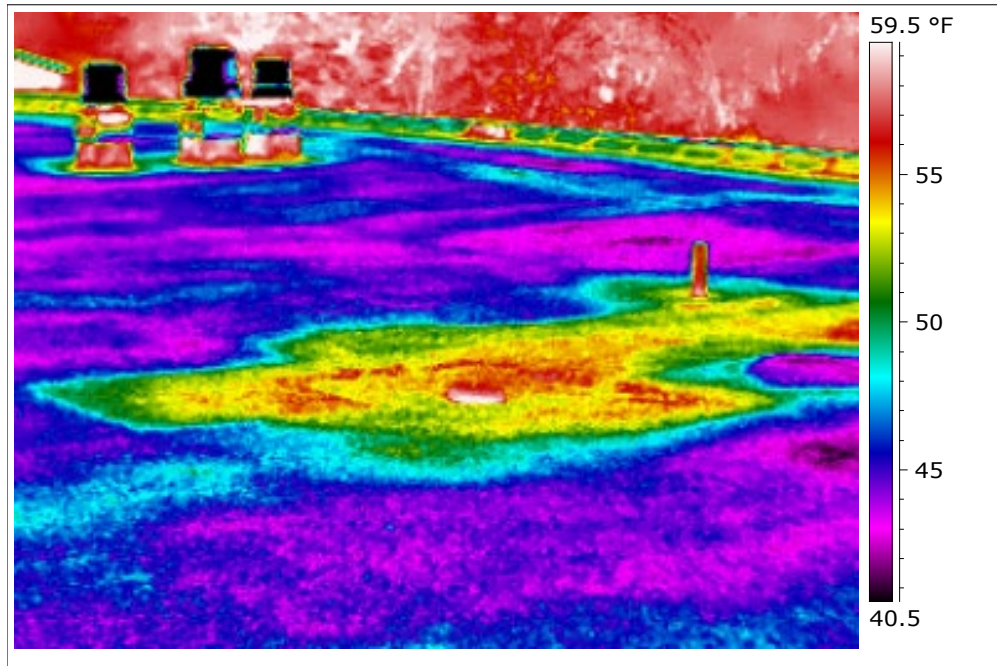
Thermogram # 1

Wet Area #1

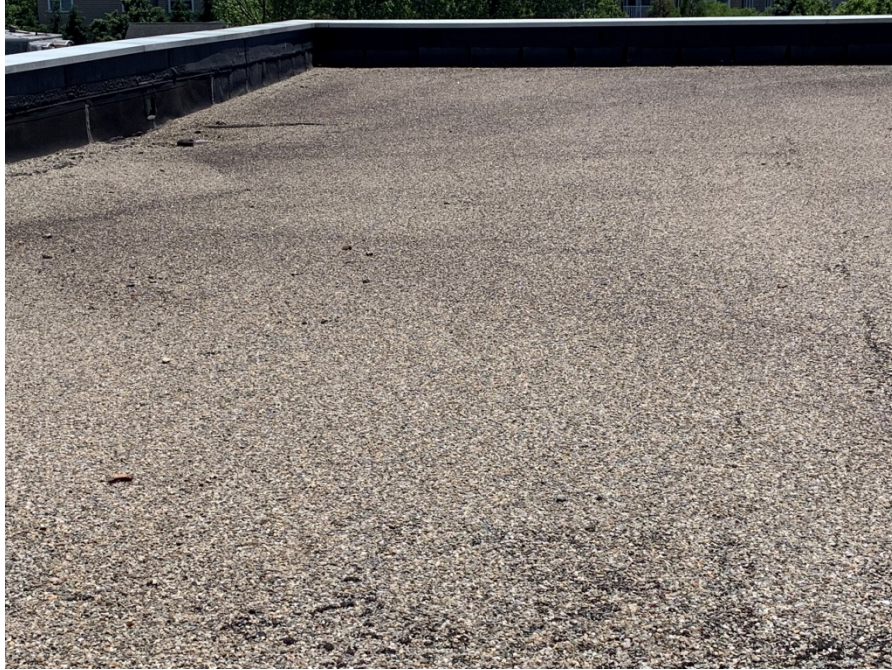
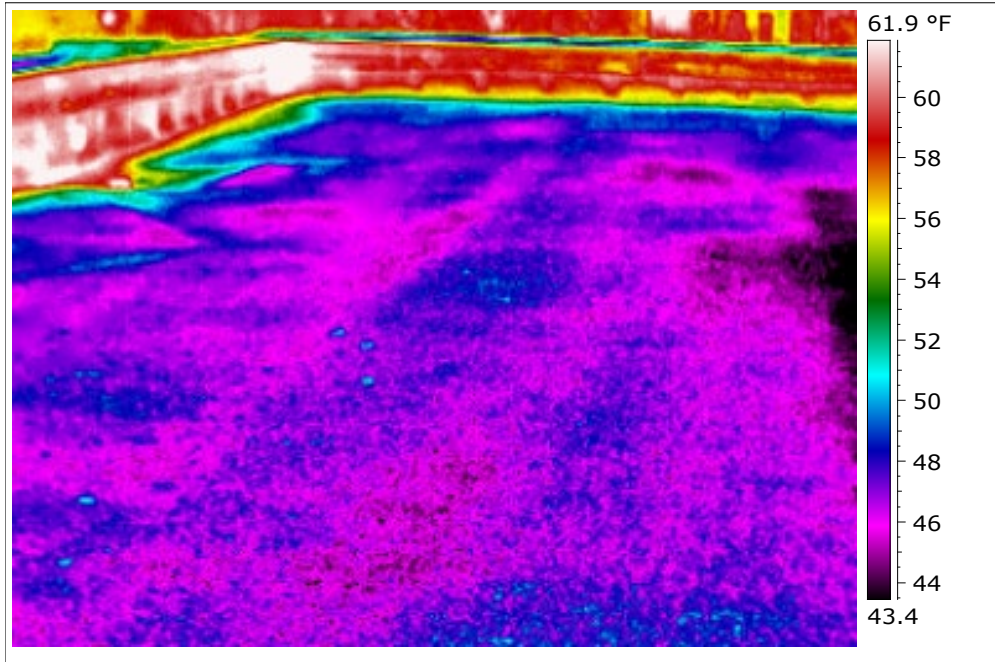
Thermogram # 2

Dry area of roofing

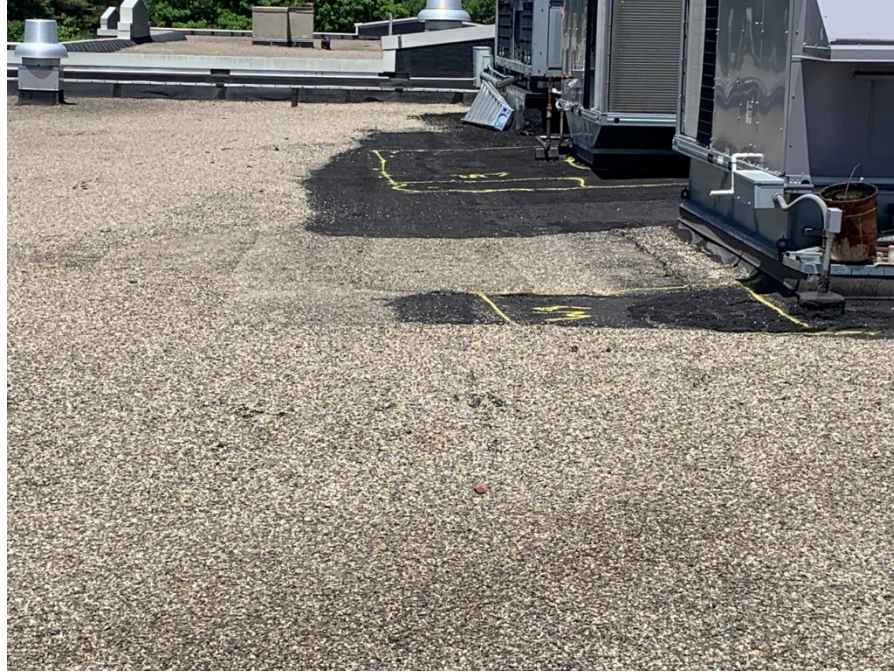
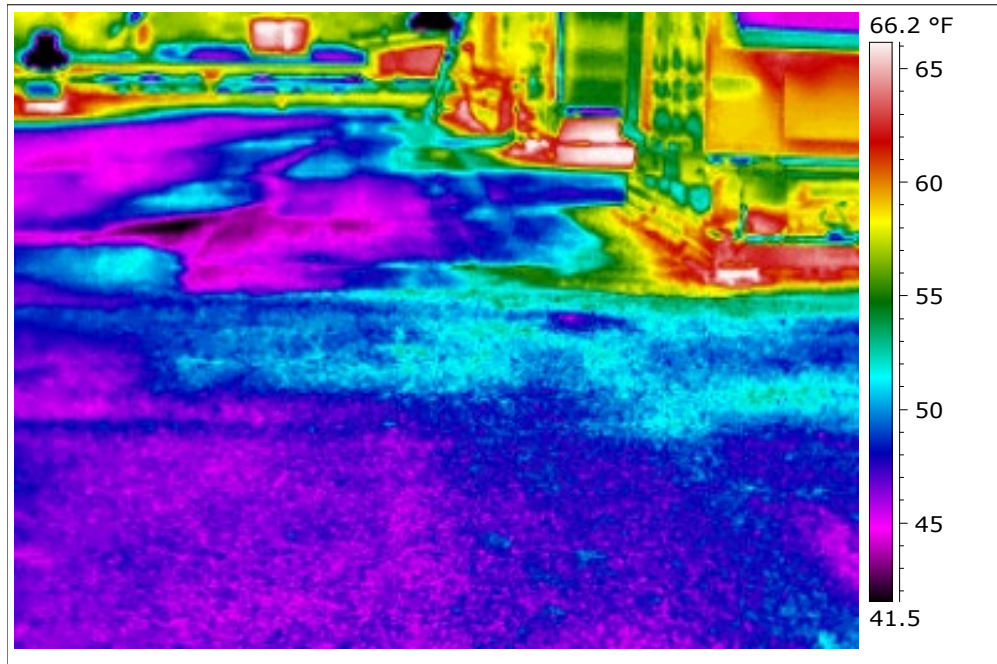
Thermogram # 3

Wet Areas #4 & 5

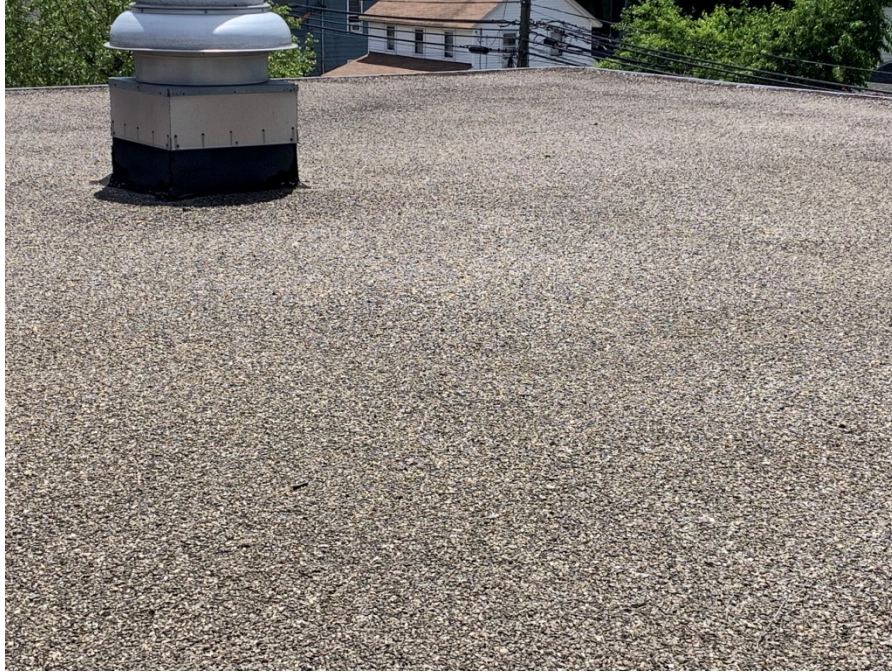
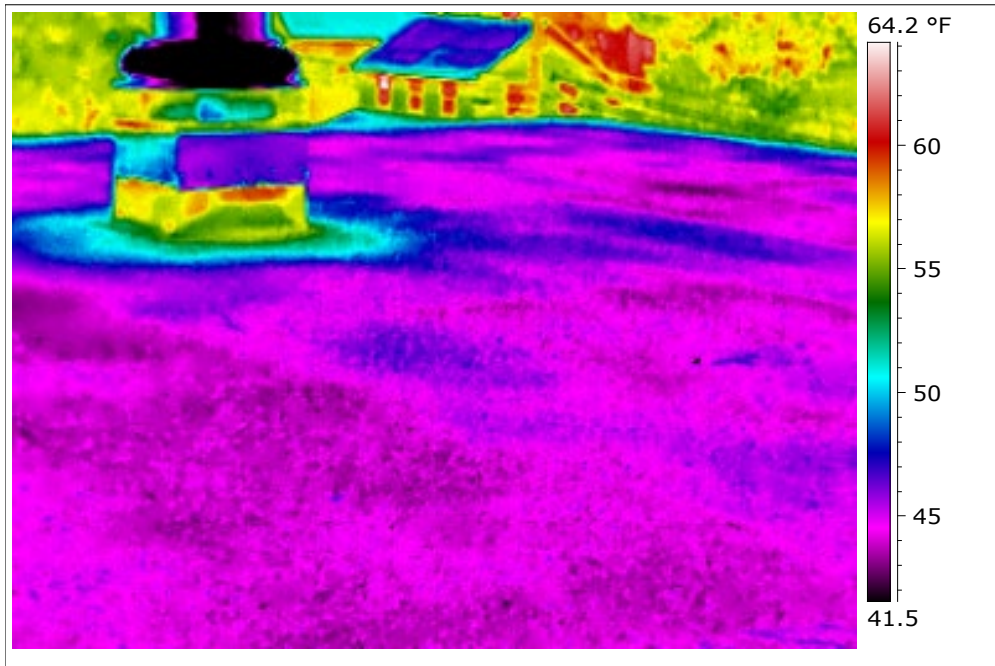
Thermogram # 4

Dry area of roofing

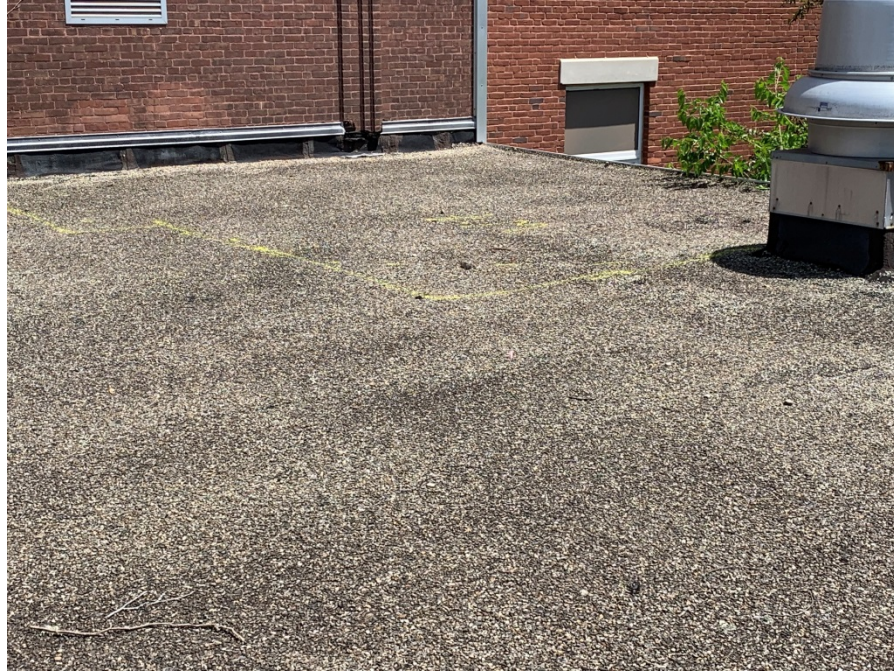
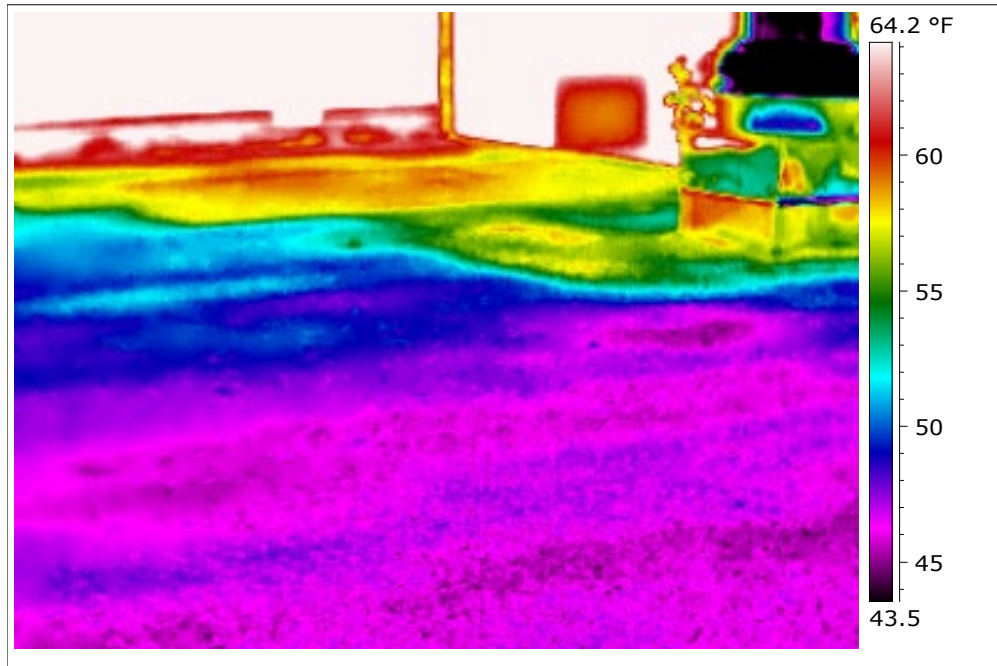
Thermogram # 5

Wet Area #7

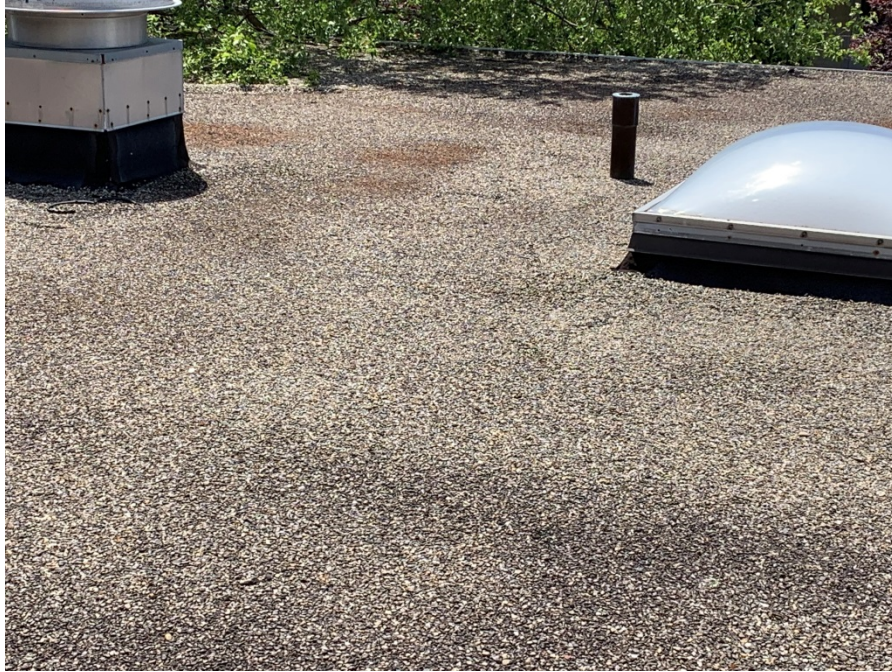
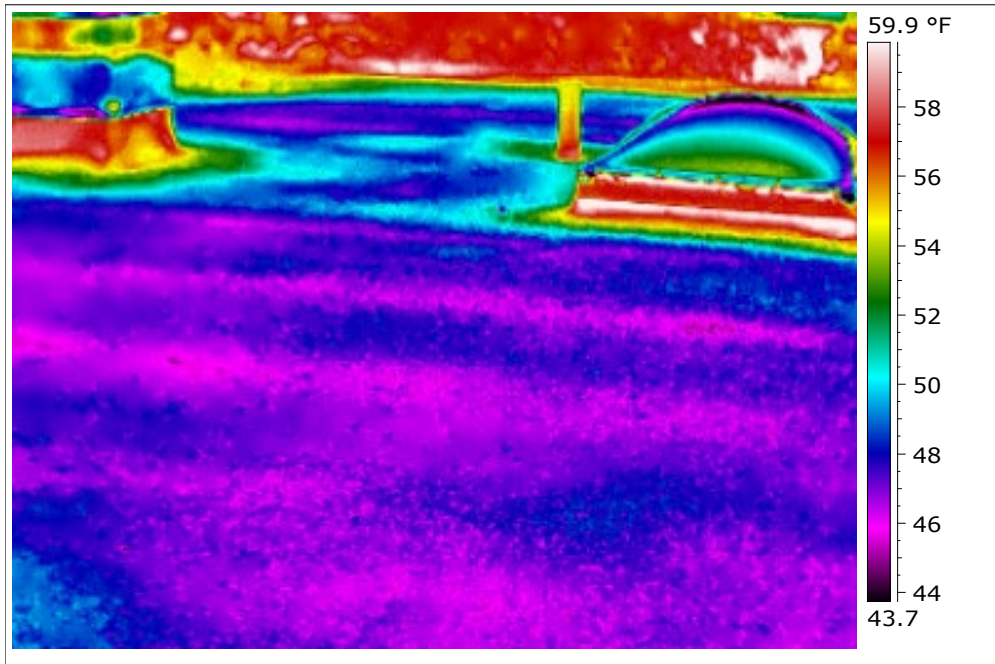
Thermogram # 6

Dry area of roofing
