**INFRA-RED ROOF MOISTURE ANALYSIS**

VIKING CONSTRUCTION  
 BRIDGEPORT, CT  
 ACADEMY OF INFORMATION TECH. & ENG.  
 STAMFORD, CT

SCALE:	1/16"=1'-0"
DATE:	05-15-19
PAGE:	1 OF 1
DRAWN BY:	DMR
JOB#:	19231X20

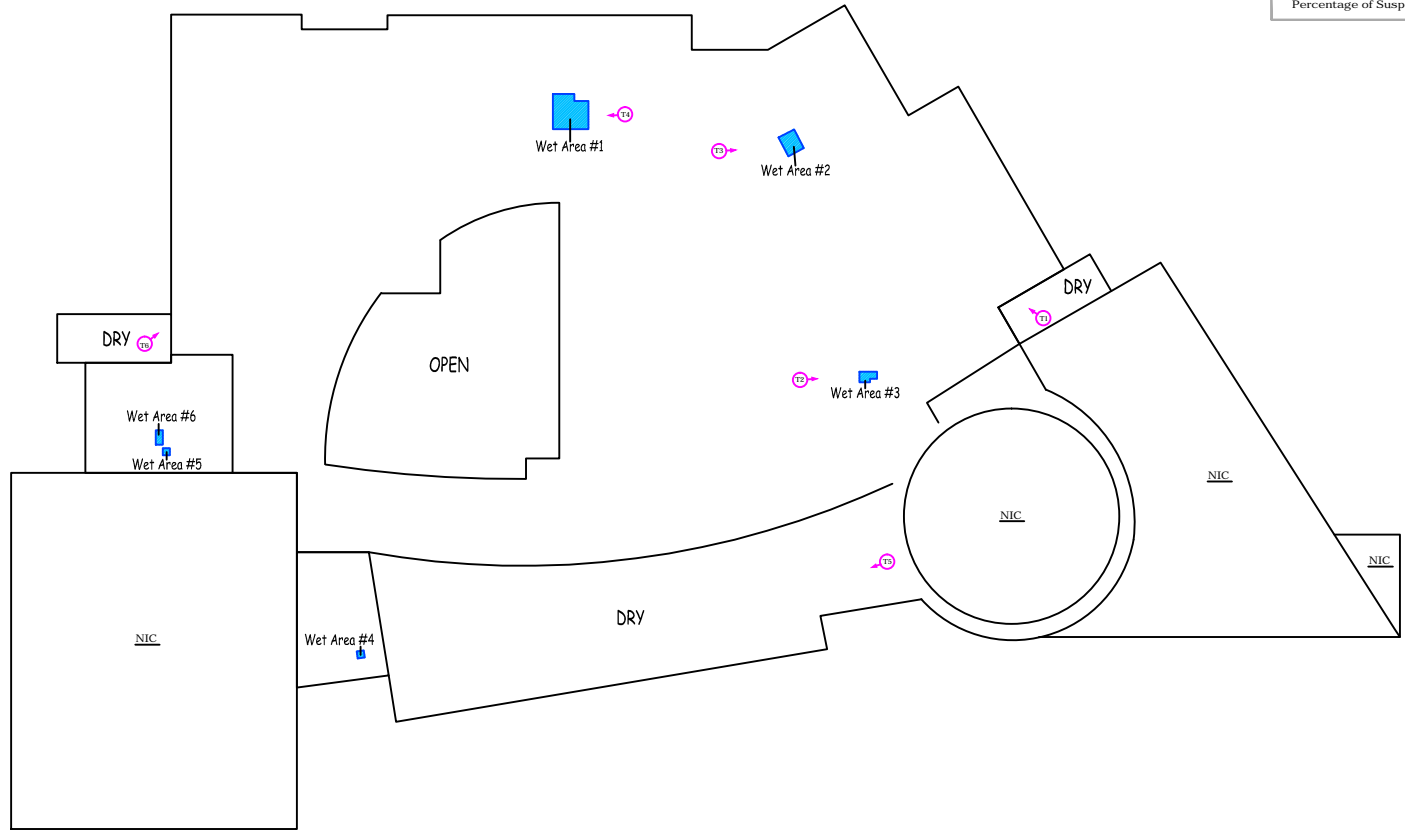
Areas: Total of All Roofs		
<small>(in approximate square feet)</small>		
Square Footage of Roof Inspected:		37,705
Square Footage of Suspected Wet Area:		151
Percentage of Suspected Wet Area:		<1%
