January 31, 2024

CITY OF
Stamford
CONNECTICUT

Reporting Period 7/1/2022 – 6/30/2023

CT DEEP National Pollutant Discharge
Elimination System Permit for the Discharge
of Stormwater from Municipal Separate
Storm Sewer Systems (MS4)

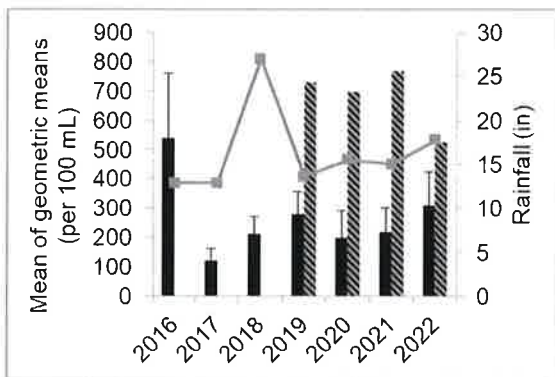
Figure 10.1. (Top) Mean of freshwater site geomeans (black bars) and saltwater site geomeans (striped bars) from 2016-2022 and total rainfall from May through September each year (grey squares and line).

Figure 10.2. (Right) Geomean of bacteria concentrations at each site in 2022.

Indicator bacteria: In 2022, observed mean freshwater concentrations were slightly elevated above historic levels, but mean saltwater concentrations were slightly decreased (Figure 10.1). Bacteria concentrations at 6 of the 8 sites on the Noroton River exceeded the CT DEEP geomean criteria (Figure 10.2). Additionally, 32% of all samples processed exceeded the CT DEEP single sample maximum criteria (Table 10.1). Harbor Watch has historically worked with both the City of Stamford and Town of Darien to pinpoint sources of pollution to the River. At this time, no sources have been identified, but we continue to partner with both municipalities to investigate the reason for these elevated concentrations.

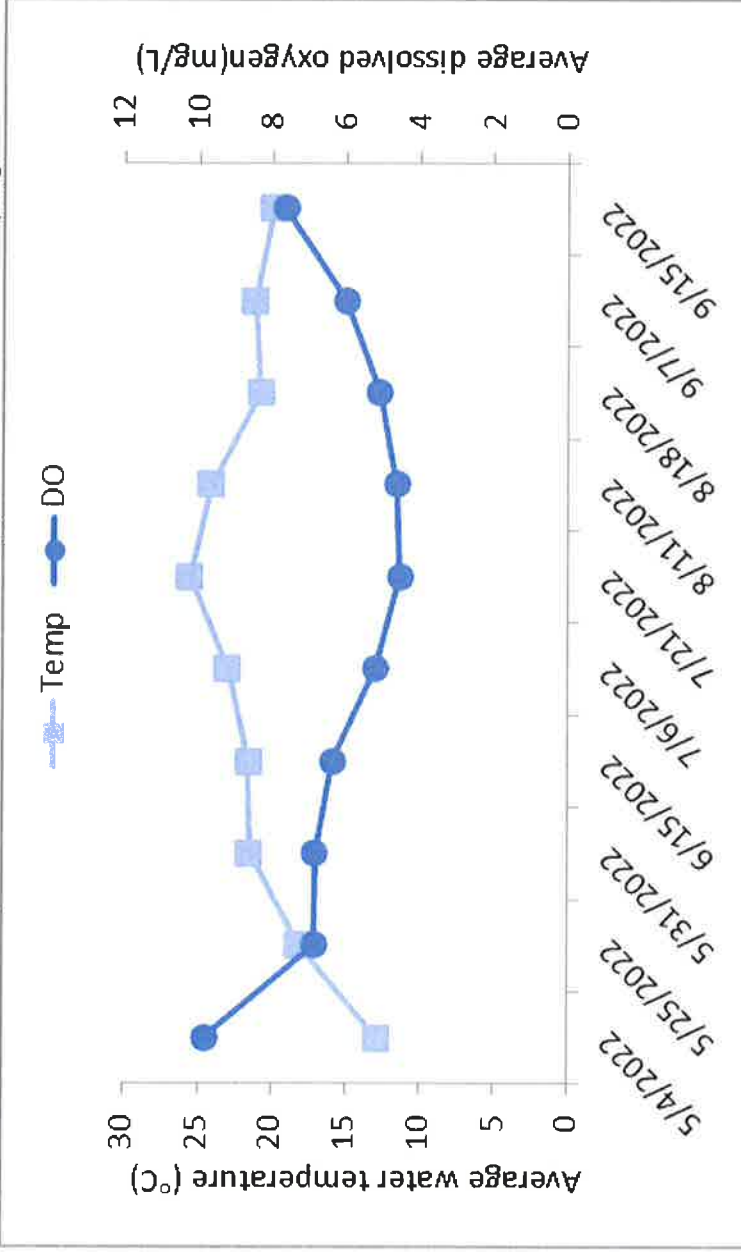
Figure 10.4. Mean water temperature and mean dissolved oxygen of all sites on each sampling date in Noroton River.

Dissolved oxygen and water temperature: Dissolved oxygen readings varied at each site throughout the watershed (Figure 10.3). While the majority of individual dissolved oxygen readings met the CT DEEP minimum criteria, 16 readings were observed below 5 mg/L at every freshwater site at least once, except Noroton 3, and three readings were observed below 3 mg/L at saltwater site Noroton 1. The highest frequency of low readings was observed at site Noroton 8 (80% of the time). High water temperatures in the summer months were a contributing factor to the observed low dissolved oxygen readings during this time (Figure 10.4).

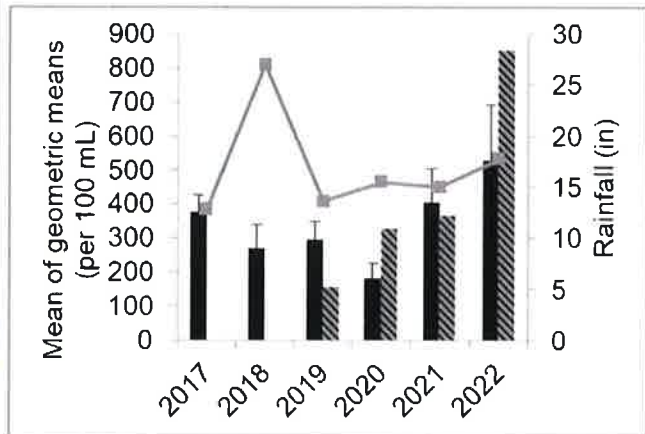
Figure 14.1. (Above) Mean of freshwater site geomeans (black bars) and saltwater site means (striped bars) from 2017-2022 and total rainfall from May through September each year (grey squares and line).

Figure 14.2. (Left) Geomean of bacteria concentrations at each site in 2022.

Indicator bacteria: Harbor Watch has been monitoring the Rippowam River since 2017, and concentrations within the watershed have been observed to increase slightly each of the last three years (Figure 14.1). Eight sites exceeded the CT DEEP geomean criteria for indicator bacteria (Figure 14.2). Additionally, 38% of all samples processed in the Rippowam River exceeded the CT DEEP single sample maximum criteria (Table 14.1).
