**MIANUS RIVER PARK  
STAMFORD  
FAIRFIELD COUNTY, CONNECTICUT**

**MIANUS RIVER RESTORATION:  
STREAM RESTORATION DESIGN**

Prepared For:  
Mianus Chapter Trout Unlimited  
P.O. Box 475  
Wilton, Connecticut

Prepared By:  
Trout Scapes River Restoration LLC  
280 W. Kagy Boulevard, Suite D #310  
Bozeman, MT 59715

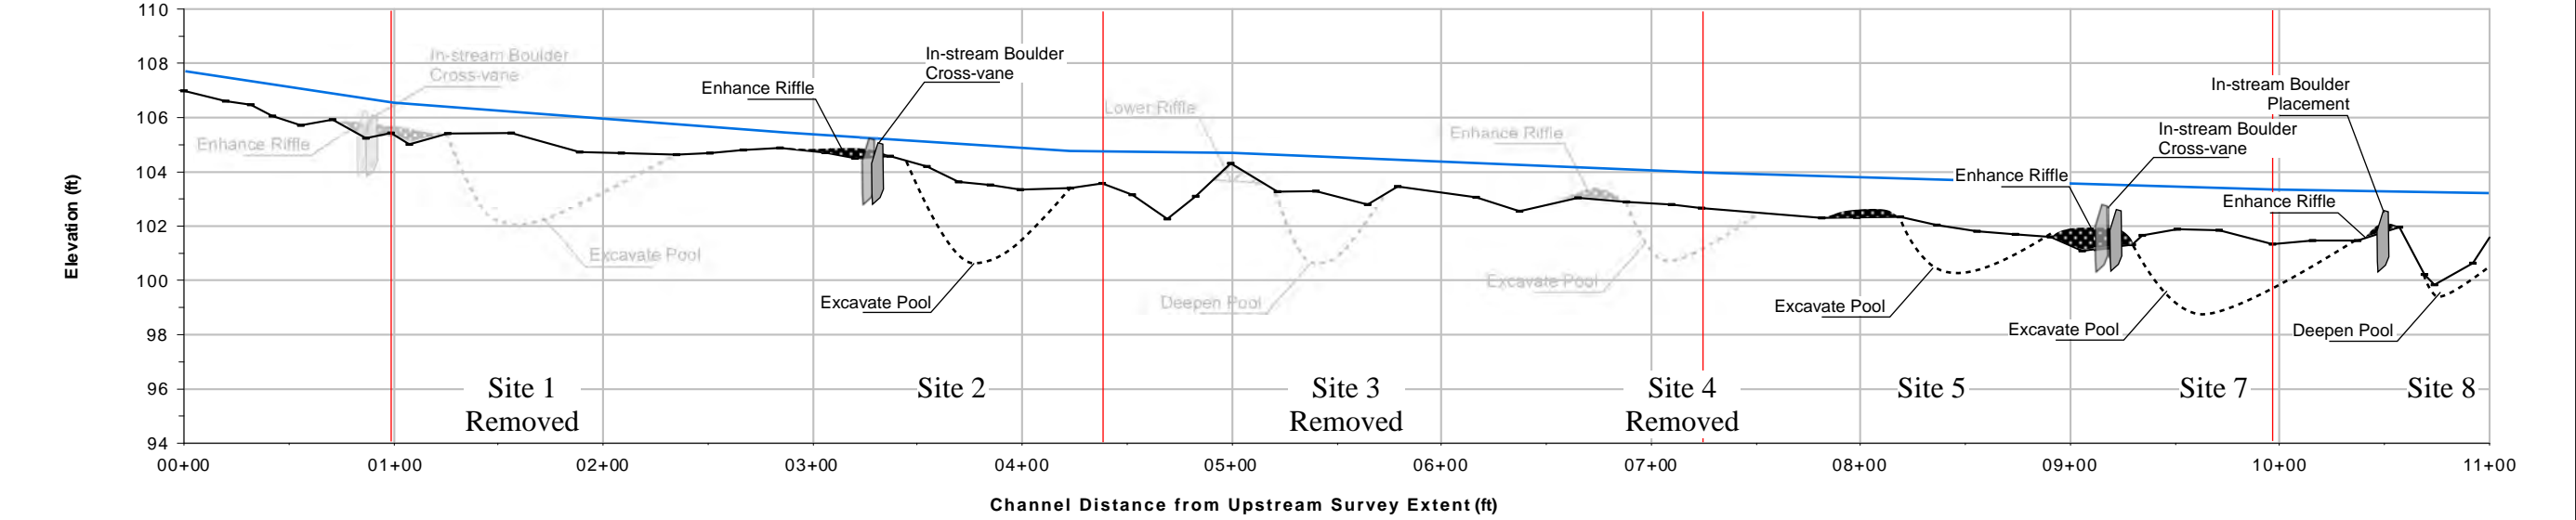
Figure 1. Reach 1 - Mianus River Restoration

MIANUS RIVER LONGITUDINAL PROFILE (00+00 - 11+00)

Site 2 (fig.1, sh.5) (03+05-04+22): Install boulder cross-vane (figs.14&15, sh.27) to stabilize channel and concentrate flow through the proposed pool. Excavate pool 3 feet below current stream bed, excavated material will be relocated to construct left bank bar (fig.10&11, sh.25) and enhance upstream riffle. Install wood and boulder habitat (figs. 8&9, sh.24) into the excavated pool. Anchor logs with imported boulders and vertical logs buried into the stream bed. Imported boulders will be used to construct the cross-vane. See Table 1 for material quantities. Cross-section 2 (sh.13) transects the proposed pool’s tail-out.

Site 5 (fig.1, sh.5) (07+85-08+90): Excavate pool 2 feet below current stream bed, excavated material will be relocated to enhance the upstream riffle.

Site 6 (fig.1, sh.5) (Tributary): Install three (3) boulder cross-vanes (figs.14&15, sh.27) in the Mianus River Tributary to prevent further stream channel degradation and promote sediment transport. Re-slope and reclaim 60 linear feet of the actively eroding right bank, replacing the woody debris revetment. Disturbed stream bank will be stabilized with erosion control matting and seeded with a native seed mix. Cross-section 4 (sh.14) transects the proposed stream bank stabilization location. Imported boulders will be used to construct the cross-vanes, see Table 1 for material quantities.

Site 7 (fig.1, sh.5) (09+50-10+37): Install boulder cross-vane (figs.14&15, sh.27) to stabilize channel and concentrate flow through the proposed pool. Install boulder deflector into the left bank to further provide relief to the eroding left bank. Downstream of the deflector fill scallop with excavated stream bed material and install wood and boulder habitat (figs. 8&9, sh.24). Anchor logs with imported boulders and vertical logs buried into the stream bed. Excavate pool 3 feet below current stream bed, excavated material will be relocated to construct right bank bar (fig.10&11, sh.25), fill left bank scallop, and enhance upstream riffle. Imported boulders will be used to construct the cross-vane. See Table 1 for material quantities. Cross-section 5 (sh.13) transects the proposed pool and wood/boulder habitat location.

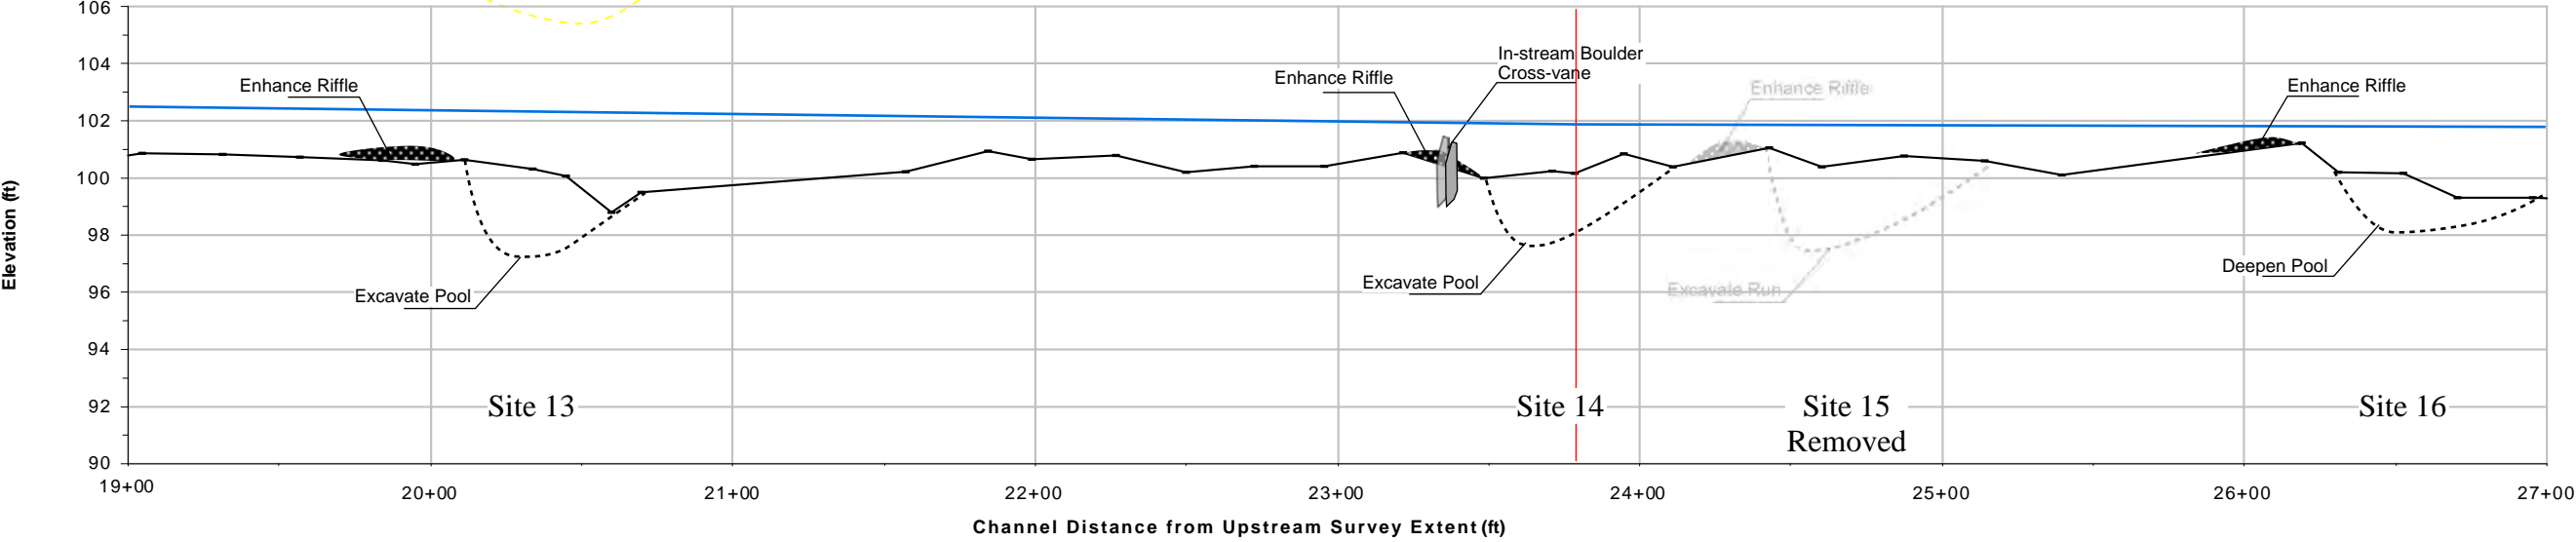
Figure 3. Reach 3 - Mianus River Restoration

MIANUS RIVER LONGITUDINAL PROFILE (19+00 - 27+00)

Site 13 (fig.3, sh.7) (19+80-20+70): Excavate pool 2 feet below current stream bed, excavated material will be relocated to enhance the upstream riffle and construct left bank bar.

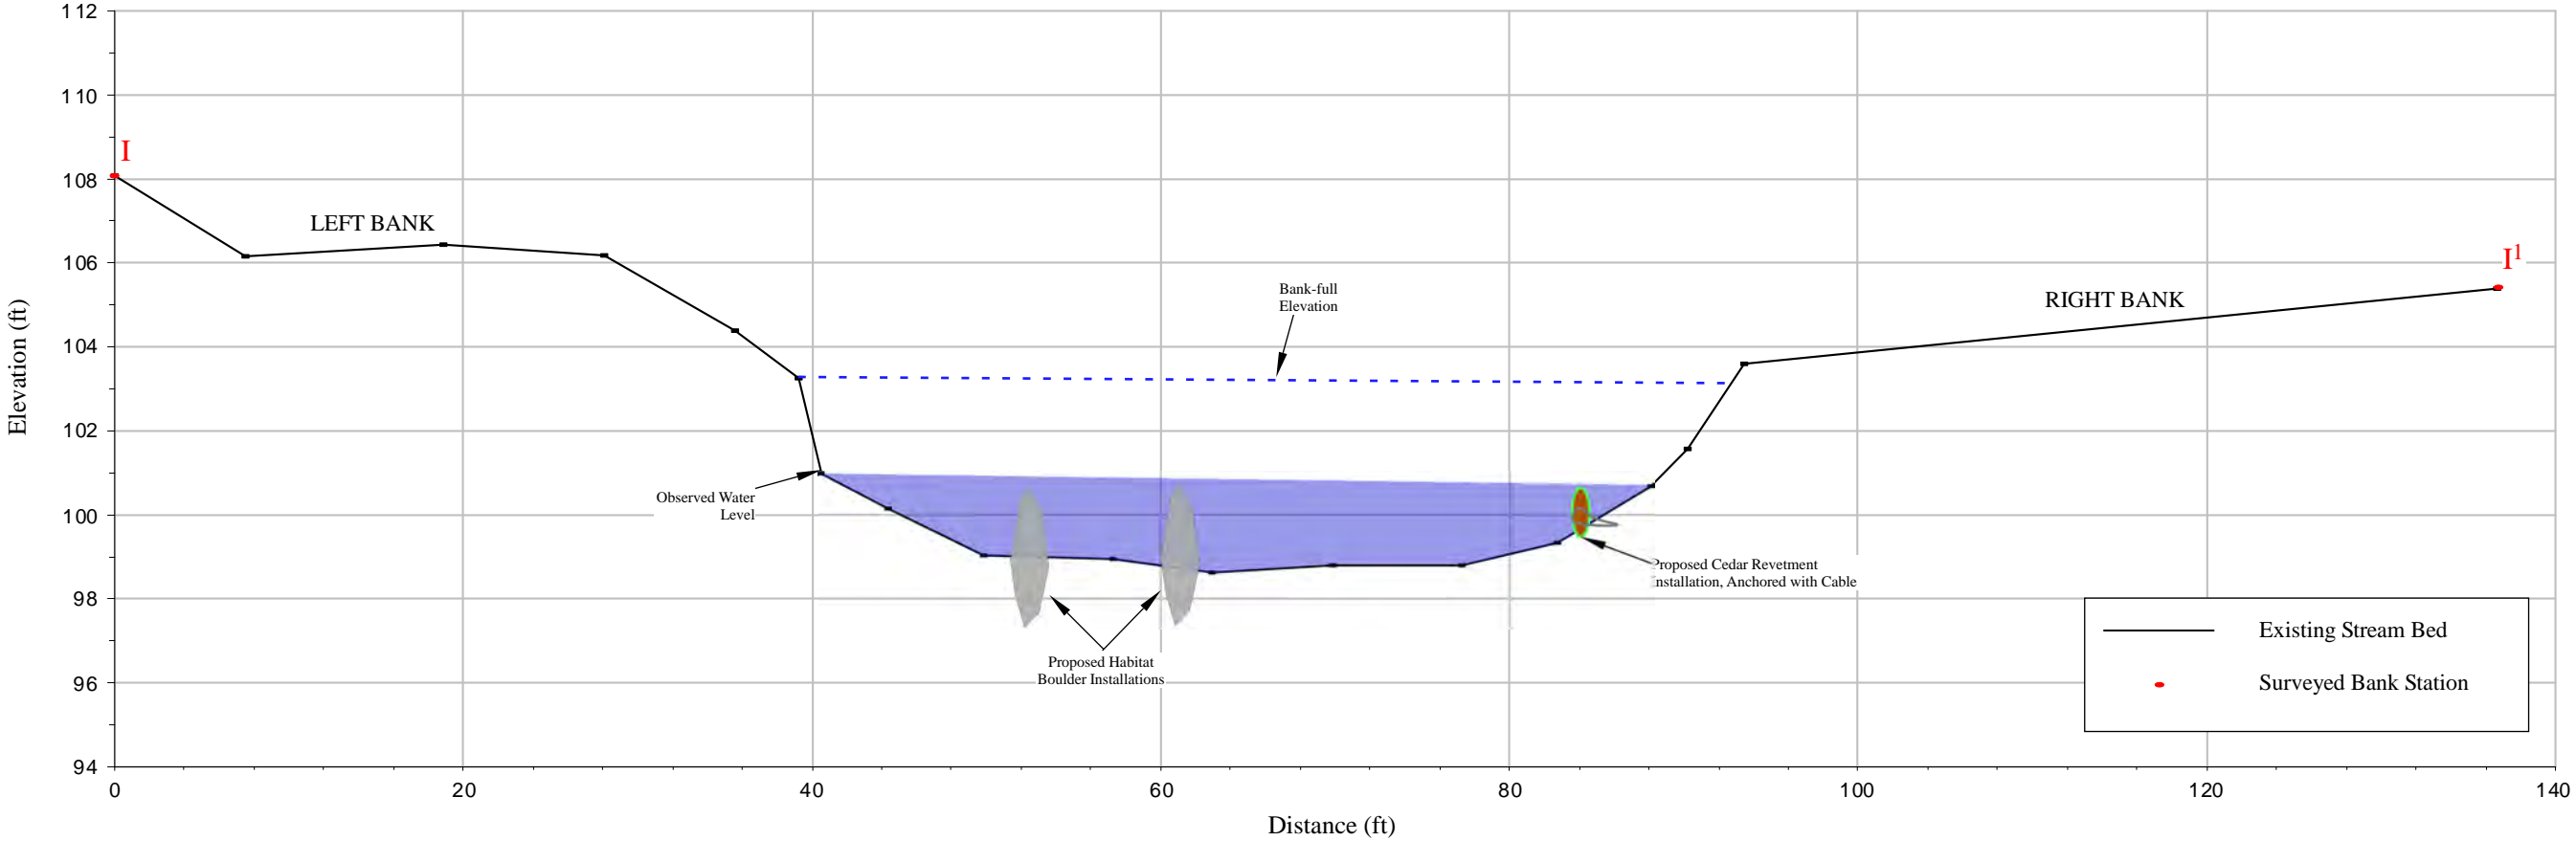
Cross-section 9 I-I<sup>1</sup> (28+66): Restoration Site 17

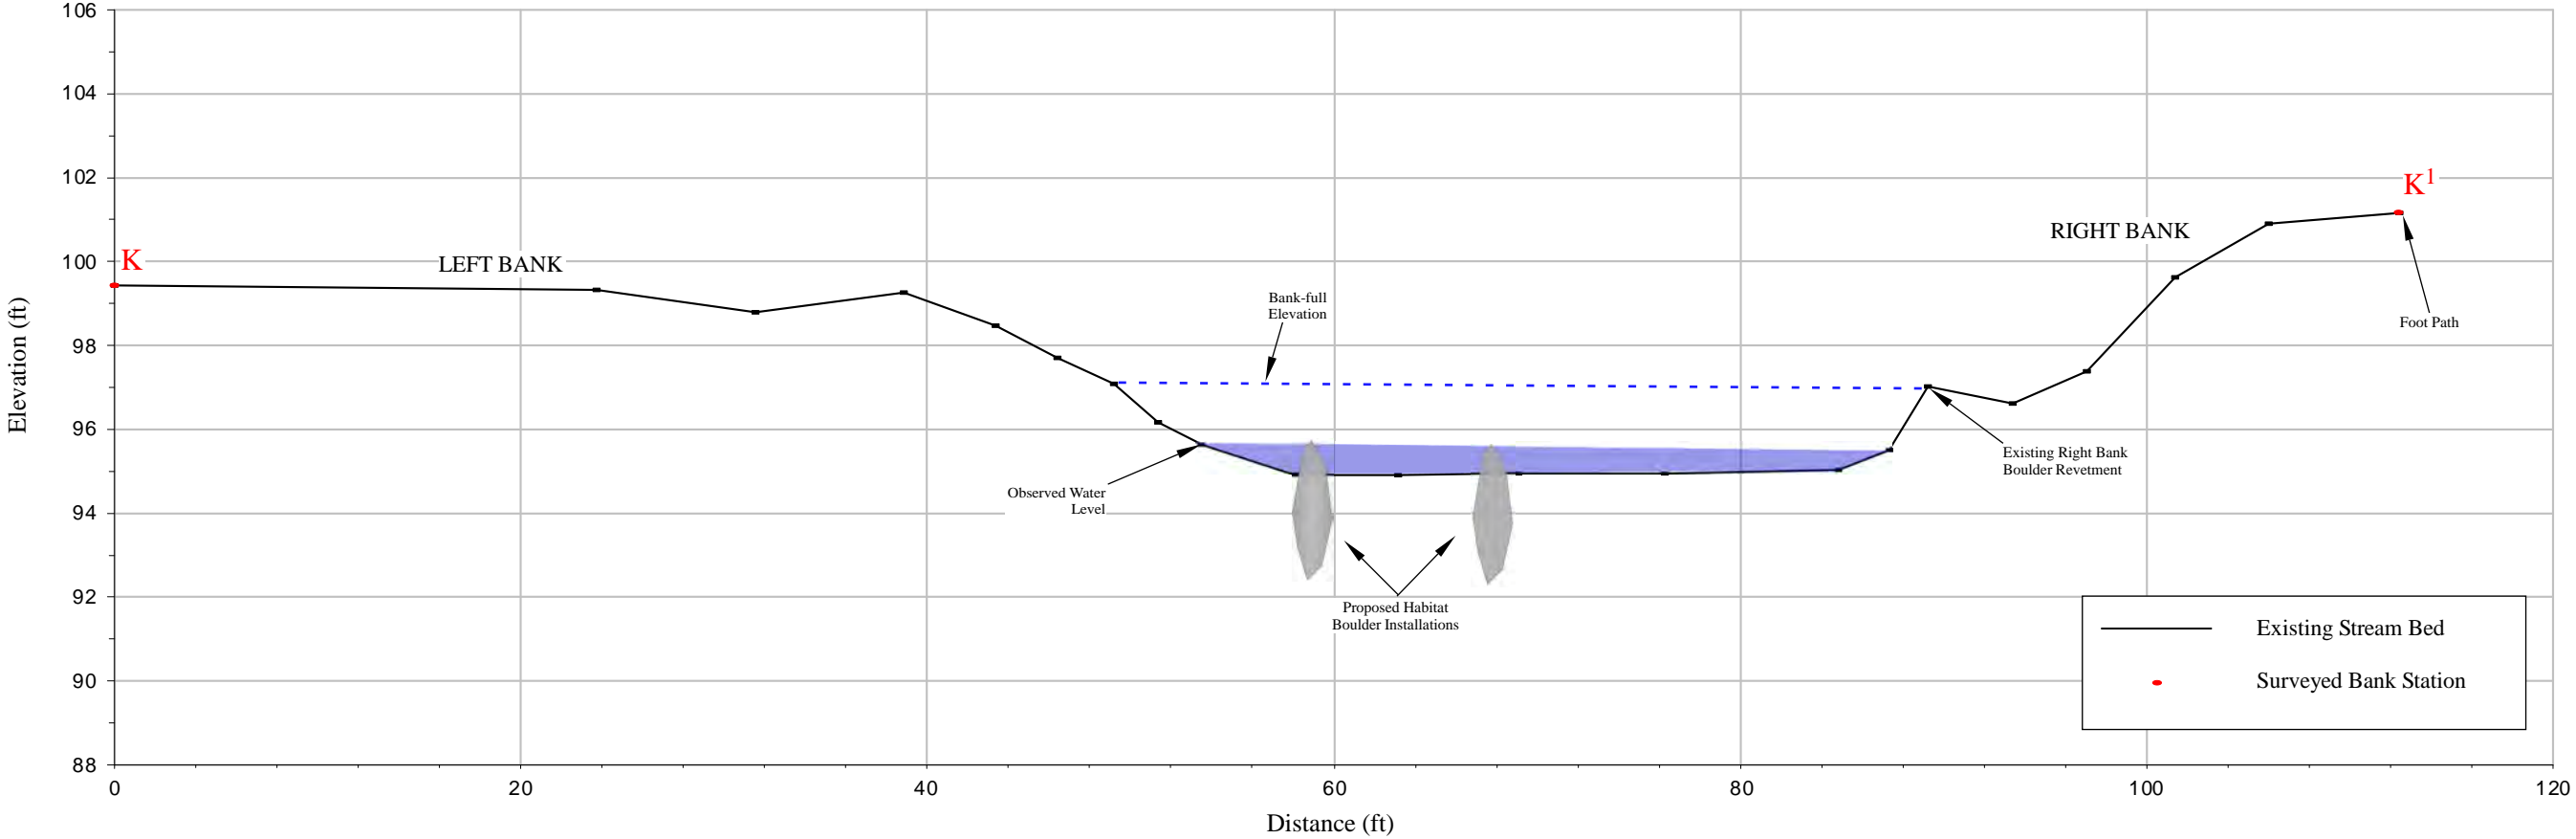
Cross-section 11 K-K<sup>1</sup> (36+61): Restoration Site 23

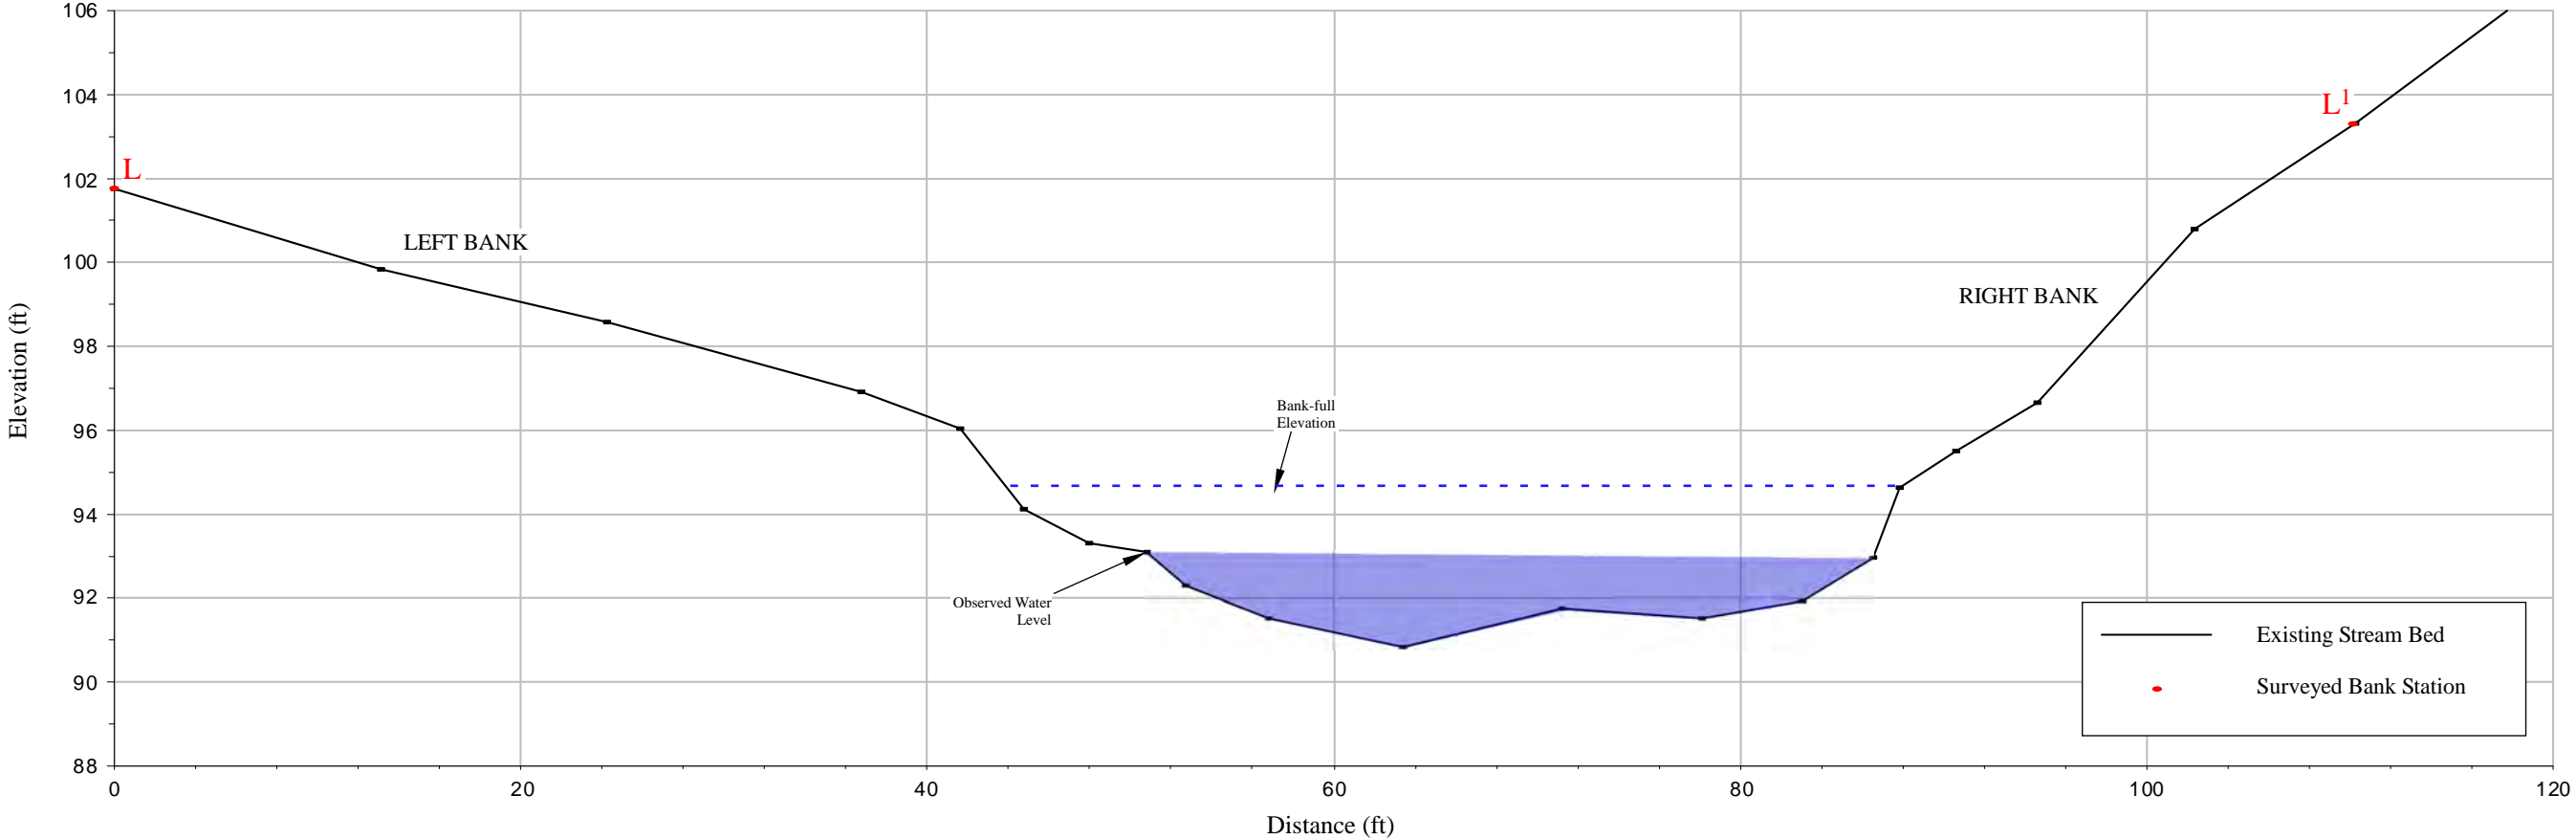
Cross-section 12 L-L<sup>1</sup> (41+80): Downstream Restoration Site 25

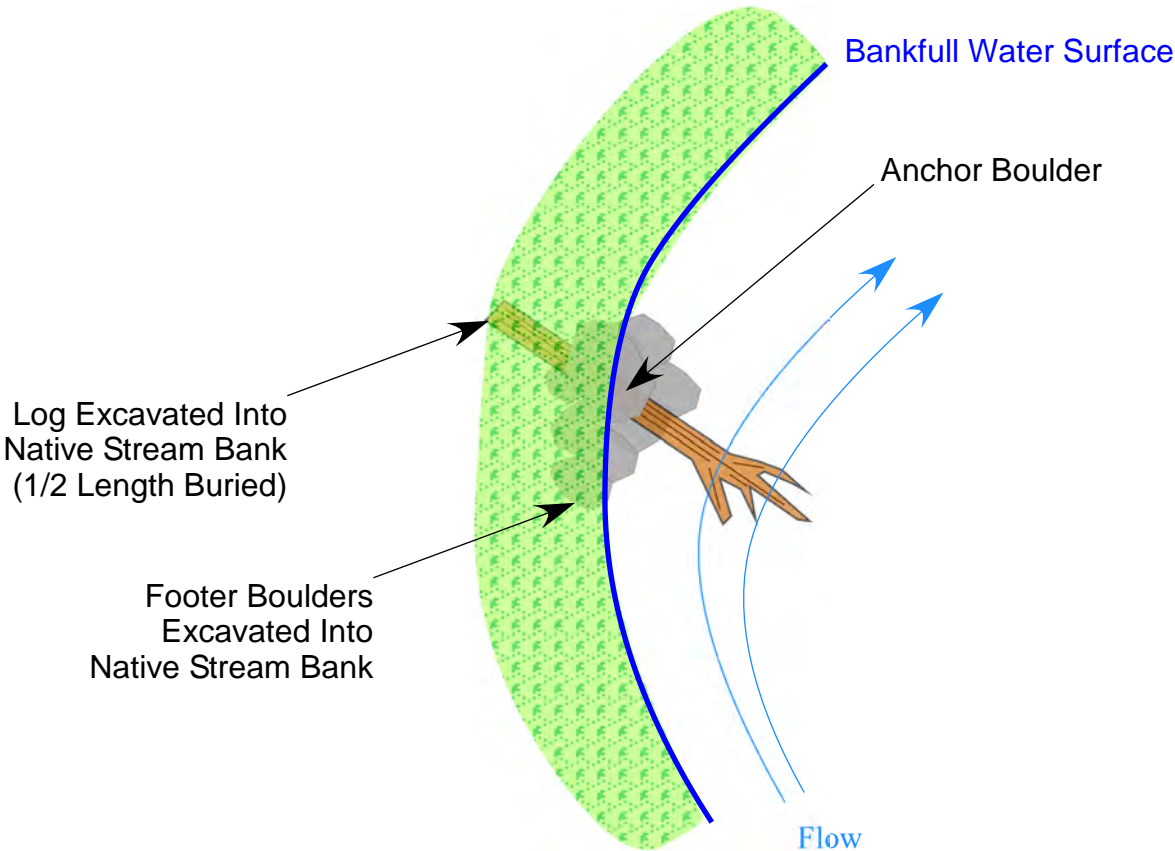
Figure 8. Typical Rootwad Revetment  
Plan View

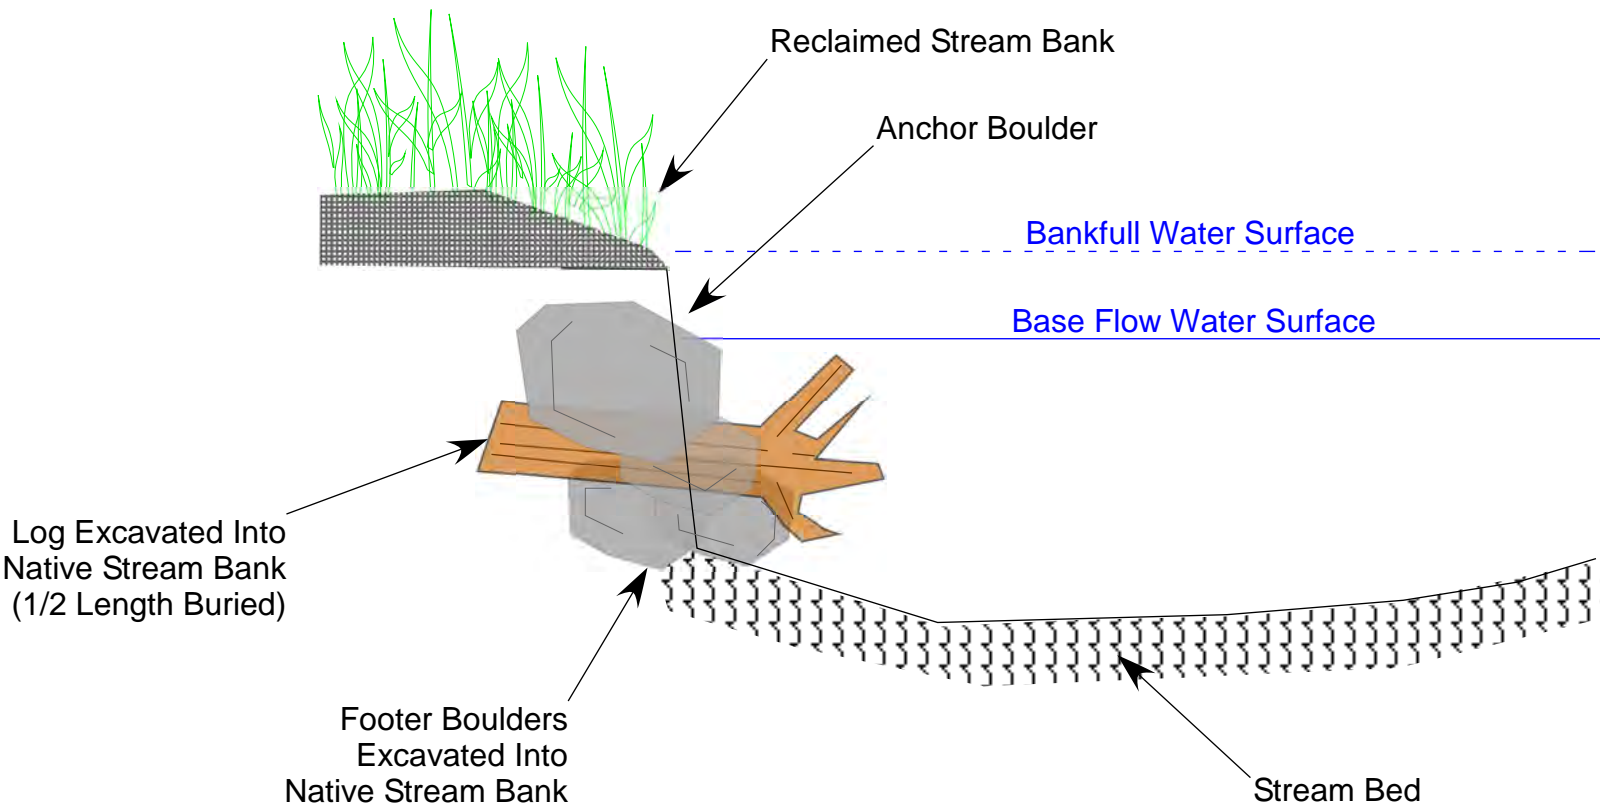
Figure 9. Typical Rootwad Revetment  
Cross-section View

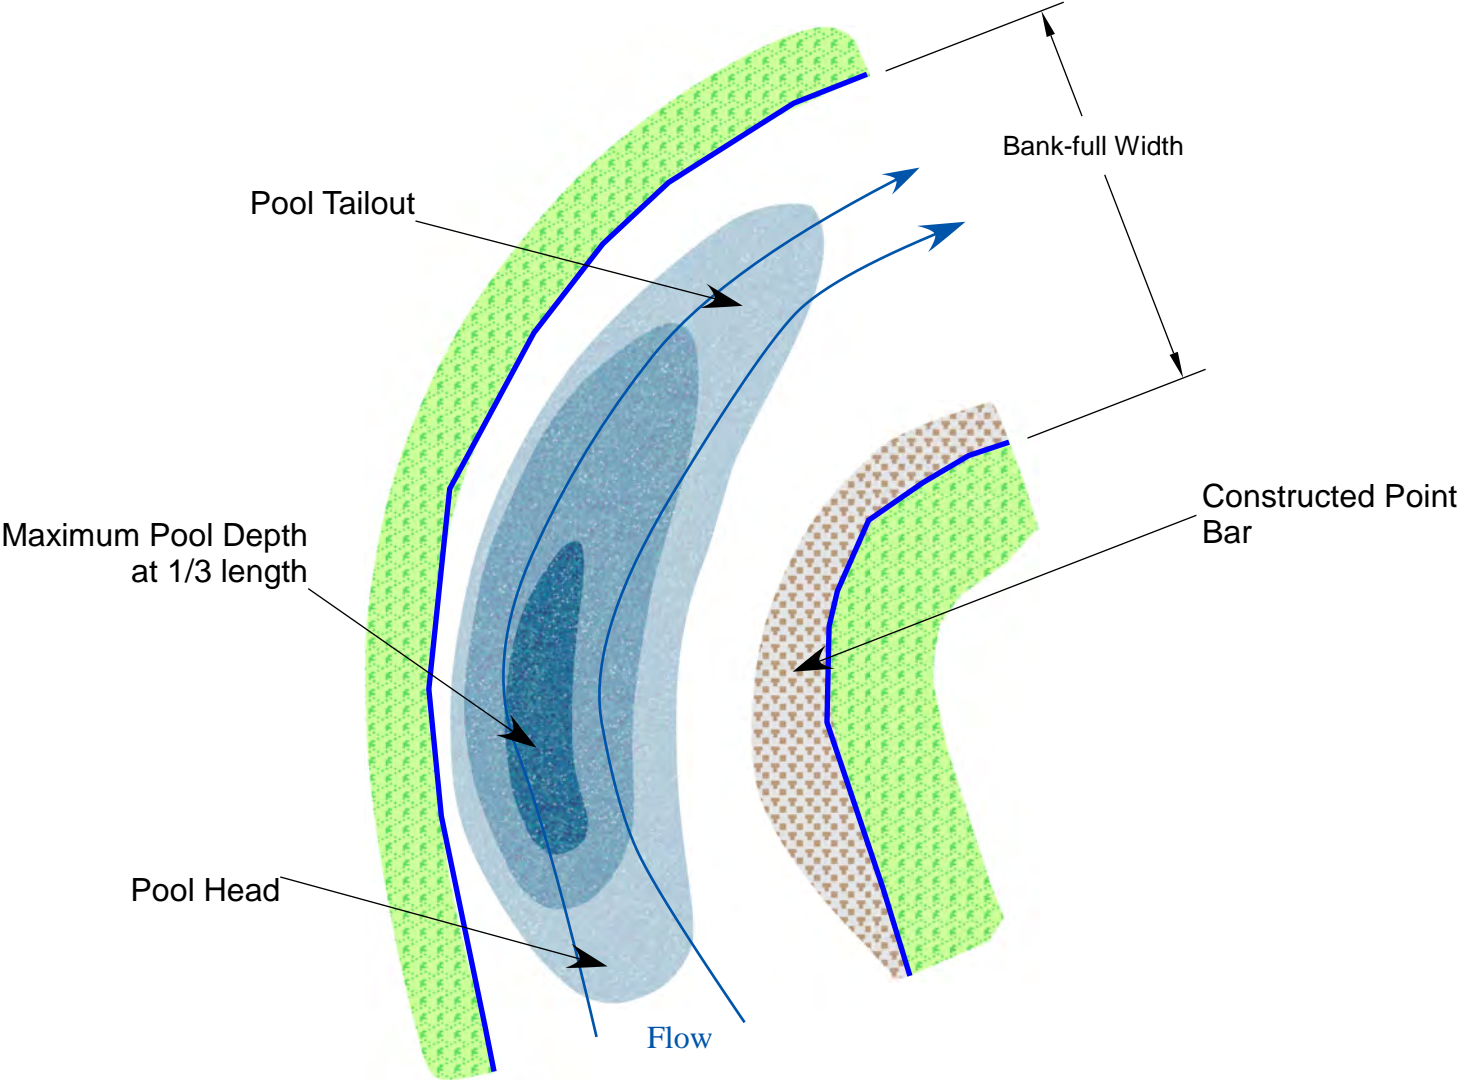
Figure 10. Typical Pool Excavation  
Plan View

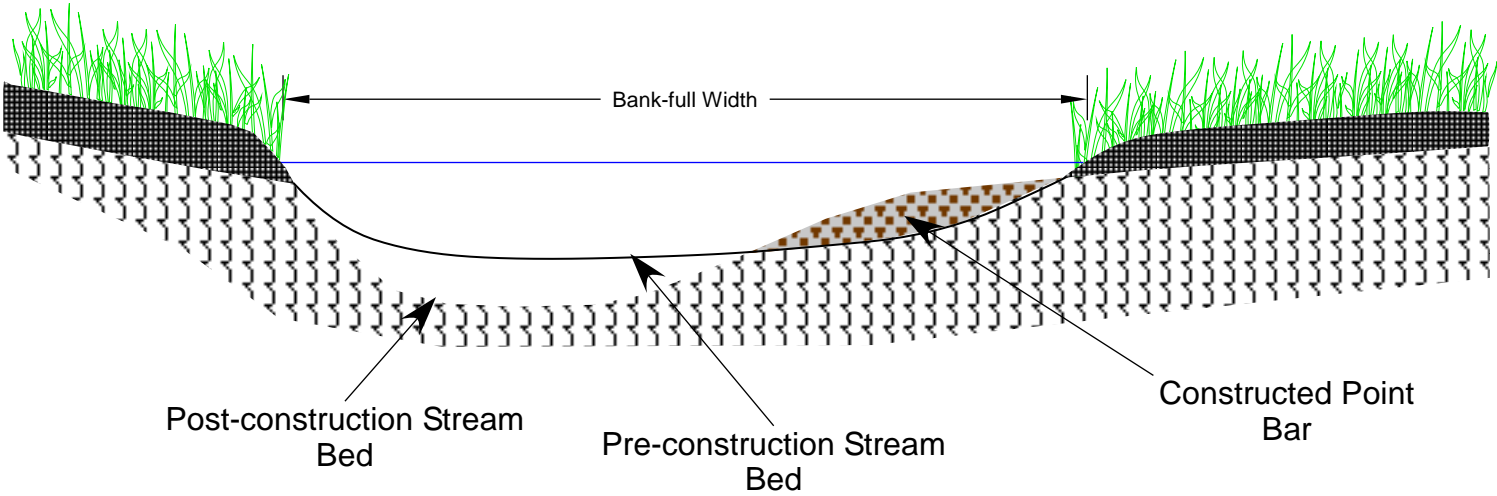
Figure 11. Typical Pool Excavation  
Cross-section View

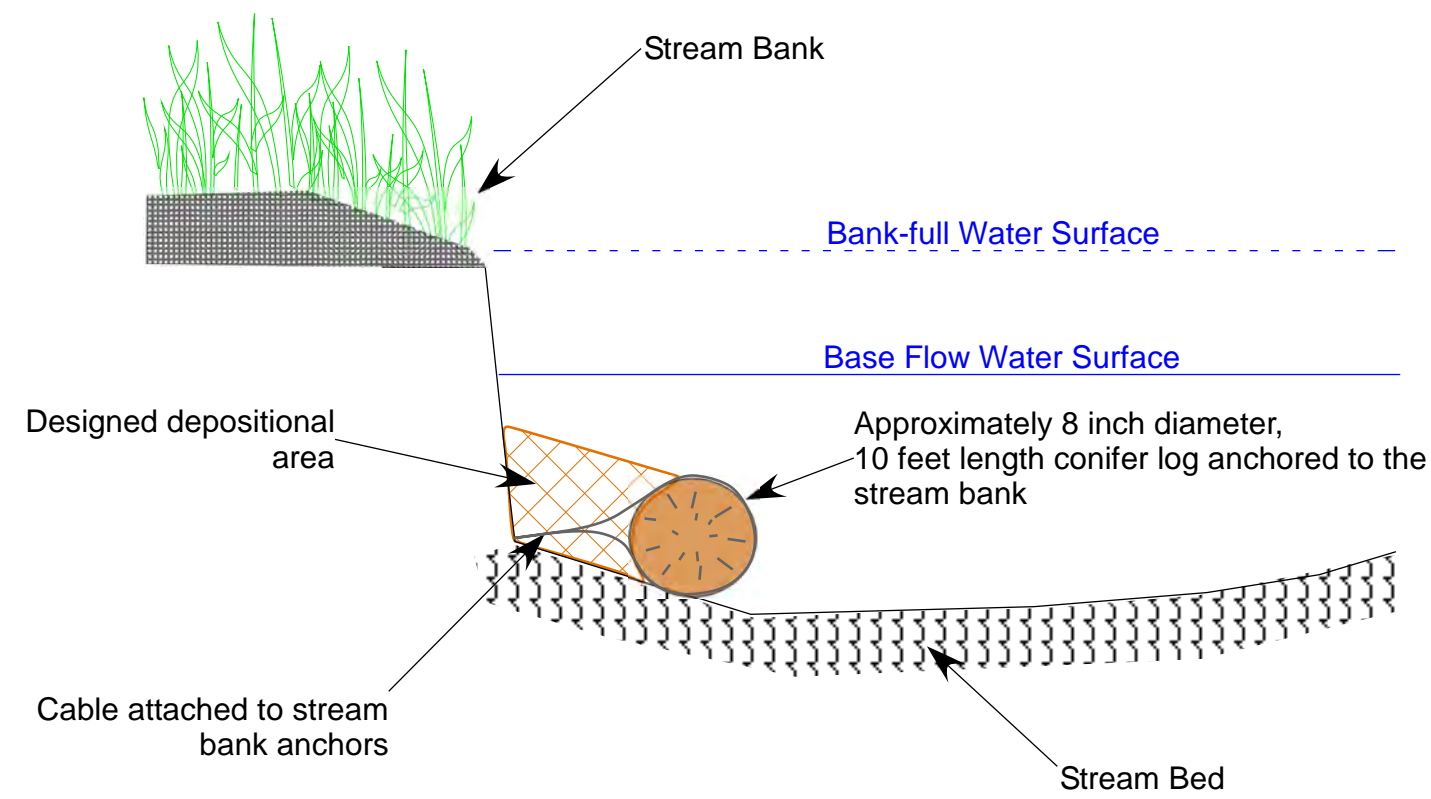
Figure 12. Typical Conifer Revetment Installation  
Cross-section View

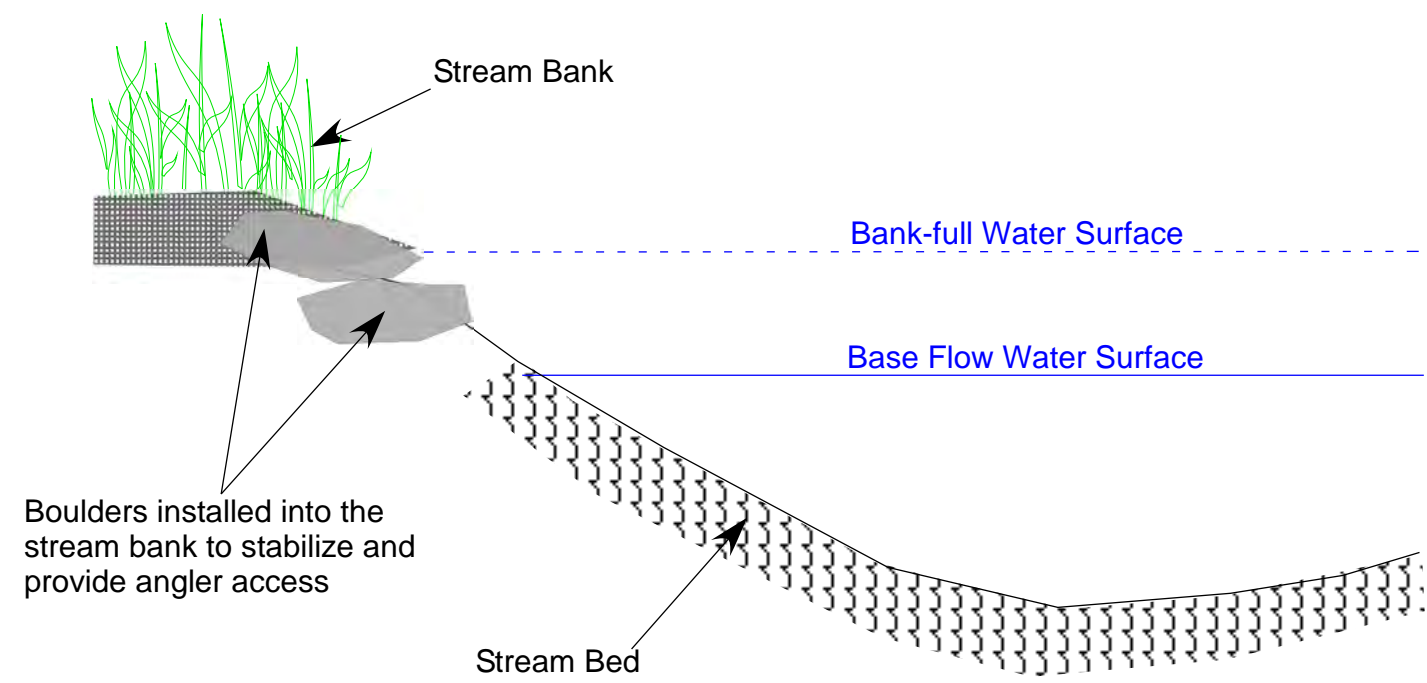
Figure 13. Typical Angler Access Boulder Placement  
Cross-section View

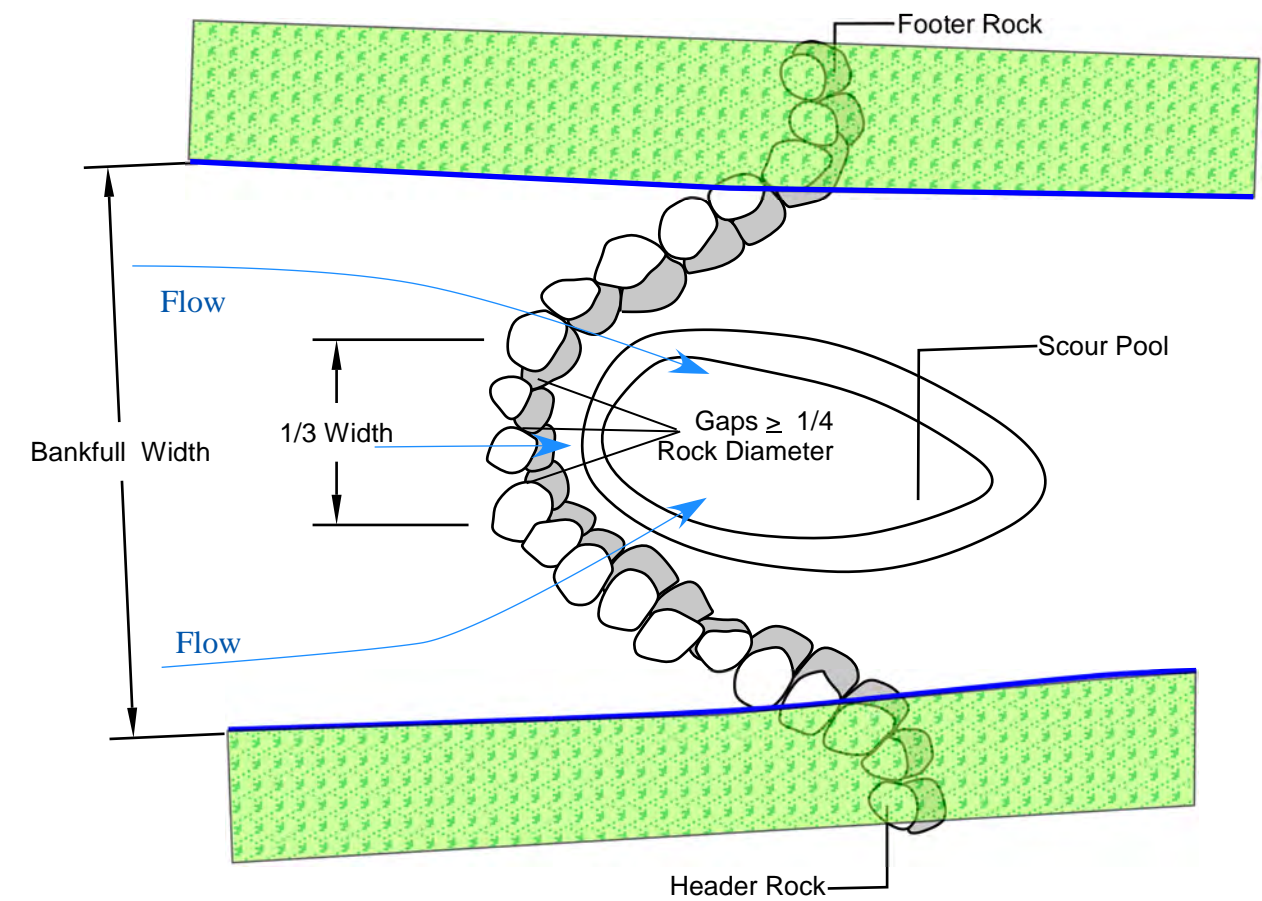
Figure 14. Typical Cross-vane  
Plan View

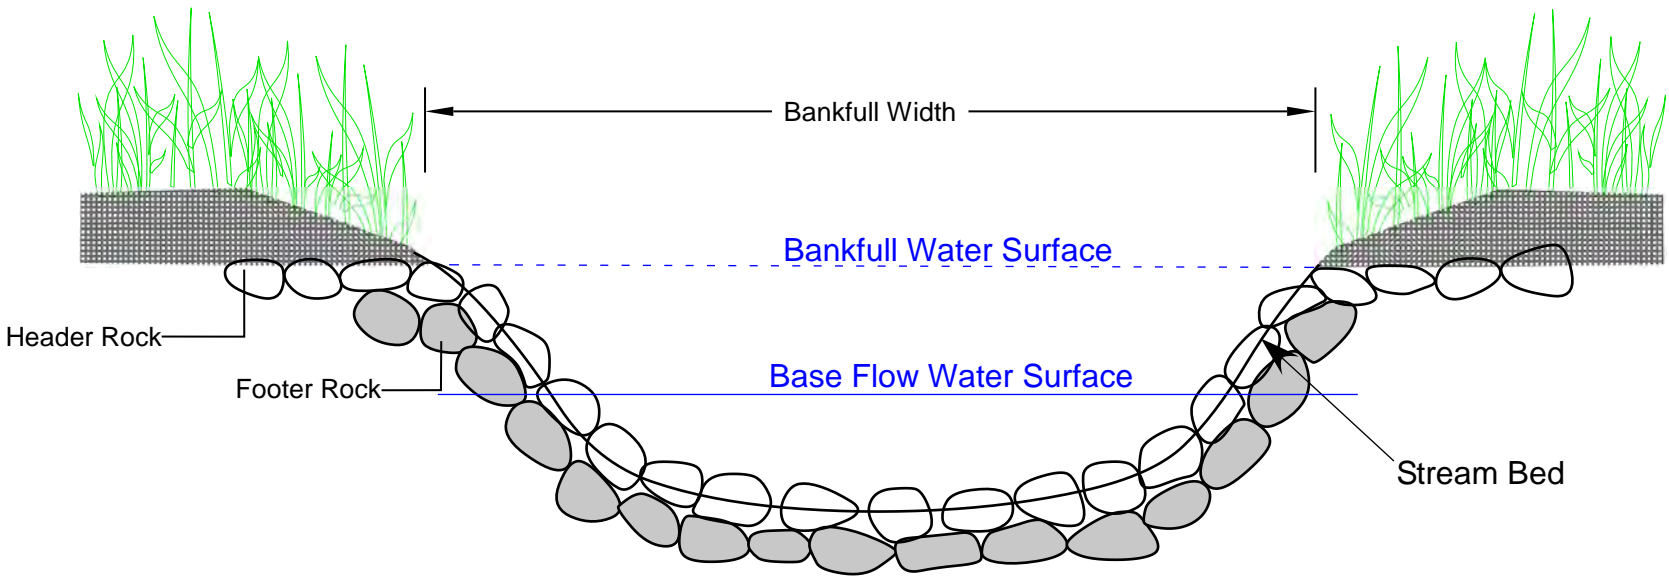
Figure 15. Typical Cross-vane  
Cross-section View
