ENVIRONMENTAL ASSESSMENT OF WETLAND/WATERCOURSE AREA

25 SHADY KNOLL DRIVE, STAMFORD, CT

PREPARED BY:

September 15, 2024

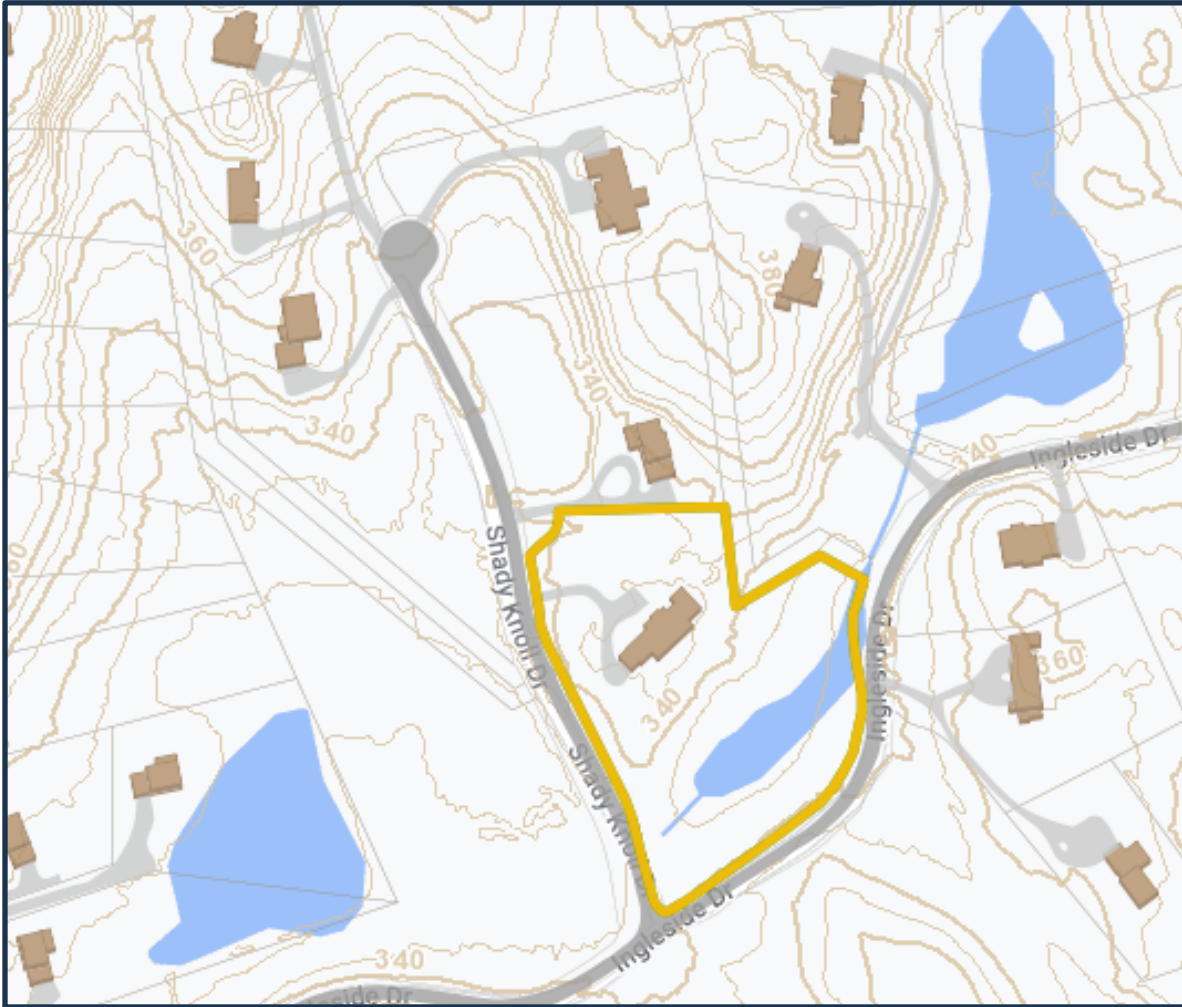
The regulated area at the site consist of a man-made pond (0.86ac), associated narrow wetland (0.03ac) fringe and 25-foot wide upland review area (URA) (0.53ac). The pond is connected by a brook to a pond located off-site to the northeast and by piped overflow to a pond also located off-site to the southwest.

Pond connection to the adjacent waterbodies.

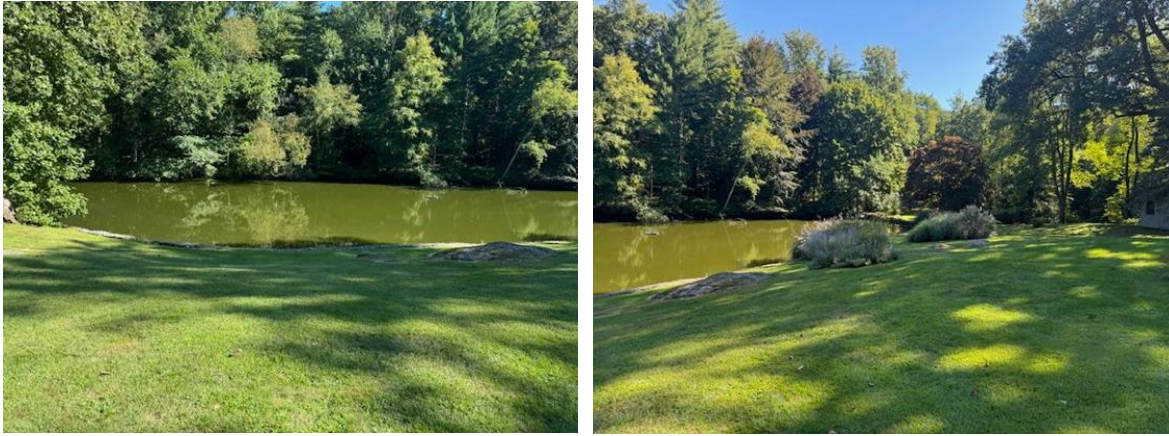
The wetland area is very narrow and only present outside of the stone wall. A stone retaining wall is defining the edge of the pond viewed from the residence. This area was filled in the past most likely when the existing septic system was installed. The wetland edges along the northern and southern edge of the pond are maintained in their natural state supporting trees, shrubs and herbaceous ground cover. The area behind the stone retaining wall is maintained as a lawn with two islands of ornamental grasses and flowering herbaceous ground cover. A Japanese maple is the only tree shading the pond within this area. Two small ledge outcrops piercing through the lawn.

Edge of the pond behind the stone retaining wall, view from the residence.
