**Stark Elementary School**

City of Stamford

**DRAFT** Figure 1.1 - Areas of Concerns

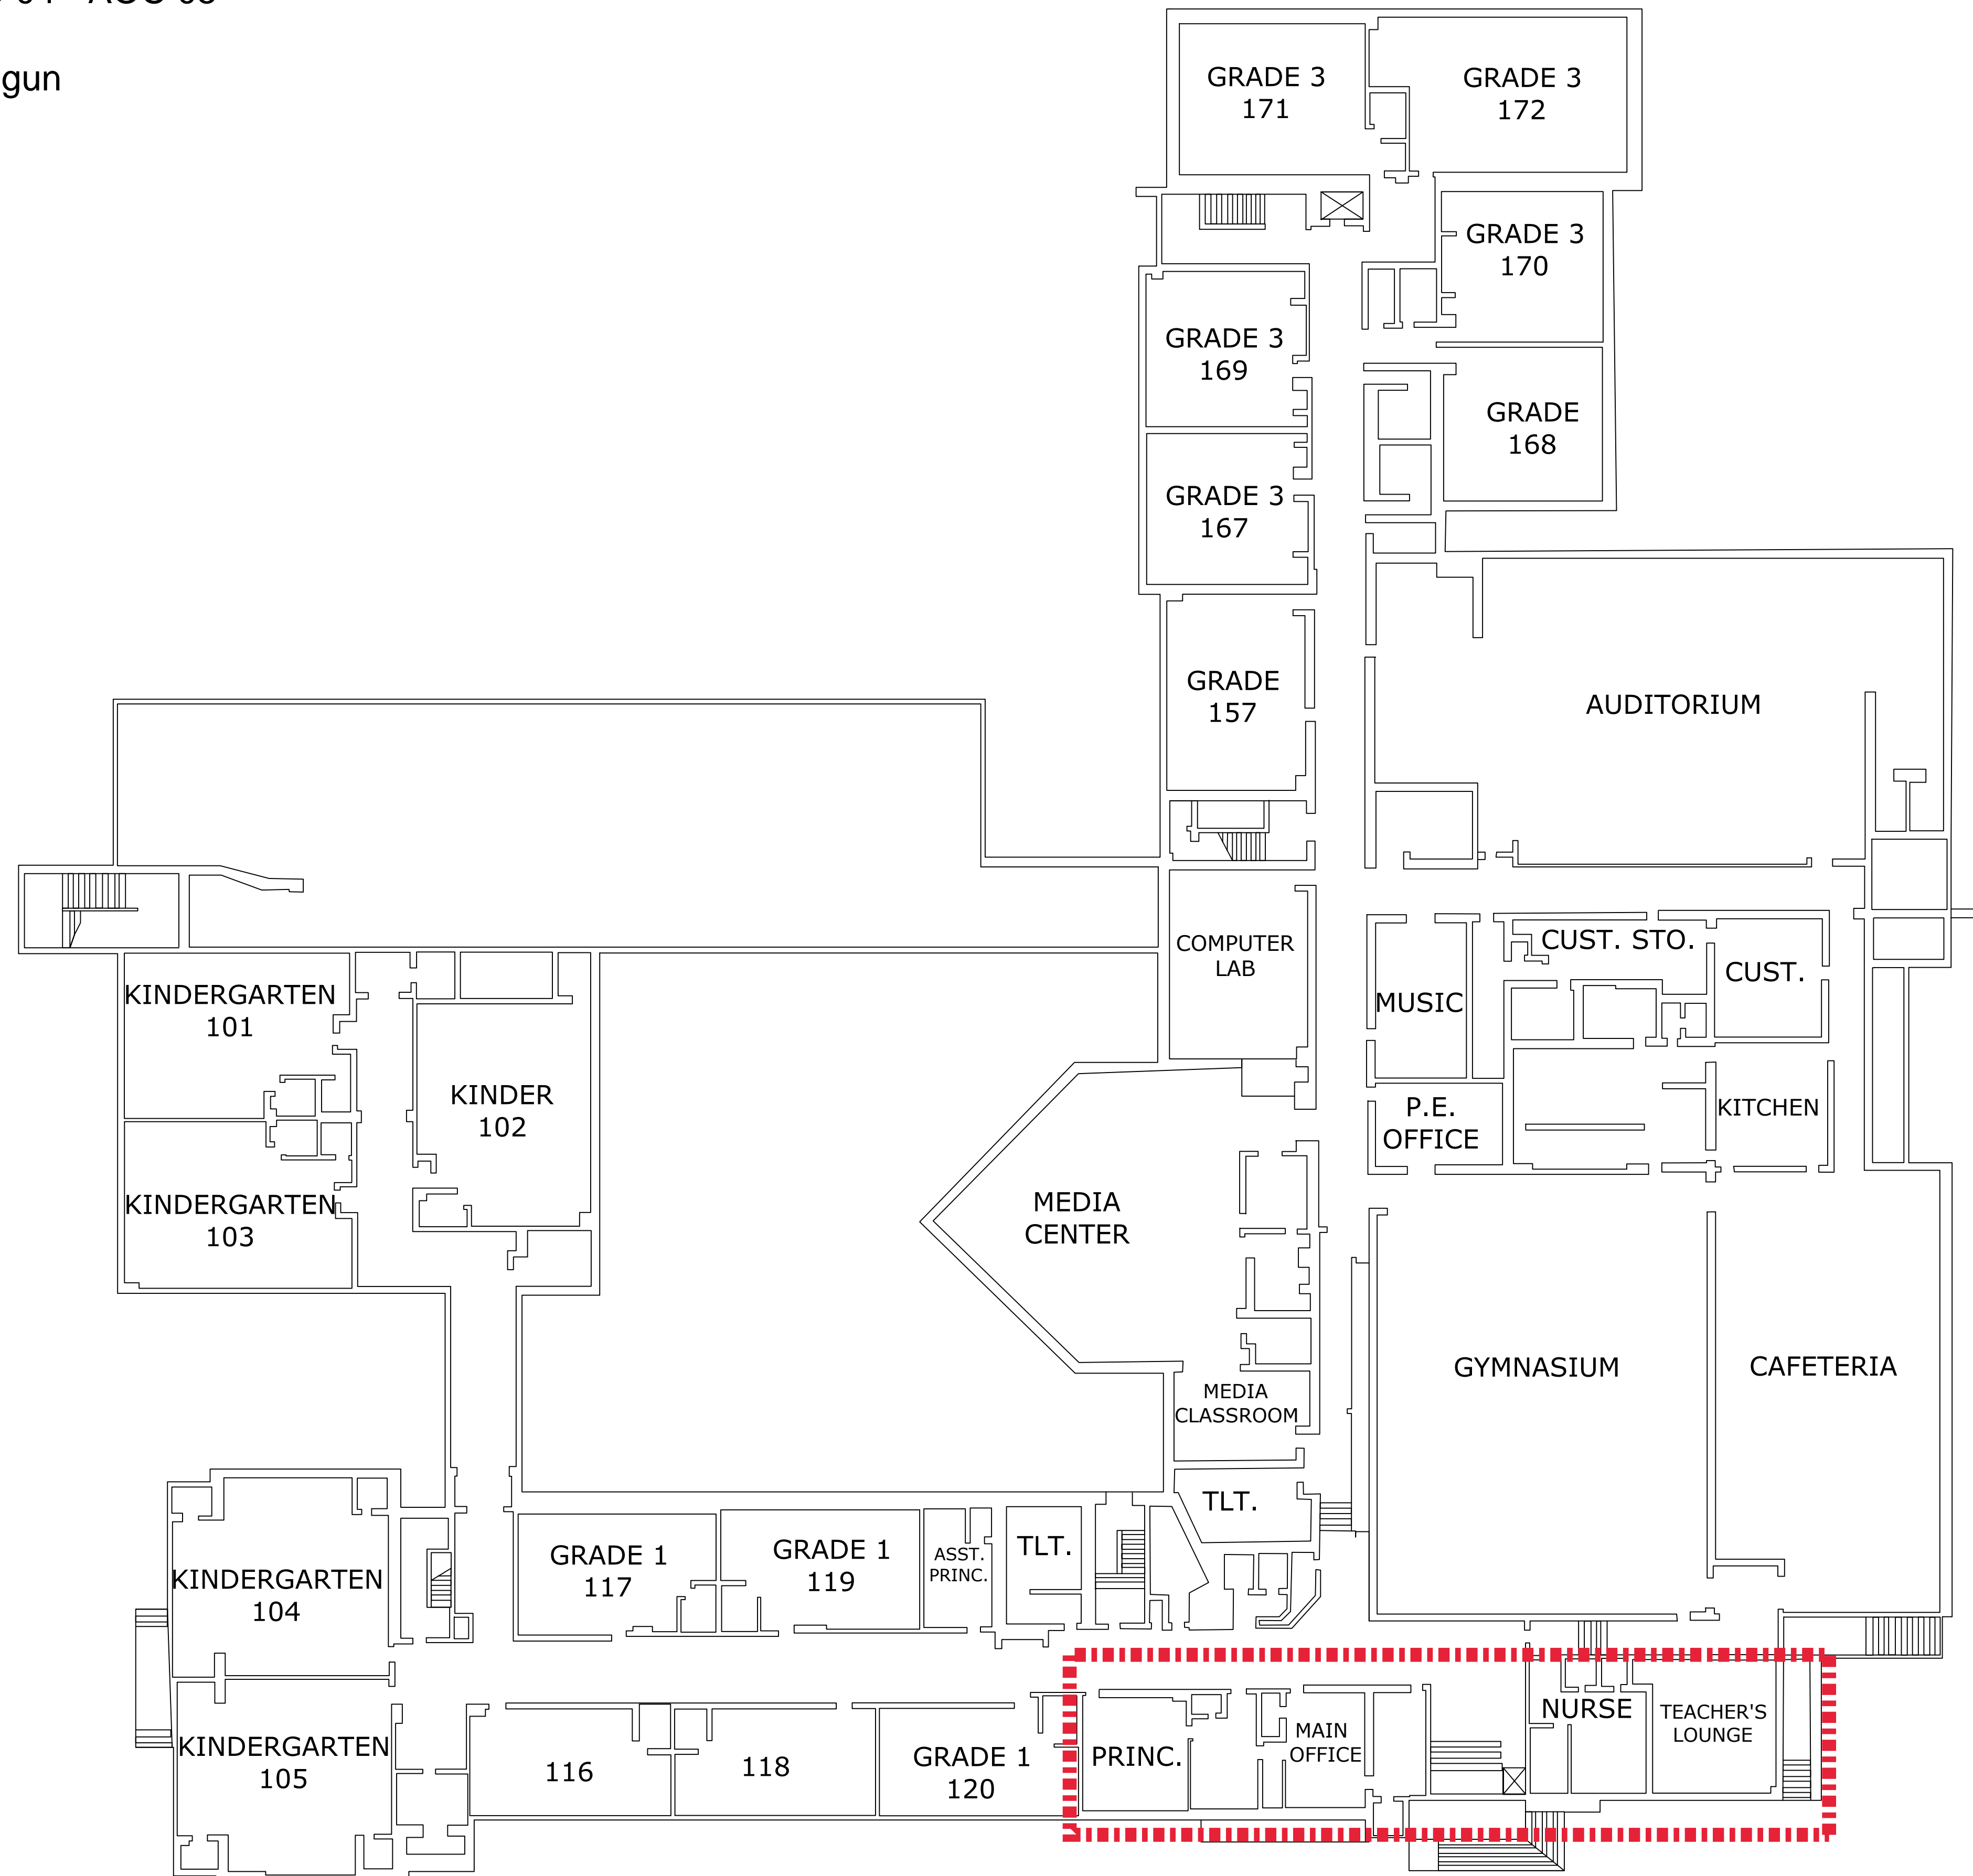
**Nurses Office, Teacher's Lounge, Main Office, Principals Office:**

AOC 01 - AOC 02, AOC 04 - AOC 05

Work in area has not begun

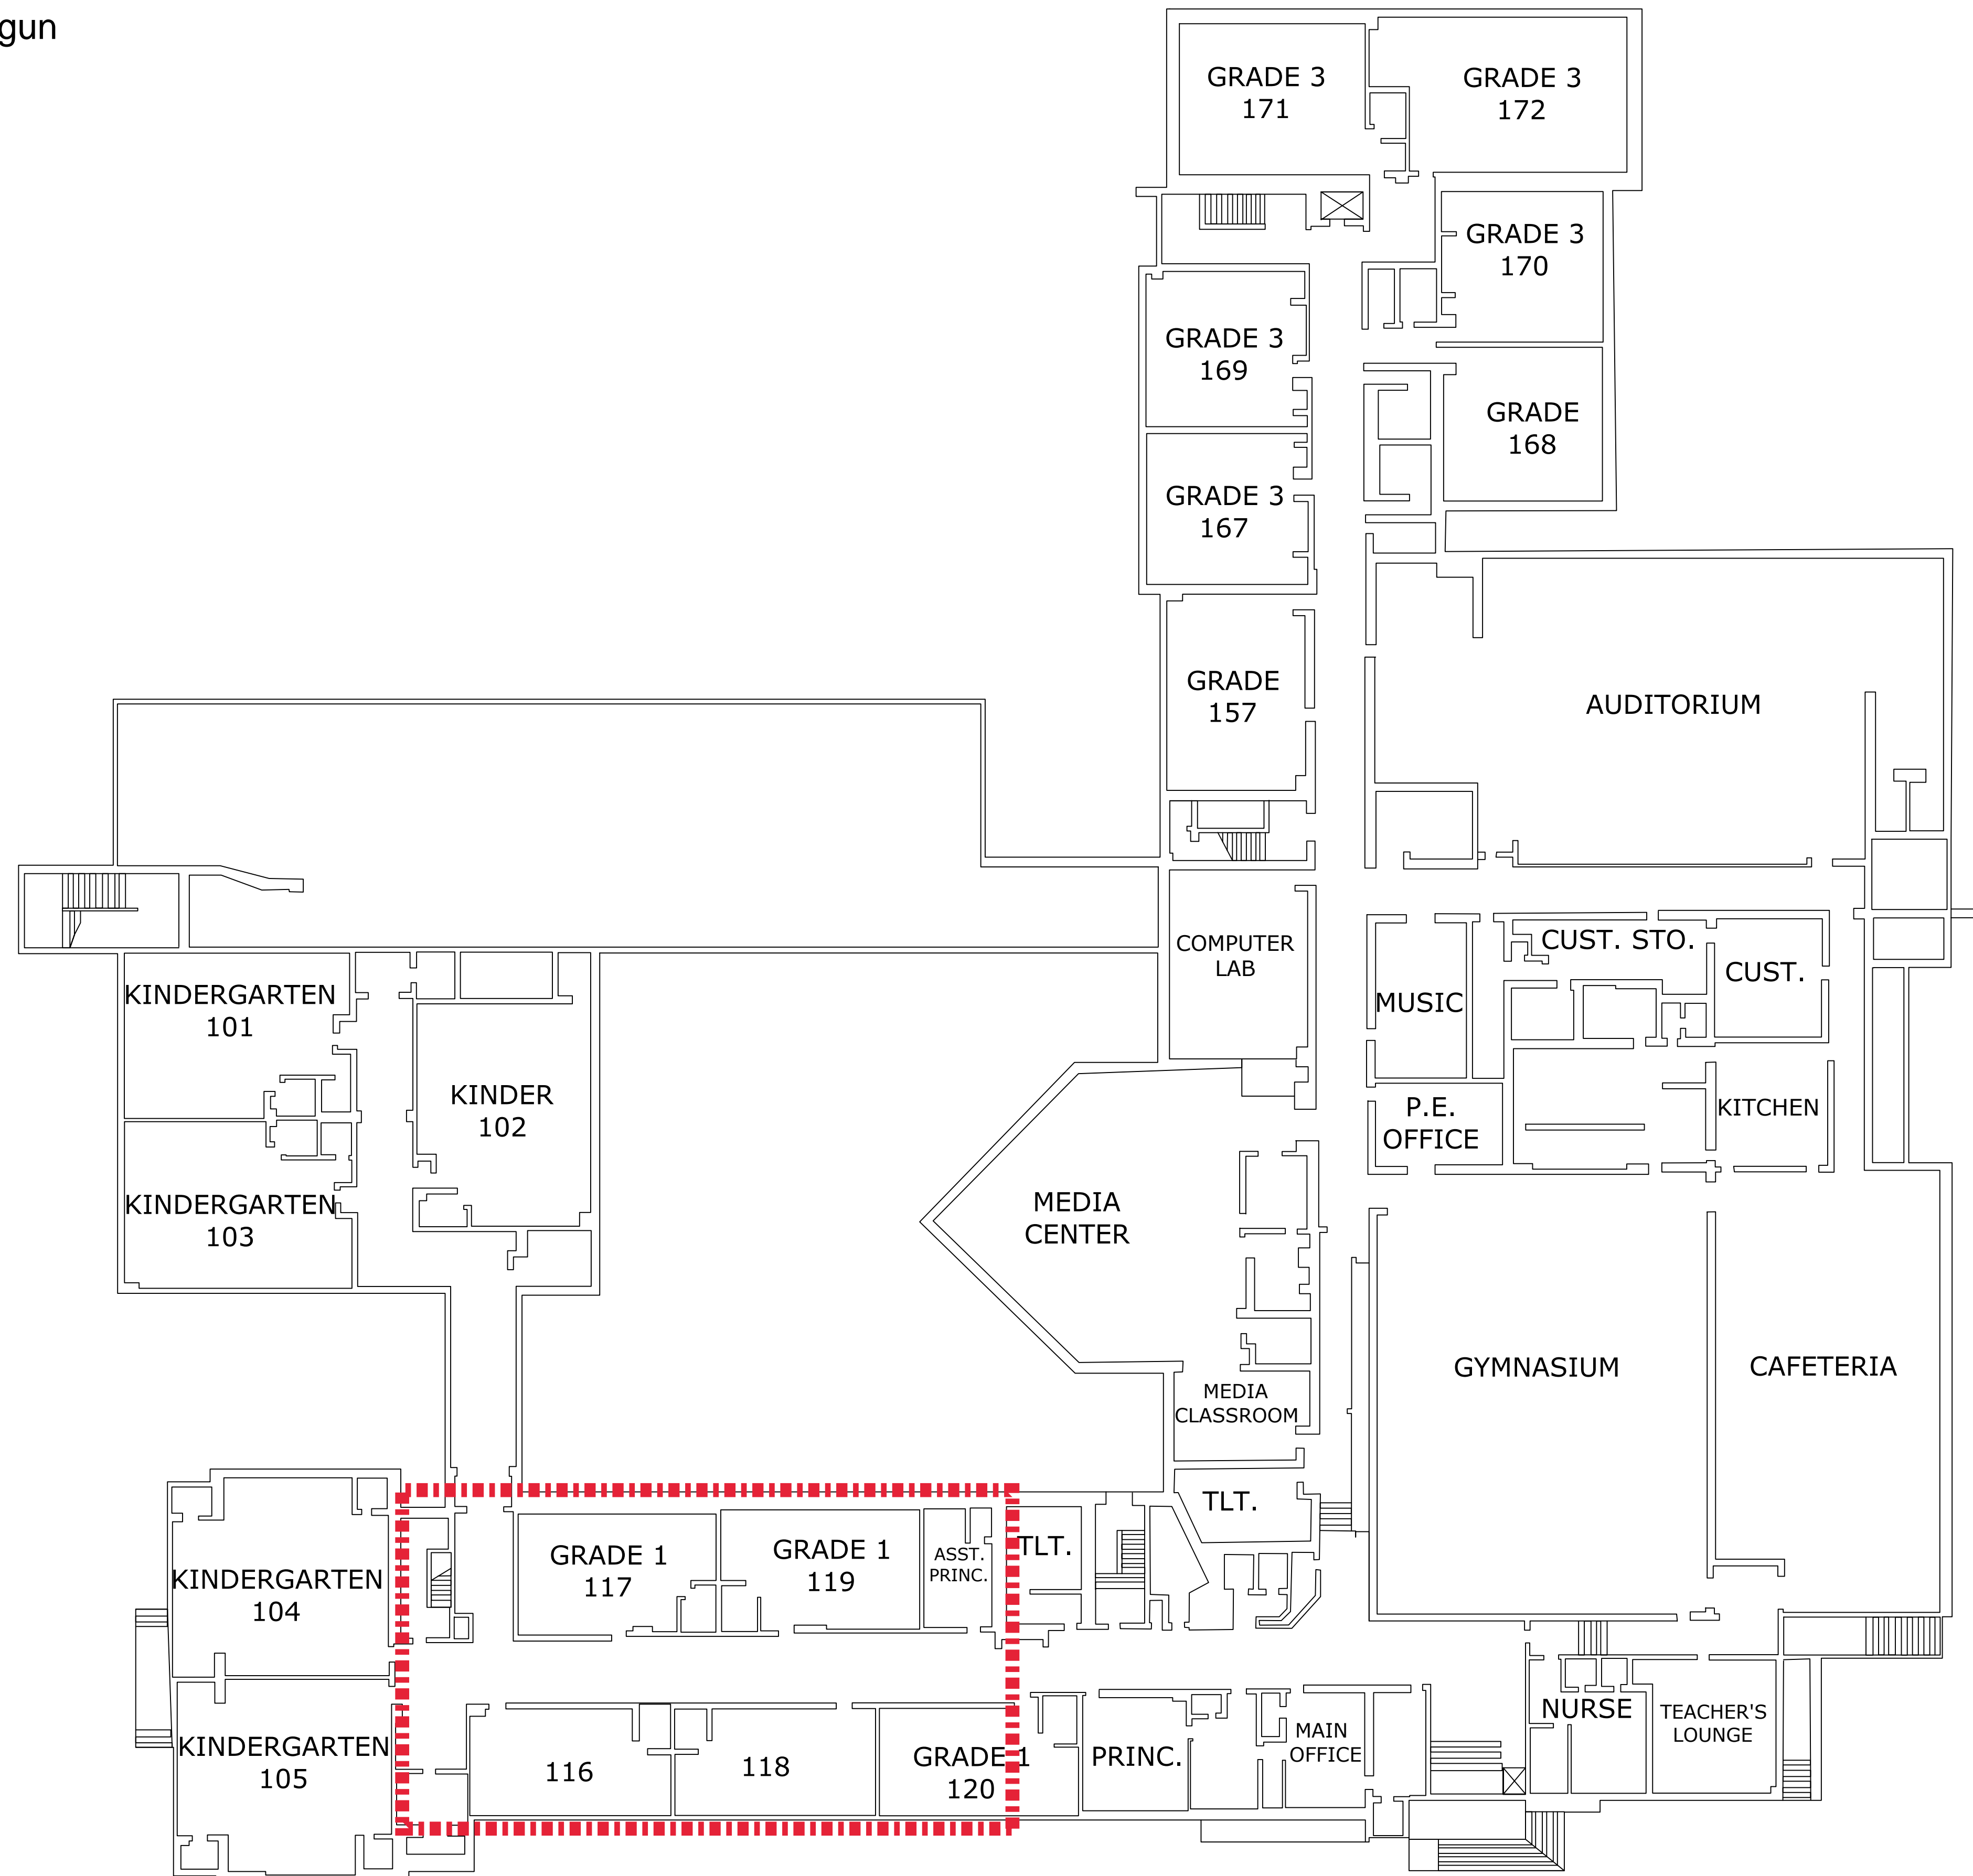
**Assistant Principals Office, Rooms 116 - 120:**

AOC 06, AOC 69 - AOC 70, AOC 72 - AOC 74

Work in area has not begun

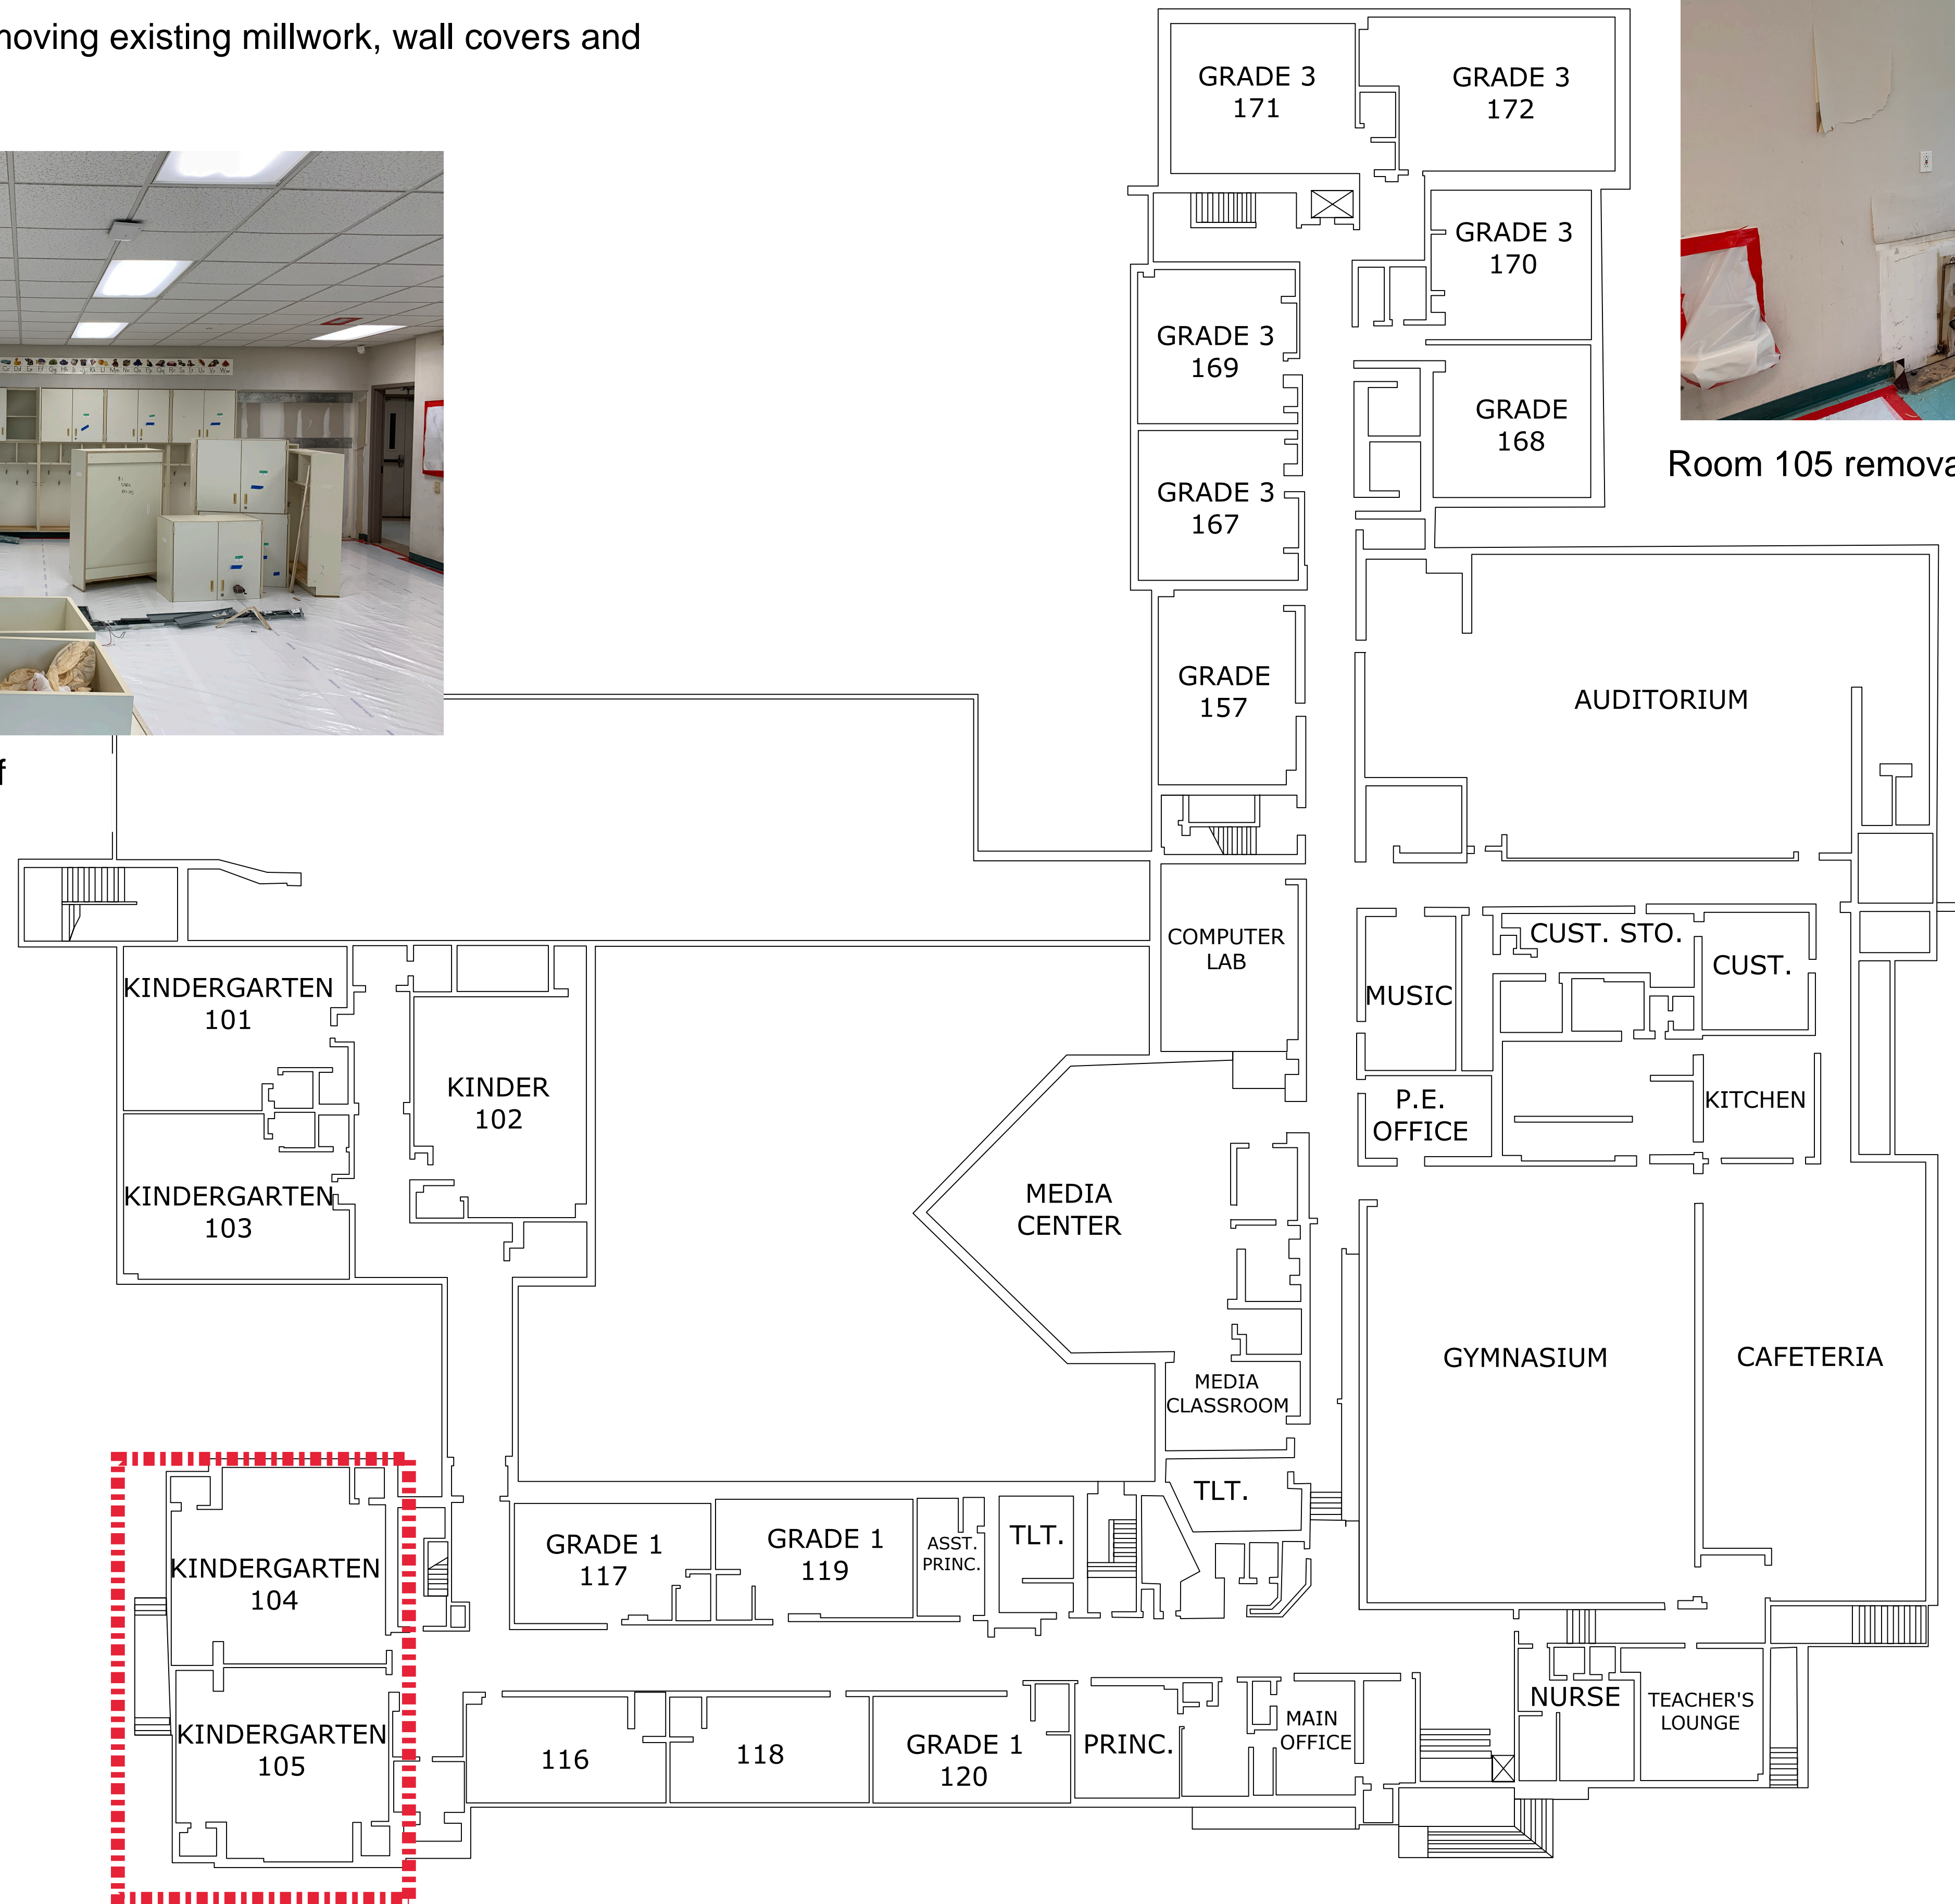
**Rooms 104 - 105:**

AOC 75 - AOC 76

In process of demo: removing existing millwork, wall covers and drywall

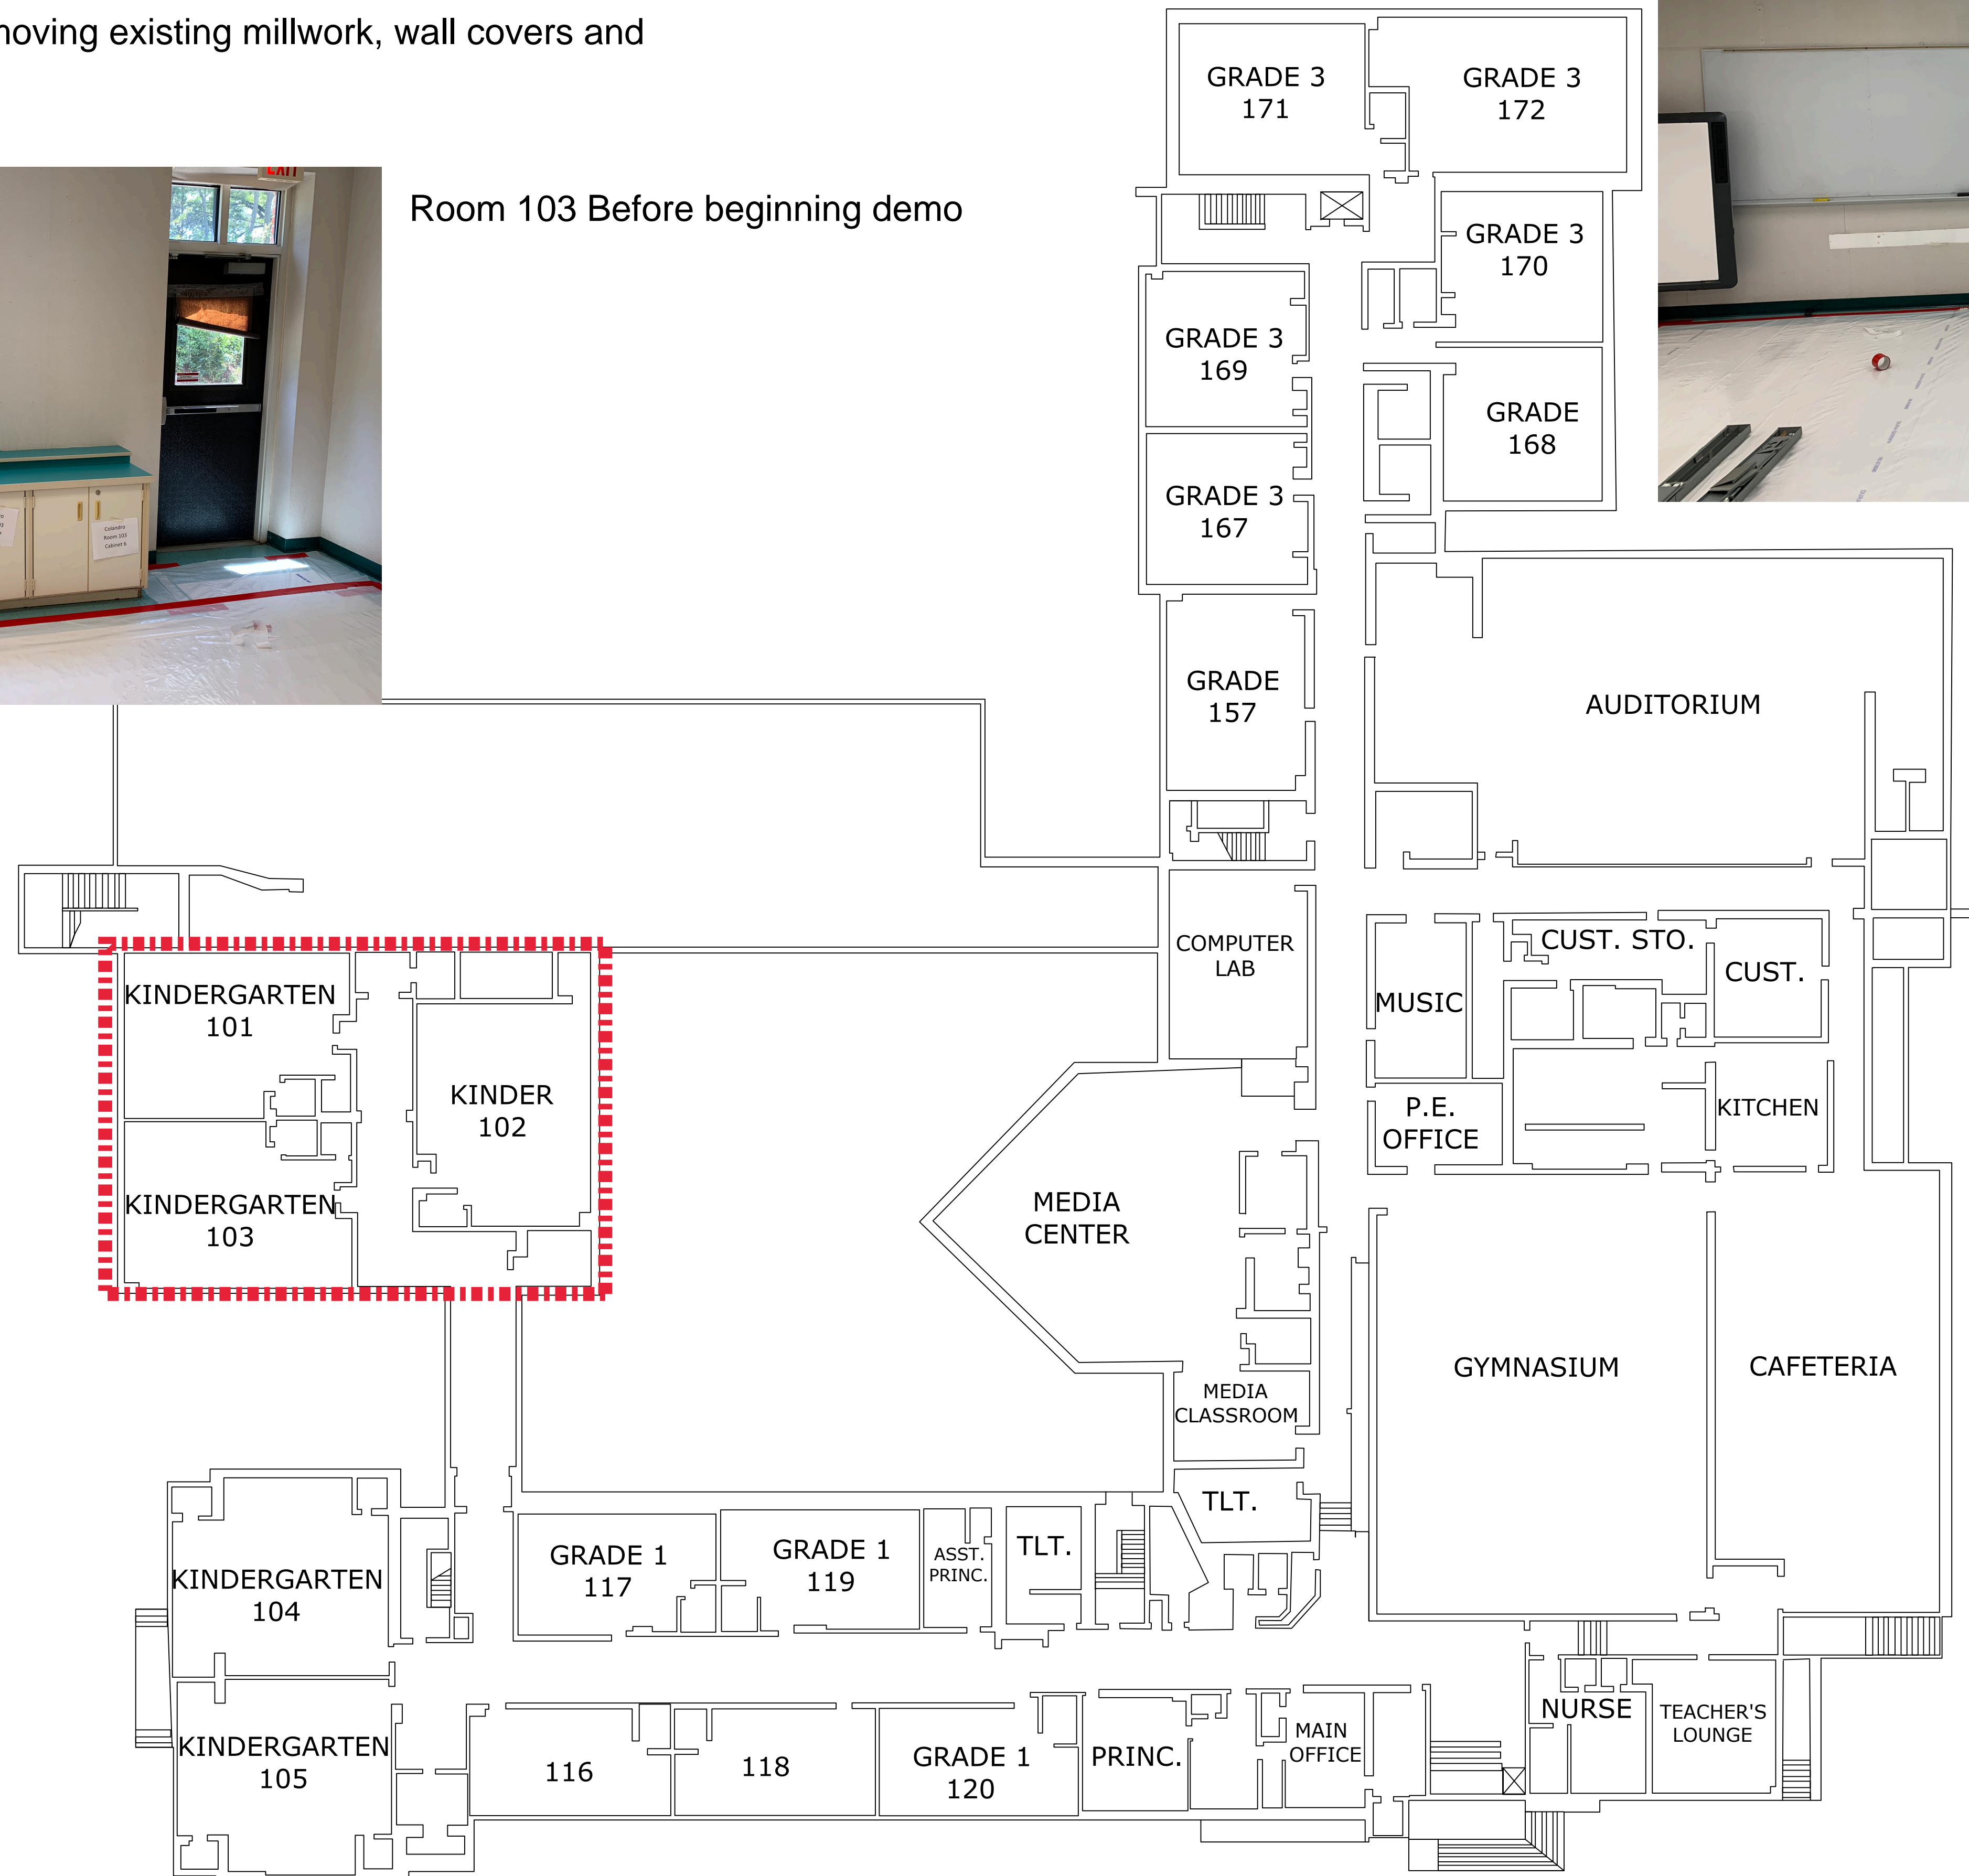
**Rooms 101 - 103:**

AOC 78 - AOC 81

In process of demo: removing existing millwork, wall covers and drywall

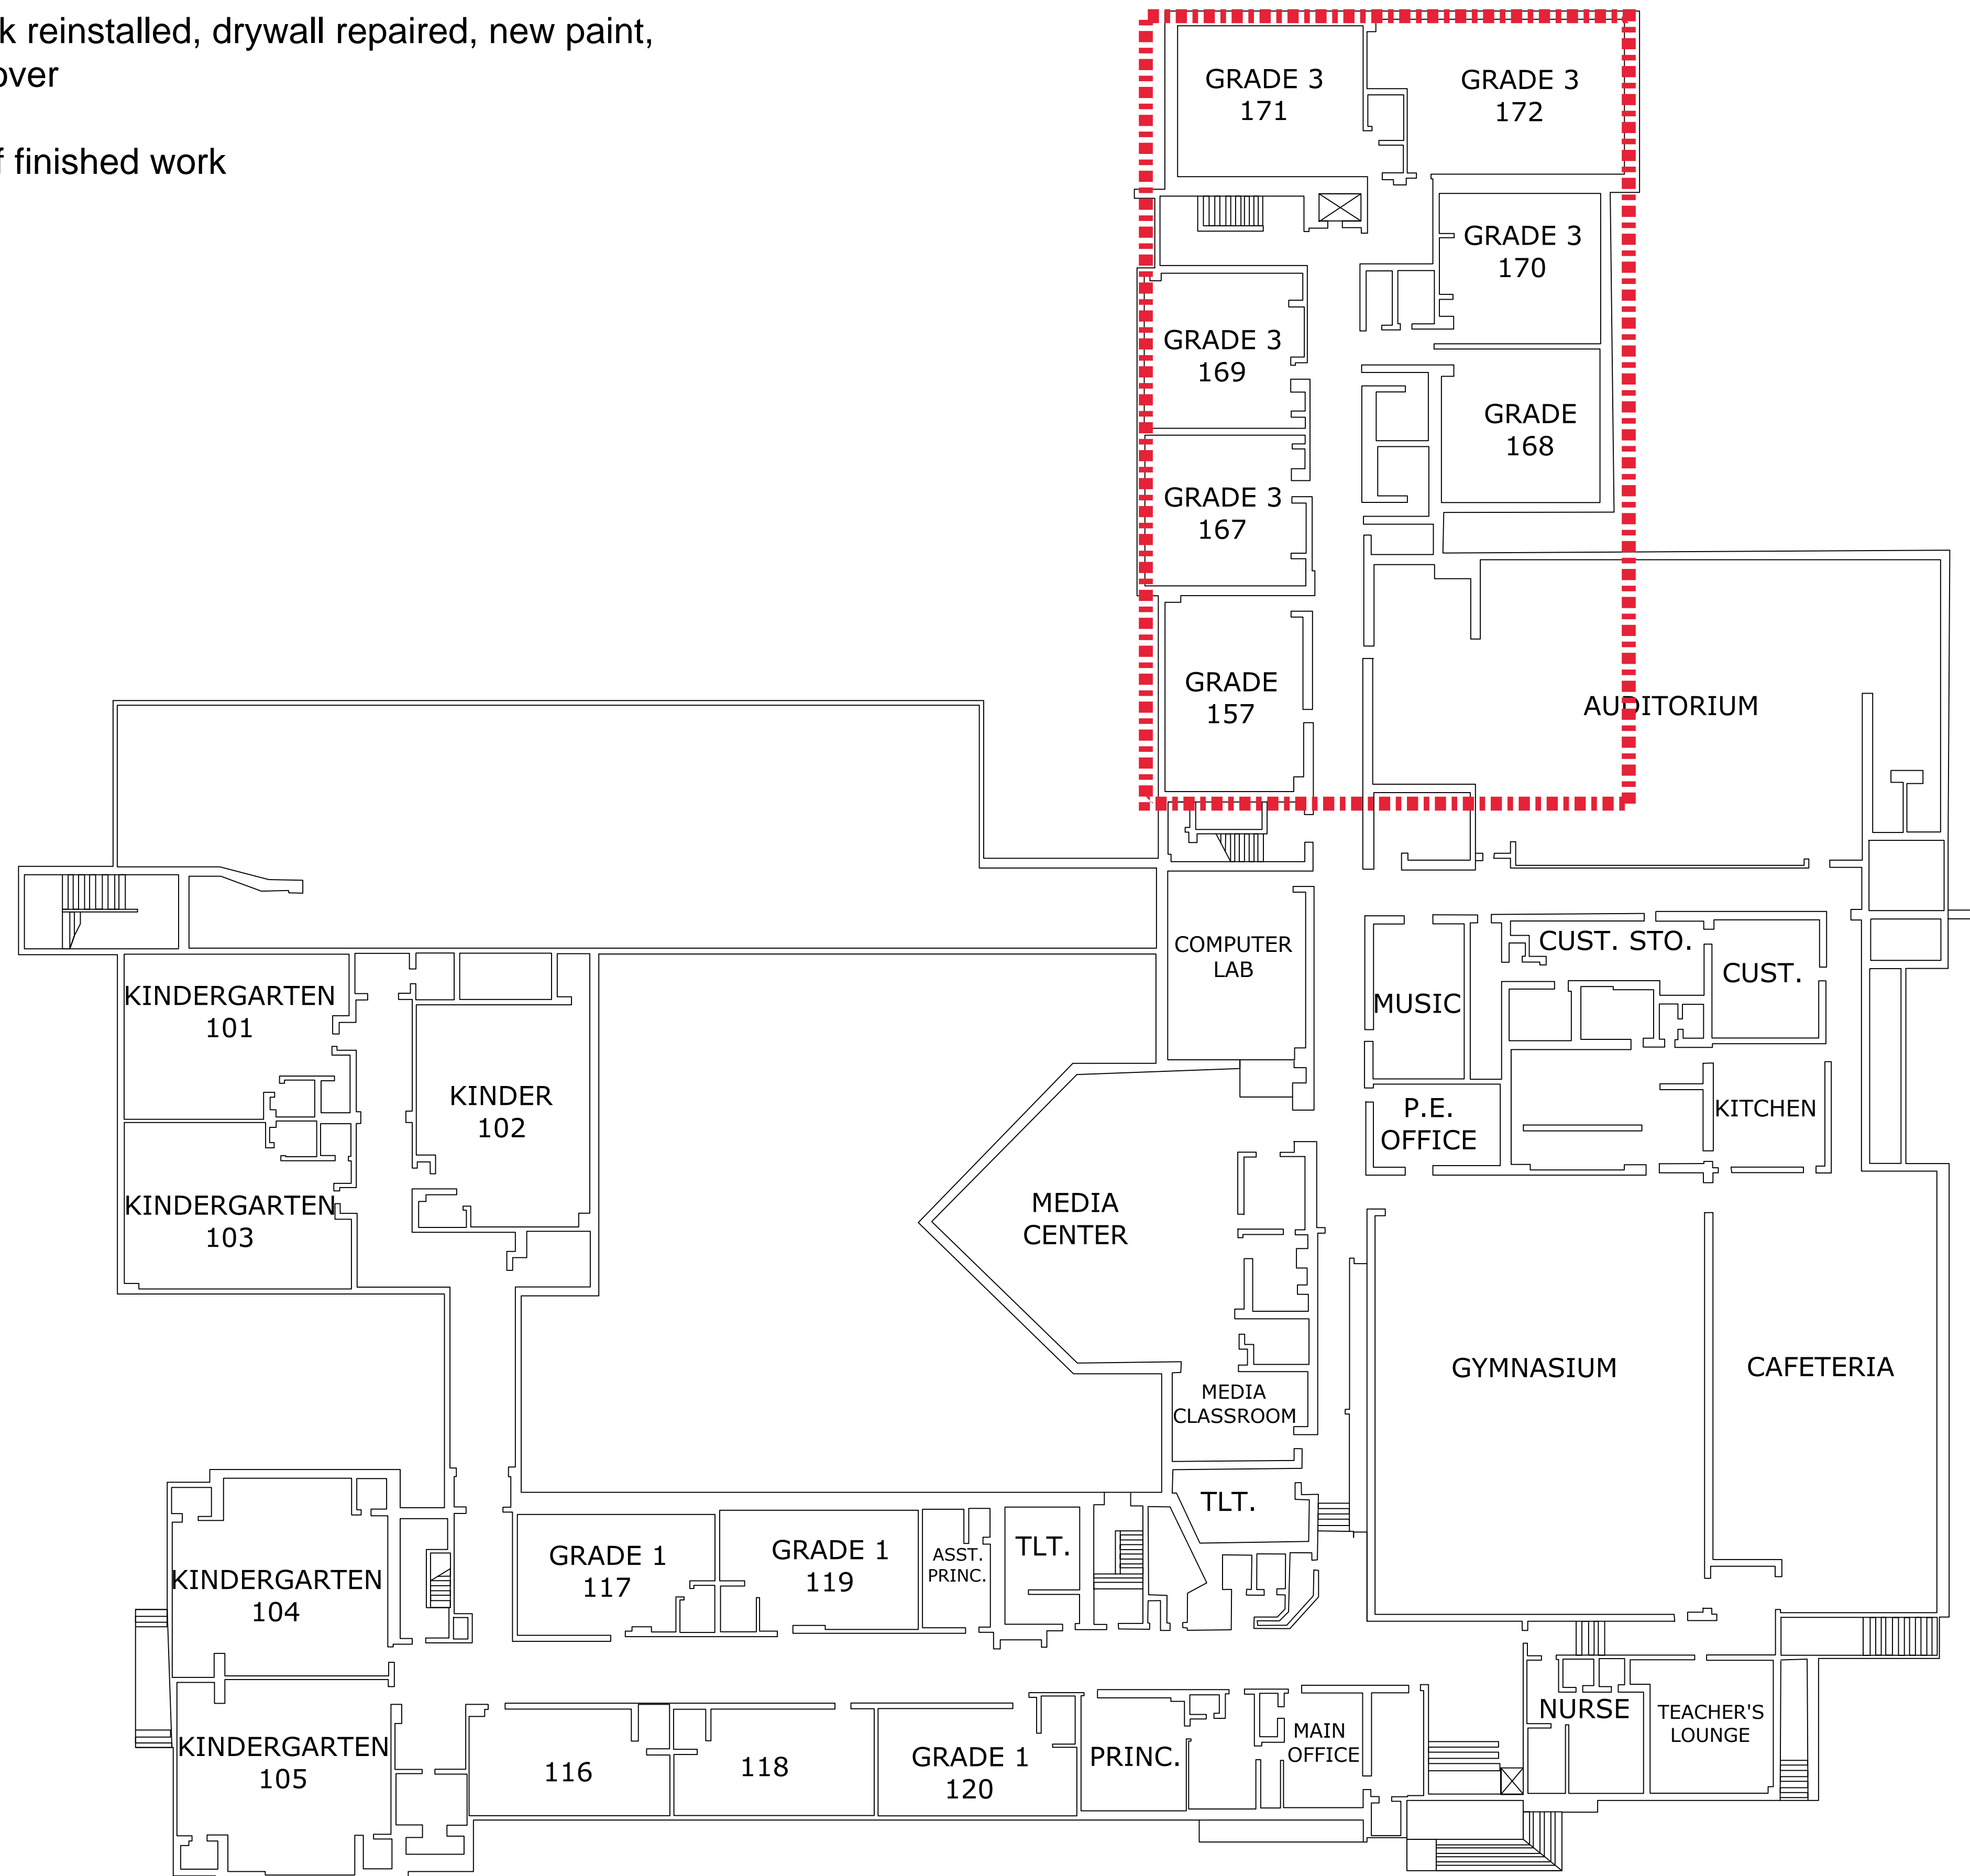
**Room 157, Rooms 167 - 172**

AOC 83 - AOC 89

Area complete: Millwork reinstalled, drywall repaired, new paint, final clean and turned over

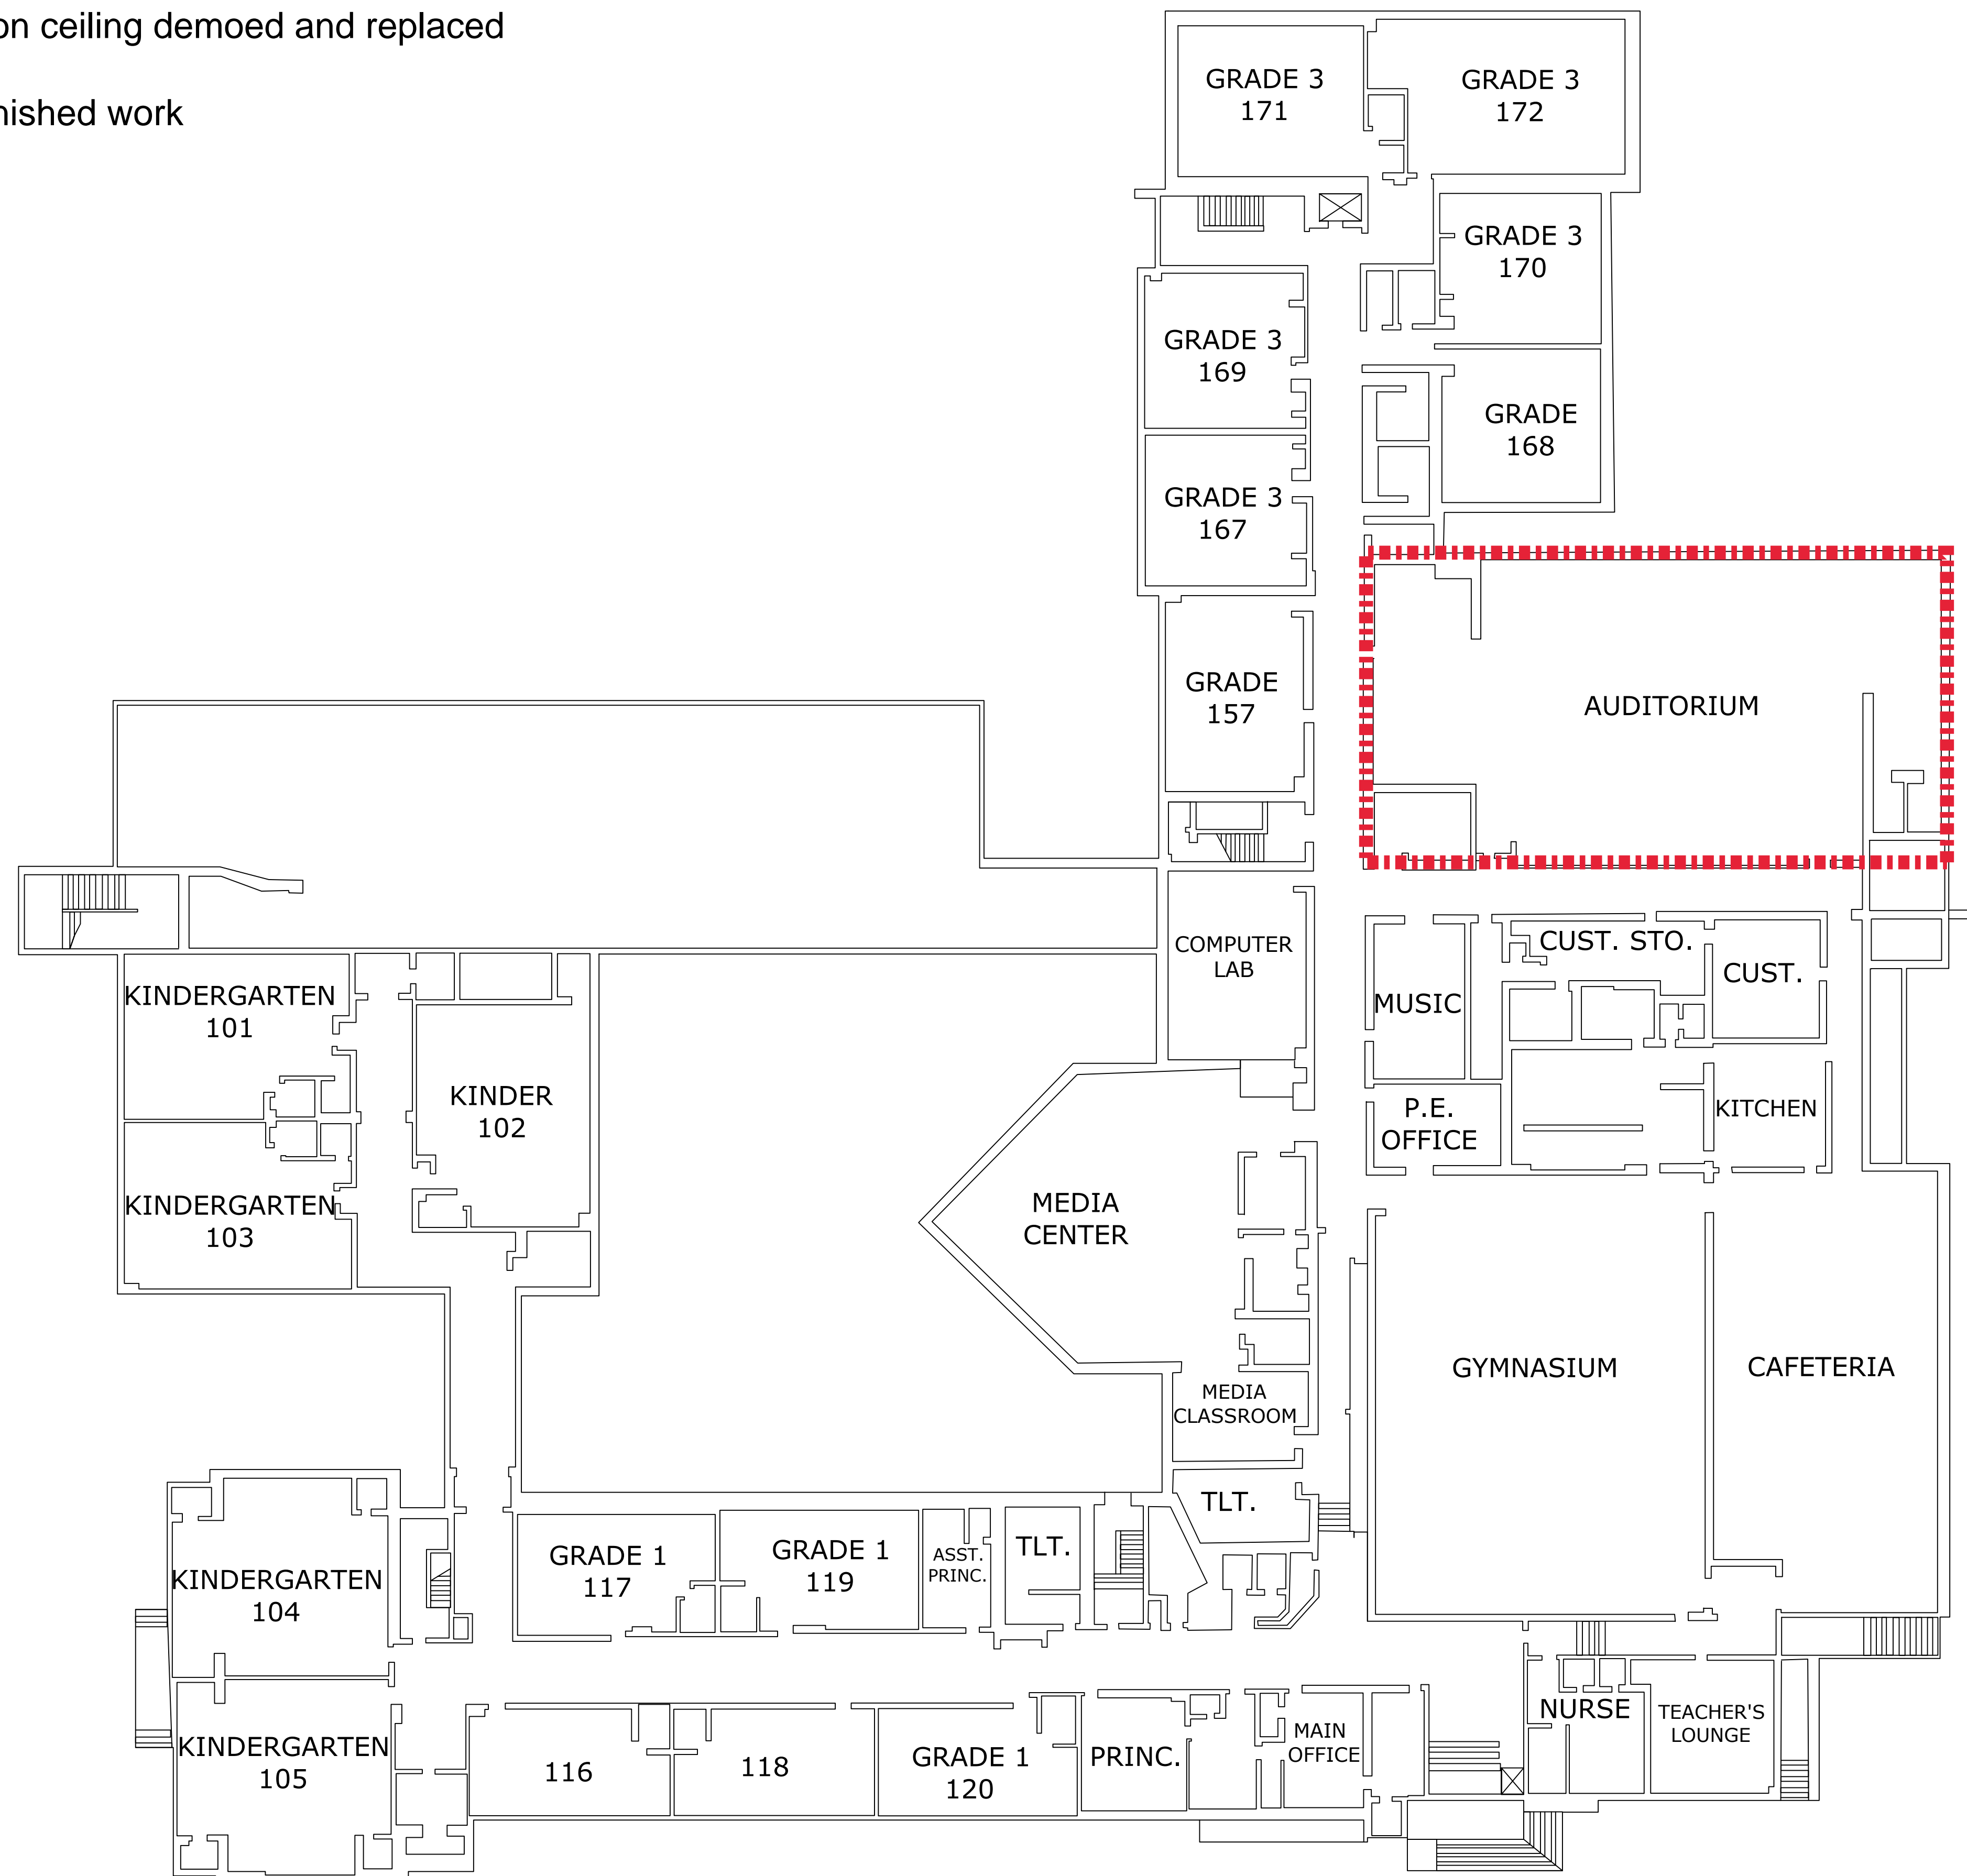
**Auditorium and Side Area, Auditorium Lobby/ Rear Area:**

AOC 11 - AOC 12

Area complete: Drywall on ceiling demoed and replaced
