**Stark Elementary School**

City of Stamford

**DRAFT** Figure 1.1 - Areas of Concerns

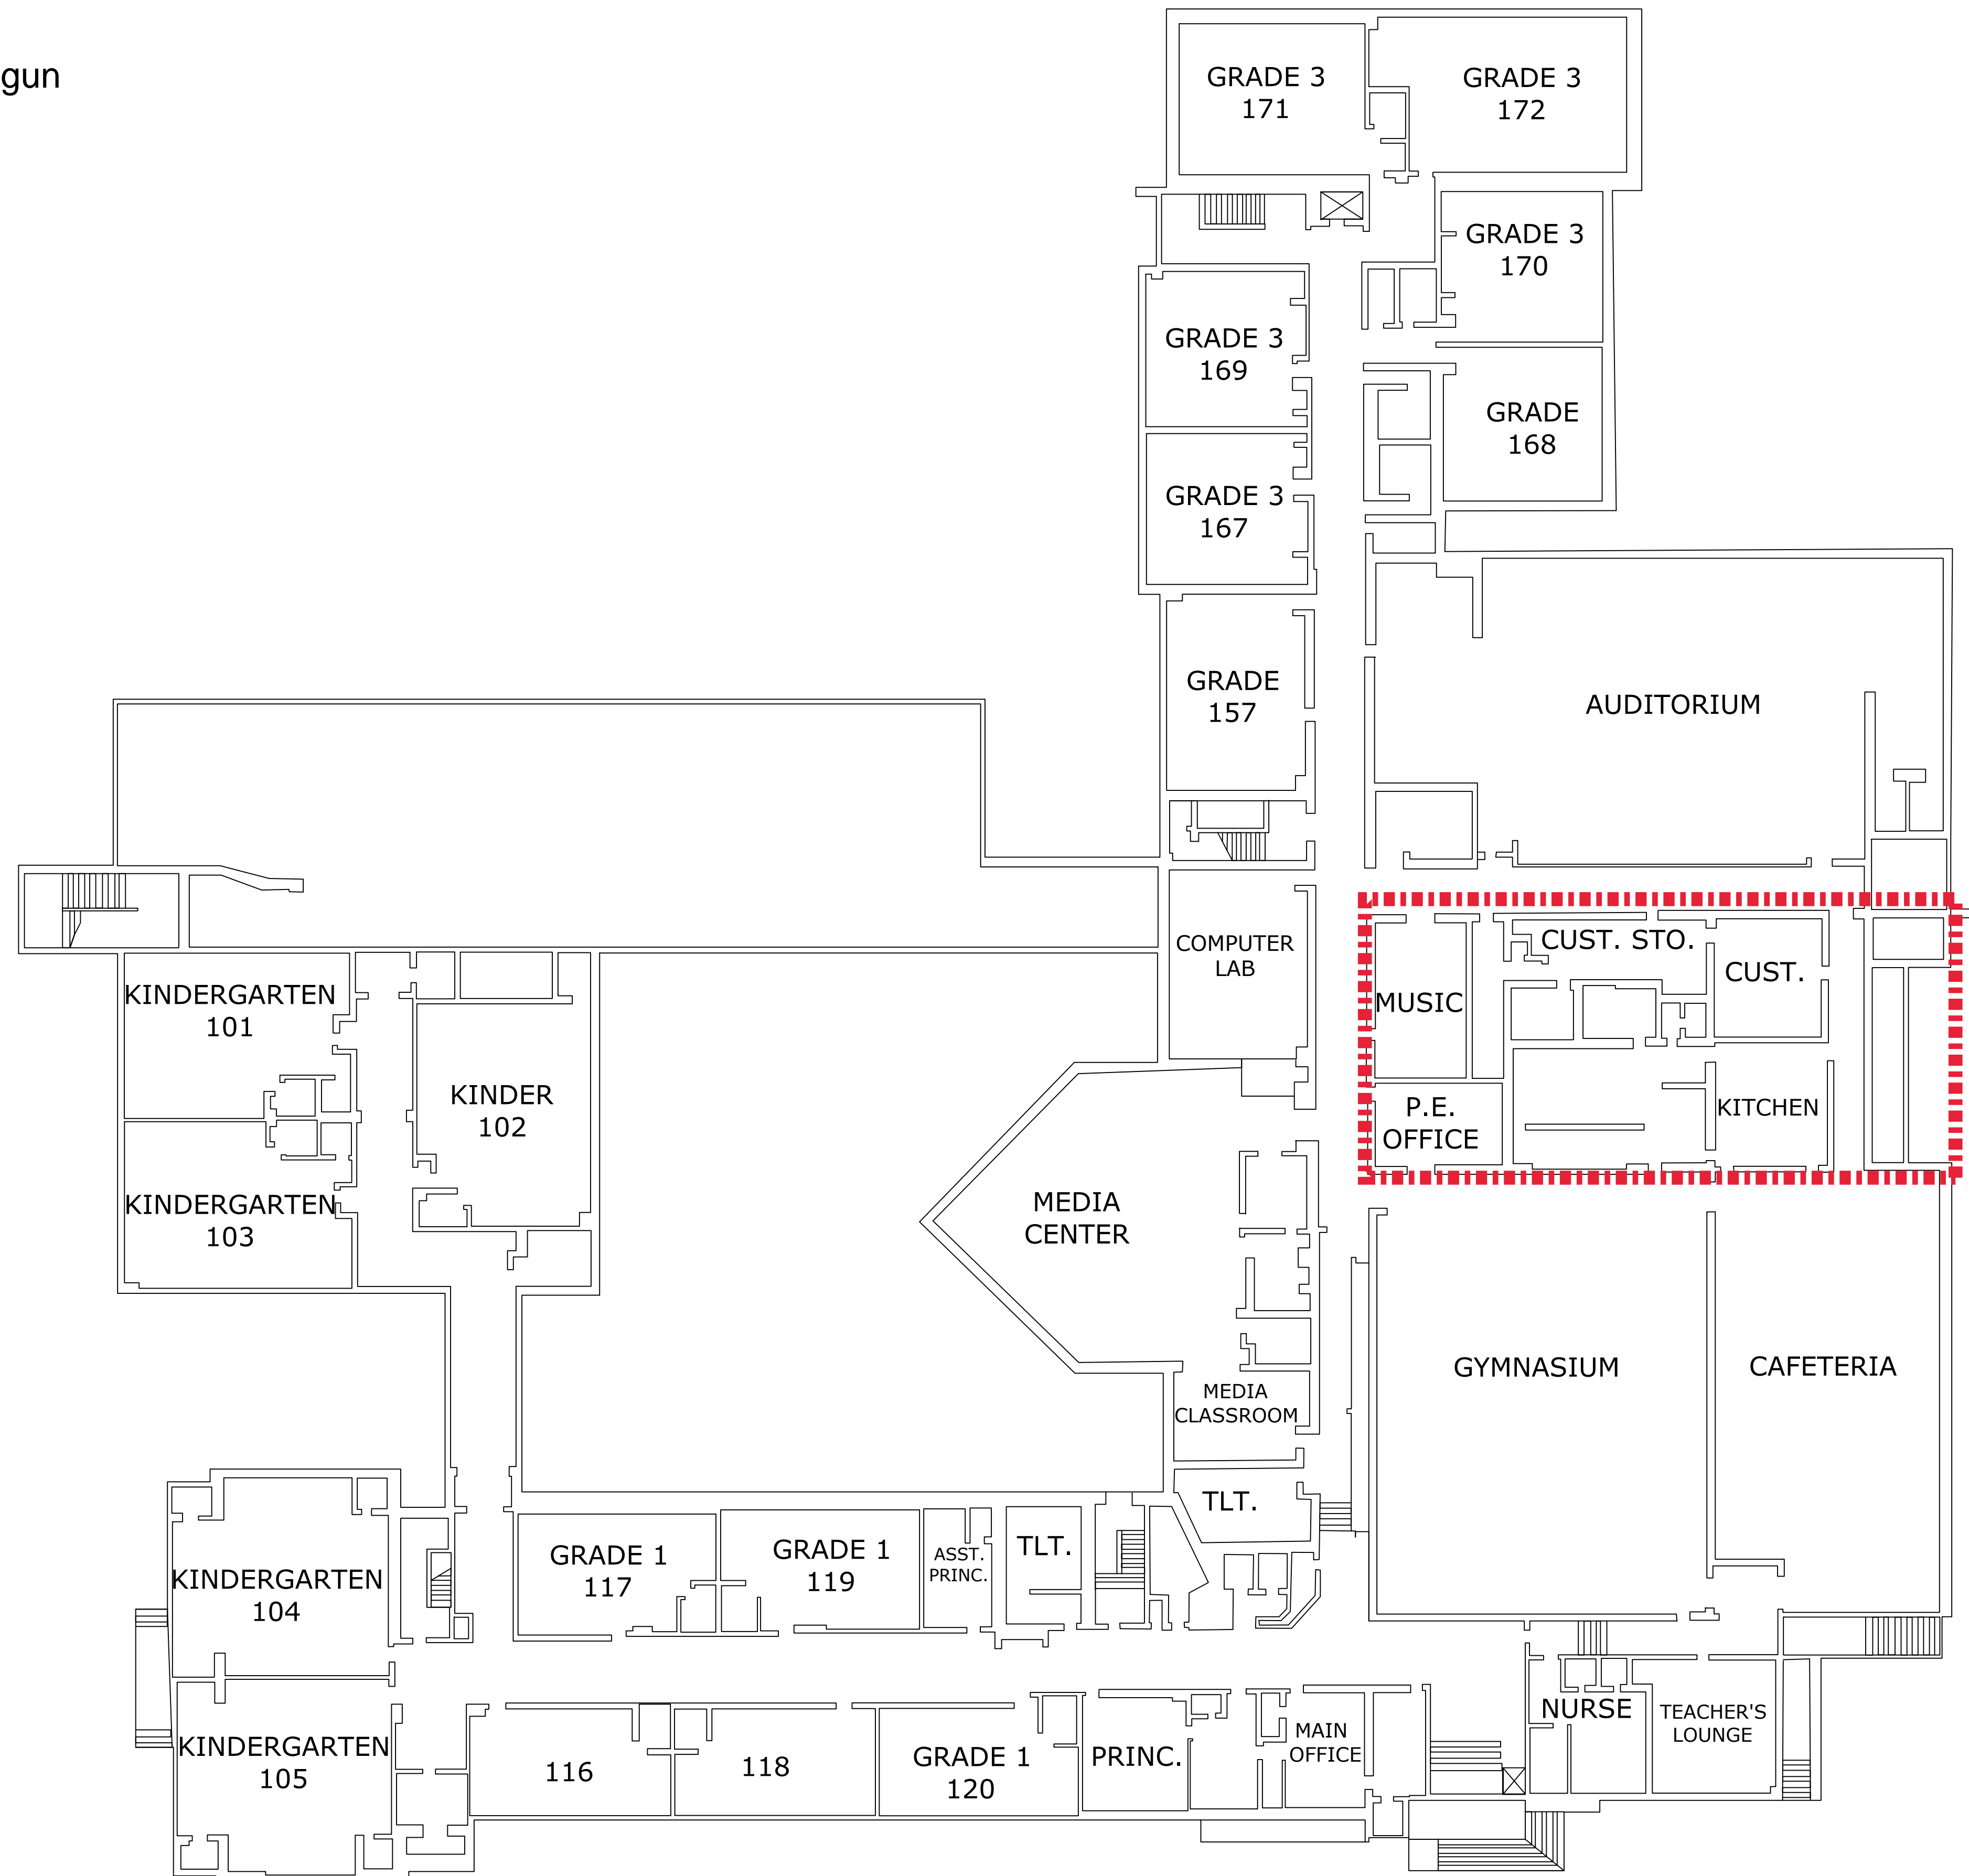
**Kitchen, Custodial Area, Room 143 (Music Room), P.E. Office:**

AOC 13 - AOC 16

Work in area has not begun

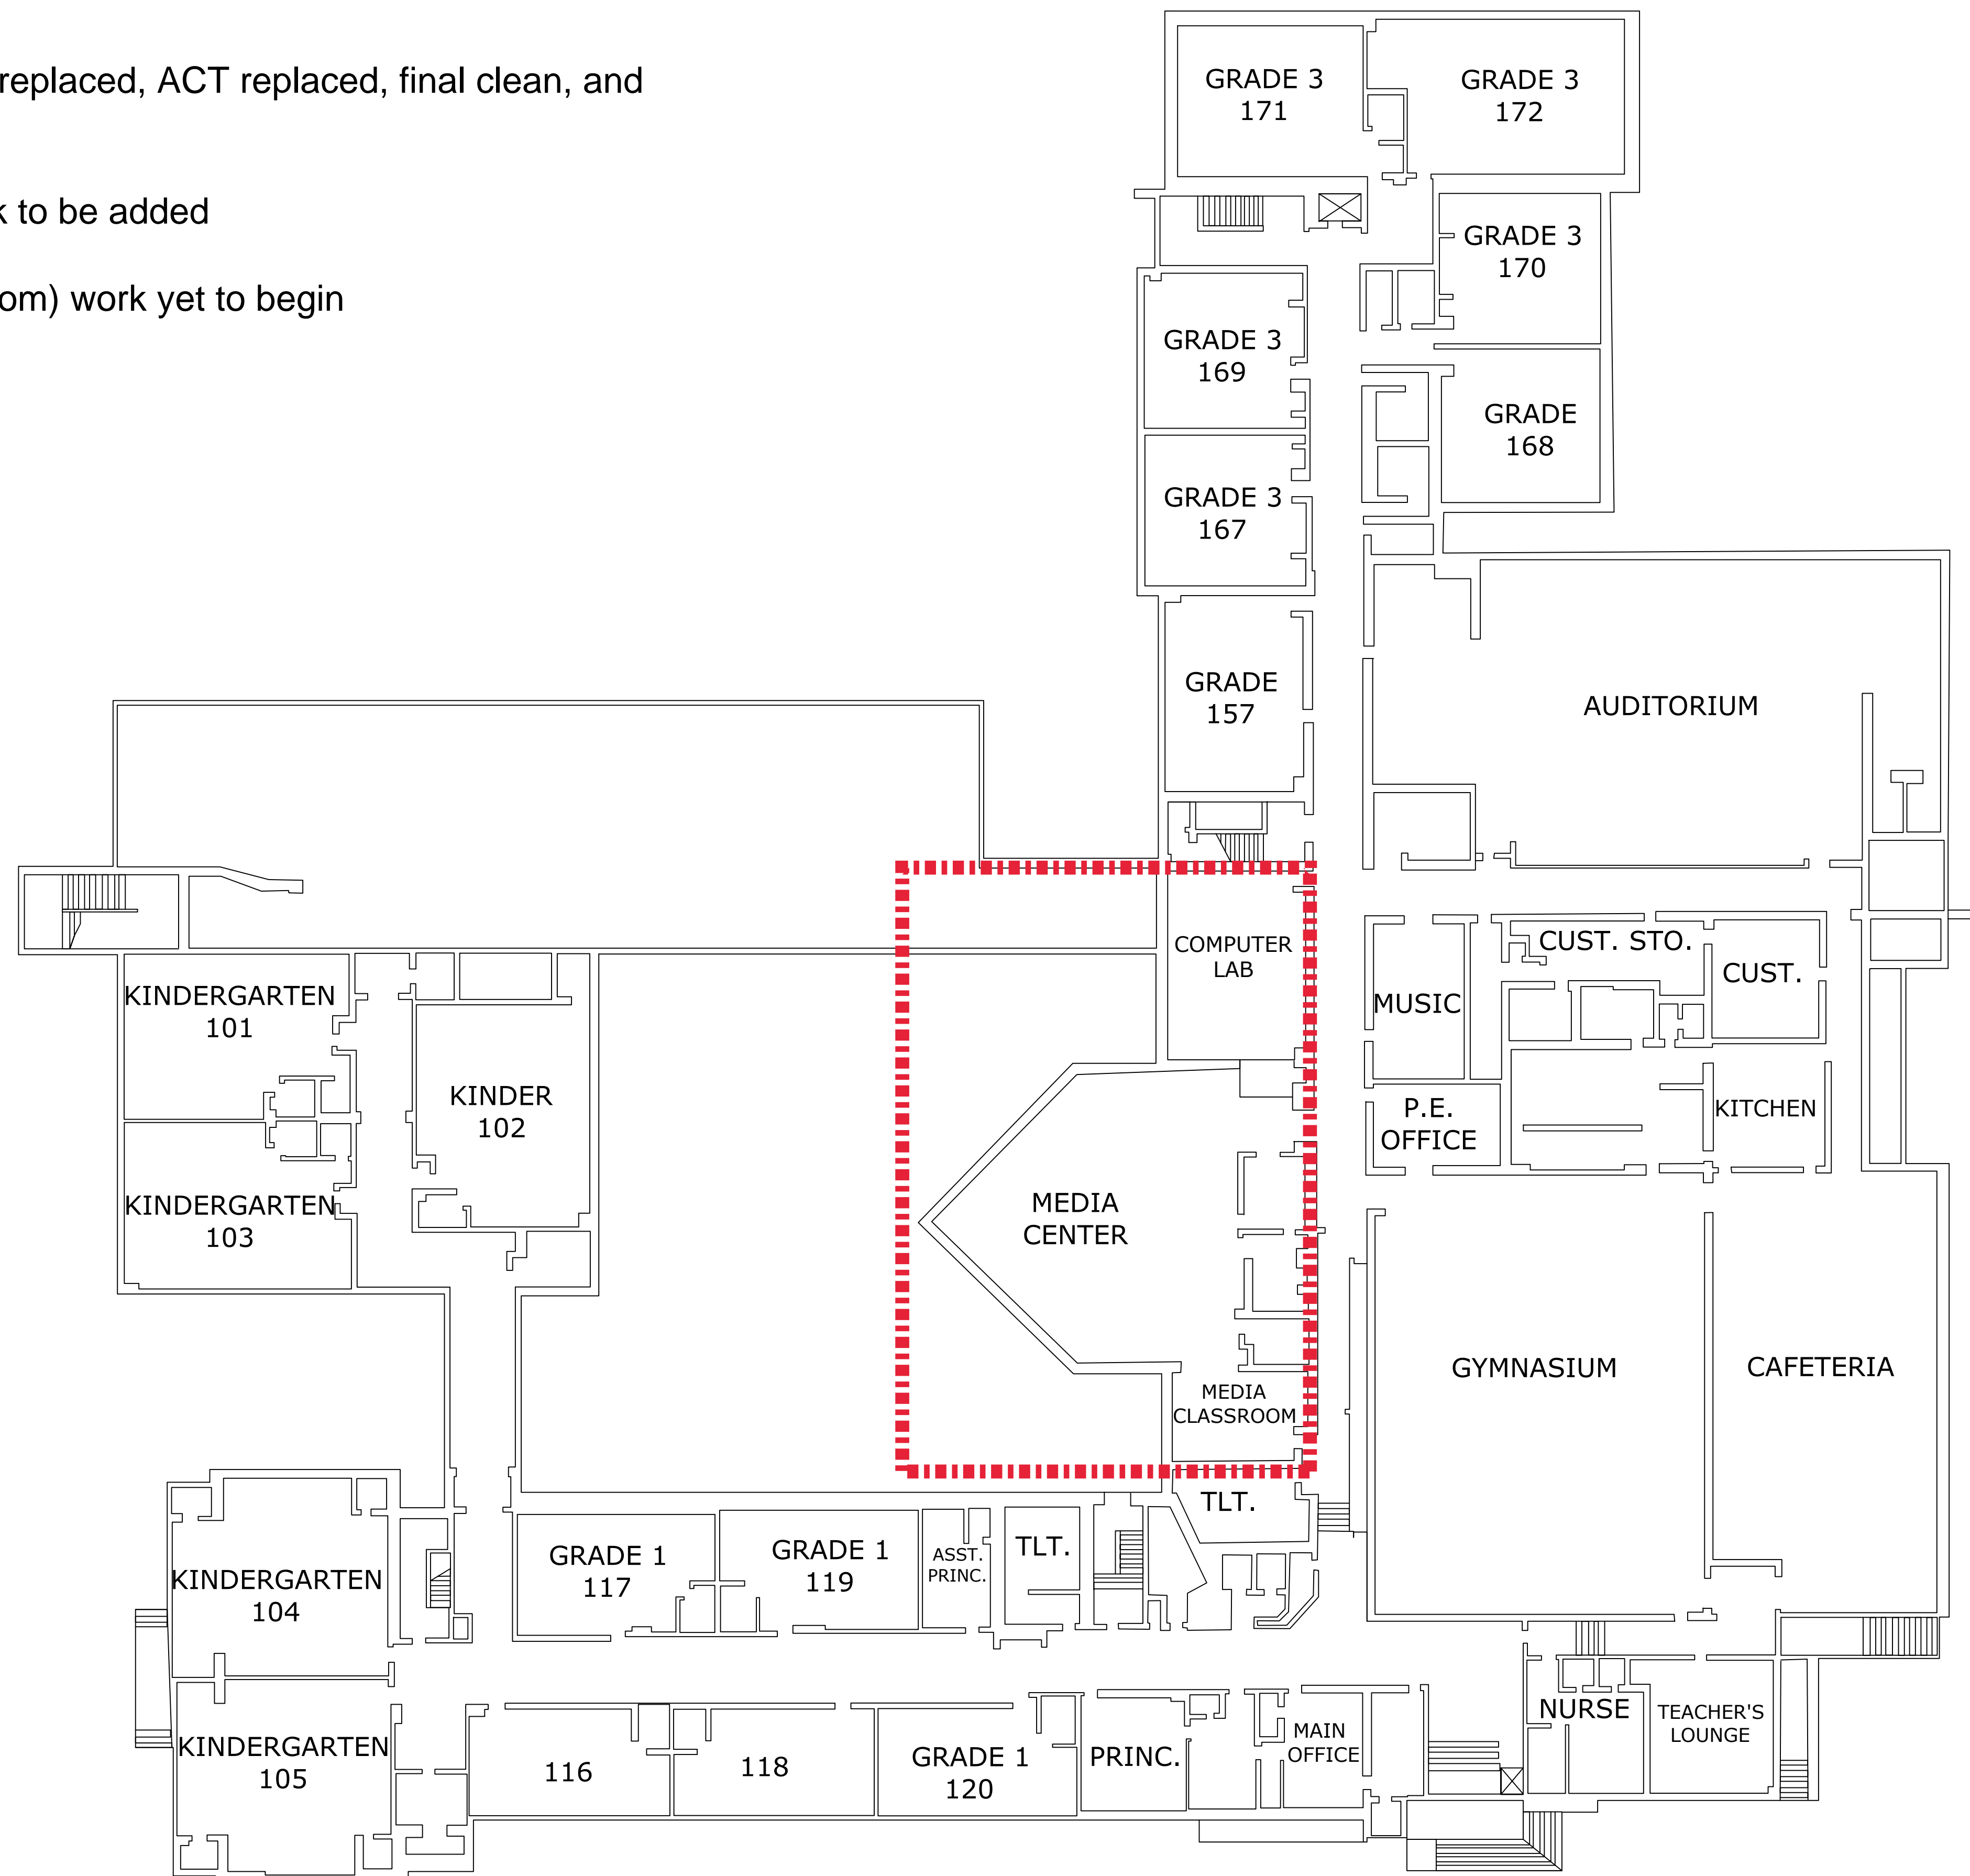
**Media Center at IT Closet/Entry Door, Media Center and Computer Lab, Media Classroom:**

AOC 17 - AOC 19

AOC 19 (Media Classroom) work yet to begin

Area complete: Drywall replaced, ACT replaced, final clean, and area turned over

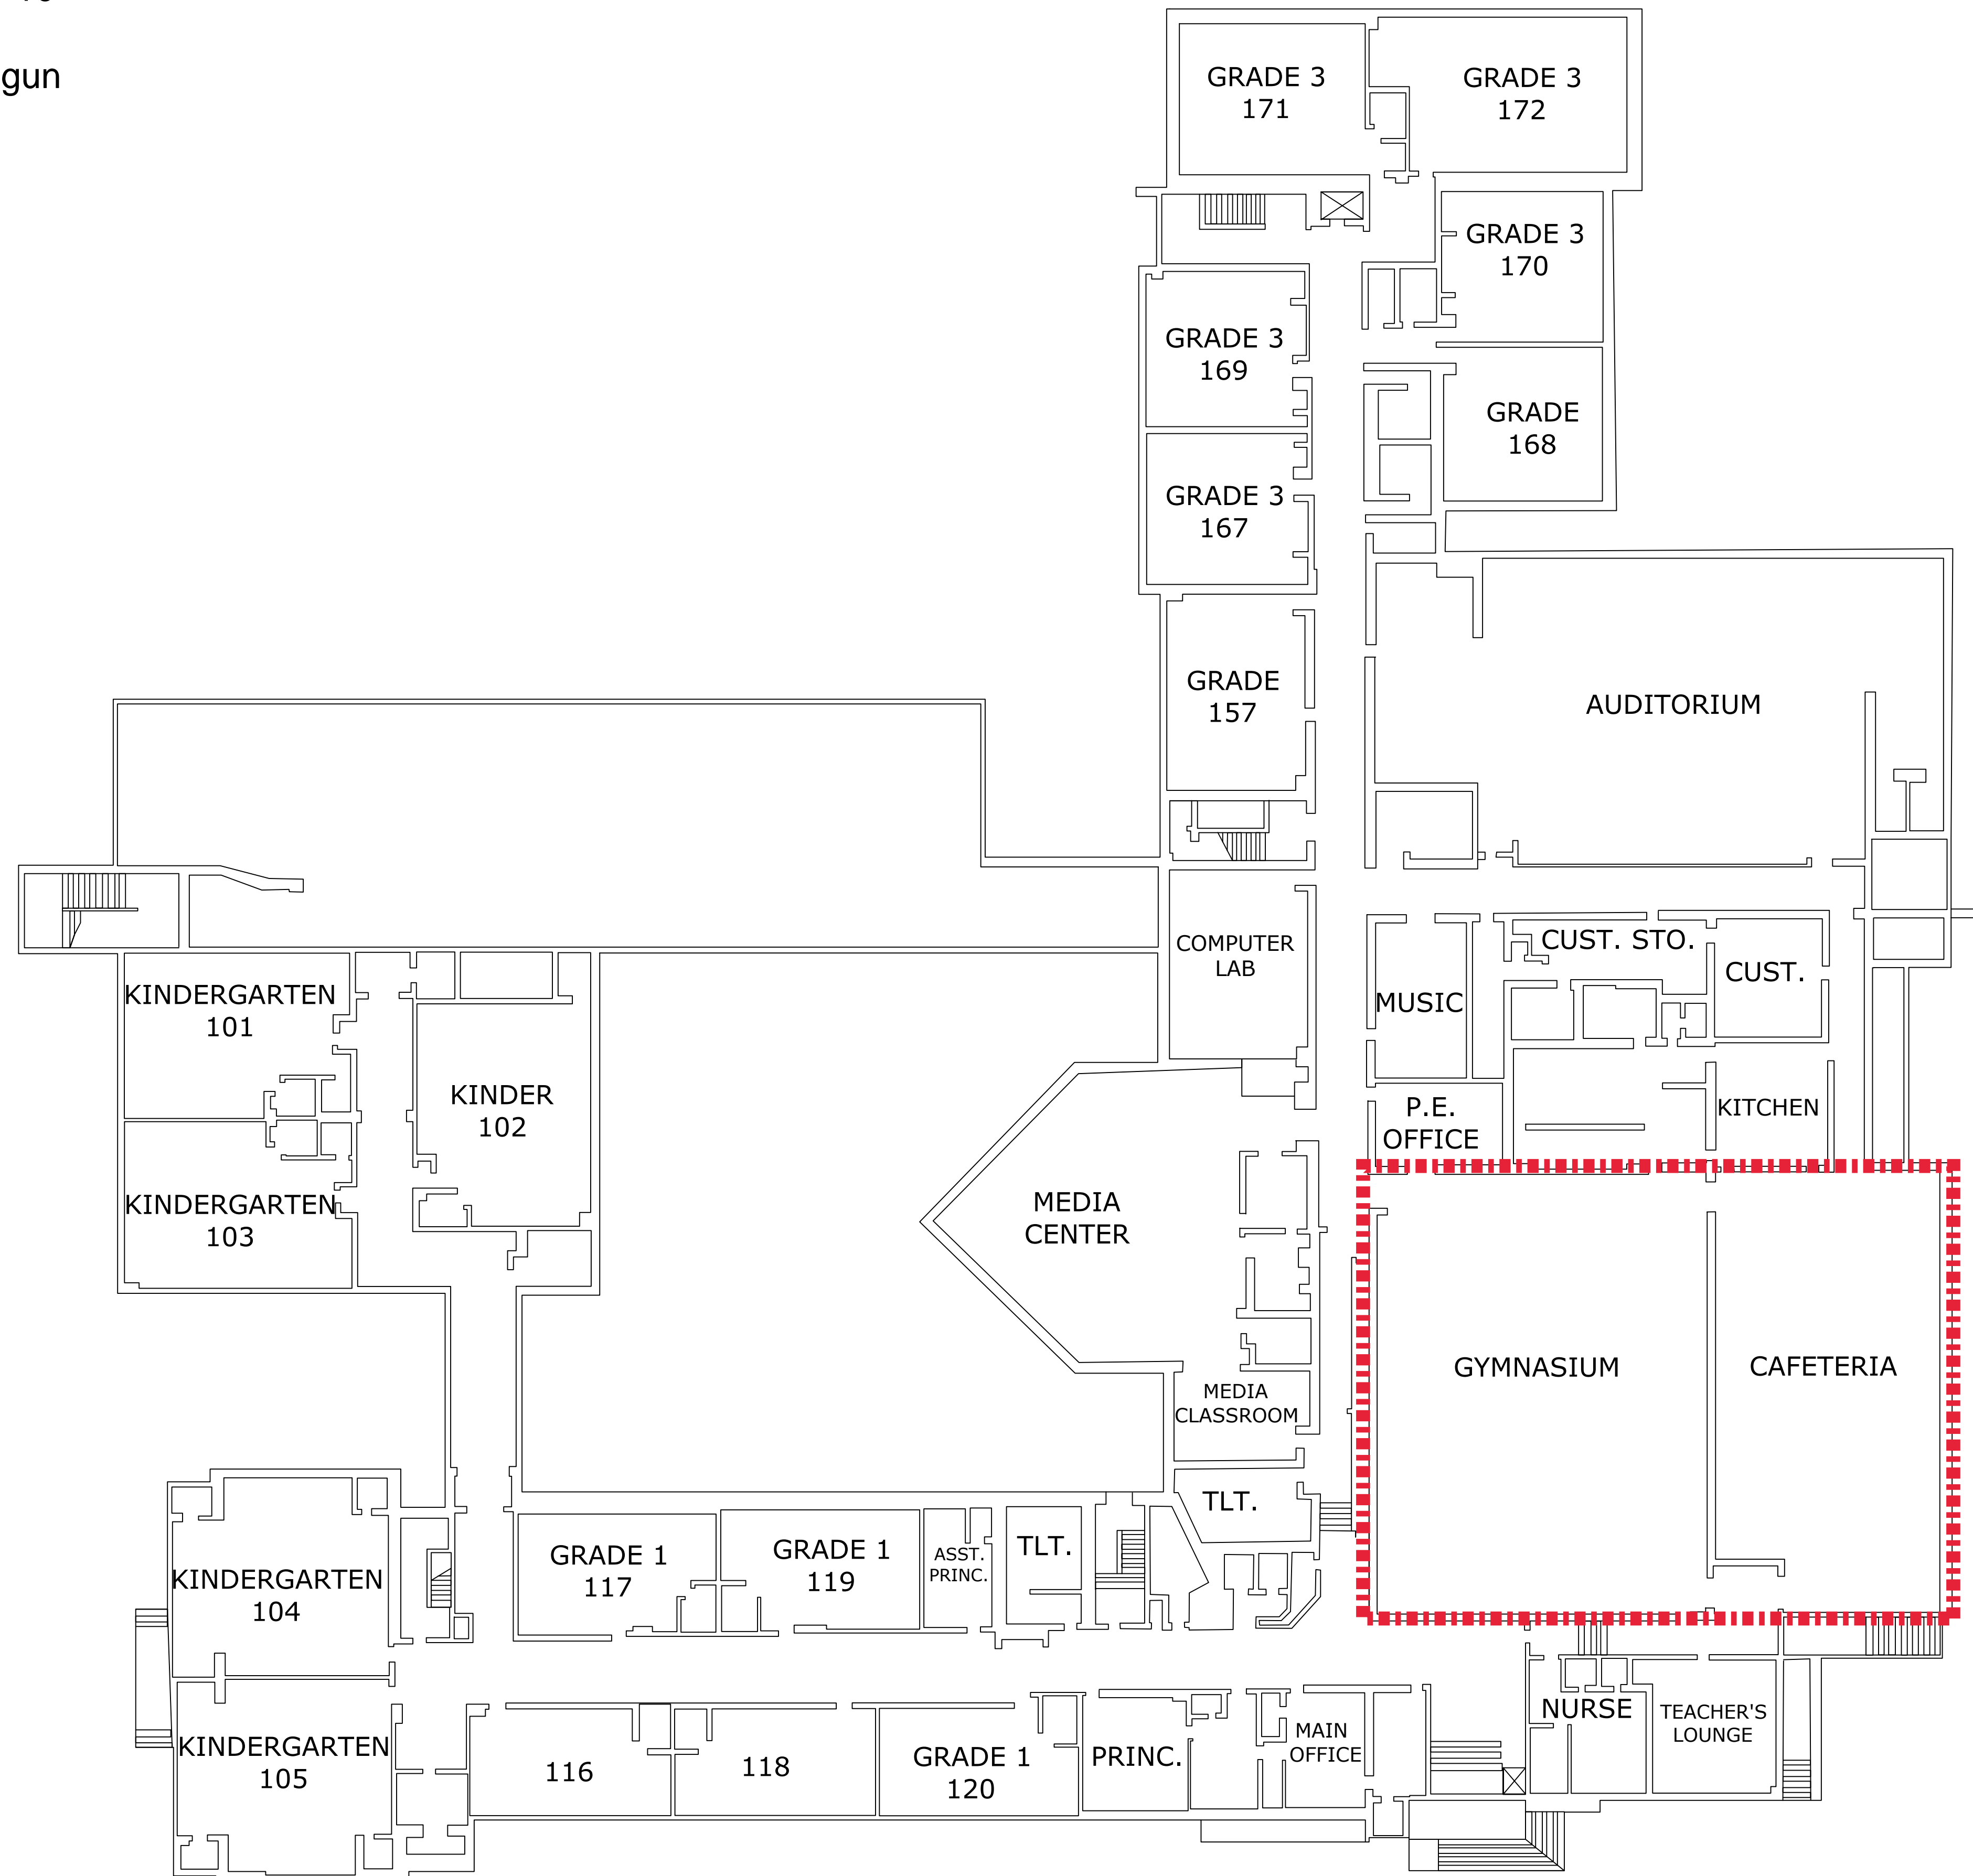
**Cafeteria, Cafeteria Entryway at Teacher's Lounge,  
Gymnasium:**

AOC 03, AOC 09 - AOC 10

Work in area has not begun

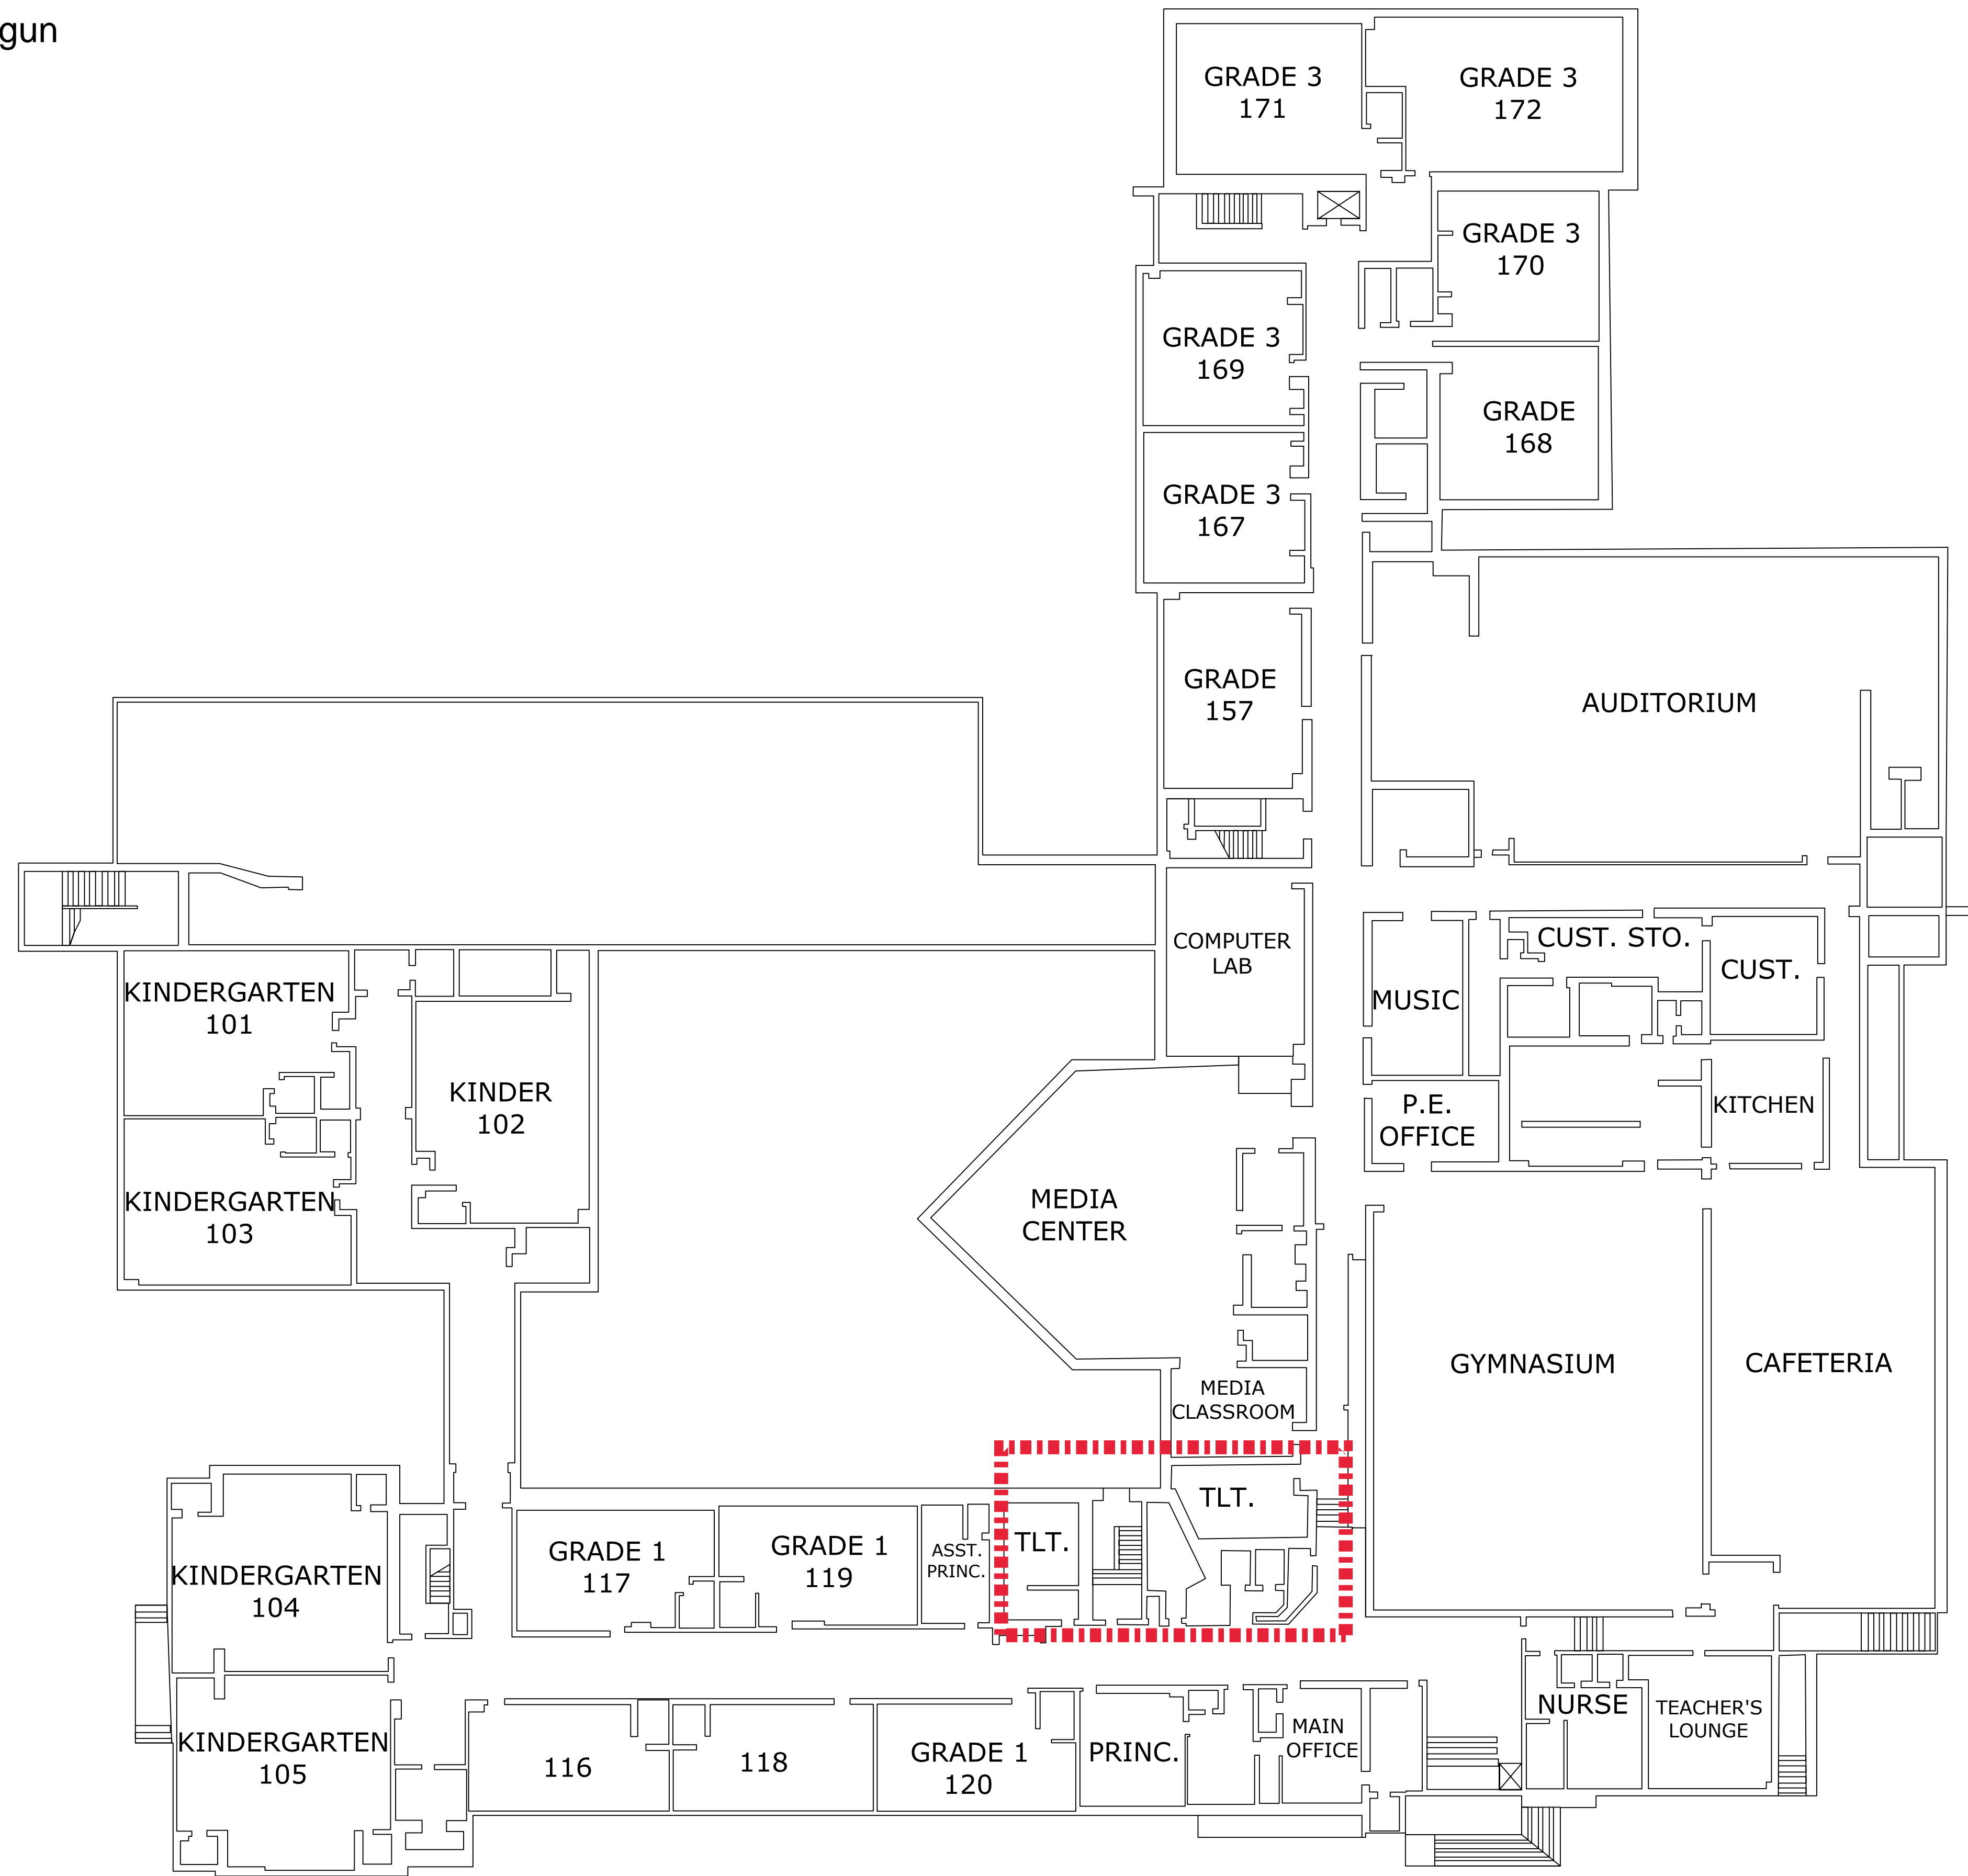
**First Floor TLT (Boys Bathroom and Girls Bathroom):**

AOC 07 - AOC 08

Work in area has not begun

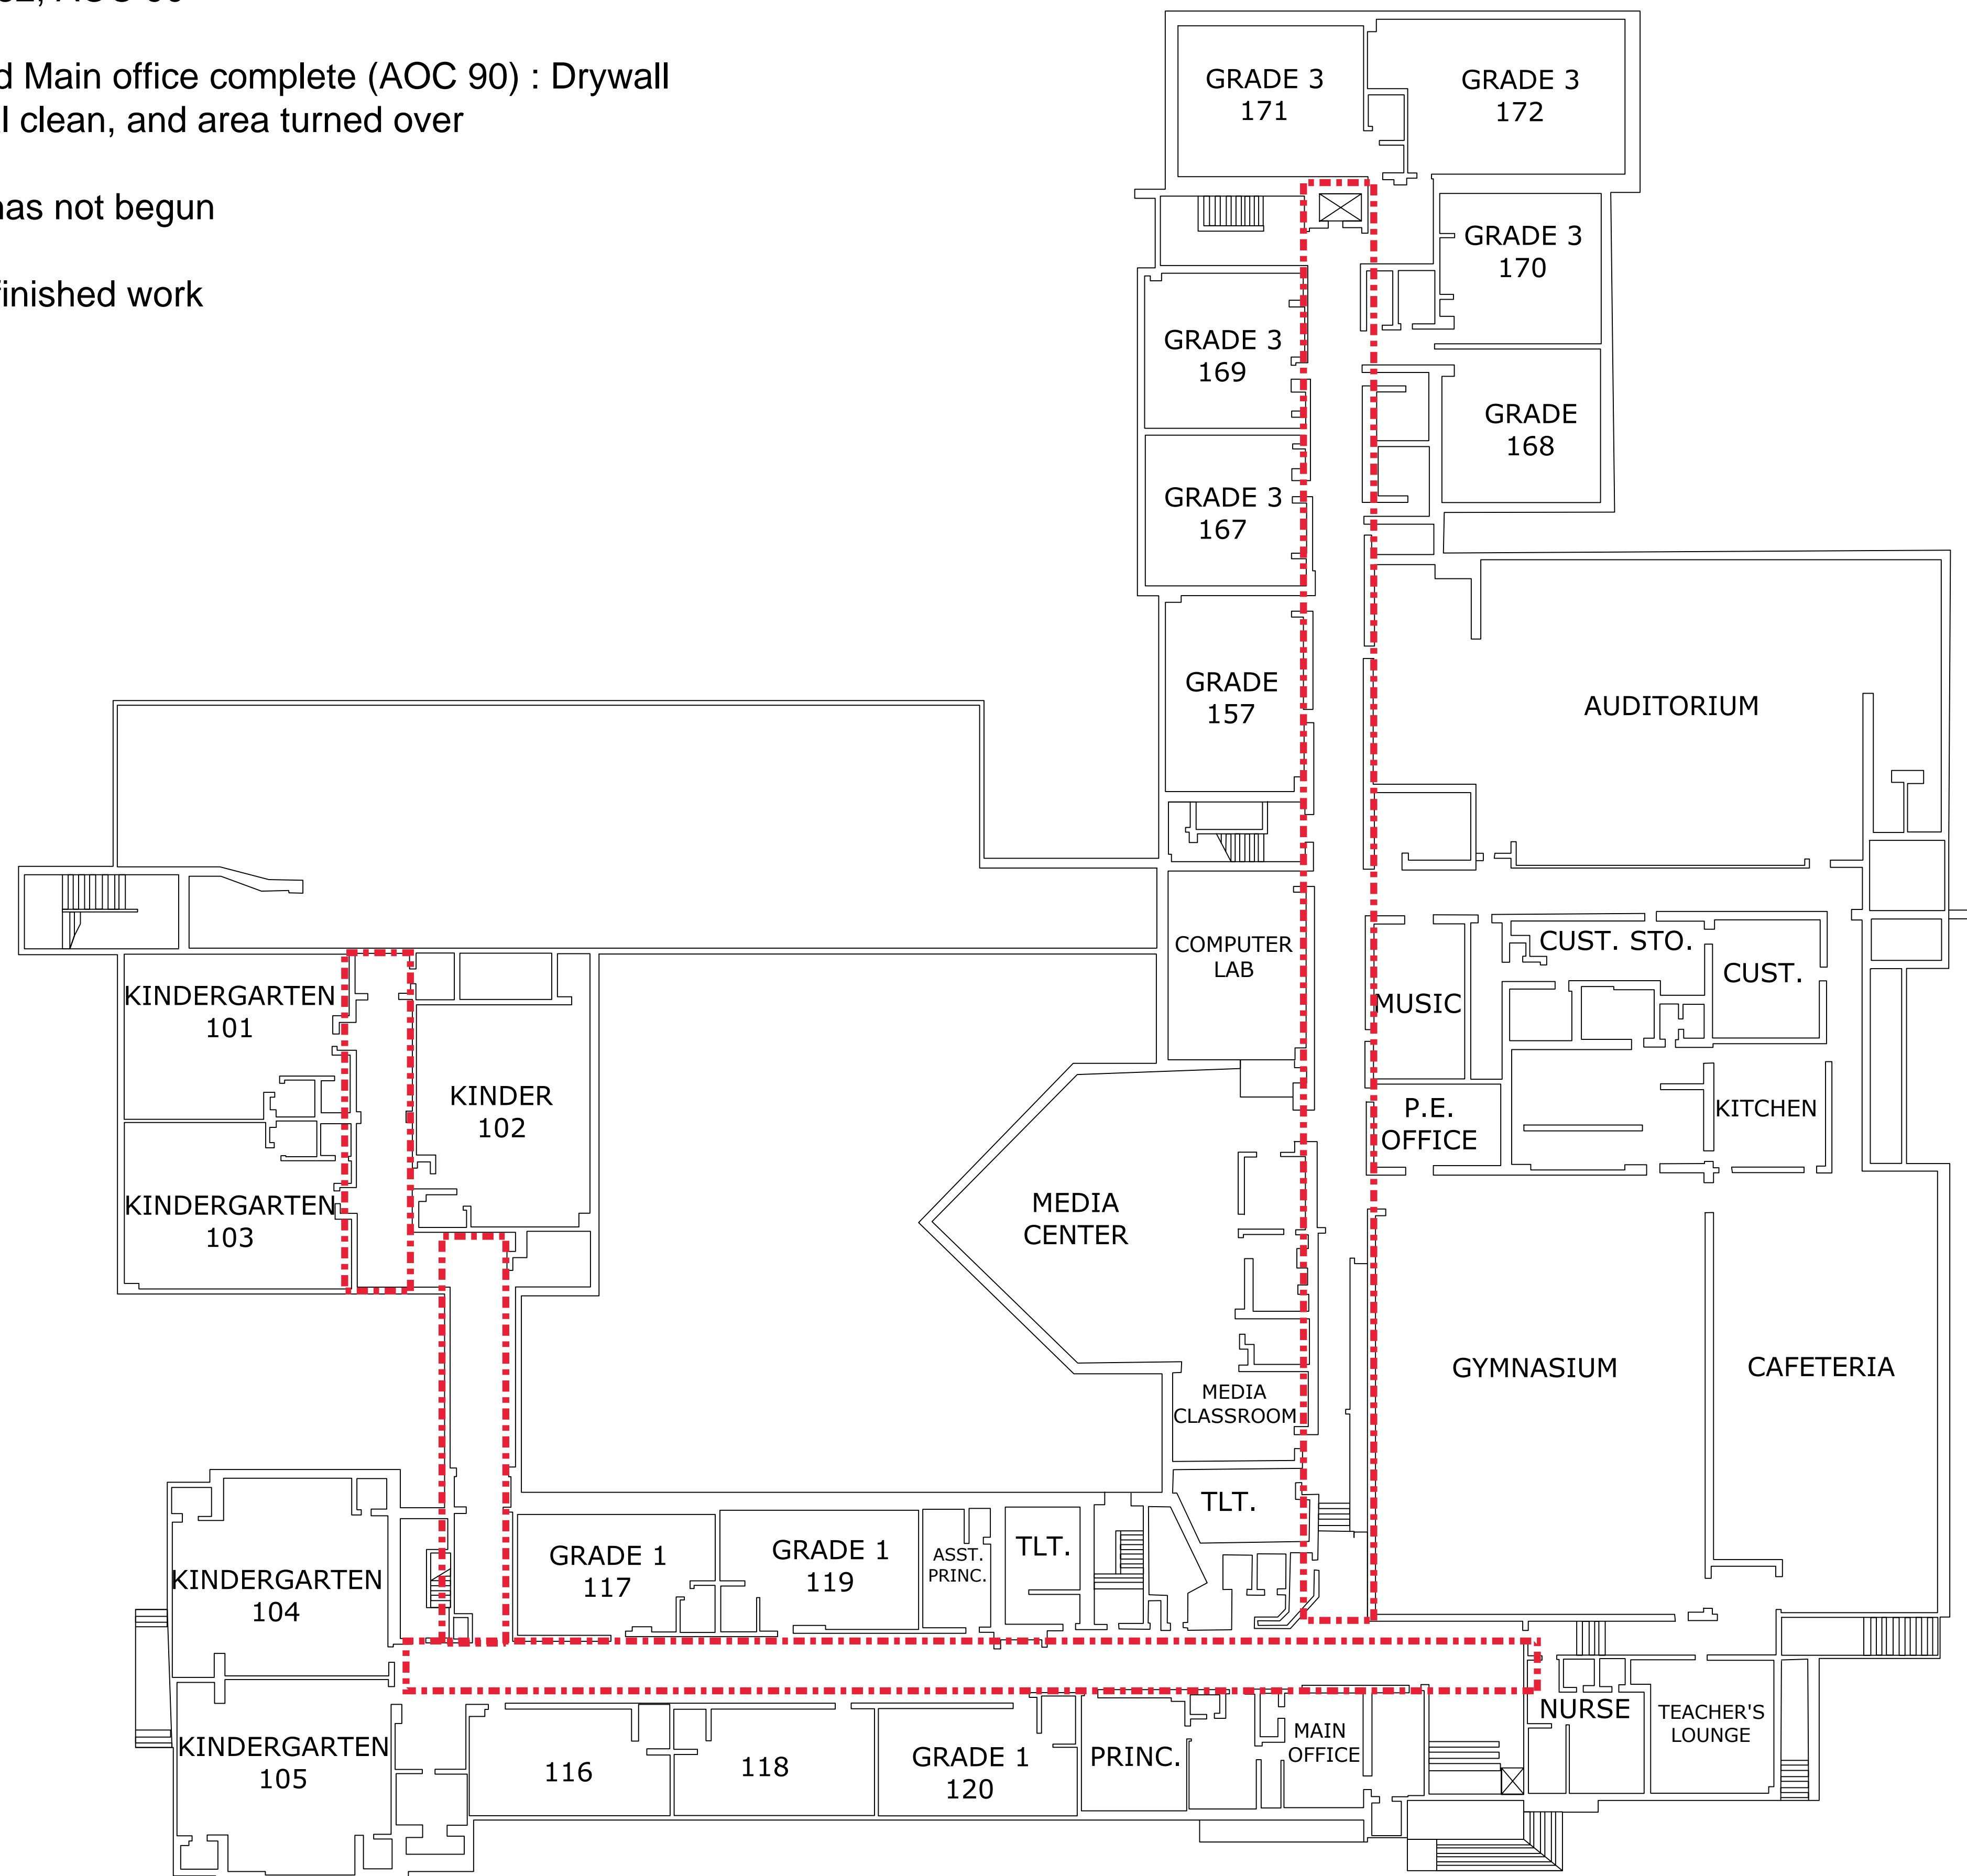
**Corridor b/w 117 - 103, Corridor b/w 105 - Nurse's Office,  
Corridor b/w 101 - 103, Corridor b/w 172 - Main Office:**

AOC 71, AOC 77, AOC 82, AOC 90

Remaining AOCs work has not begun

Corridor b/w Rm 172 and Main office complete (AOC 90) : Drywall replaced, new paint, final clean, and area turned over
