M. Gottfried, Inc.

RE: Roof report and repair quotation
Julia Stark Elementary School
398 Glenbrook Road
Stamford, CT 06906

As per your request we went to the above school to perform an inspection of the roofs, and, using the Infrared Thermographic Roof Moisture Analysis Report as a guide, look for possible sources of water leaks in the noted "wet areas". We also were to perform test cuts to verify the wetness and determine the roof components in those areas. We were also asked to provide pricing on replacing the wet areas, and to provide a recommendation and pricing for roof maintenance.

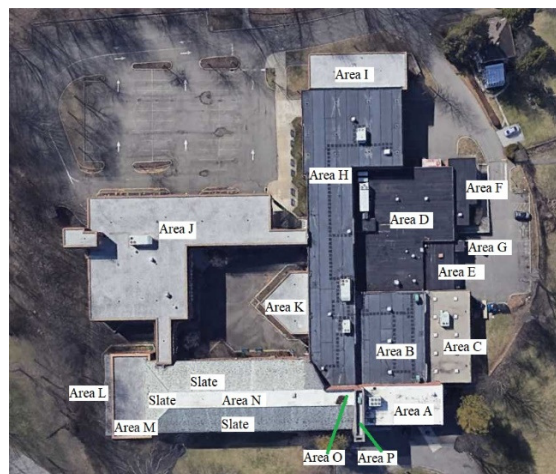
Roof with labeled roof areas

We were provided with two active warranties on the roofs at Stark School. One warranty (from GAF) covers a smaller gravel surfaced BUR. This warranty expires in August of 2023. The infra-red scan showed one small wet area on this roof against the wall of the adjacent higher section. The other warranty (from RPI) covers a much larger area of the roof and spans 3 roof areas. An overall look at the roofs of the school and the moisture scan shows the roofs to be in relatively good shape, with only one roof area (at the top of the slate roof) that is entirely wet and needs replacement.

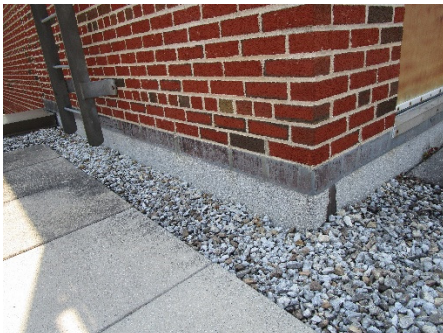
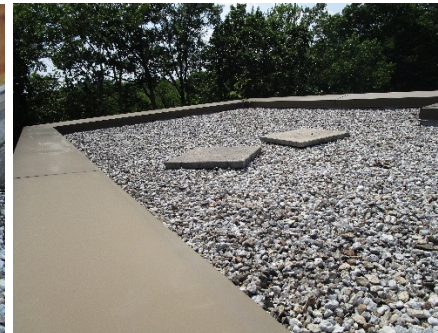
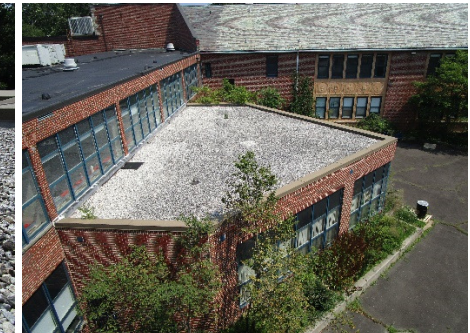
Roofs I, J and K are all inverted or "IRMA" built-up roofing systems. The membrane is on the deck, then insulation, filter fabric and ballast are on top of it. This type of system tends to have very long life spans because of the protected and temperature regulated nature of the assembly. Going by time span pictures of the school, it looks like these roofs cover an addition that was installed in the early 2000's. Only the visible portion of the flashings were inspected on these roofs and all look to be in good condition. General maintenance to remove organic growth, clear drains, etc., should be performed. There are also two conditions that need more attention.
