FACILITIES NEEDS ASSESSMENT

STAMFORD PUBLIC SCHOOLS

Facilities Needs Assessment

K.T. MURPHY ELEMENTARY SCHOOL

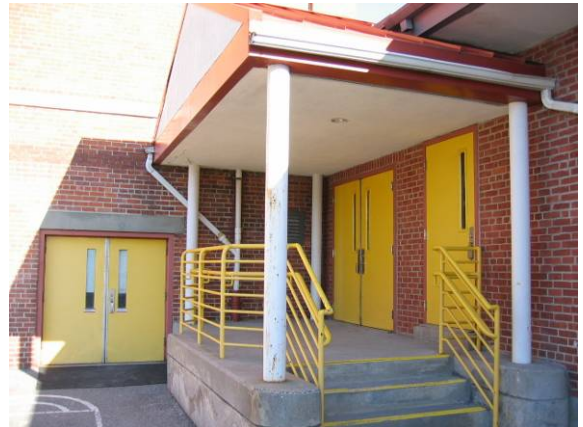
Photo #4: Secondary common entrances exist on all façades. note peeling paint

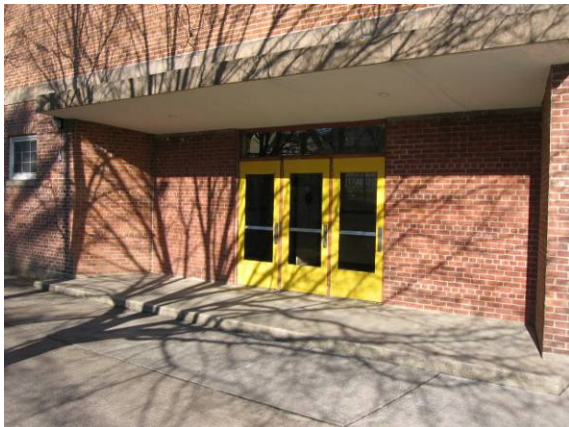
Photo #5: View of the common entrance to the auditorium - no ADA ramp exists

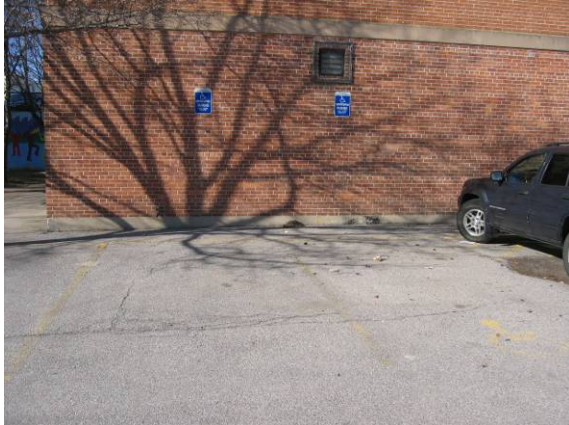
Photo #7: View of the two on-site ADA parking stalls - striping is faded and no access aisle exists

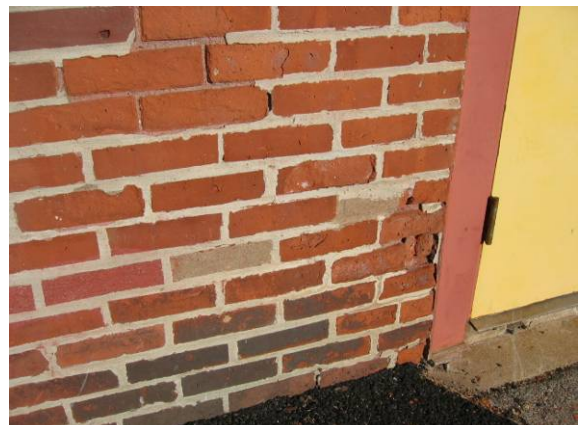
Photo #12: Detail of the isolated brick step cracks and open mortar joints

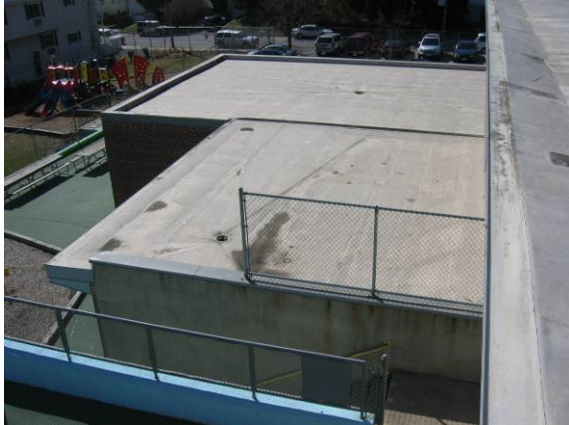
Photo #25: A short length of chain link fence was installed but has been unsuccessful

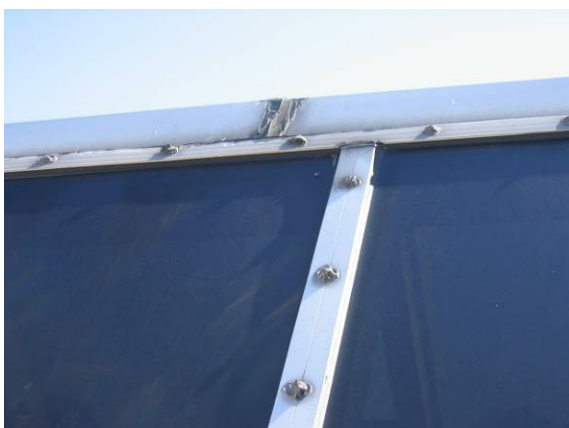
Photo #29: One occasional leak was reported in the media center skylight system

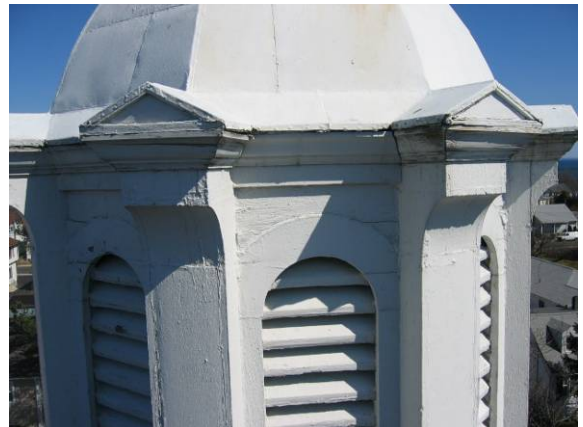
Photo #36: Detail view of the wood and painted metal bell tower - note the deteriorated wood work

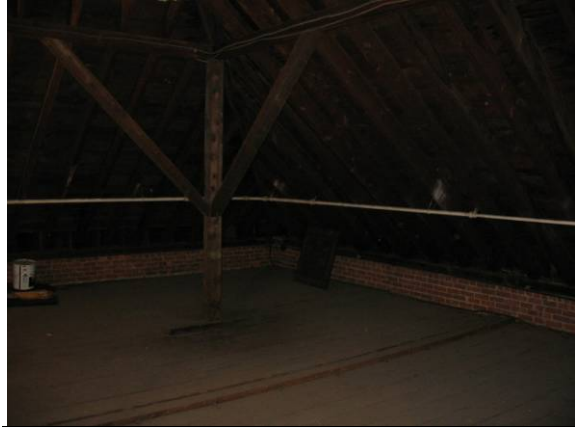
Photo #38: View of the pitched roof attic - no insulation exists

6.3	2820	Blown in Cellulose Attic Insulation R-30	40	39	1	4200	SF	\$1.68	\$7,038		\$7,038										\$7,038
6.3	2497	Replace roof hatch	25	16	9	4	EA	\$1,770.31	\$7,081										\$7,081		\$7,081

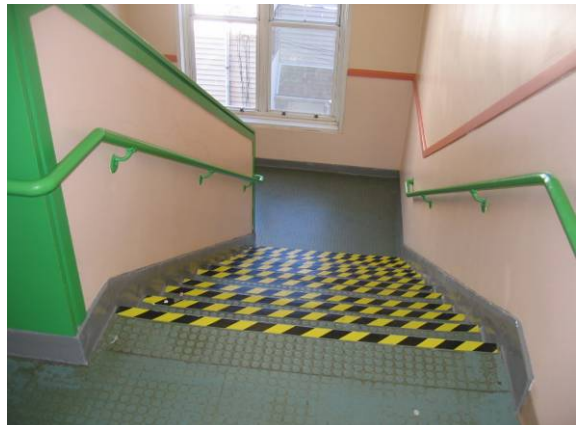
Photo #54: The two interior wood stairwells within the 3-story portion appear out of level/plumb and with soft spots

6.4	2515	Replace and finish wood clapboards, third floor	0	0	0	56	CSF	\$1,519.56	\$85,095	\$85,095											\$85,095
6.5	2514	Remove and replace wood stairs	0	0	0	144	Riser	\$302.40	\$43,546	\$43,546											\$43,546

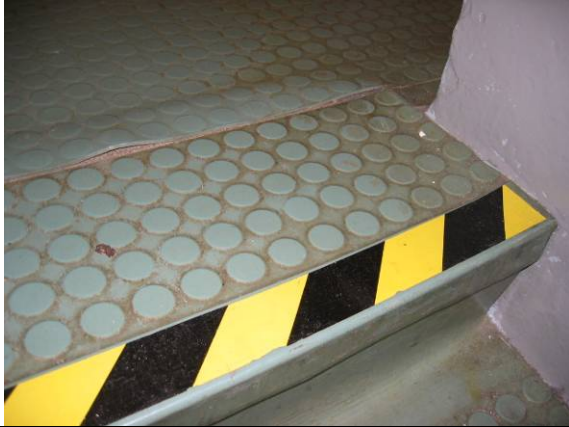
Photo #55: Several sections of the textured vinyl floor material are lifting on the landings

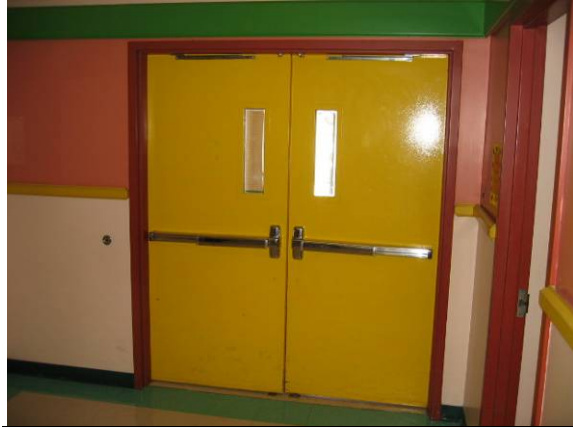
Photo #56: Several of the interior corridor/stairwells fire doors do not close properly

6.6	2510	Replace 3'-0" x 7'-0" solid core, w/safety glass, ptd. door	40	37	3	26	EA	\$1,869.84	\$48,616				\$48,616								\$48,616
6.6	2518	Fire door, steel, flush, 90 minute, vision lite, including demo, with hardware	25	24	1	10	EA	\$1,512.00	\$15,120		\$15,120										\$15,120

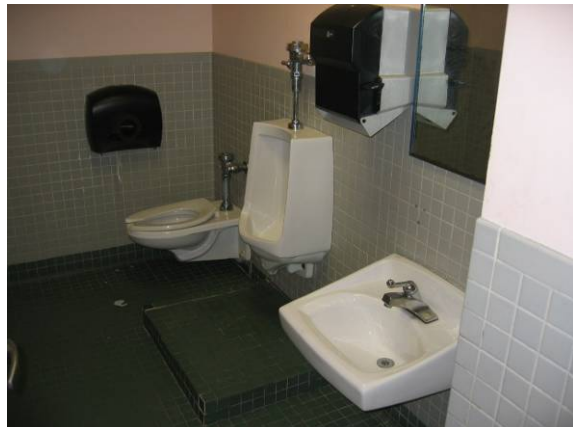
Photo #60: Second view of a typical toilet room with limited handicapped access

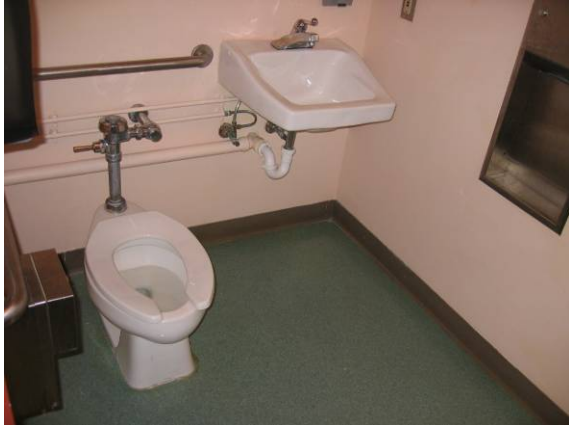
Photo #61: The single user toilet room within the nurse's office has one grab bar

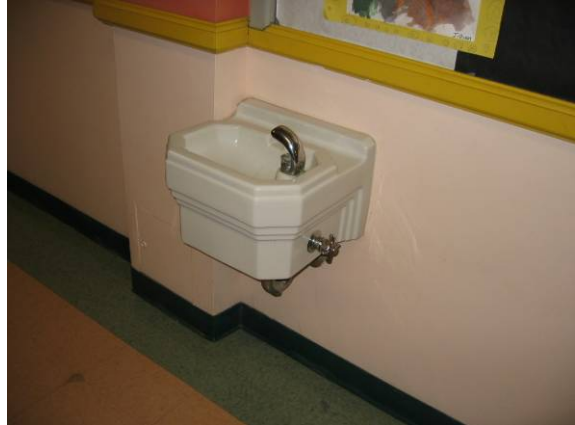
Photo #62: None of the corridor or gymnasium child water fountains are accessible

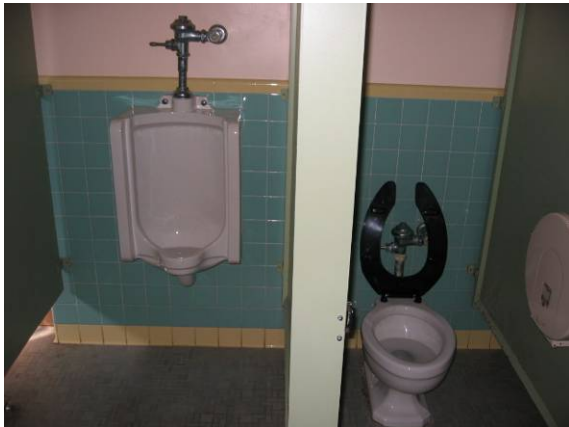
Photo #63: Neither of the multi-user toilet rooms near the auditorium provide ADA access

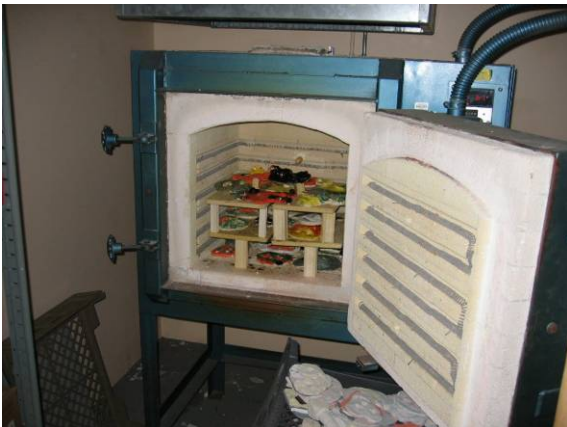
Photo #71: View of the on-site kiln, located near the first floor art room (Room #42)

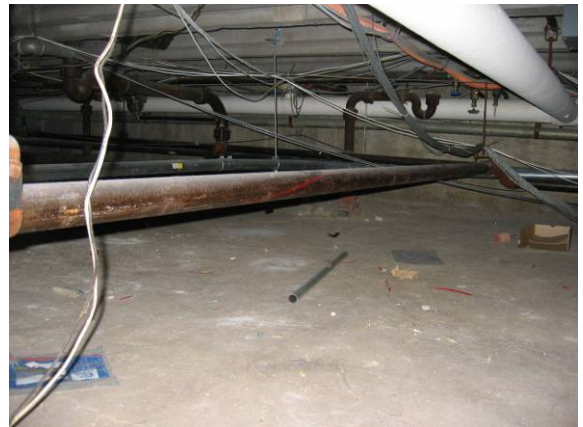
Photo #72: Limited portions of the school have crawl space type cellars

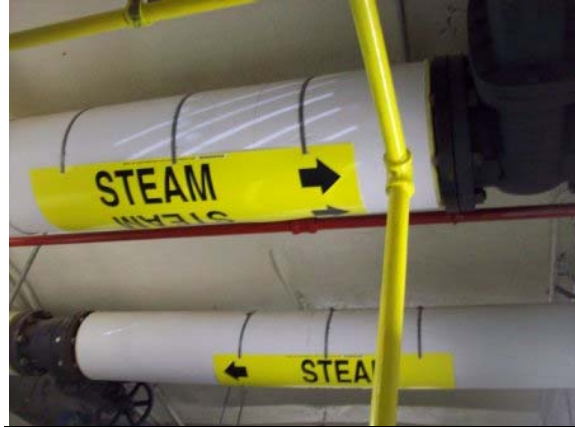
Photo #74: Steam distribution lines

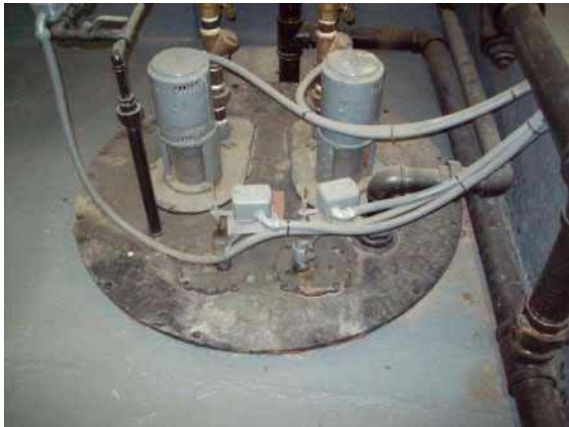
Photo #75: Condensate pumps

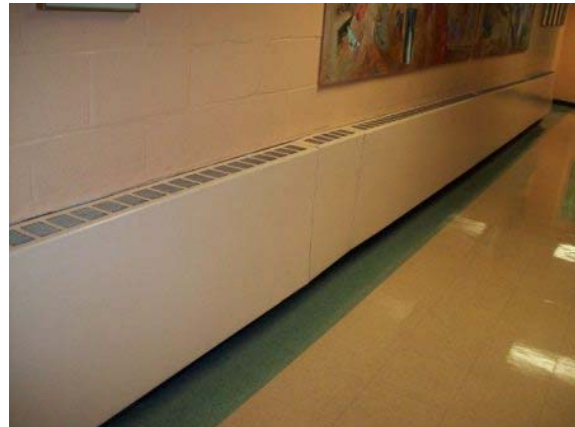
Photo #76: Typical radiant heat unit

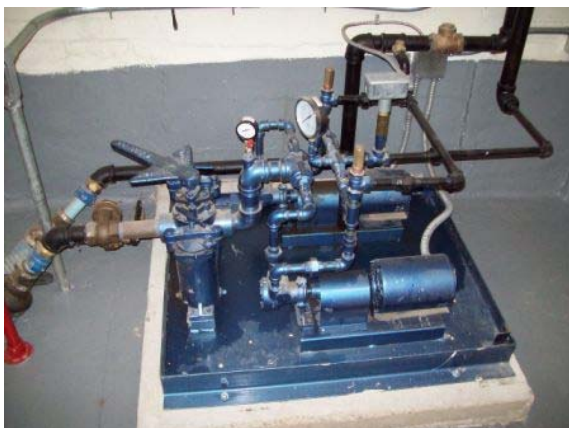
Photo #77: Fuel oil pump set

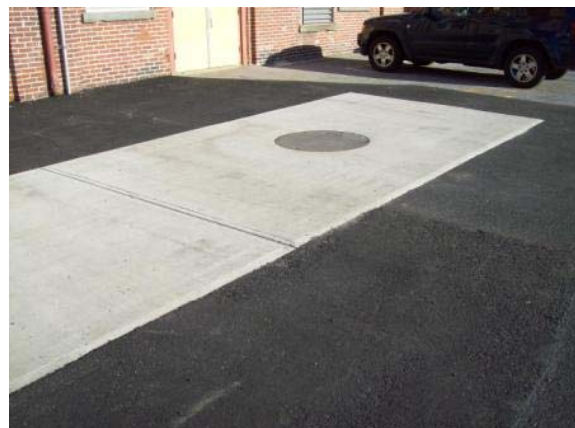
Photo #78: Underground storage tank location

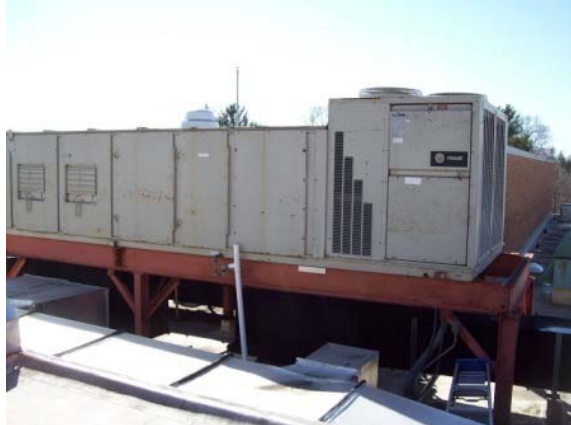
Photo #79: Rooftop air conditioning unit for media center area

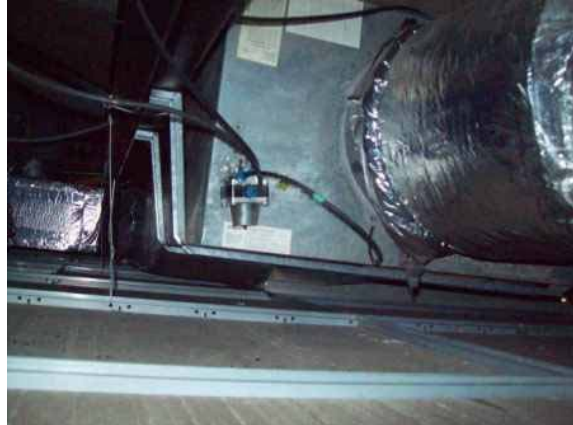
Photo #80: Typical VAV terminal

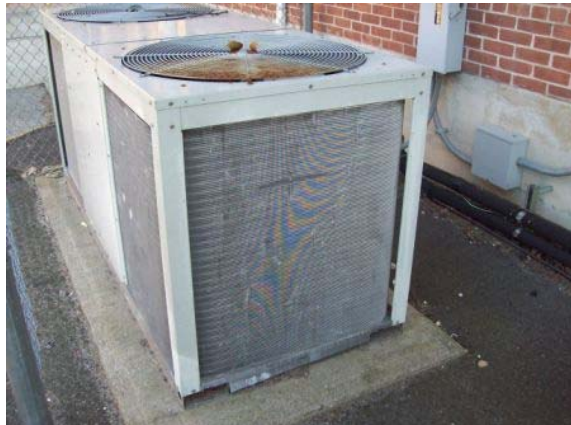
Photo #81: Split condenser for auditorium (1 of 2)

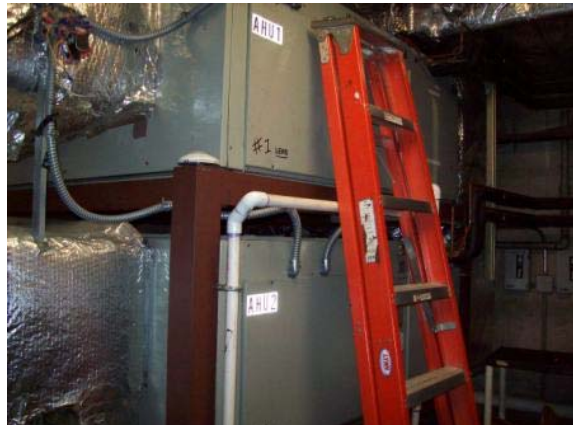
Photo #82: Fan coil units for auditorium

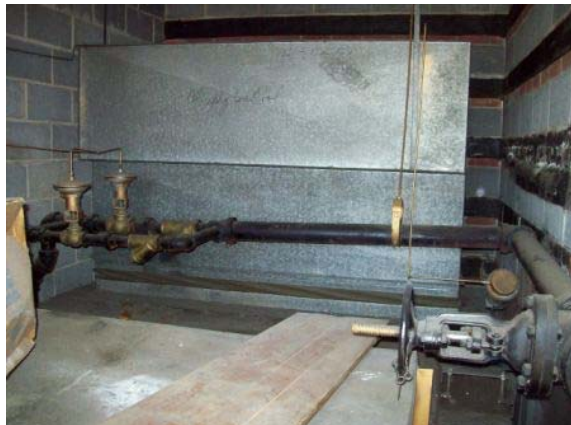
Photo #83: Make-up air unit for gymnasium/cafeteria

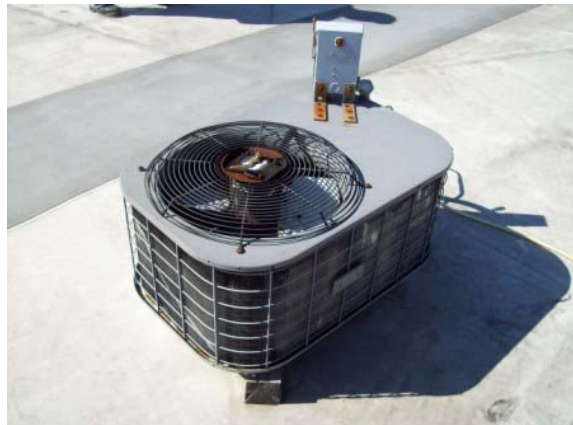
Photo #84: Split condensing unit for Classroom 1

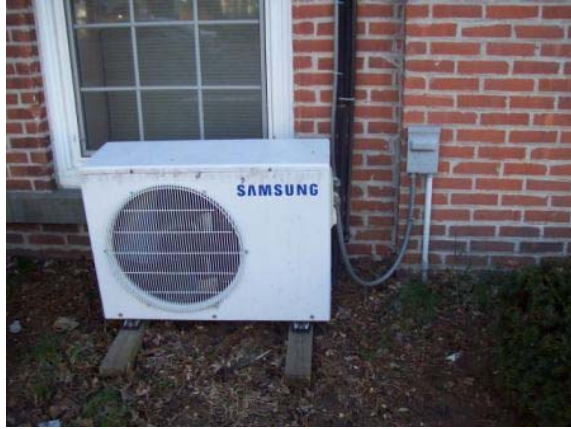
Photo #85: Ductless split system for Classroom 16

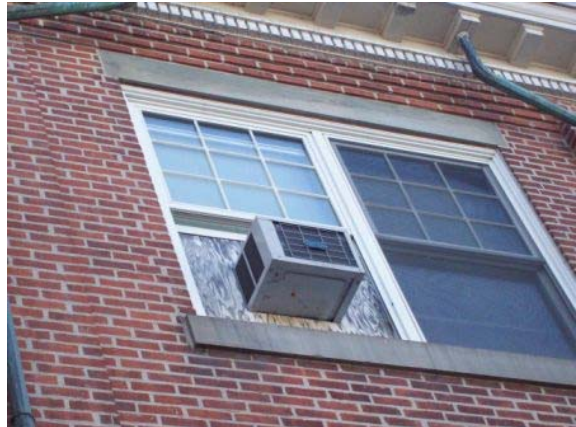
Photo #86: Typical window air conditioning unit note plywood installation

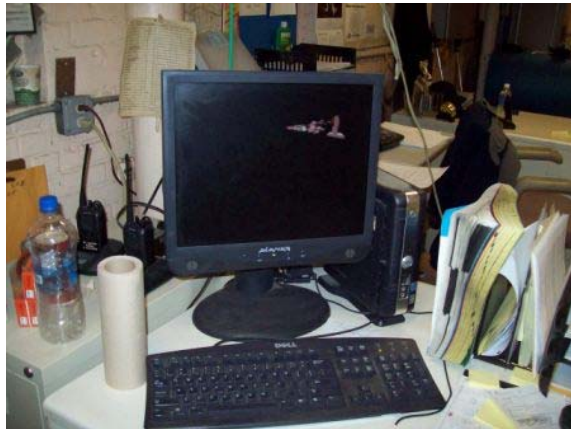
Photo #87: HVAC control terminal

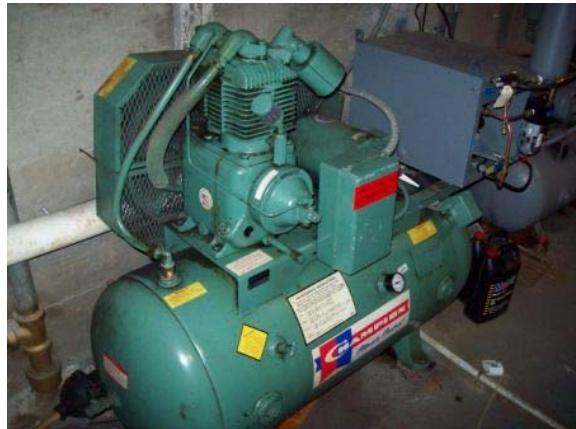
Photo #88: Compressor for pneumatic controls

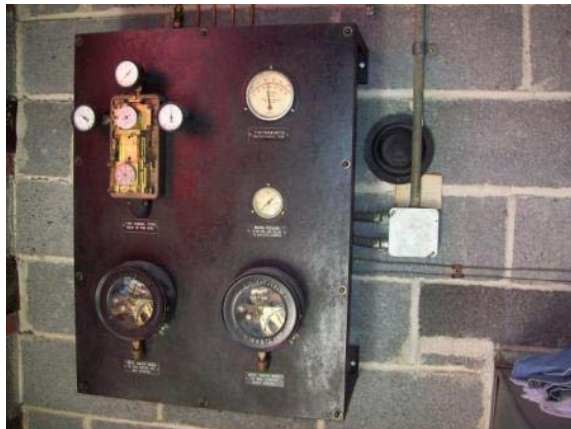
Photo #89: Pneumatic control panel

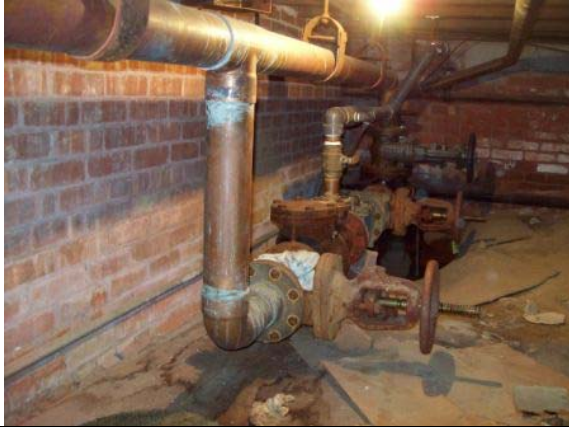
Photo #91: Domestic water service line

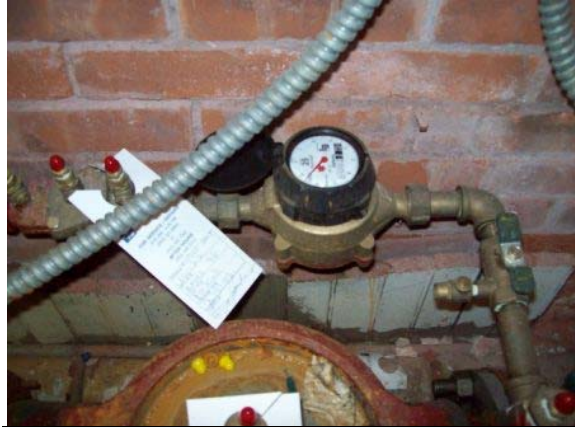
Photo #92: Domestic water meter

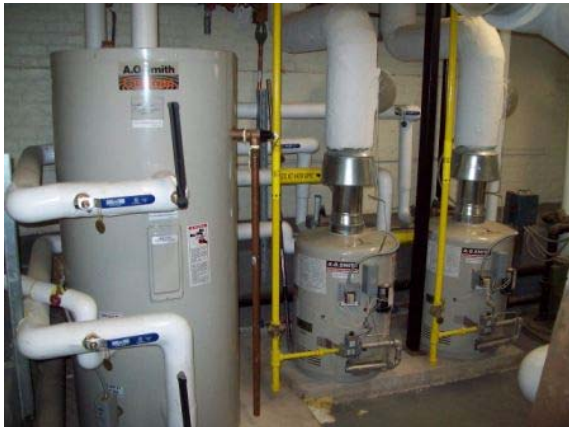
Photo #93: Domestic water boilers and storage tank

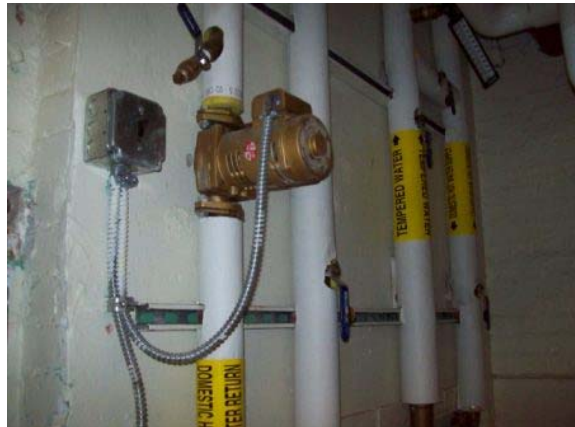
Photo #94: Domestic water circulating pump

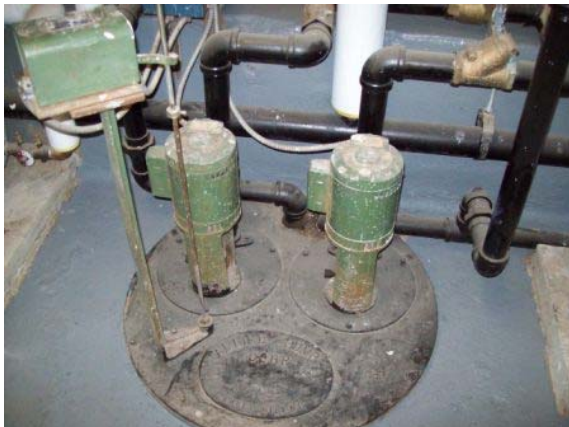
Photo #95: Sump pump

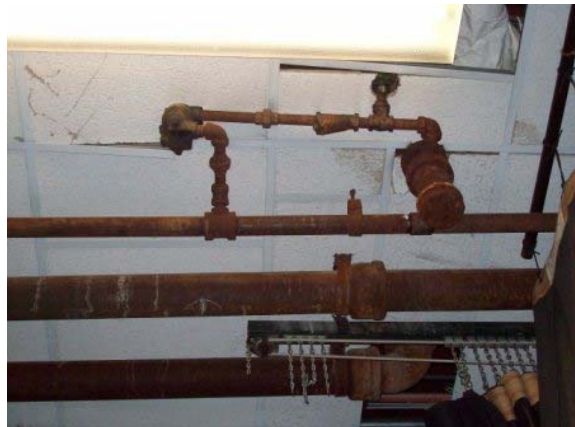
Photo #96: Corroded sanitary waste lines

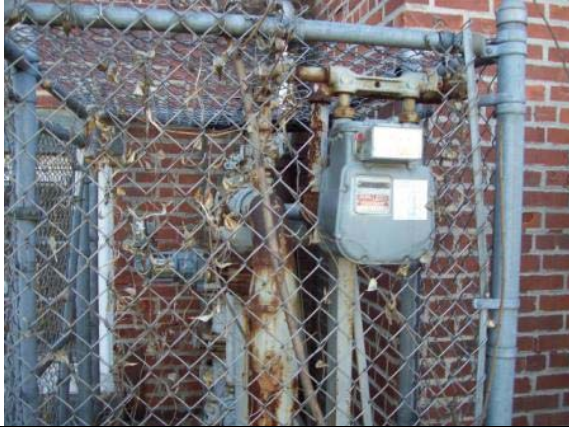
Photo #97: Natural gas meter

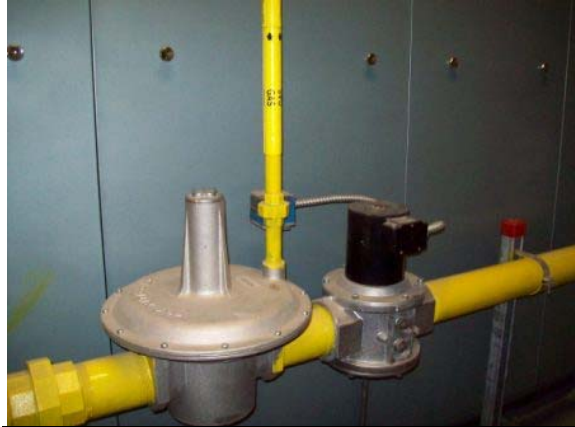
Photo #98: Natural gas regulator and distribution lines for boilers

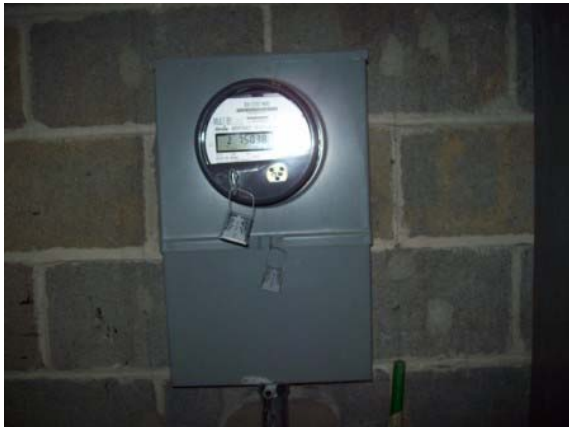
Photo #99: Electric meter

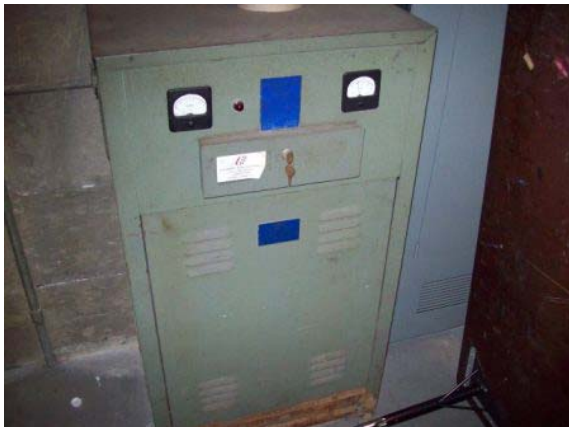
Photo #101: Battery backup system

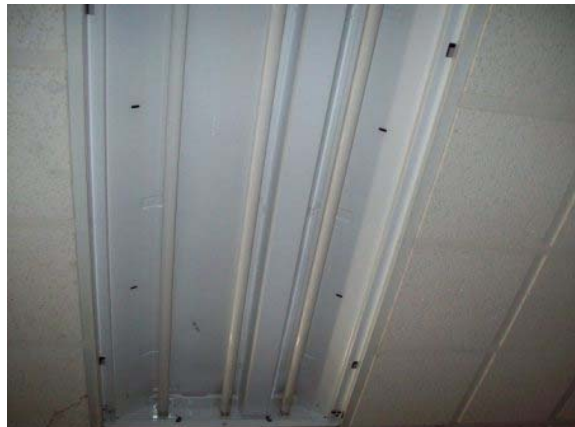
Photo #102: Typical fluorescent lighting ballast

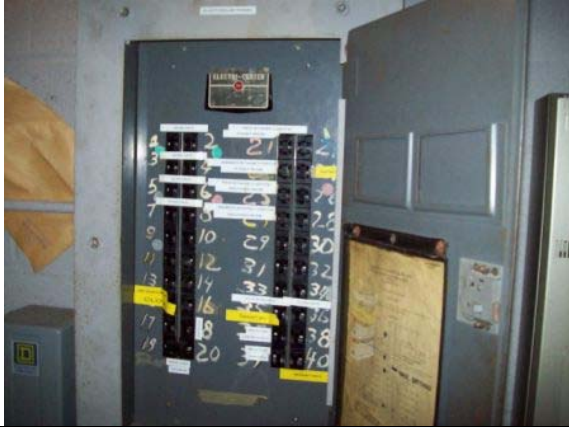
Photo #103: Breaker panel for stage lighting control

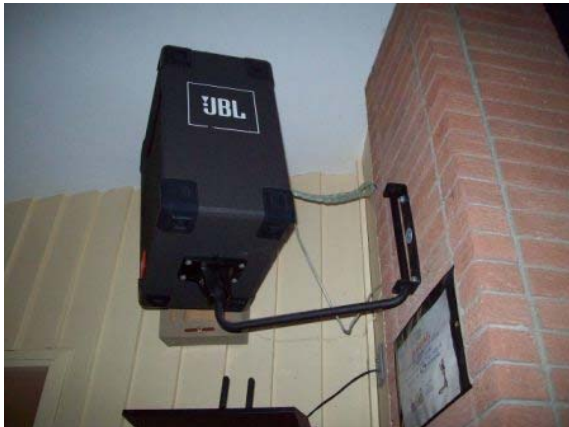
Photo #105: Auditorium sound system

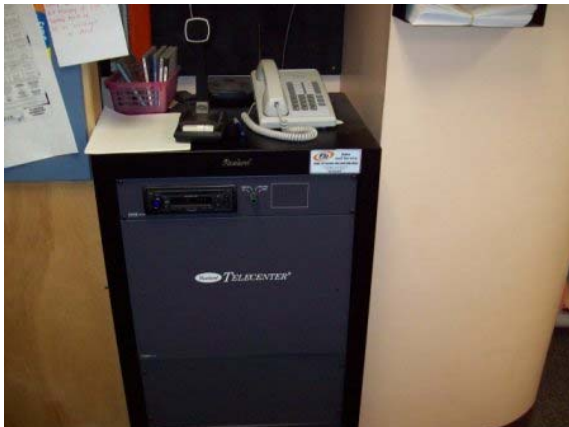
Photo #107: Public address system control unit

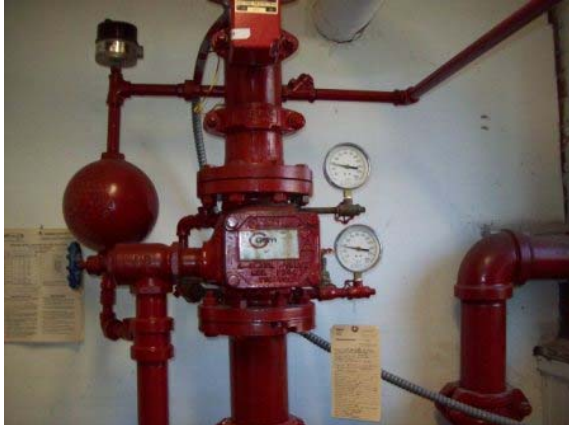
Photo #109: Wet pipe sprinkler riser

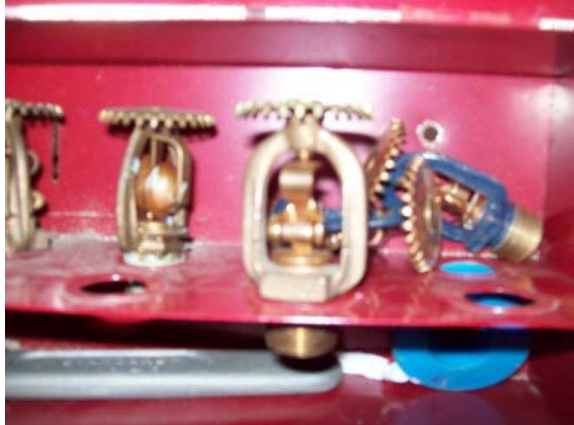
Photo #110: Wet pipe sprinkler head

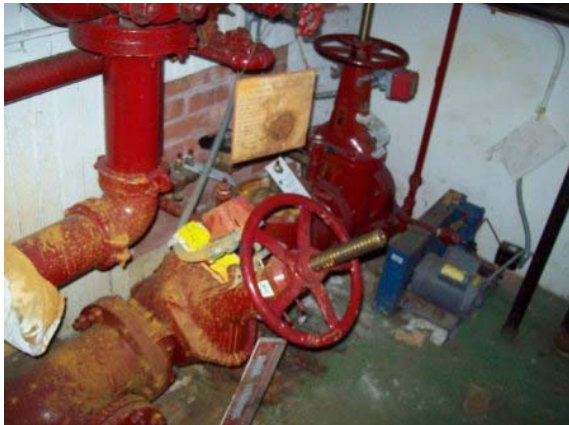
Photo #111: Dry-pipe sprinkler riser and compressor

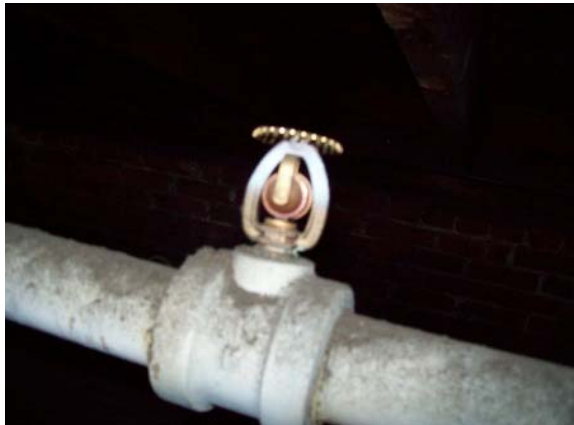
Photo #112: Dry-pipe sprinkler head in attic

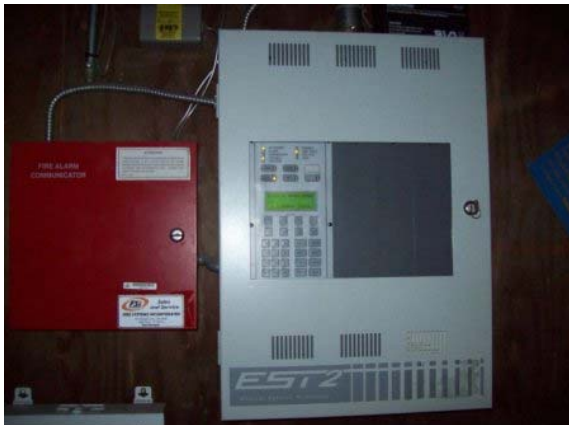
Photo #113: Fire alarm control panel

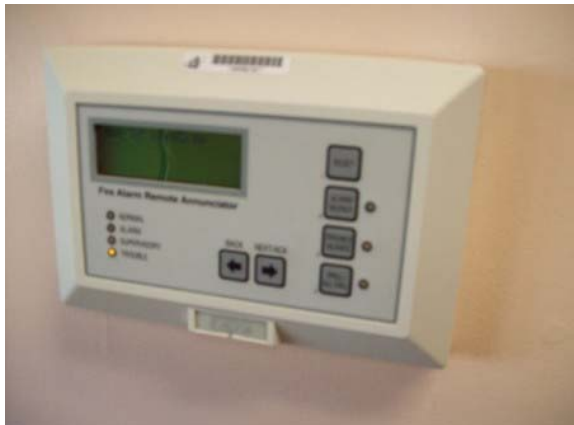
Photo #114: Fire alarm annunciator panel

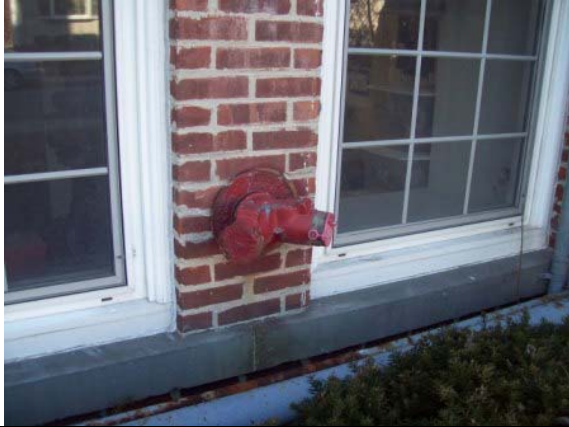
Photo #115:	Fire department Siamese connection on building exterior
-------------	---------------------------------------------------------

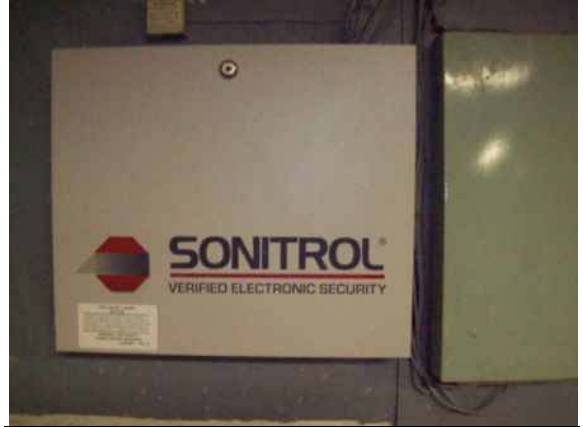
Photo #116:	Security control panel
-------------	------------------------

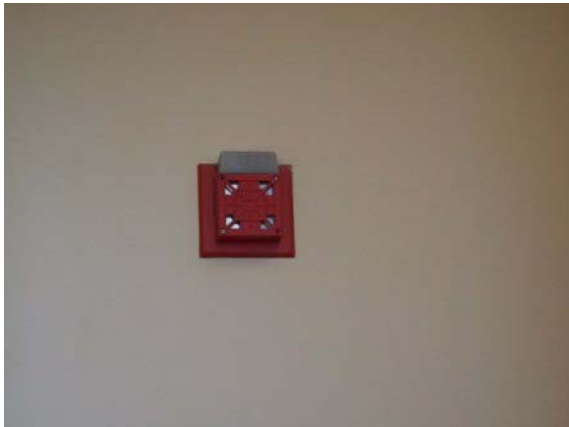
Photo #117:	Fire alarm horn with strobe light
-------------	-----------------------------------

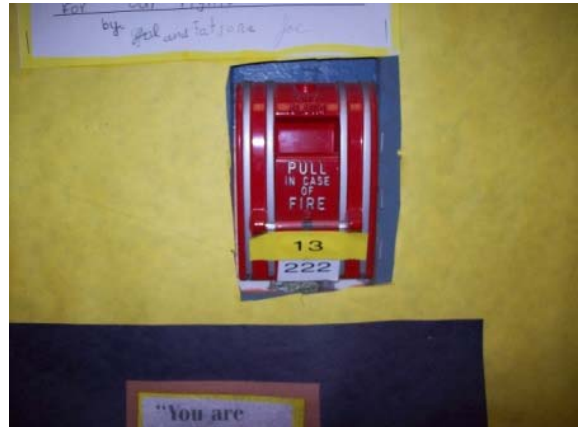
Photo #118:	Fire alarm pull station
-------------	-------------------------

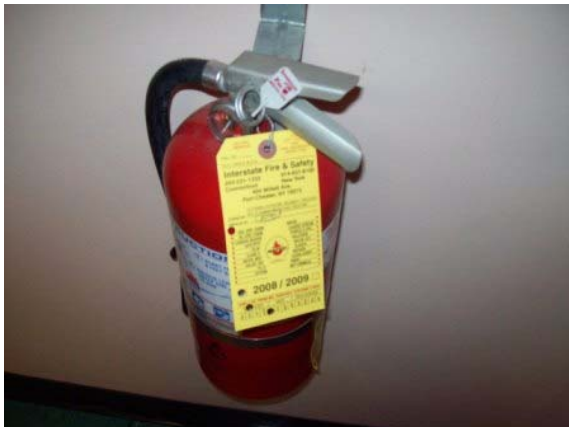
Photo #119:	Fire extinguisher
-------------	-------------------

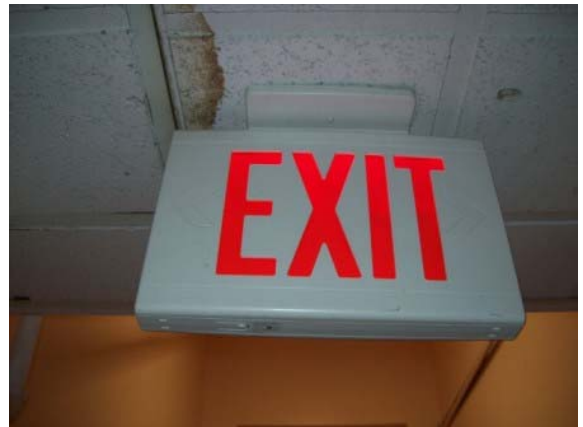
Photo #120:	Exit light
-------------	------------

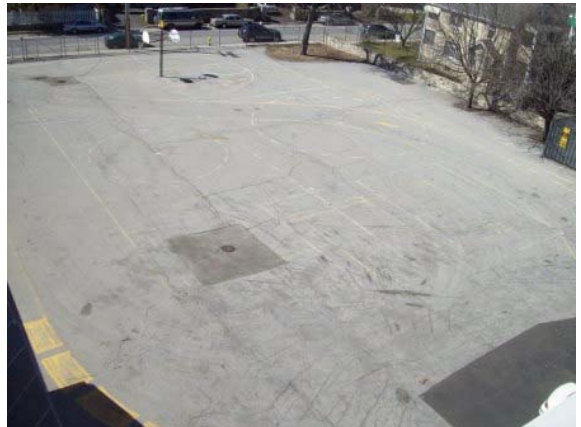
Photo #124: Northwest paved area

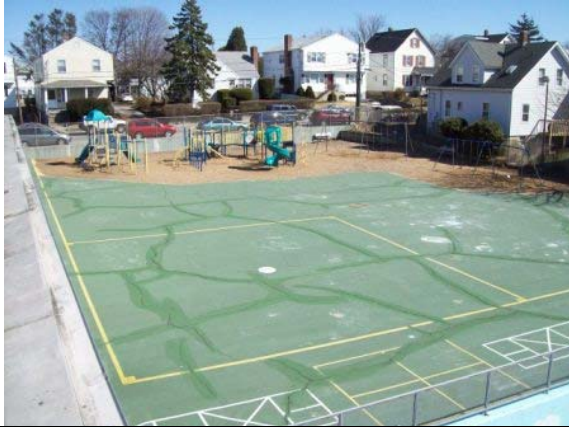
Photo #127: Paved area at playground

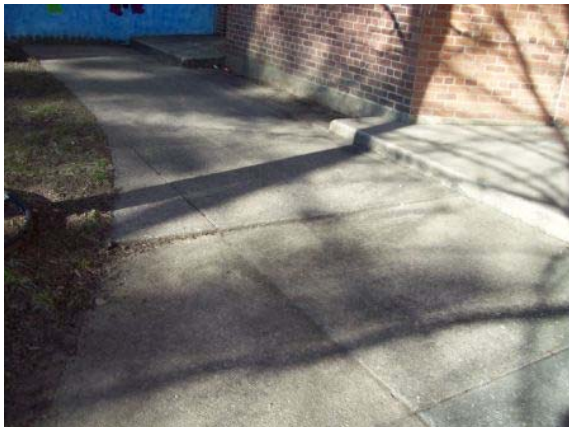
Photo #131: Concrete sidewalk

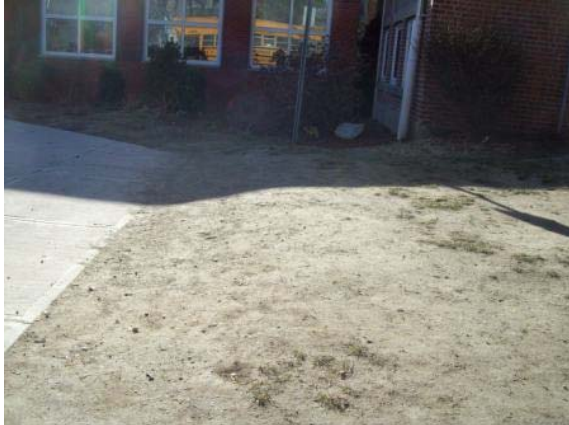
Photo #133: Barren landscaping near front entrance

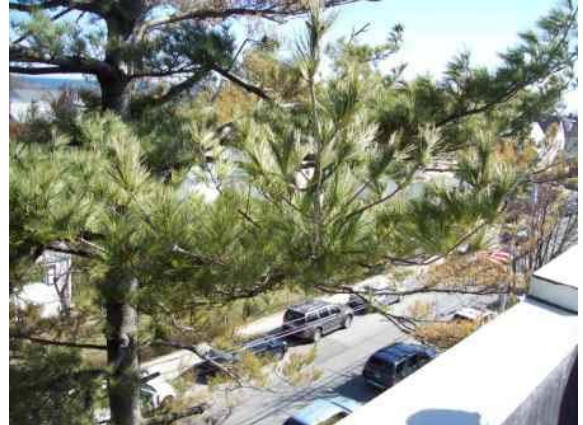
Photo #134: Tree growing close to school building

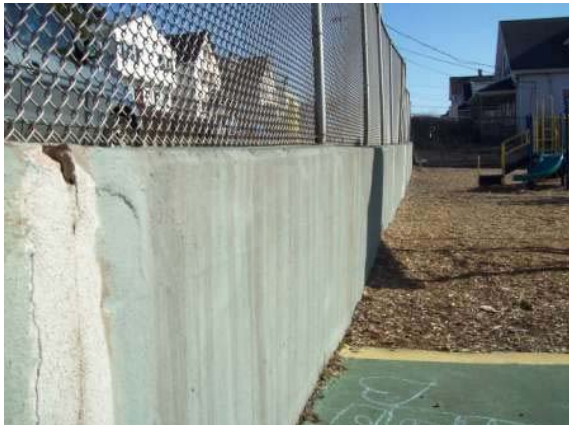
Photo #135: Concrete retaining wall along east property line

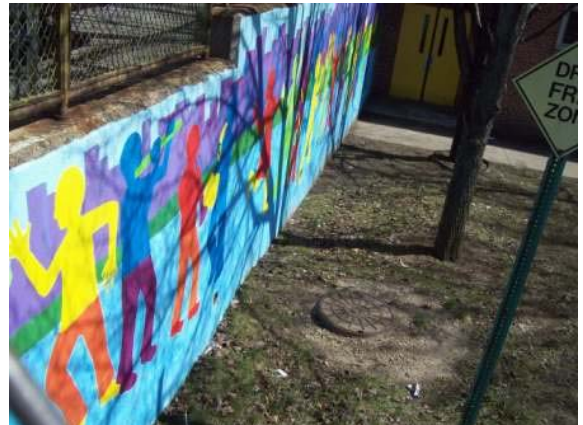
Photo #136: Concrete retaining wall at west side of building

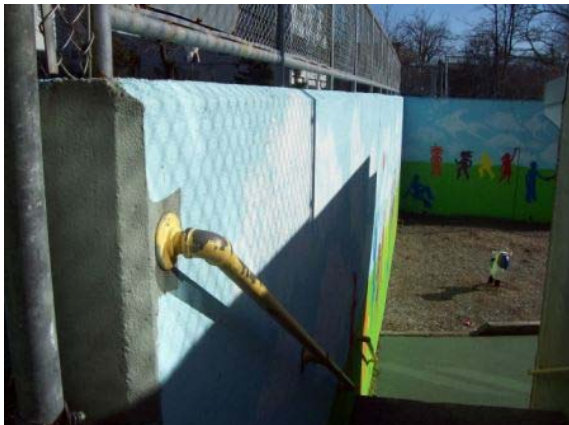
Photo #137: Concrete retaining wall near playground at south side of building

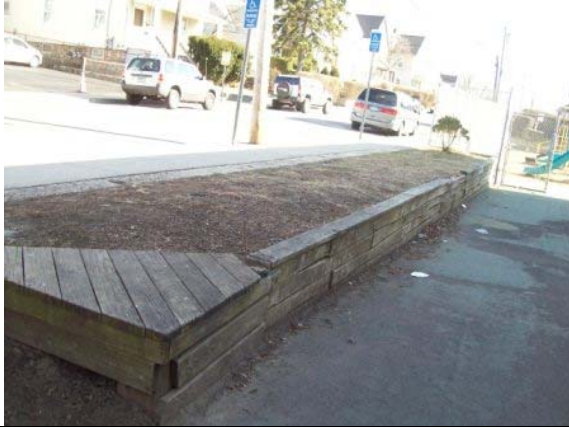
Photo #139: Wood timber retaining wall at east side of building

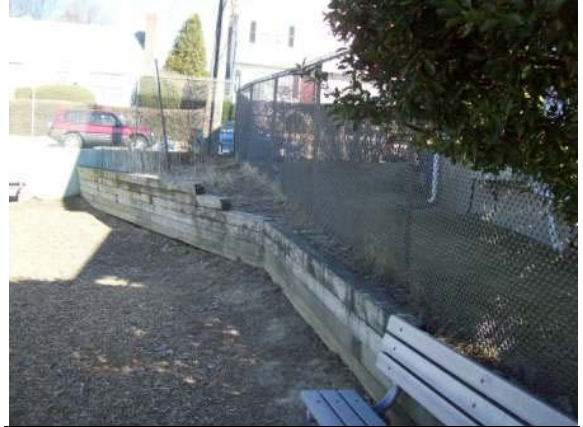
Photo #140: Wood timber retaining wall at southeast corner of property

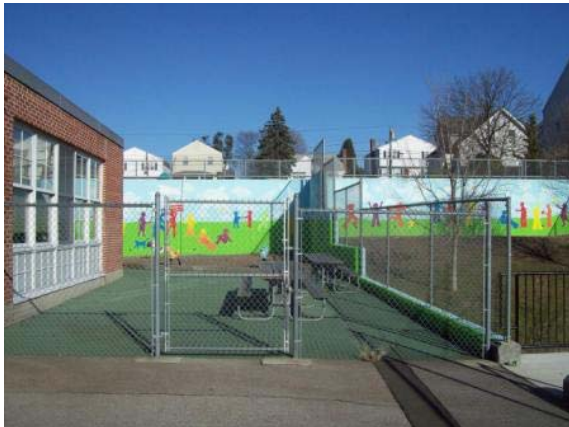
Photo #141: Typical site fencing

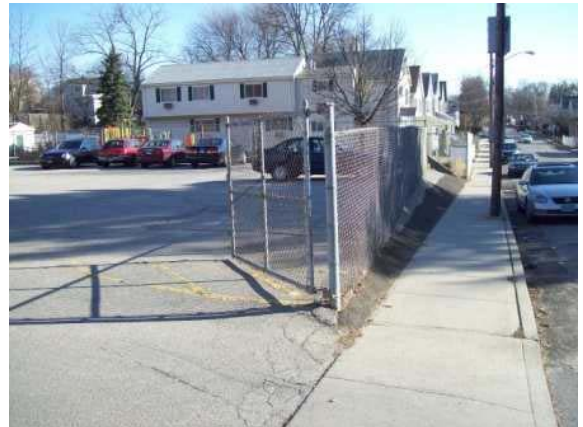
Photo #142: Perimeter fence at parking lot

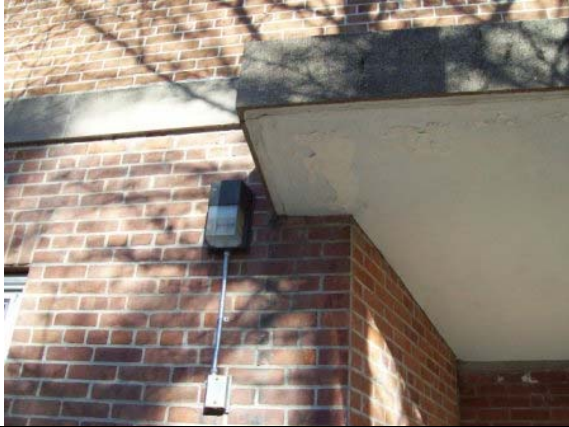
Photo #145: Exterior building-mounted lighting

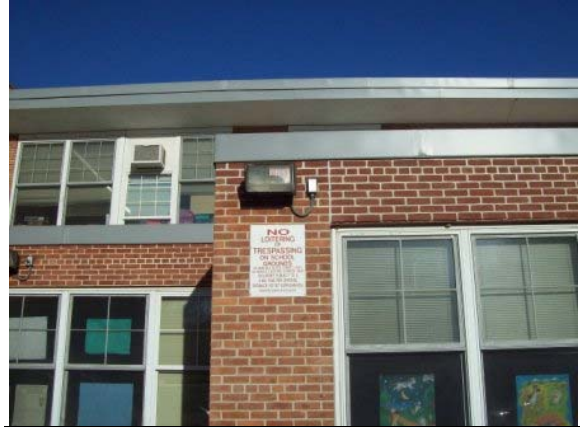
Photo #146: Exterior building-mounted lighting

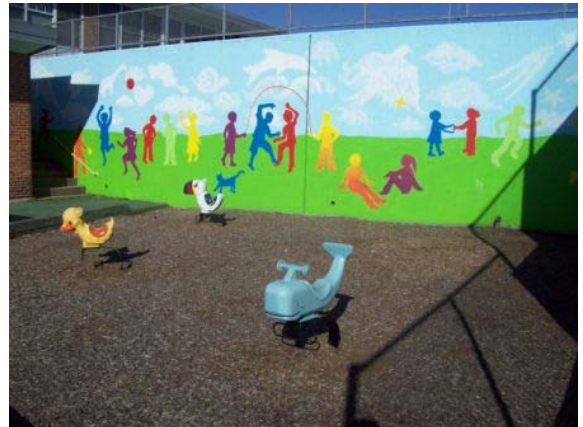
Photo #148: Minor playground equipment west of retaining wall
