FACILITIES NEEDS ASSESSMENT

STAMFORD PUBLIC SCHOOLS

FACILITIES NEEDS ASSESSMENT OF NORTHEAST ELEMENTARY SCHOOL

EMG Project #: 88166.09R-010.017
Date of Report: August 27, 2009
On-site Date: February 17 and 18, 2009

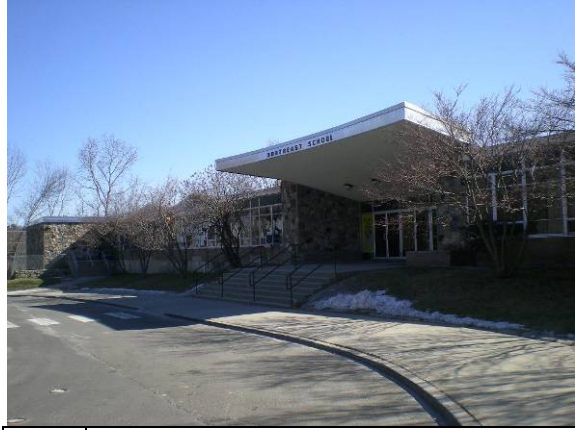
Photo #2: Front elevation and main entrance

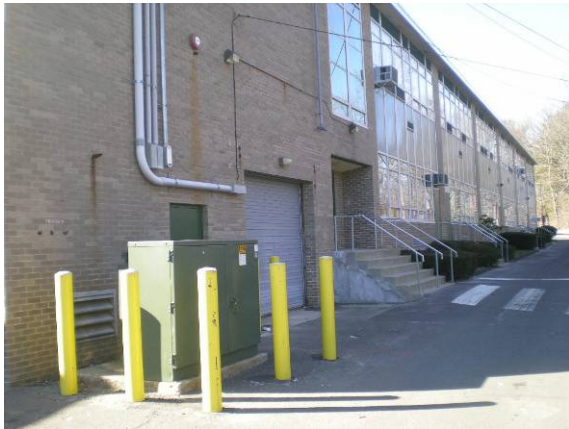
Photo #3: East elevation

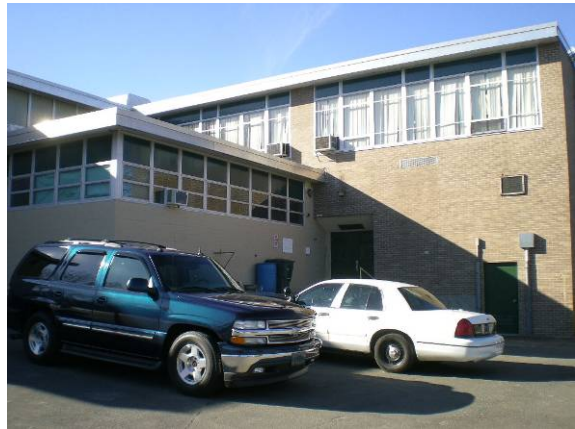
Photo #4: Southeast corner – loading dock area

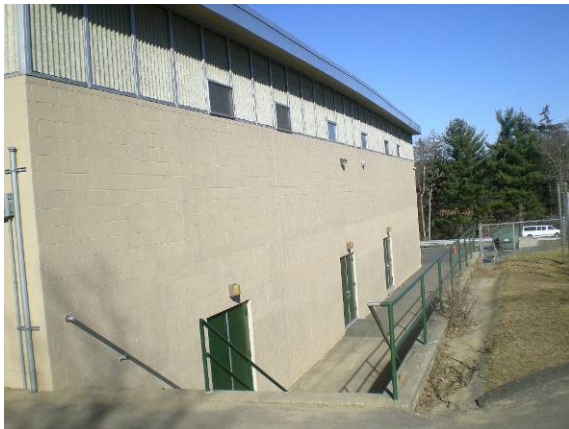
Photo #5: Rear/south elevation of gymnasium

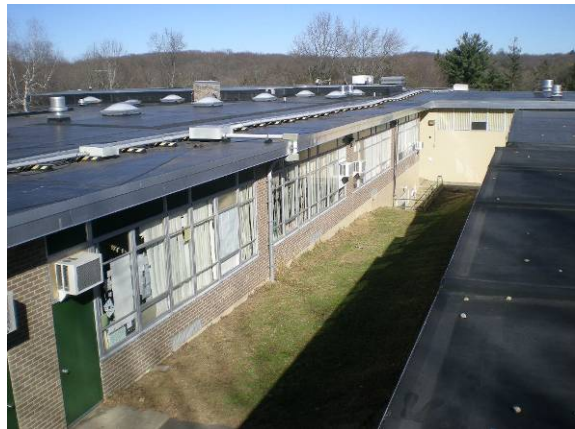
Photo #6: South elevation of classrooms at original school building

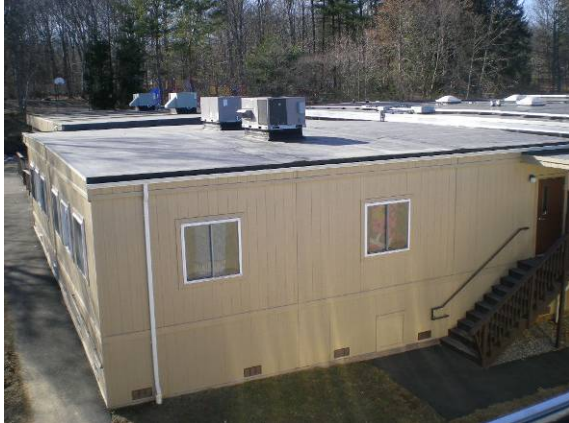
Photo #7: Modular classroom addition on south end of building

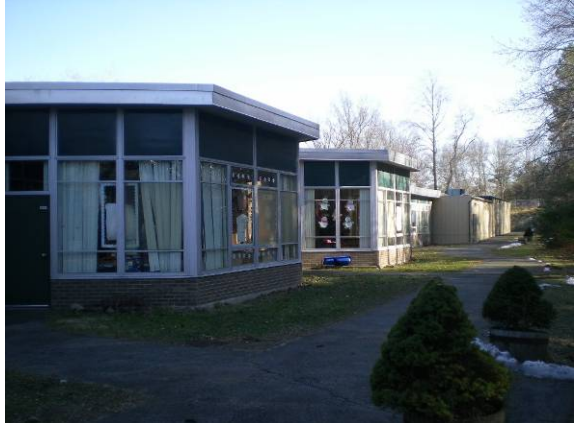
Photo #8: West elevation

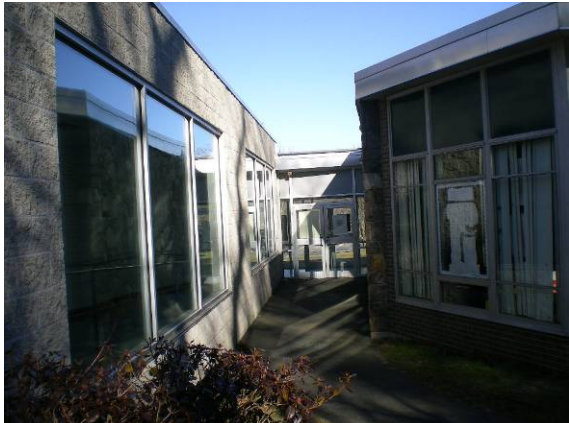
Photo #9: Junction between original school and Media Center

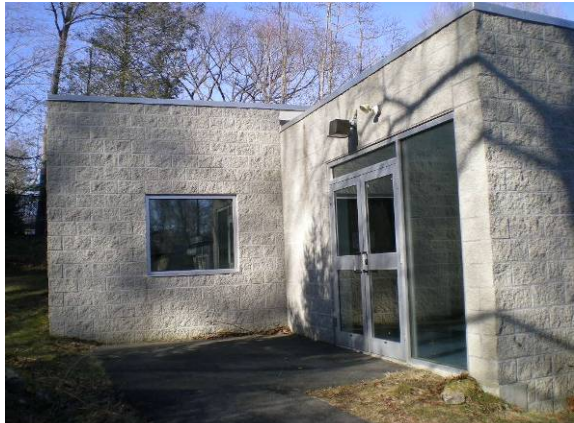
Photo #10: Rear/west elevation of Media Center

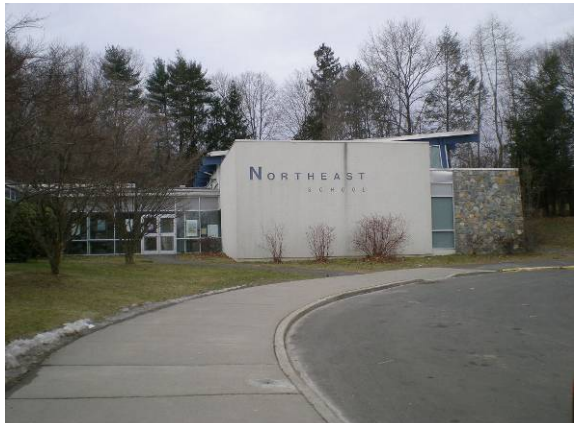
Photo #12: Front/east elevation of Media Center and only handicapped route

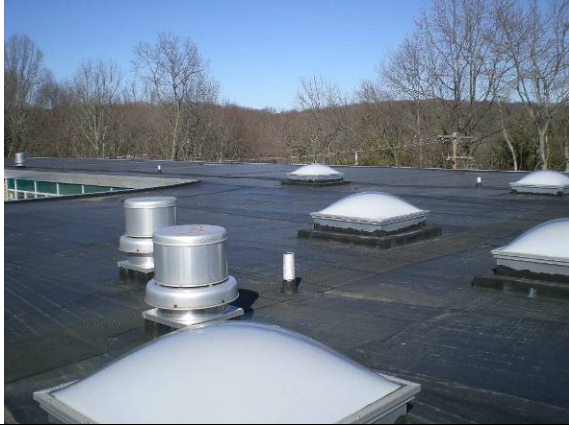
Photo #13: Roof overview of original school building

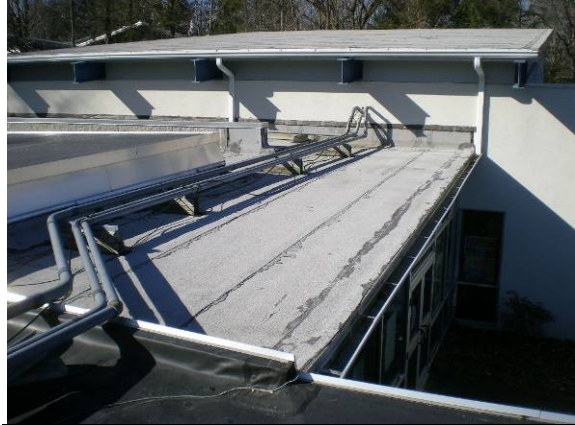
Photo #14: Built up roofing over Media Center

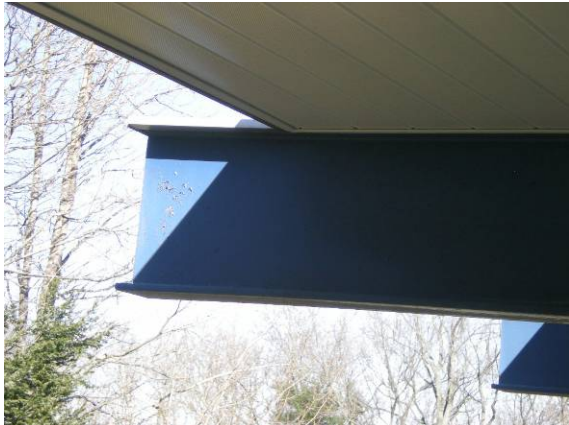
Photo #15: Exposed structure of Media Center with isolated rust

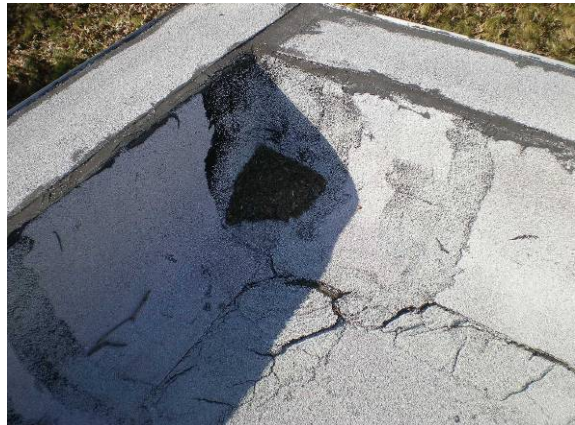
Photo #18: Cracked built up roofing and parapet wall topped with built up membrane

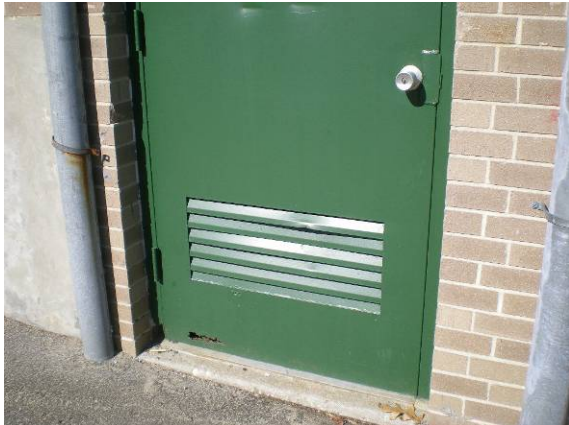
Photo #21: Service door condition

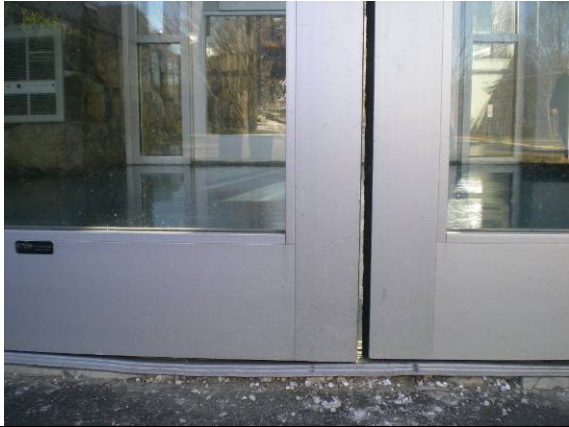
Photo #25: Storefront doors not set properly. Threshold bent from non level substrate

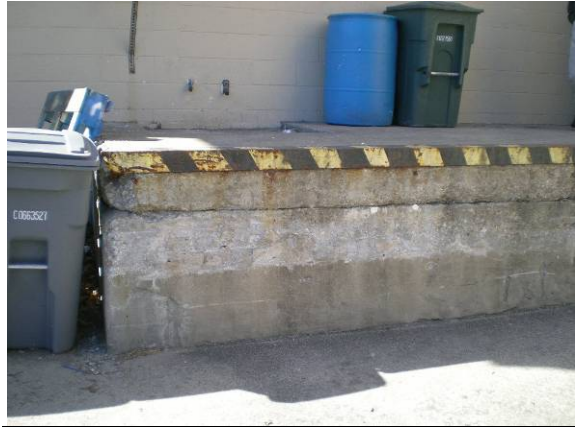
Photo #26: Loading dock conditions

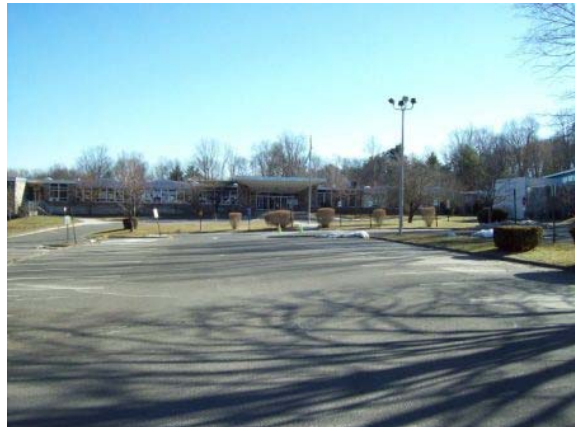
Photo #28: Main parking lot

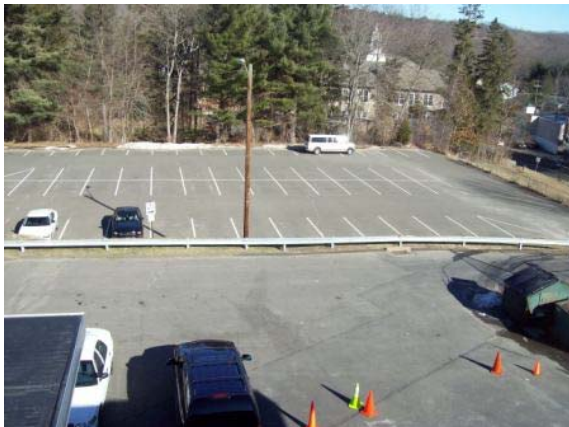
Photo #29: East parking lot

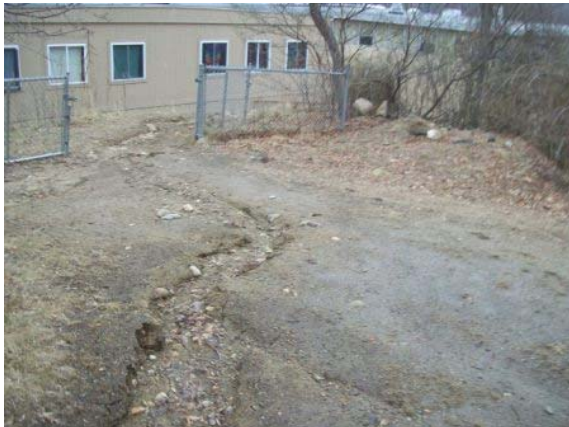
Photo #39: Erosion at south side of building, from baseball fields

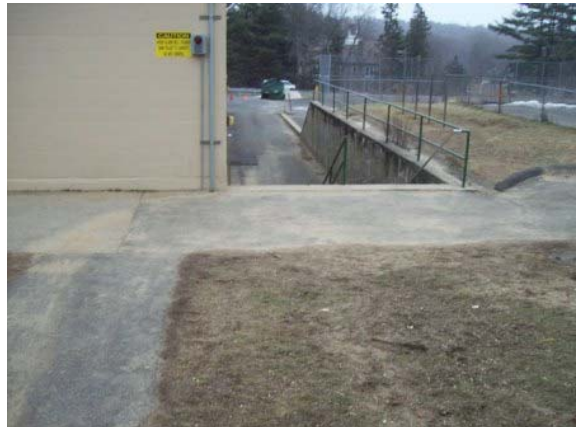
Photo #40: Area of reported drainage problems at south side of building

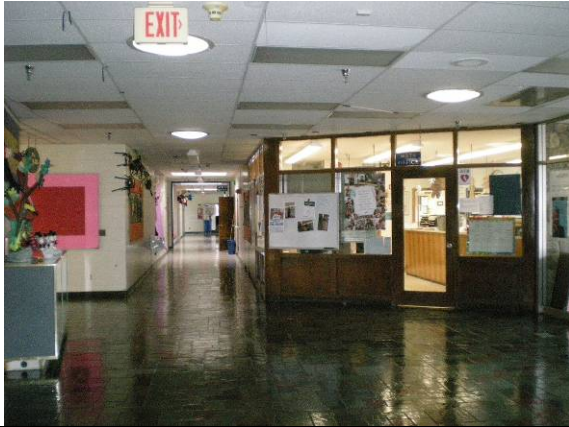
Photo #49: Main lobby

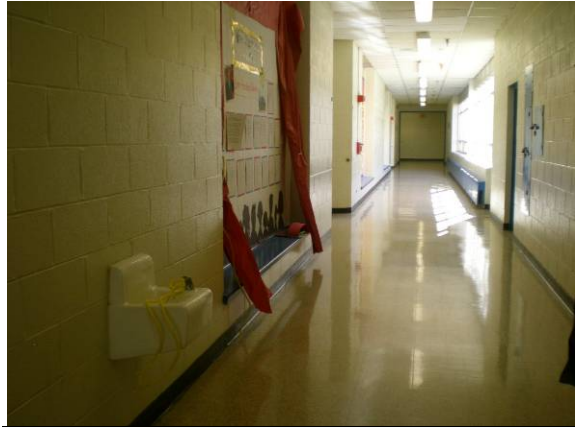
Photo #50: Corridor with protruding drinking fountain

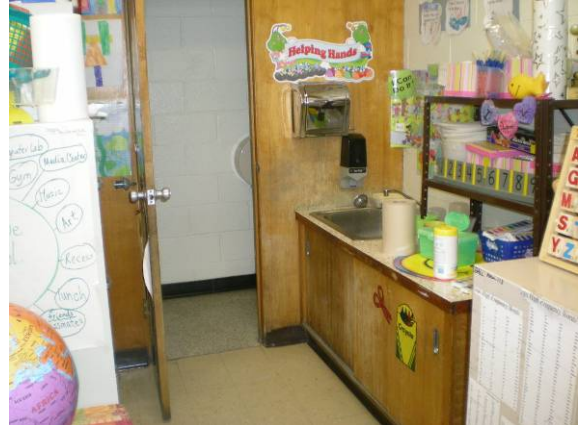
Photo #56: Typical sink and toilet room in some classrooms

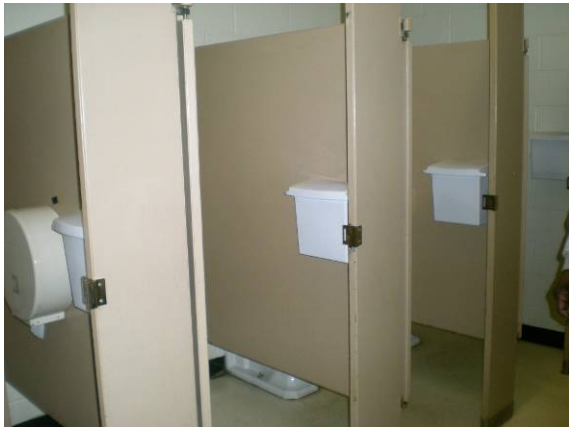
Photo #57: Common restroom

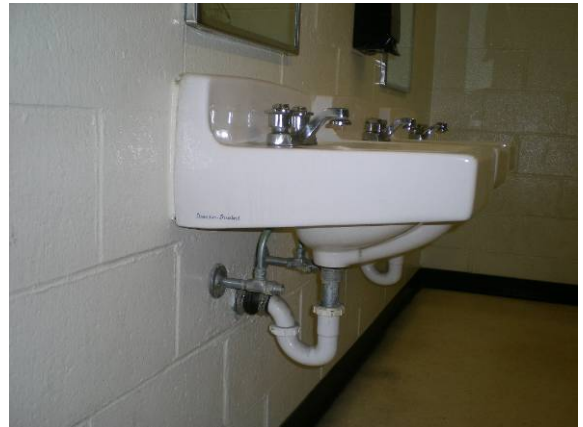
Photo #58: Common restroom

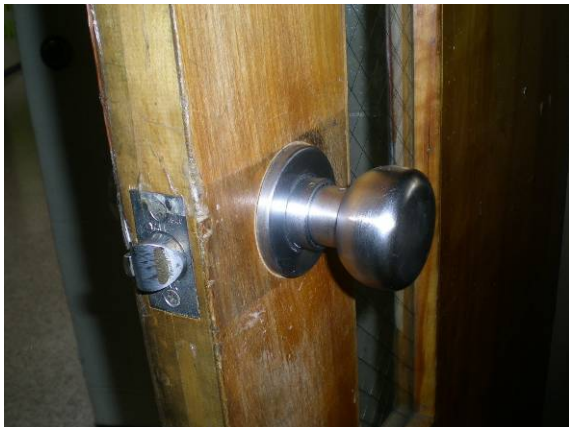
Photo #59: Classroom door hardware with no locking mechanism from interior

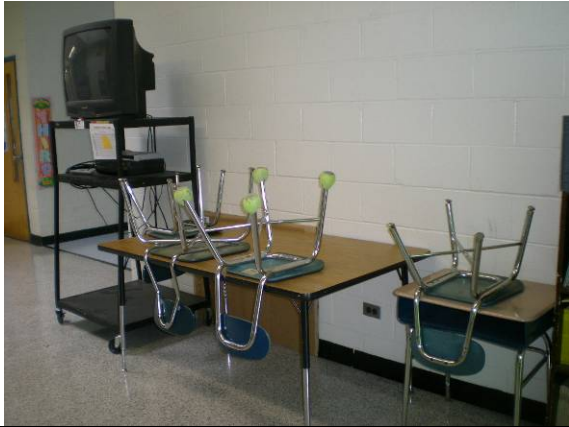
Photo #61: Makeshift classroom in corridor

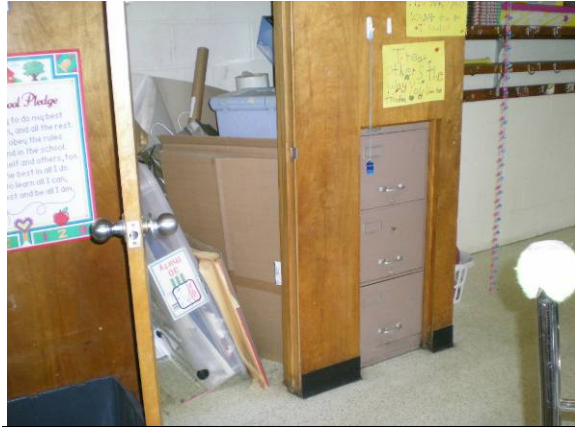
Photo #62: Typical storage area in some classrooms

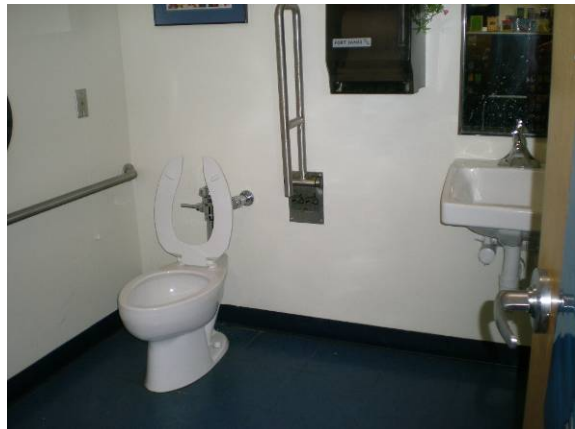
Photo #64: Media Center ADA unisex restroom

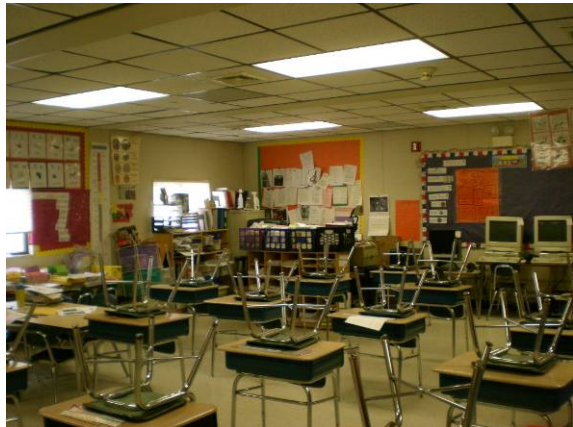
Photo #69: Classroom in modular wing

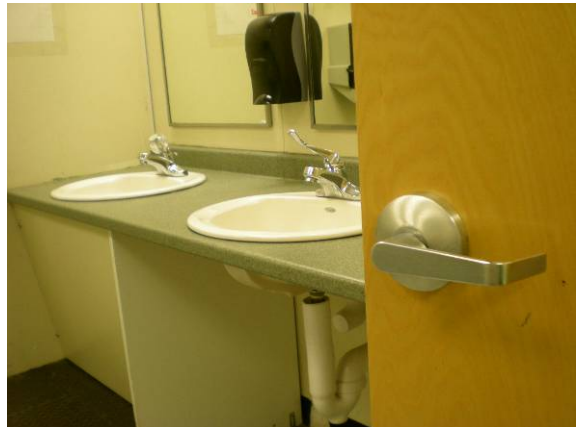
Photo #70: Restroom in modular wing

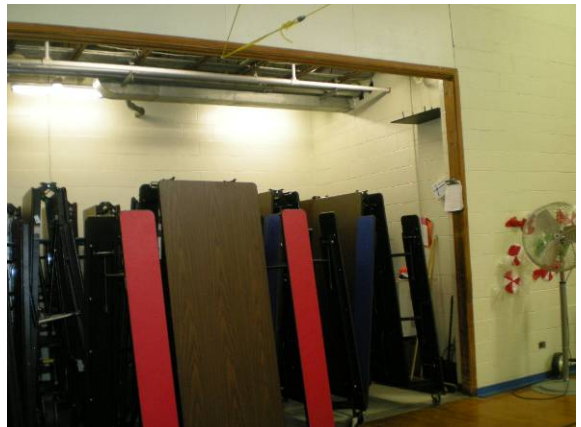
Photo #72: Storage of cafeteria use tables in gymnasium

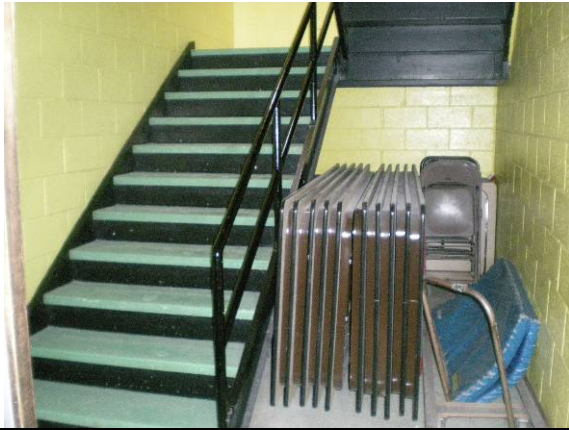
Photo #73: Storage under stairwell

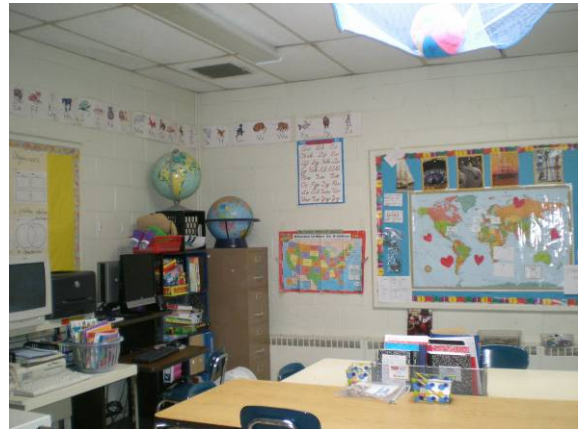
Photo #76: Small classroom with skylight

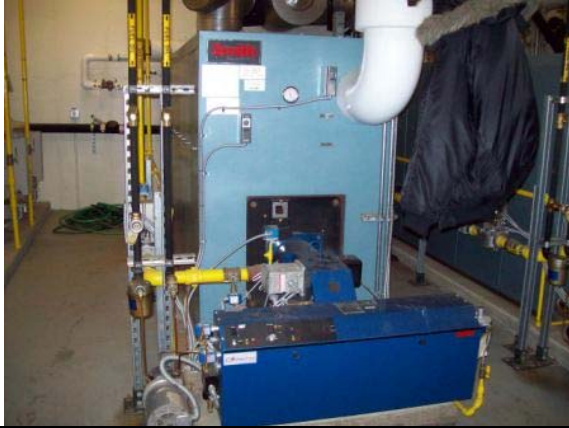
Photo #79: Boiler (1 of 2)

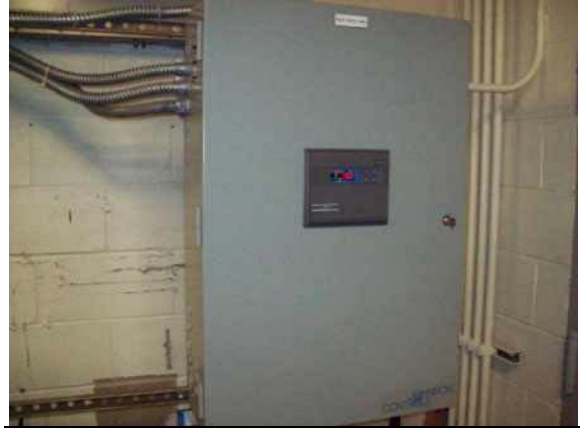
Photo #80: Boiler control unit

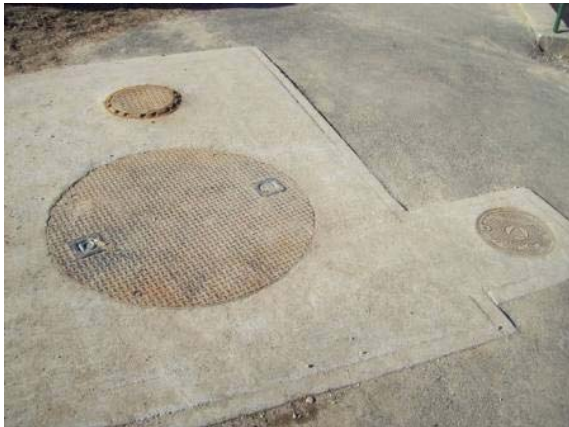
Photo #81: Fuel oil underground storage tank

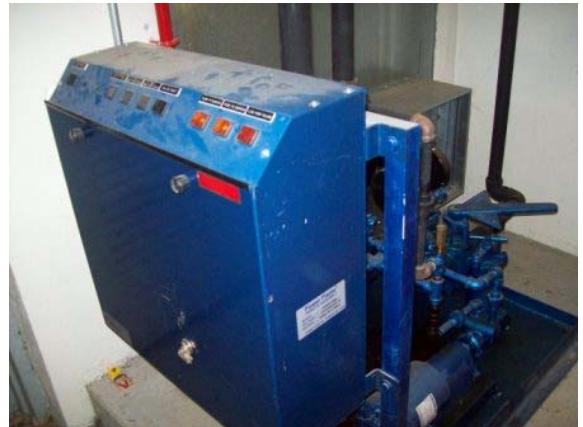
Photo #82: Fuel oil pump set

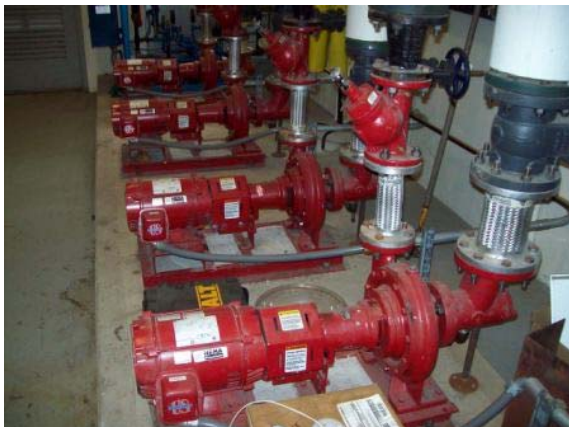
Photo #83: Hot water circulating pumps

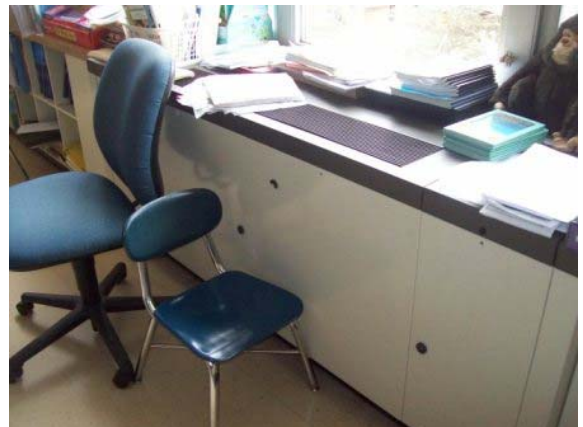
Photo #84: Typical unit ventilator

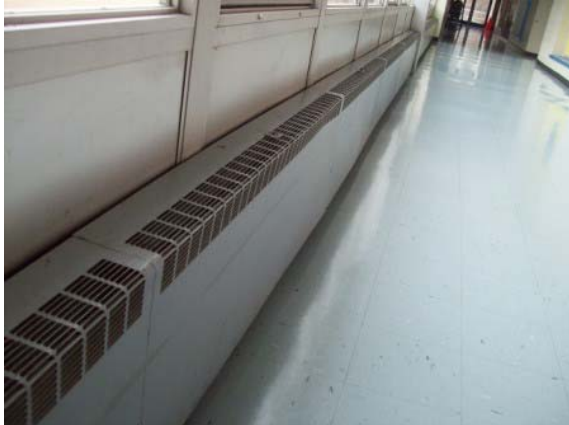
Photo #85: Typical finned-tube radiant heat unit

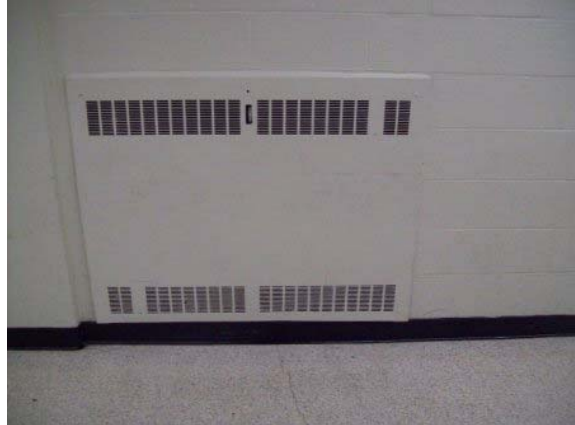
Photo #86: Typical convection unit

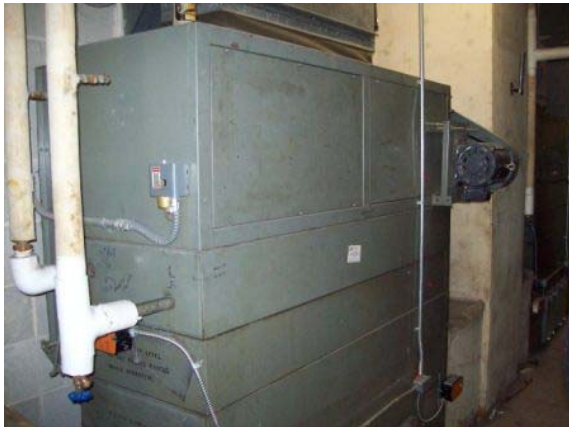
Photo #87: Air handling unit (1 of 3)

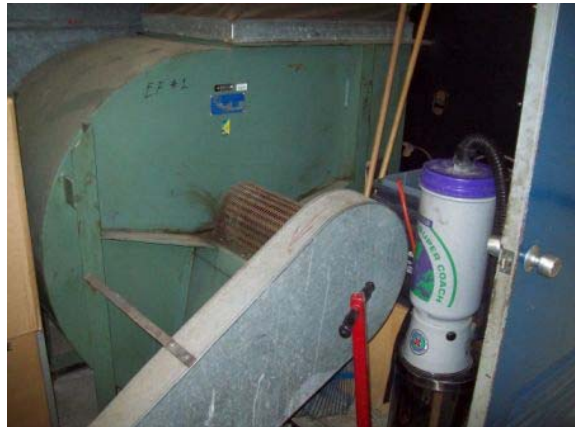
Photo #88: Auditorium exhaust fan

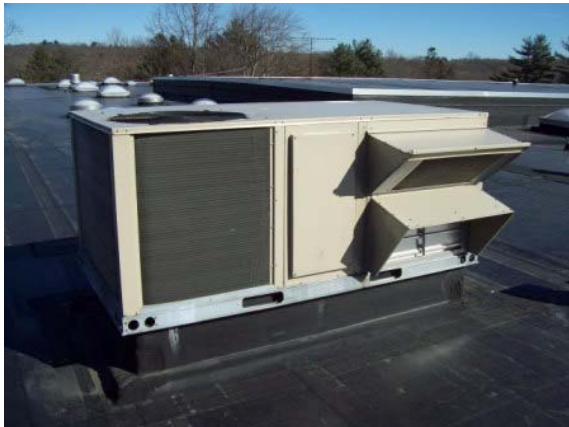
Photo #89: Typical rooftop unit

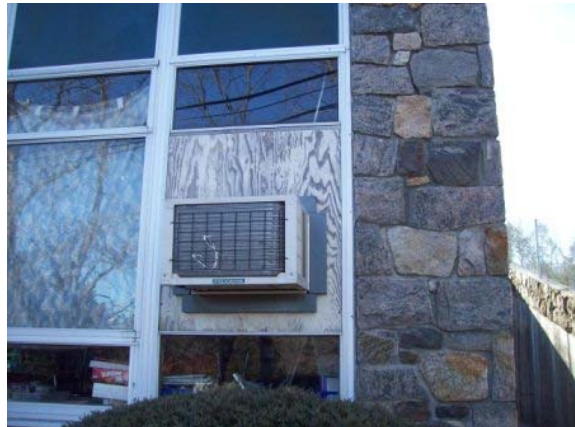
- The window mounted air-conditioning unit is in fair condition. The cost to replace the air-conditioning unit is relatively insignificant and the work can be performed as part of the property management's routine maintenance program. The cost of this work is not included in the cost tables.

Photo #90: Typical window air conditioning unit

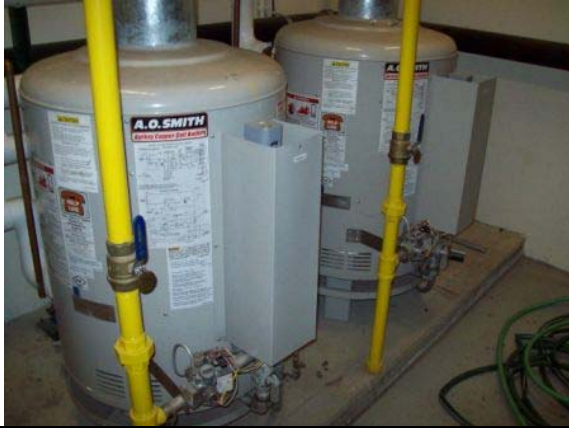
Photo #91: Domestic water boilers

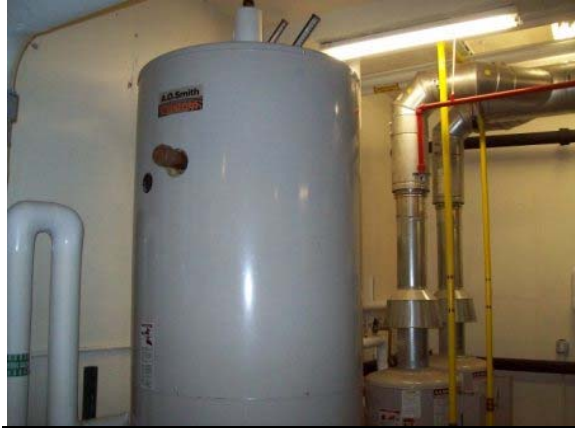
Photo #92: Domestic hot water storage tank

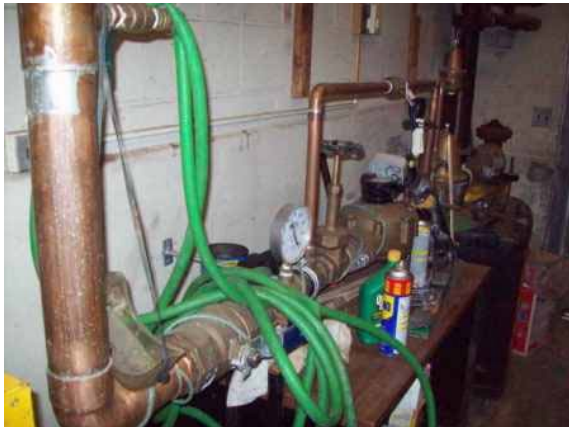
Photo #93: Domestic water service connection

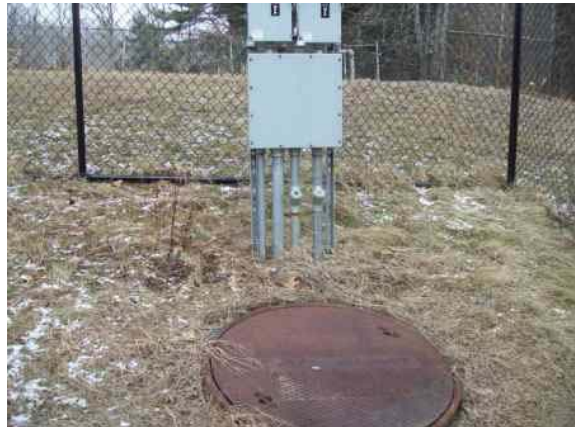
Photo #94: Sanitary waste force main pumping station

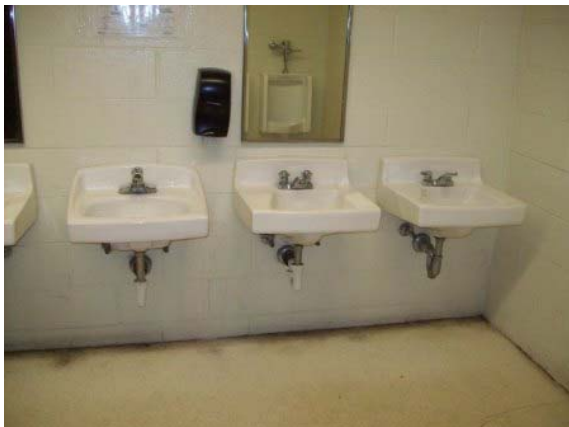
Photo #95: Typical restroom fixtures

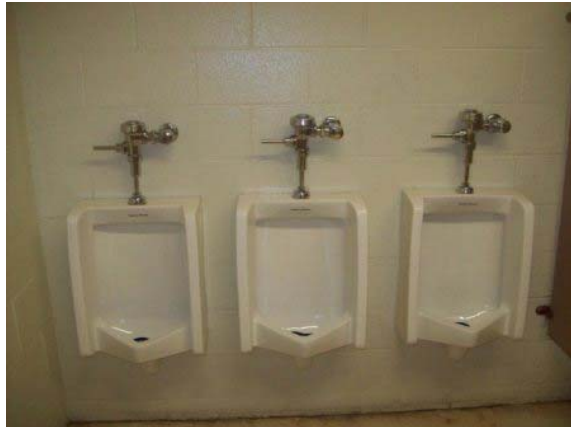
Photo #97: Typical urinal fixtures

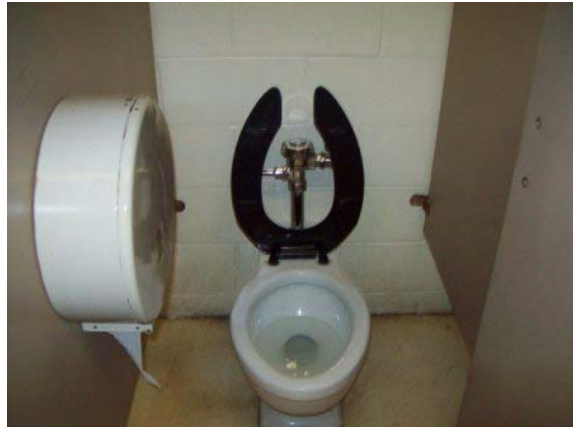
Photo #98: Typical toilet fixture

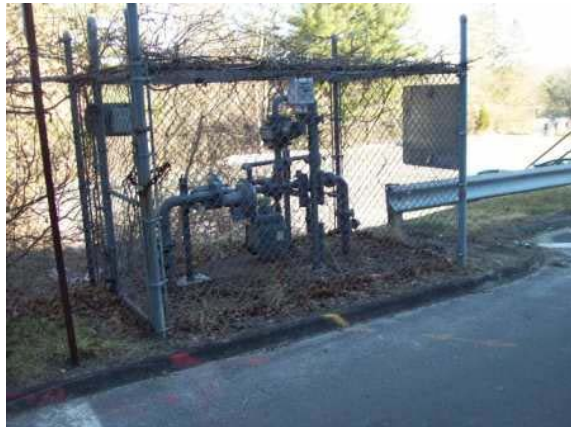
Photo #99: Gas meter and regulator

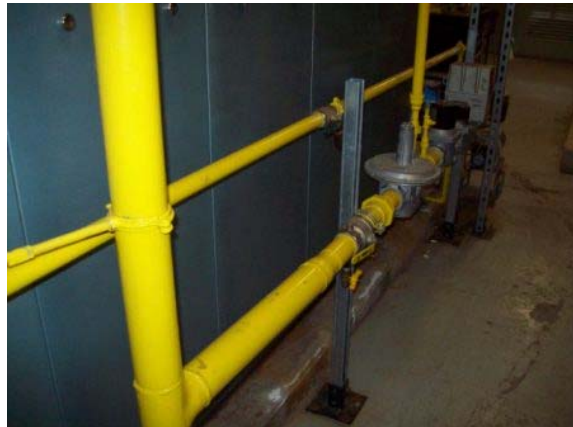
Photo #100: Gas lines in boiler room

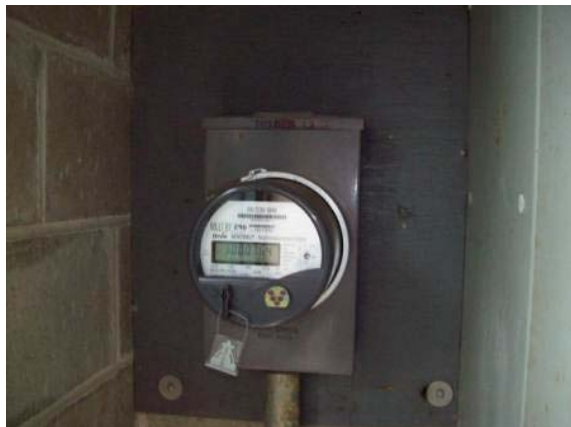
Photo #101: Electric meter

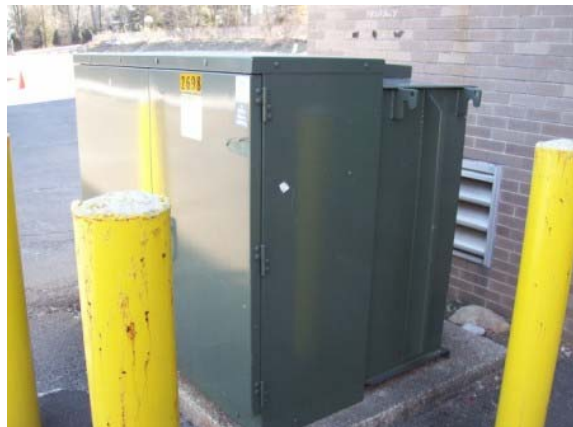
Photo #102: Electrical transformer

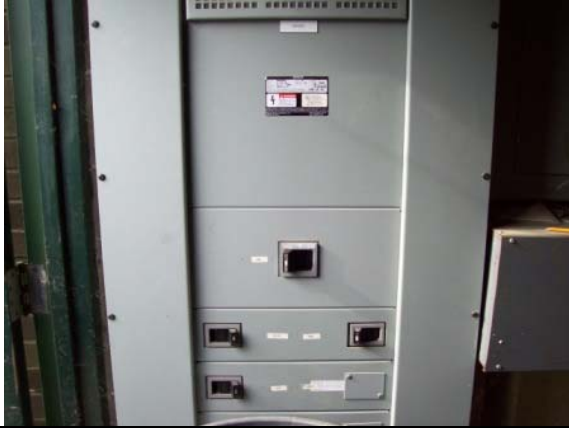
Photo #103: Main breaker panel

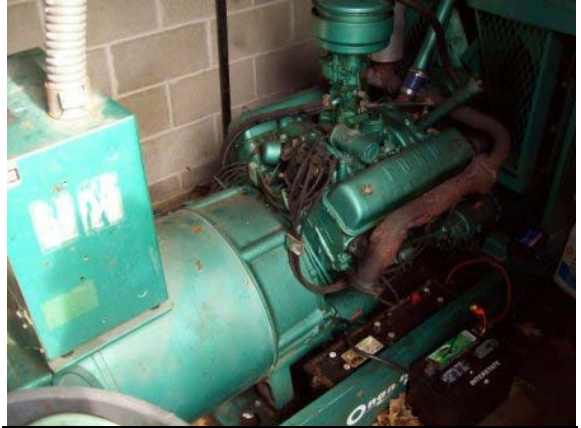
Photo #104: Emergency generator

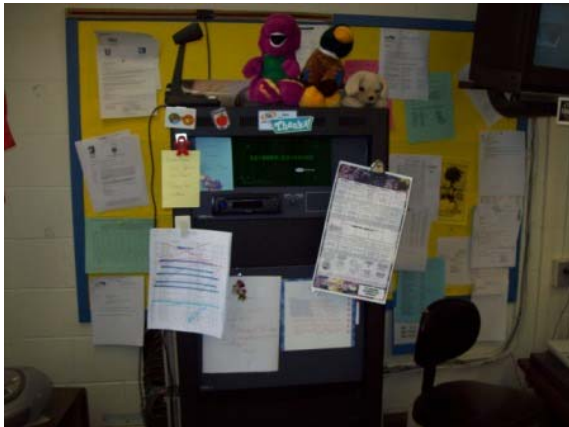
Photo #105: PA system in main office

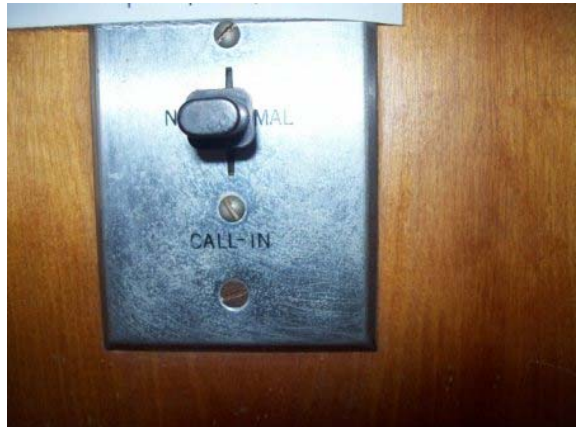
Photo #106: Typical PA call panel in classroom

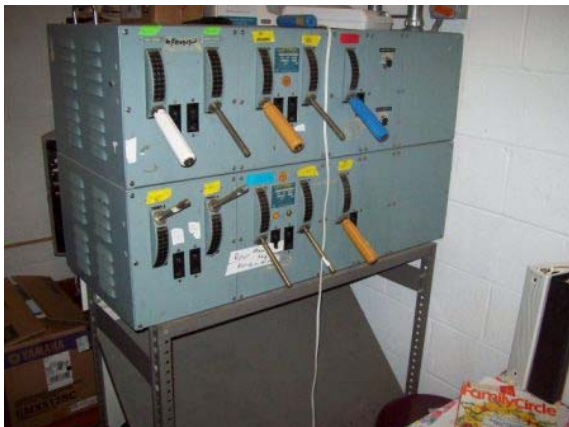
Photo #107: Lighting controls for auditorium

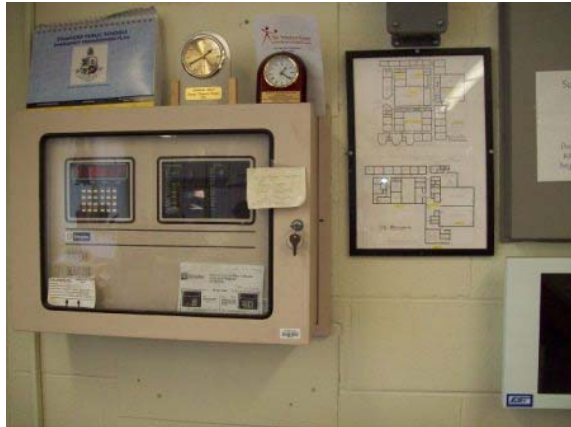
Photo #109: Fire alarm annunciator panel

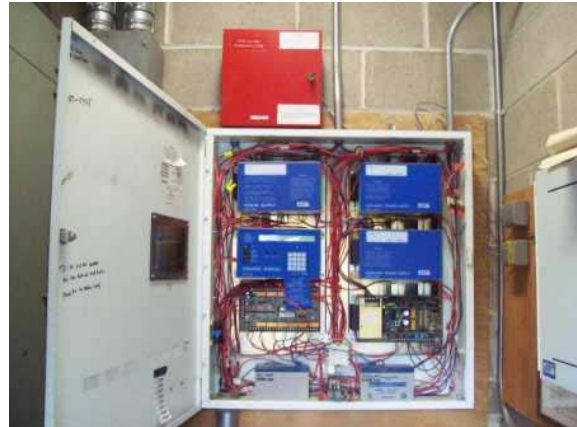
Photo #110: Fire alarm battery panel

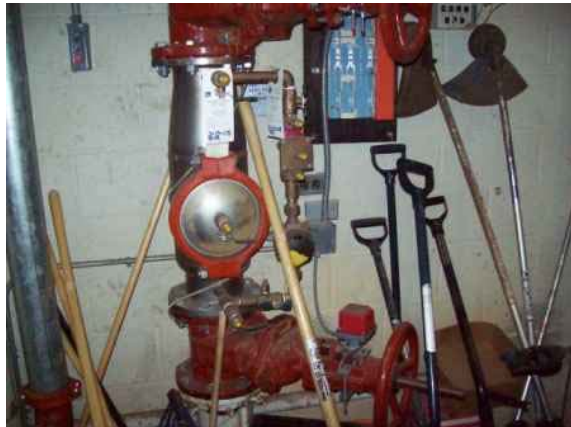
Photo #111: Backflow preventer for sprinkler system

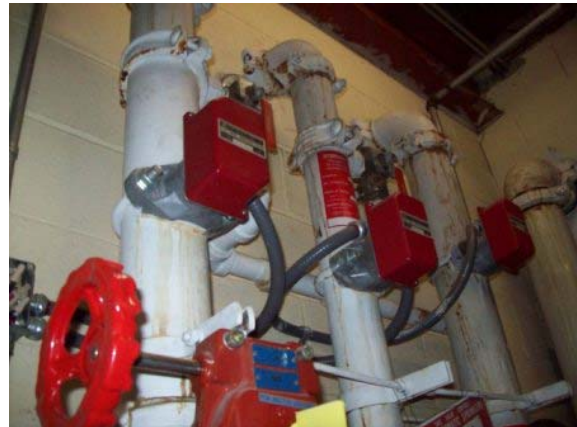
Photo #112: Fire sprinkler risers

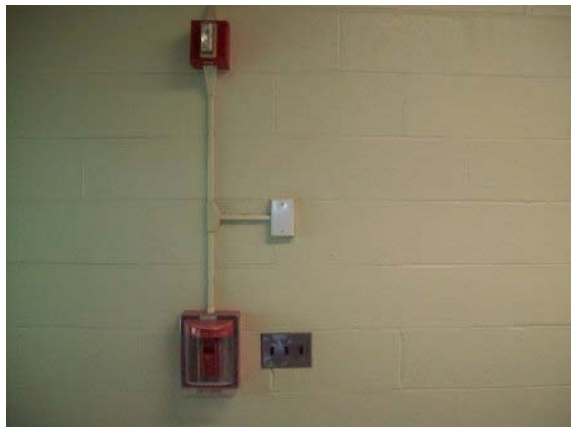
Photo #113: Fire alarm pull station and alarm horn with strobe light

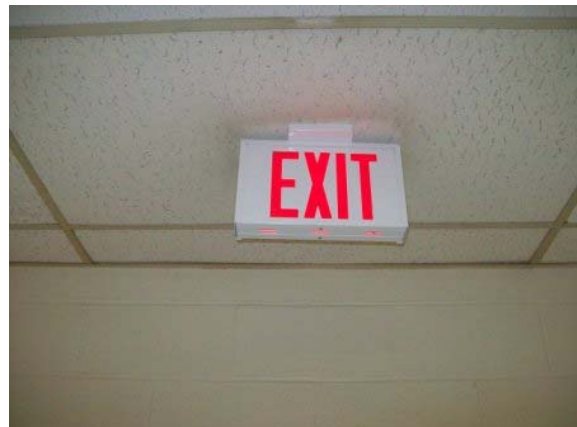
Photo #114: Typical illuminated exit sign

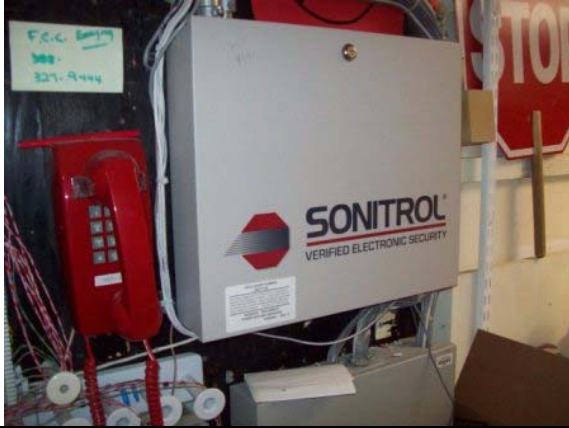
Photo #115: Security panel
