# FACILITIES NEEDS ASSESSMENT

## STAMFORD PUBLIC SCHOOLS

## Facilities Needs Assessment of ROGERS ELEMENTARY SCHOOL

**EMG Project #:** 88166.09R-007.017  
**Date of Report:** August 28, 2009  
**On site Date:** February 19 and 20, 2009

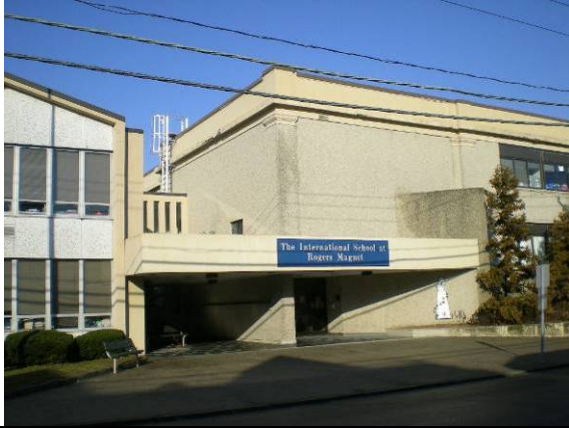
Photo #1: Main entrance off Lockwood Avenue

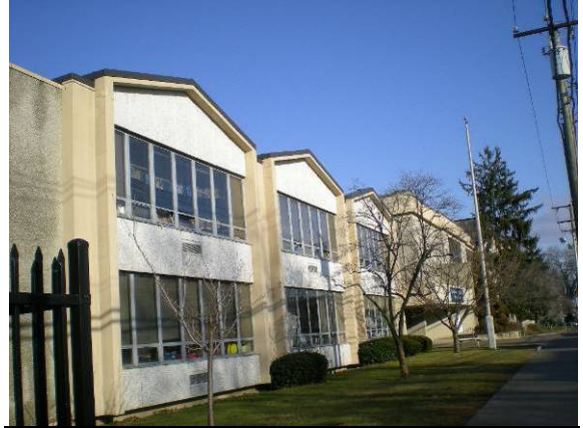
Photo #2: Partial front elevation off Lockwood – left end

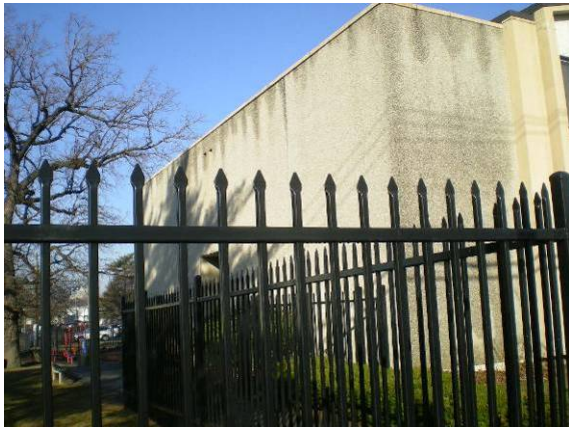
Photo #3: Left side elevation of south wing

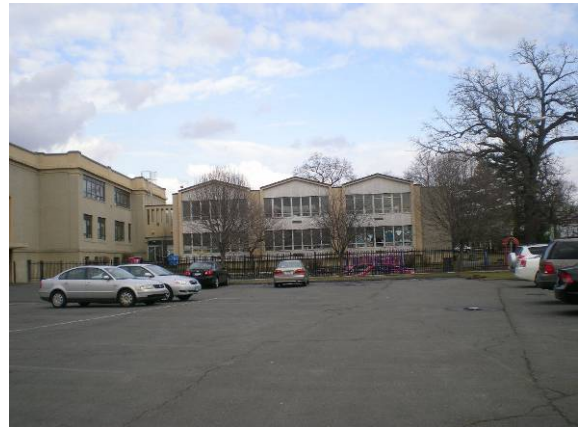
Photo #4: West elevation of south wing

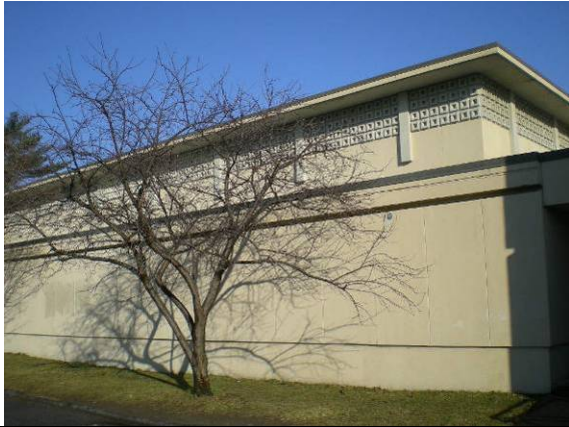
Photo #7: South elevation of gymnasium

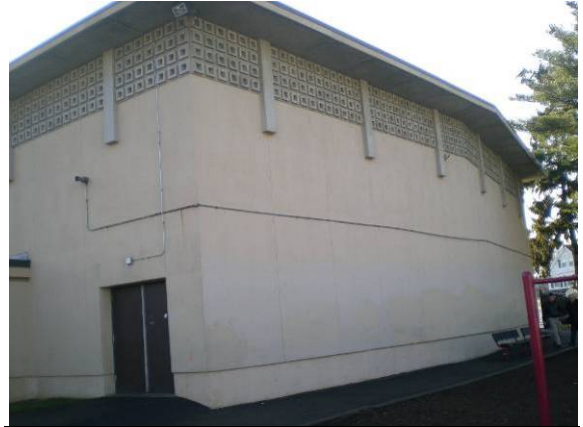
Photo #8: West elevation of gymnasium

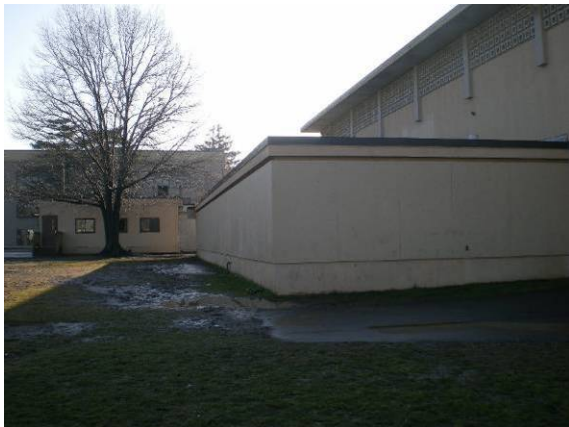
Photo #9: North elevation of gymnasium

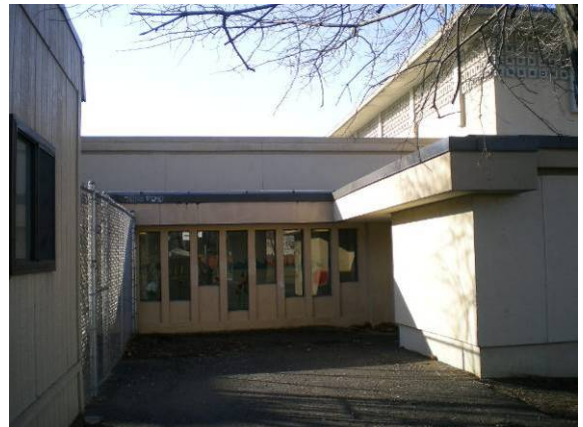
Photo #10: Elevation of corridor on north side

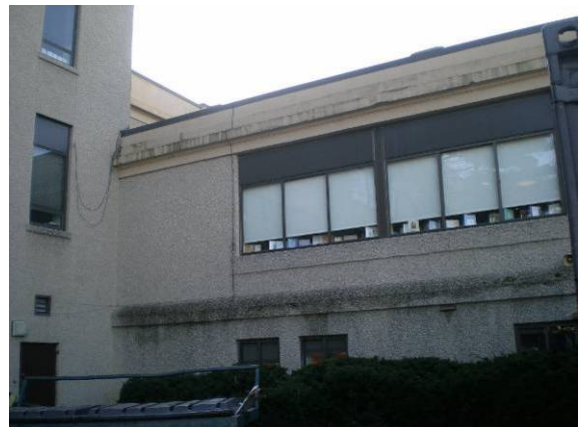
Photo #12: Upper partial north facing elevation

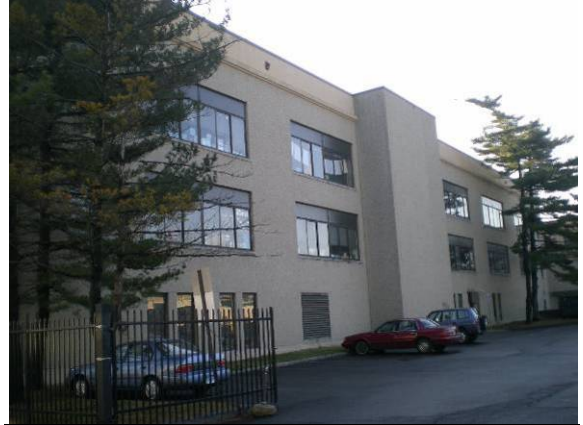
Photo #14: West elevation of north wing

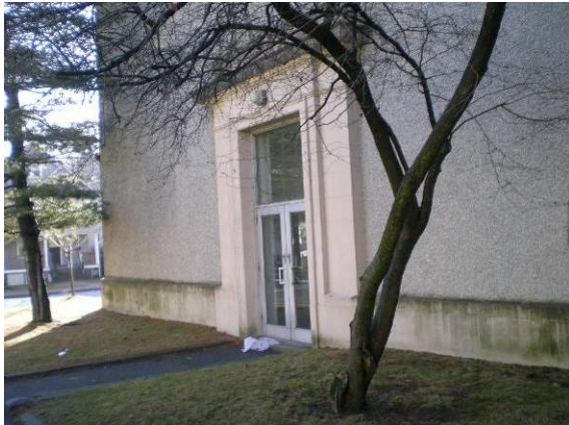
Photo #15: North elevation of north wing

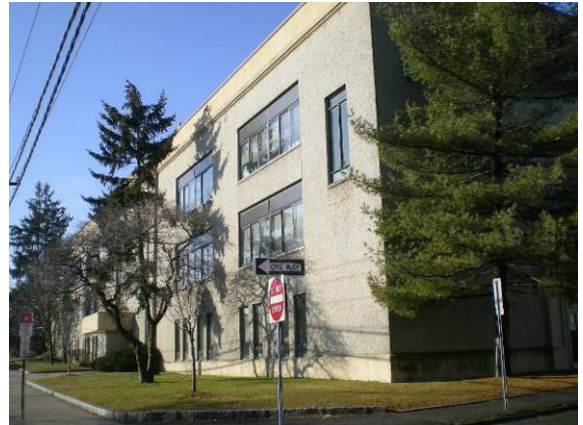
Photo #16: Partial front elevation along Lockwood – right section

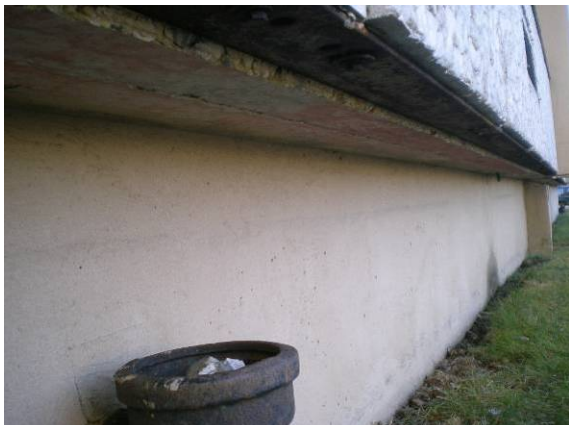
Photo #17: Underside detail south wing – steel angle supporting exposed aggregate panels

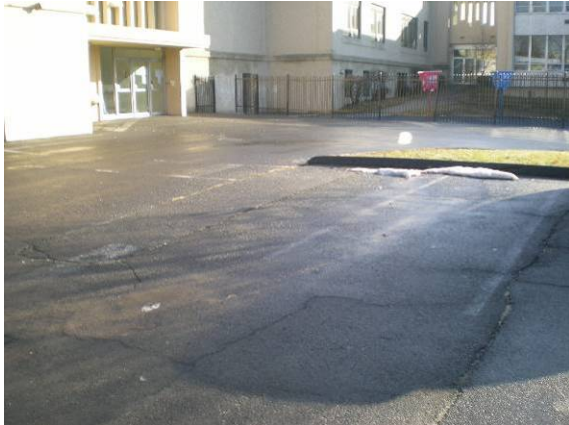
Photo #19:	Potential for ADA entrance from south lot
------------	---

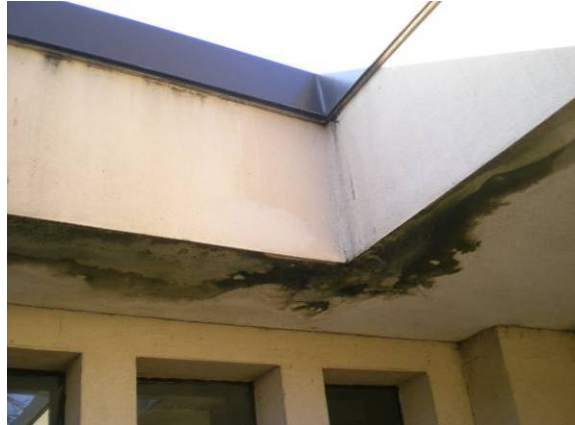
Photo #20:	Mildew on soffit at north facing corridor elevation
------------	---

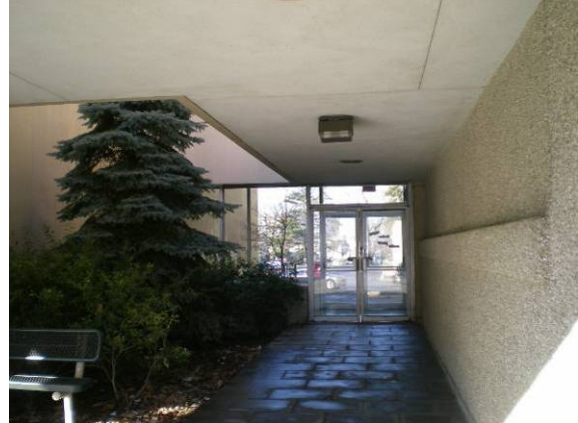
Photo #26: Side entrance into connector between main entrance and south wing

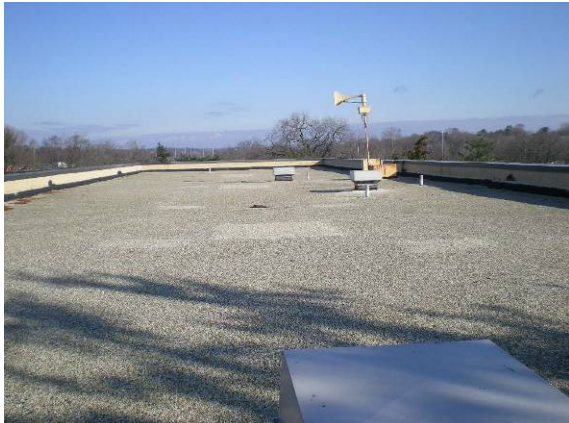
Photo #27: Roof over north wing

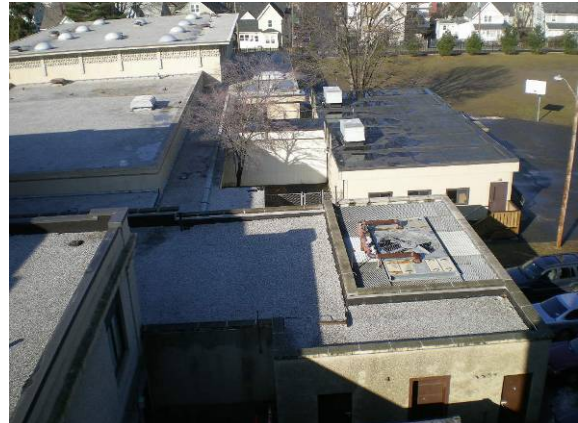
Photo #28: Various roofs looking towards gymnasium, including modular roofing

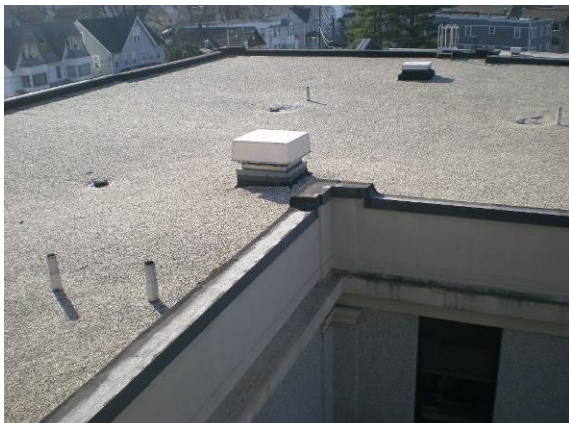
Photo #29: Middle section of school roofing

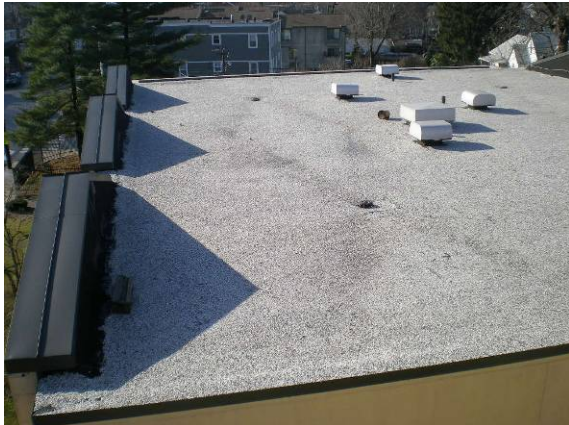
Photo #33:	Roof over south wing
------------	----------------------

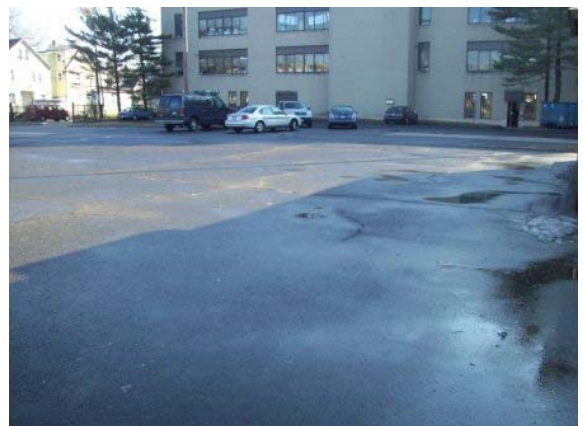
Photo #36:	North parking lot
------------	-------------------

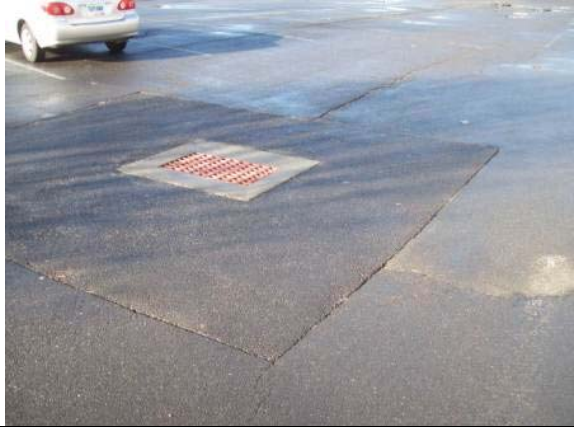
Photo #38: Catch basin for municipal storm drainage

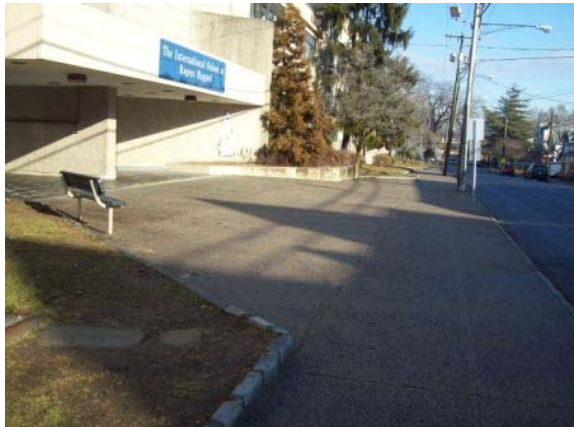
Photo #40: Pedestrian pavement near Lockwood Avenue entrance

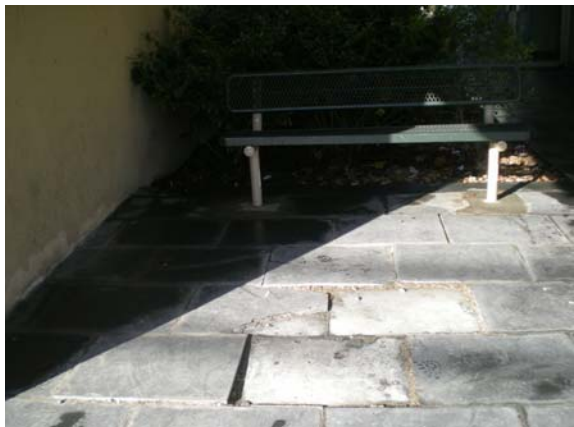
Photo #42: Tripping hazard near main entrance

5.2	1270	Remove & replace 4' wide concrete sidewalk	25	24	1	20	LF	\$40.65	\$813	\$813	\$813										\$813
5.3	5700	Rogers - Site drainage improvement budgetary allowance	0	0	0	1	EA	\$100,800.00	\$100,800	\$100,800											\$100,800

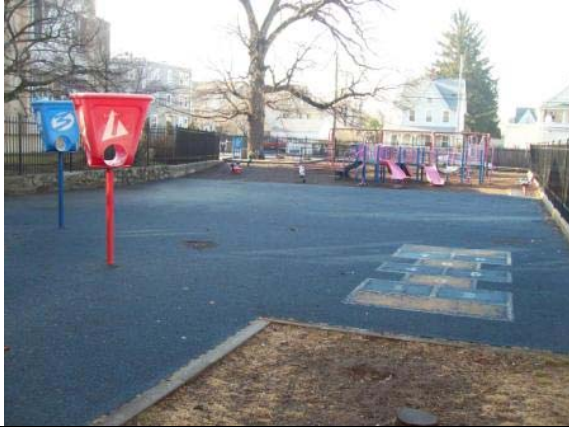
Photo #43: South playground area

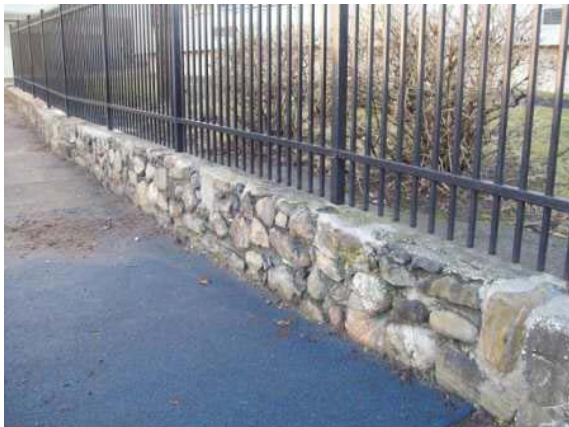
Photo #47: Retaining wall and fencing

5.4	4569	Replace stone retaining wall, mortar set	50	46	4	2600	SF Face	\$94.82	\$246,519					\$246,519							\$246,519
5.4	1273	Re-grading and establishment of ground cover at playing field	25	24	1	4	1000 SF	\$1,962.80	\$7,851	\$7,851	\$7,851										\$7,851

5.5	4570	Replace metal tube steel fence	20	16	4	1150	LF	\$79.70	\$91,649												\$91,649
5.5	1419	Replace metal tube steel fence	20	18	2	30	LF	\$79.70	\$2,391		\$2,391										\$2,391

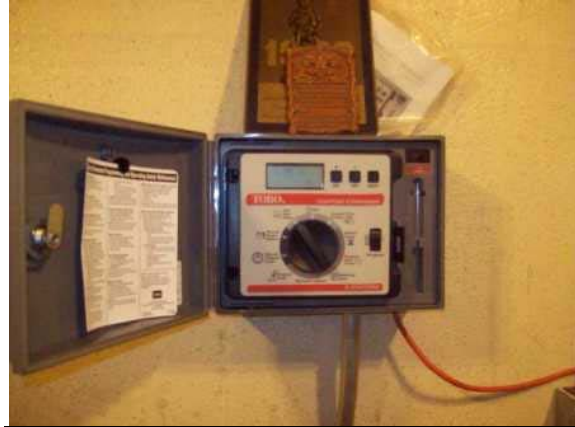
Photo #50: Irrigation controls for soccer field

5.5	6099	Replace irrigation system, residential 1" supply	20	20	0	30000	SF	\$1.26	\$37,800	\$37,800											\$37,800
6.3	1433	Replace stucco and lath	25	25	0	350	CSF	\$913.12	\$319,593	\$319,593											\$319,593

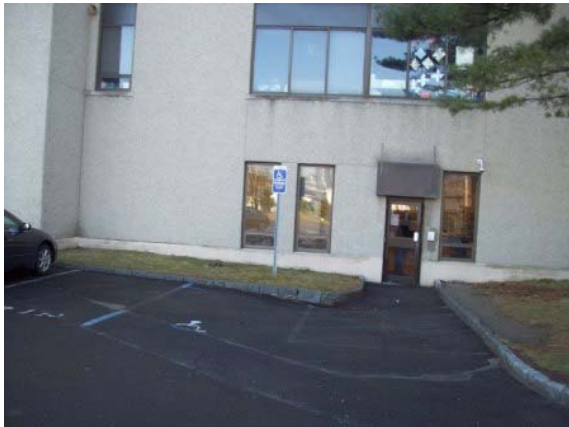
Photo #51: Area of drainage issue in north parking lot

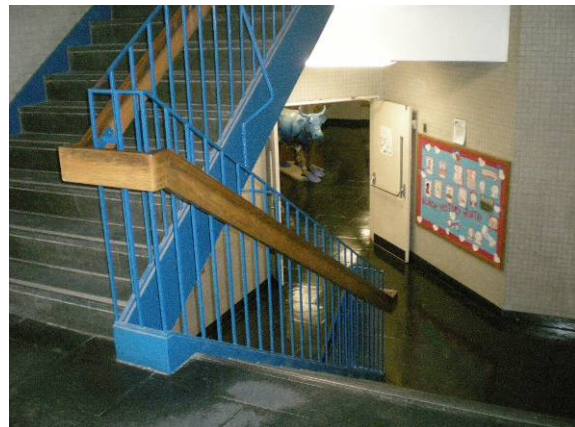
Photo #54: Split level main entrance – looking down to main office level

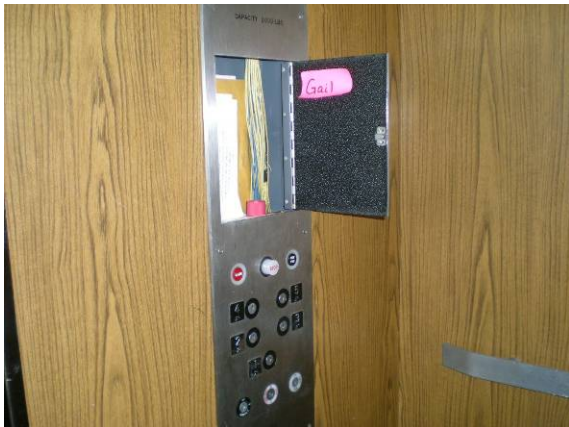
Photo #57: Elevator with no emergency communication

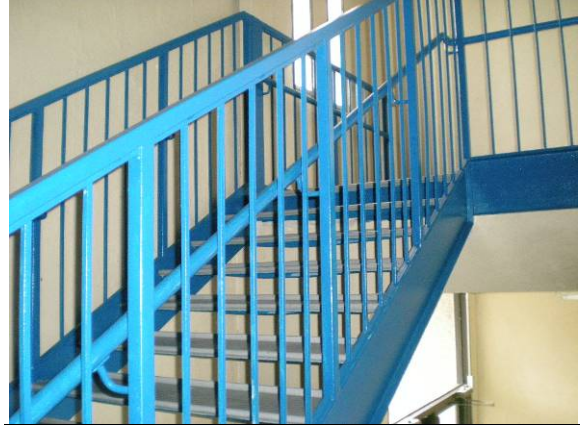
Photo #68: Open riser stair

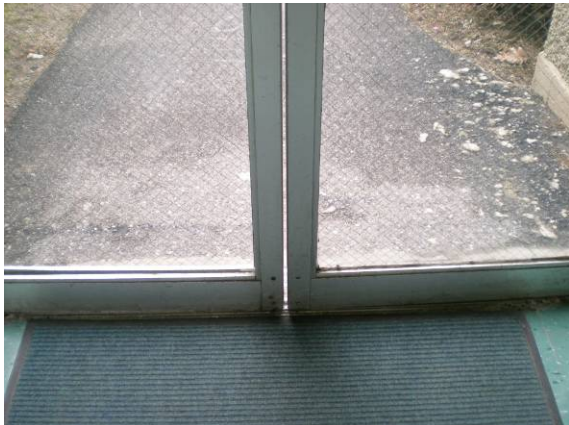
Photo #71: No weather stripping at door

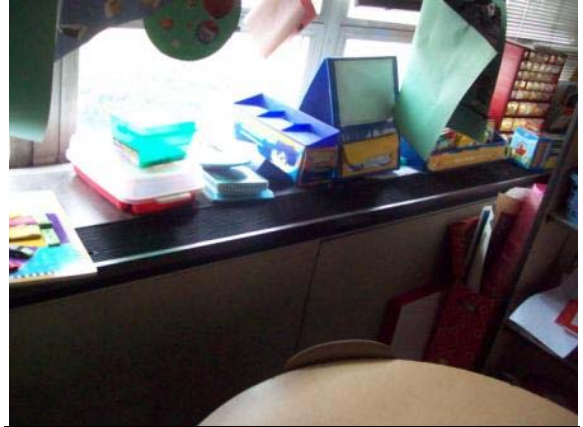
Photo #103:	Perimeter finned-tube heating unit for classroom
-------------	--

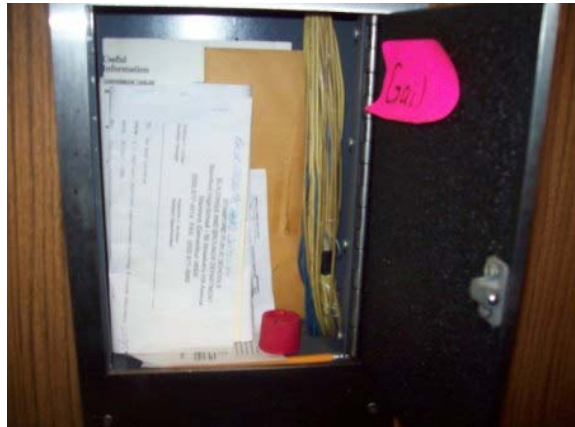
Photo #124: Missing elevator communication equipment
