# FACILITIES NEEDS

### FACILITIES NEEDS ASSESSMENT OF ROXBURY ELEMENTARY SCHOOL

751 West Hill Road  
Stamford, Connecticut 06902

**EMG Project #:** 88166.09R-006.017  
**Date of Report:** August 28, 2009  
**On site Date:** March 25, 2009

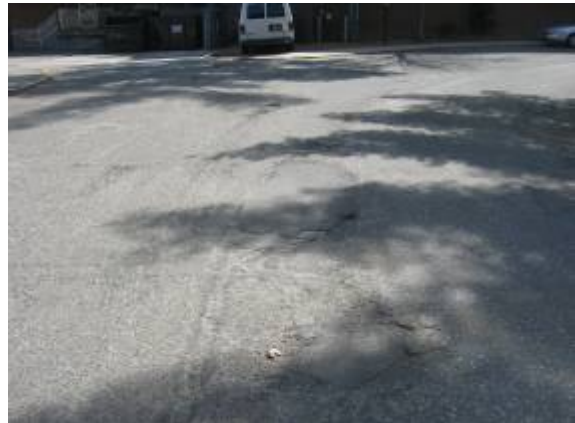
Photo #2:	View of asphalt paved entry driveway.
-----------	---------------------------------------

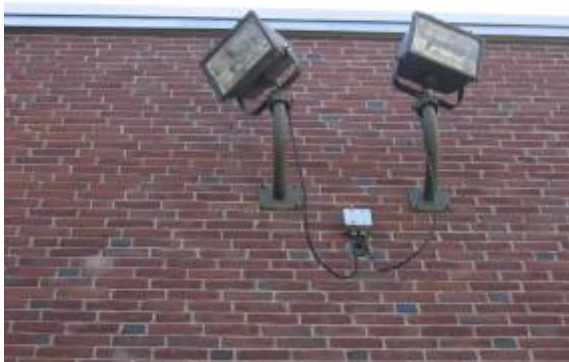
Photo #3:	View of building mounted site lighting fixtures.
-----------	--

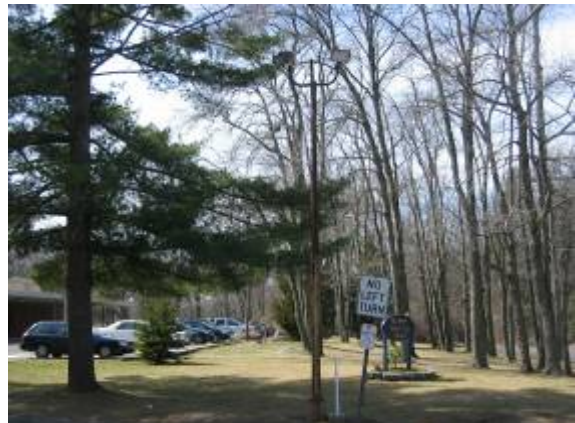
Photo #4:	View of pole mounted site lighting fixtures.
-----------	--

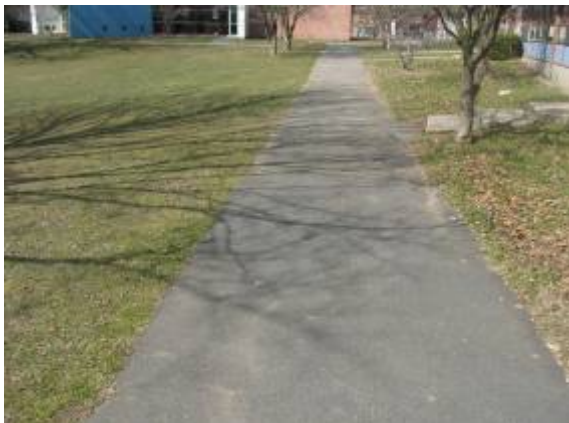
Photo #5:	View of asphalt paved sidewalks.
-----------	----------------------------------

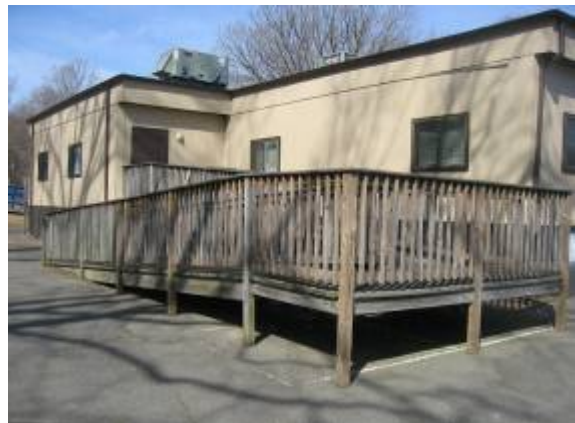
Photo #6:	View of wood framed ramp, which is located at the end of the 100 corridor.
-----------	--

6.5	2712	Replace pressure treated ramp	20	15	5	450	SF	\$112.90	\$50,803						\$50,803						\$50,803
6.6	2723	Minor repairs to concrete loading dock	0	0	0	30	SF	\$50.84	\$1,525	\$1,525											\$1,525

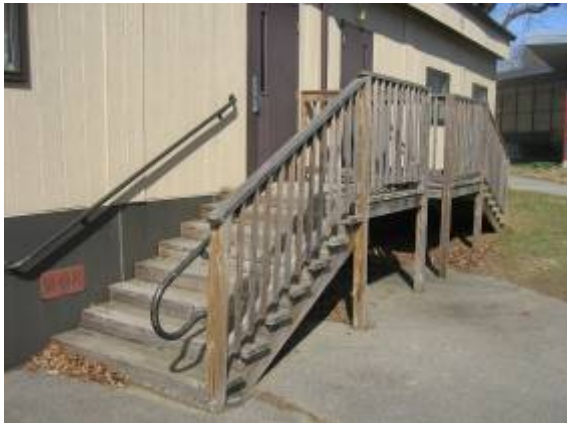
Photo #7: View of wood framed steps, which are provided at a majority of the modular classrooms.

6.5	2711	Replace metal handrail	0	0	0	200	LF	\$54.05	\$10,811	\$10,811											\$10,811
6.5	2710	Replace pressure treated wood stairs	20	15	5	450	SF	\$141.75	\$63,788						\$63,788						\$63,788

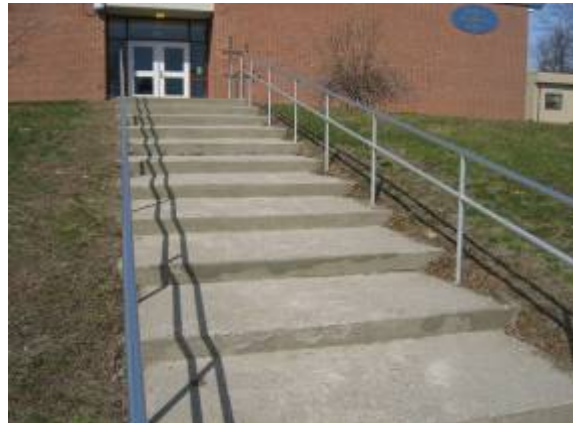
Photo #8: View of cast in place concrete steps, which are located at the end of the 400 corridor.

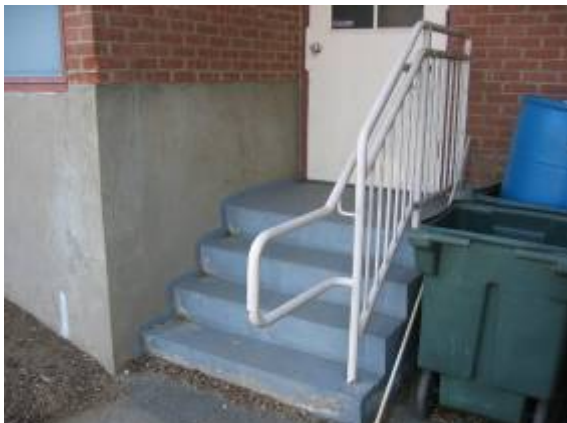
Photo #9: View of cast in place concrete steps, which are located at the receiving dock.

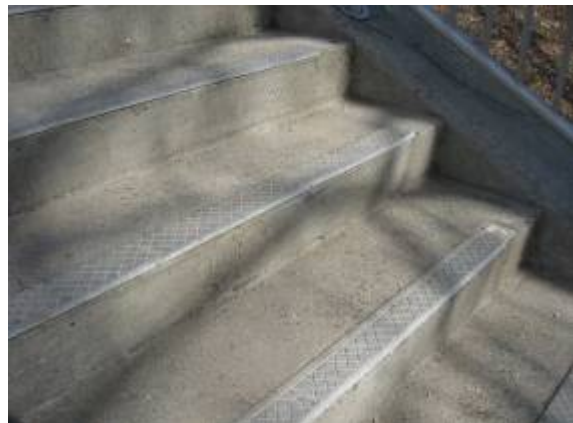
Photo #10: View of cast in place concrete steps at the end of the 200 corridor, whose metal tread noses are becoming dislodged.

3.1	2646	ADA, Wrap drain pipes below accessible lavatory	0	0	0	4	EA	\$81.90	\$328	\$328											\$328
5.2	2713	Exterior concrete stair repairs - Major	0	0	0	104	SF	\$94.50	\$9,828	\$9,828											\$9,828

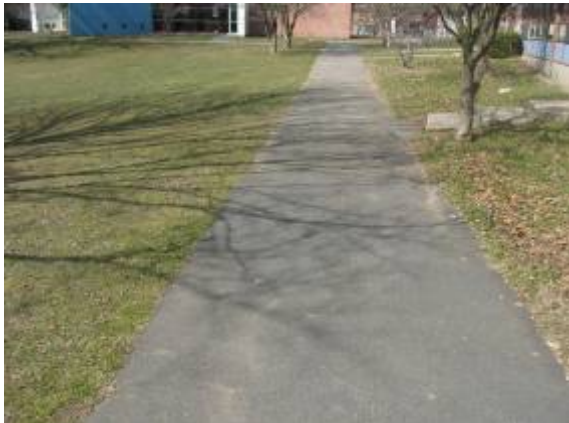
Photo #13: View of asphalt paved sidewalks.

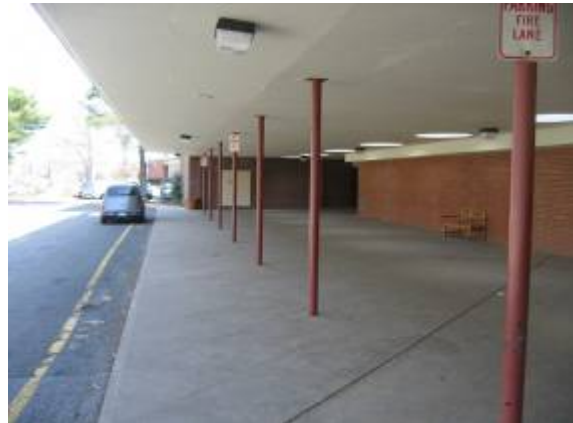
Photo #14: View of concrete paved sidewalks, which are located at the main entrance.

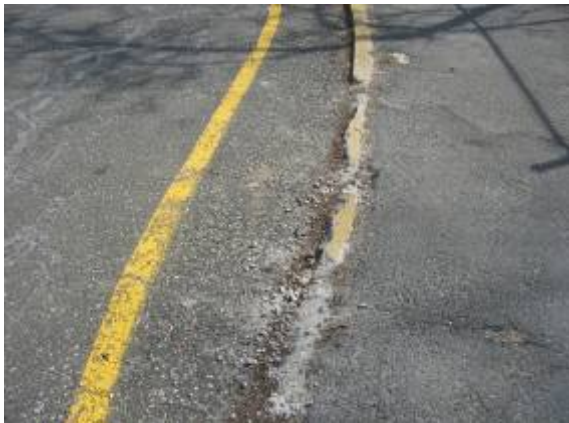
Photo #15: View of deteriorated concrete curbing along the main entry drive.

5.2	3181	Replace concrete curbs	25	25	0	50	LF	\$38.12	\$1,906	\$1,906											\$1,906
5.2	3182	Replace concrete curbs	25	20	5	1500	LF	\$38.12	\$57,173						\$57,173						\$57,173

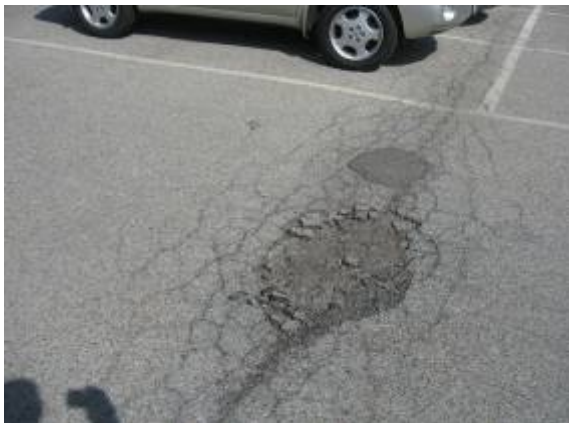
Photo #17: View of deteriorated asphalt pavement.

5.2	3167	Repair and Seal Coat asphalt	5	5	0	4	10000 SF	\$5,848.92	\$23,396	\$23,396											\$46,791
5.2	3165	Cut & Patch asphalt	10	10	0	2500	SF	\$3.01	\$7,529	\$7,529											\$7,529

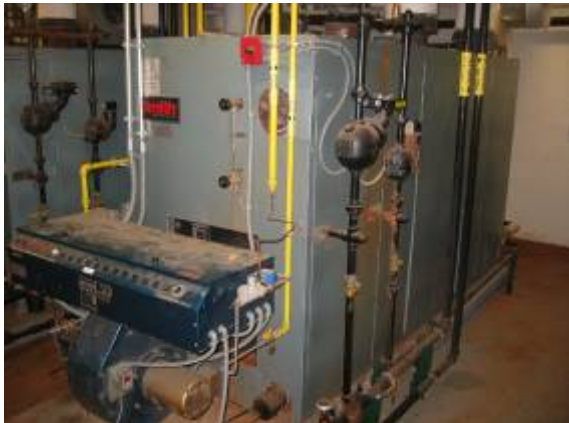
Photo #23: View of Boiler No.1.

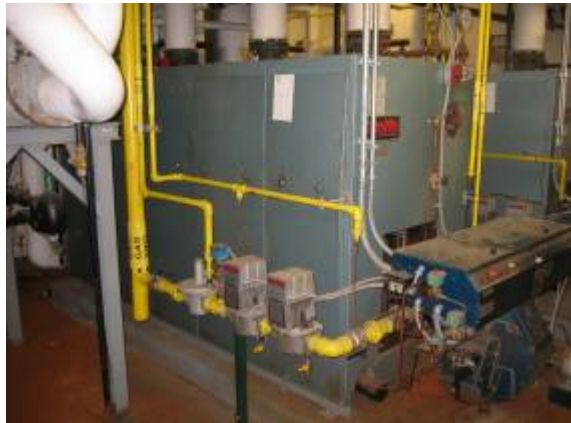
Photo #24: View of Boiler No.2.

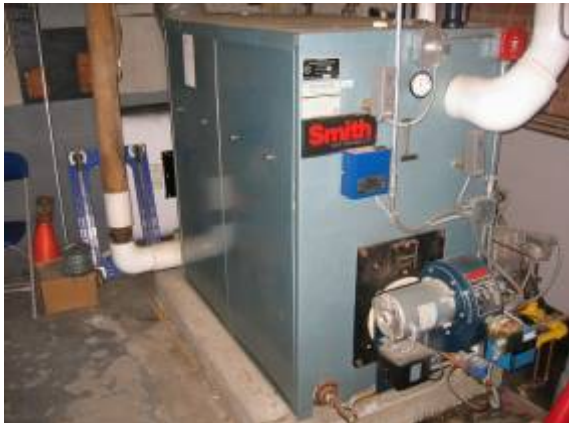
Photo #25: View of Boiler No.3.

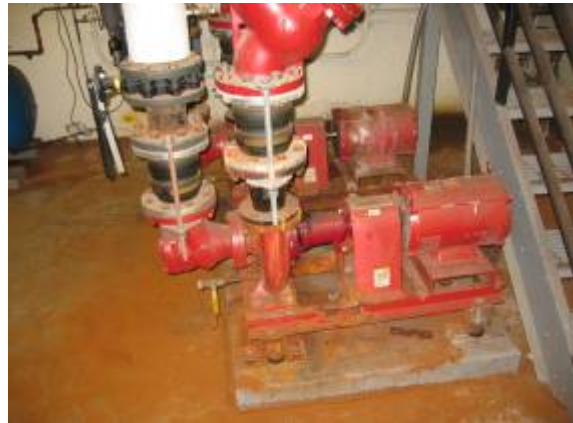
Photo #26: View of hot steam distribution pumps.

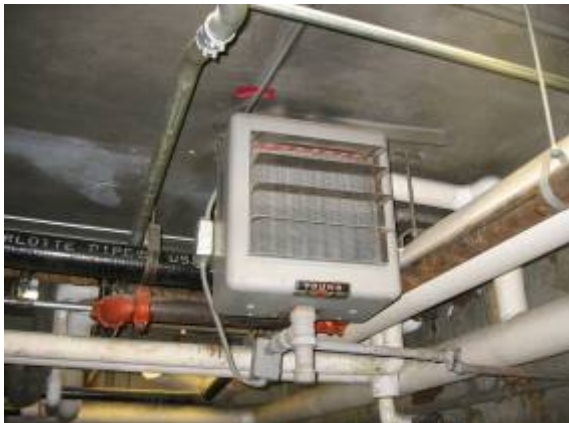
Photo #27: View of auxiliary heaters.

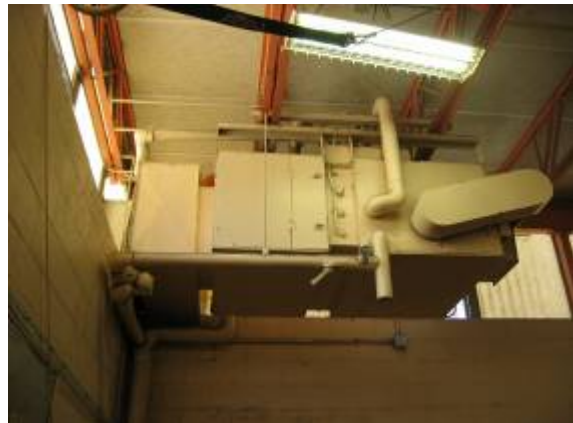
Photo #28: View of make-up air unit, which is located in small gymnasium.

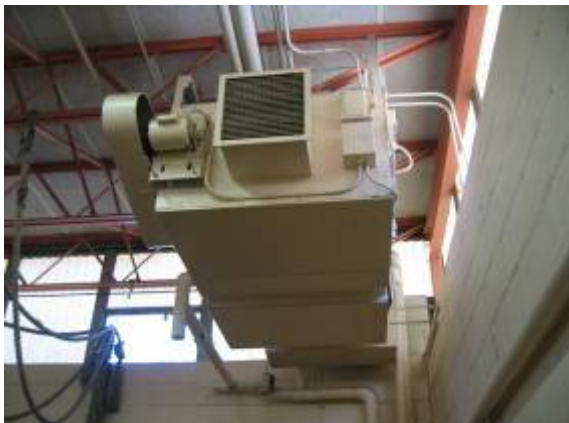
Photo #29: View of make-up air unit, which is located in small gymnasium.

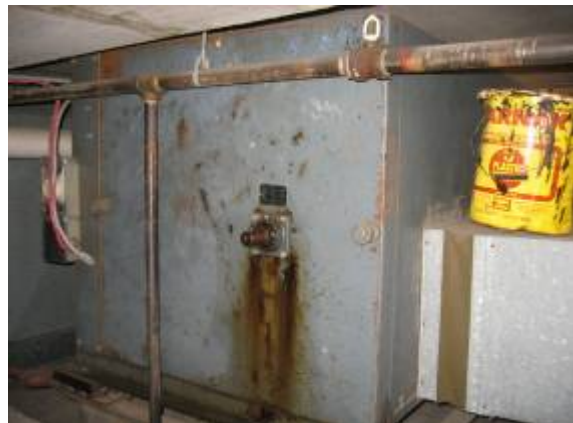
Photo #30: View of make-up air unit, which serves the cafeteria.

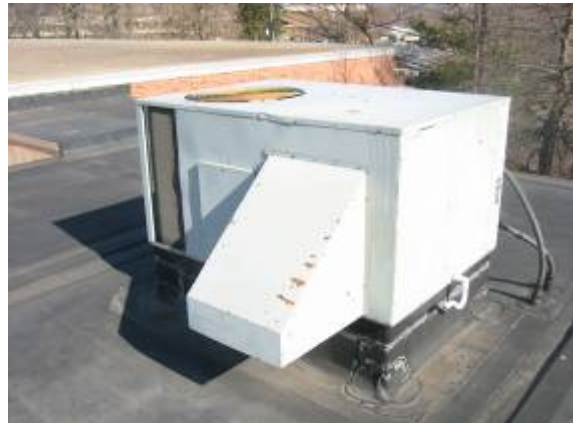
Photo #32: View of RTU 500-1.

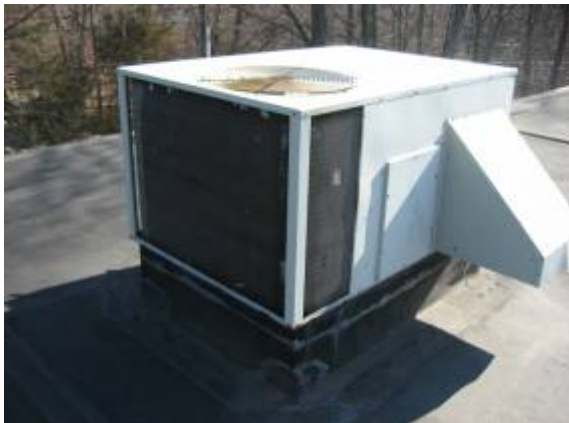
Photo #33: View of RTU 500-2.

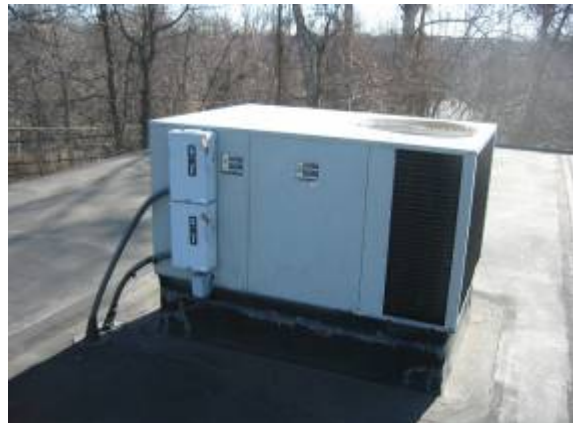
Photo #34: View of RTU 500-3.

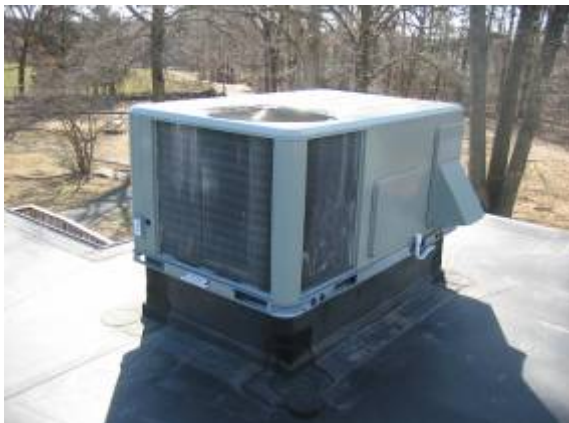
Photo #35: View of RTU 100-7.

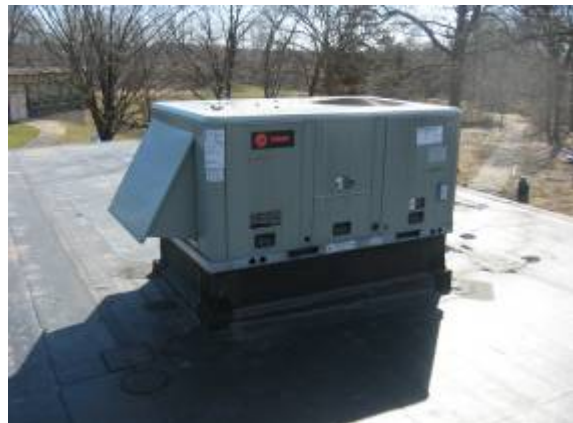
Photo #36: View of RTU 100-6.

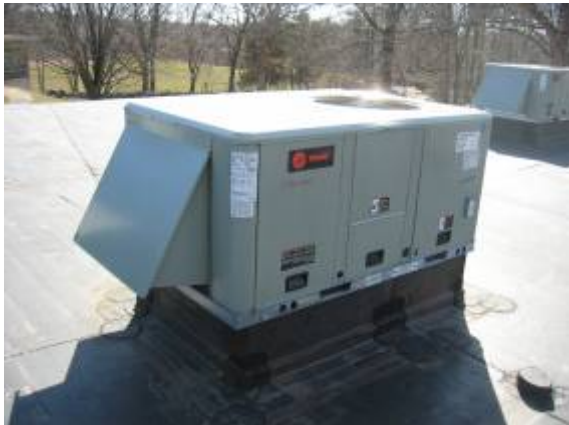
Photo #37: View of RTU 100-5.

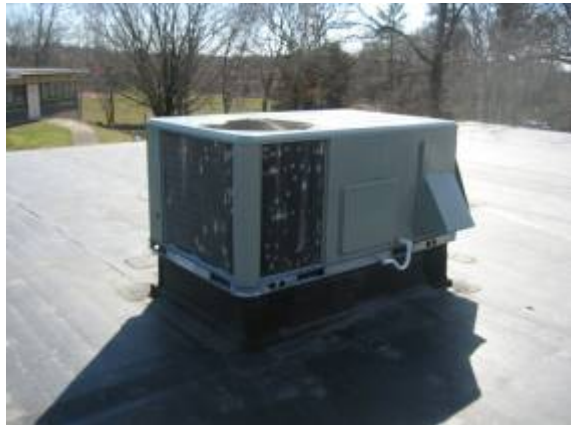
Photo #38: View of RTU 100-4.

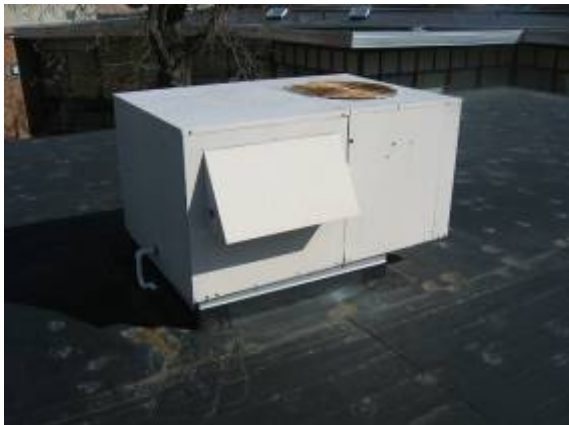
Photo #39: View of RTU 100-3.

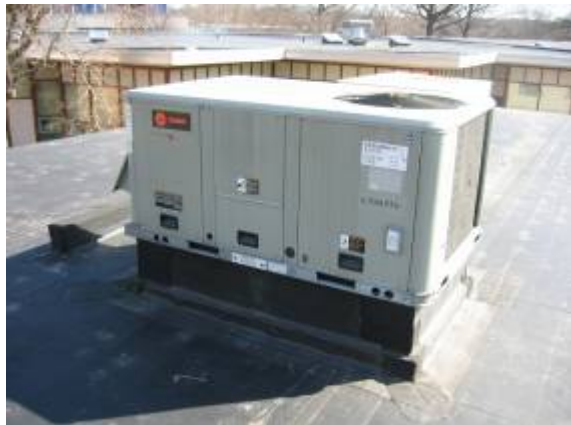
Photo #40: View of RTU 100-2.

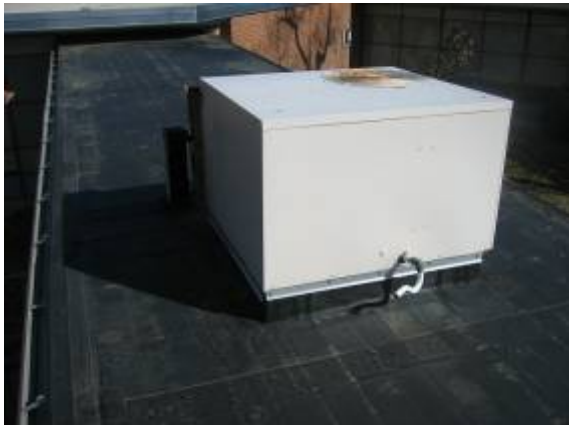
Photo #41: View of RTU 100-1.

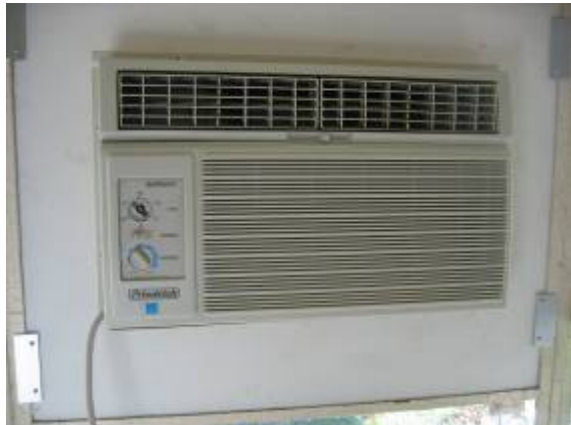
Photo #42: View of window mounted air conditioning unit.

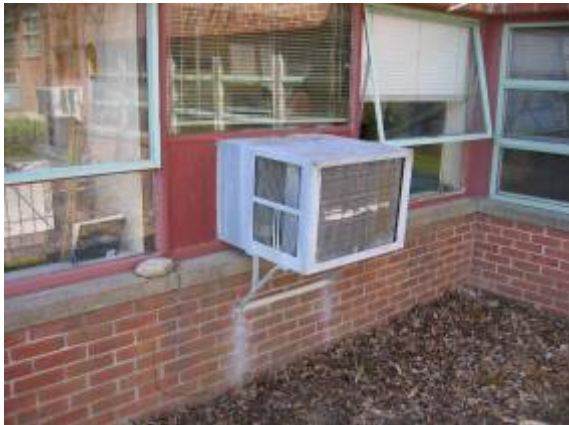
Photo #43: View of window mounted air conditioning unit.

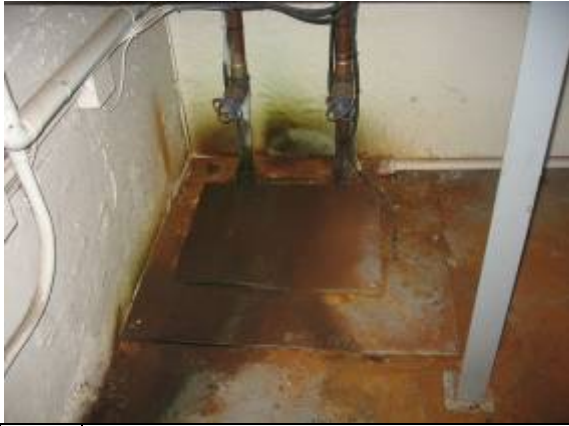
Photo #49: View of sump pump.

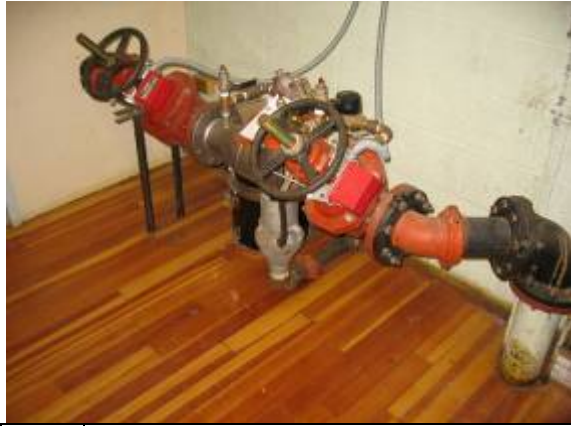
Photo #50: View of water metering equipment.

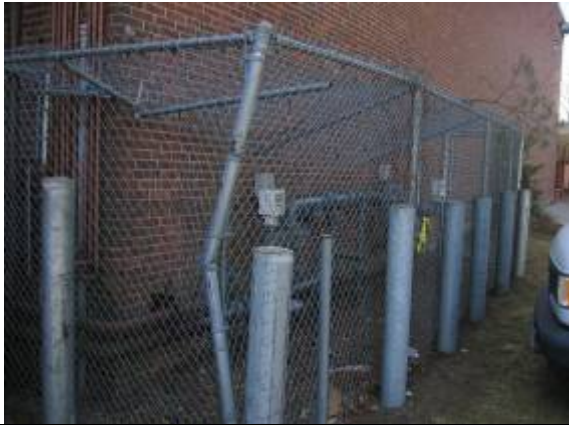
Photo #51: View of natural gas metering equipment.

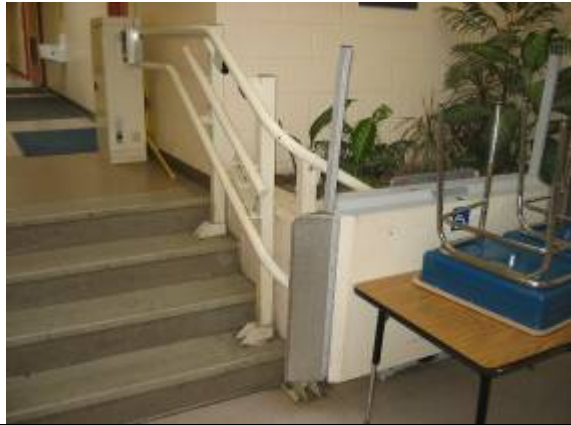
Photo #52: View of wheel chair lift, which is located within the 300/500 corridors.

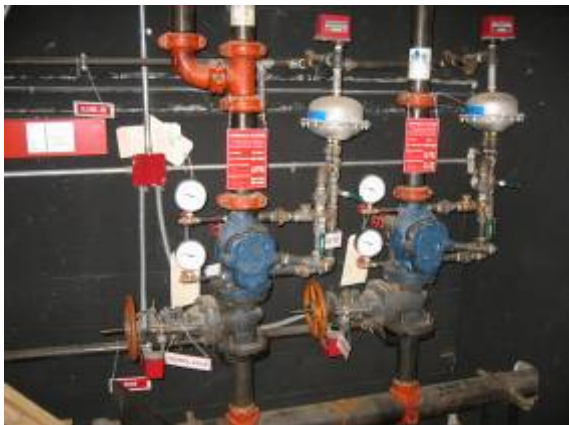
Photo #59: View of main sprinkler valves.

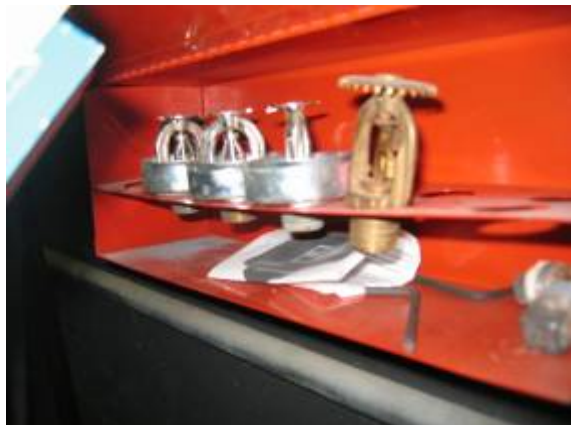
Photo #60: View of spare sprinkler heads.

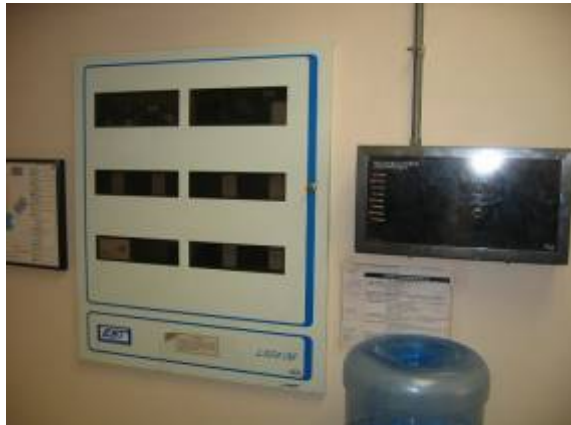
Photo #61: View of fire control panel.

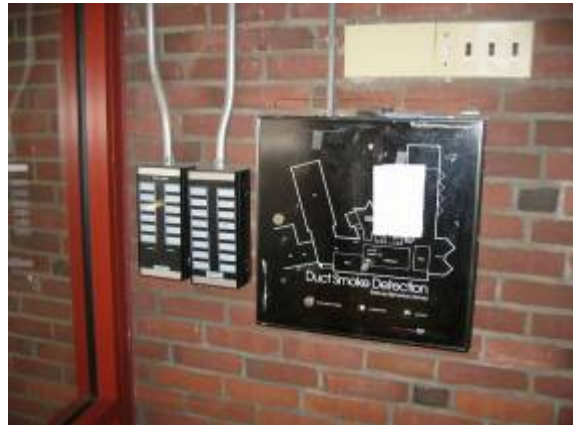
Photo #62: View of fire annunciator panel.

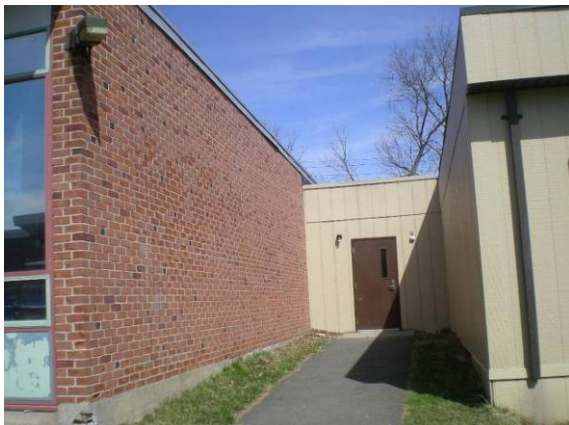
Photo #77: Link between 500 wing and north end modular addition note damaged corner

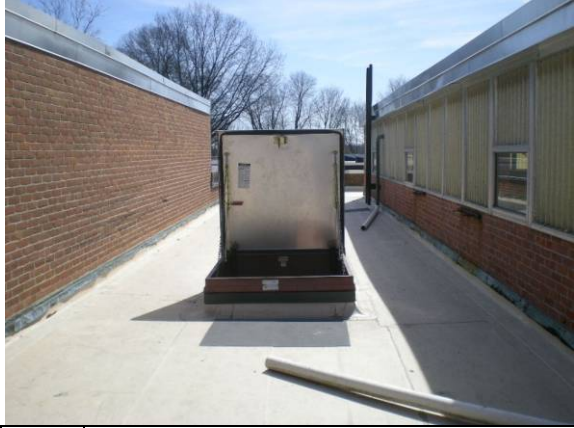
Photo #80: Roof hatch

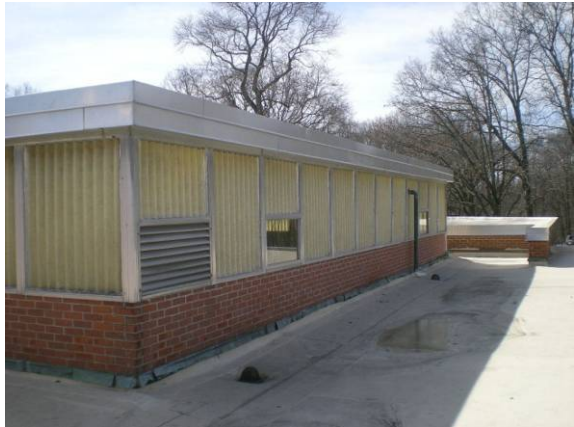
Photo #82: Clerestory section of gym

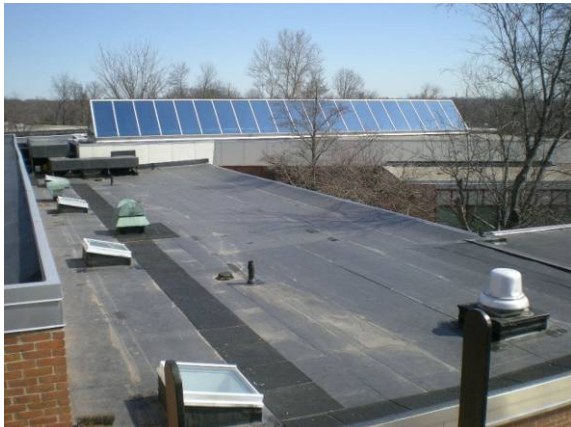
Photo #83: Roof over main office area and view of Media Center skylight

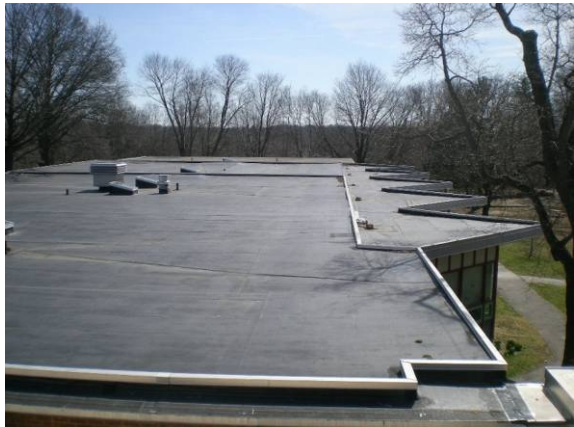
Photo #84: Roof overview over 200 wing

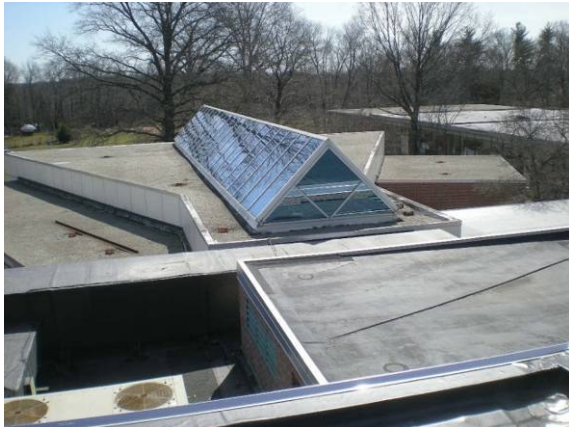
Photo #87: Roof over Media Center

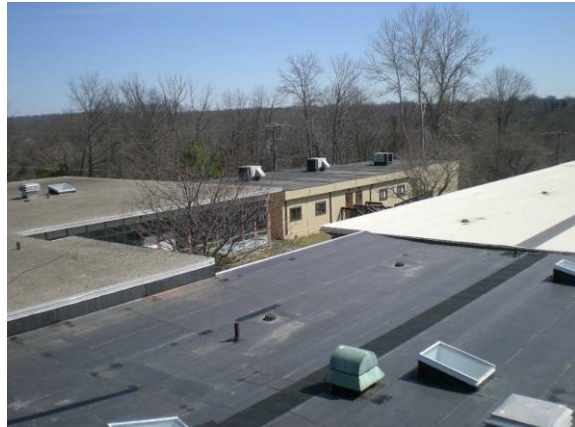
Photo #88: Roof overview looking towards 500 wing and north end modular wing

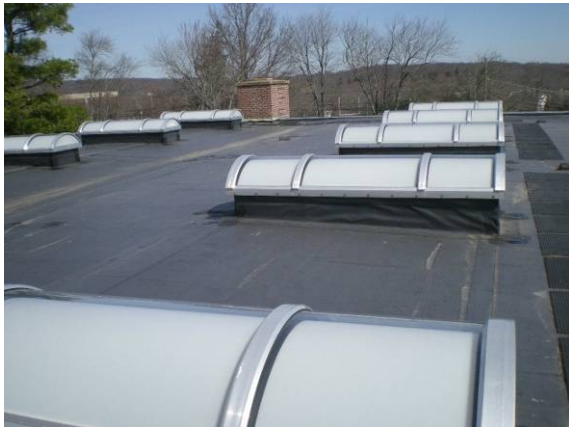
Photo #89: Roof over cafeteria

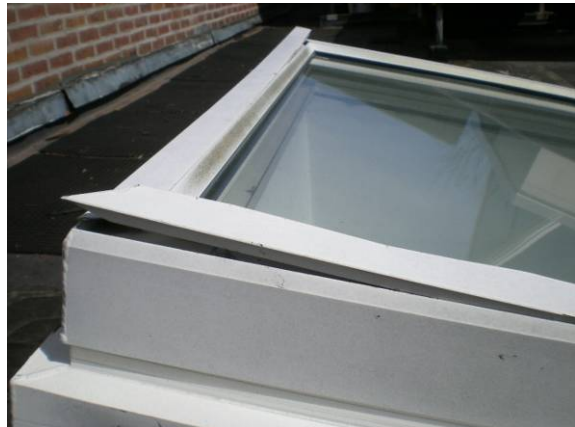
Photo #90: Close up detail of skylight

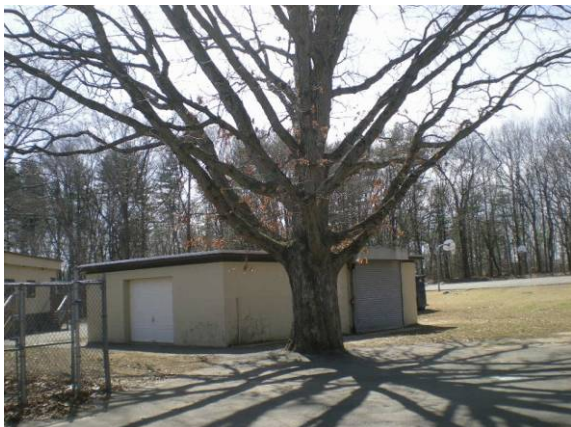
Photo #95:	Storage building at south end of property
------------	---

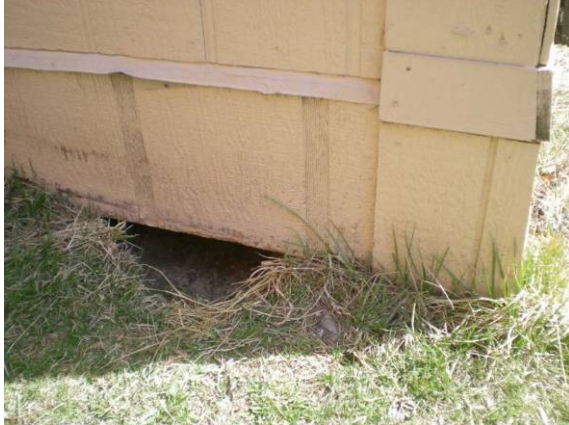
Photo #103: Evidence of burrowing animals under north modular addition

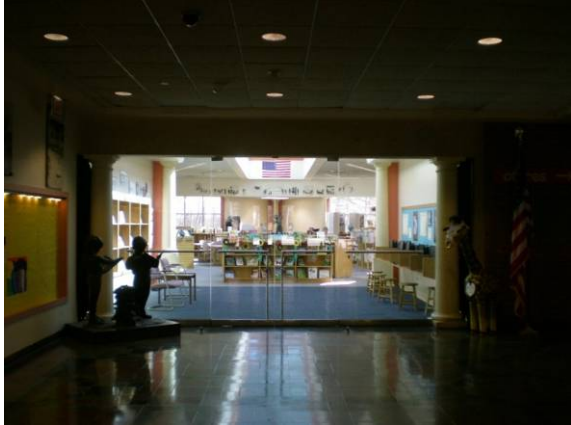
Photo #109: Main lobby looking towards Media Center

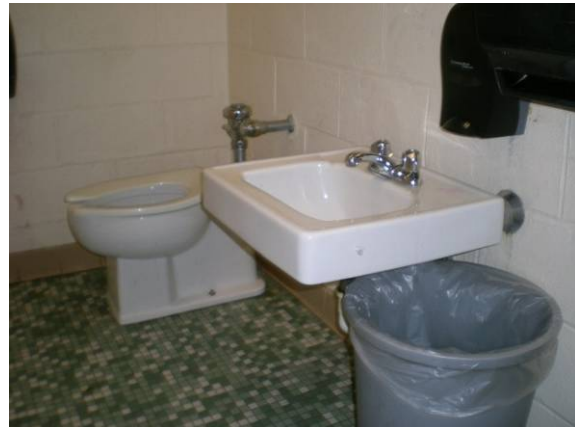
Photo #120: Restroom across from gym

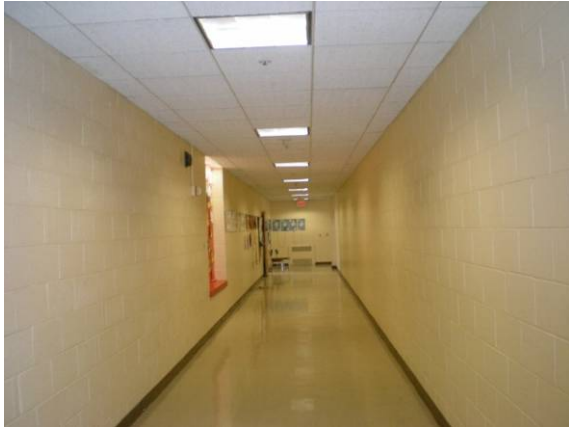
Photo #121: Corridor to Kindergarten room at far southwest corner

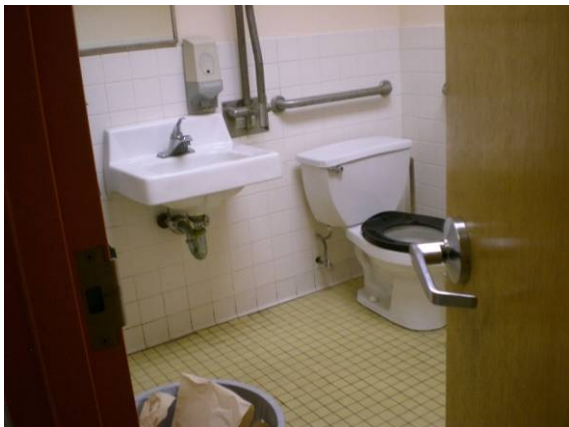
Photo #125: ADA restroom at junction between K classroom and south modular wing

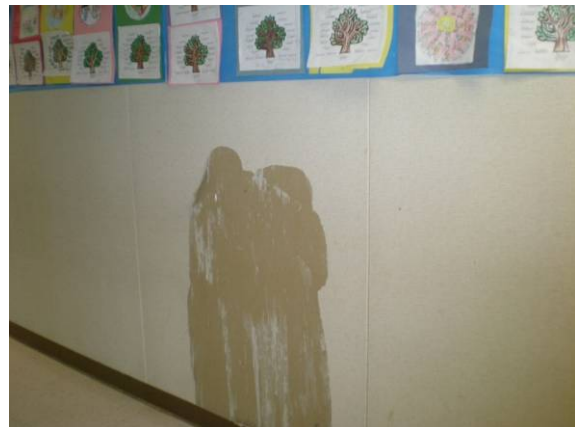
Photo #126: Vinyl wall covering in south modular wing

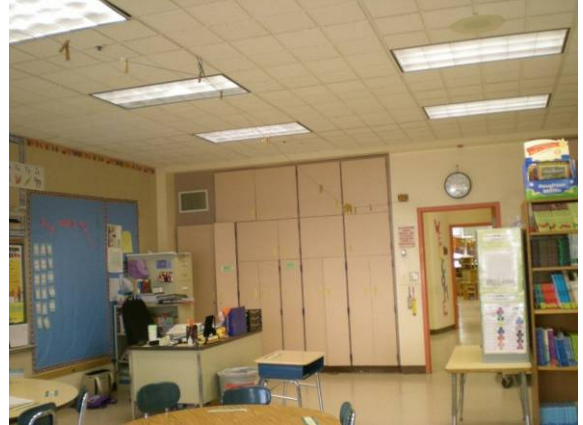
Photo #128: Typical storage in regular classrooms

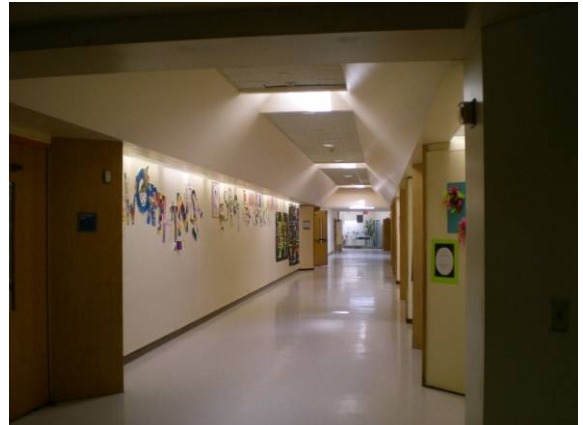
Photo #130: Corridor along cafeteria

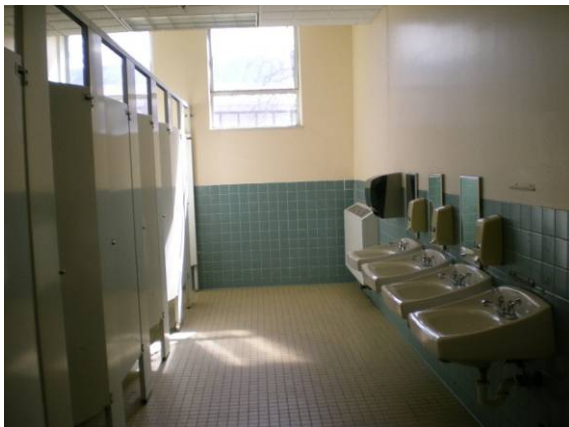
Photo #137: Restroom at beginning of 400 wing

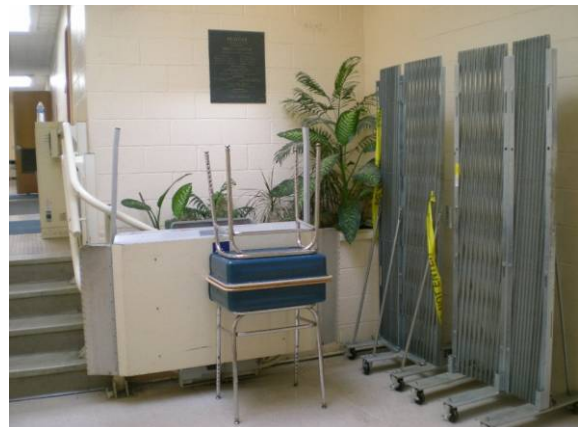
Photo #138: Stair lift to access 500 wing
