M. Gottfried, Inc.

DATE: February 28, 2019

RE: Roof Report and Repair and Maintenance Proposal
Roxbury School
Stamford, CT

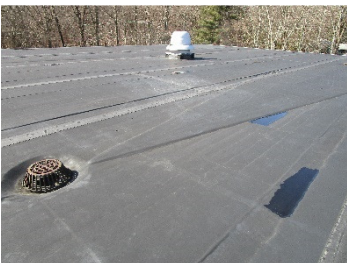
Roof Area F-2

Roof area F-2 is a fully adhered EPDM roof.

Roof area F-2 is in very good shape. We saw no items in need of attention during our walk-thru. If we are performing the other maintenance and repair work on the surrounding roofs, we will walk this roof again and perform any minor repairs we see at no additional cost.
