Toquam Magnet Elementary School

Exterior Façade Investigation

398 Glenbrook Road
Stamford, CT 06906

FINAL Report
November 12, 2019

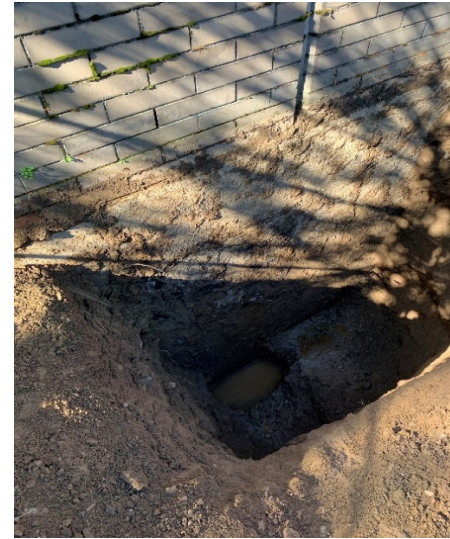
Photo # 3: Compromised water proofing and groundwater over footing.
