Toquam Magnet School

City of Stamford

SUMMER 2019 WORK

Figure 3.1

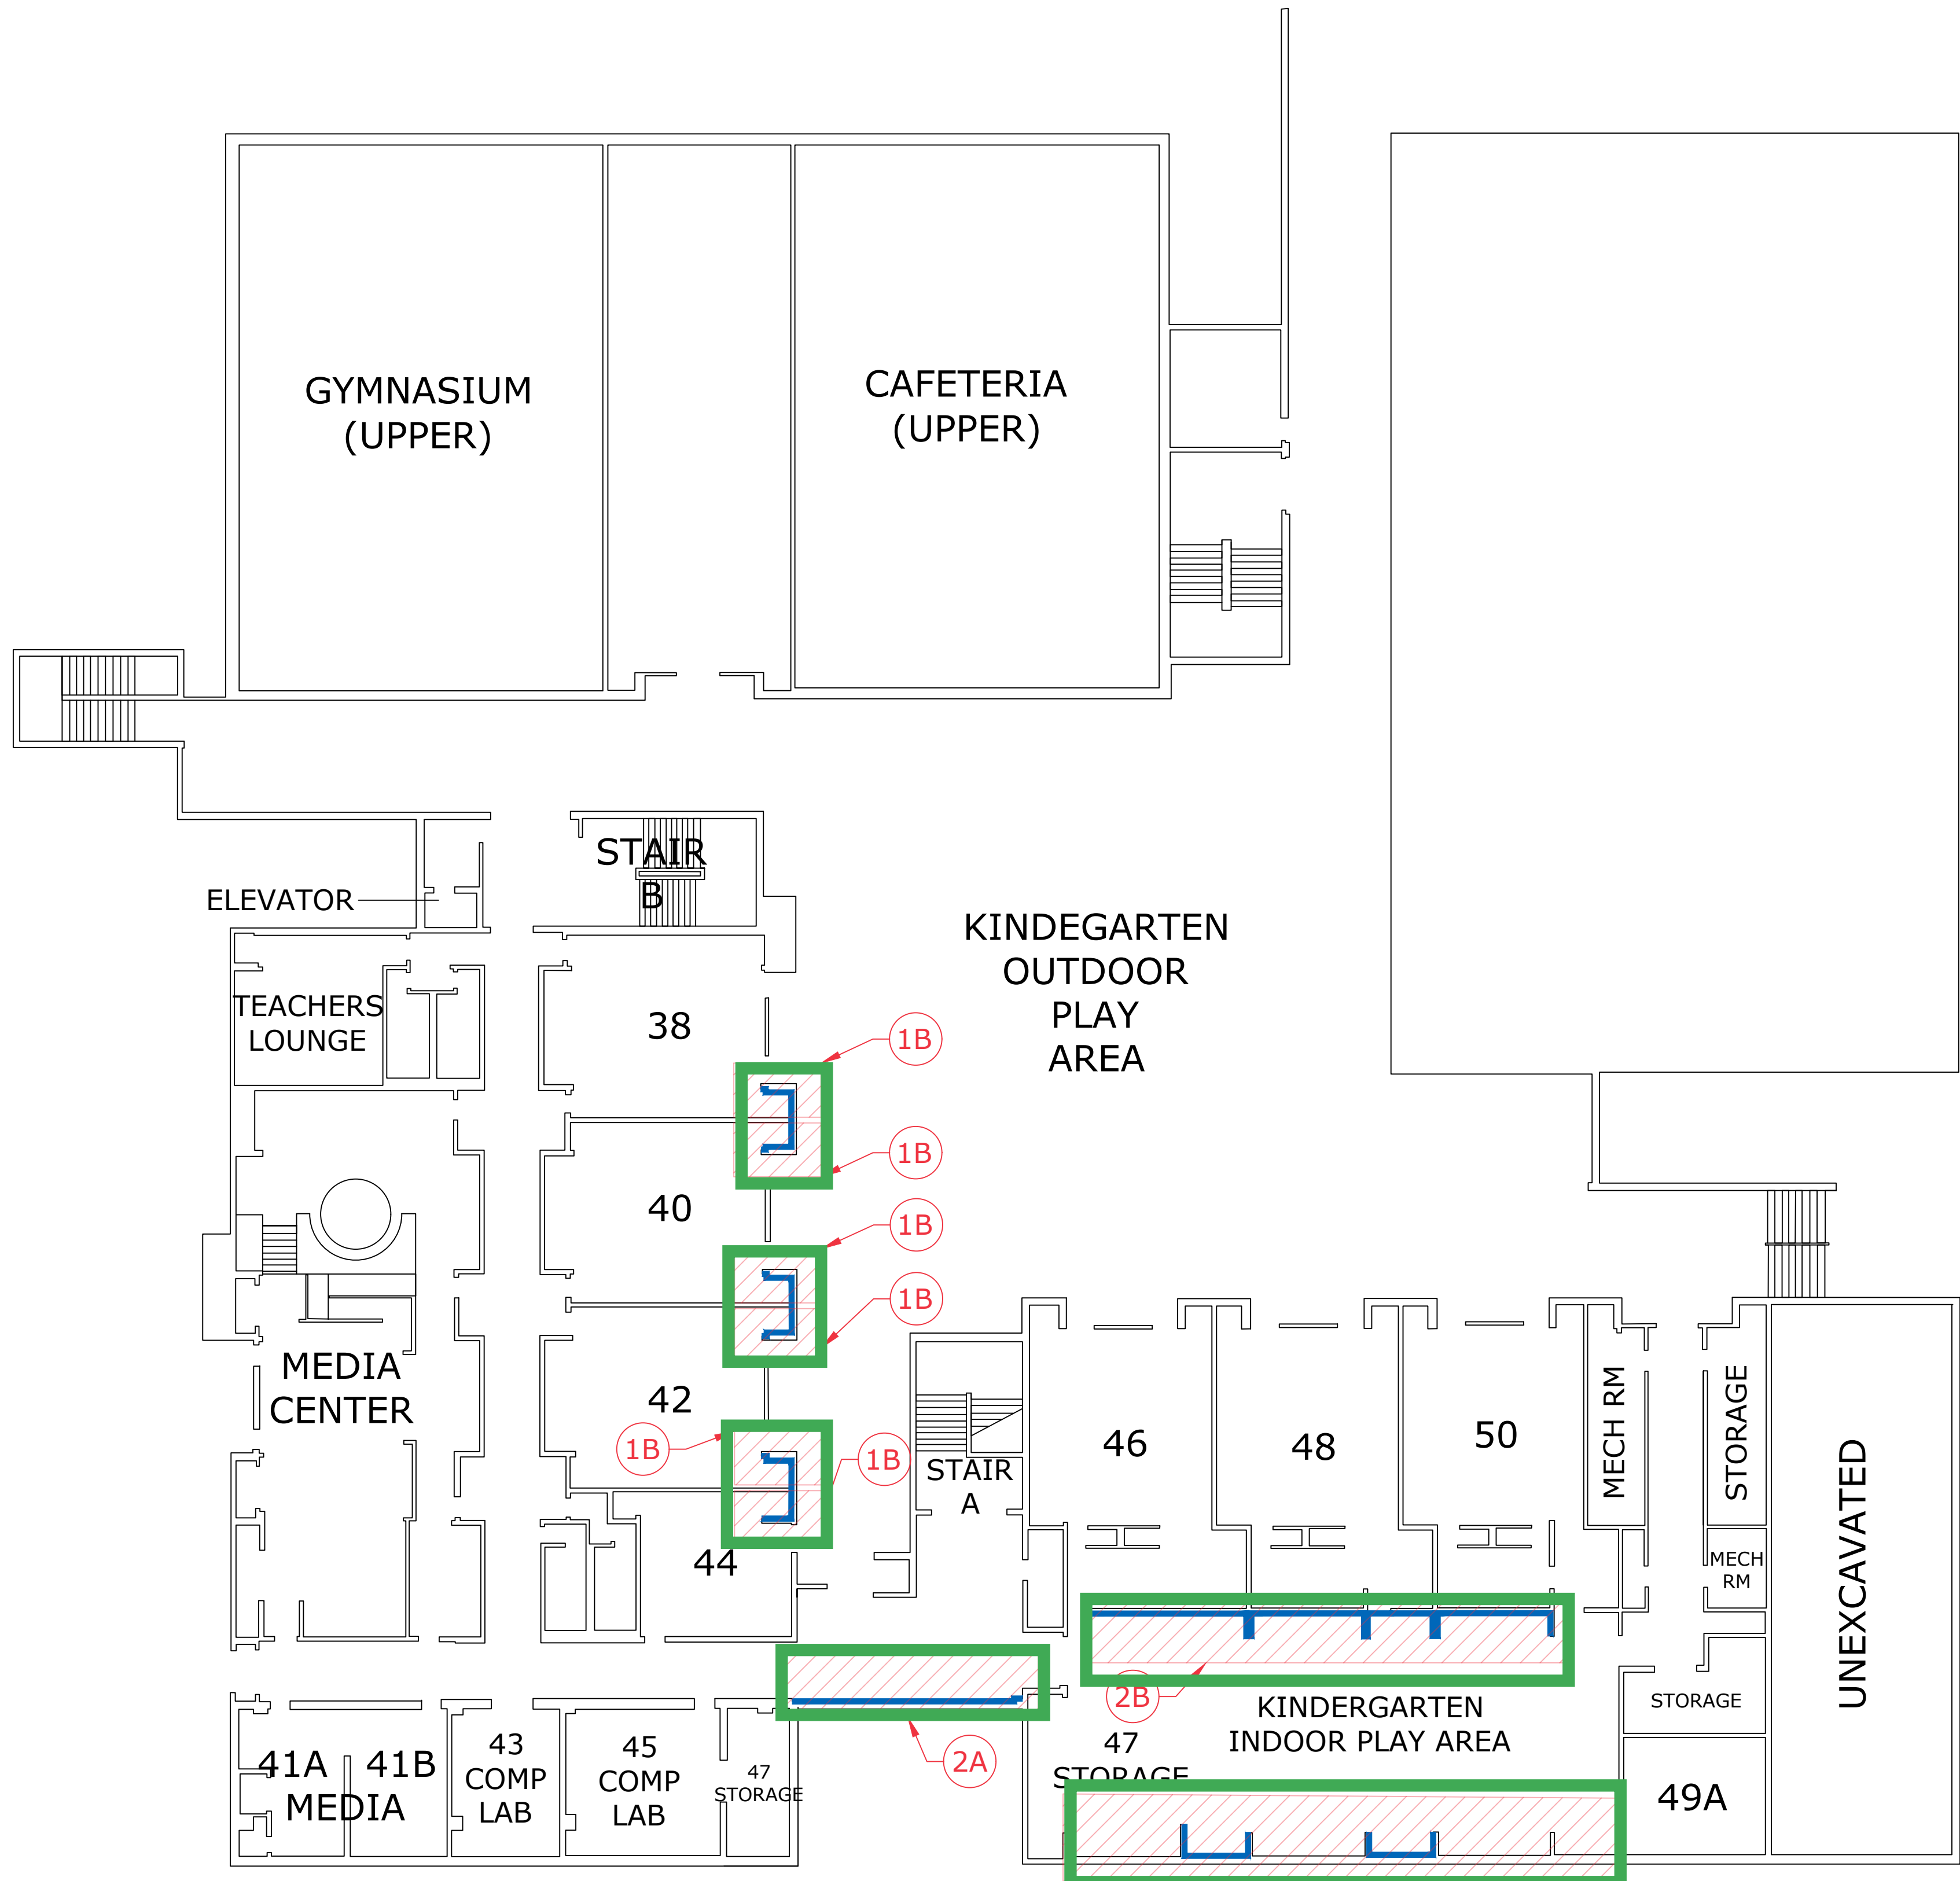
Hallways Throughout:

AOC

Work in area has not begun

- 1D:** UPPER LEVEL CORRIDORS - REMOVAL INCLUDES VERTICAL WALL AT CLASSROOM ENTRY TO FLOOR, VERTICAL SIDE WALLS TO CMU, VERTICAL WALL FACING ENTRY, AND SLANTED CEILING. REMOVAL TO INCLUDE ALL ASBESTOS CONTAINING COMPOUND DAUBS ON CMU LOCATED BEHIND GYPSUM WALLS.

- 2. THE CONTRACTOR SHALL REMOVE, PACKAGE, AND TRANSPORT ASBESTOS-CONTAINING JOINT/TAPING COMPOUND AND ASSOCIATED GYPSUM BOARD WALLS.
 - 2A:** UPPER LEVEL CORRIDORS AND MIDDLE LEVEL CORRIDORS AND PLAY AREA - REMOVAL INCLUDES WALL LOCATIONS WITH VINYL COVERING.

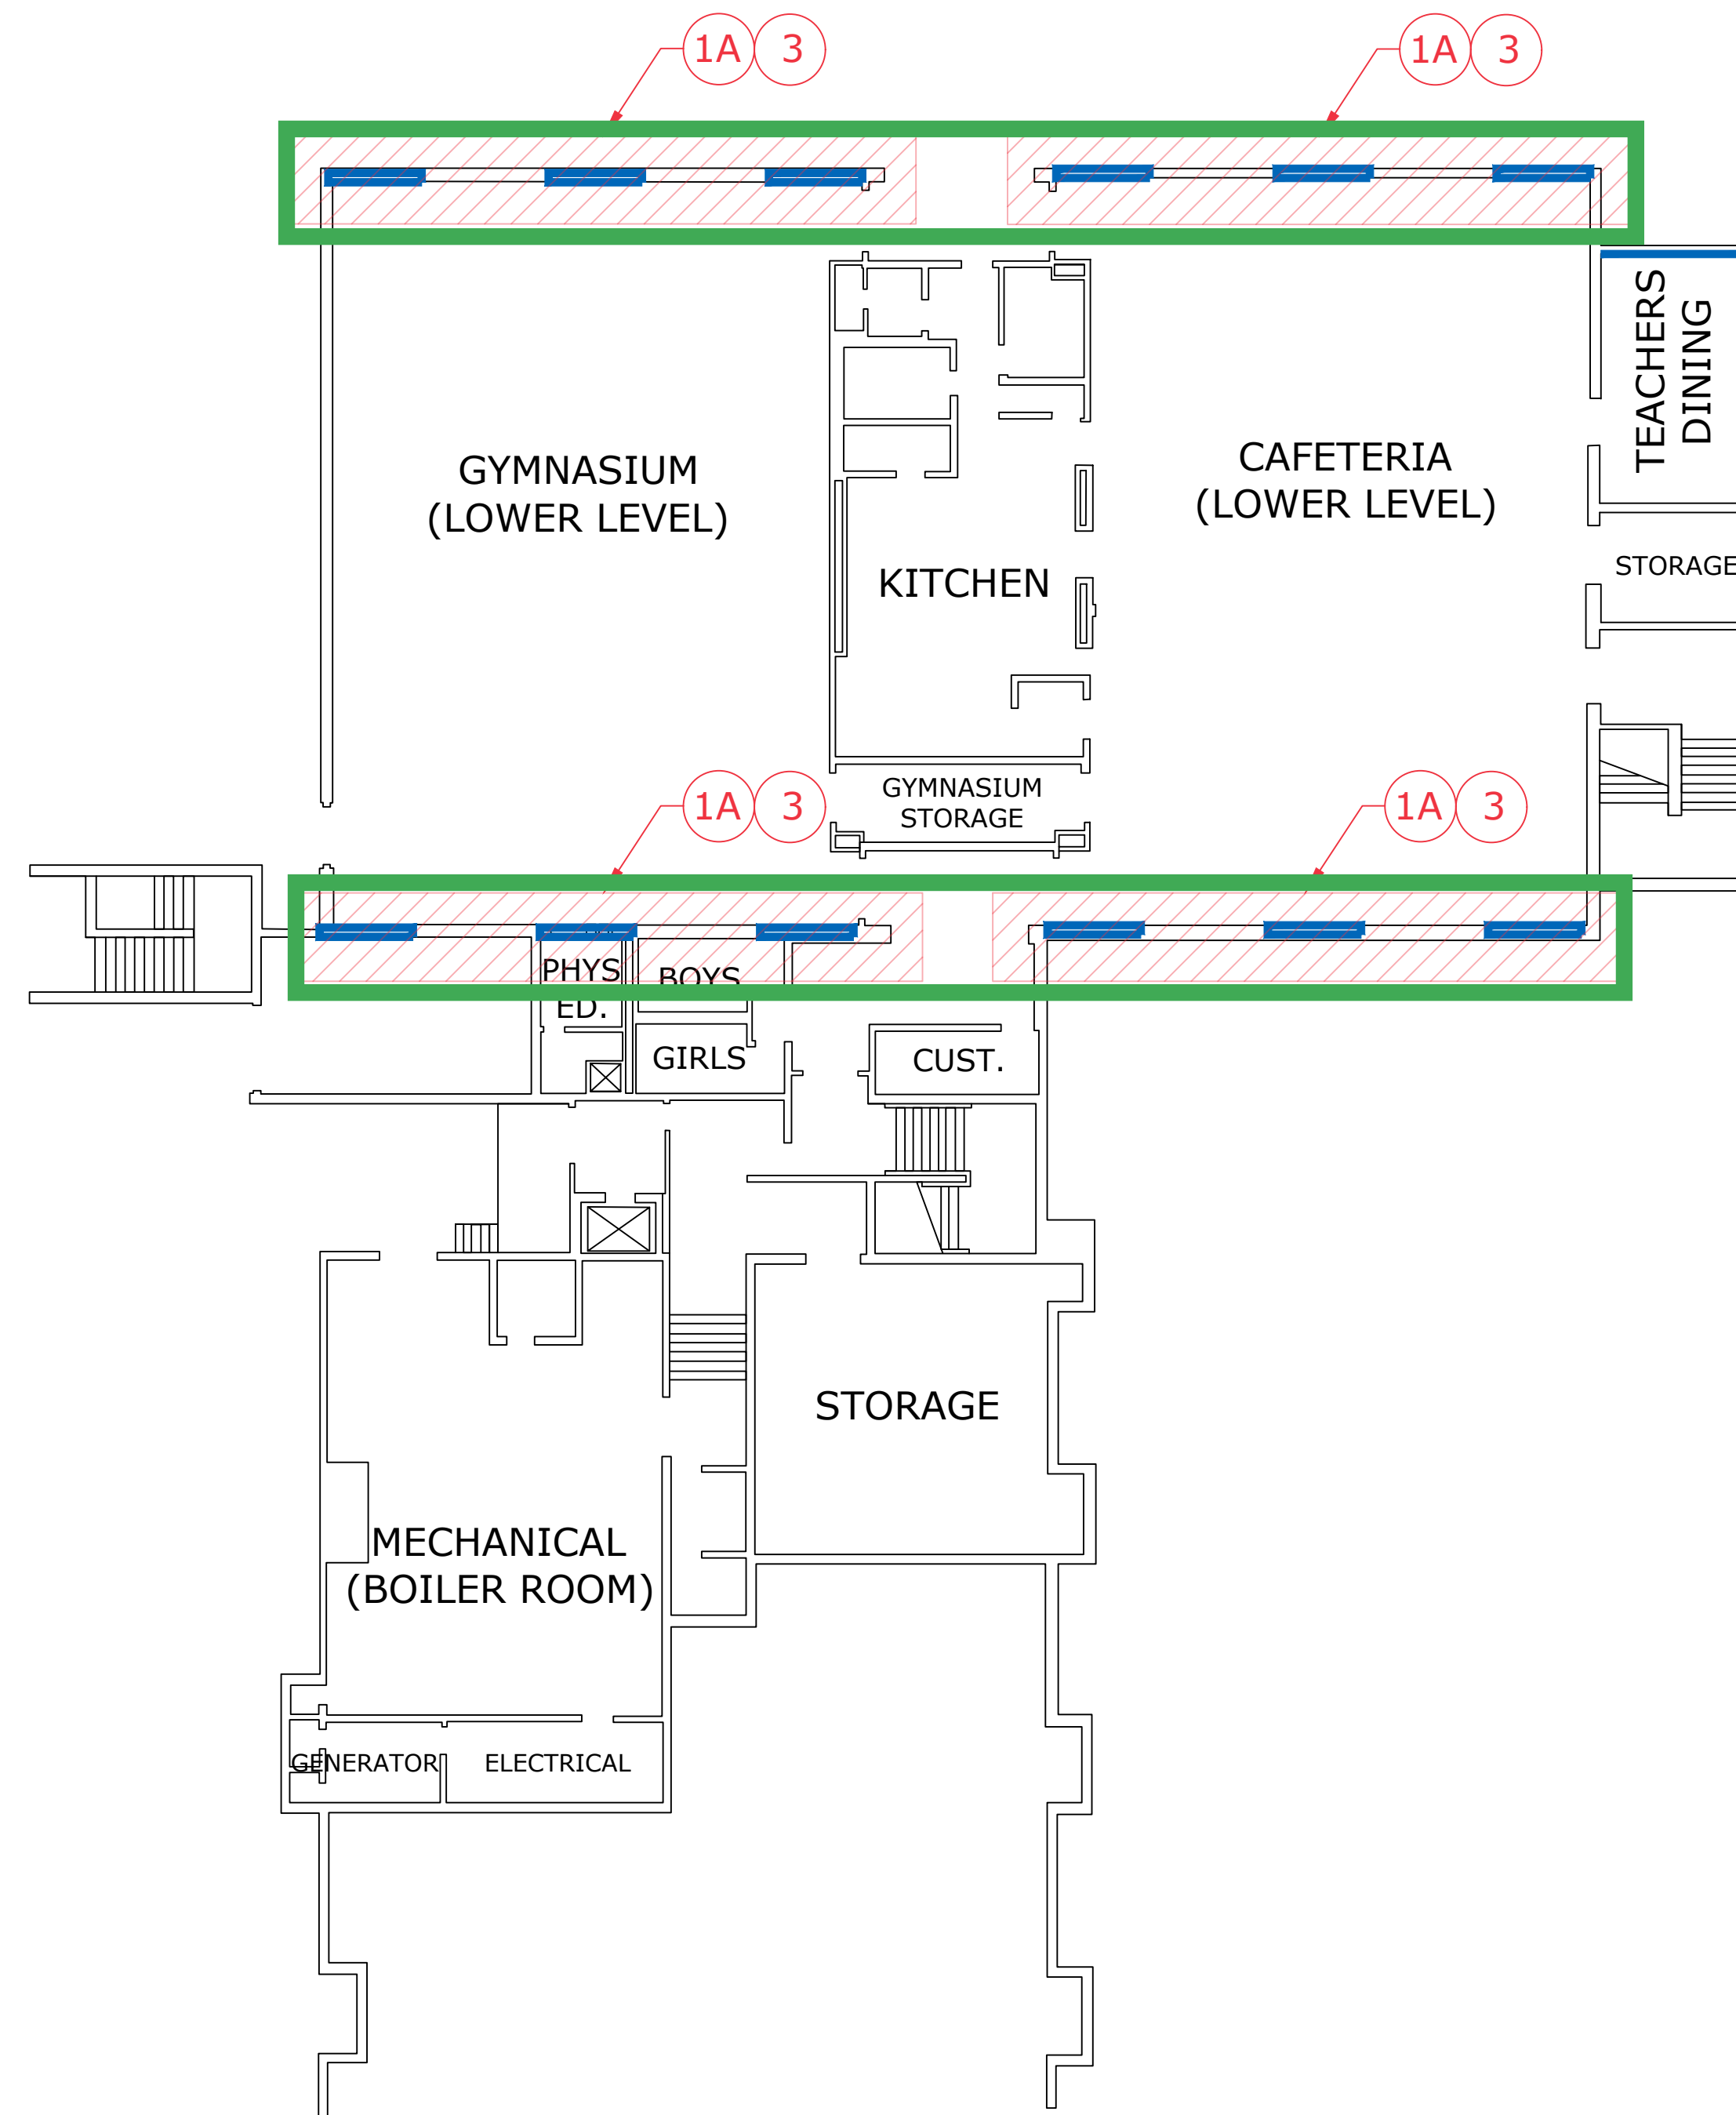
Figure 3.2

Hallways Throughout:

AOC 19

Work in area has not begun

- FLOOR, VERTICAL WALL FACING EXTERIOR TO CEILING LINE, AND VERTICAL SIDE WALLS AND CEILINGS TO STEEL COLUMN (35" OUT FROM EXTERIOR WALL).
- 1D:** UPPER LEVEL CORRIDORS - REMOVAL INCLUDES VERTICAL WALL AT CLASSROOM ENTRY TO FLOOR, VERTICAL SIDE WALLS TO CMU, VERTICAL WALL FACING ENTRY, AND SLANTED CEILING. REMOVAL TO INCLUDE ALL ASBESTOS CONTAINING COMPOUND DAUBS ON CMU LOCATED BEHIND GYPSUM WALLS.

2. THE CONTRACTOR SHALL REMOVE, PACKAGE, AND TRANSPORT ASBESTOS-CONTAINING JOINT/TAPING COMPOUND AND ASSOCIATED GYPSUM BOARD WALLS.
- 2A:** UPPER LEVEL CORRIDORS AND MIDDLE LEVEL CORRIDORS AND PLAY AREA - REMOVAL INCLUDES WALL LOCATIONS WITH VINYL COVERING.
