WESTOVER MAGNET ELEMENTARY SCHOOL STATUS UPDATE

412 Stillwater Avenue

Mold Task Force

March 6, 2019

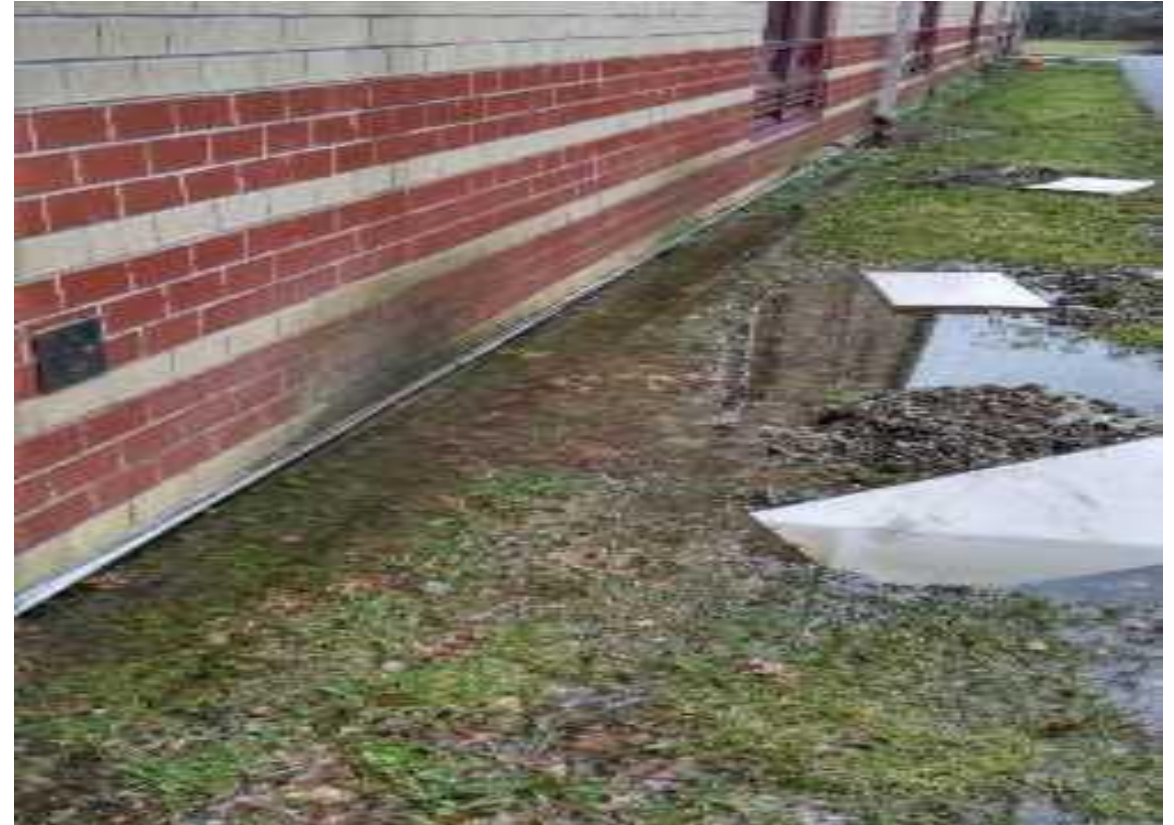
- At the North and West side of the building, the fire access road is at or near the finished floor in the building and traps/directs water towards the building – this water may infiltrate the layer of fill between the slab bottom and the vapor barrier and be trapped
- Preliminary calculations indicate that the tributary area has the potential to direct a quantity of water to the site that **greatly exceeds the capacity** of the storm drainage system to convey off the site

- Lower the fire access road elevation and change grade to pitch away from building
- Repair/replace roof gutter and downspout drainage

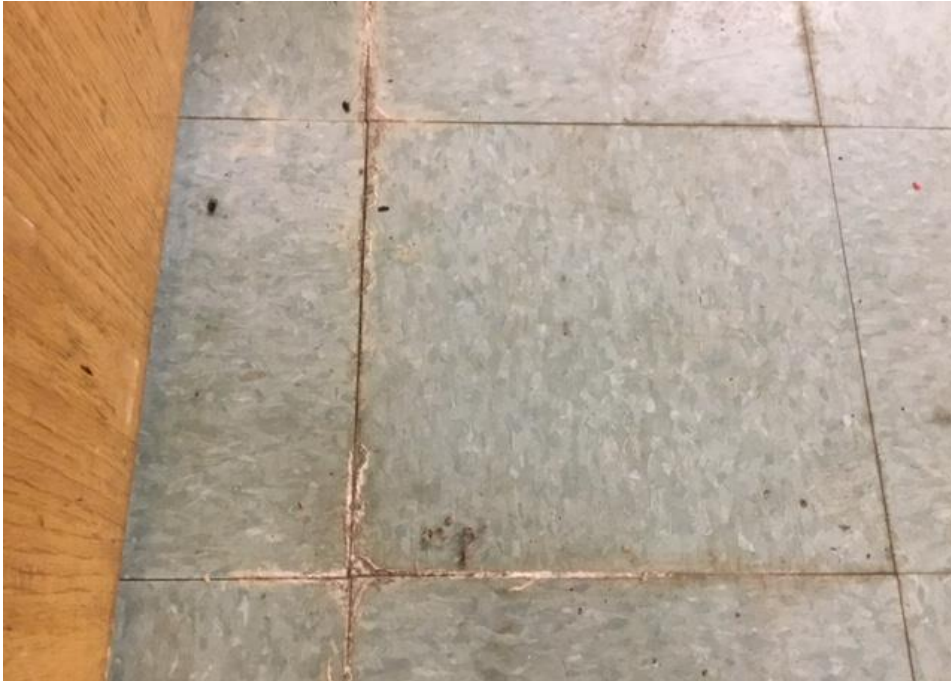
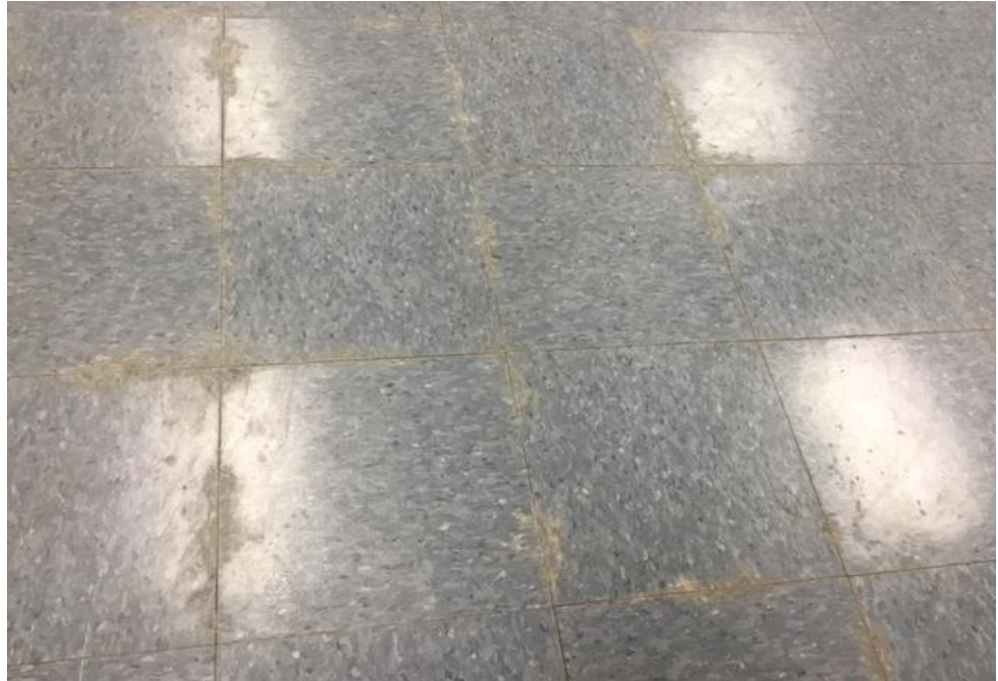
- Conducted Relative Humidity (RH) probe tests on foundation slab

- Based on the results of the RH testing, a moisture mitigation plan will be developed, which is likely to include the addition of a moisture barrier between the concrete and Vinyl Composition Tile (VCT) flooring

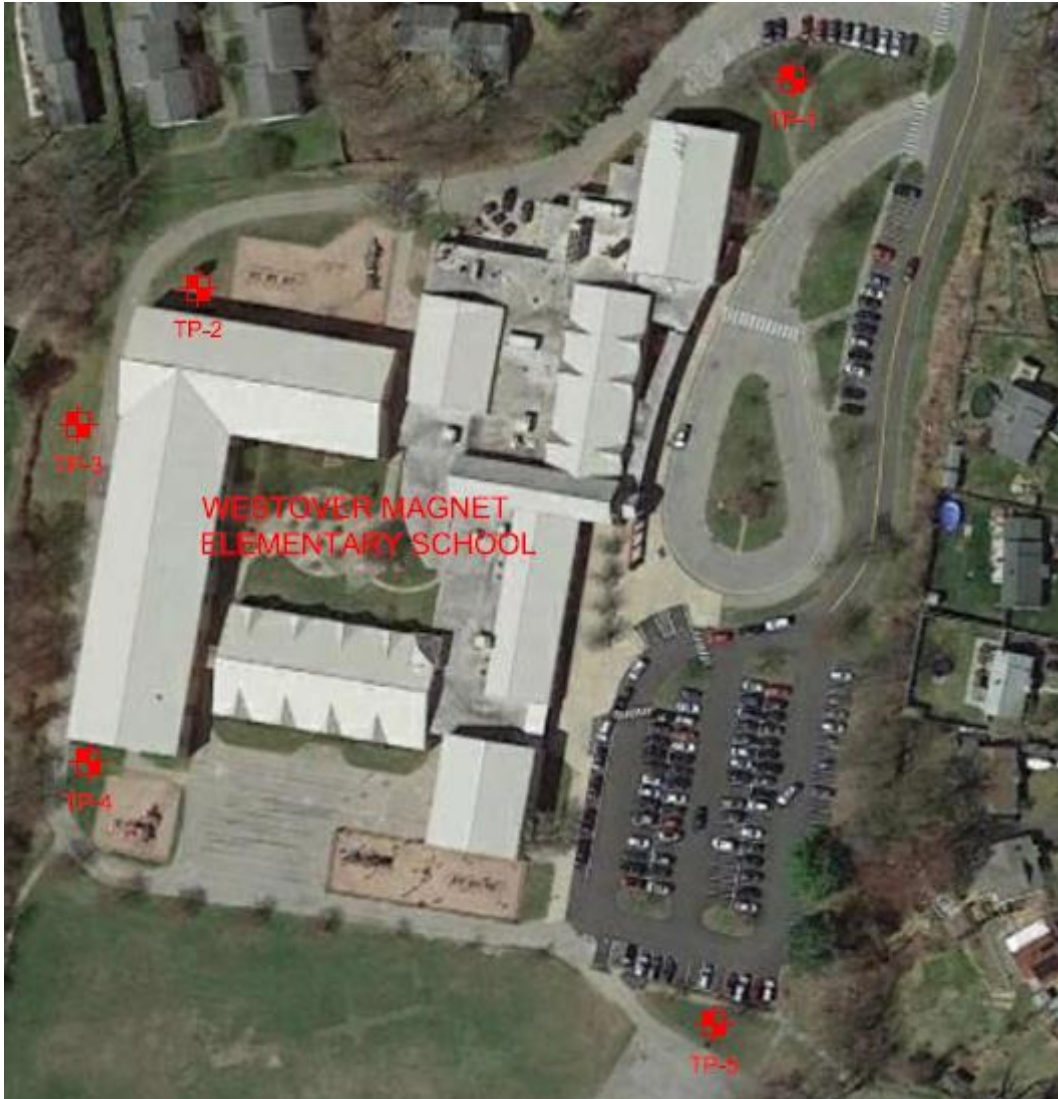
Test Pit Log

TEST PIT LOG					
GZA GeoEnvironmental, Inc. Engineers and Scientists		PROJECT Westover Elementary School 412 Stillwater Road Stamford, Connecticut		Test Pit No. TP-2 File No. 15.0166727.00 Reviewed by NLR	
GZA Engineer B. Carias Weather Overcast, 30's		EXCAVATION EQUIPMENT Contractor Conte Company Operator E. Monroe Make Caterpillar Model 303C Capacity 0.714 cu. yd. Reach 10 ft.		Date 1/25/19 Ground Elevation 38.5± Time Started 0741 Time Completed 0810	
Depth (ft)	SOIL DESCRIPTION		Excav. Effort	Boulder Count Qty. Class	Remark No.
1	TOPSOIL		E	6A	
1	0.5' Brown, fine to coarse Sand and Silt, little fine to coarse Gravel, trace Roots, trace Debris (Fill)		E	4B	
2	2.0' Brown, olive, fine to medium SAND, little Silt, trace Roots (Fill)		E	9A	
3	3.0' Brown, fine to coarse SAND and COBBLES, little Silt, little fine to coarse Gravel, little Wood, trace Roots, trace Debris (Fill)		M	12A	
4			M	7B	
5			H	1C

6			E	9A	1
7	7.0' End of Exploration at 7 ft.				
8					
9					
10					
11					
12					
13					
REMARKS:					
1. Groundwater encountered 6.5 ft. below ground surface.
