# FACILITIES NEEDS ASSESSMENT

## STAMFORD PUBLIC SCHOOLS

## Facilities Needs Assessment of CLOONAN MIDDLE SCHOOL

**EMG Project #:** 88166.09R-009.017  
**Date of Report:** August 27, 2009  
**On-site Date:** April 1, 2009

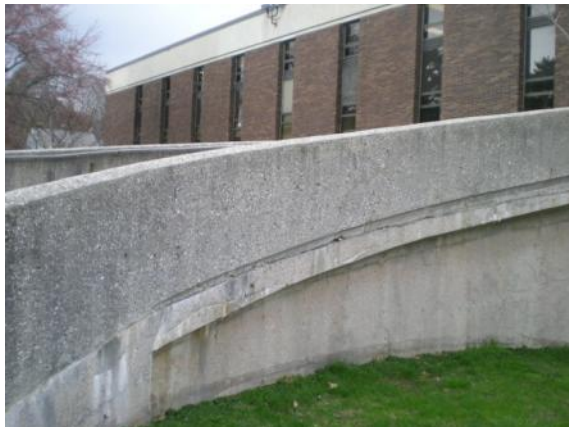
Photo #5:	Front entrance – main stair showing water evidence penetrating concrete
-----------	---

6.4	3597	Recaulk expansion and control joints up to 1/2" wide	10	8	2	2000	LF	\$16.58	\$33,163			\$33,163								\$33,163
6.5	3598	Exterior concrete stair repairs - Major	0	0	0	6833	SF	\$76.86	\$525,184	\$525,184										\$525,184

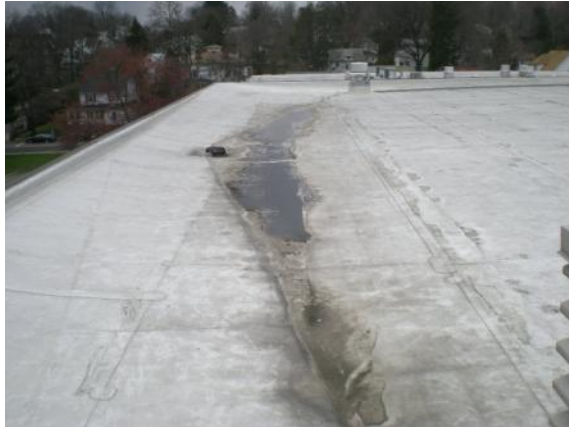
Photo #19: Ponding on roof - tapered insulation does not promote proper drainage

6.3	7584	Single-Ply fully adhered complete removal and re-slope for positive drainage	0	0	0	12	SQ	\$1,134.00	\$13,608	\$13,608										\$13,608
6.3	3592	Metal steep roofing, total metal panel replacement	30	22	8	33	SQ	\$1,060.10	\$34,983									\$34,983		\$34,983

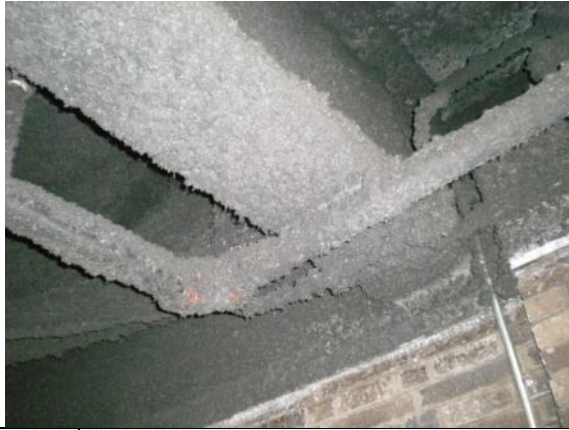
Photo #25: Fire proofing at auditorium ceiling

6.8	6762	Capital Plan - Install Sound Attenuation at walls/ceilings	0	0	0	50	CSF	\$882.00	\$44,100	\$44,100										\$44,100
6.8	3800	Remove and replace spray on fireproofing	20	19	1	10000	SF	\$5.20	\$52,038		\$52,038									\$52,038

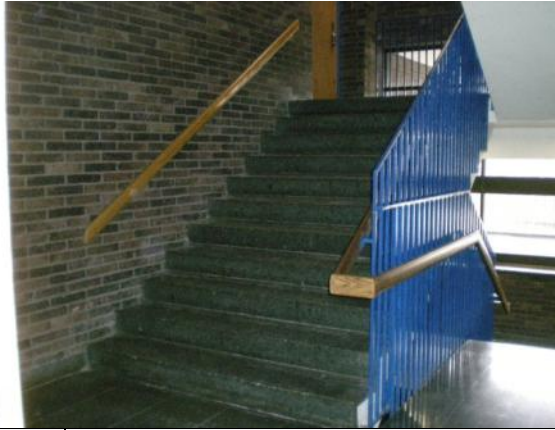
Photo #31: Stair with no railing extensions

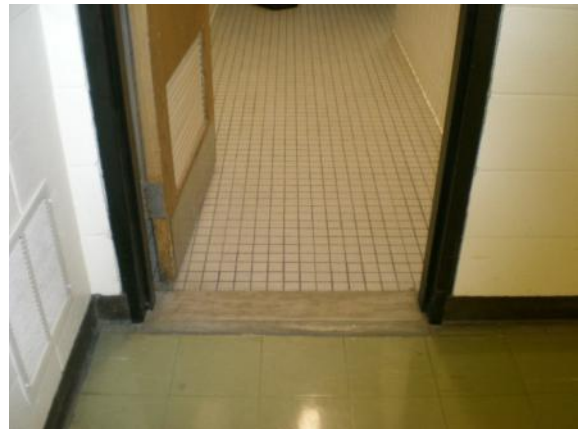
Photo #34: High threshold at restroom for 110

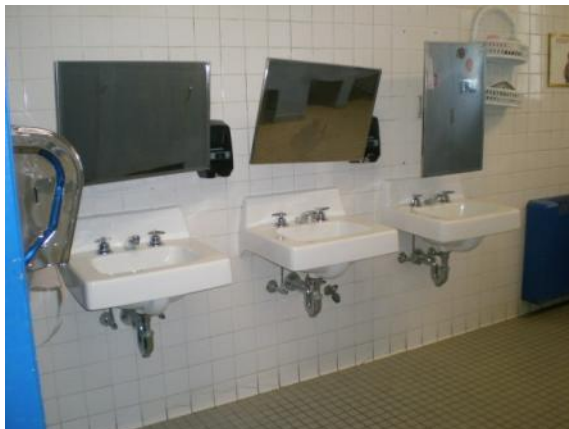
Photo #35: Non-insulated drain lines in restroom for 110

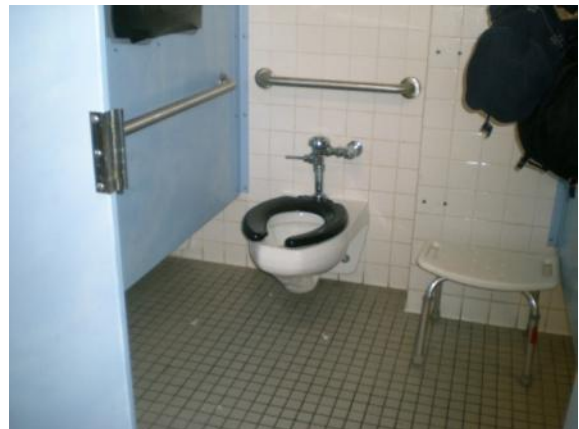
Photo #36: Grab bars mounted too high and not compliant in length at restroom for 110

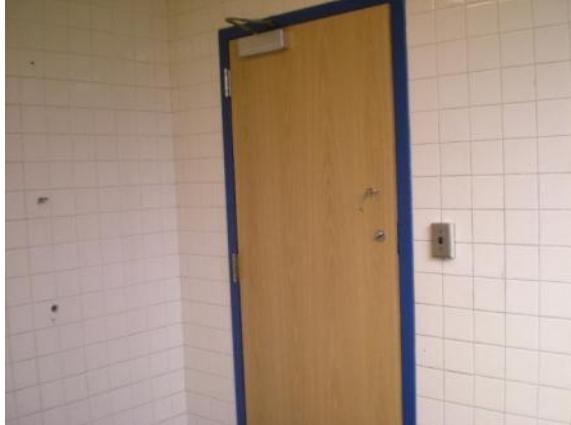
Photo #55: No pull side hardware in restroom

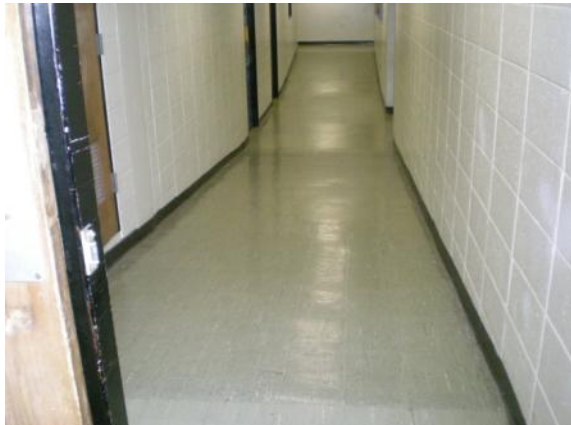
Photo #59: Interior ramp with no handrails

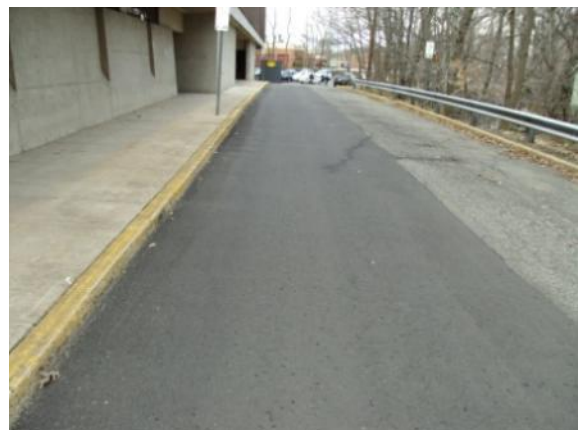
Photo #66: Drive lane at right side of building (east elevation)

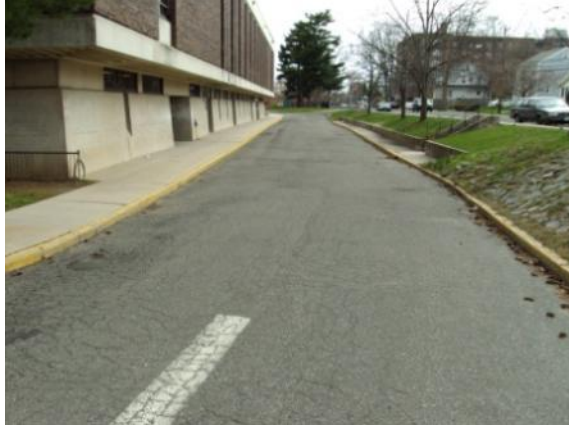
Photo #67:	Drive lane at left side of building (west elevation)
------------	--

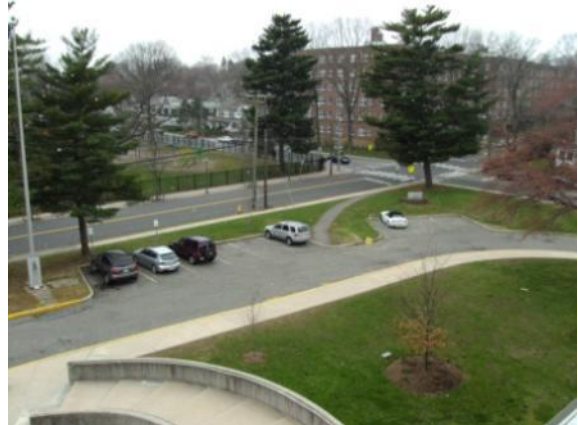
Photo #68:	Parking area at front of building, with two accessible parking stalls
------------	---

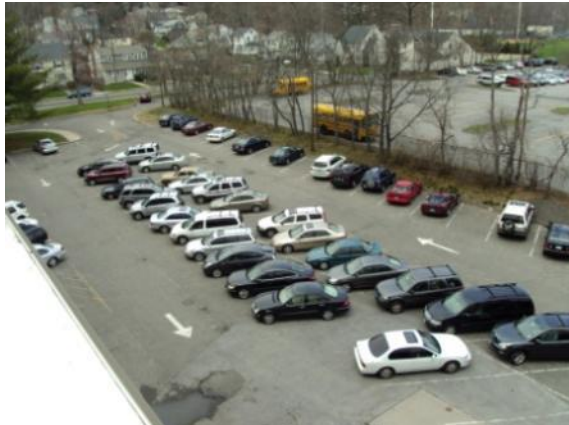
Photo #69:	Main parking lot at rear of building
------------	--------------------------------------

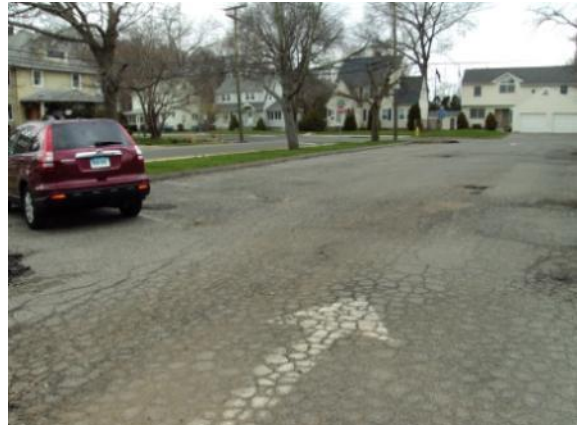
Photo #70:	Parking area at the northwest corner of property
------------	--

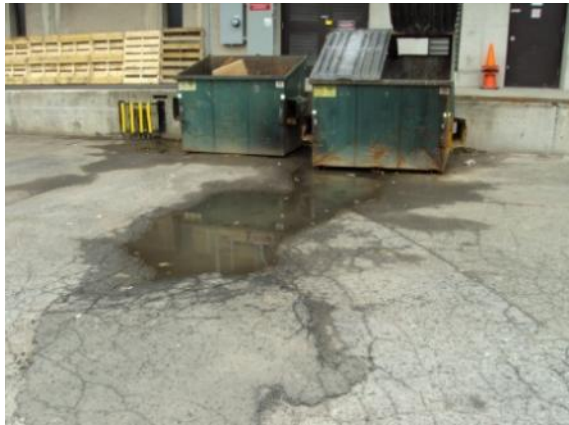
Photo #71:	Ponding at asphalt pavement – adjacent to rear loading dock
------------	---

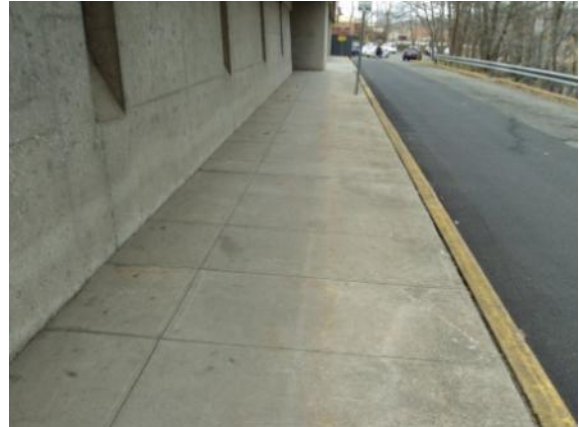
Photo #86: Concrete sidewalk and curbing along right side of building

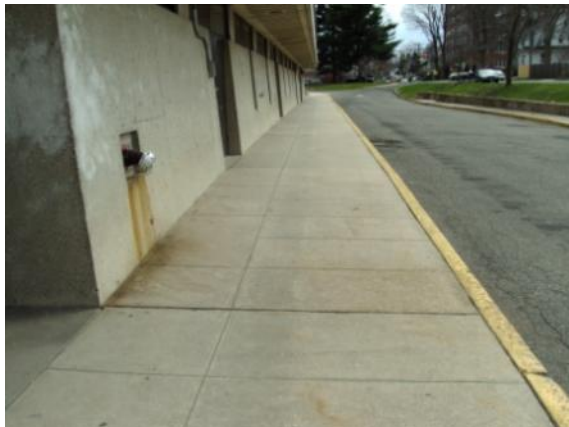
Photo #87: Concrete sidewalk and curbing along left side of building

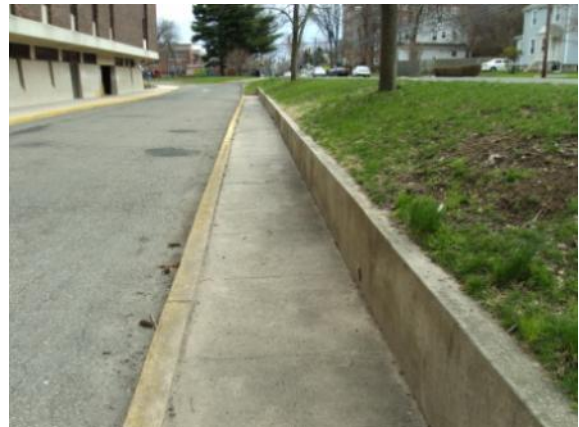
Photo #88: Concrete sidewalk, curbing and retaining wall at west elevation

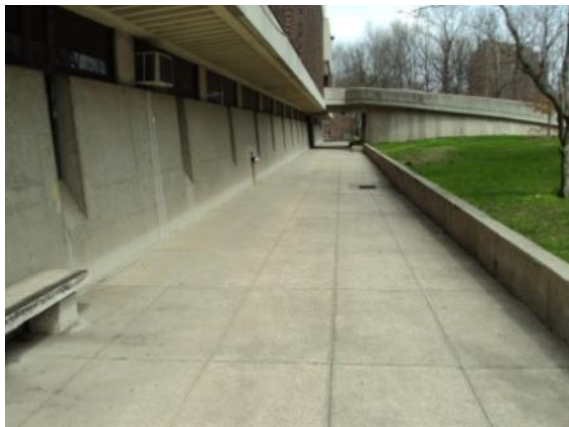
Photo #89: Concrete sidewalk along front of building

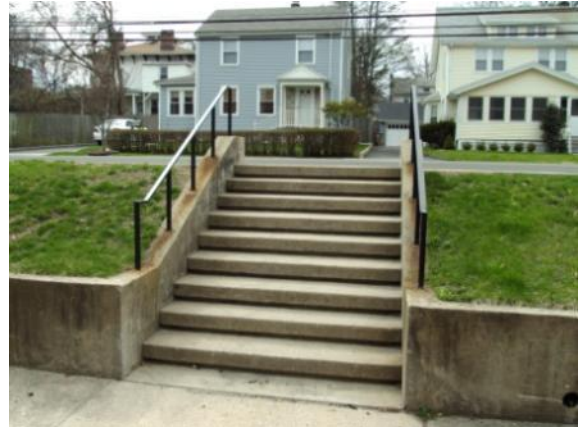
Photo #98: Concrete steps and retaining walls at west elevation

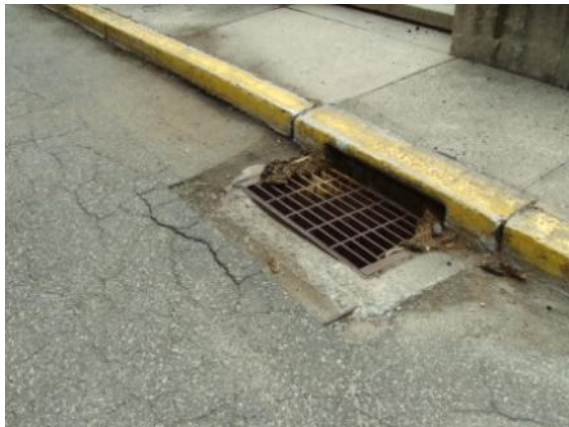
Photo #105: Drainage inlet

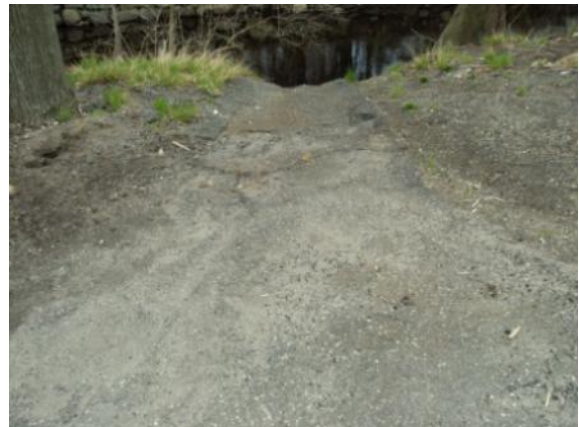
Photo #106: Asphalt swale draining to river at east elevation

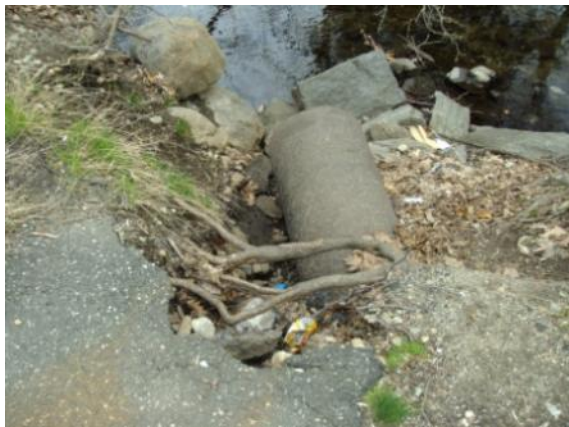
Photo #107: Drainage swale requiring stone riprap at east elevation

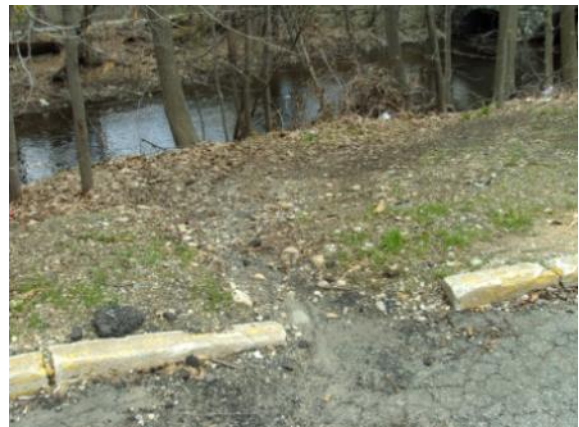
Photo #108: Drainage area requiring stone riprap at east elevation

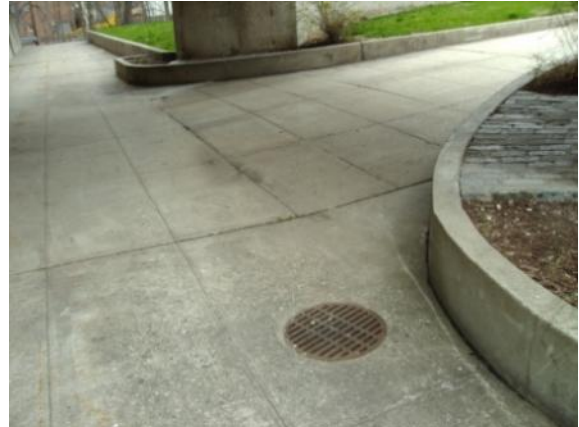
Photo #110: Concrete sidewalks and retaining walls at front elevation

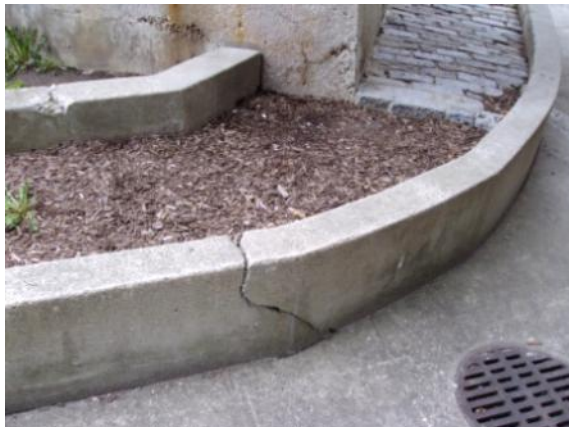
Photo #111: Cracking/shifting of concrete retaining wall at front elevation

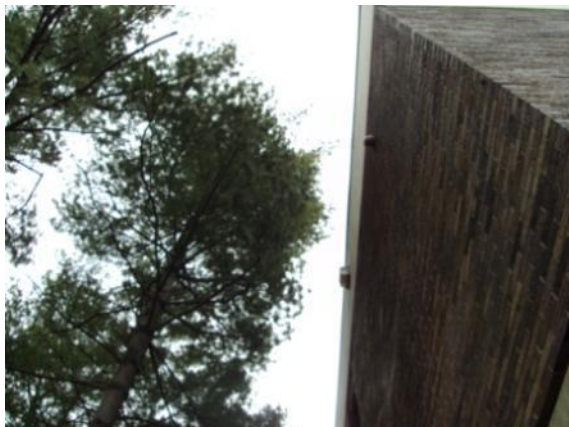
Photo #113: Overgrown trees at rear of building

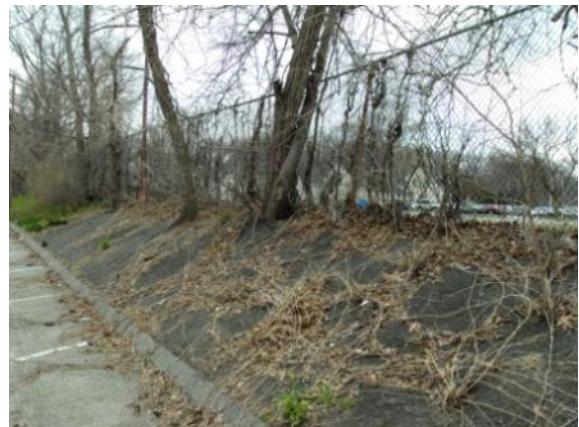
Photo #114: Asphalt overlay on landscape hill and excessive vegetation at north property line

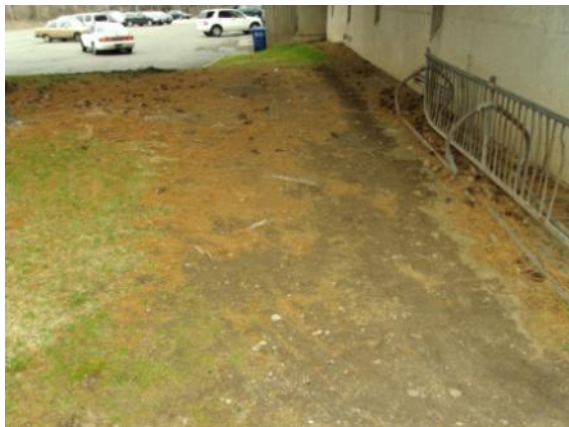
Photo #119: Landscape condition at rear of building (note metal bike rack condition)

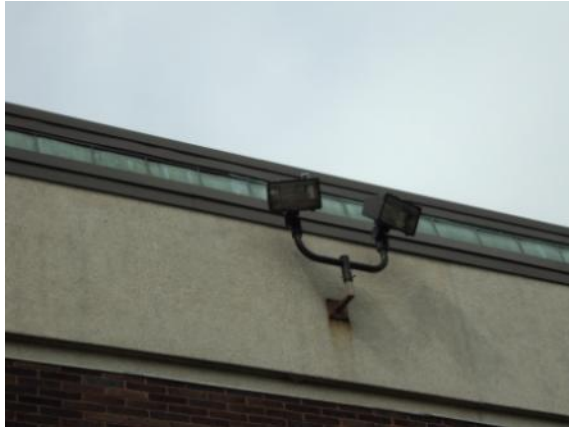
Photo #121: Building-mounted light fixture

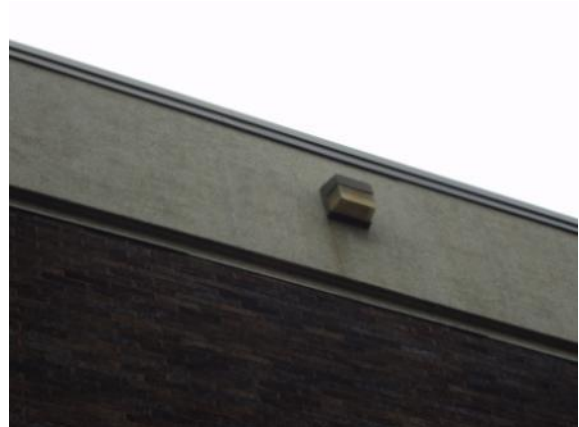
Photo #122: Building-mounted light fixture

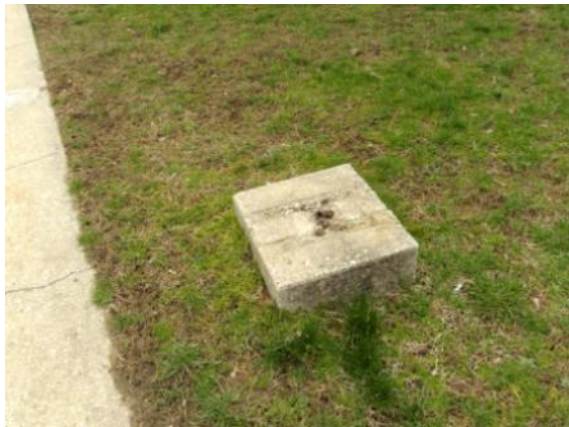
Photo #123: Abandoned concrete base adjacent to front sidewalk

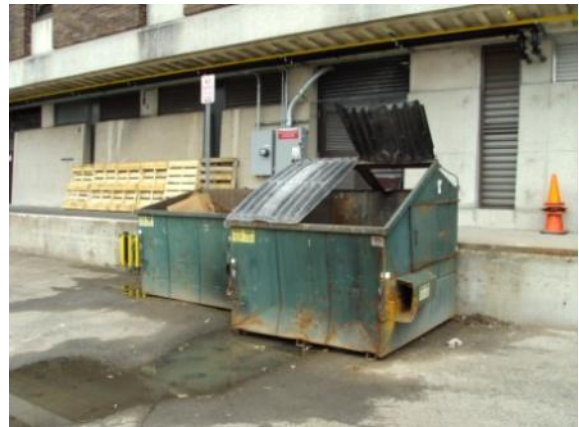
Photo #124: Dumpsters set on asphalt pavement adjacent to rear loading dock

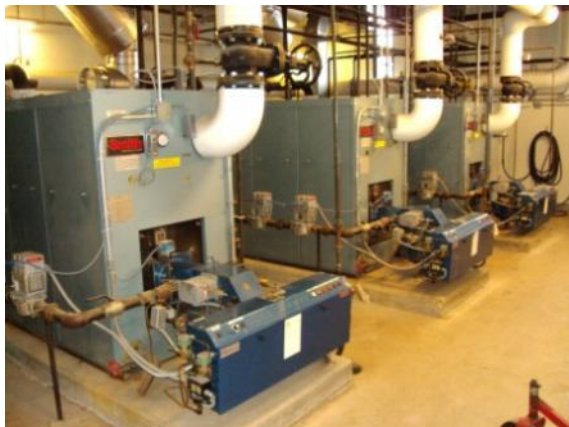
Photo #125: Three hot water heating boilers

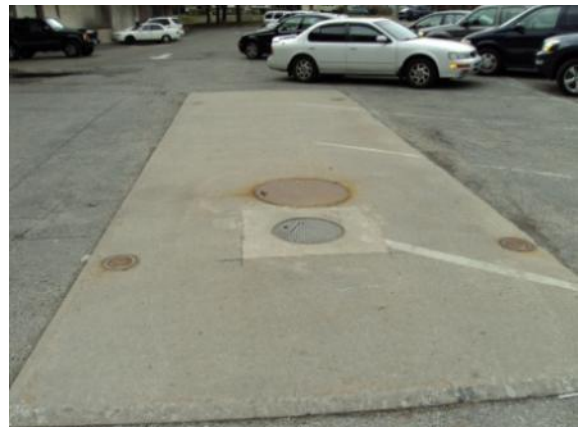
Photo #126: Underground 10,000-gallon fuel oil storage tank at rear of building

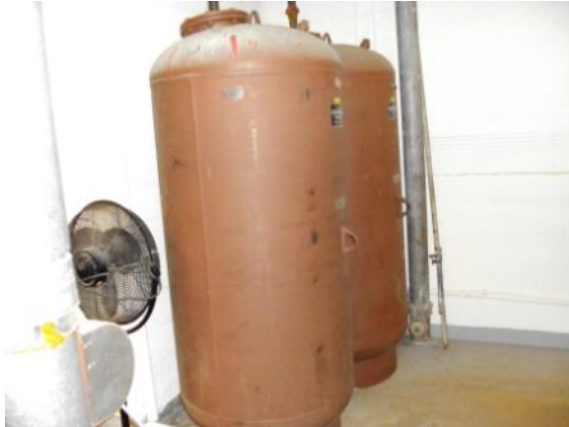
Photo #127: Boiler expansion tanks

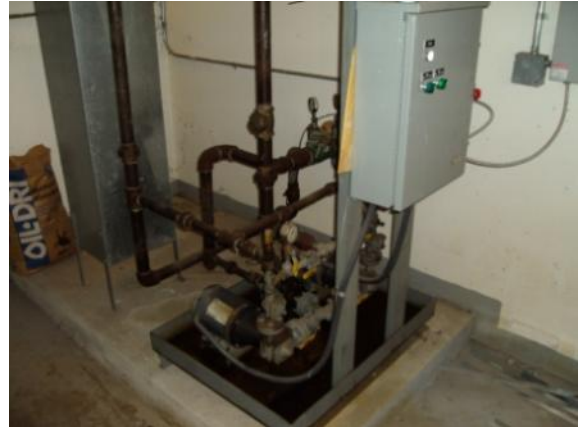
Photo #128: Oil pump set for boilers

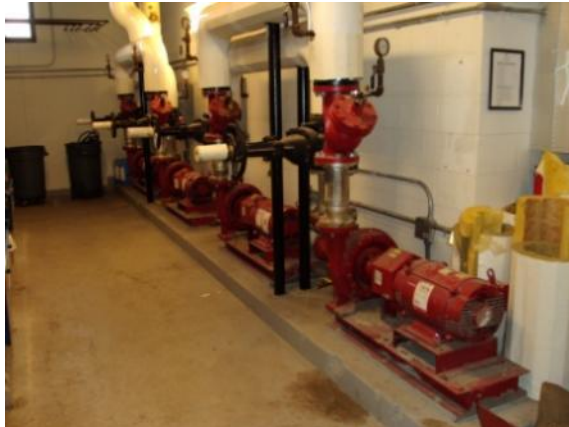
Photo #129: Hot water circulating pumps

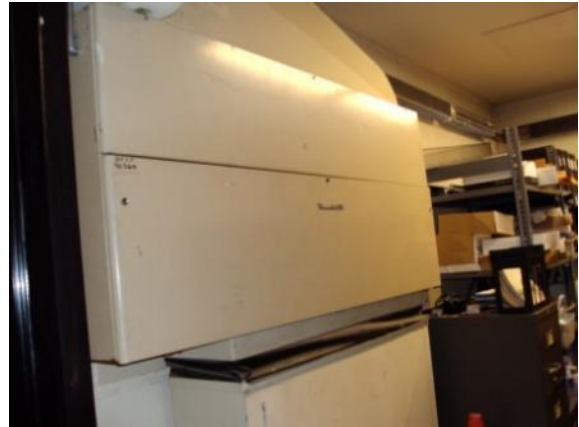
Photo #130: Original unit ventilator serving lobby

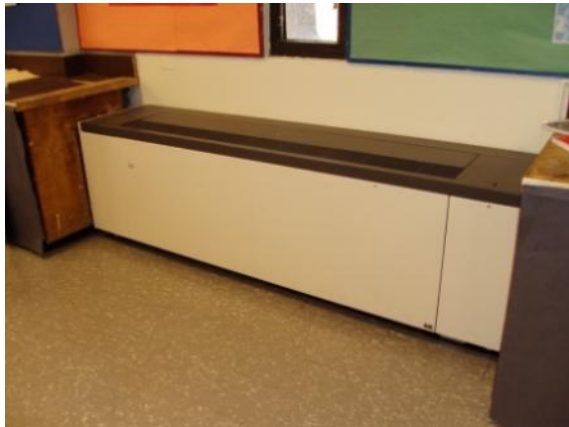
Photo #131: Replacement unit ventilator at classroom

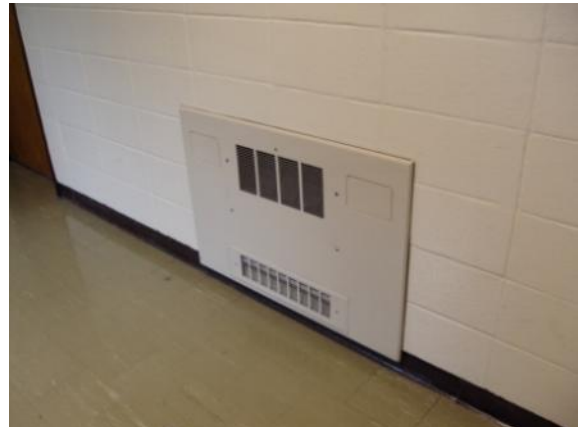
Photo #132: Recessed cabinet radiant unit

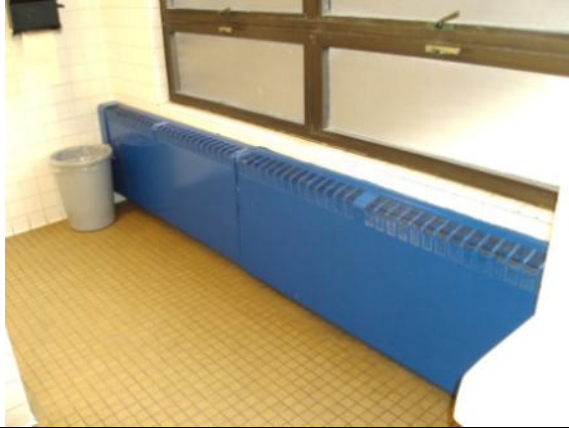
Photo #133: Wall-mounted cabinet radiant unit at restroom

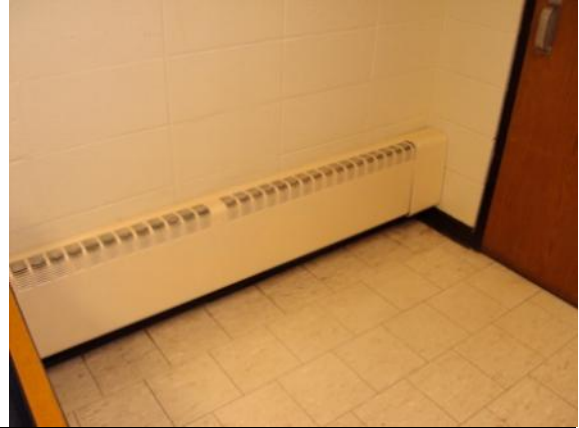
Photo #134: Baseboard-mounted cabinet radiant unit at restroom

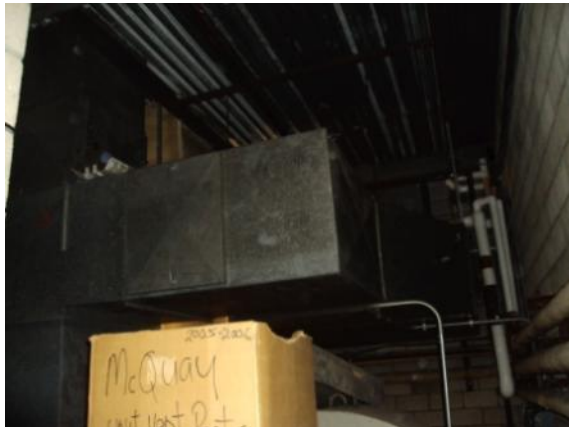
Photo #135: Air handling unit (AHU-16)

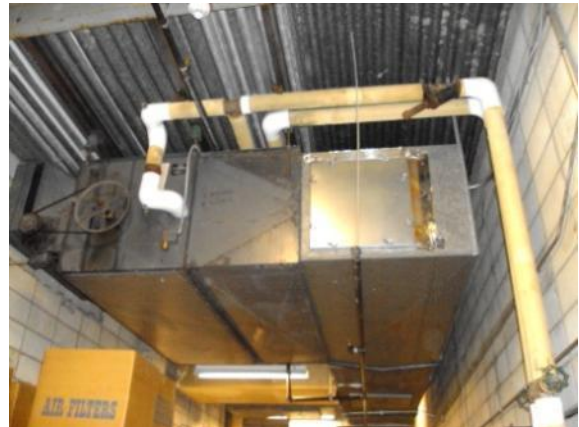
Photo #136: Air handling unit (AHU-17)

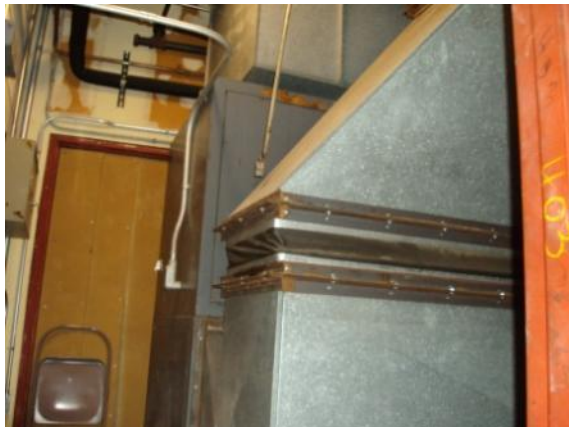
Photo #137: Air handling unit (AHU-18)

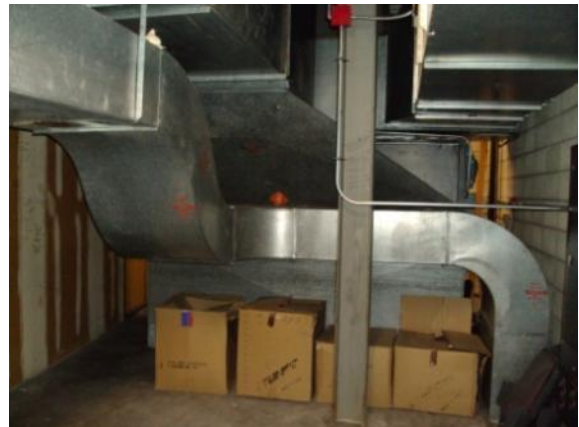
Photo #138: Air handling unit (AHU-19)

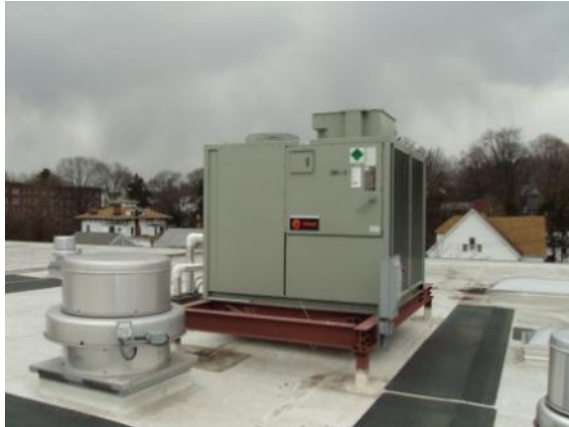
Photo #139: Rooftop air-cooled liquid chiller

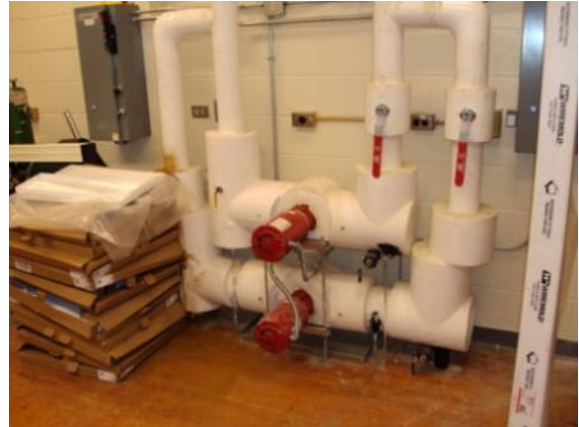
Photo #140: Chiller circulating pumps

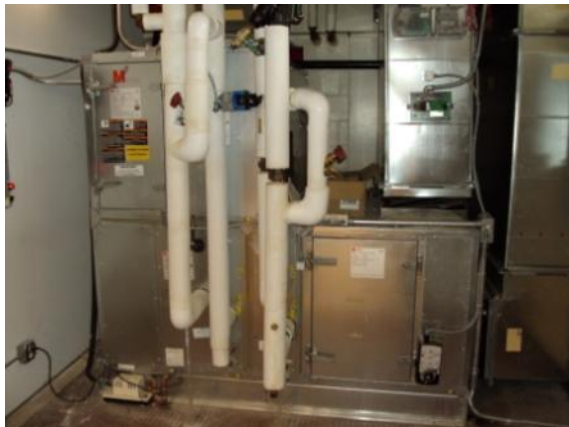
Photo #141: Air handling unit (AHU-1)

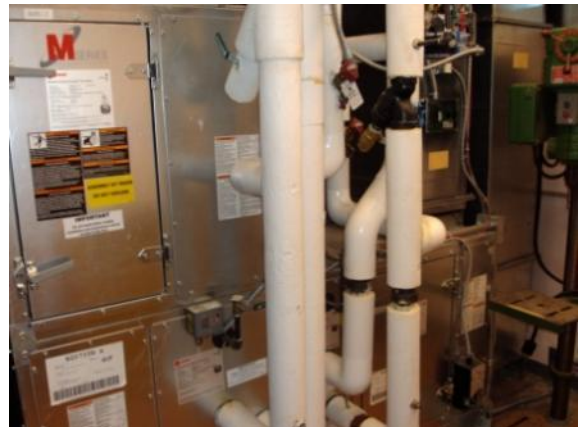
Photo #142: Air handling unit (AHU-2)

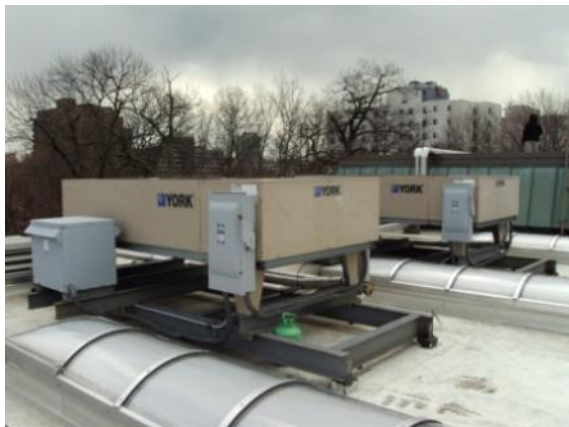
Photo #143: Rooftop condensers for auditorium

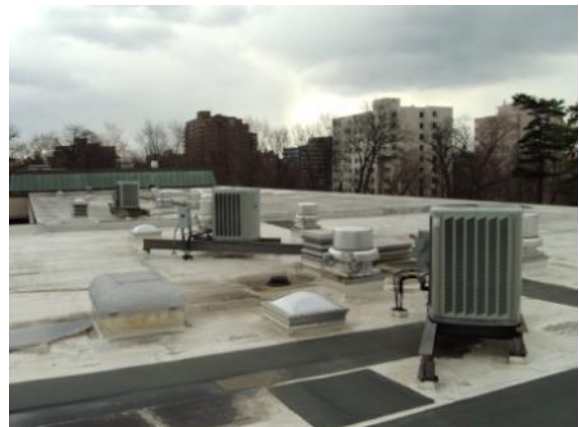
Photo #144: Rooftop condensers for offices/teachers lounge areas

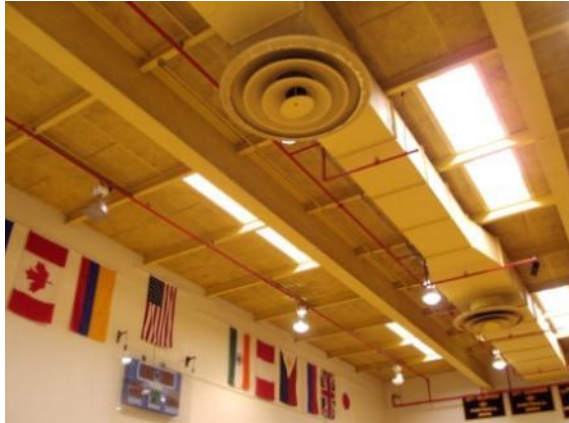
Photo #145: Gym with ceiling-mounted HVAC ducts and diffusers

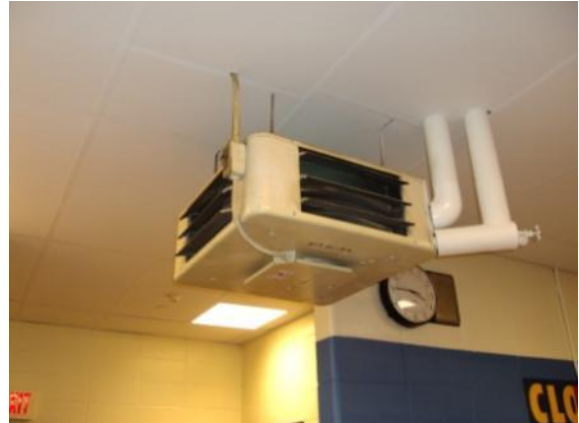
Photo #146: Ceiling-mounted unit heater at kitchen

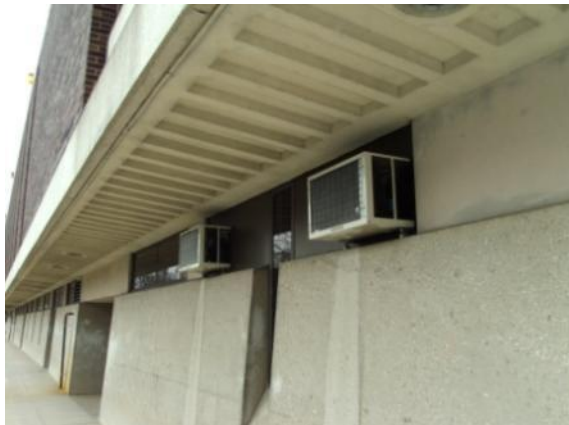
Photo #147: Through-wall air conditioning units for classroom 110

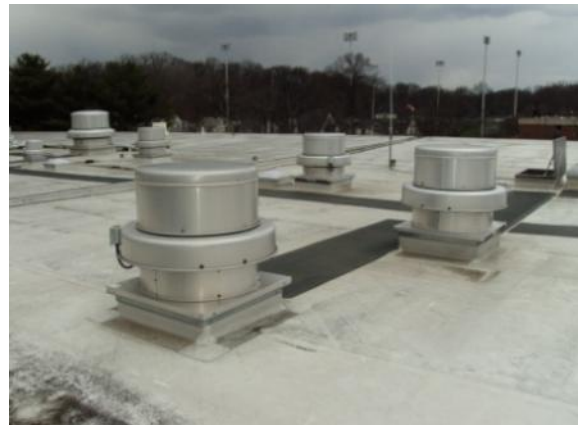
Photo #148: Rooftop exhaust fans, with larger fan for kitchen

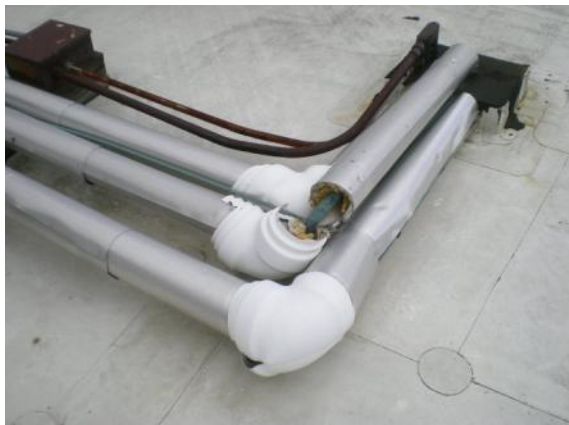
Photo #149: Damaged refrigerant line insulation and rusting electrical conduit at roof

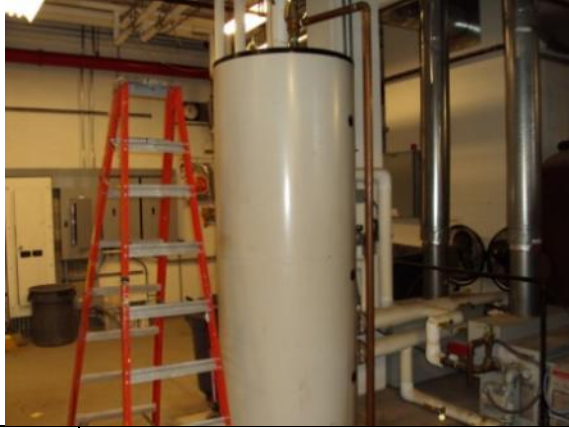
Photo #151: Domestic hot water storage tank

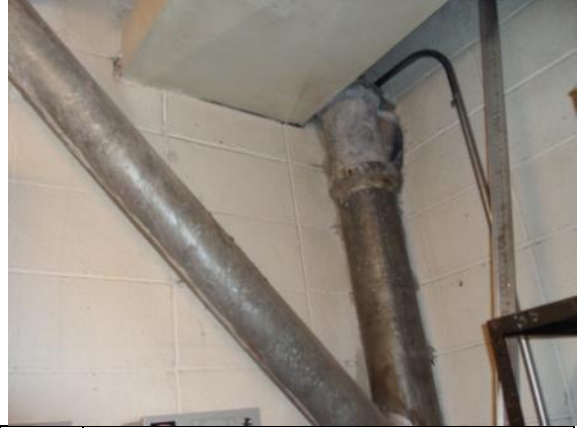
Photo #152: 4-inch galvanized steel piping

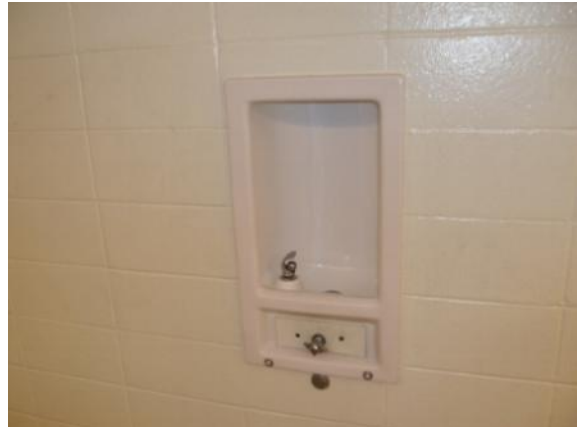
Photo #154: Original common area drinking fountain

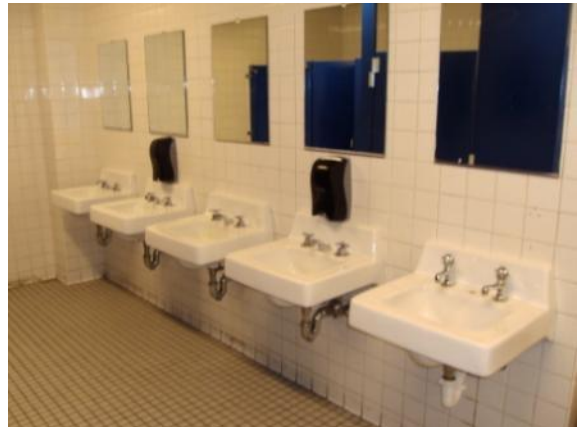
Photo #156: Common area restroom lavatory sinks

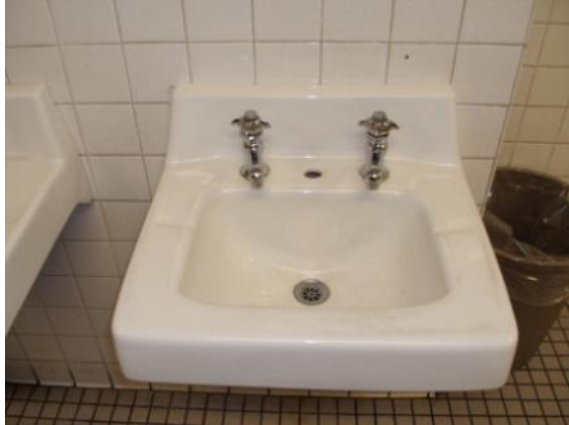
Photo #157: Common area restroom lavatory sink with single hot and cold faucet

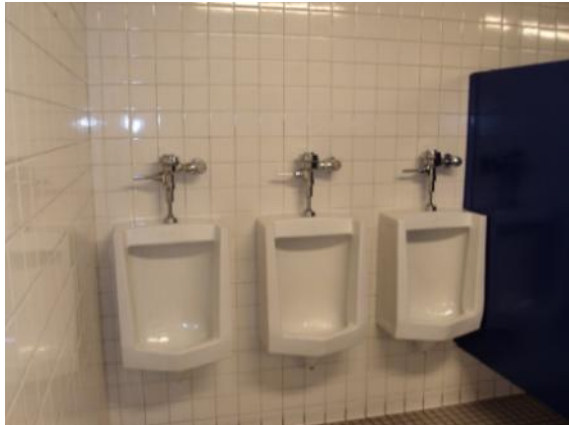
Photo #159: Boys common area restroom urinals

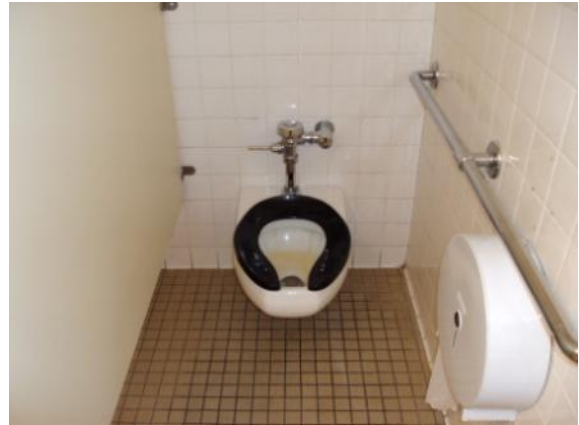
Photo #160: Wall-mounted toilet at restroom

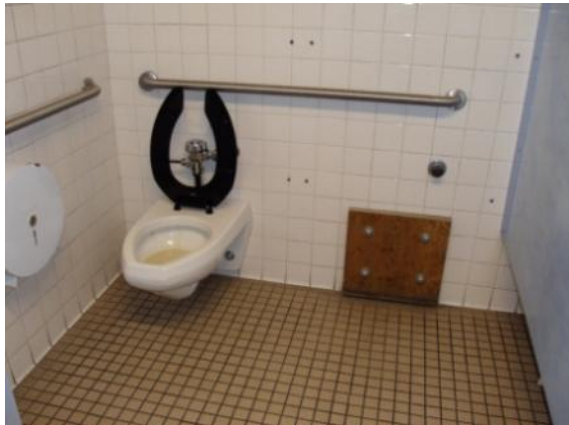
Photo #161: Toilet removed to make ADA stall at common area restroom

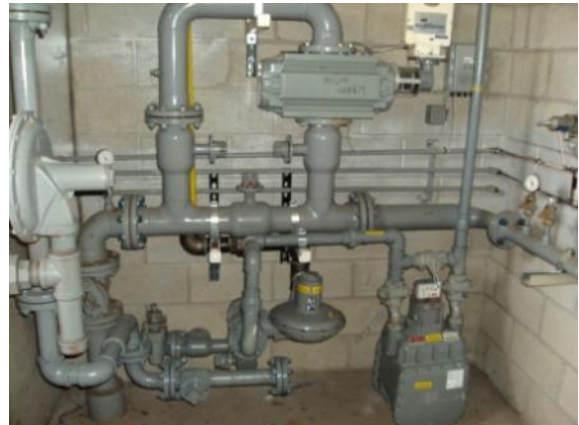
Photo #162: Gas metering

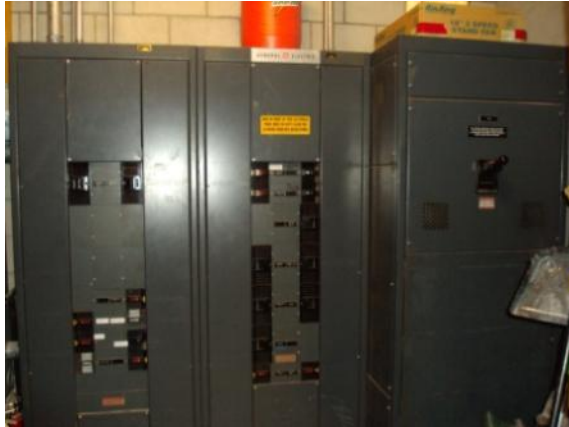
Photo #163: Main electrical switchgear (adjacent to the custodial break room)

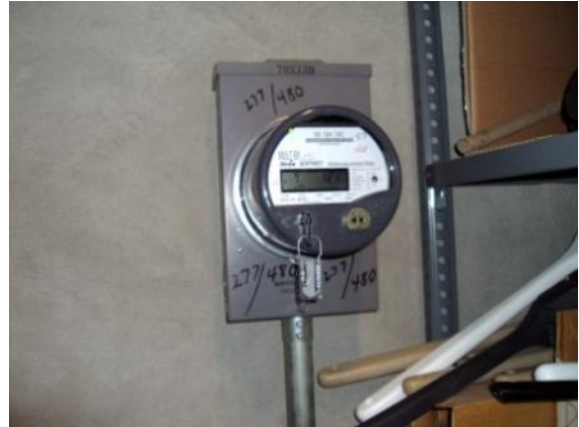
Photo #164: Electric meter at main electrical room

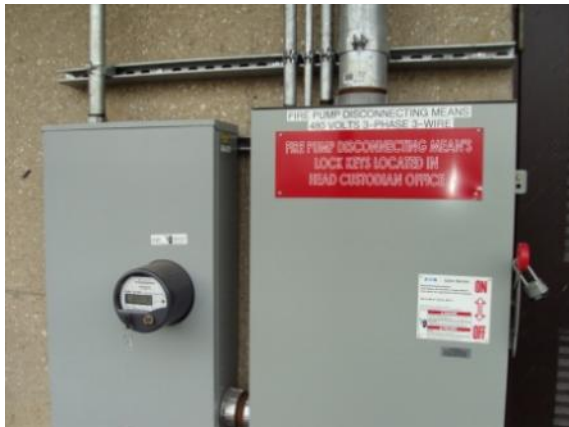
Photo #165: Fire pump meter at rear of building

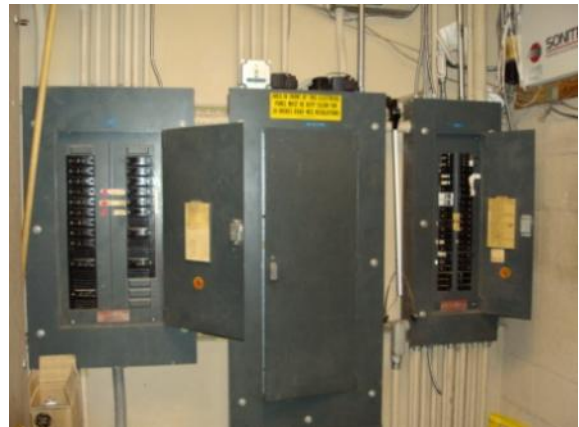
Photo #166: Original circuit breaker panels in electrical closet

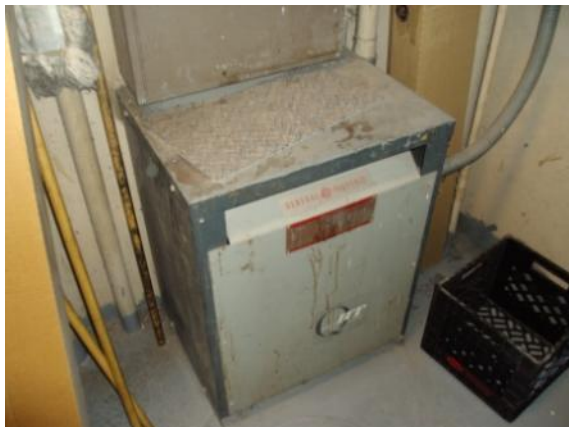
Photo #167: Step-down transformer at electrical closet

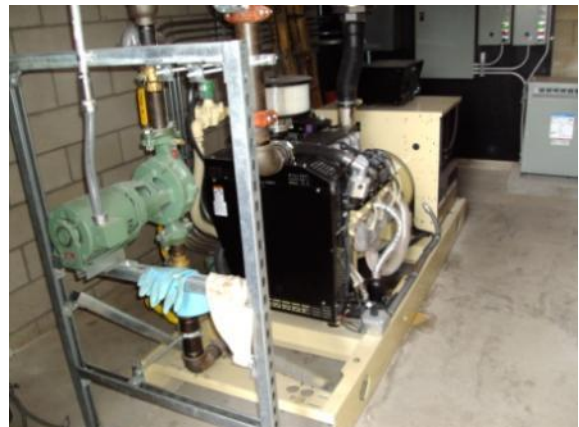
Photo #168: Emergency generator in locked room at rear loading dock area

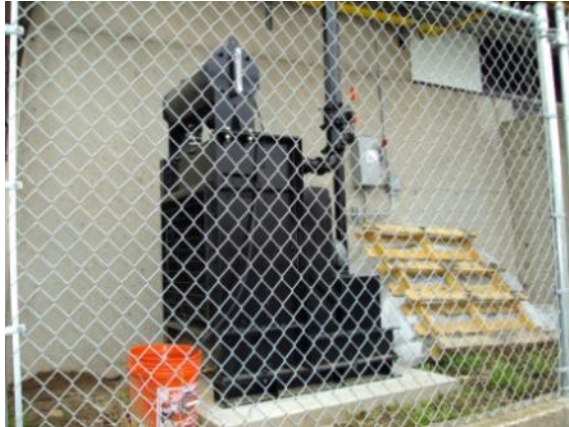
Photo #169: Chain link fence enclosures the generator cooling system at the rear of the building

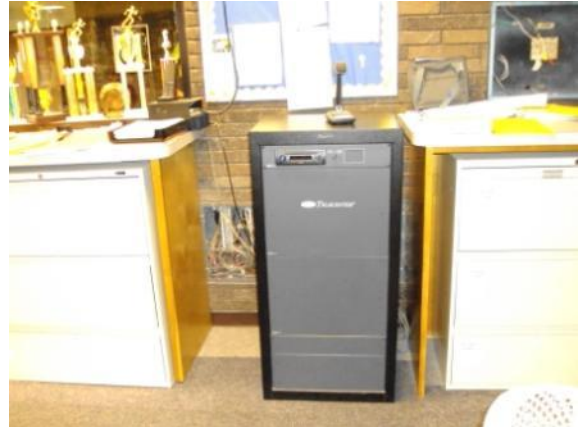
Photo #170: School PA system equipment at office

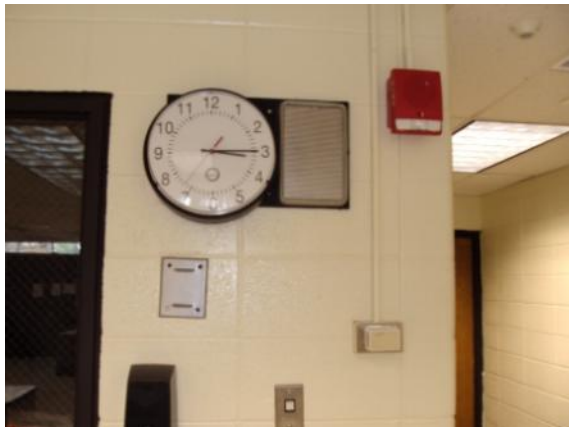
Photo #171: PA system call button and speaker in classroom, with adjacent clock, thermostat and strobe alarm

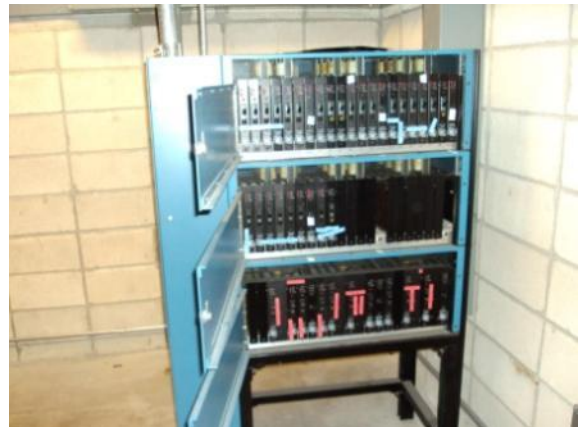
Photo #172: Auditorium lighting controls in auditorium mechanical room

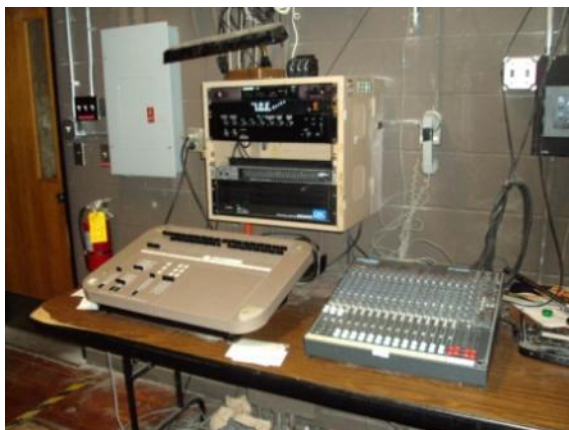
Photo #173: Auditorium audio and light controls at stage

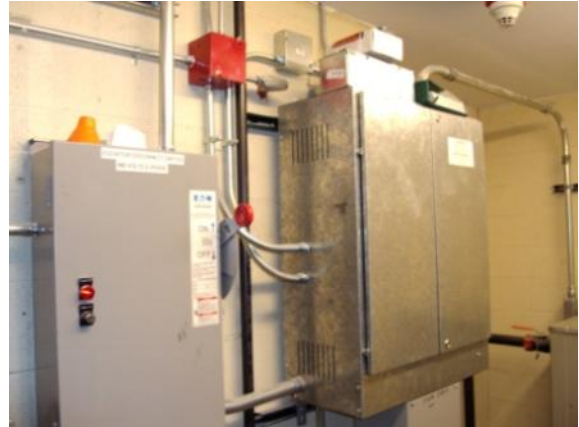
Photo #176: Elevator controls

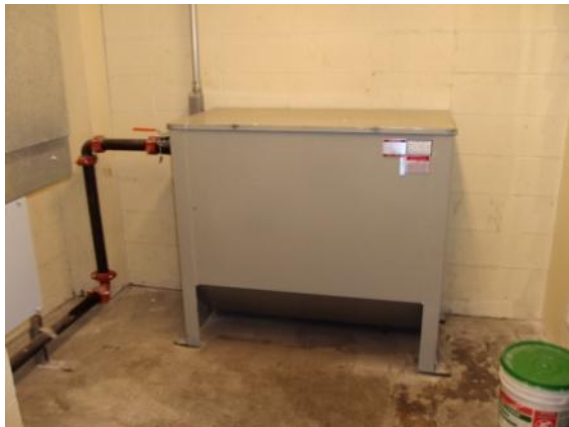
Photo #177: Elevator hydraulic machinery

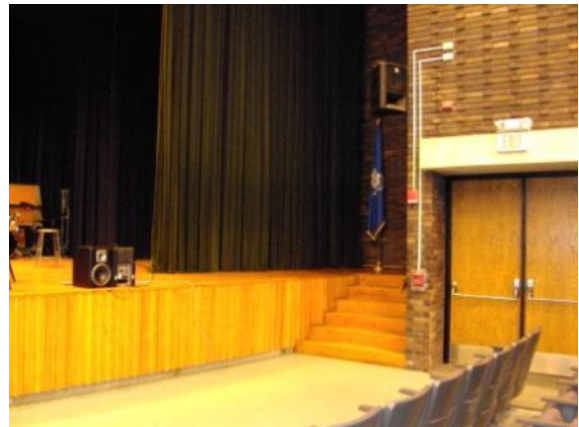
Photo #178: Auditorium stage requiring a wheelchair lift for accessibility

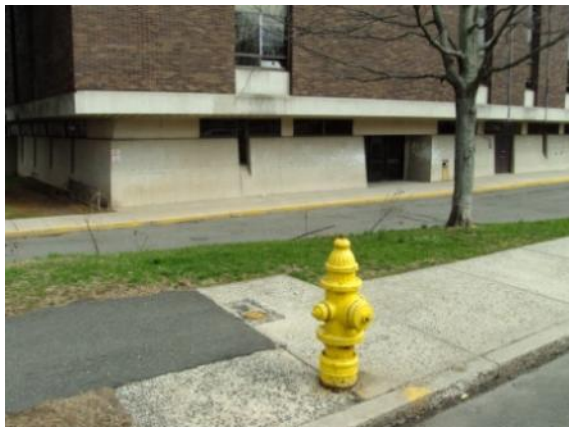
Photo #179: Fire hydrant along Powell Place

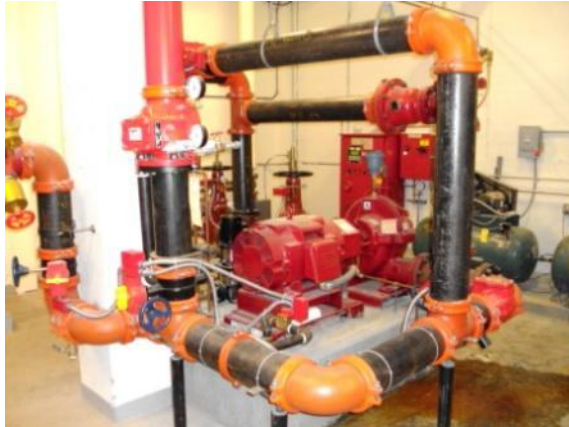
Photo #181: Main fire suppression system at basement mechanical room with fire pump

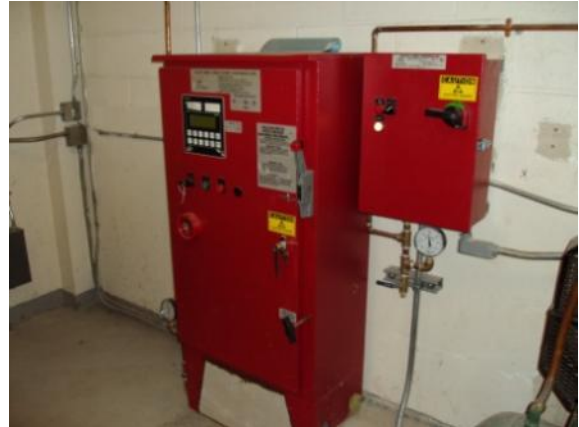
Photo #182: Fire pump controller

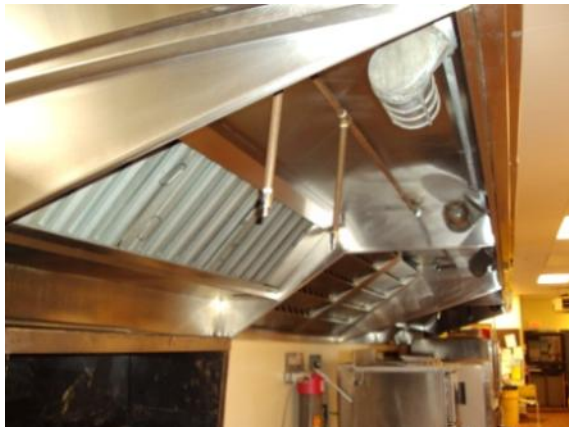
Photo #183: Exhaust hood with fire suppression

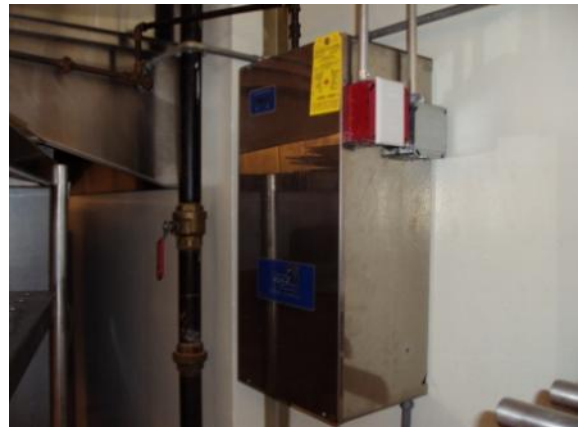
Photo #184: Ansul system for kitchen hood

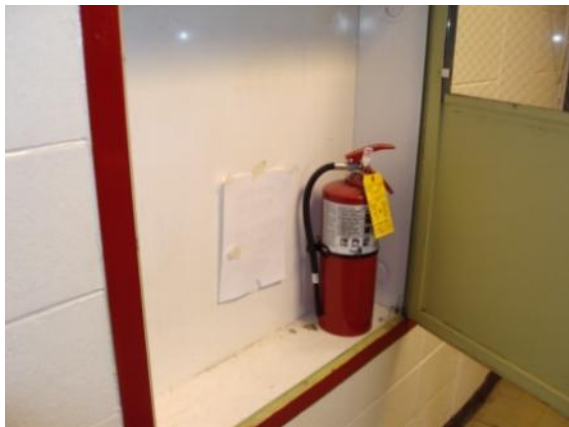
Photo #185: Cabinet-mounted fire extinguisher

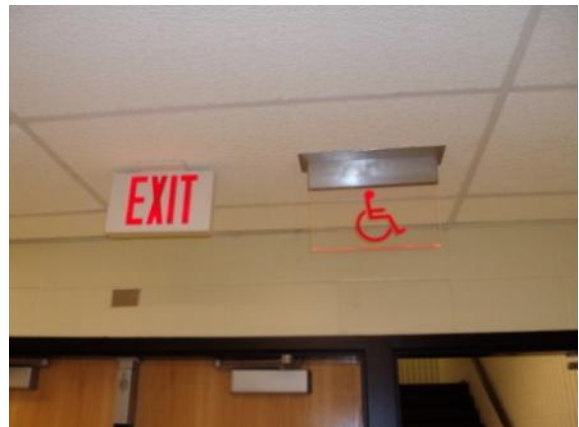
Photo #186: Illuminated exit sign and ADA sign at corridor
