# FACILITIES NEEDS ASSESSMENT

## STAMFORD PUBLIC SCHOOLS

## Facilities Needs Assessment of CLOONAN MIDDLE SCHOOL

**EMG Project #:** 88166.09R-009.017  
**Date of Report:** August 27, 2009  
**On-site Date:** April 1, 2009

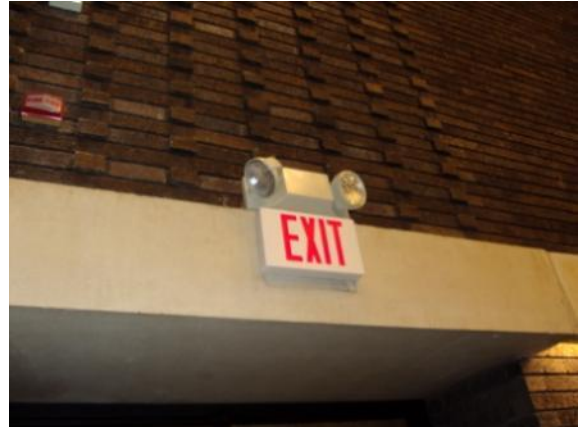
Photo #188: Illuminated exit sign and emergency lights at auditorium

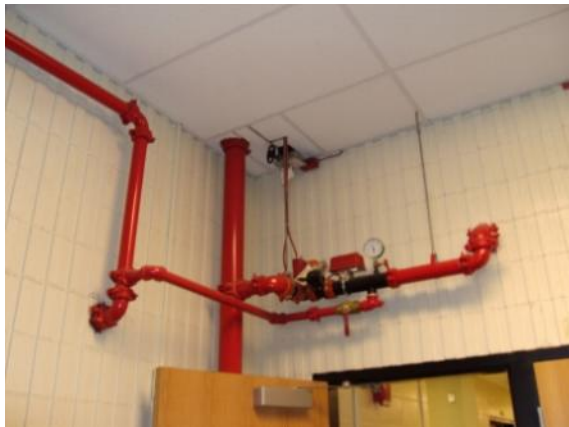
Photo #189: Fire standpipe at stairwell

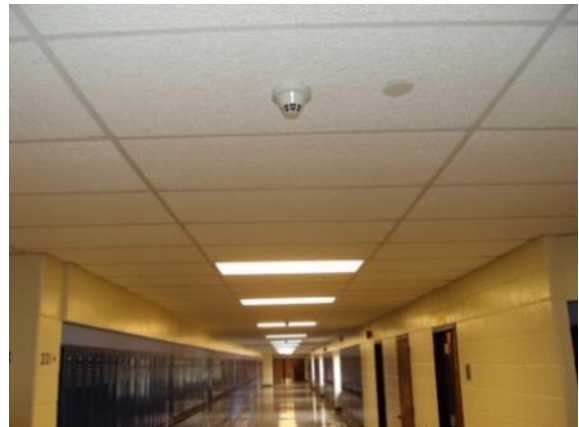
Photo #190: Smoke detector and recess sprinkler head at corridor

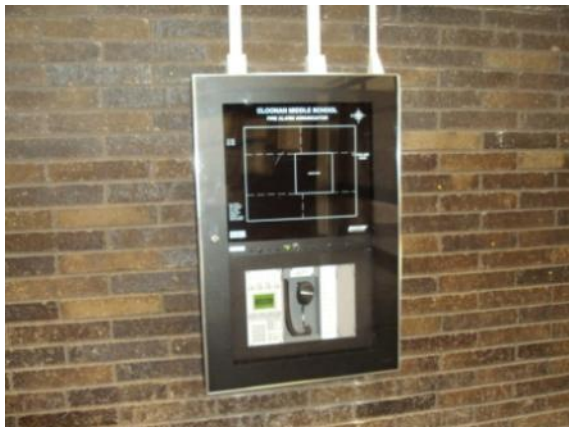
Photo #191: Annunciator panel at lobby

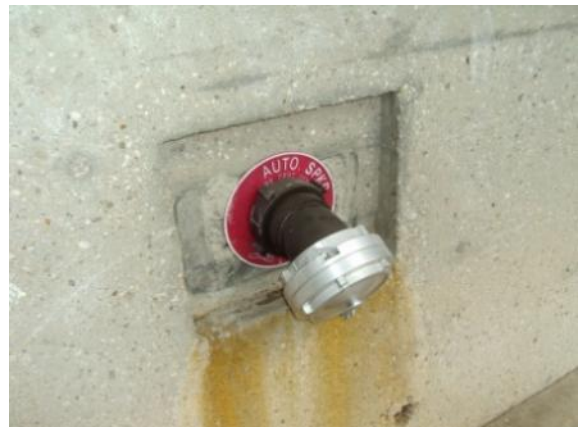
Photo #192: Fire house connection at building exterior wall

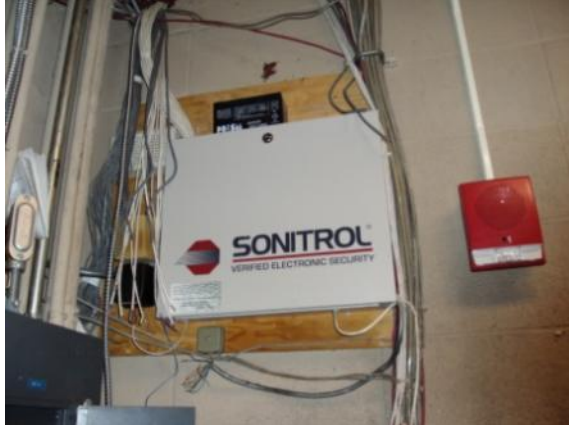
Photo #193: Security alarm panel in electrical closet by main office

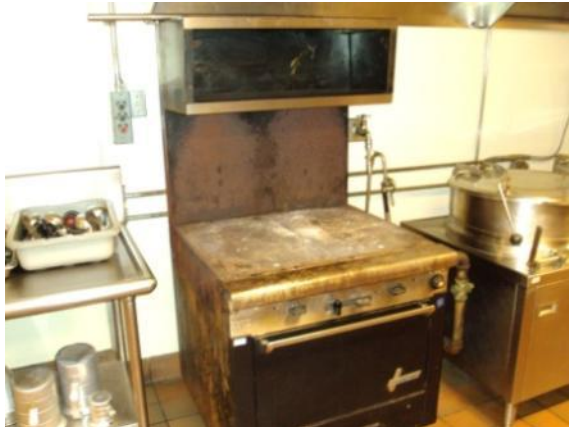
Photo #195: Kitchen gas range

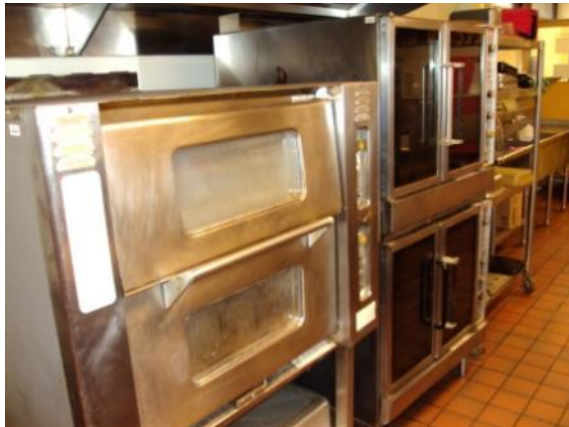
Photo #197: Kitchen gas ovens

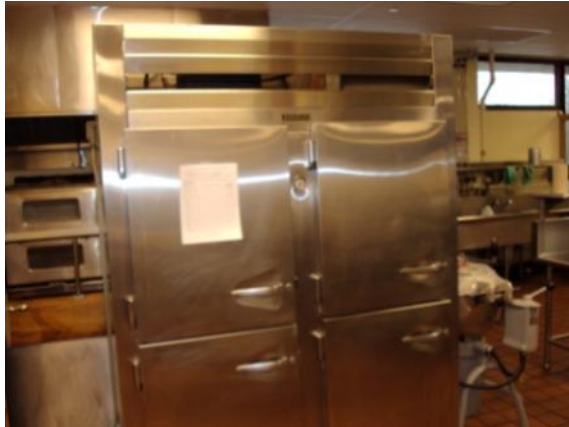
Photo #199:	Refrigeration unit in kitchen
-------------	-------------------------------

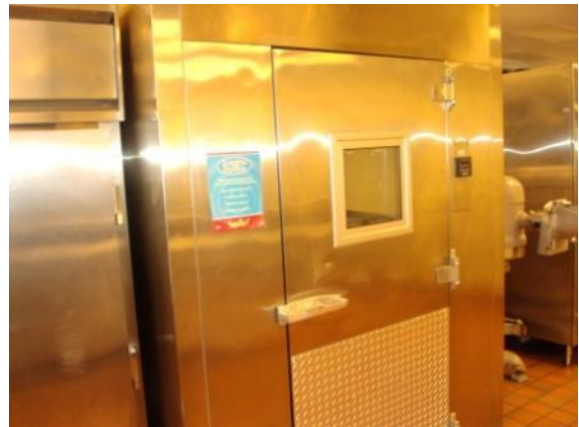
Photo #202:	Roll-in refrigeration unit at kitchen
-------------	---------------------------------------
