FACILITIES NEEDS

STAMFORD PUBLIC SCHOOLS

SCOFIELD MAGNET MIDDLE SCHOOL

EMG Project #: 88166.09R-016.017
Date of Report: August 29, 2009
On site Date: April 16, 2009

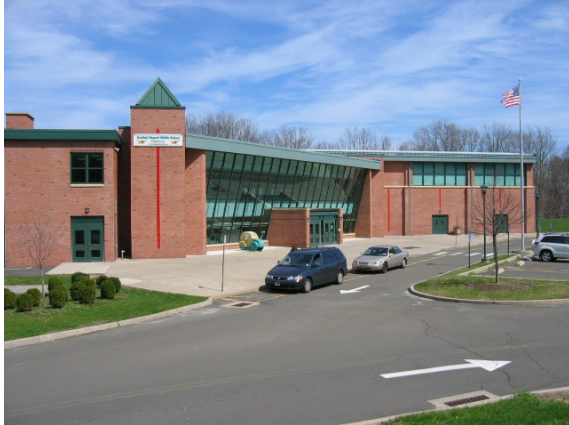
Photo #1:	Overview of the front façade of the Scofield Magnet Middle School
-----------	---

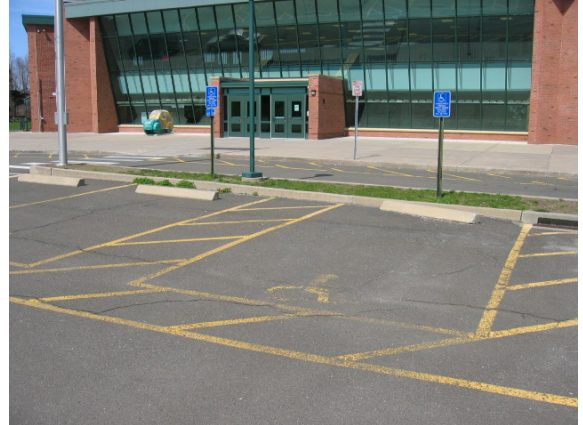
Photo #2:	Five handicapped accessible parking stalls are provided in front
-----------	--

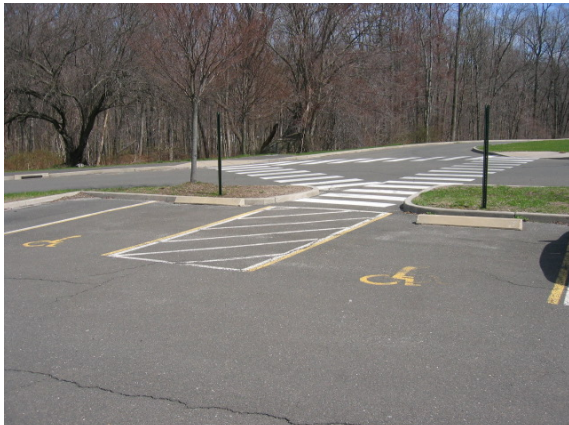
Photo #3:	Two handicapped accessible parking stalls are provided in the rear
-----------	--

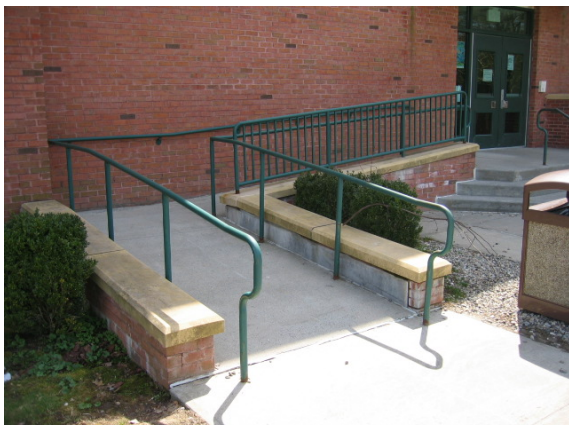
Photo #5:	Typical secondary common entrance with steps and an ADA ramp
-----------	--

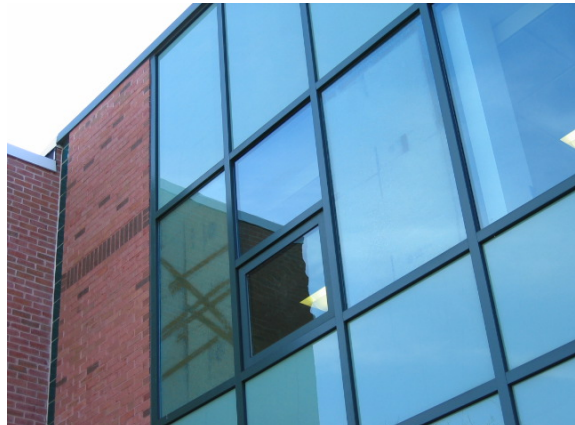
Photo #10: Two 2nd floor windows were observed to be shattered

6.6	4302	Replace 6' x 3' aluminum window upper floor	25	25	0	2	EA	\$2,232.72	\$4,465	\$4,465									\$4,465
6.6	4303	Horizontal Blinds aluminum 1" slats	7	7	0	1350	SF	\$6.49	\$8,760	\$8,760						\$8,760			\$17,520

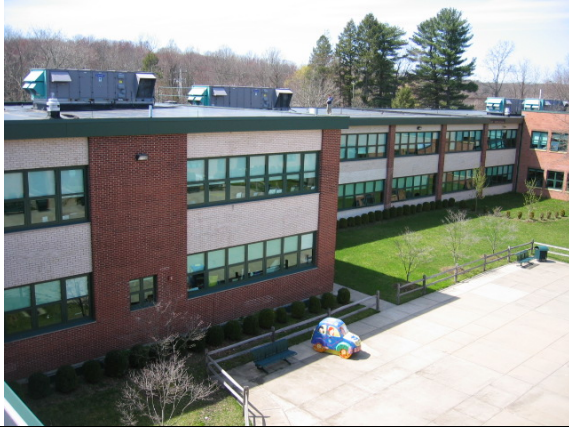
Photo #13: West side of the inner courtyard area

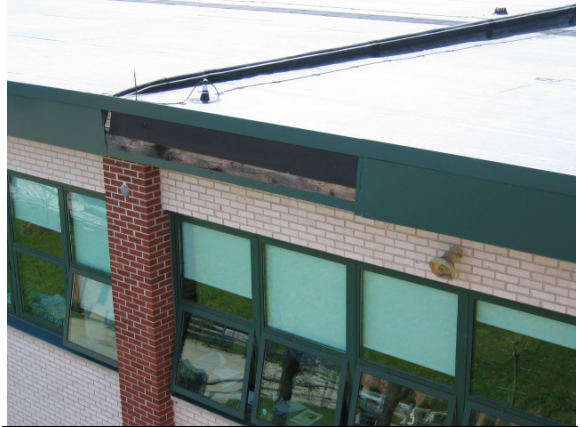
Photo #14: One section of roof edge fascia is missing, minor repairs are needed

6.3	12247	Stamford Roof Assessment - EPDM Replacement	20	20	0	115	SQ	\$1,595.75	\$183,511	\$183,511									\$183,511
6.3	12244	Stamford Roof Assessment Roof Repair Recommendations	0	0	0	1	EA	\$3,455.44	\$3,455										\$3,455

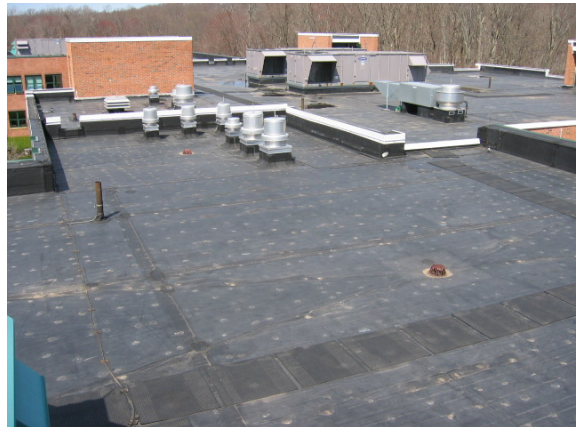
Photo #16: Most areas of the school are covered with a fully adhered EPDM

5.5	6194	Install underground irrigation system	0	0	0	60000	SF	\$1.26	\$75,600	\$75,600									\$75,600
6.3	12246	Stamford Roof Assessment - EPDM Replacement	20	14	6	142	SQ	\$1,631.21	\$231,632						\$231,632				\$231,632

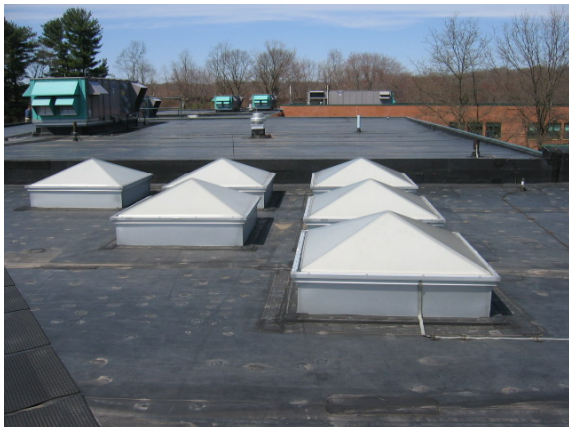
Photo #17: Several skylights are provided above the 2nd floor atrium lobby

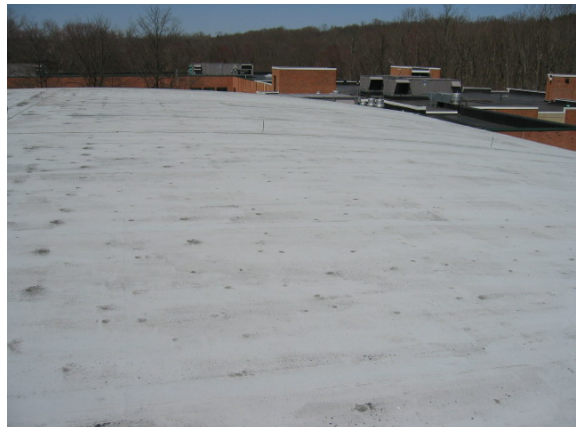
Photo #18: The gymnasium is covered with a shallow barrel vaulted EPDM

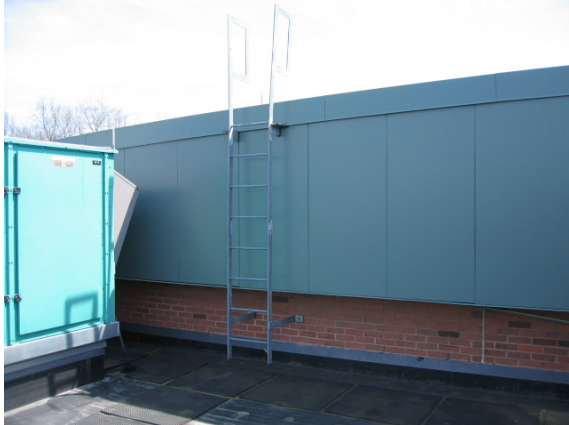
Photo #19: Roof levels are accessed by fixed ladders

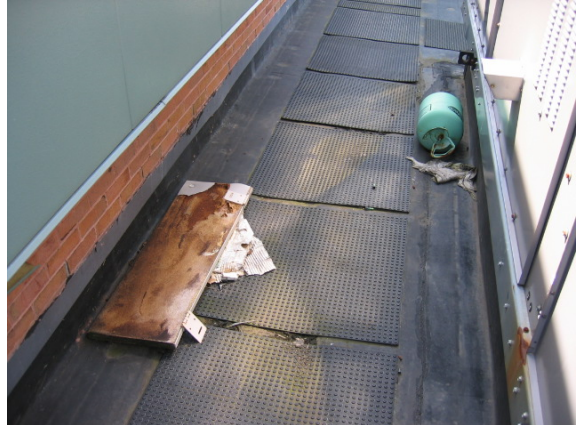
Photo #20: Isolated sections of roof debris were noted

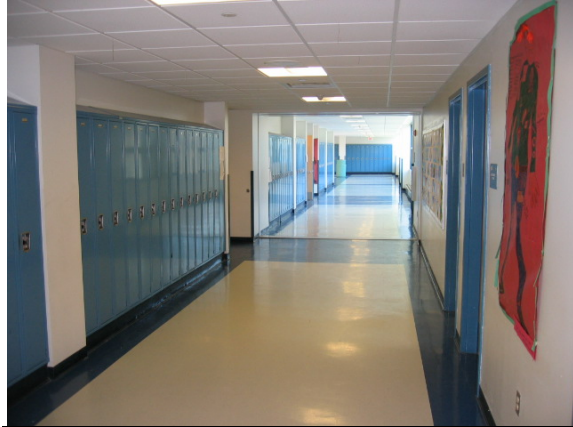
Photo #26: Typical 1st floor classroom corridor

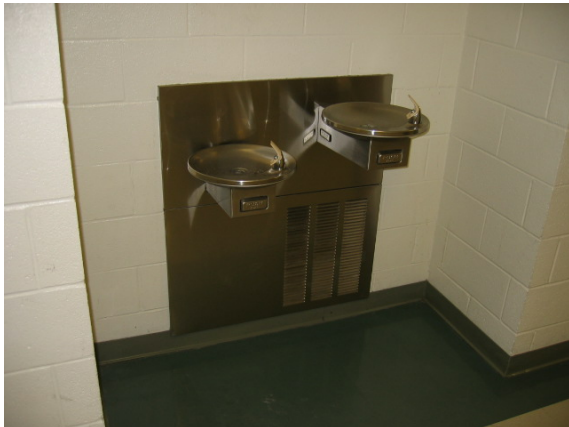
Photo #27: Handicapped-accessible water fountains are found throughout the corridors

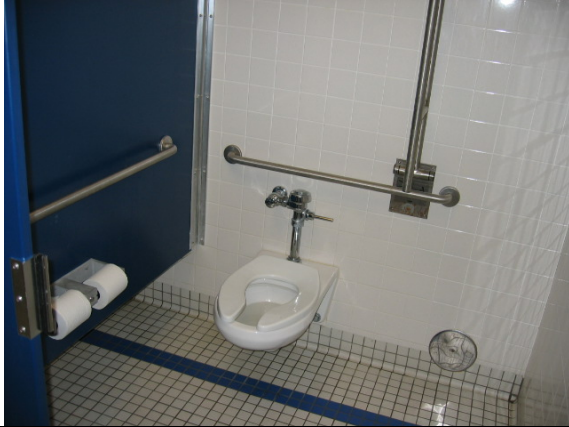
Photo #31: ADA accessible toilets are provided in cafeteria

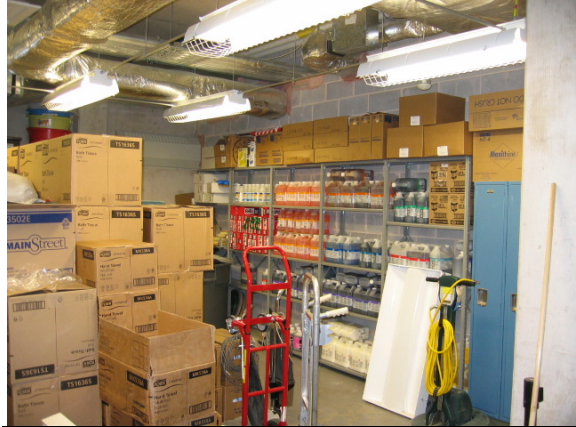
Photo #32: Storage room

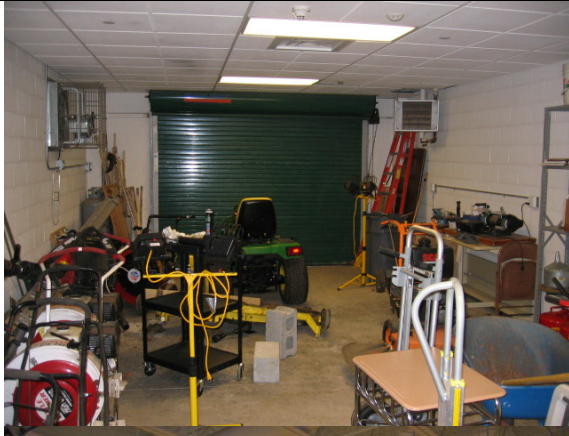
Photo #33: Maintenance shop storage room

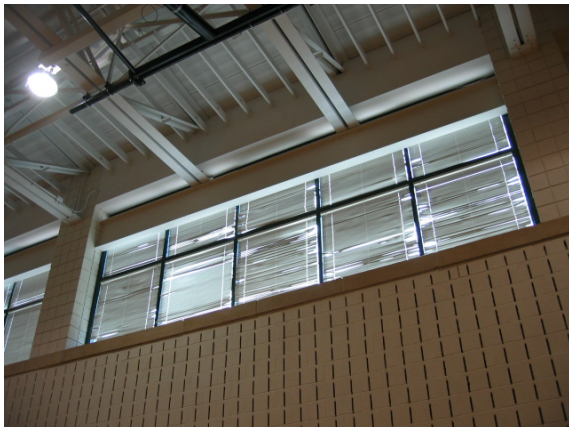
Photo #35: Detail of the damaged gymnasium window blinds

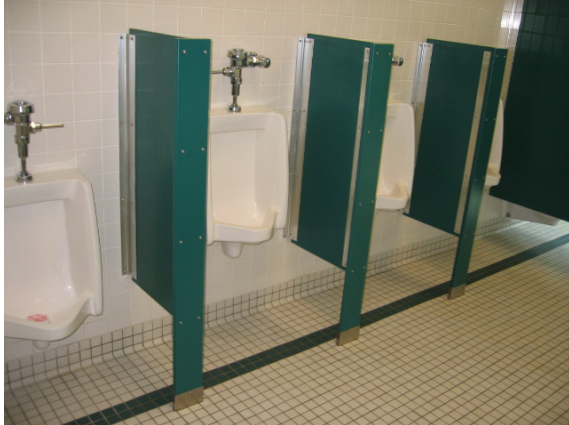
Photo #37: All common toilet rooms throughout the school provide full ADA access

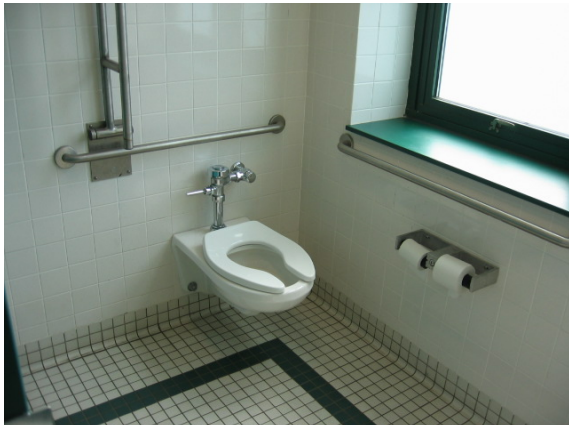
Photo #39: Handicap-accessible toilet stall

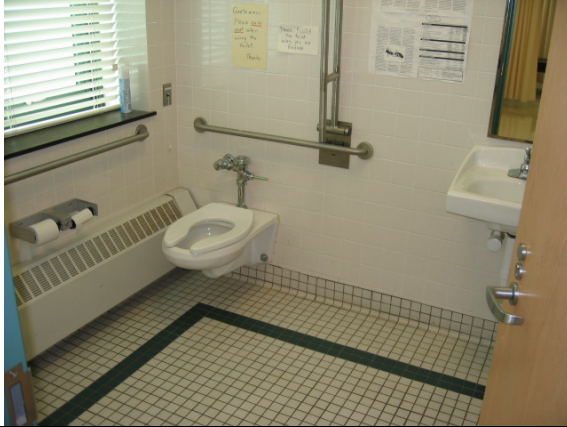
Photo #43: A full ADA accessible, single user toilet room exists in the nurse's office

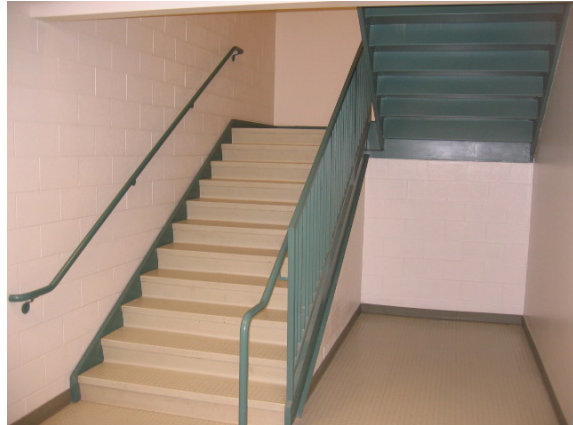
Photo #46: Several stairwells provided access and egress to the 2nd floor

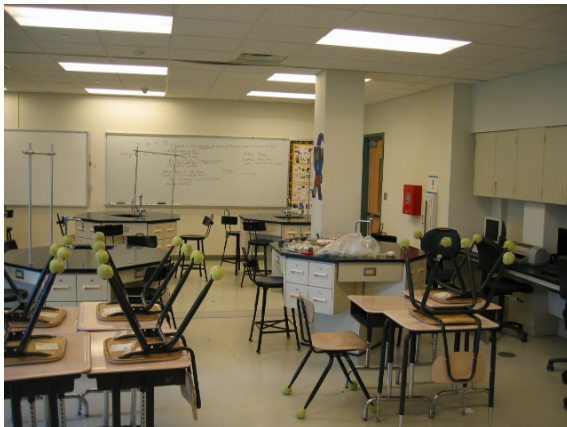
Photo #47: Typical first floor classroom interior

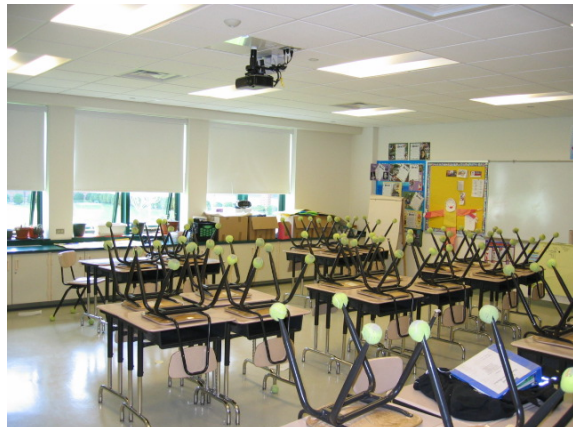
Photo #48: Typical first floor classroom interior

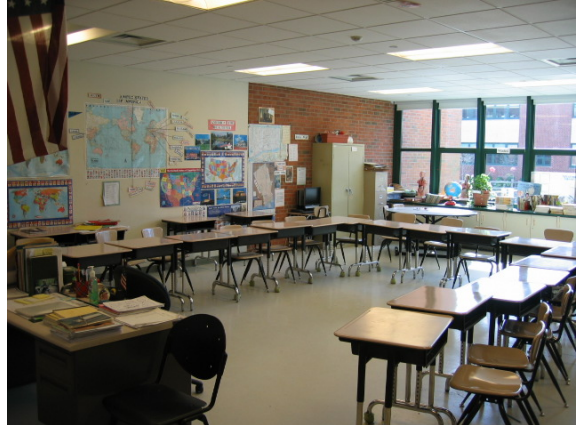
Photo #50: Typical first floor classroom interior, note exposed brick

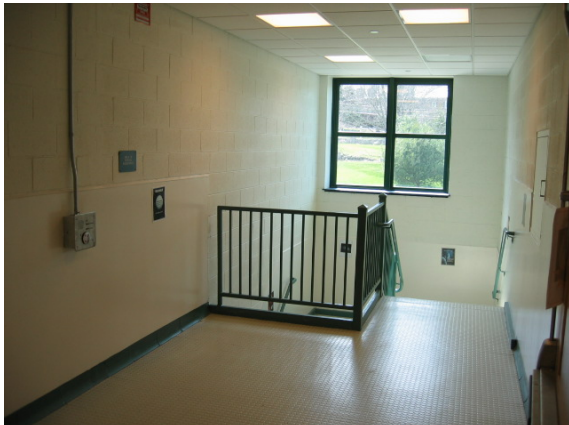
Photo #51: Each stairwell provides an area of refuge at top landing

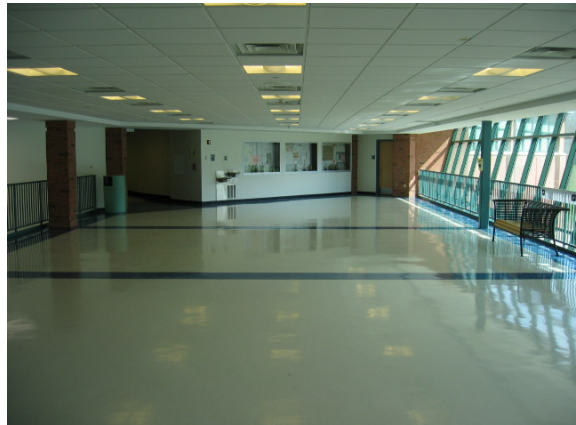
Photo #52: 2nd floor atrium lobby space

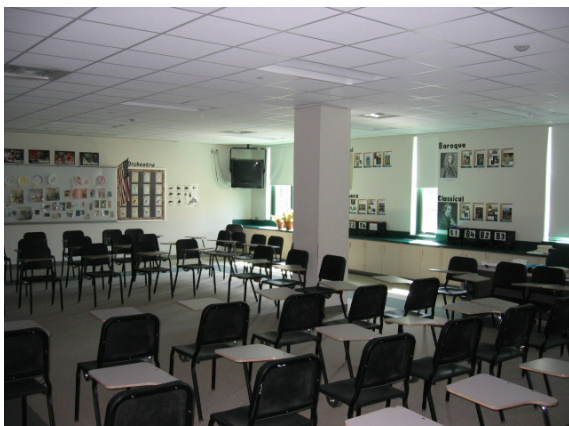
Photo #53: Typical 2nd floor classroom interior

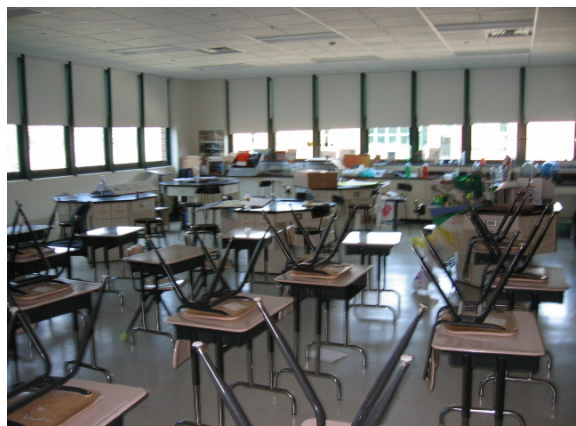
Photo #54: Typical 2nd floor classroom interior

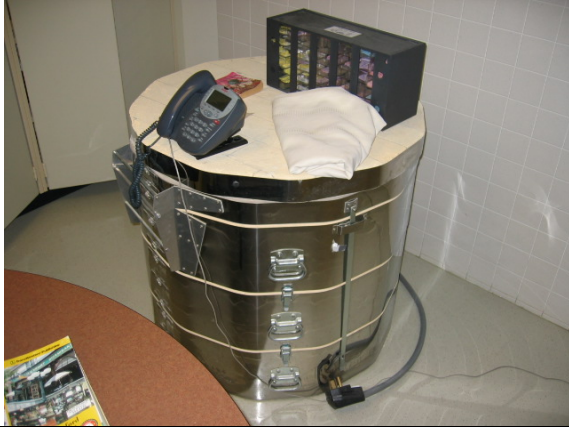
Photo #55: The school's kiln is currently in storage and not connected for use

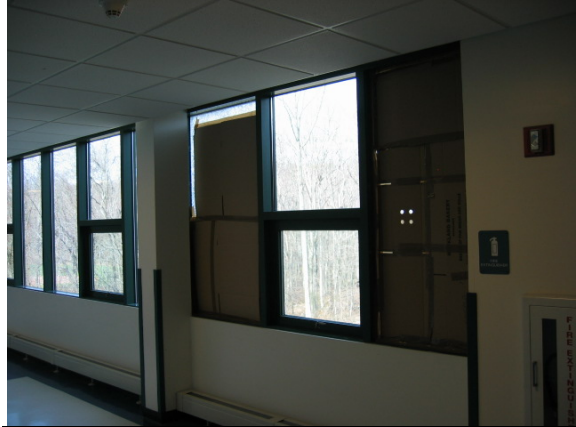
Photo #56: Inside view of two corridor windows that have shattered and been covered with cardboard

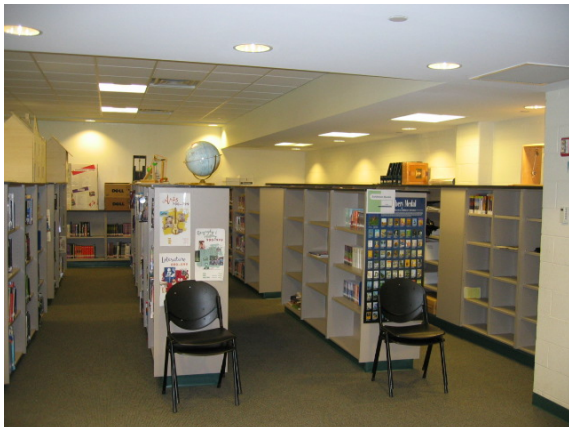
Photo #61: Second view of the media center towards the book stacks

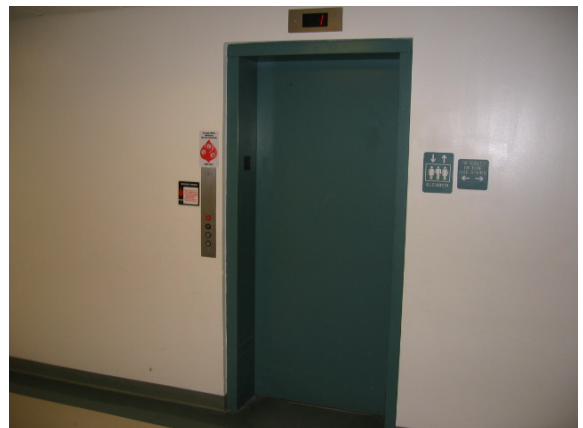
Photo #64: 3-stop hydraulic elevator at cafeteria

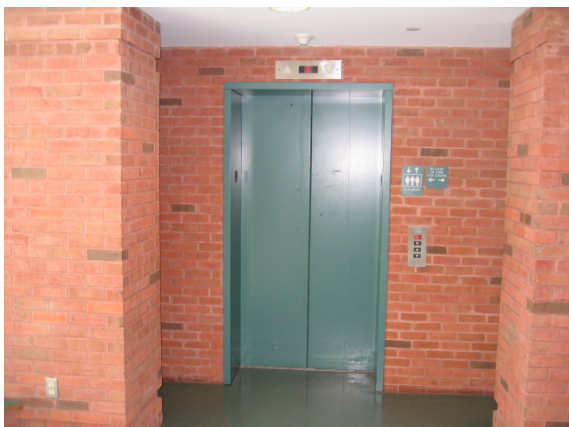
Photo #65: 2-stop hydraulic elevator near the main office

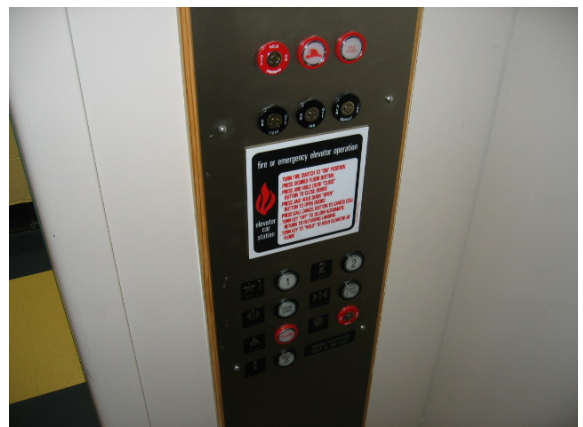
Photo #66: Each elevator provides substantial ADA access

- A sustainable recommendation for the elevators is to equip the hydraulic pumps with high efficiency motors to reduce energy consumption.

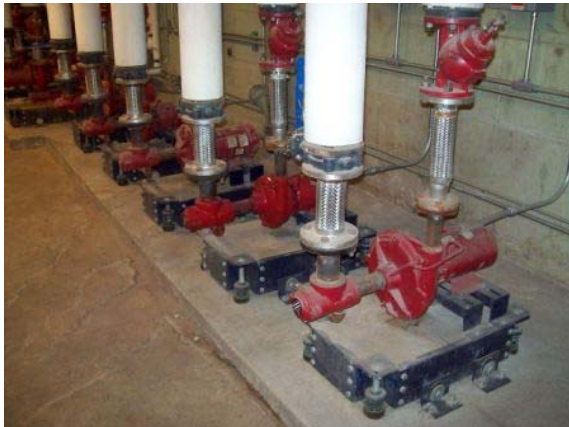
Photo #69: Hot water circulating pumps

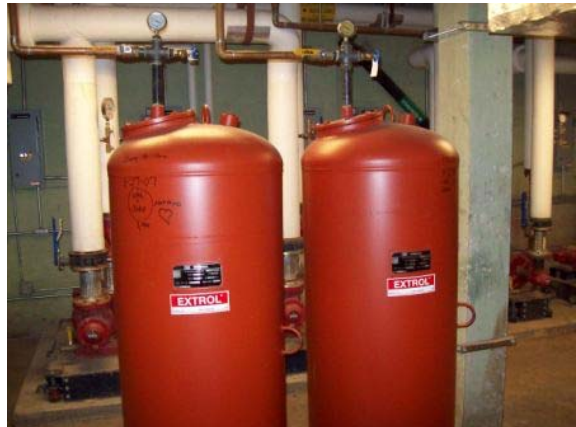
Photo #70: Expansion tanks

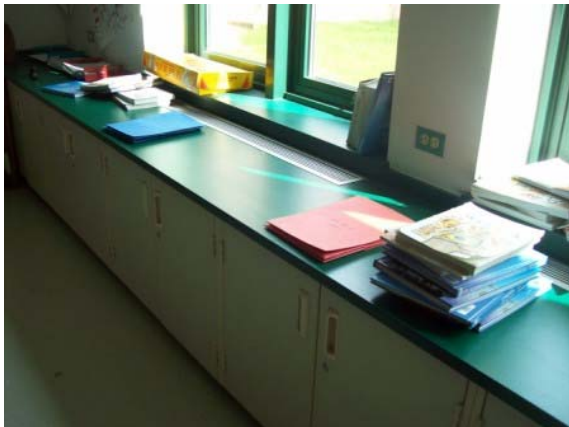
Photo #71: Cabinet-mounted finned tube radiant heat unit

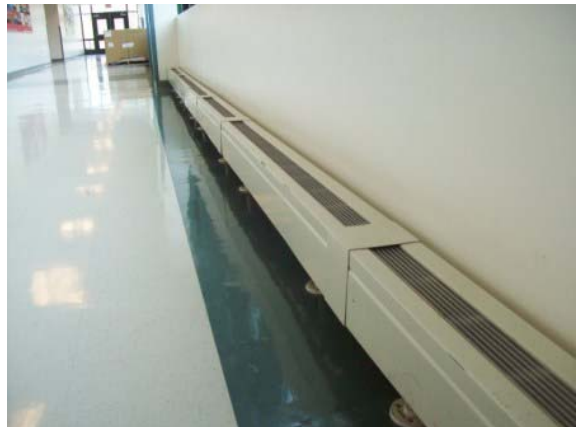
Photo #72: Baseboard-mounted finned tube radiant heat unit

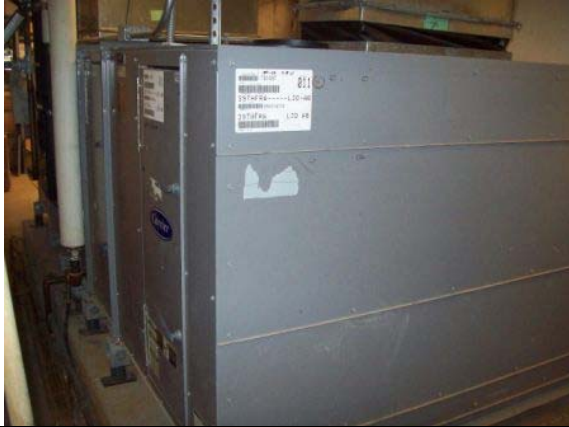
Photo #85: AC-7 serving cafeteria

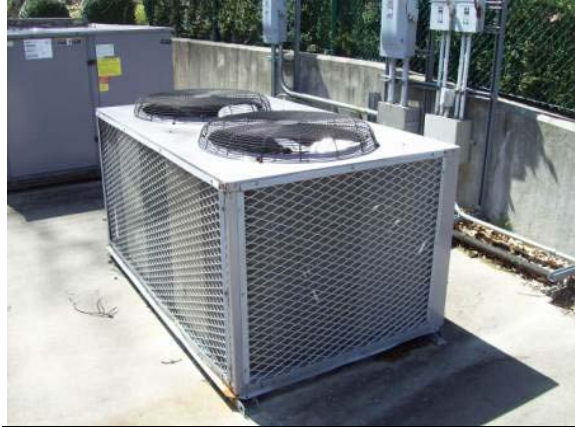
Photo #86: Condensing units for AC-7

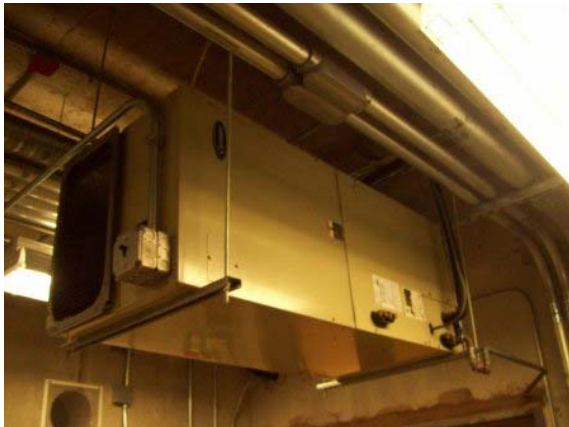
Photo #87: AC-9 serving electrical room

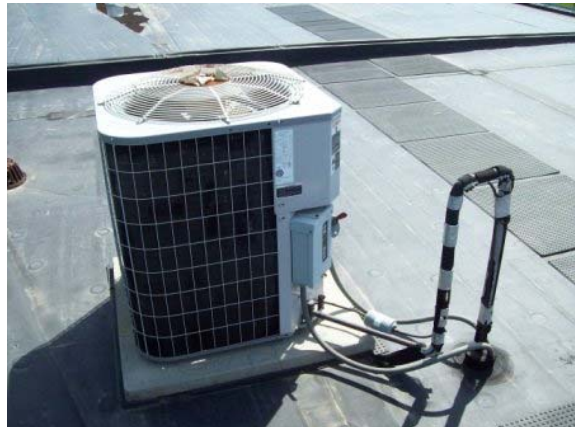
Photo #88: Condensing unit for AC-9

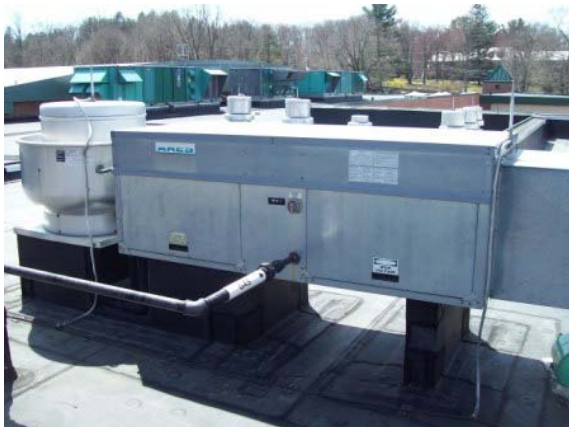
Photo #89: Make-up air unit for kitchen

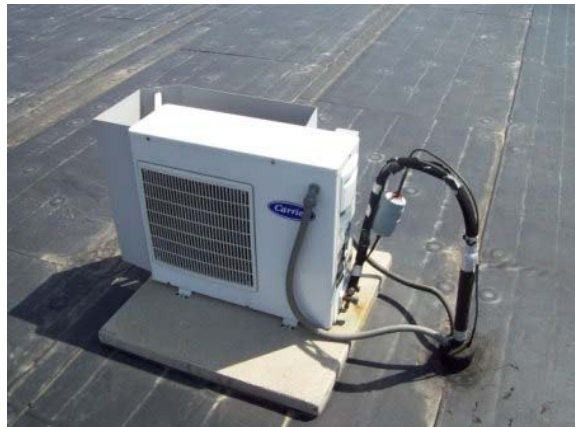
Photo #90: Condensing unit for wall-mounted AC

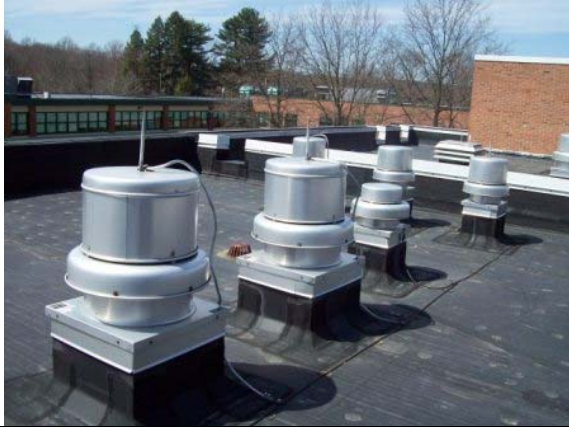
Photo #91: Roof-mounted exhaust fans

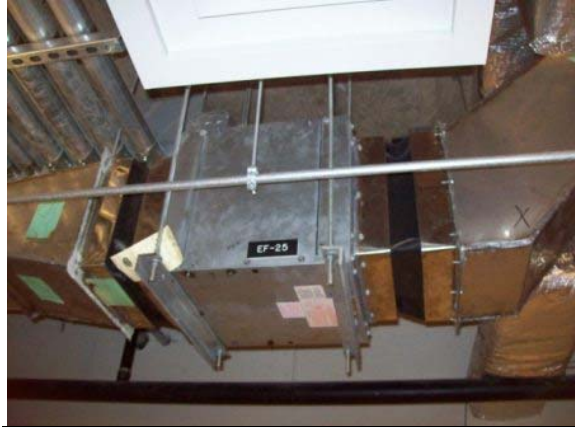
Photo #92: Ceiling-mounted exhaust fan

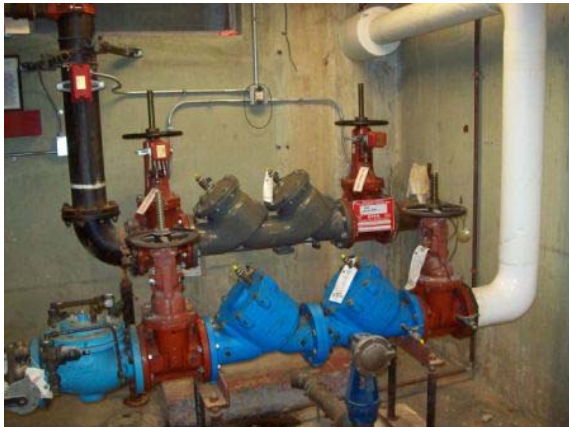
Photo #93: Domestic water service

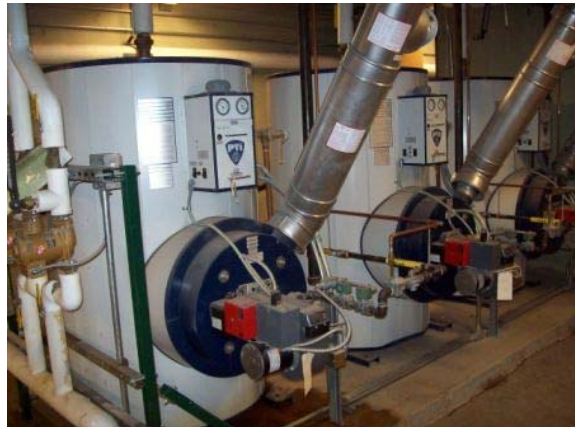
Photo #94: Domestic water boilers

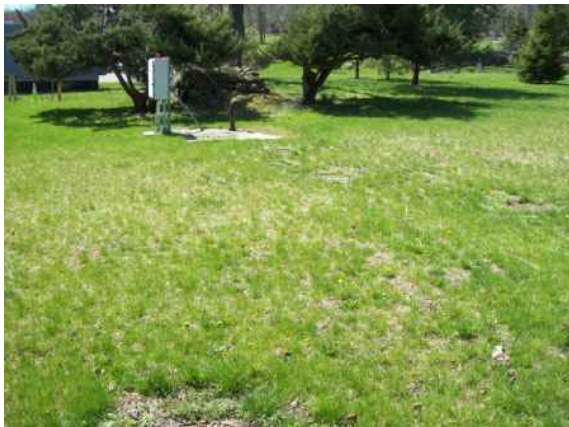
Photo #95: Septic system holding tanks and lift station at west side of property

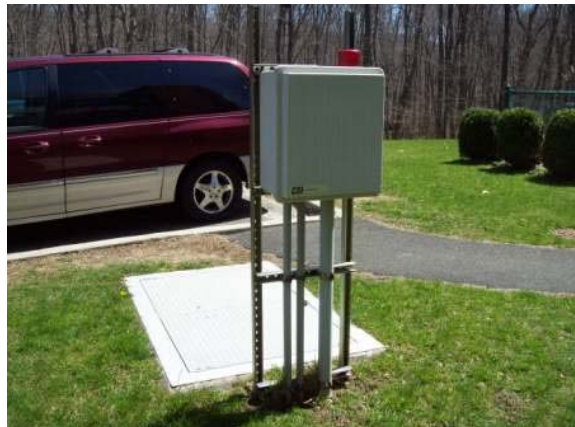
Photo #96: Lift station at east side of property

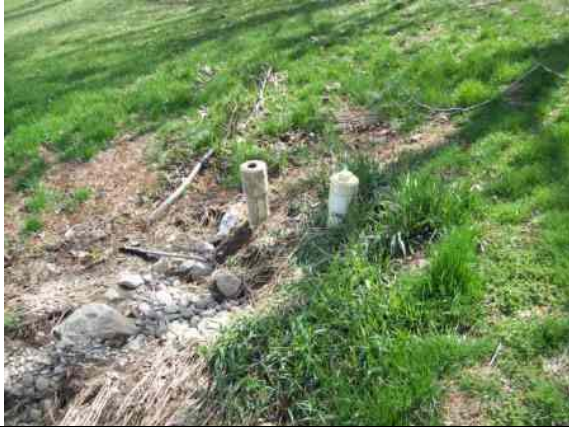
Photo #97: Septic system cleanouts

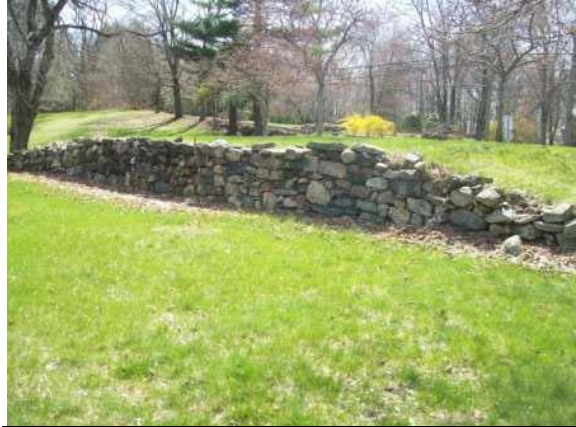
Photo #98: Area of septic leach fields

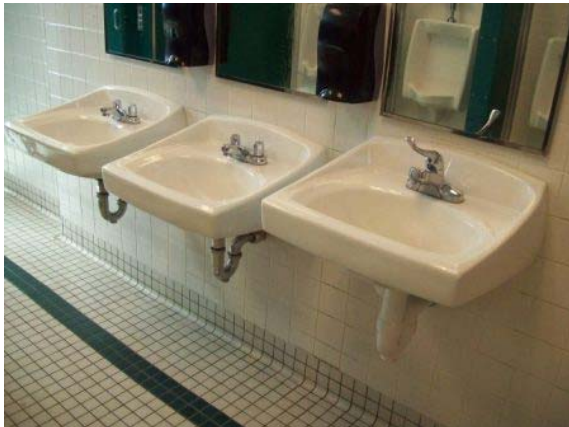
Photo #99: Typical restroom fixtures

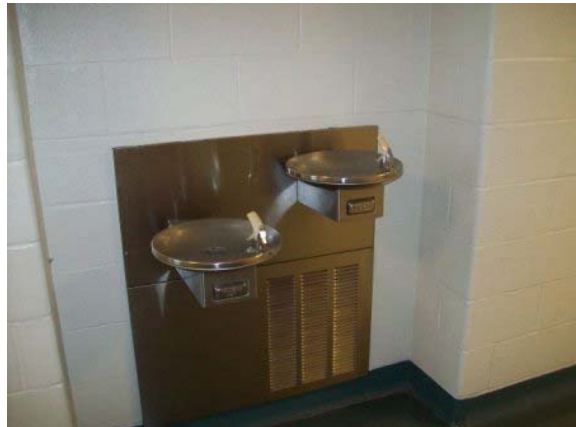
Photo #100: Typical drinking fountains

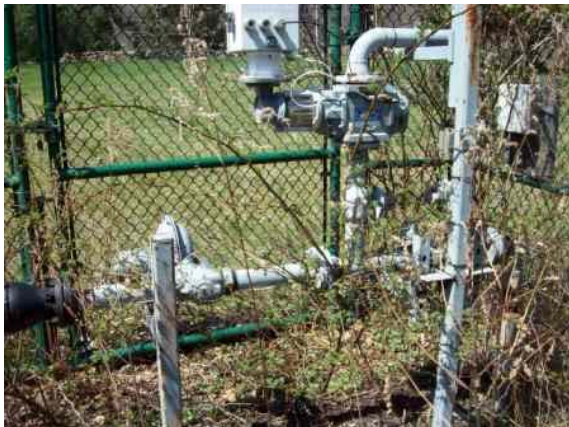
Photo #101: Gas meter and regulator

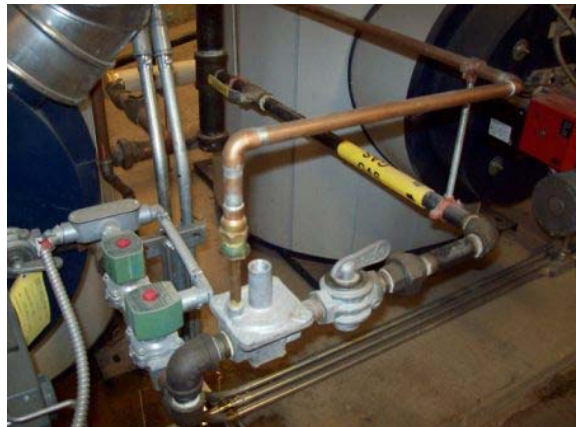
Photo #102: Gas feed for domestic water boiler

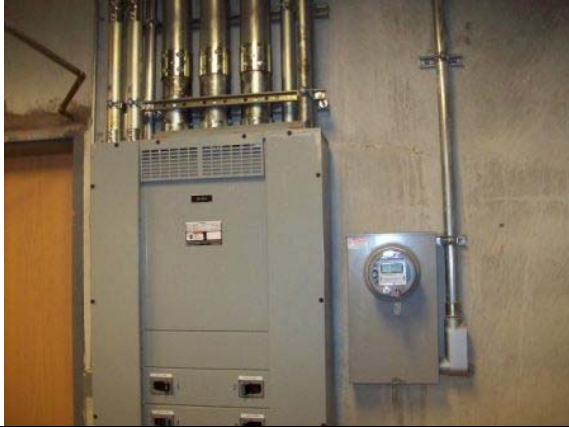
Photo #103: Electric meter

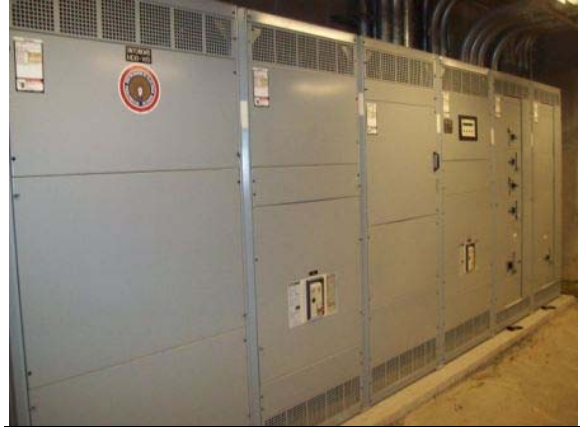
Photo #104: Main switchgear

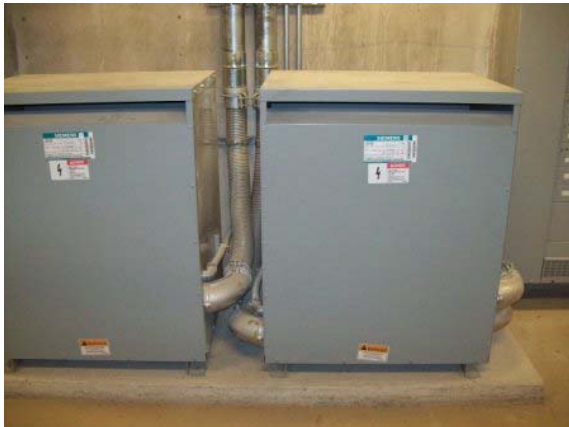
Photo #105: Step down transformers

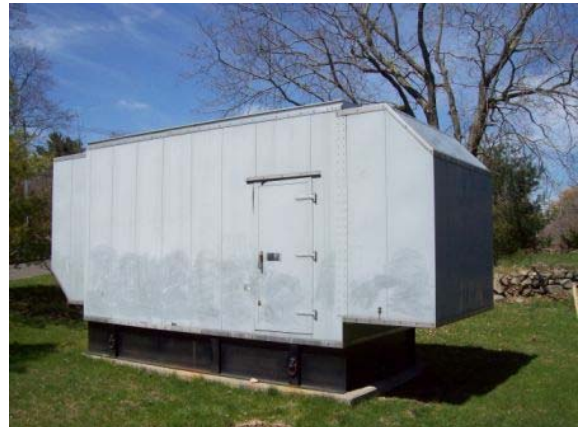
Photo #106: Emergency generator enclosure

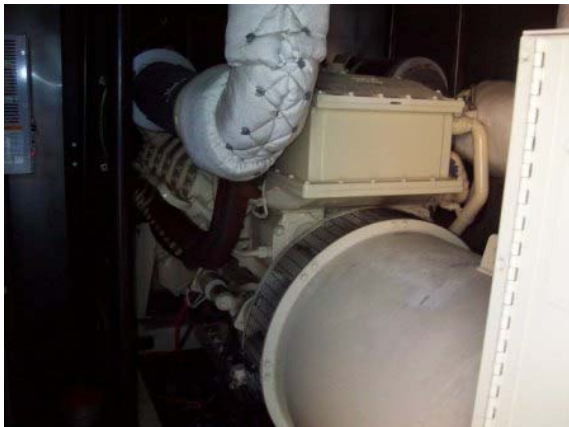
Photo #107: Emergency generator

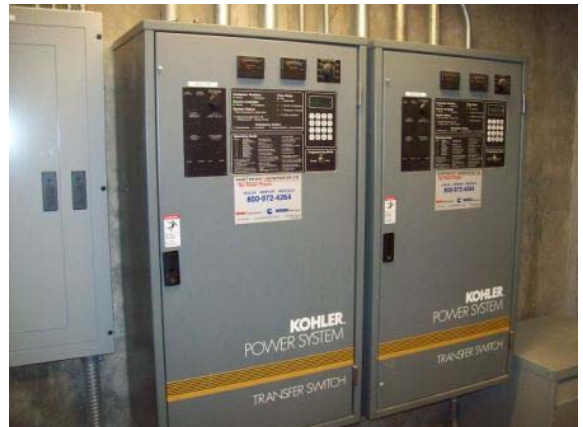
Photo #108: Transfer switches

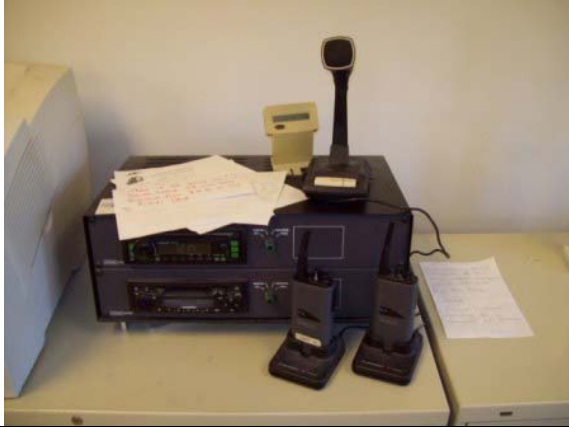
Photo #109: PA system in main office

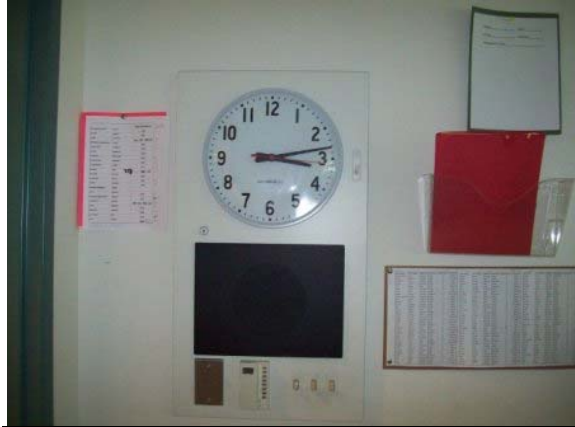
Photo #110: PA panel in classroom

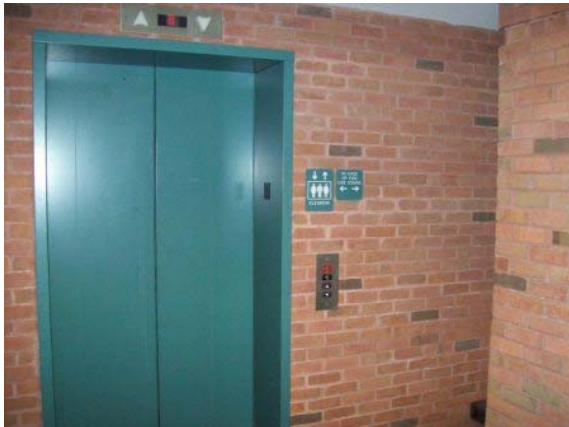
Photo #111: Main elevator

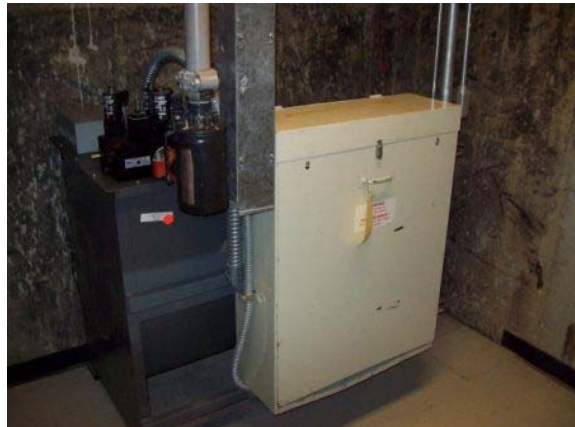
Photo #112: Main elevator hydraulic equipment

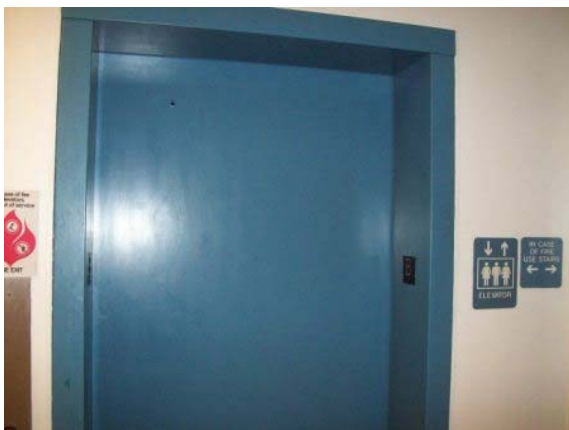
Photo #113: Cafeteria elevator

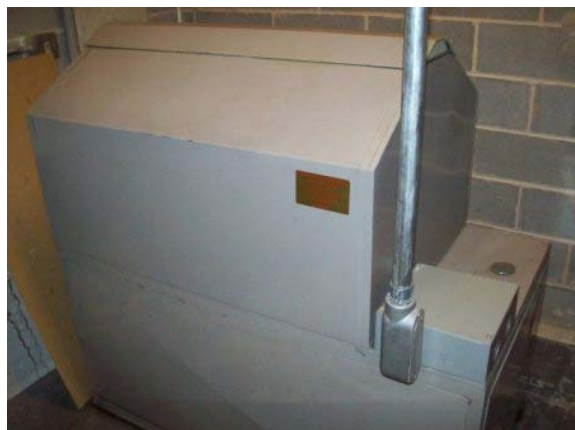
Photo #114: Cafeteria elevator hydraulic equipment

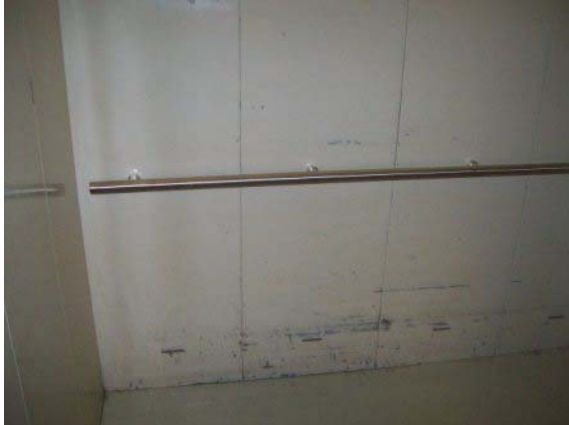
Photo #115: Cafeteria elevator cab interior

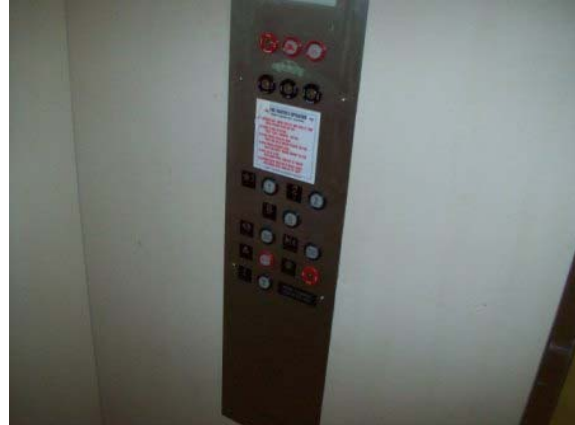
Photo #116: Cafeteria elevator control panel

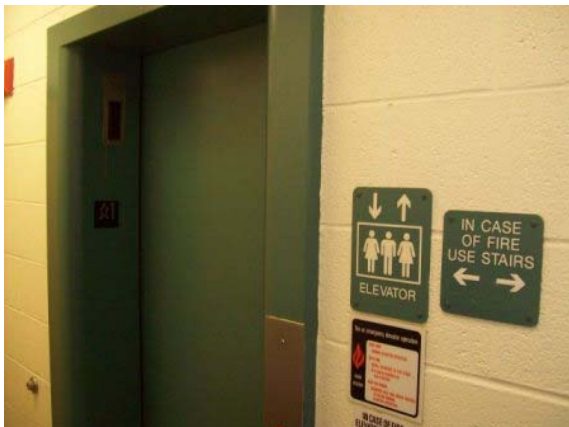
Photo #117: Bus entrance elevator

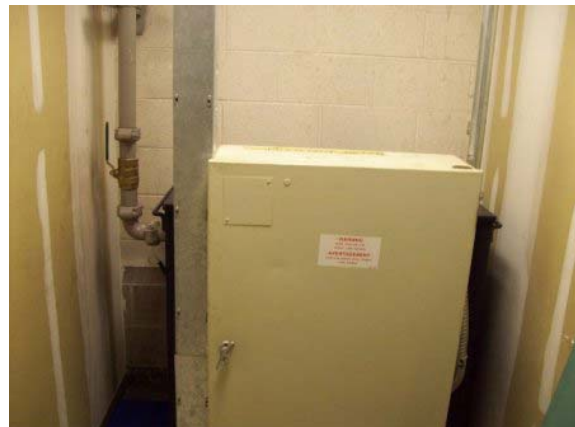
Photo #118: Bus entrance elevator hydraulic equipment

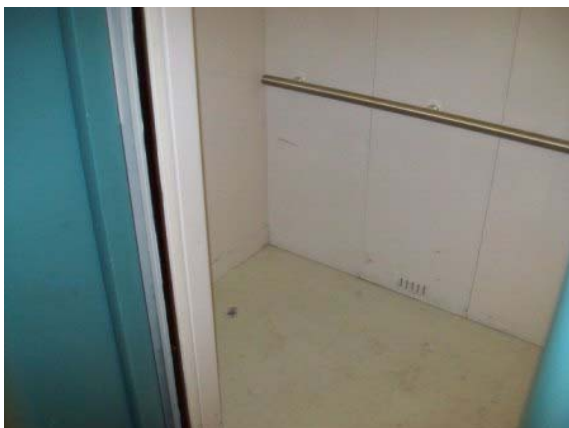
Photo #119: Bus entrance elevator cab interior

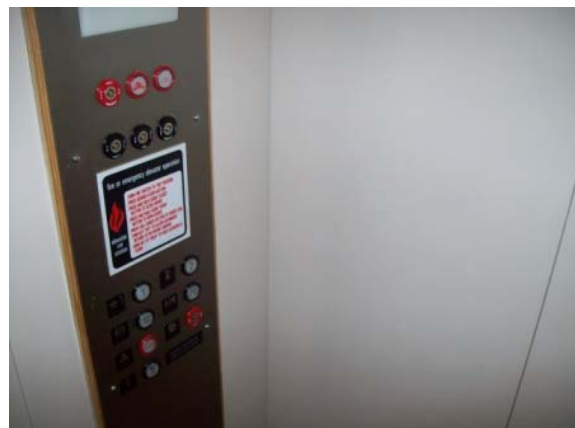
Photo #120: Bus entrance elevator control panel

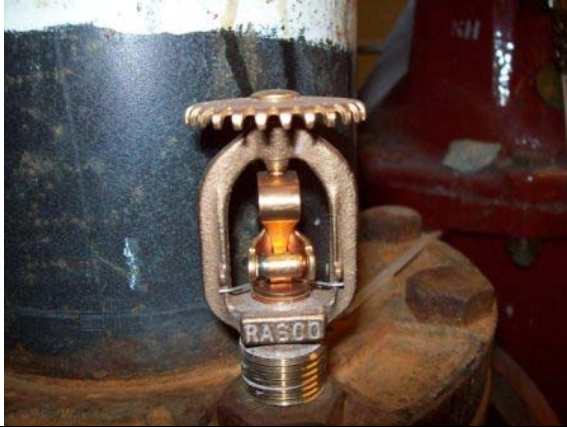
Photo #121: Typical sprinkler head

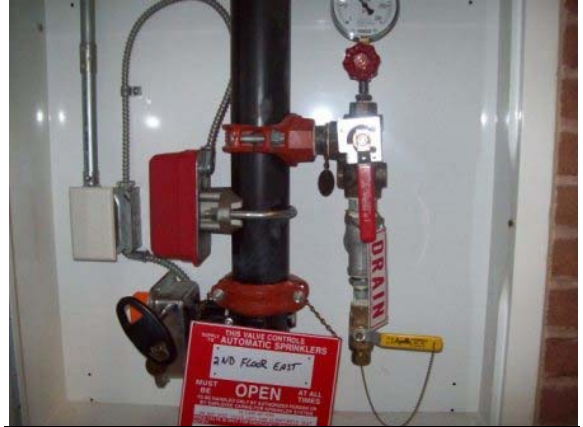
Photo #122: Sprinkler stand pipe and test valves

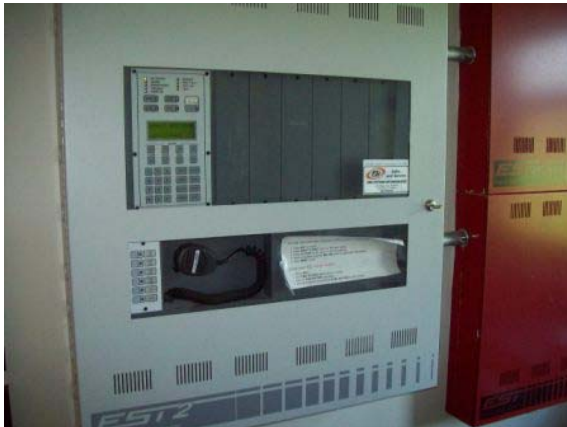
Photo #123: Fire alarm control panel

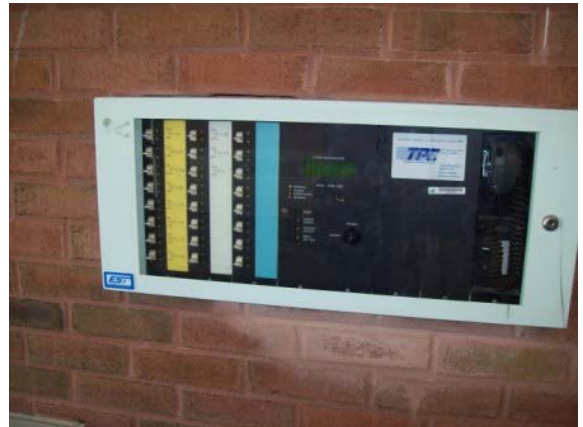
Photo #124: Fire alarm annunciator panel

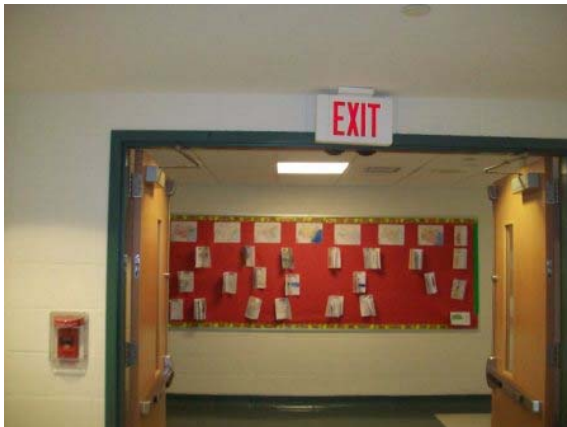
Photo #125: Emergency exit sign and pull station

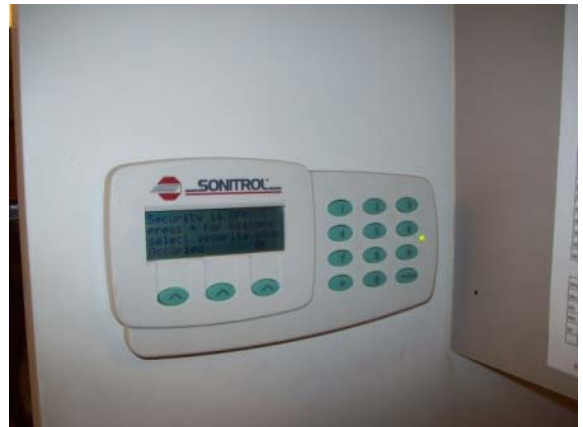
Photo #126: Security interface panel

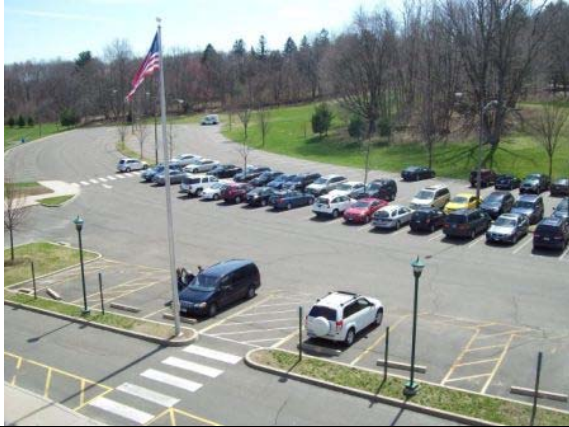
Photo #127: Overview of main parking lot

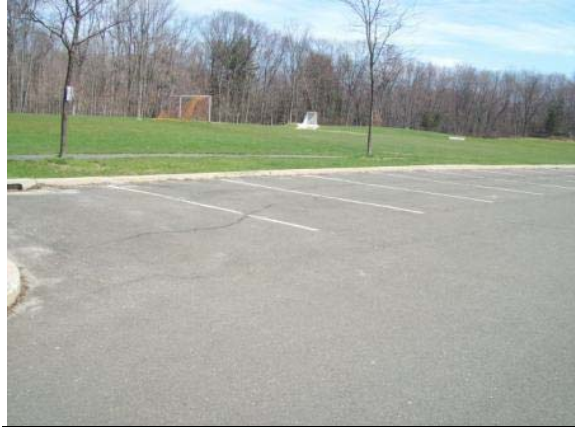
Photo #128: Asphalt detail

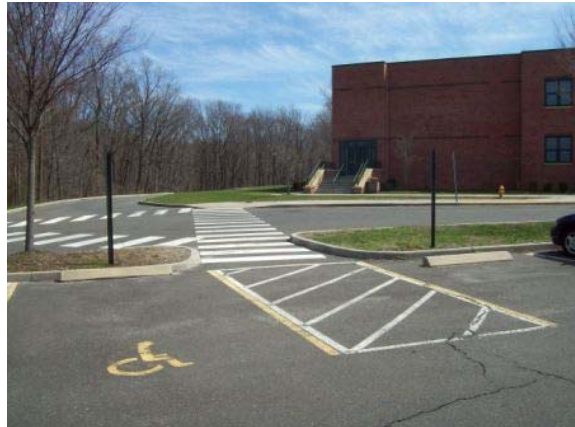
Photo #132: Accessible parking stalls with missing signage

3.1	4300	Replace existing ADA two-way communication system	0	0	0	3	EA	\$8,253.00	\$24,759										\$24,759
3.1	4299	ADA - Install signage indicating Van Accessible Parking, pole mounted	0	0	0	4	Sign	\$134.01	\$536										\$536

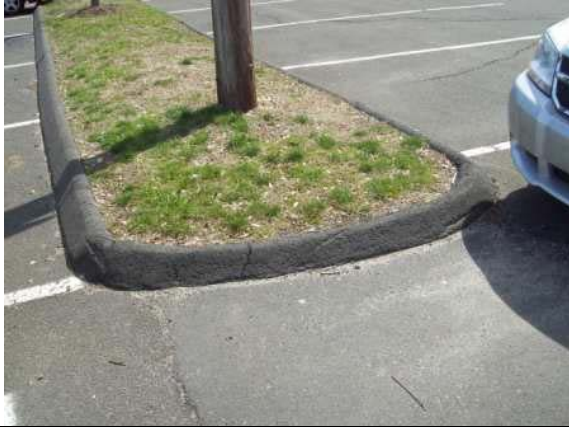
Photo #133: Extruded asphalt curbing

5.2	3931	Repair and Seal Coat asphalt	5	4	1	7.53	10000 SF	\$5,848.92	\$44,042	\$44,042									\$88,085
5.2	3932	Replace asphalt curbs	10	4	6	350	LF	\$14.63	\$5,120	\$5,120									\$5,120

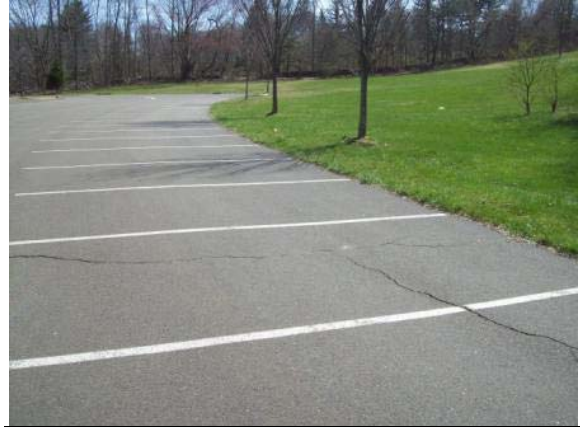
Photo #134: Asphalt with no curbing

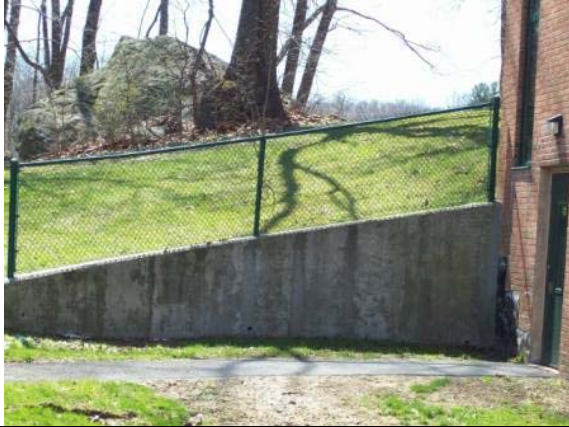
Photo #139:	Concrete retaining wall at east side of building
-------------	--

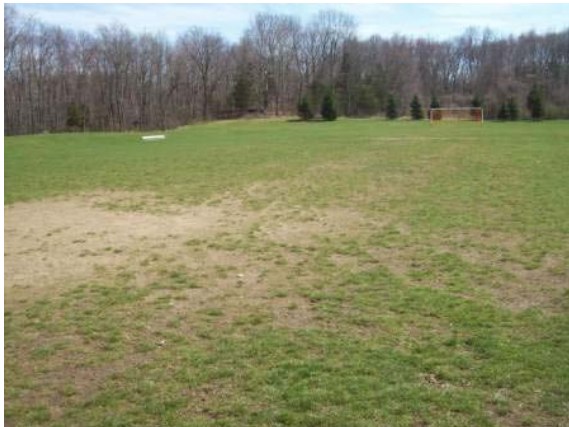
Photo #147: Barren grass on soccer field
