# FACILITIES NEEDS ASSESSMENT

## STAMFORD PUBLIC SCHOOLS

## FACILITIES NEEDS ASSESSMENT OF TURN OF RIVER MIDDLE SCHOOL

**EMG Project #:** 88166.09R-014.017  
**Date of Report:** August 29, 2009  
**On-Site Date:** April 6 and 7, 2009

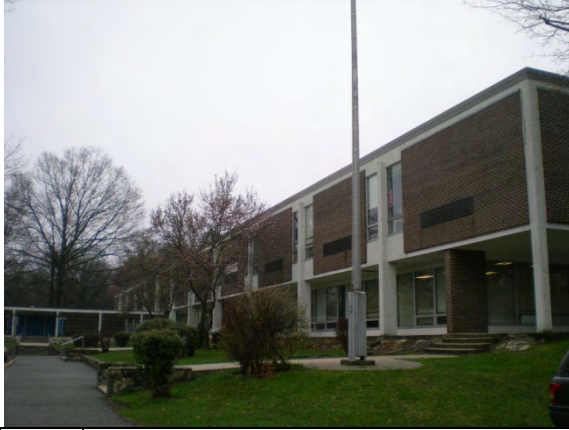
Photo #1:	Front entrance elevation (west facing elevation)
-----------	--

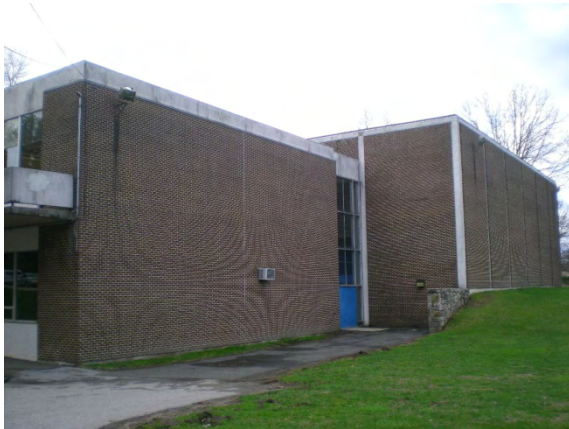
Photo #3:	West elevation of auditorium and classrooms
-----------	---

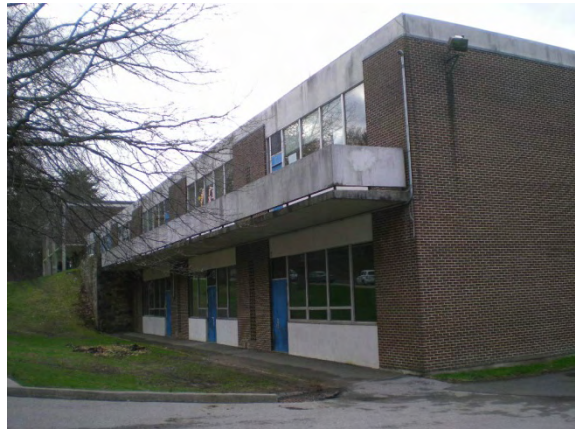
Photo #4:	North elevation along service drive
-----------	-------------------------------------

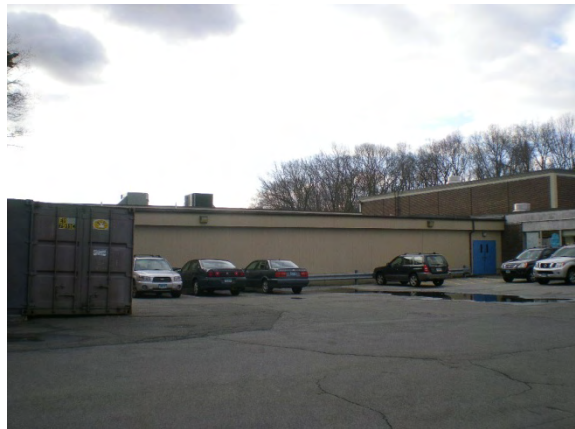
Photo #6:	West elevation of modular addition
-----------	------------------------------------

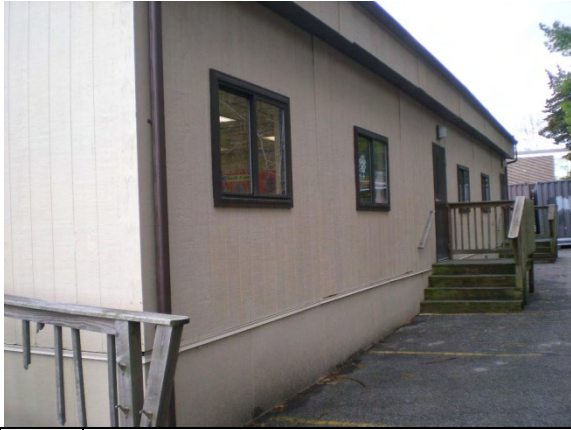
Photo #7: North elevation of modular addition

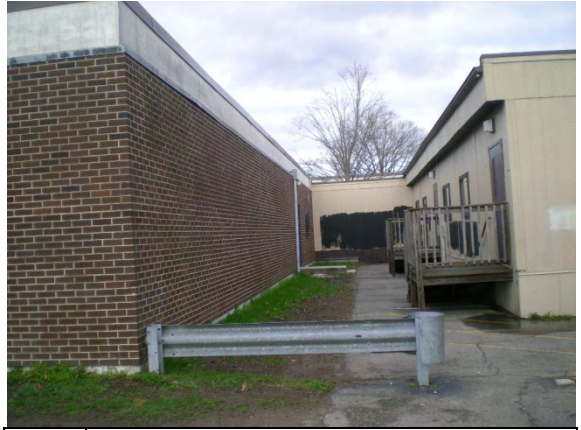
Photo #8: East elevation of modular showing connection to main building

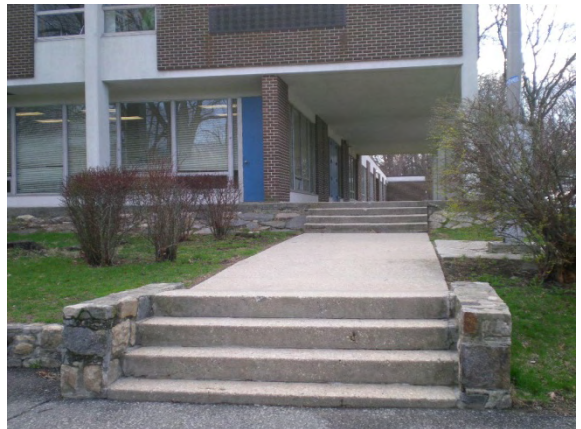
Photo #10: Exterior stairs with no railings and partial south elevation

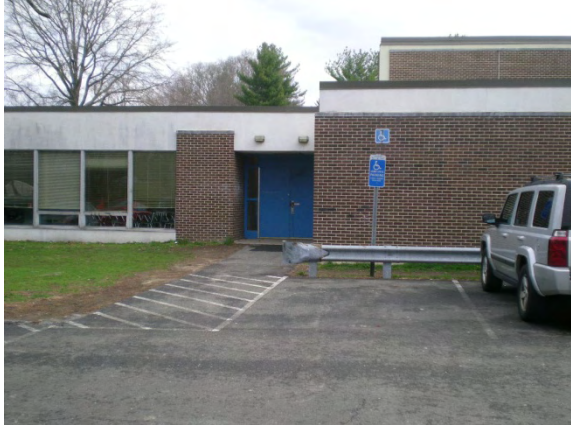
Photo #13:	ADA entrance and parking at south entrance
------------	--

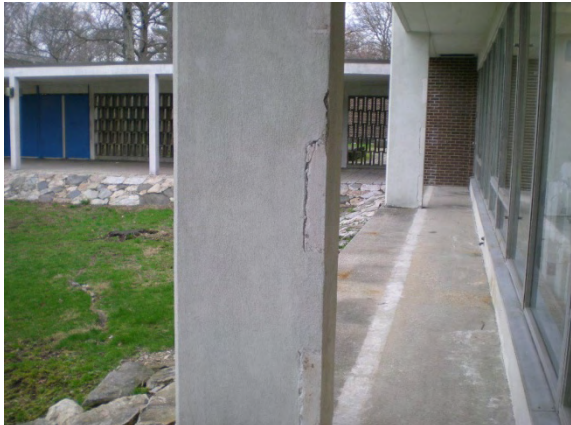
Photo #15:	Damaged column from former concrete block wall attachment
------------	---

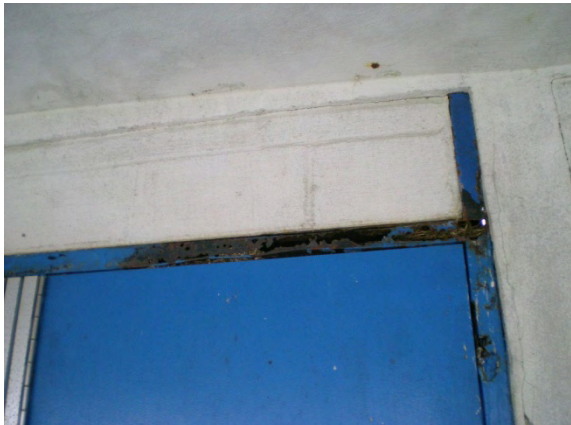
Photo #17:	Rusted through door frame at west courtyard entrance
------------	--

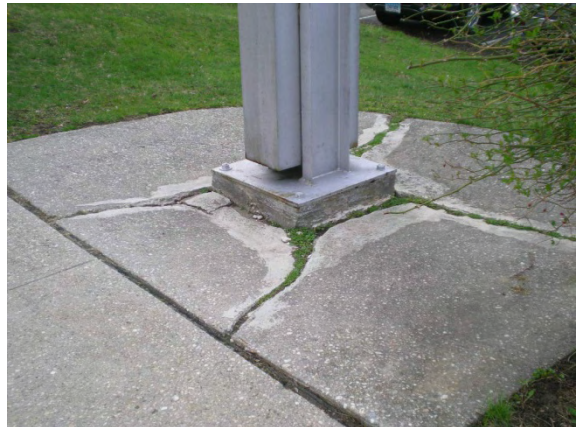
Photo #36:	Condition of base at flag pole
------------	--------------------------------

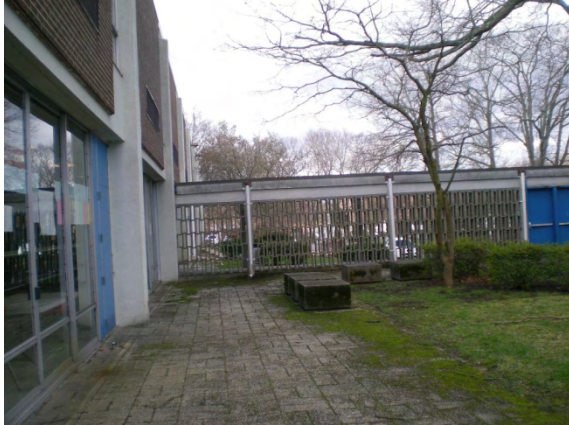
Photo #37: Courtyard pavers condition and partial elevations

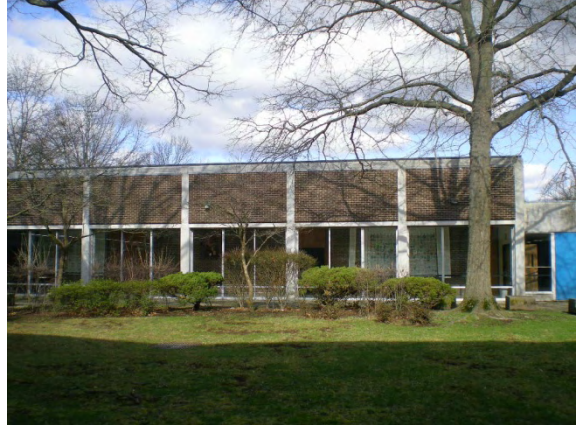
Photo #38: Courtyard elevation towards auditorium

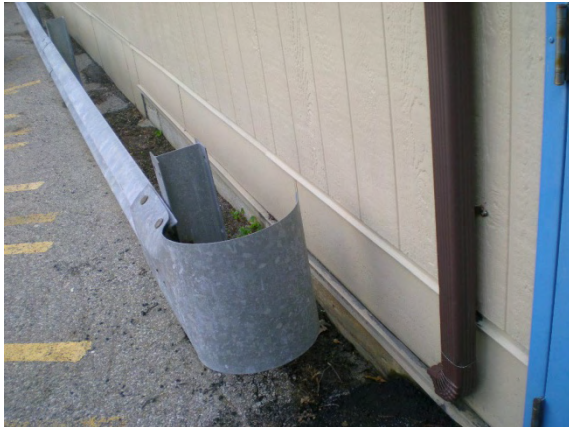
Photo #39: Modular addition slab connection at service yard area

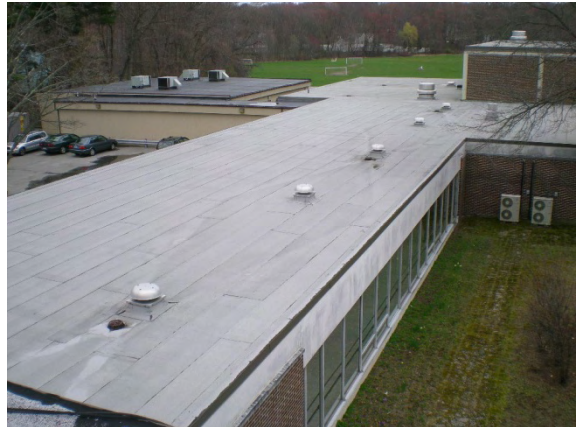
Photo #40: Roof overview of modular addition and partial roof around east courtyard

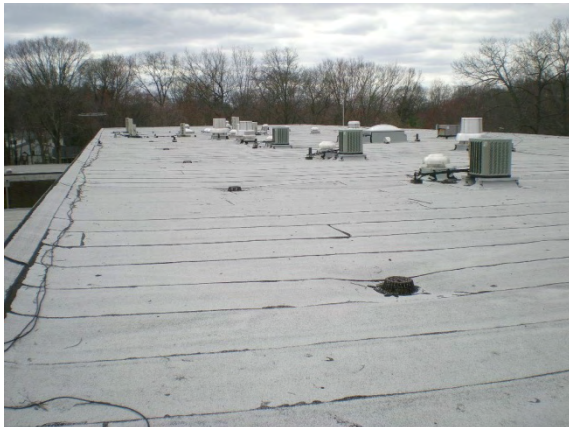
Photo #41: Roof overview of central building spine including main office and cafeteria

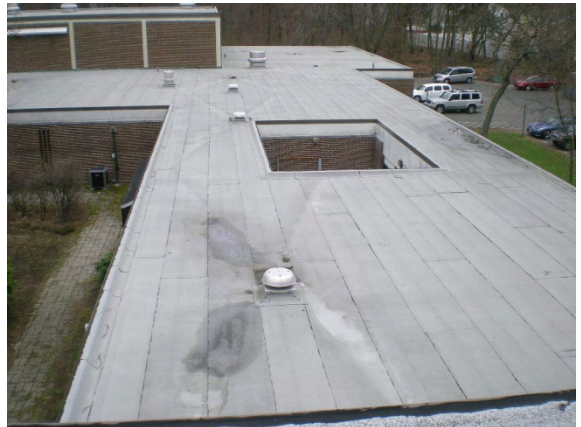
Photo #42: Roof overview along south section

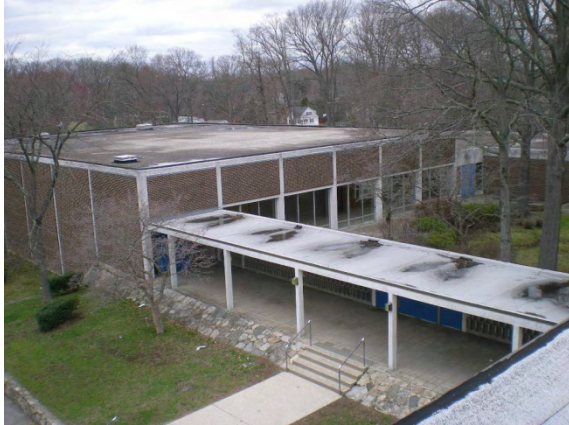
Photo #43: Roof overview of covered walkway and auditorium

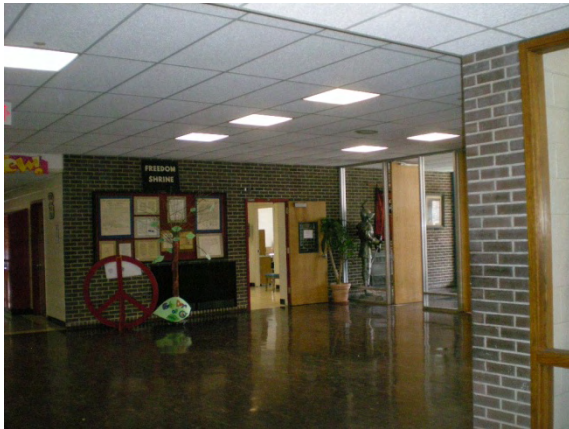
Photo #45: Main lobby

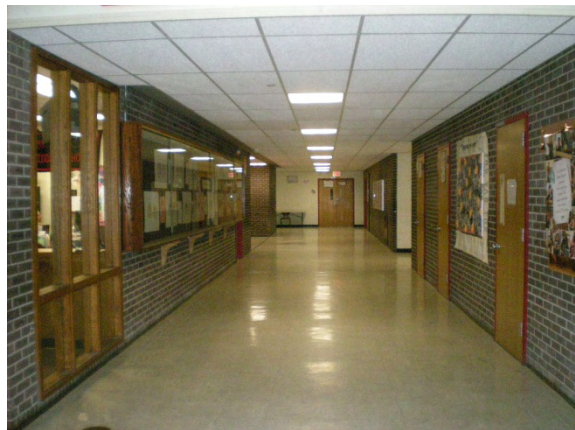
Photo #48: Corridor along main office

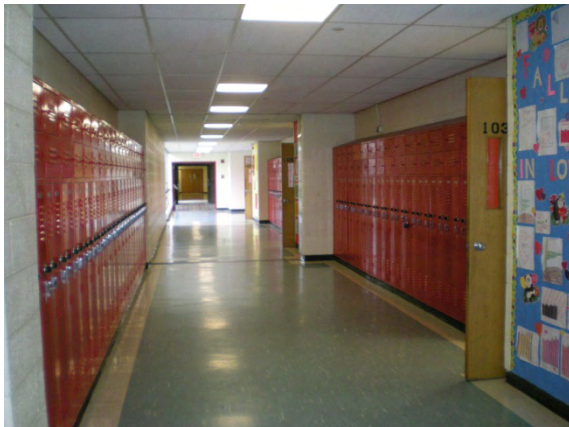
Photo #51: Typical corridor

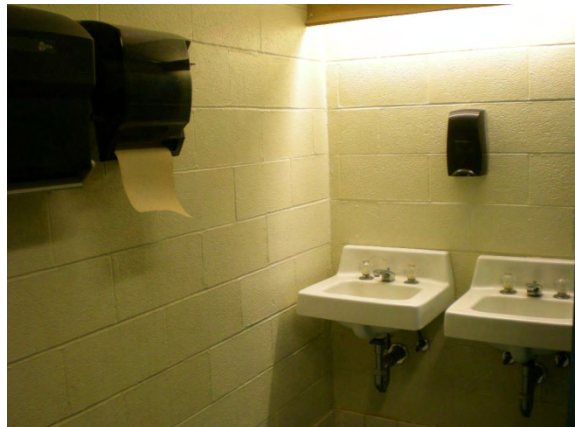
Photo #52: Women's restroom closest to main entrance

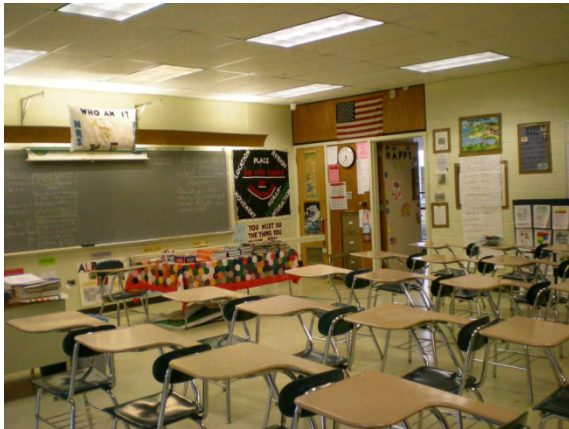
Photo #57: Typical classroom

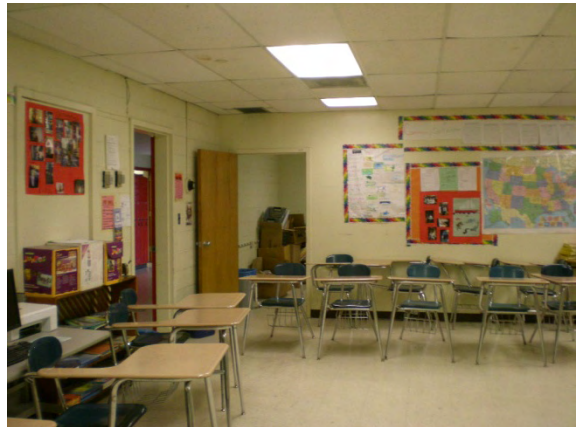
Photo #60: Classroom 115 with small classroom carved out. Access through 115 only

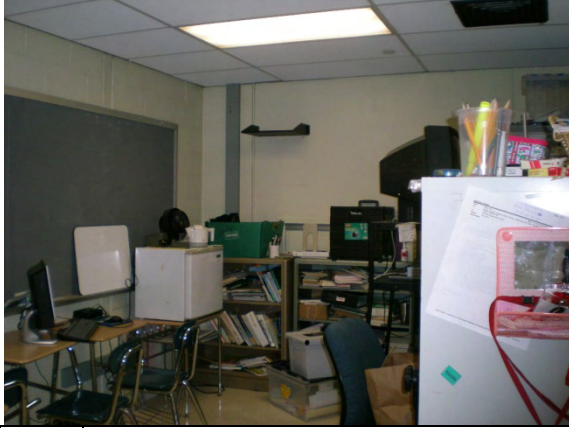
Photo #61: Interior classroom off 115

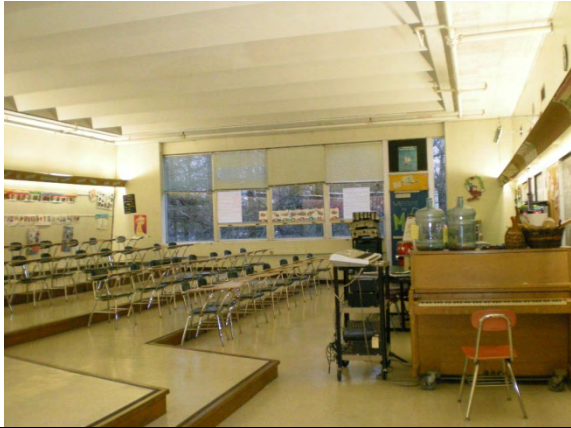
Photo #79:	Music room with high ceilings and acoustic treatment
------------	--

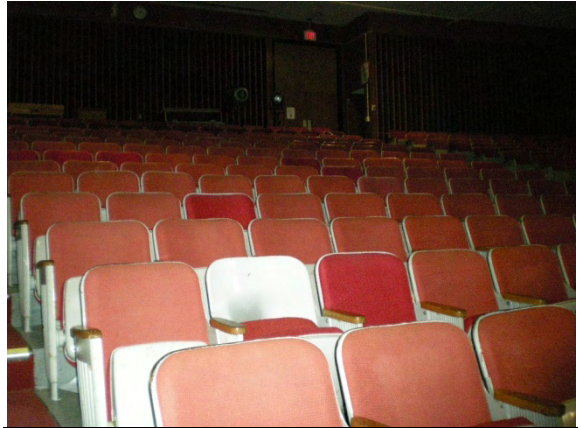
Photo #80:	Condition of auditorium seating
------------	---------------------------------

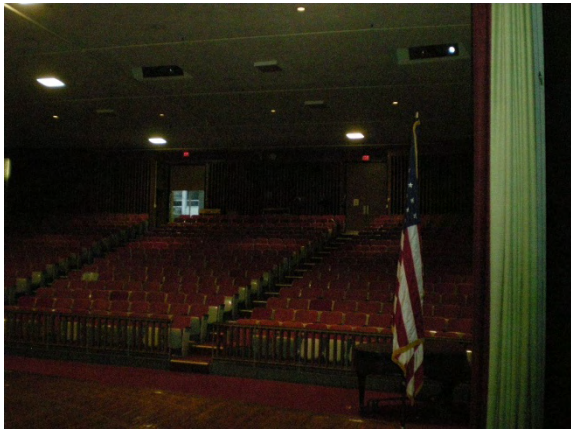
Photo #81:	Overview of auditorium
------------	------------------------

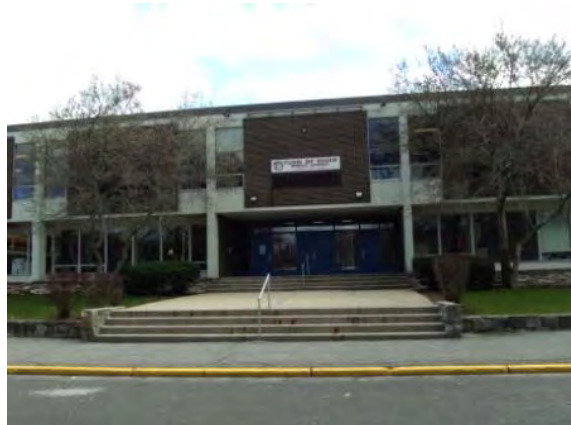
Photo #92: Front elevation of building and building identification signage (west elevation)

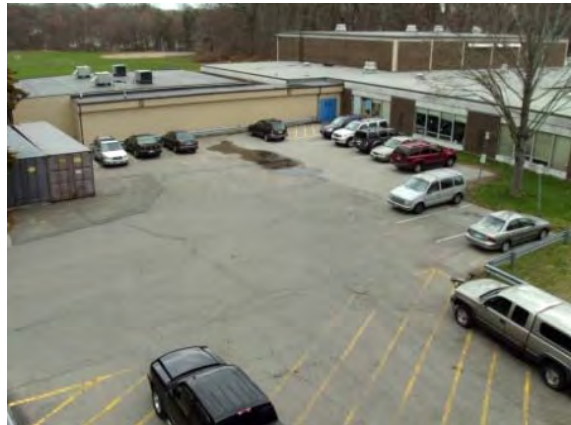
Photo #94: Parking lot at rear of building (north elevation)

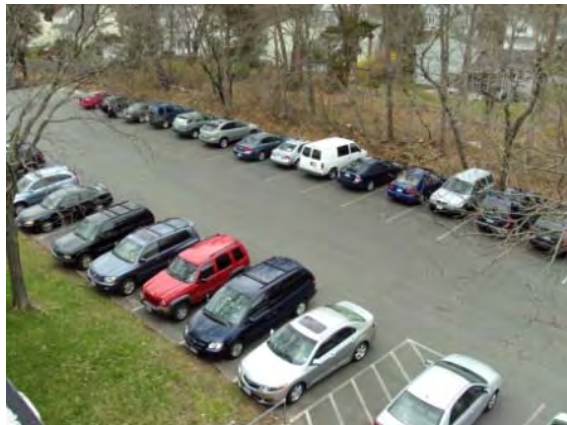
Photo #95: Parking lot at right side of building (south elevation)

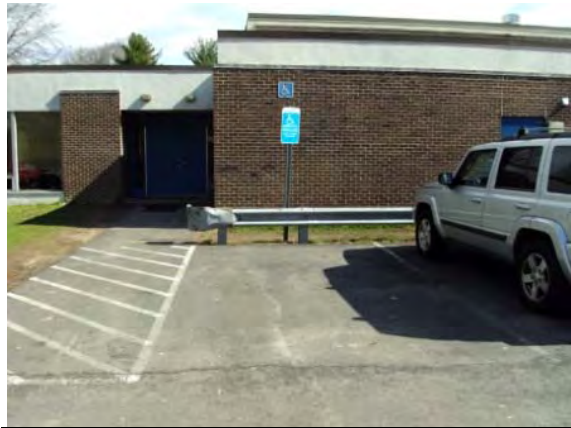
Photo #98:	Accessible parking at right side of building (south elevation)
------------	--

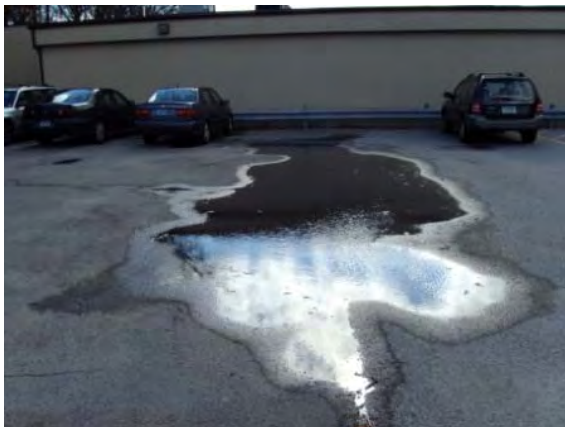
Photo #99:	Ponding at asphalt pavement at rear parking lot
------------	---

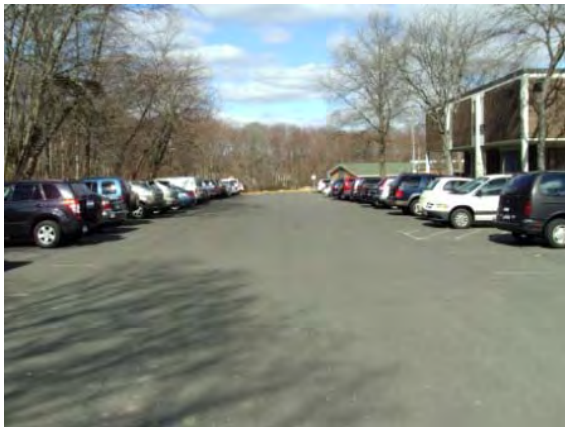
Photo #101:	Worn pavement and striping at right side of building
-------------	--

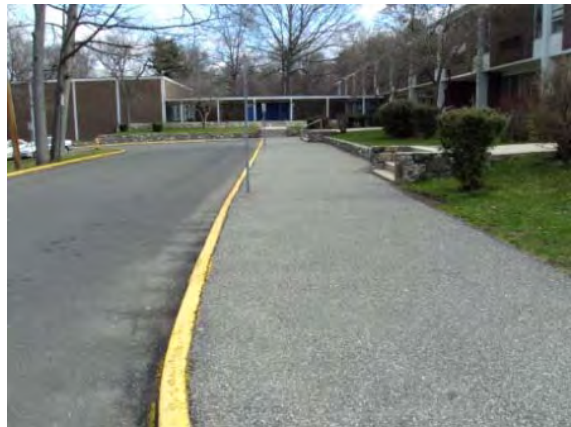
Photo #102:	Asphalt sidewalk and curbing at front elevation
-------------	---

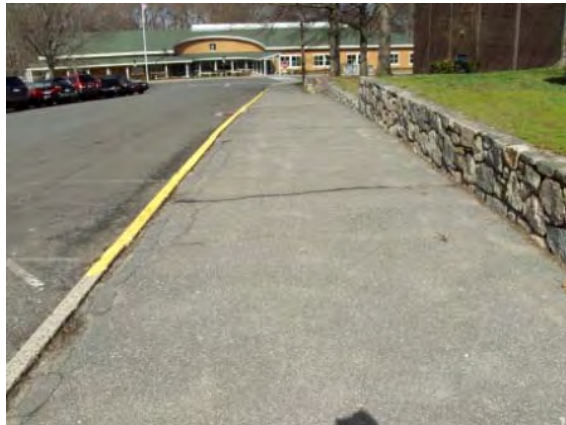
Photo #103: Asphalt sidewalk and curbing at side elevation

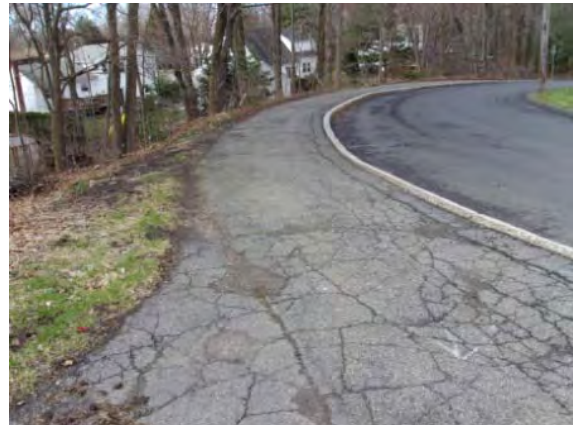
Photo #104: Asphalt condition at sidewalk leading to adjacent neighborhood (south elevation)

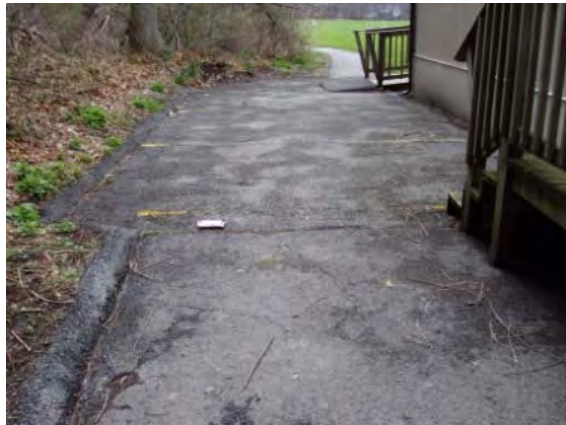
Photo #105: Asphalt condition at sidewalk adjacent to modular building

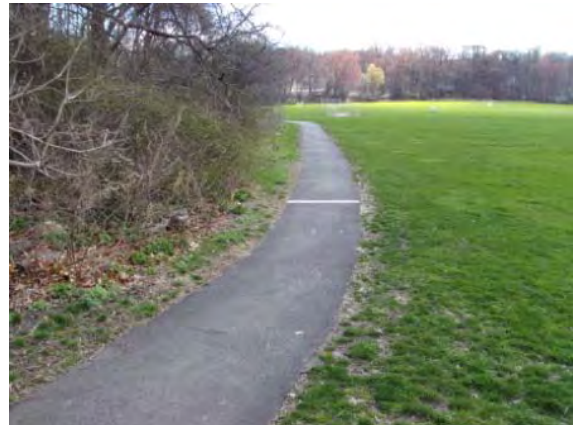
Photo #106: Asphalt walking path leading to playfields at the northeast elevation

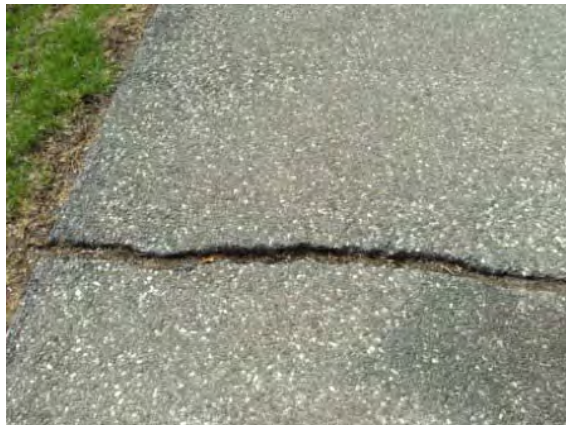
Photo #107: Settlement and cracking at asphalt sidewalk at left side of building

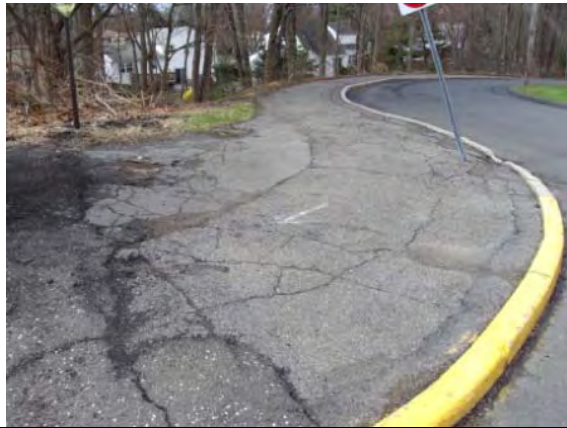
Photo #109: Asphalt deterioration at sidewalk leading to adjacent neighborhood (south elevation)

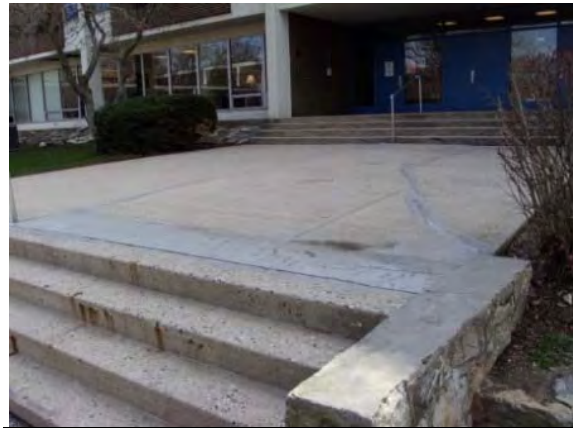
Photo #110: Concrete sidewalk leading to main entrance

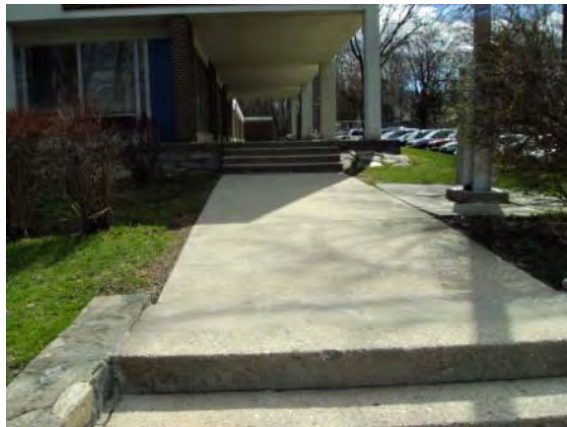
Photo #111: Concrete sidewalk at front elevation

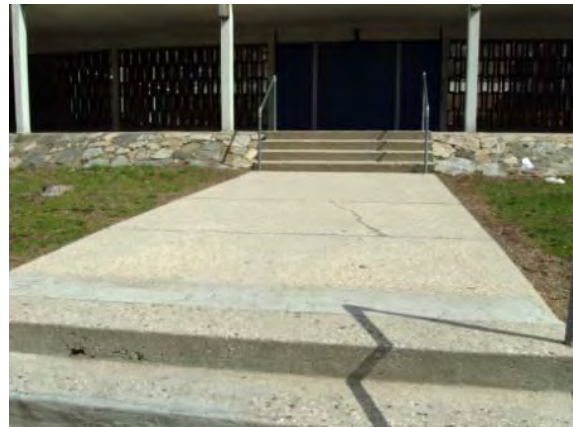
Photo #112: Concrete sidewalk at side elevation

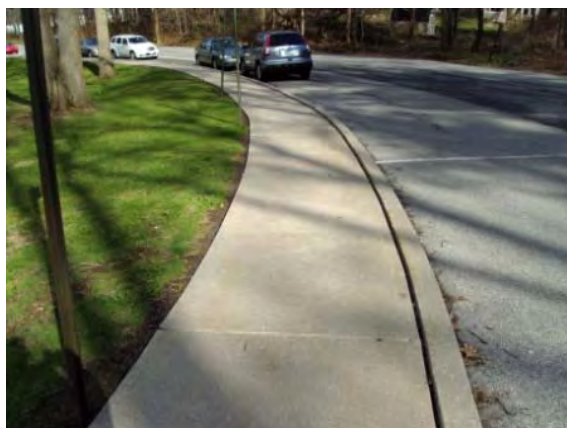
Photo #113: Concrete sidewalk and curbing along rear drive lane

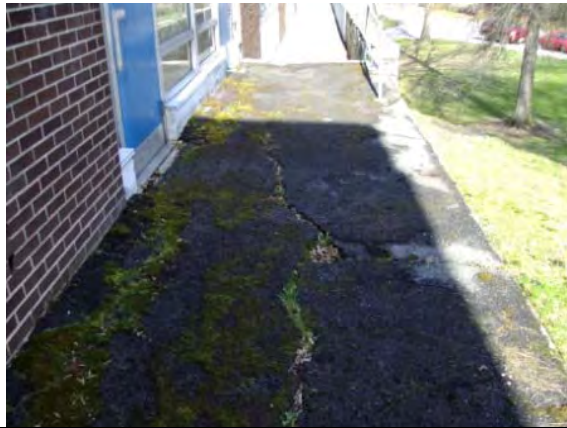
Photo #115: Deteriorated asphalt on top of concrete sidewalk at rear of building

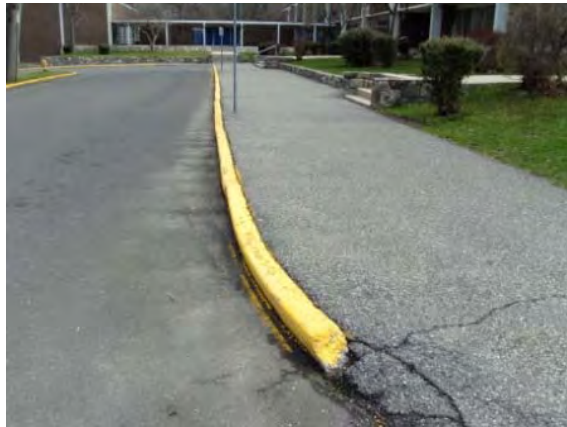
Photo #117: Shifting concrete curbing along front sidewalk

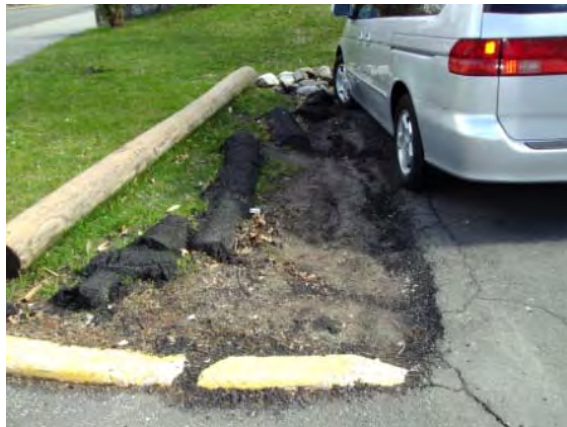
Photo #119: Displaced asphalt curbing at south parking lot

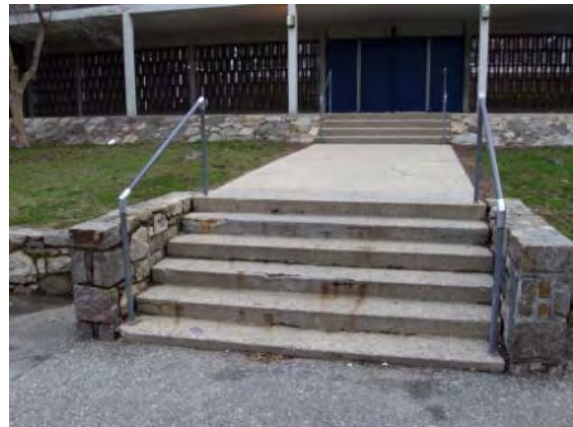
Photo #120: Concrete steps with metal handrails

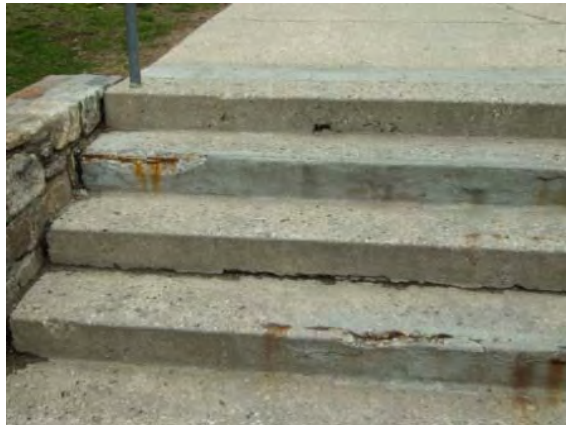
Photo #121: Deterioration at concrete steps at side elevation

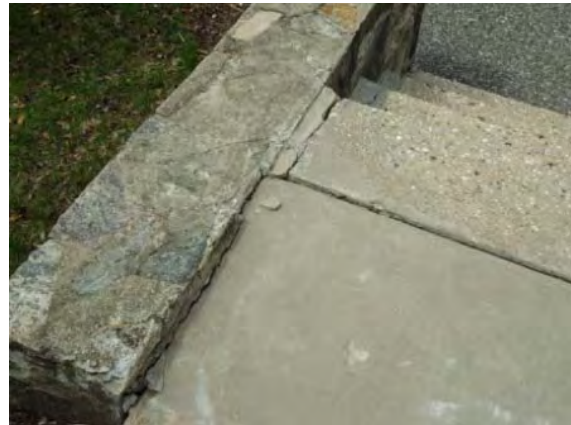
Photo #122: Deterioration at concrete steps at front elevation

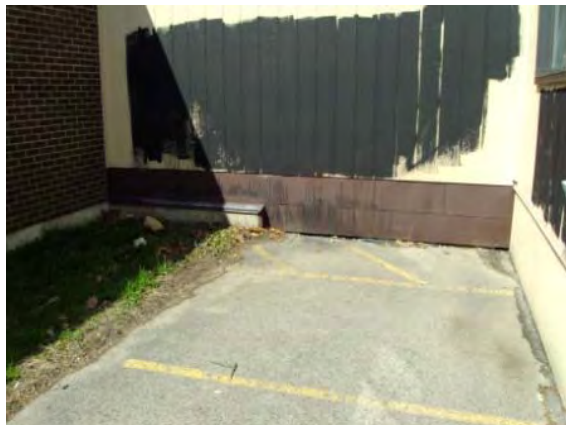
Photo #123: Inadequate drainage at rear of modular building (east elevation)

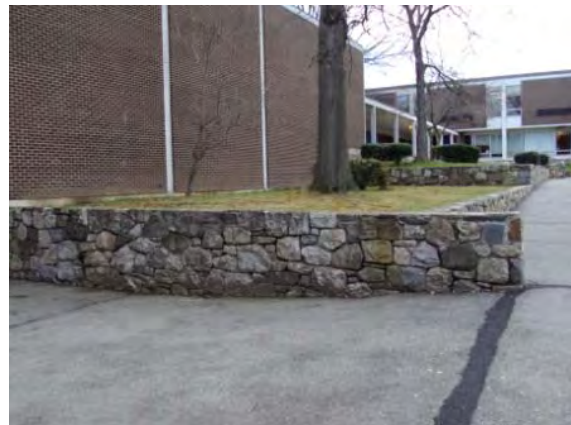
Photo #124: Stone masonry retaining walls along side elevation of building

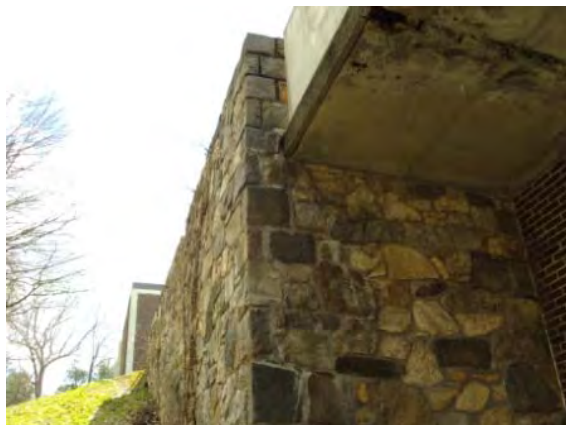
Photo #125: Stone masonry retaining wall at rear of building

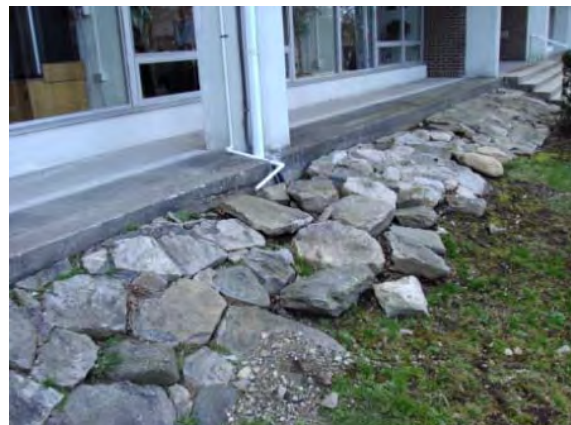
Photo #126: Loose stones and deteriorated mortar at sloped stone retaining wall (front elevation)

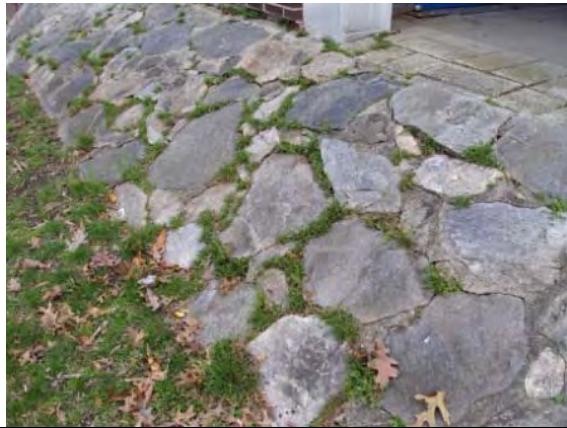
Photo #127: Vegetation growth at sloped stone masonry retaining wall (side elevation)

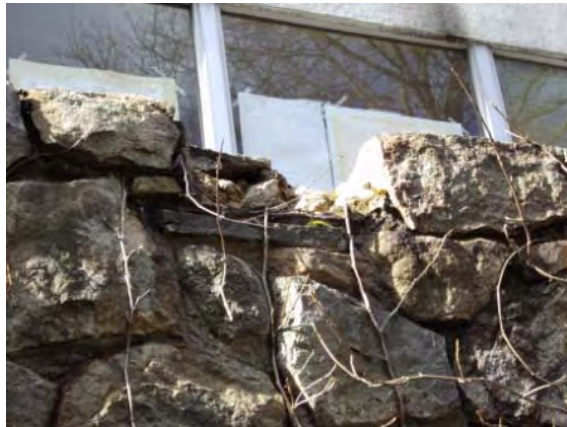
Photo #129: Deterioration at rear stone retaining wall

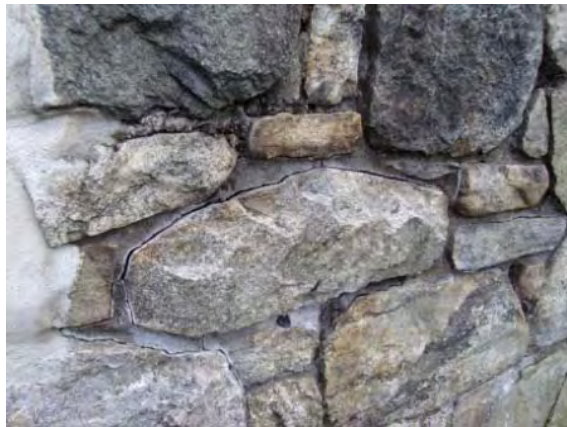
Photo #131: Cracking mortar at stone retaining wall at left side of building

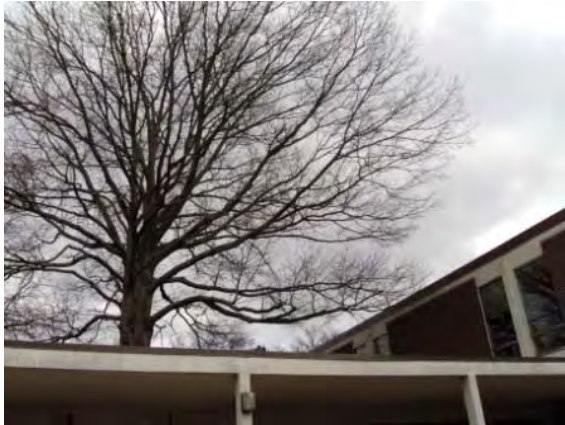
Photo #133: Tree overhanging roof surface at courtyard

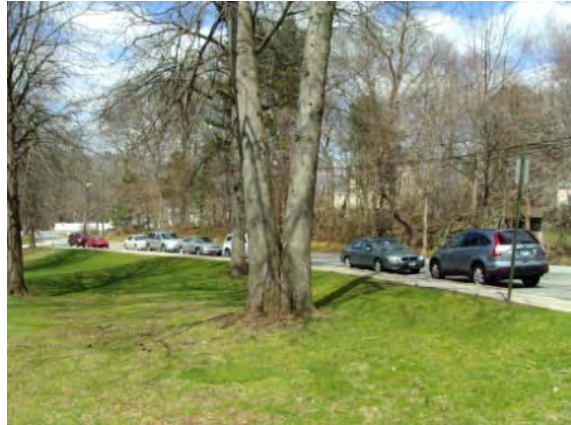
Photo #134: Tree splitting and leaning towards building at rear elevation

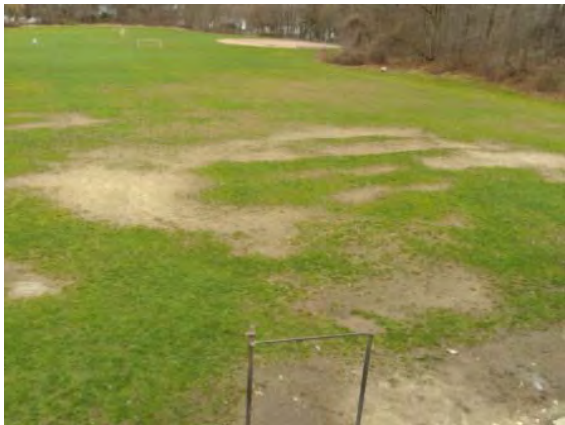
Photo #135: Barren landscaping at rear of building (east elevation)

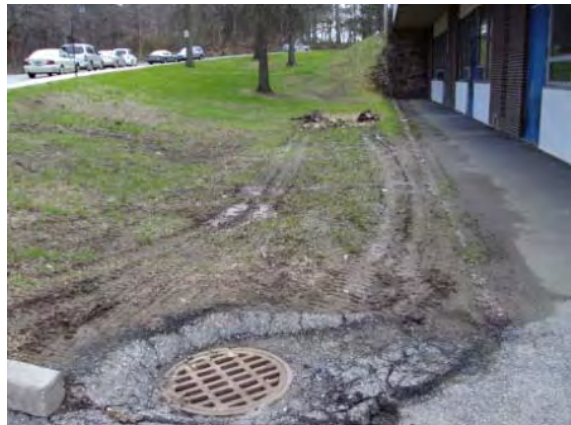
Photo #136: Barren landscaping and deterioration at drainage inlet - rear of building (northwest elevation)

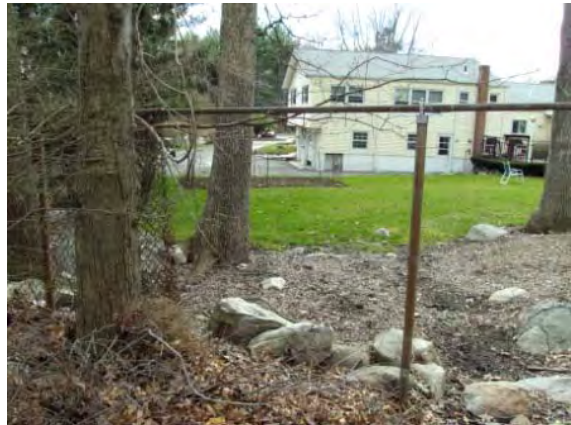
Photo #142: Damaged chain link fencing along perimeter at southeast elevation

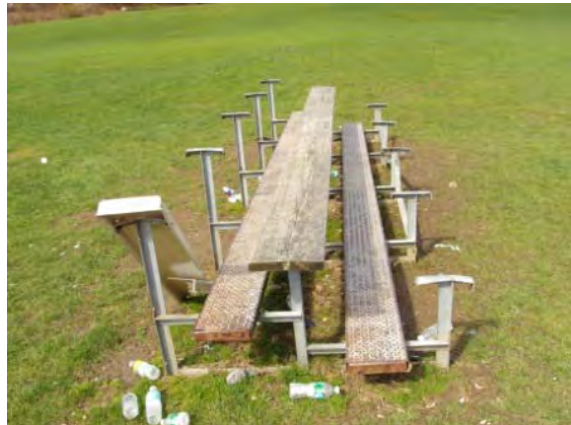
Photo #150: Bleacher at soccer field (damaged and missing seats)

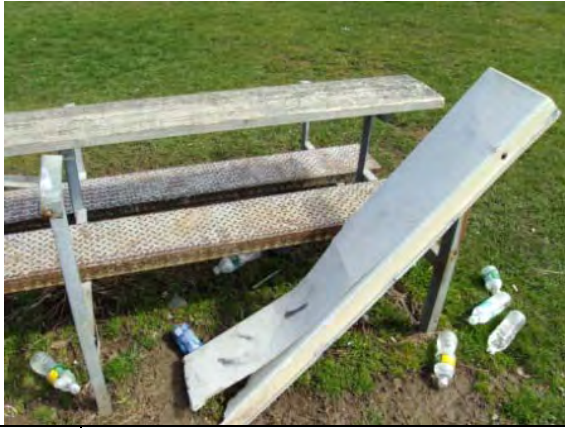
Photo #151: Damaged bleacher seat at soccer field

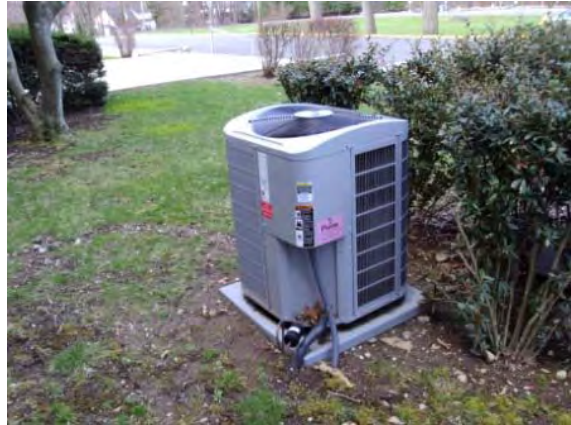
Photo #170: Pad-mount condensing unit at front of school

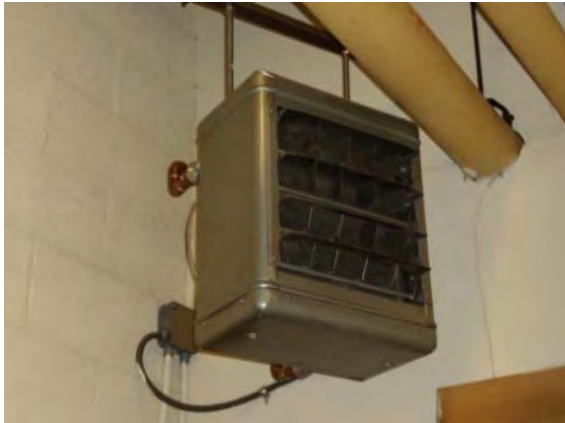
Photo #171: Unit heater at custodian office

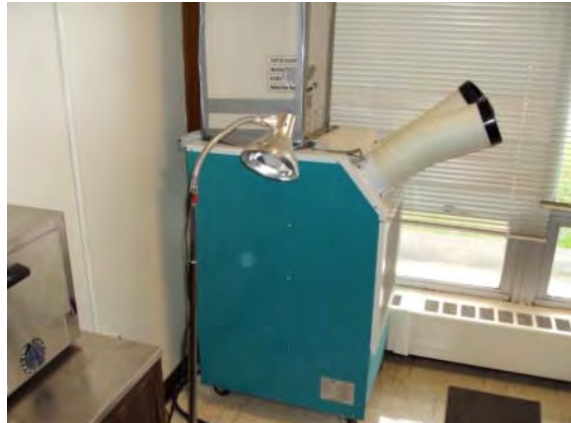
Photo #172: Portable AC unit at Nurses office

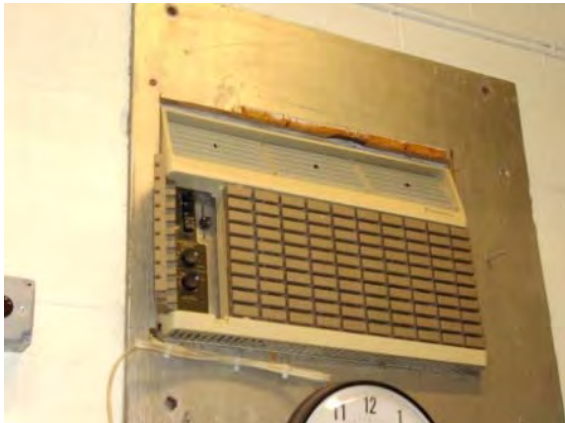
Photo #173: Through-wall AC unit at custodian office

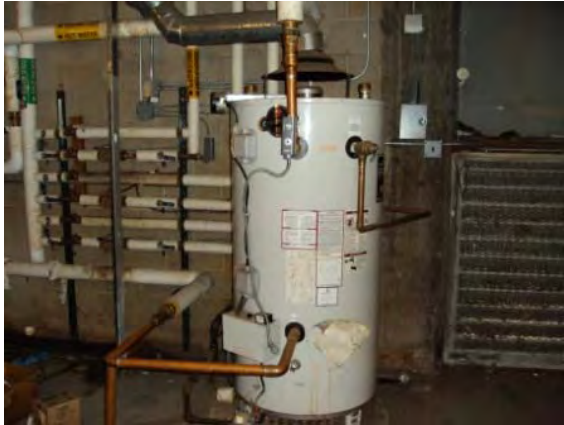
Photo #175: Domestic water heater at basement mechanical room

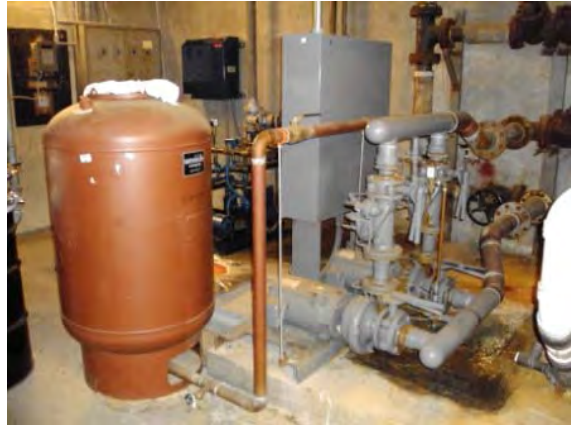
Photo #176: Domestic water booster system at basement mechanical room

32. Are the water heaters/boilers more than ten years old?	✓				
33. Is polybutylene piping used at the property?		✓			
34. Are there any plumbing leaks or water pressure problems?	✓				Only pressure issue, but booster works

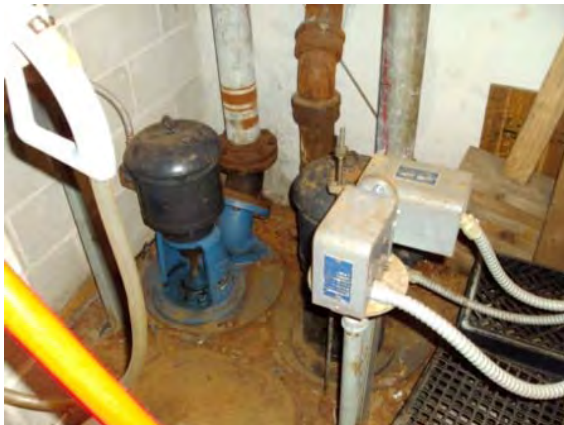
Photo #177: Dual sewage pump system at lower level

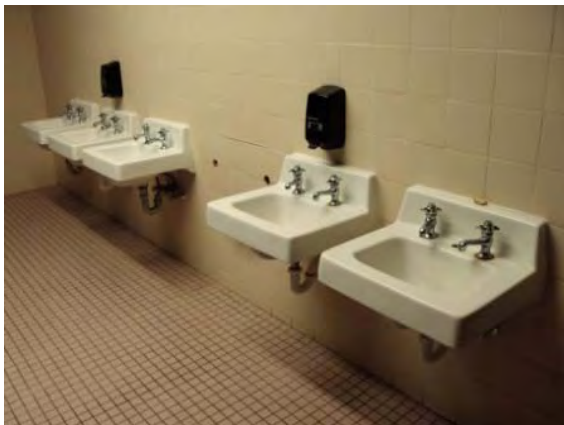
Photo #179: Common area restroom lavatory sinks

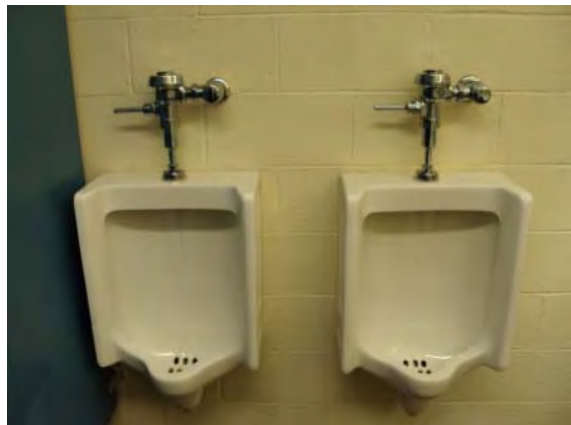
Photo #180: Boys common area restroom urinals

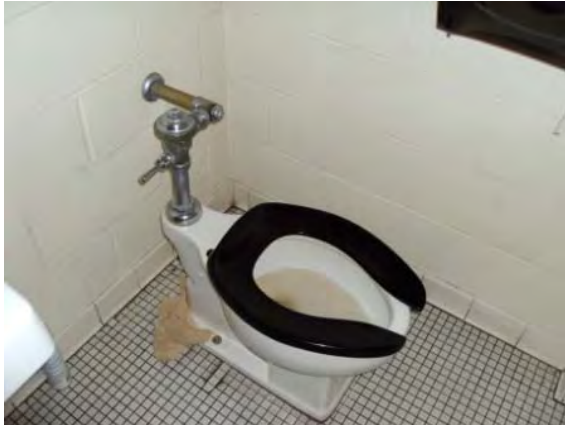
Photo #181: Floor-mounted toilet at restroom

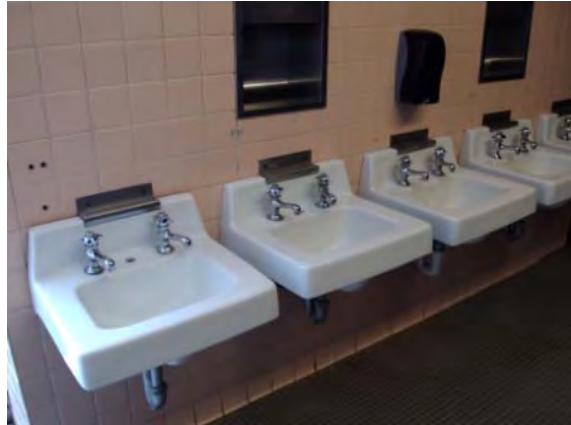
Photo #182: Girls common area restroom lavatory sinks with wall-bracket for added support

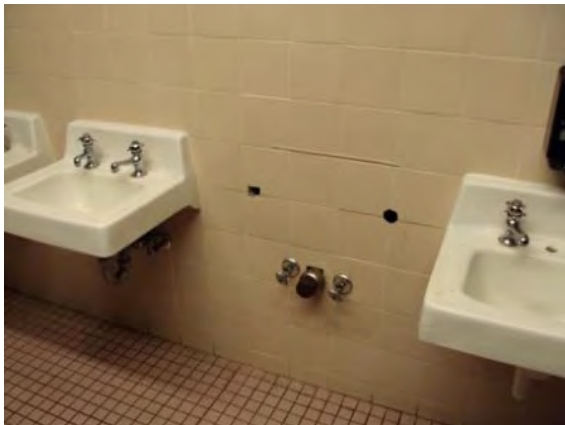
Photo #183: Girls common area restroom missing a lavatory sink

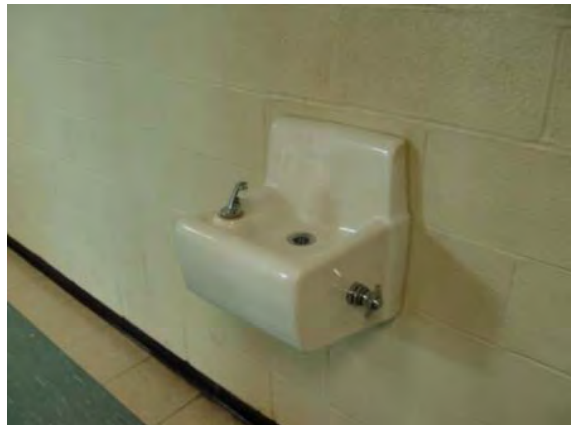
Photo #184: Common area drinking fountain at corridor

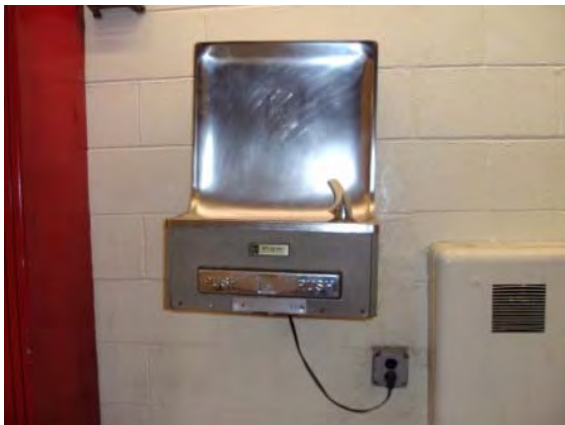
Photo #185: Common area drinking fountain at corridor missing GFCI outlet

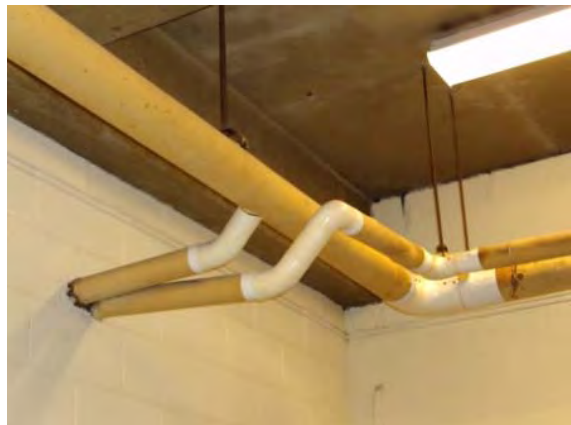
Photo #186: Suspect ACM at pipe covering at custodian office

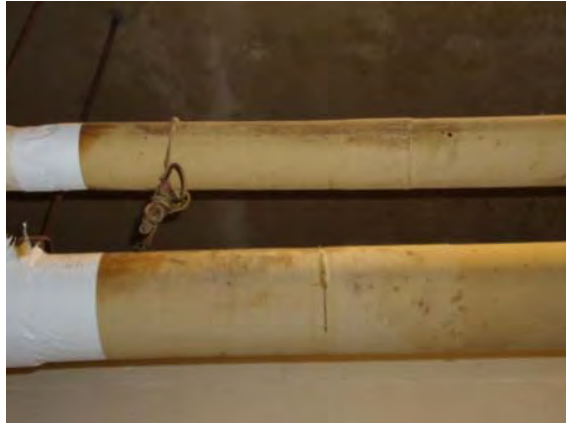
Photo #187: Damaged suspect ACM at pipe covering at custodian office

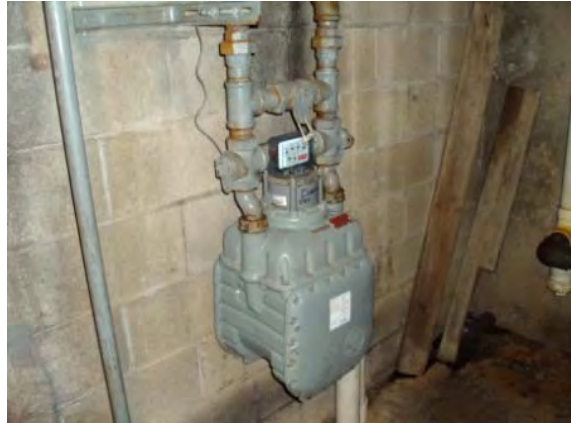
Photo #188: Gas metering at basement

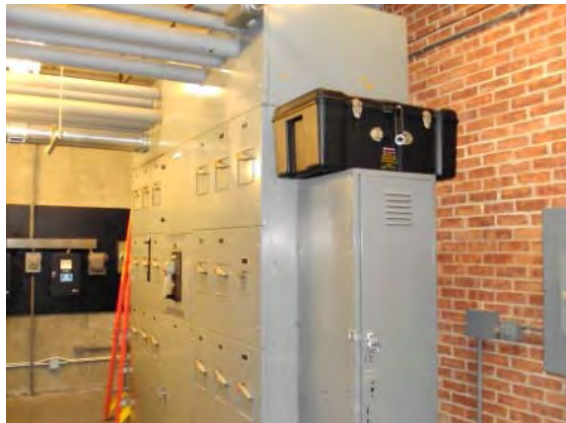
Photo #189: Main electrical switchgear in basement of building

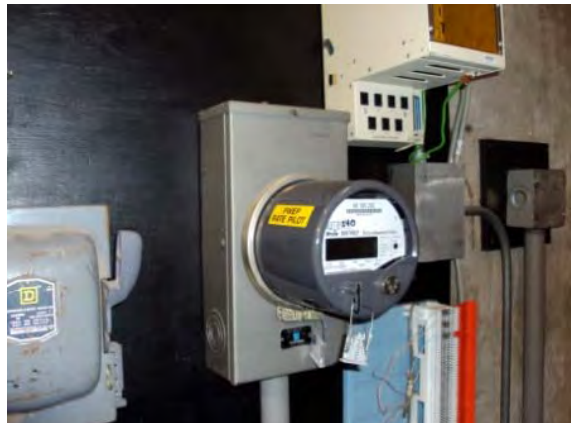
Photo #190: Electric meter at main electrical room

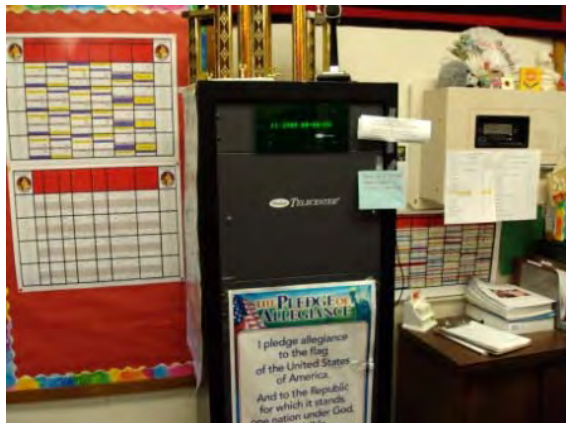
Photo #191: School PA system equipment at office

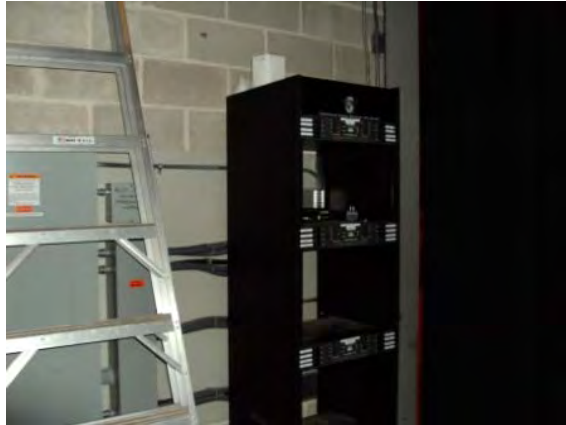
Photo #193: Auditorium lighting controls

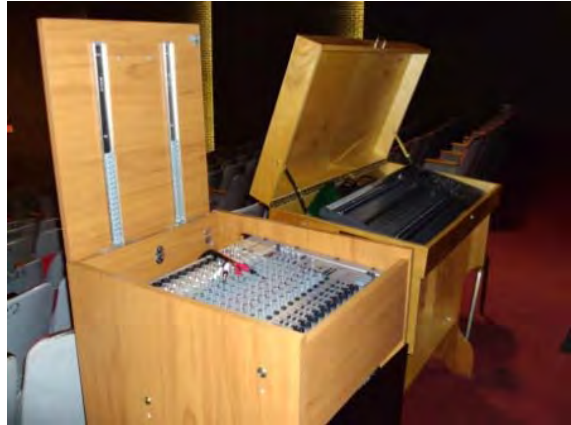
Photo #194: Auditorium audio controls

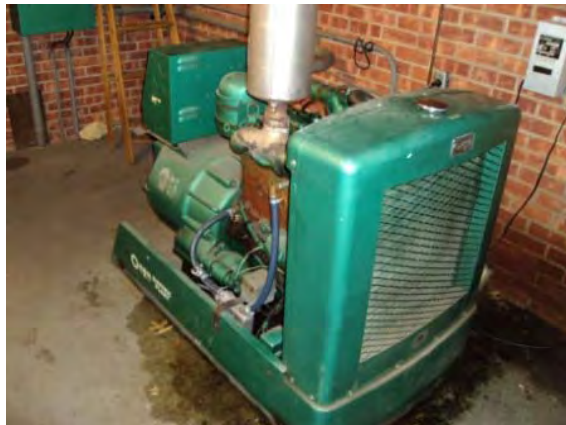
Photo #195: Emergency generator in basement
