# FACILITIES NEEDS ASSESSMENT

## STAMFORD PUBLIC SCHOOLS

## FACILITIES NEEDS ASSESSMENT OF TURN OF RIVER MIDDLE SCHOOL

**EMG Project #:** 88166.09R-014.017  
**Date of Report:** August 29, 2009  
**On-Site Date:** April 6 and 7, 2009

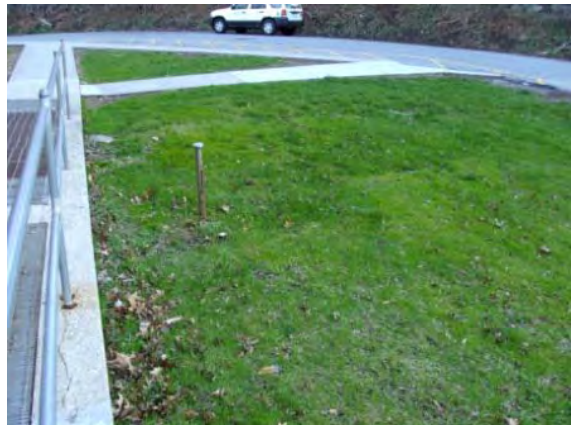
Photo #196: Generator underground fuel storage tank at rear of building

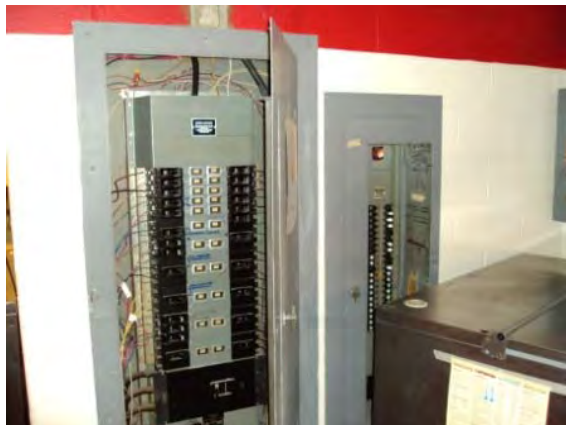
Photo #197: Original circuit breaker panels in kitchen

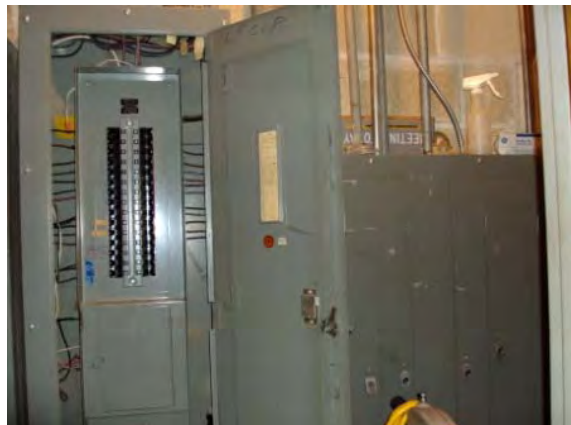
Photo #198: Original circuit breaker panels in electrical closet

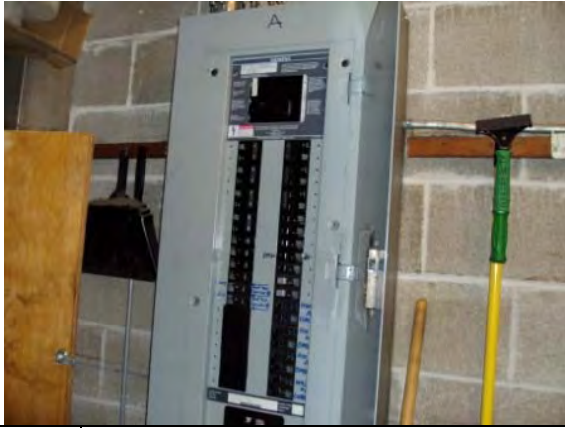
Photo #1339 : Replacement circuit breaker panel

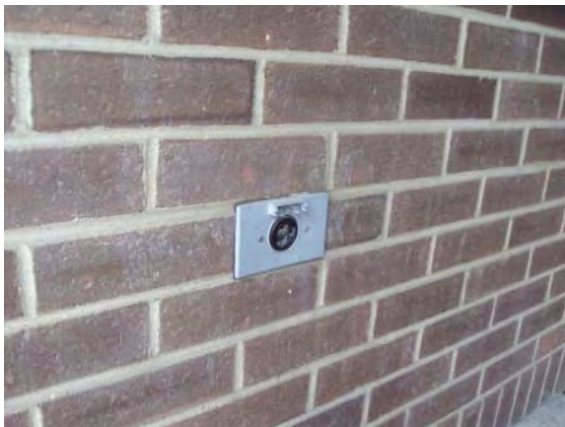
Photo #135: Exterior outlet missing GFCI and cover at main entrance

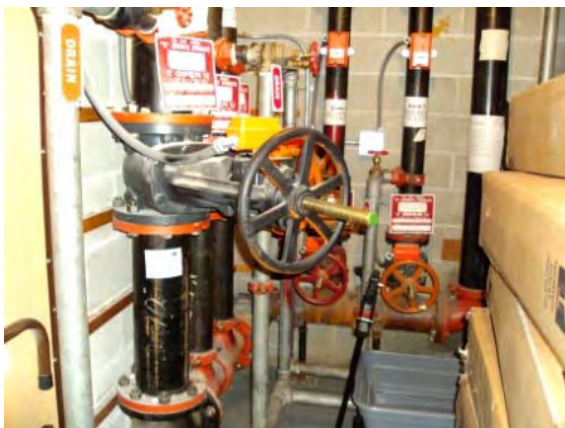
Photo #137: Fire suppression risers

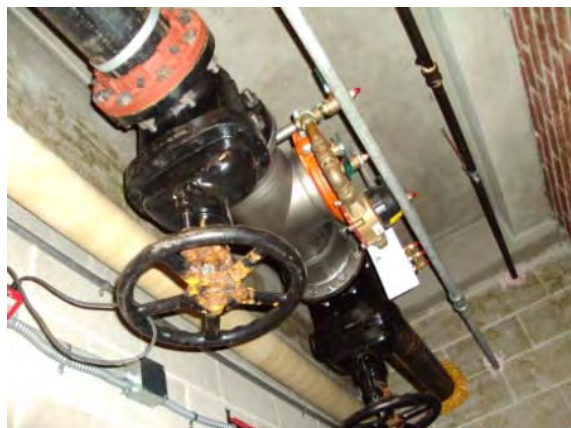
Photo #138: BFP for fire sprinkler system

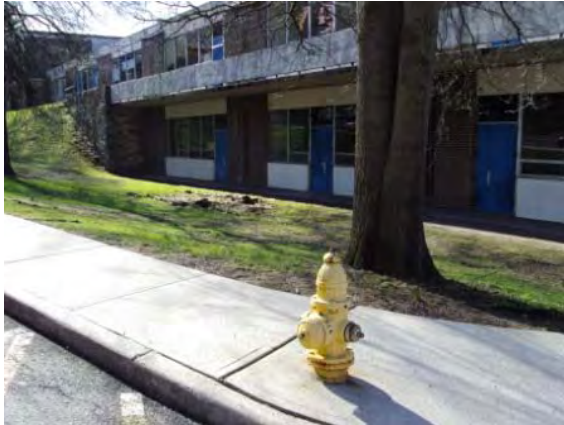
Photo #139: Fire hydrant at left side of building

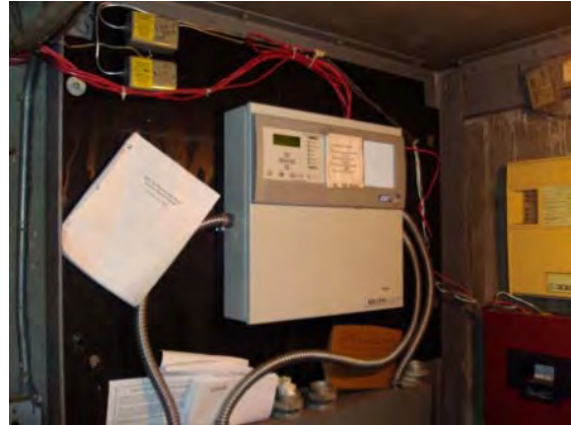
Photo #140: Central fire alarm panel at basement mechanical room

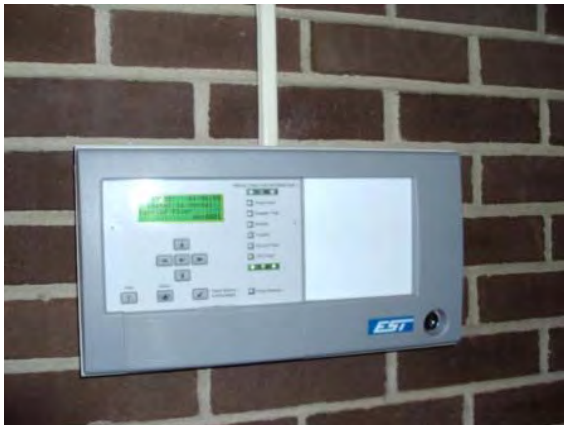
Photo #141: Annunciator panel at entry vestibule

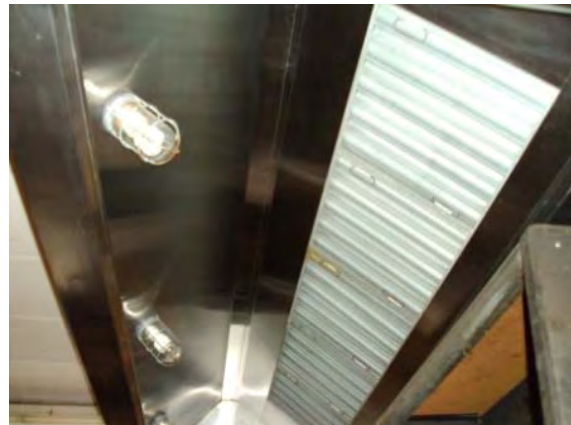
Photo #142: Exhaust hood without Ansul fire suppression

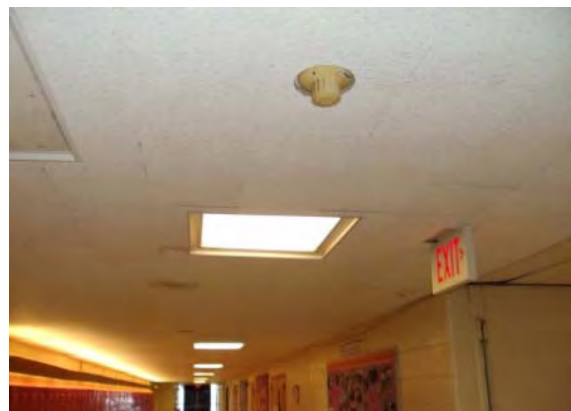
Photo #210: Smoke detector and illuminated exit sign

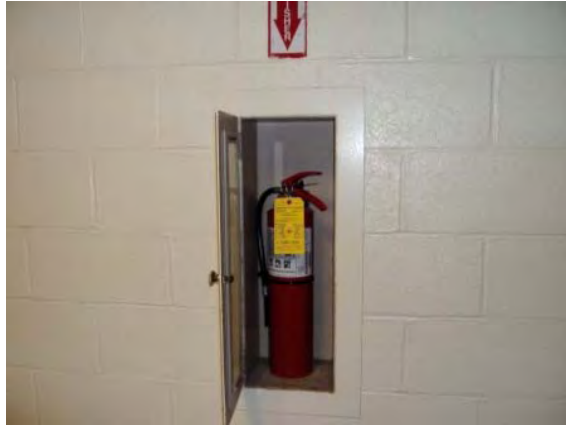
Photo #211: Cabinet-mount fire extinguisher

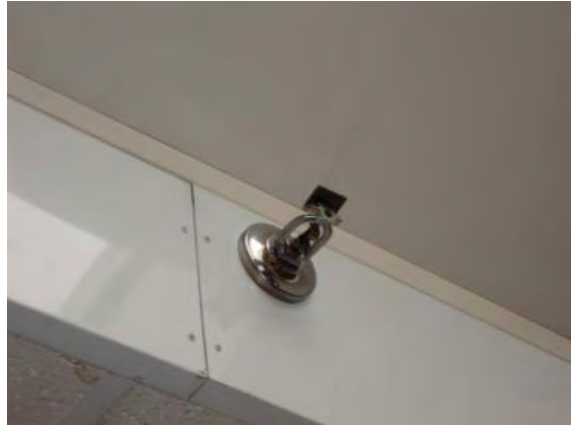
Photo #212: Sprinkler head

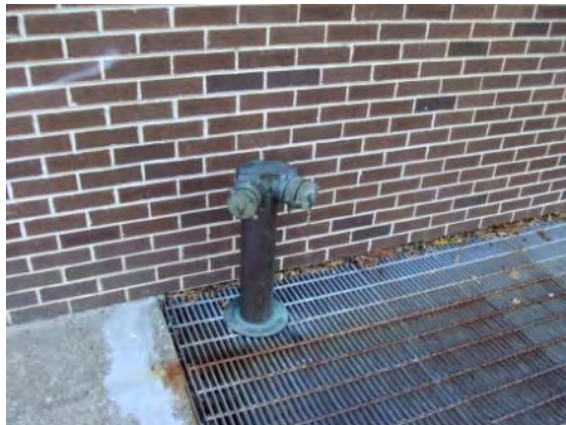
Photo #213: Siamese connection at rear of building

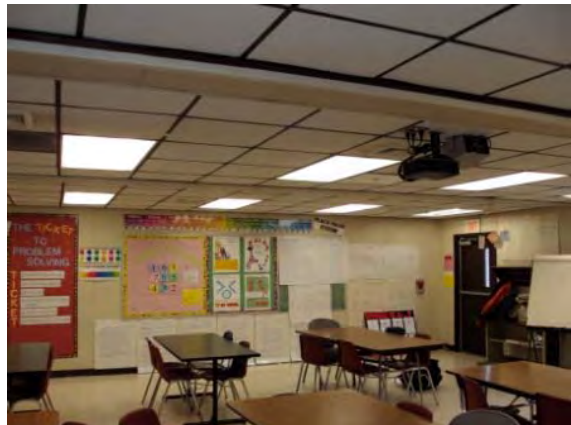
Photo #214: Modular classroom with sprinkler heads

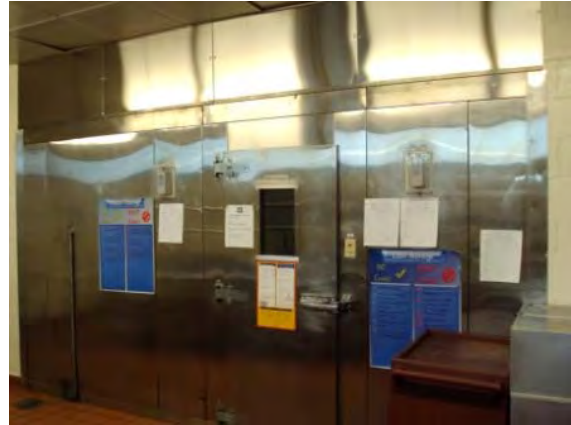
Photo #218:	Walk-in refrigerator/freezer
-------------	------------------------------

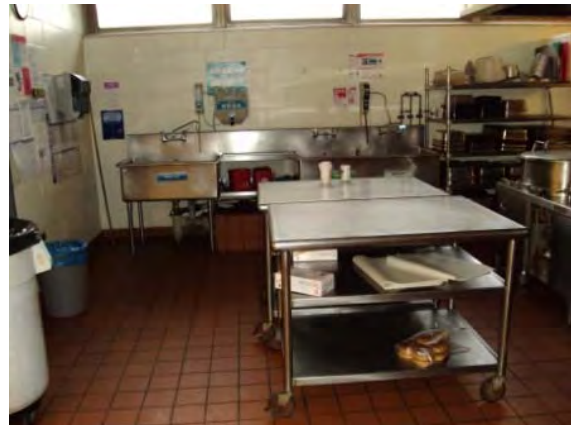
Photo #220:	Kitchen work tables and 3-compartment sink and faucets
-------------	--
