M. Gottfried, Inc.

DATE: October 14, 2019

RE: Roof report and repair quotation
Turn of River Middle School
117 Vine Road
Stamford, CT 06905

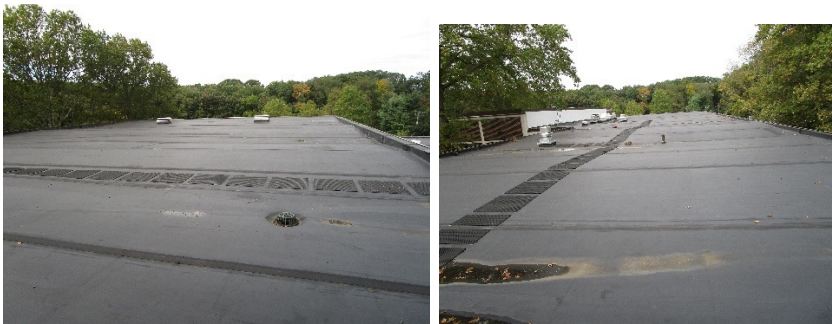
The last large area is a **JM EPDM roof** that was installed in 2013. It has an active 20-year warranty in place. The JM EPDM roof is relatively new and still in excellent shape. That being said, there are a number of items on the roof that need attention. No wet areas were found on this roof in the infra-red scan.

Views of the JM EPDM roof
