FACILITIES NEEDS ASSESSMENT

STAMFORD HIGH SCHOOL

55 Strawberry Hill Avenue
Stamford, Connecticut 06902

EMG Project #: 88166.09R-021.017
Date of Report: August 30, 2009
On site Date: April 8 - 10, 13, 2009

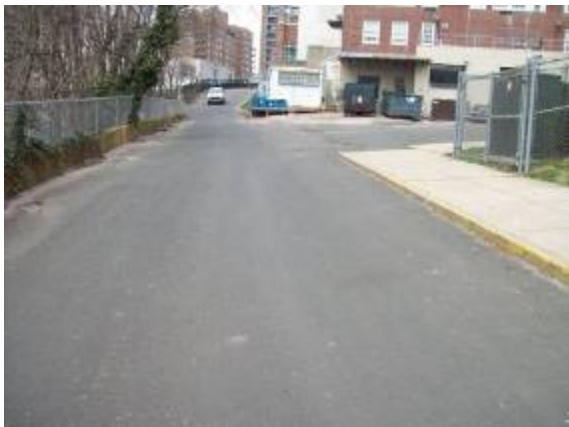
Photo #5:	Drive aisle at south side
-----------	---------------------------

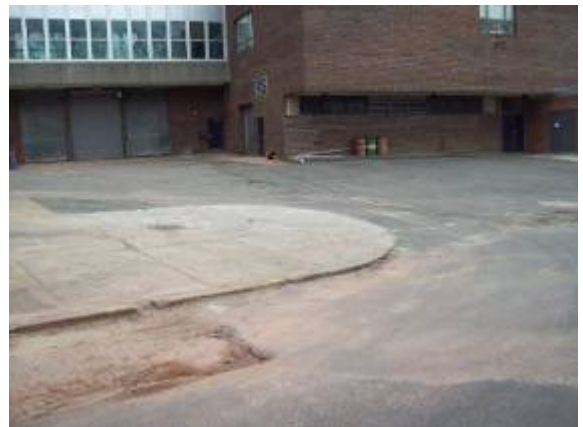
Photo #6:	Maintenance parking area
-----------	--------------------------

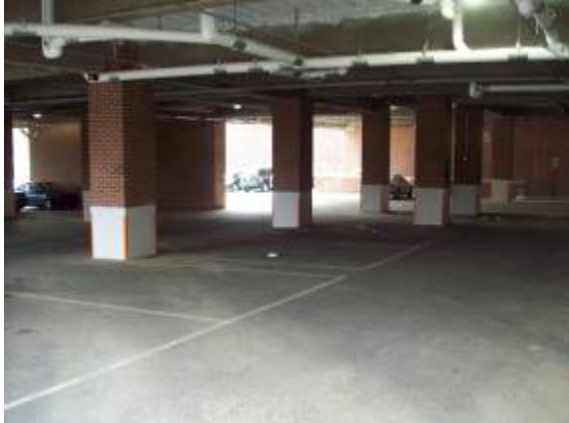
Photo #7: Parking area beneath 9th grade wing

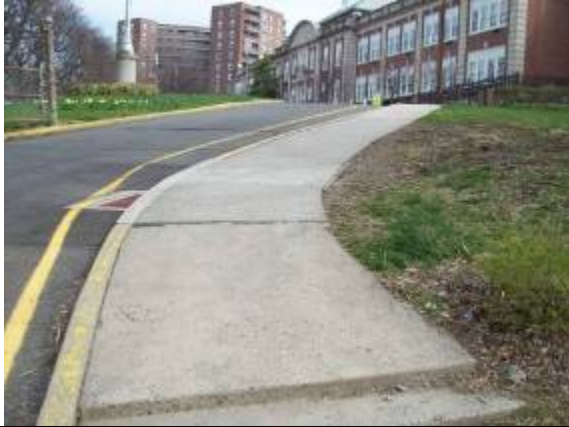
Photo #13:	Sidewalks along front elevation
------------	---------------------------------

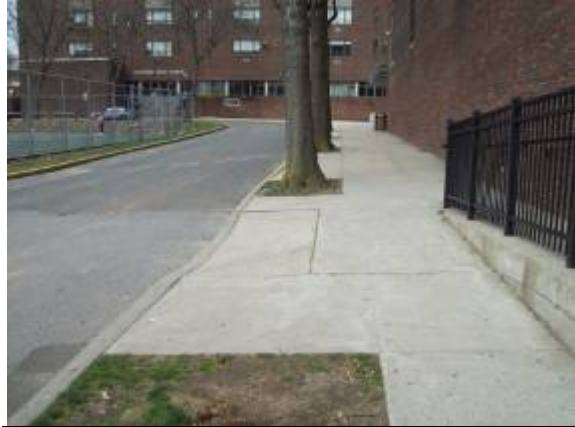
Photo #14:	Sidewalks and drive aisle along gymnasium
------------	---

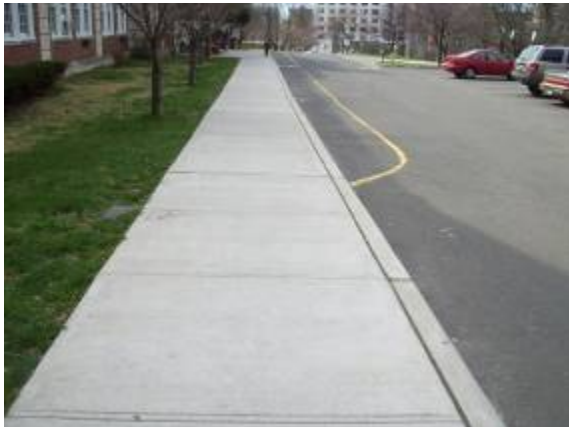
Photo #15:	New sidewalk along front elevation
------------	------------------------------------

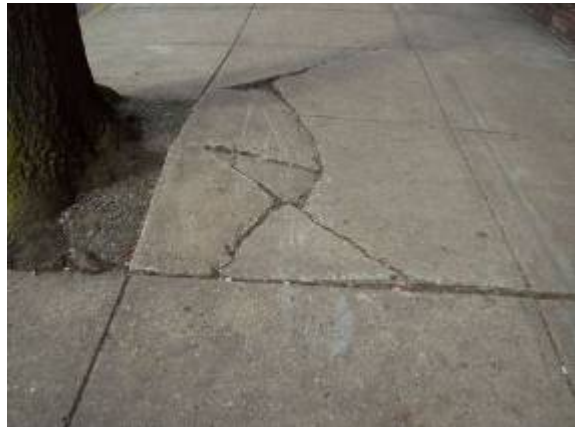
Photo #16:	Sidewalk damage near gymnasium
------------	--------------------------------

5.2	3530	Remove & replace 4' wide concrete sidewalk	25	25	0	200	LF	\$40.65	\$8,130	\$8,130											\$8,130
5.2	3516	Cut & Patch asphalt	10	9	1	8000	SF	\$3.86	\$30,845		\$30,845										\$30,845

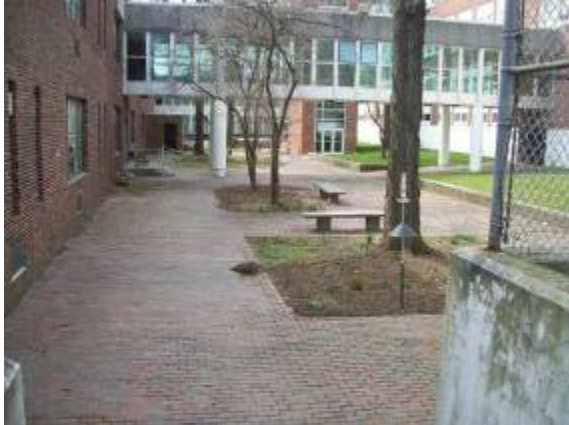
Photo #19: Brick pavers east of original building

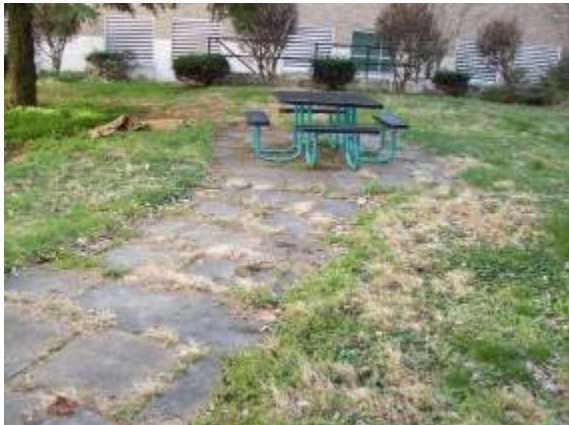
Photo #21: Interior courtyard

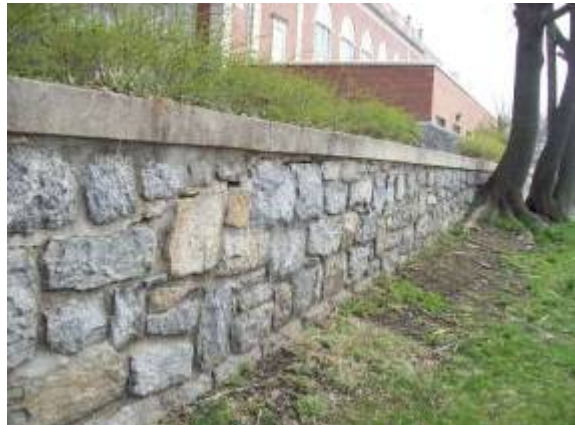
Photo #22: Retaining wall near south entrance

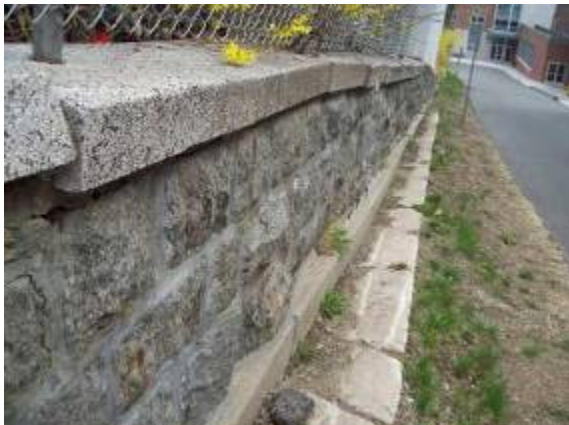
Photo #23: Retaining wall along north property line

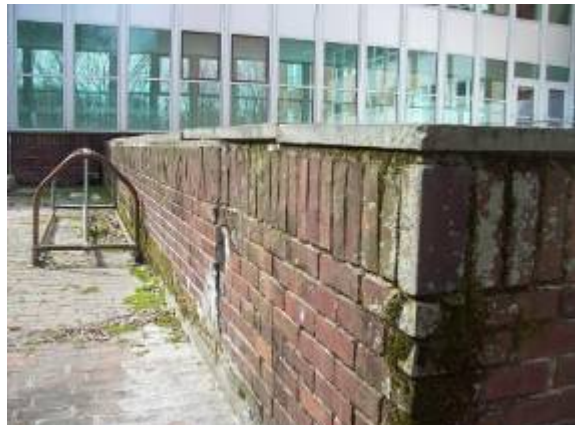
Photo #24: Retaining wall near building connector

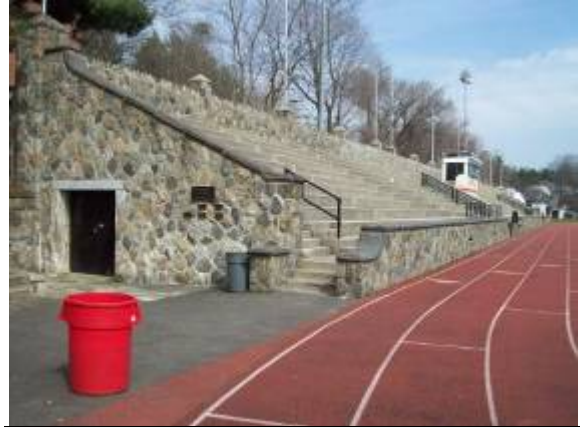
Photo #26: Seating structure at Boyle Stadium

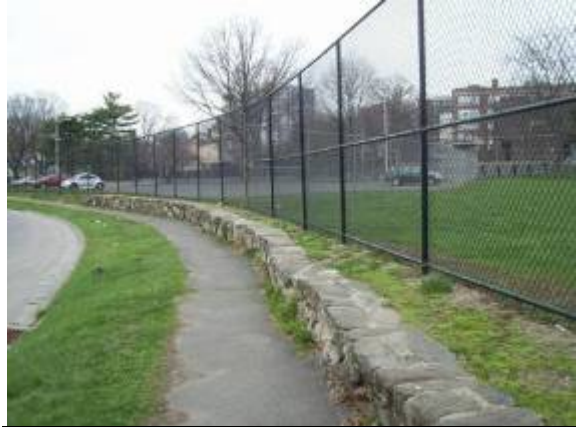
Photo #32: New fencing along Hillendale Avenue

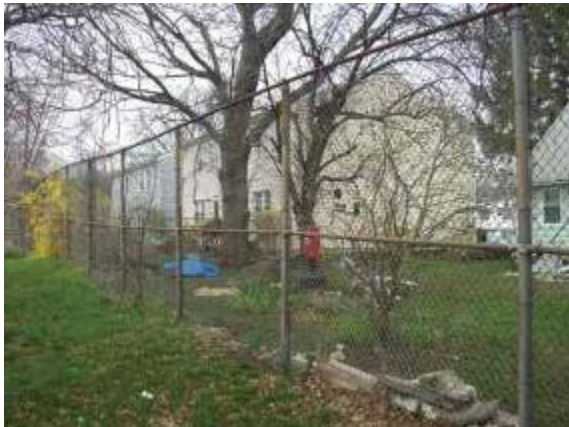
Photo #33: Old fencing near upper playing field

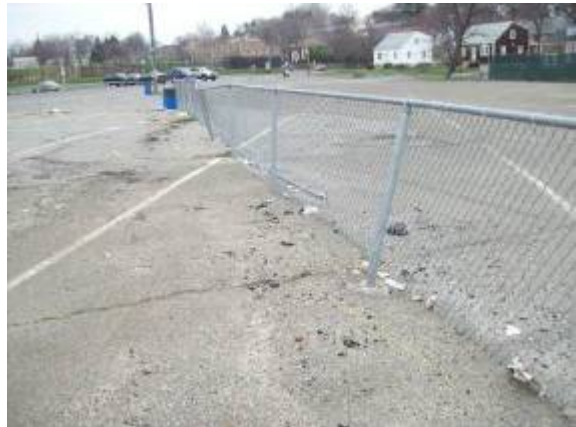
Photo #34: Damaged fencing in student parking lot

5.5	3540	Replace chain link fence, 6-foot high	20	19	1	2020	LF	\$37.31	\$75,363		\$75,363										\$75,363
5.5	3541	Remove and replace 4-foot chain link fence	10	10	0	80	LF	\$27.87	\$2,230	\$2,230											\$2,230

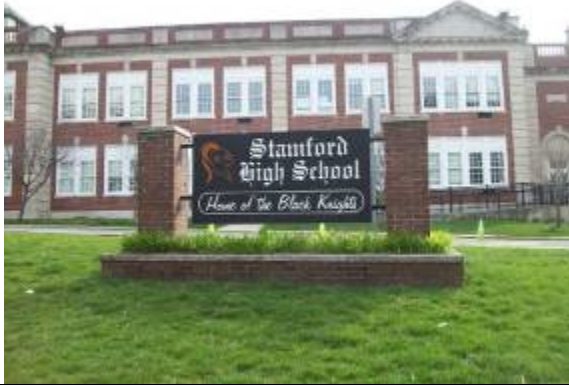
Photo #37:	Property signage
------------	------------------

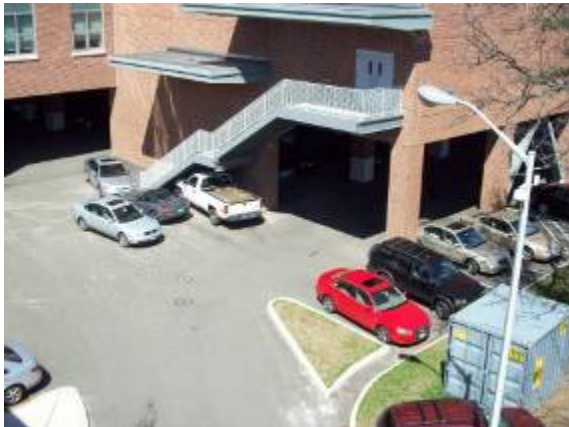
Photo #39:	Site lighting
------------	---------------

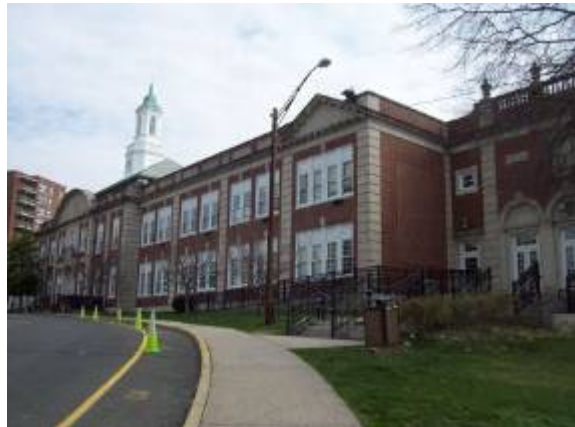
Photo #40:	Site lighting
------------	---------------

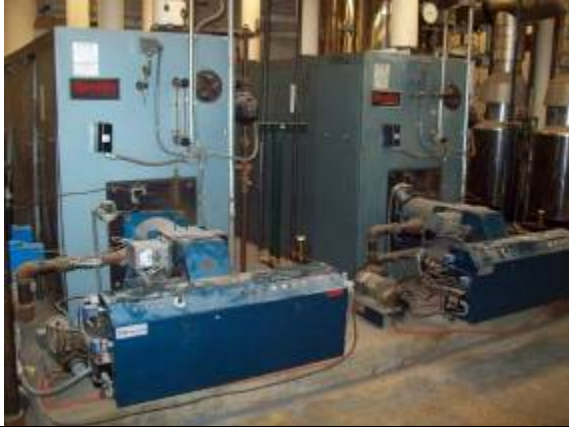
Photo #43:	Boilers (2 of 4)
------------	------------------

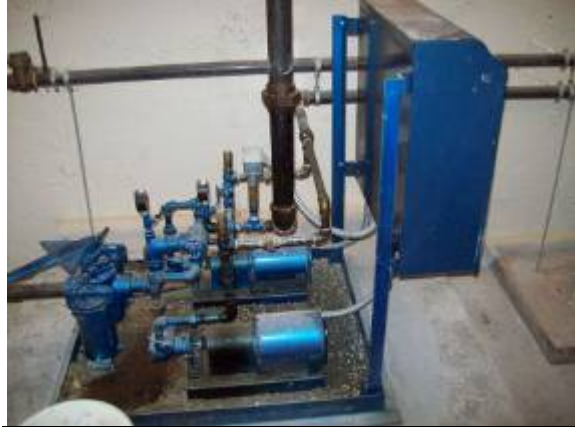
Photo #44:	Fuel oil pump set
------------	-------------------

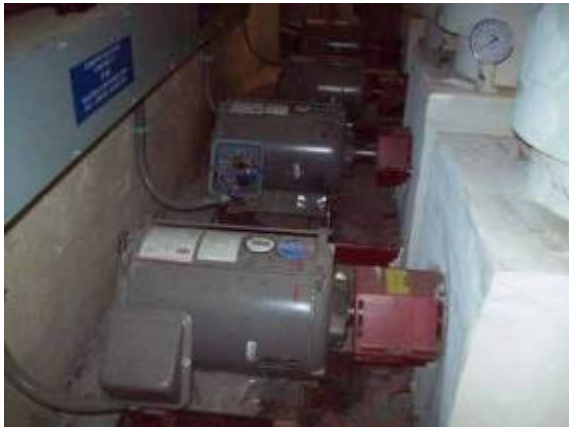
Photo #45:	Circulating pumps
------------	-------------------

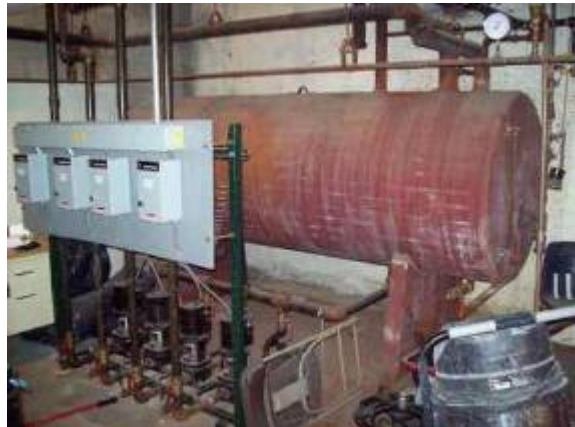
Photo #46:	Condensate return system
------------	--------------------------

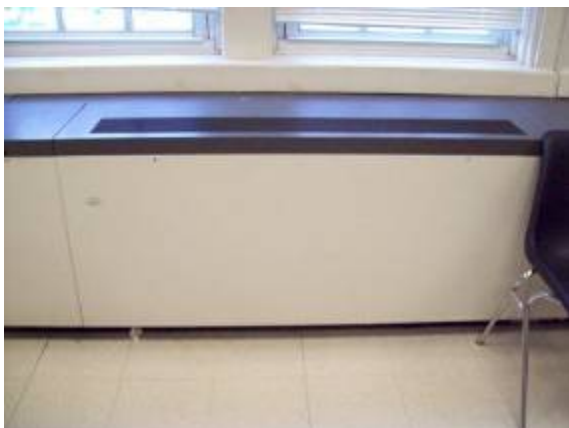
Photo #47:	Typical unit ventilator for classroom
------------	---------------------------------------

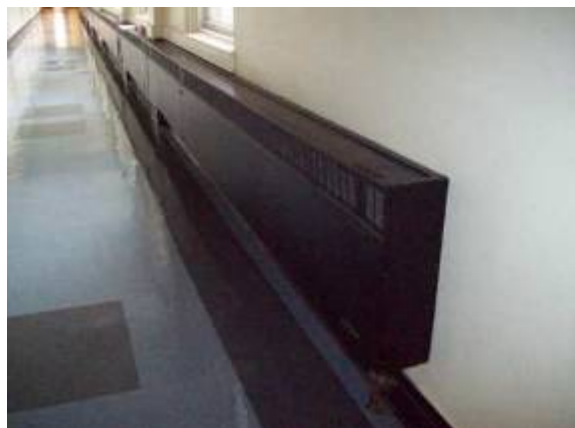
Photo #48:	Wall mounted radiant heat unit for corridor
------------	---

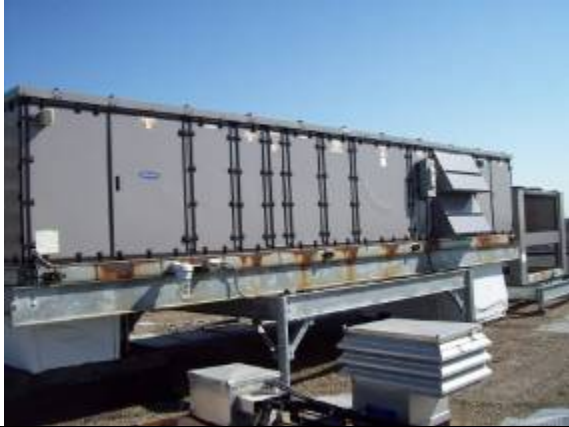
Photo #49: Air handling unit for auditorium

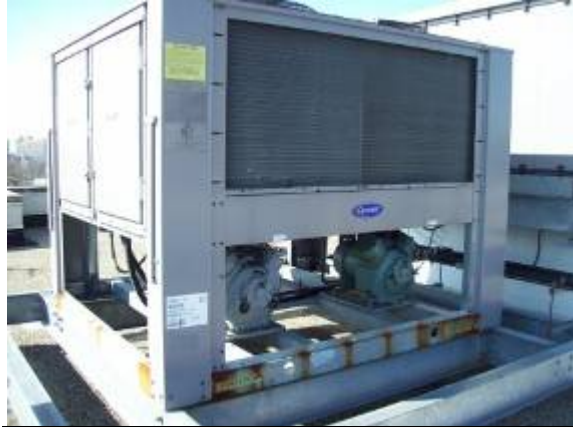
Photo #50: Condensing unit for auditorium

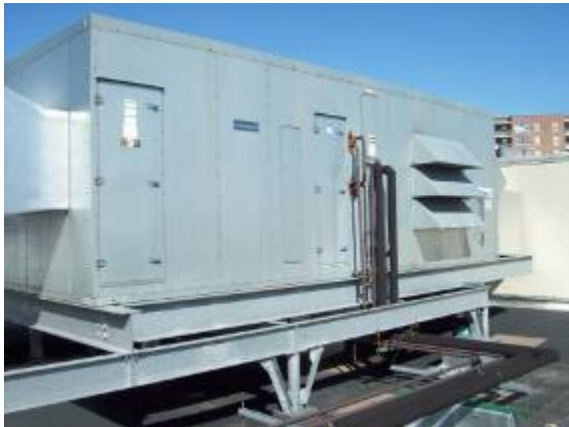
Photo #51: Ventilation unit for cafeteria

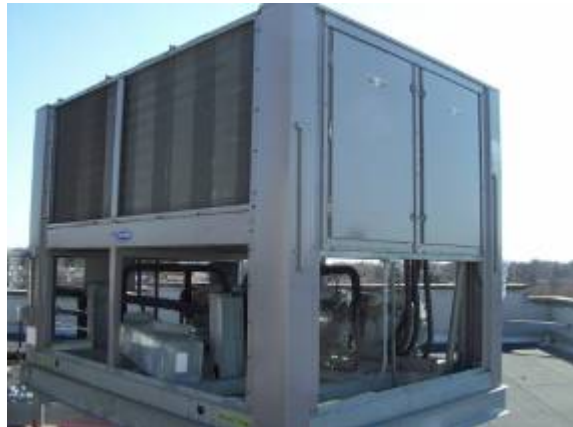
Photo #52: Condensing unit for cafeteria

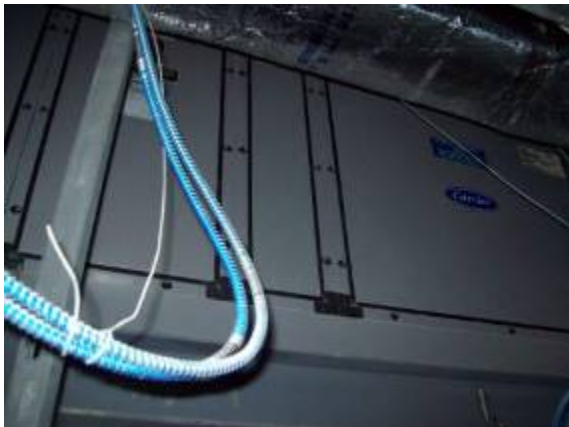
Photo #53: Air handling unit for cafeteria

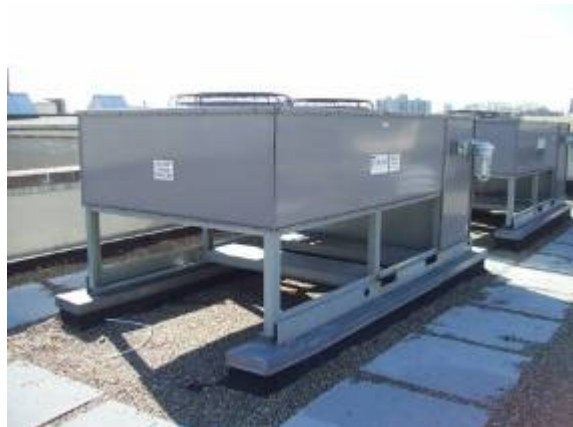
Photo #54: Condensing units for cafeteria

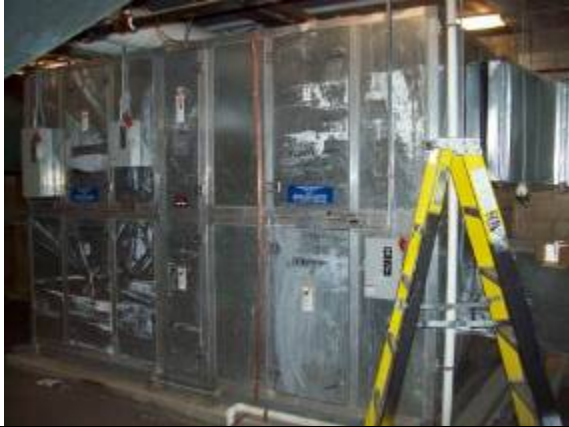
Photo #55: Air handling unit for Locker Rooms

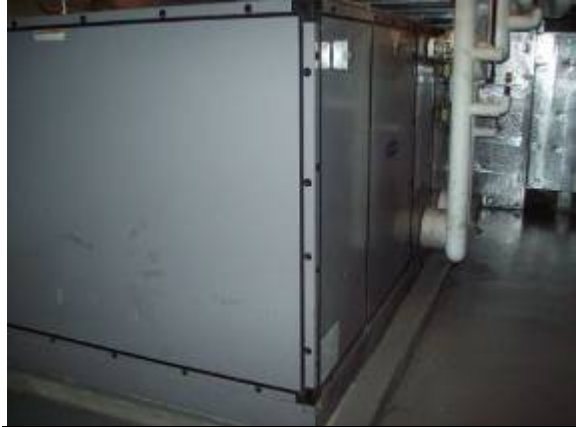
Photo #56: Air handling unit for Level F

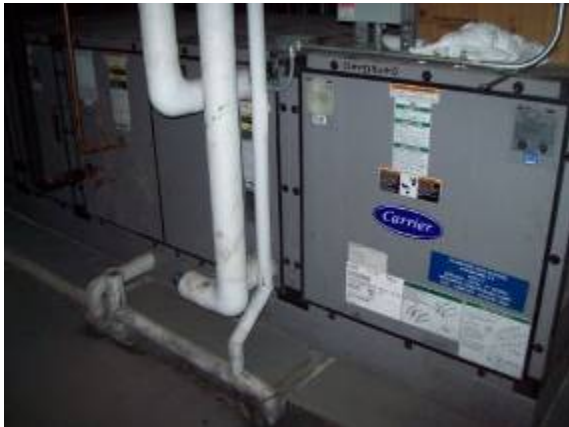
Photo #57: Air handling unit for Band Room

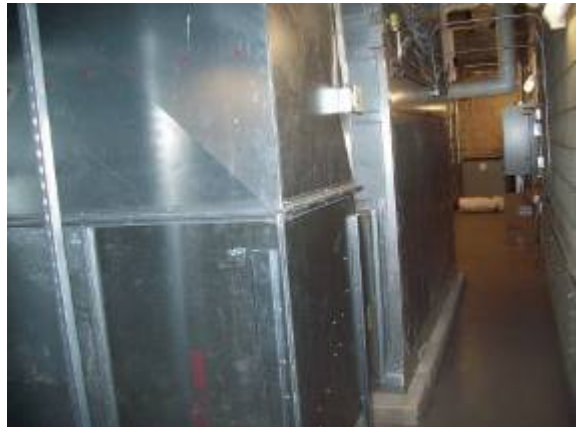
Photo #58: Air handling unit for gymnasium (1 of 2)

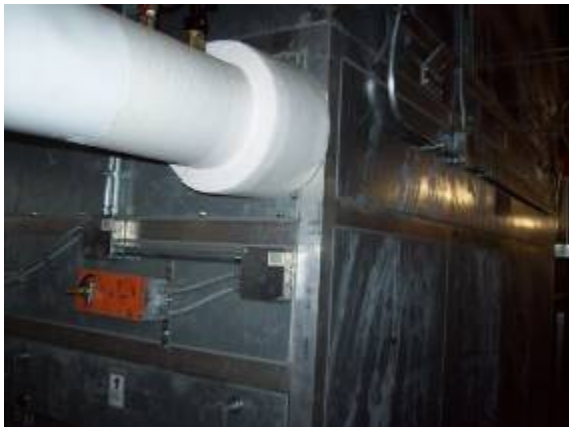
Photo #59: Air handling unit for gymnasium (2 of 2)

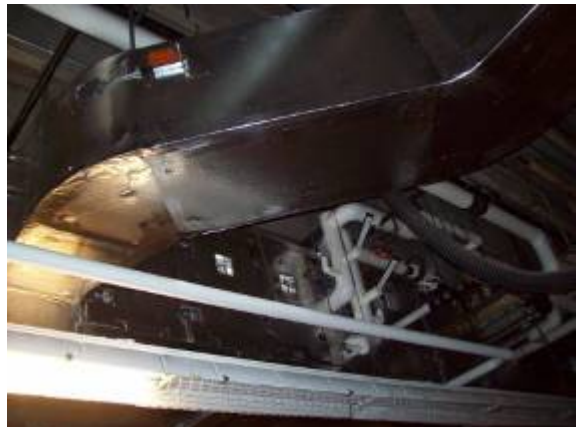
Photo #60: Air handling unit for Choral Room

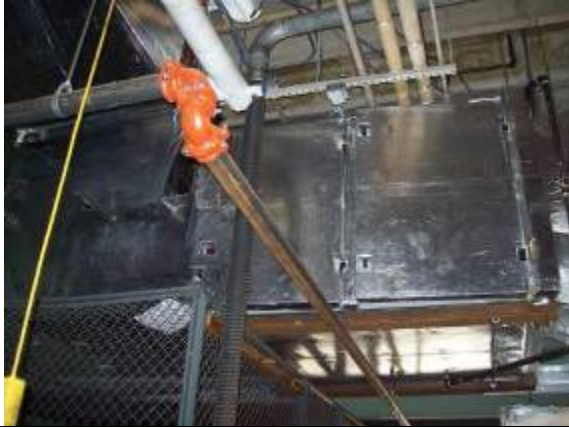
Photo #61: Air handling unit for Auto Mechanic Room

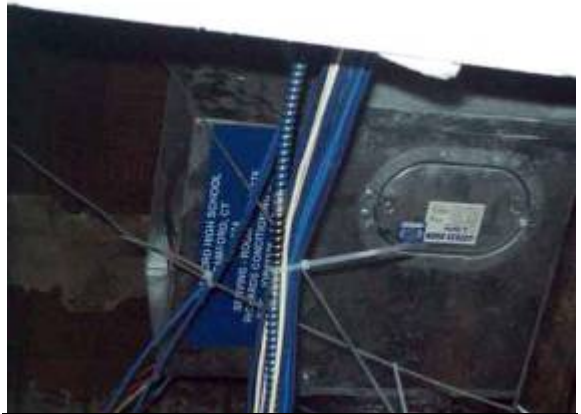
Photo #62: Typical VAV terminal

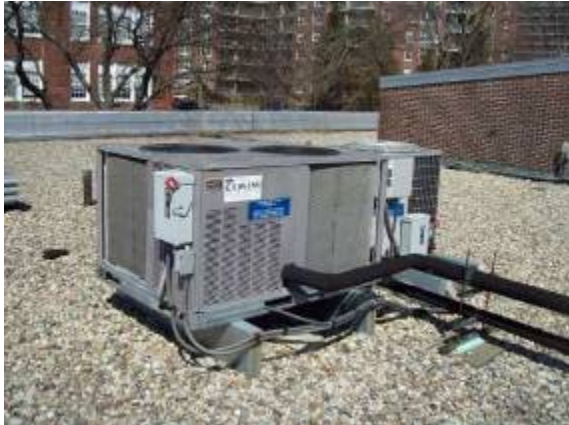
Photo #63: Typical roof-mounted condensing unit

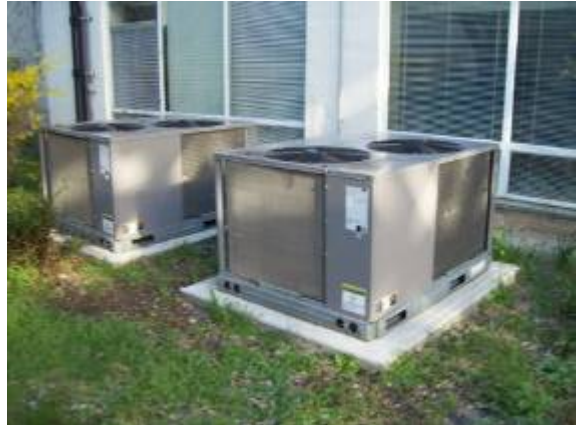
Photo #64: Typical pad-mounted condensing unit

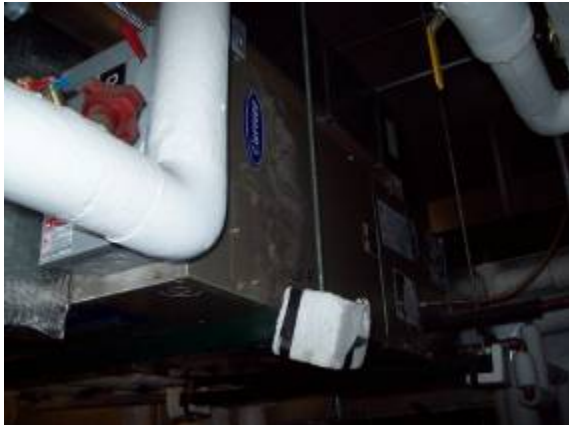
Photo #65: Typical split system air handling unit

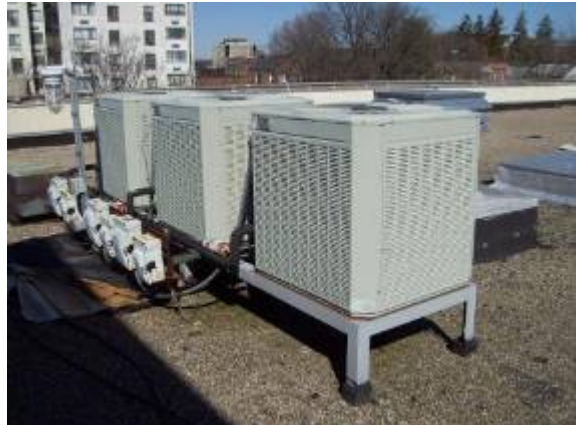
Photo #66: Typical roof-mounted condensing units

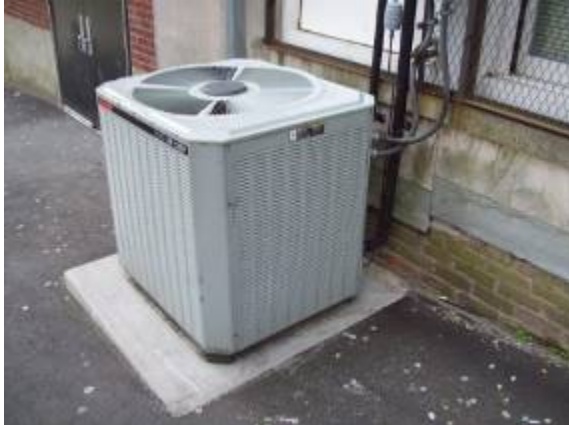
Photo #67: Typical pad-mounted condensing unit

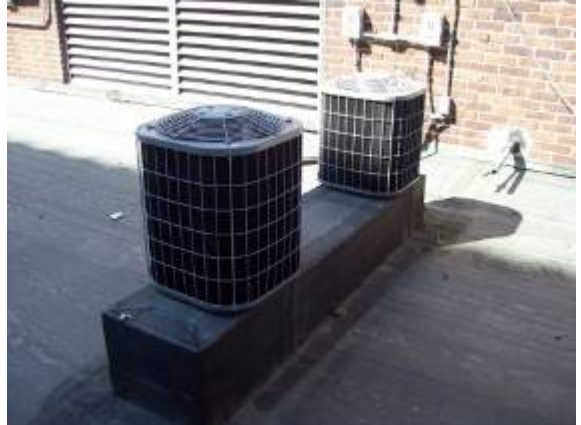
Photo #68: Small roof-mounted condensing units

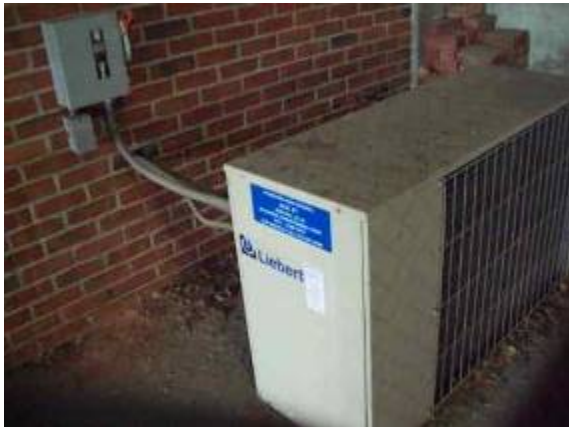
Photo #69: Liebert condensing unit for computer room

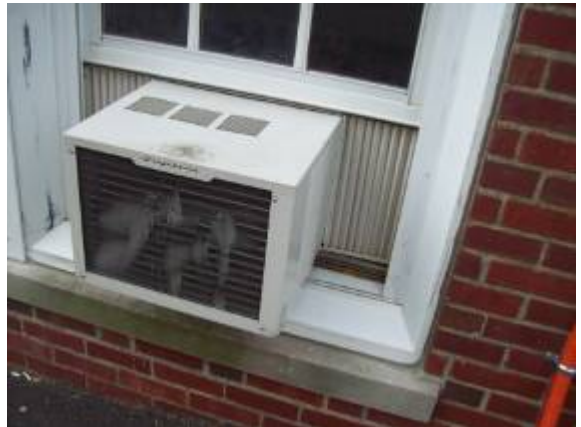
Photo #70: Typical window air conditioning unit

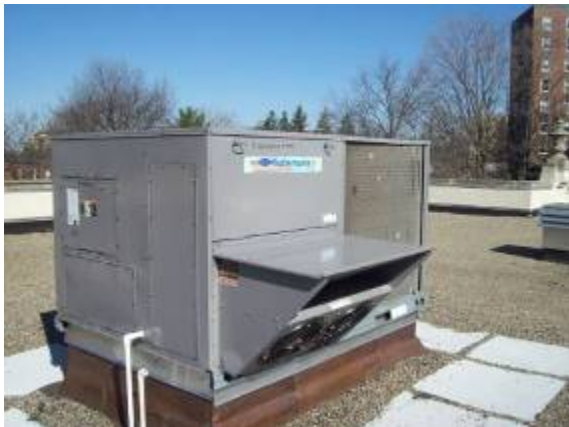
Photo #71: Rooftop unit for Large Group Instructional area

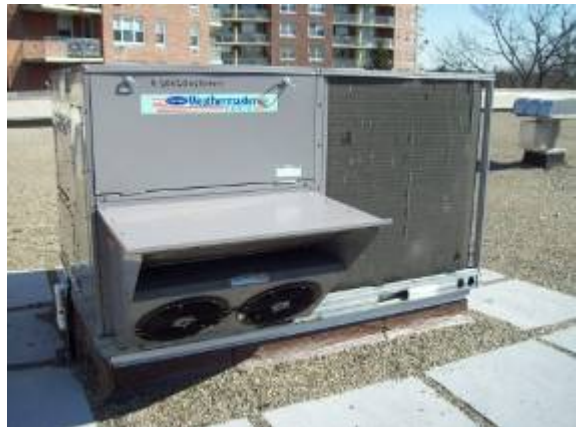
Photo #72: Rooftop unit for Administrative Offices

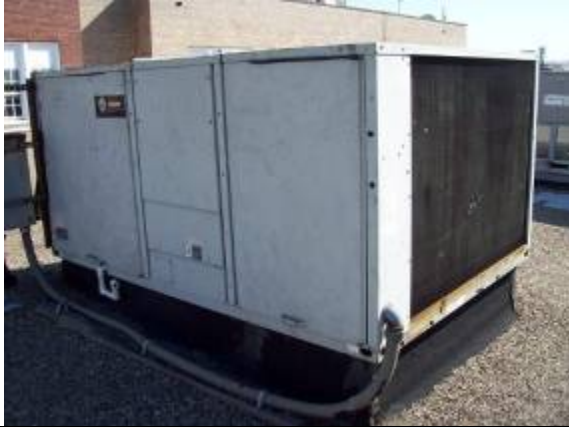
Photo #73: Rooftop unit for Guidance Office

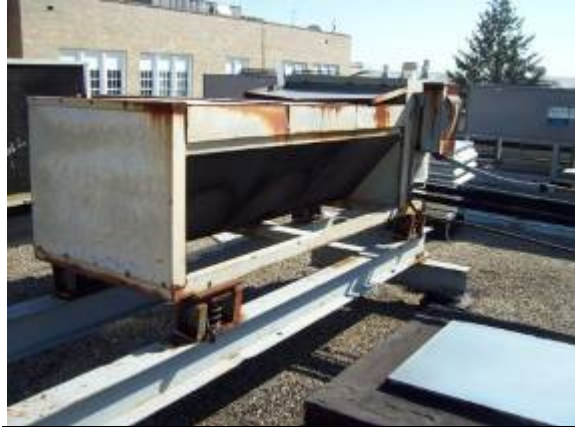
Photo #74: Condensing unit for Guidance Office

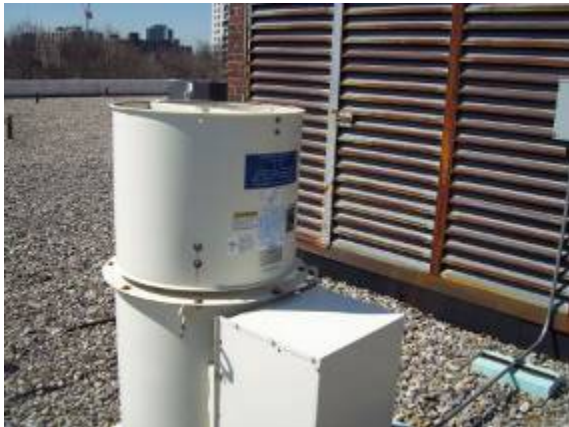
Photo #75: Typical roof-mounted exhaust fan

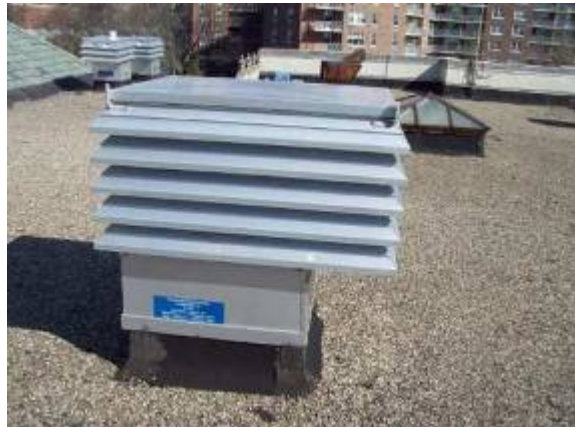
Photo #76: Typical exhaust louver

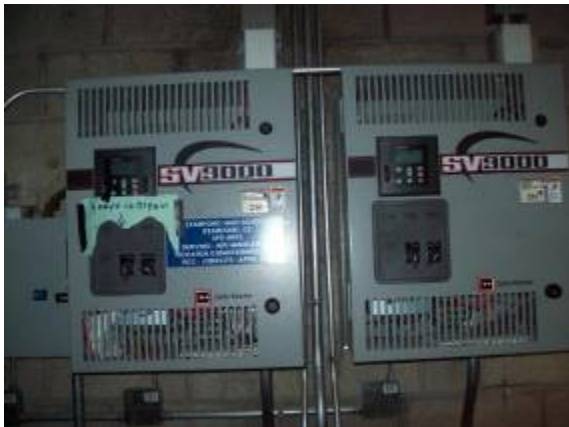
Photo #77: VFD controllers for air handling units

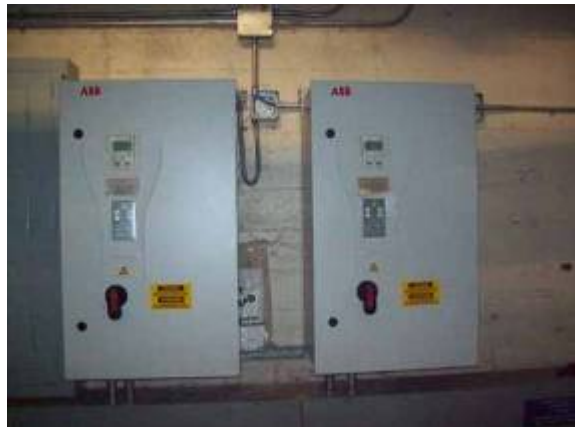
Photo #78: VFD controllers for circulating pumps

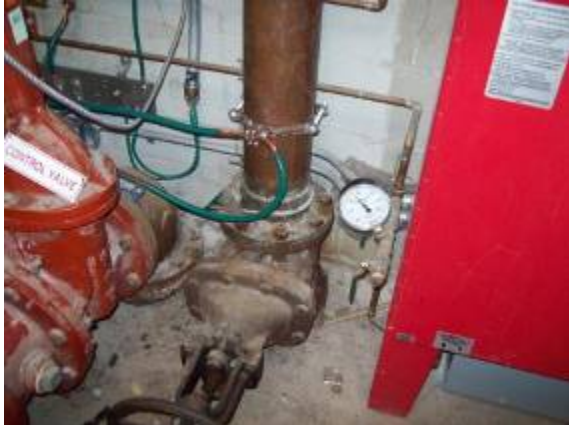
Photo #79: Incoming domestic water service

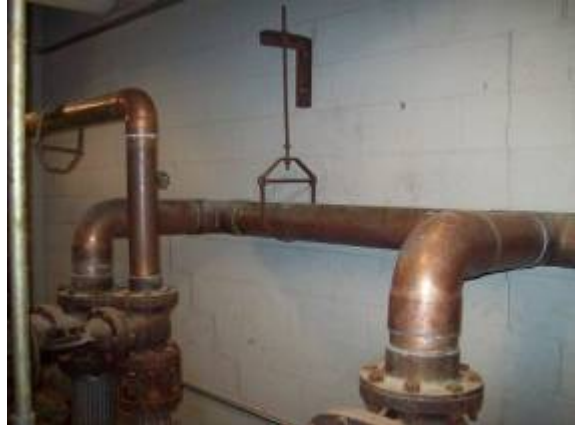
Photo #80: Domestic water distribution lines

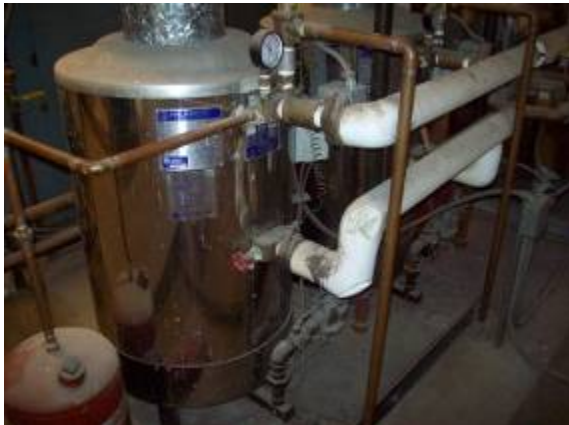
Photo #81: Domestic water boilers

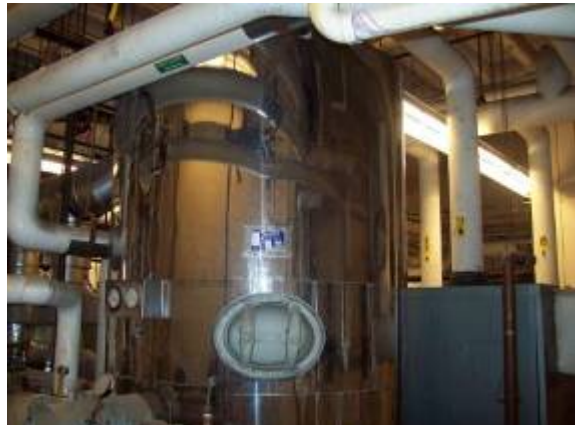
Photo #82: Domestic hot water storage tank

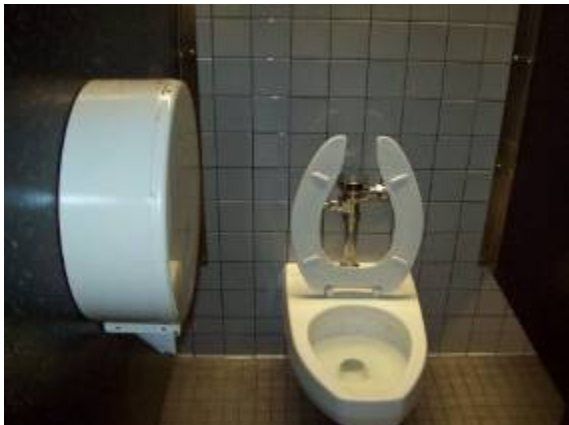
Photo #83: Restroom fixtures – water closet

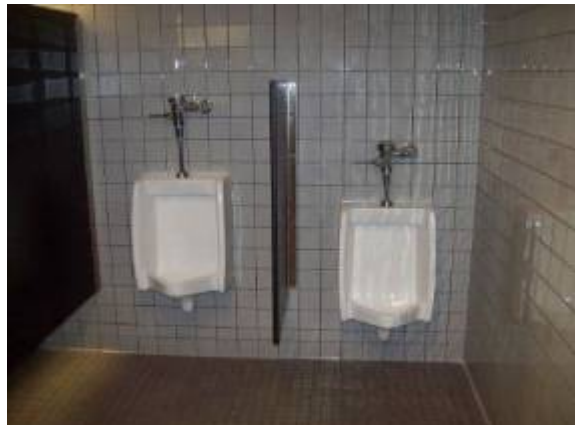
Photo #84: Restroom fixtures – urinals

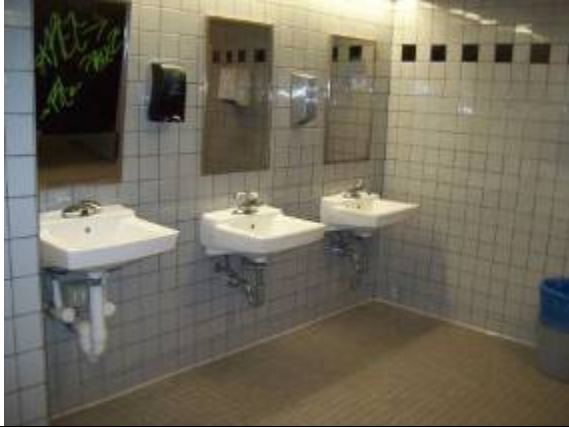
Photo #85: Restroom fixtures – lavatories

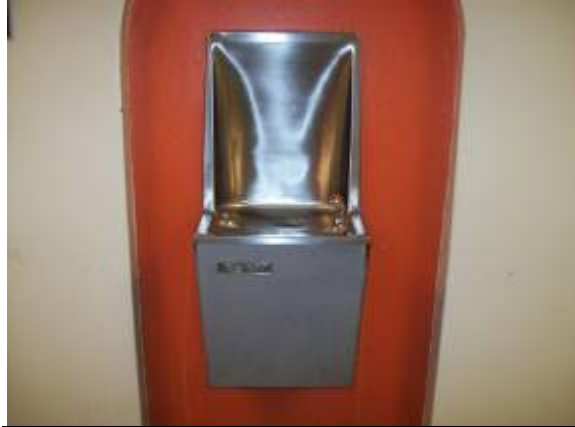
Photo #86: Plumbing fixtures – drinking fountain

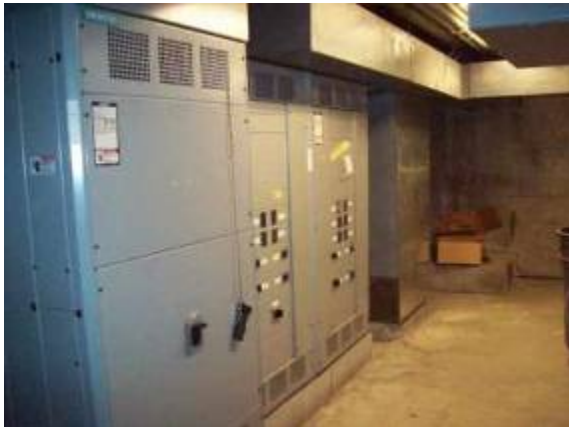
Photo #87: Main electrical switchgear

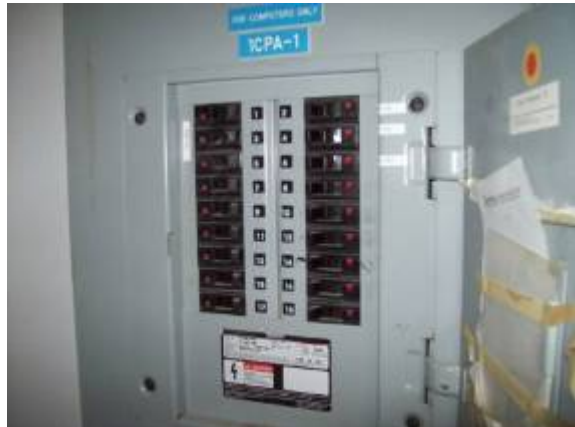
Photo #88: Typical breaker panel

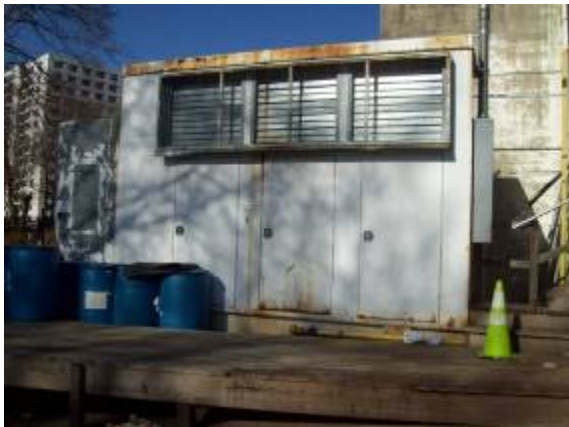
Photo #89: Generator enclosure

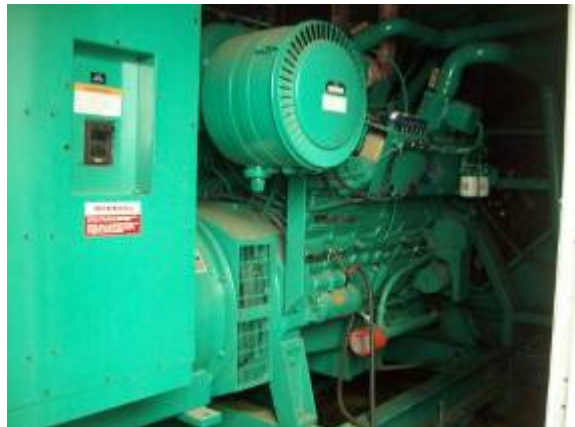
Photo #90: Emergency generator

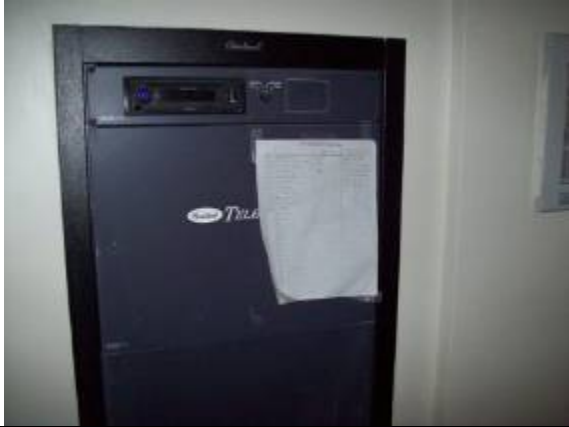
Photo #91: PA system control panel

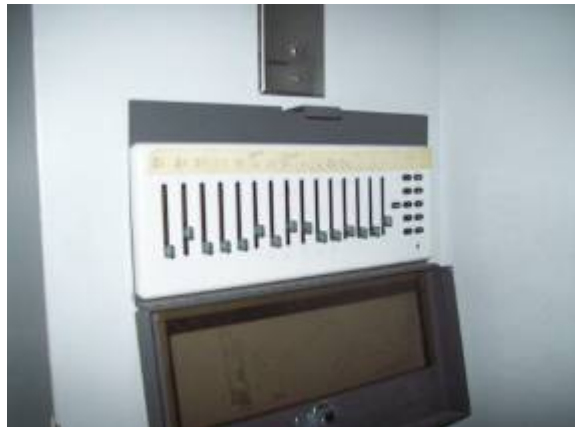
Photo #96: Advanced lighting control panel

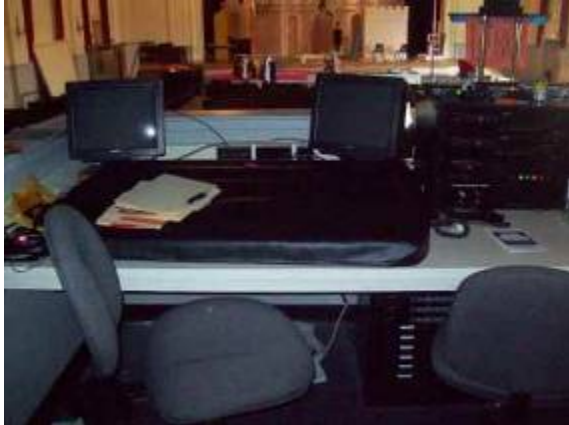
Photo #97: Auditorium lighting and sound control booth

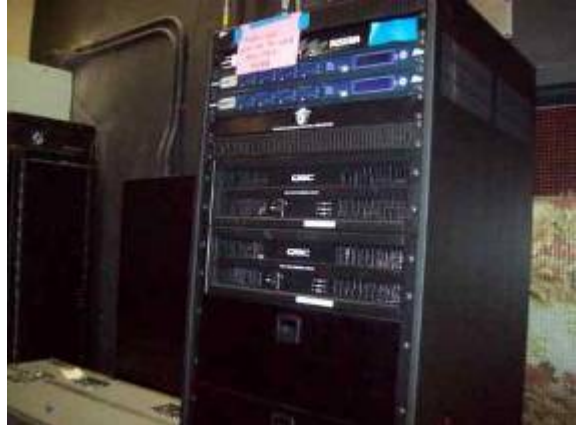
Photo #98: Auditorium sound system

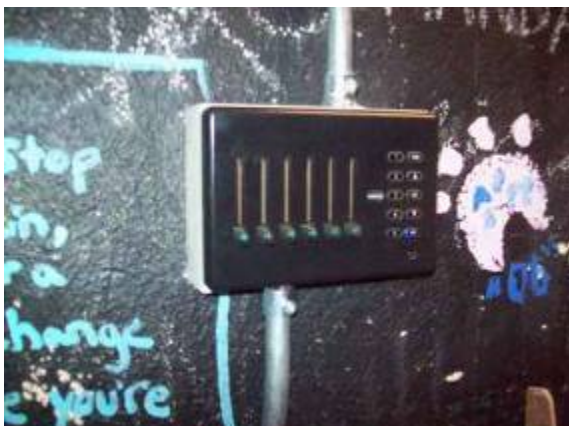
Photo #101: Stage lighting control

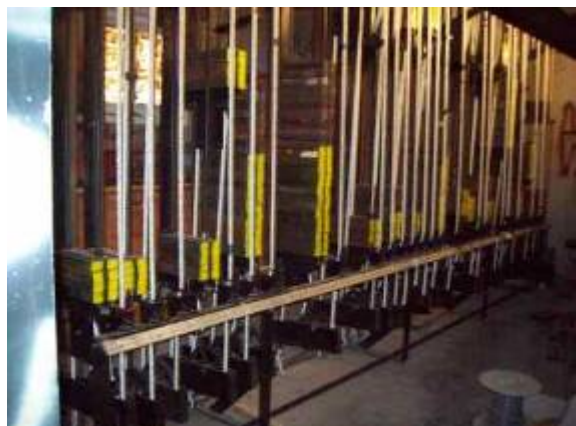
Photo #102: Stage rigging system

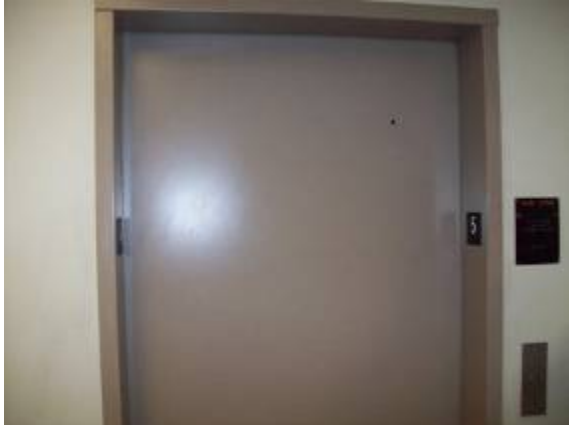
Photo #103: Elevator 1 cab doors

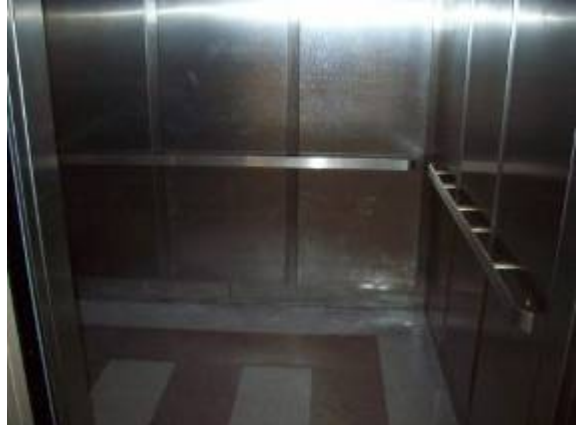
Photo #104: Elevator 1 cab interior

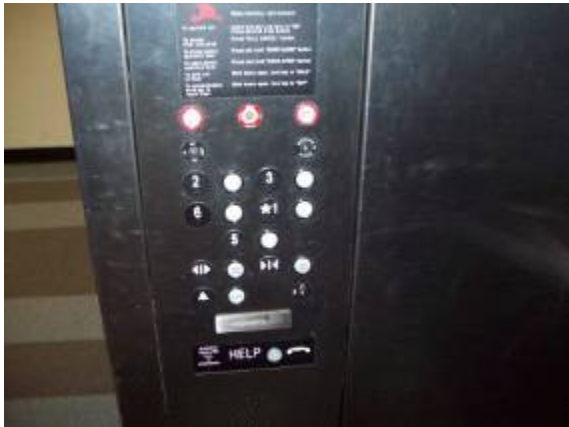
Photo #105: Elevator 1 control panel

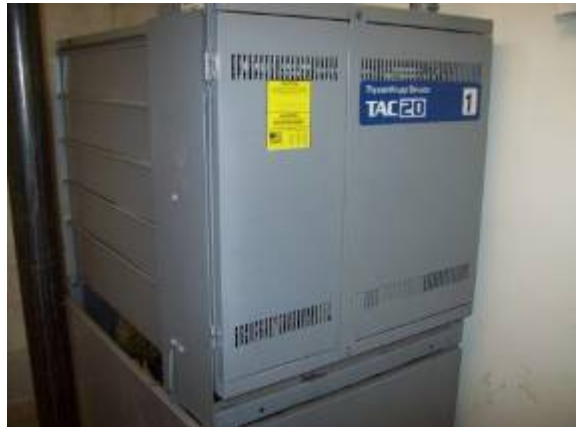
Photo #106: Elevator 1 hydraulic equipment

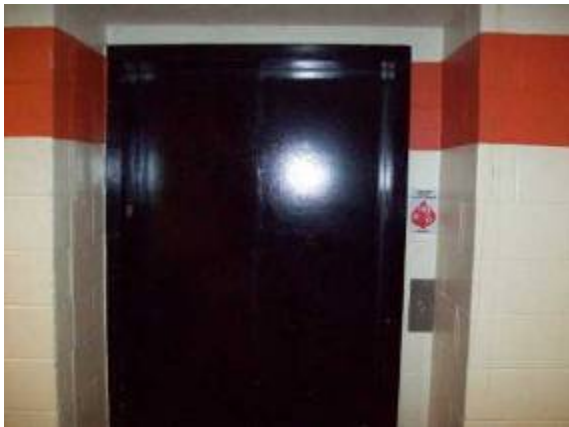
Photo #107: Elevator 2 cab doors

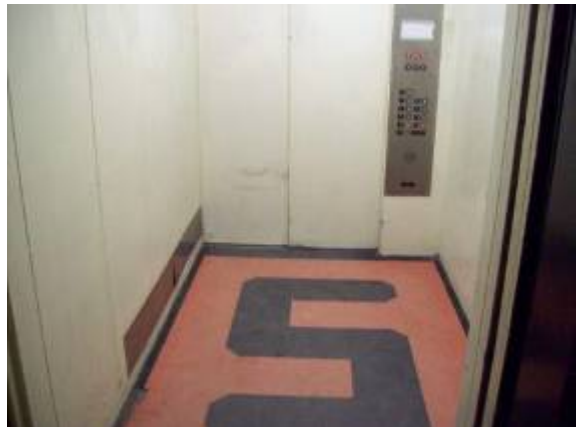
Photo #108: Elevator 2 cab interior

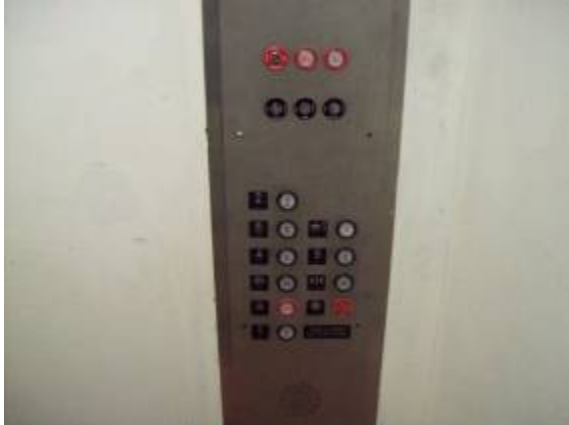
Photo #109: Elevator 2 control panel

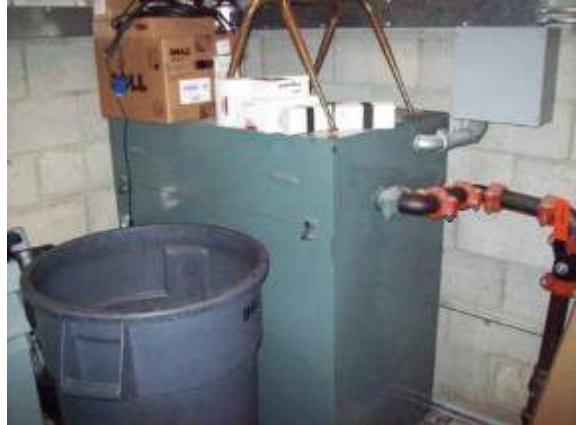
Photo #110: Elevator 2 hydraulic equipment

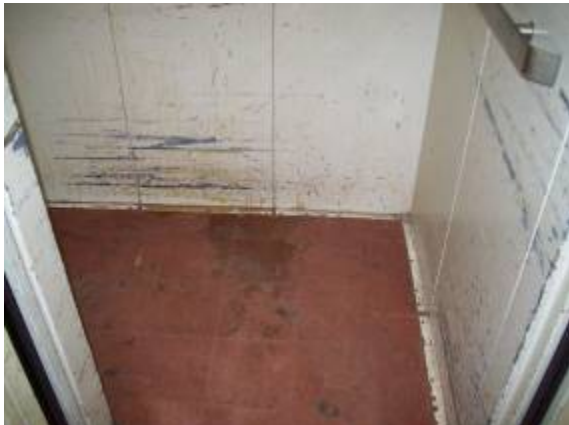
Photo #111: Elevator 3 cab interior

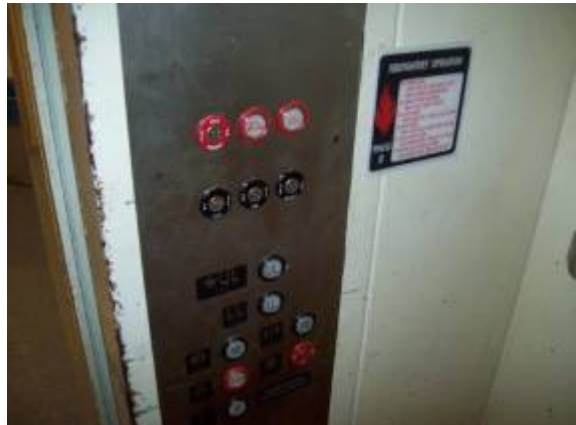
Photo #112: Elevator 3 control panel

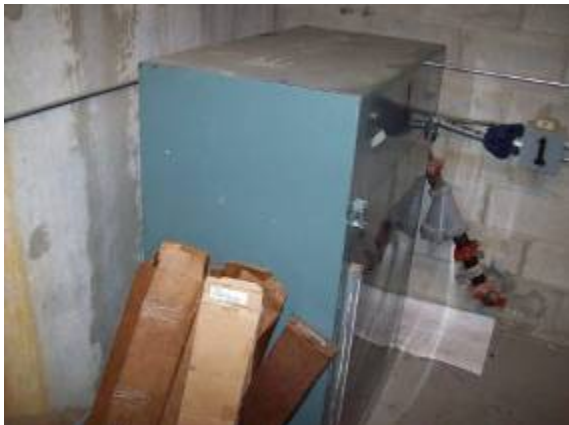
Photo #113: Elevator 3 hydraulic equipment

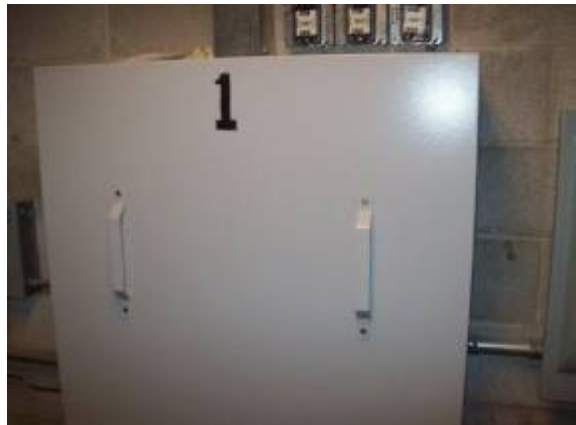
Photo #114: Elevator 3 control unit

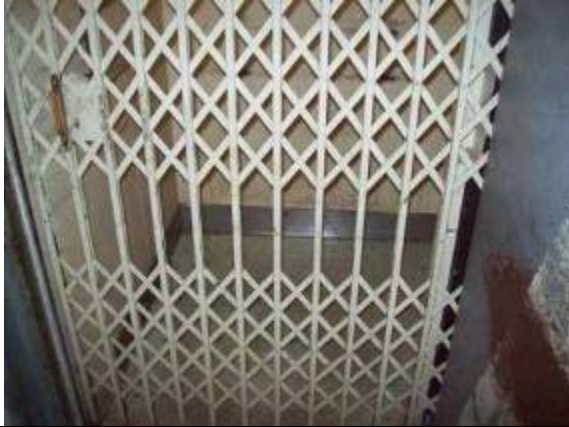
Photo #115: Elevator 4 cab interior

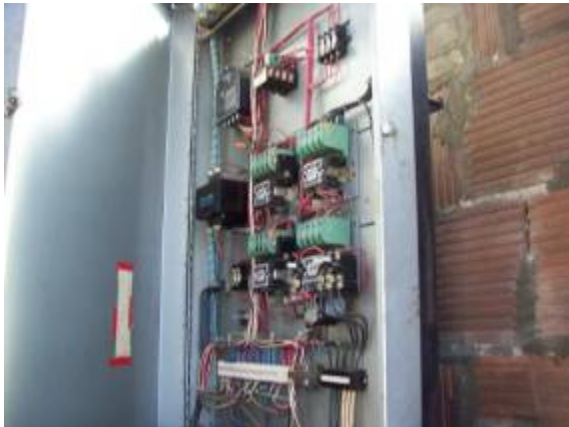
Photo #117: Elevator 4 control unit

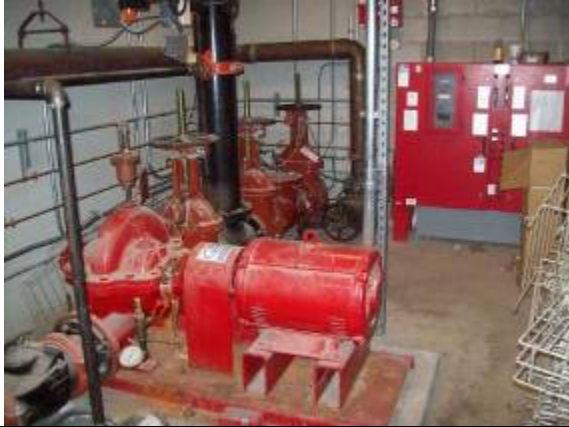
Photo #121: Fire pump and controller

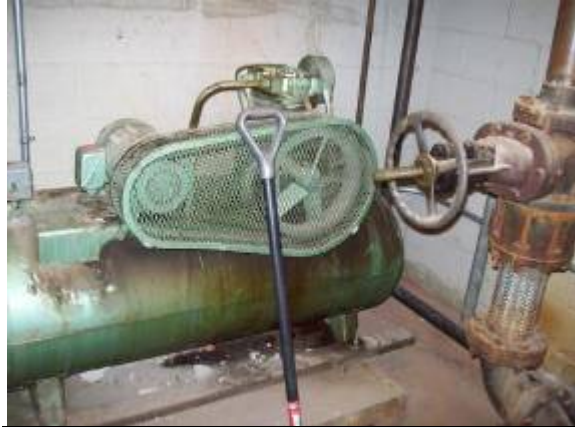
Photo #122: Air compressor for dry system section
