FACILITIES NEEDS ASSESSMENT

STAMFORD HIGH SCHOOL

55 Strawberry Hill Avenue
Stamford, Connecticut 06902

EMG Project #: 88166.09R-021.017
Date of Report: August 30, 2009
On site Date: April 8 - 10, 13, 2009

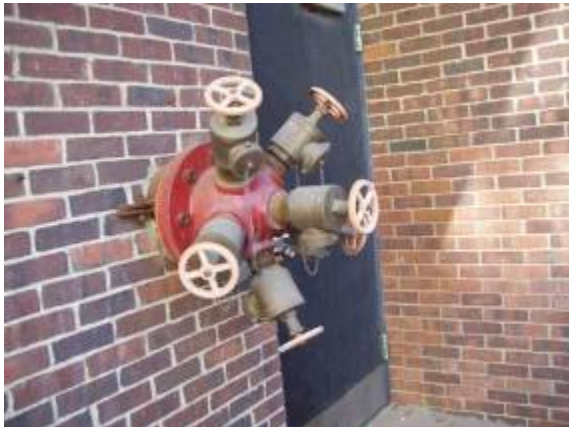
Photo #123: Fire department hose connection

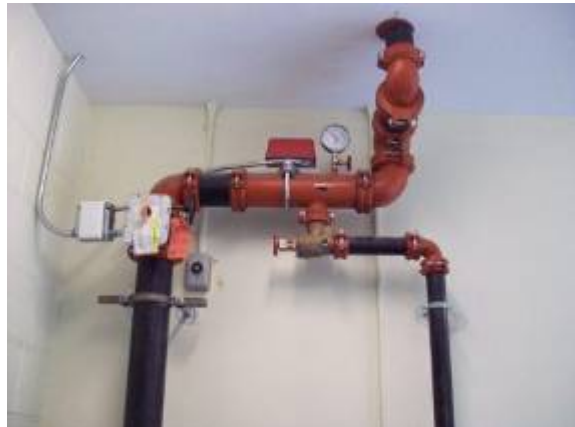
Photo #124: Fire sprinkler riser and test valves

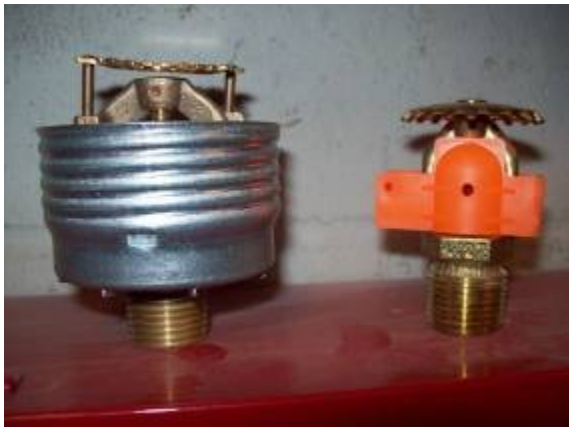
Photo #125: Fire sprinkler heads

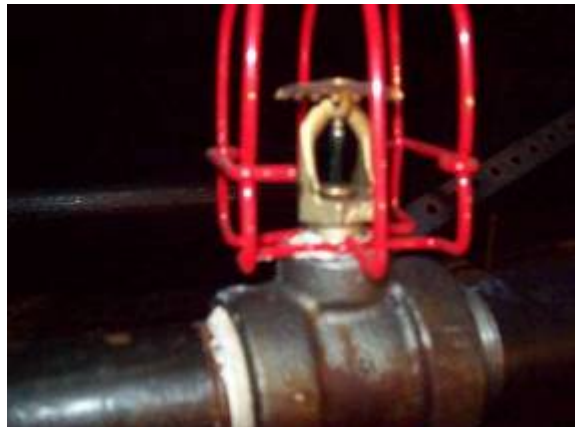
Photo #126: Fire sprinkler piping and head

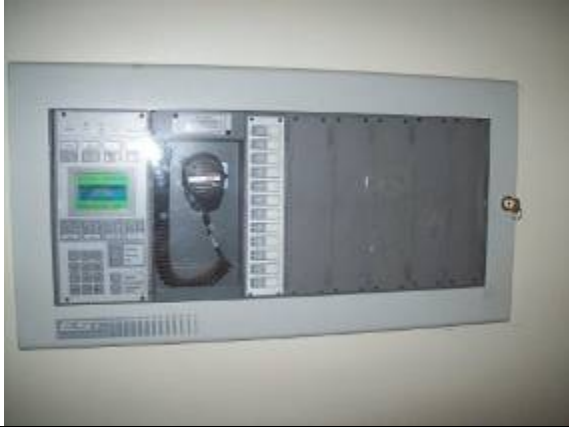
Photo #127: Fire alarm annunciator panel

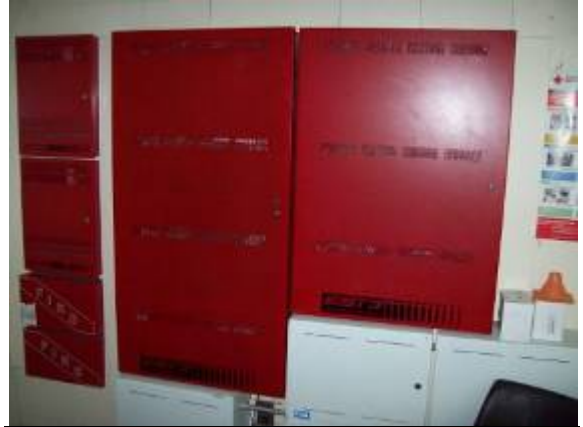
Photo #128: Fire alarm power and communicator panels

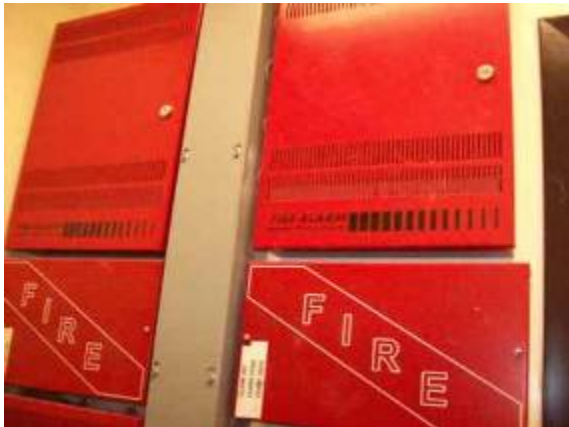
Photo #129: Fire alarm booster panels

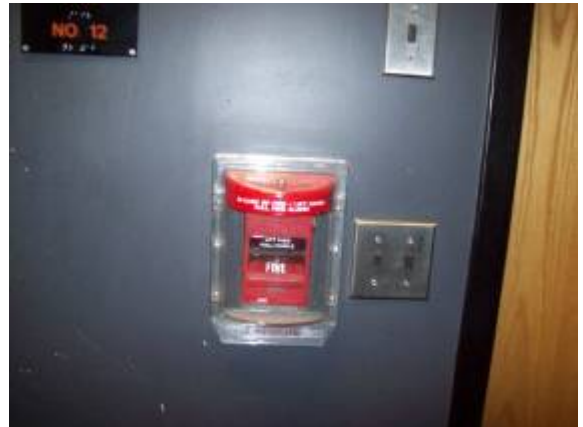
Photo #130: Fire alarm pull station

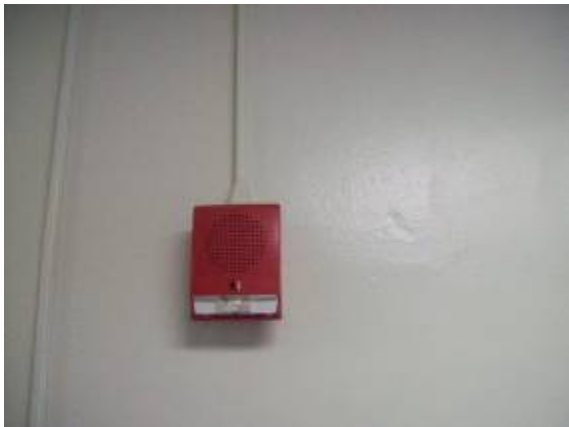
Photo #131: Fire alarm horn with strobe light

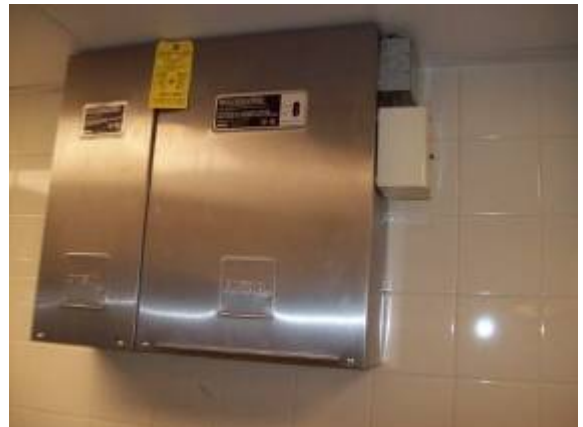
Photo #132: Ansul tanks in kitchen

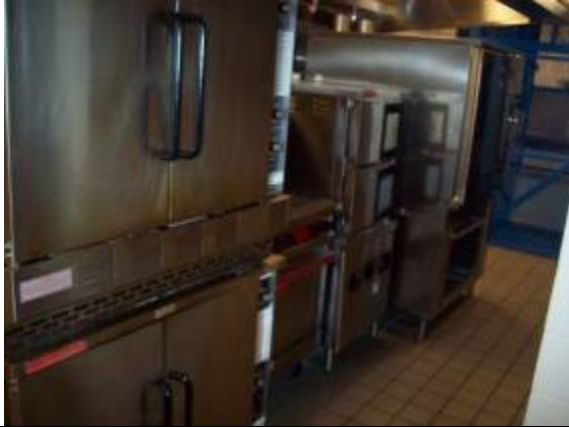
Photo #133: Kitchen equipment – Ovens

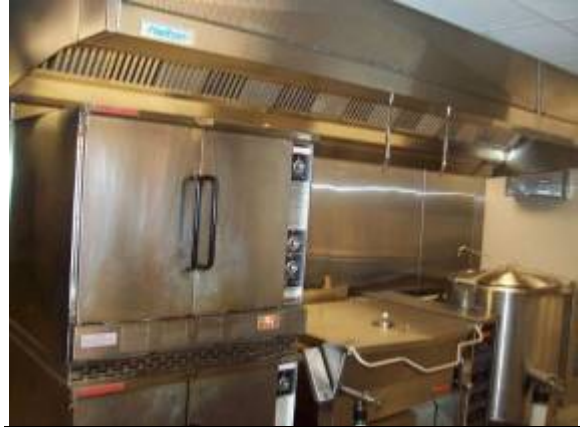
Photo #134: Kitchen equipment – Ovens and range

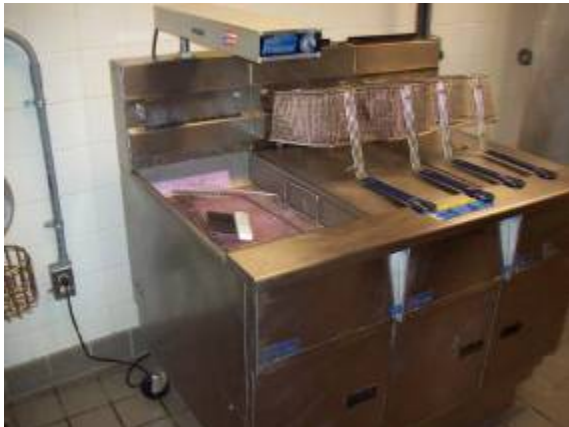
Photo #135: Kitchen equipment – Fryer

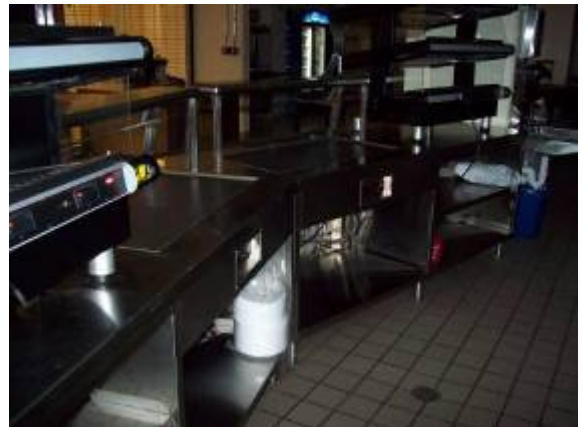
Photo #138: Kitchen equipment – Serving line
