PLAYGROUND SAFETY INSPECTION REPORT

DATE: May 8, 2019

SITE: Stillmeadow Elementary School
800 Stillwater Road
Stamford, CT 06907

DATE OF INSPECTION: April 30, 2019

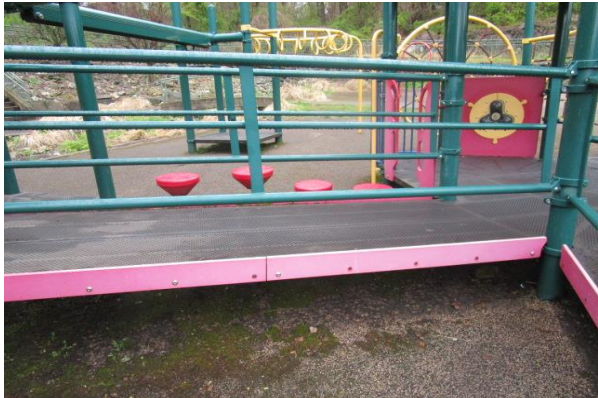
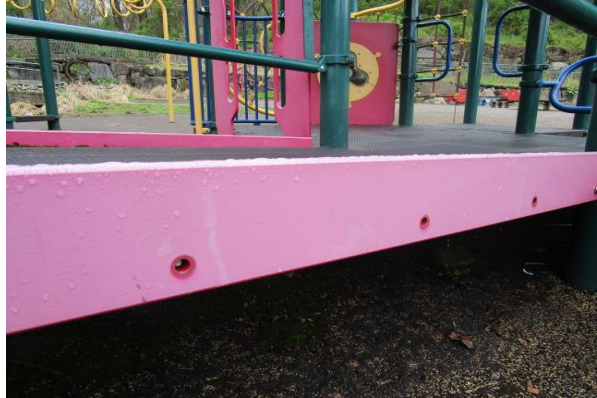
Ramps (3) - Nine bolts missing at side rail/lip - MAINTENANCE

| | Condition | Hazard Priority | Recommendation |
|---|---|---|--|
| Ramps (3) | Missing nine bolts at side rails/lip | Maint. | Replace nine bolts at side rail/lip |

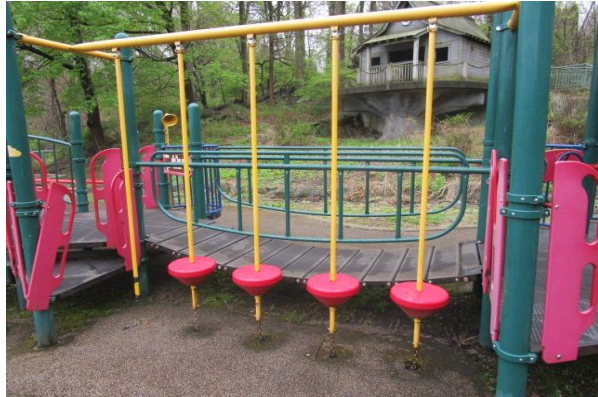
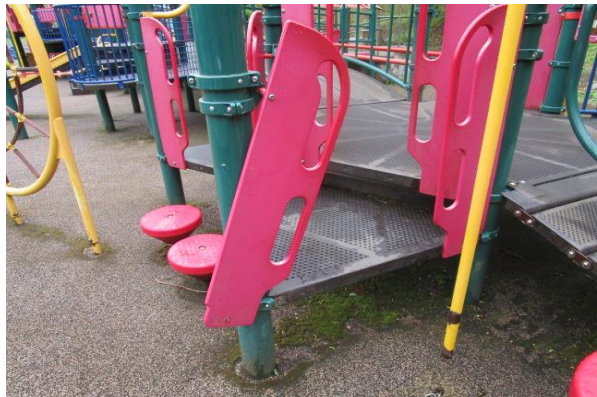
Disc Challenge - One handhold panel not attached - MAINTENANCE

| | Condition | Hazard Priority | Recommendation |
|---|---|---|--|
| Disc Challenge | One handhold at panel not attached | Maint. | Replace two bolts, reattach & tighten |

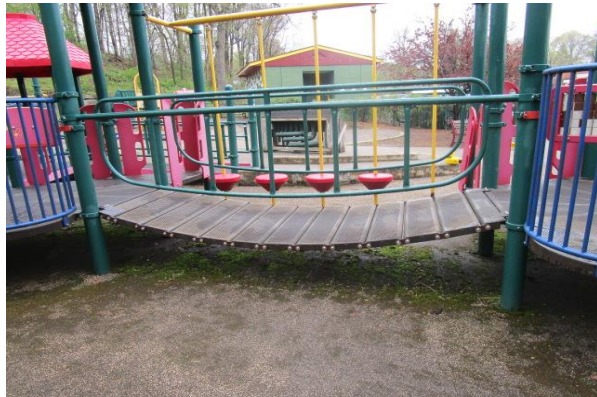
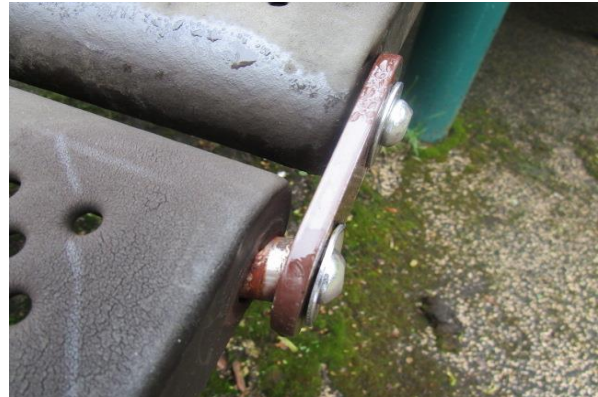
Suspension Bridge - One bolt out of one board - CLASS B HAZARD

| | Condition | Hazard Priority | Recommendation |
|---|---|---|--|
| Suspension Bridge | One bolt out of one board | B | Repair one board attachment & replace one bolt. Consult Mfr. |

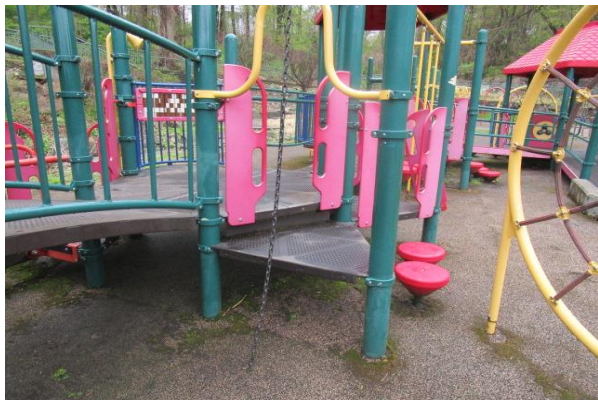
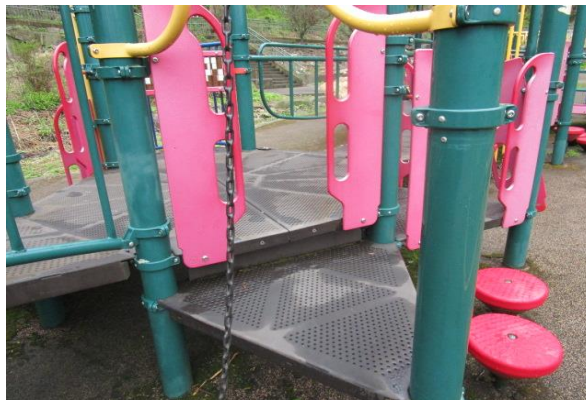
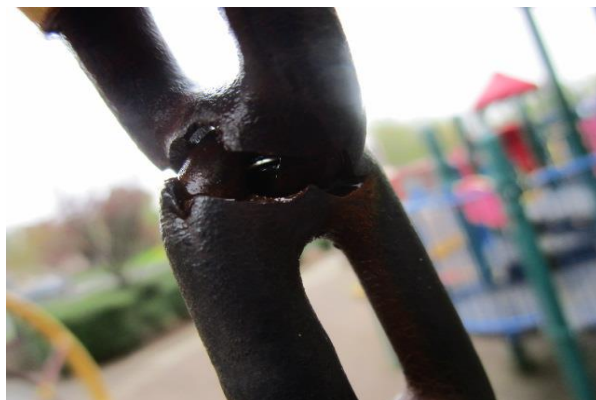
Ascending Chain - Cracked & worn - CLASS B HAZARD
Barriers removed - CLASS B HAZARD

| | Condition | Hazard Priority | Recommendation |
|---|---|---|--|
| Ascending Chain | Cracked & worn | B | Replace chain |
| | Barriers removed | B | Replace two poly side barriers. Consult Mfr. |

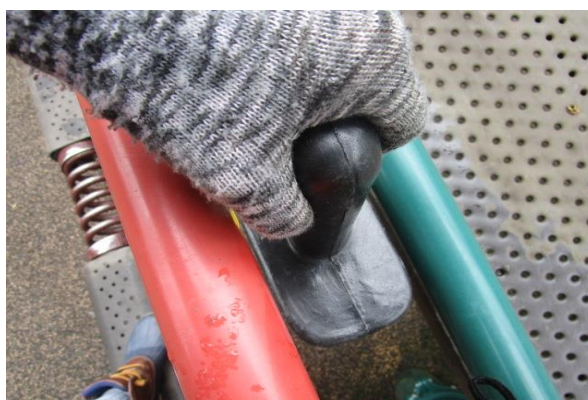
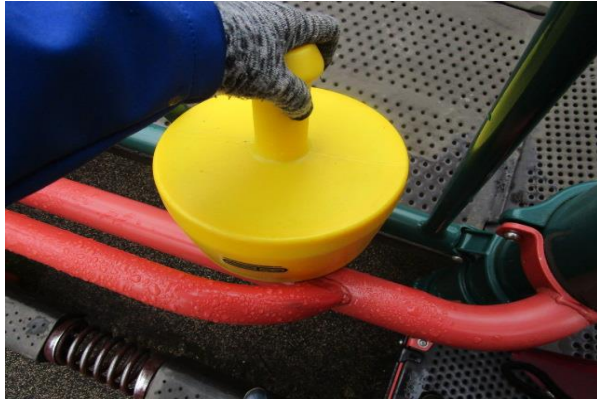
Spring Across Bridge - Head Entrapment between rail & Arch Bridge - CLASS A HAZARD

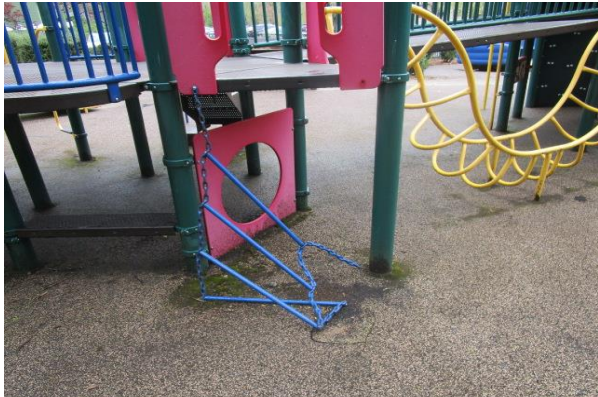
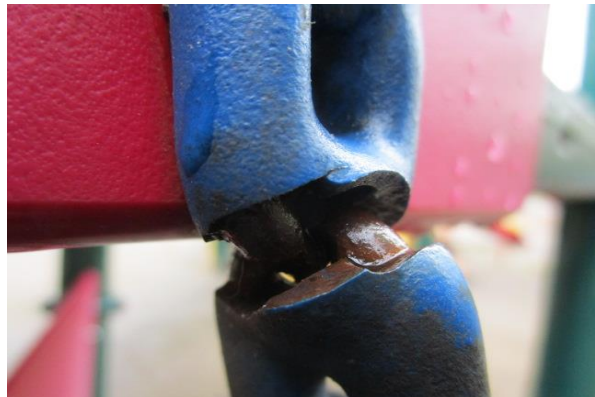
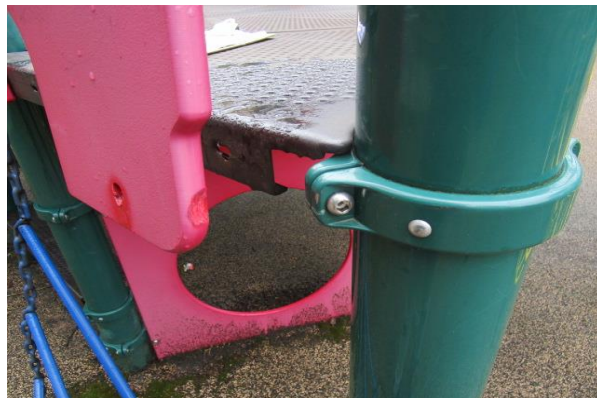
Wiggle Chain Ladder - Ladder & one handhold detached, chain worn - CLASS B HAZARD

| | Condition | Hazard Priority | Recommendation |
|---|--|---|---|
| Wiggle Chain Ladder | Ladder & one handhold detached, chain worn | B | Replace ladder & one bolt at handhold, reattach |

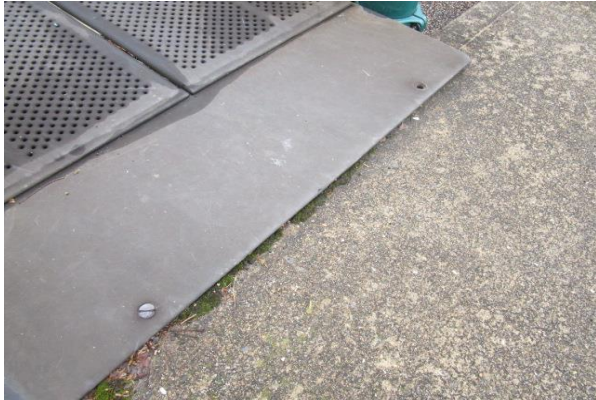
Entrance Ramp (2) - Trip hazard at three bolts missing at sidewalk - CLASS B HAZARD

| | Condition | Hazard Priority | Recommendation |
|---|--|---|---|
| Entrance Ramp (2) | Trip hazard at three bolts missing at sidewalk | B | Replace three bolts & reattach to sidewalk |

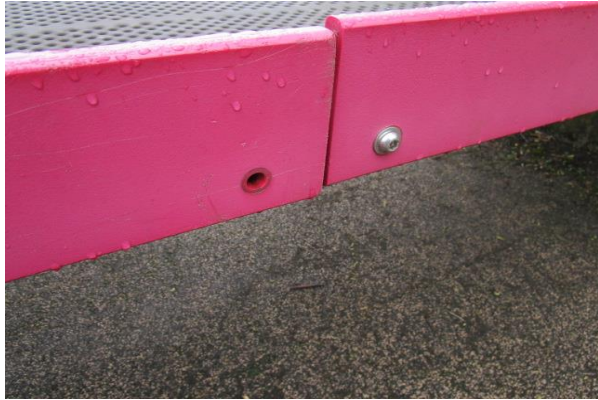
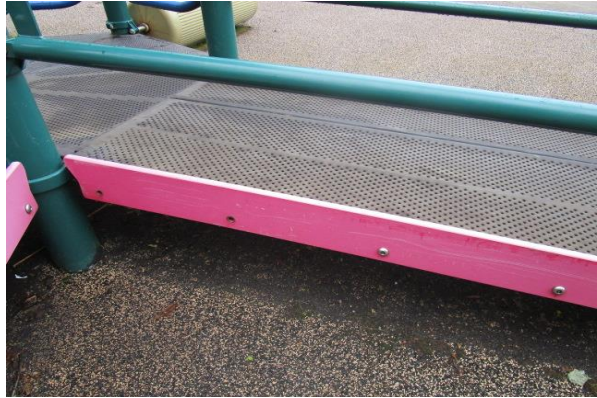
Entrance Ramp (2) - Four bolts missing at side rails - MAINTENANCE

| | Condition | Hazard Priority | Recommendation |
|---|--|---|---|
| | Four bolts missing at side rails | Maint. | Replace four bolts at side rails/lip |

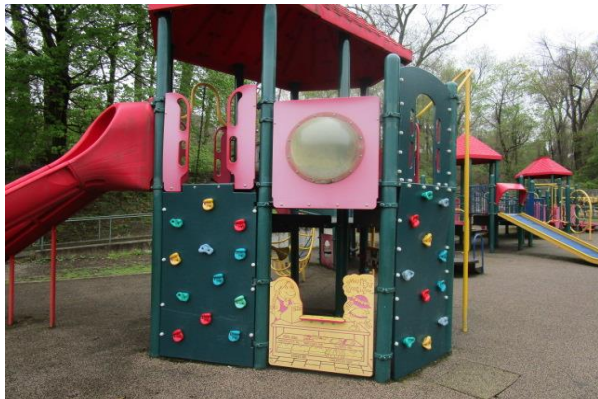
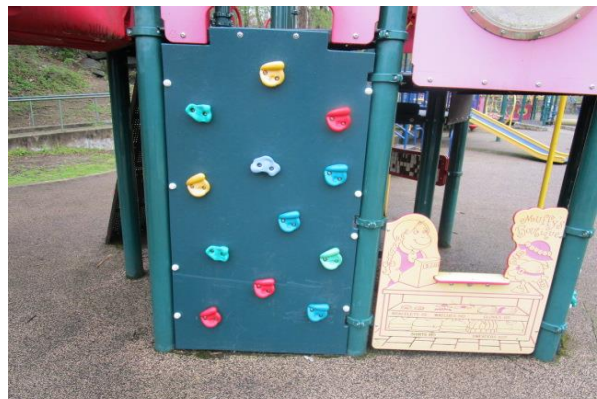
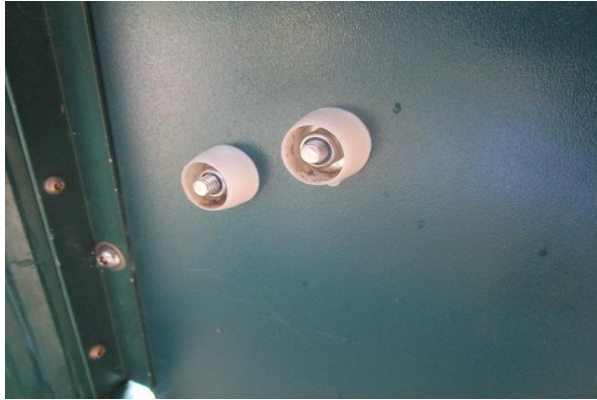
Vertical Rock Wall (2) - Non manufacturer parts, six broken bolt caps - MAINTENANCE

| | Condition | Hazard Priority | Recommendation |
|---|--|---|---|
| Vertical Rockwall | Non Manufacturer parts, six broken bolt caps | Maint. | Monitor/replace six bolt caps |

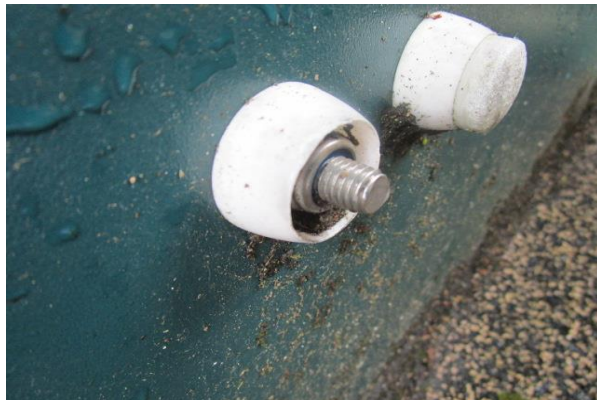
Rockwall (2) - Two protruding bolts - CLASS B HAZARD

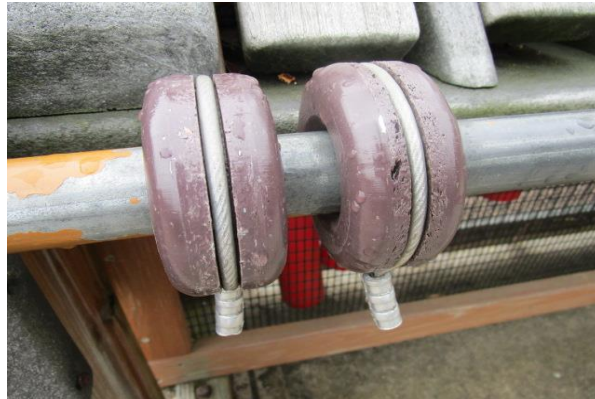
**Freestanding Equipment
Music Panels (2)(SoundPlay) - Four mallets missing - MAINTENANCE**

| | Condition | Hazard Priority | Recommendation |
|---|---|---|---|
| Music Panels (2)(SoundPlay) | Four mallets missing | Maint. | Replace four mallets or remove cable & connectors |

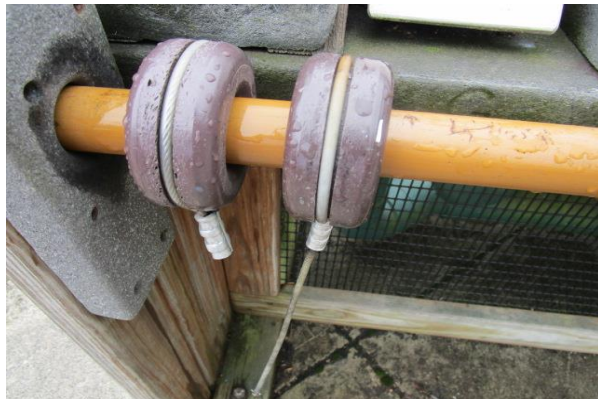
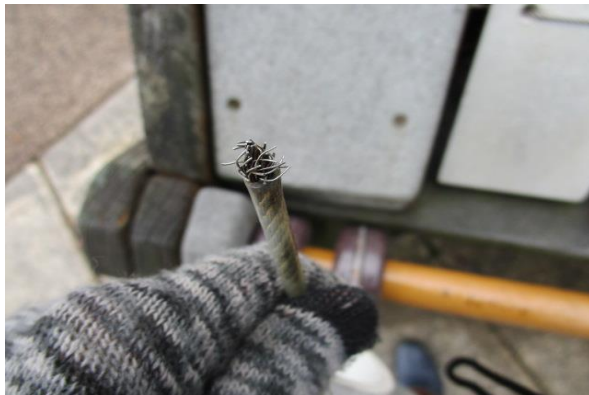
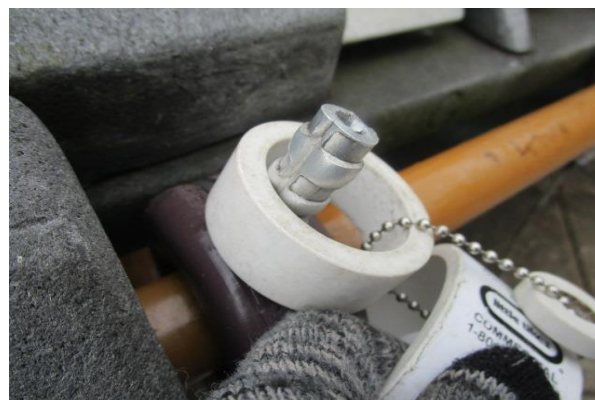
Music Panel (2)(SoundPlay) - Sharp steel & four connectors protruding at missing mallets - CLASS B HAZARD

| | Condition | Hazard Priority | Recommendation |
|---|---|---|---|
| | Sharp steel & four connectors protruding at missing mallets | B | Replace four mallets or remove cable & connectors |

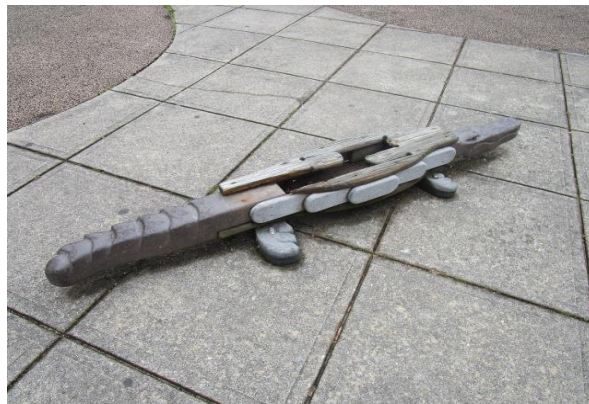
| | | Condition | Hazard Priority | Recommendation | |
|---|---|---|---|---|---|
| Alligator (SoundPlay) | | Wood broken, cracked & splintered | B | Remove Unit | |
| | | Music component is missing | Maint. | | |

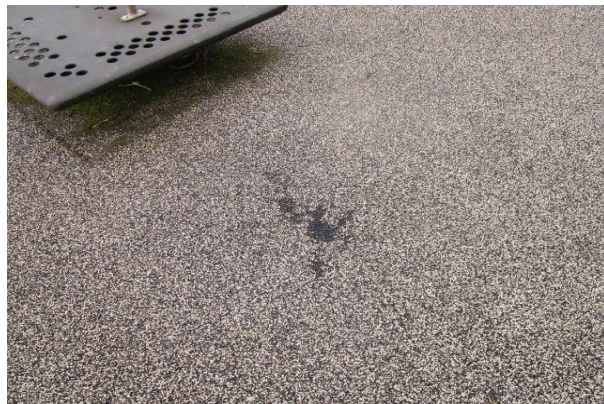
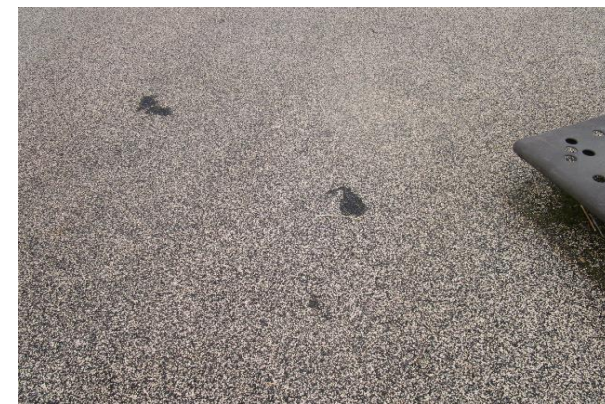
Rock-it-Cube (Landscape) - Small holes, rubber dirty - MAINTENANCE

Surfacing PIP 2½ - 3" Small cracks in rubber Maint. Repair 2 sq.ft.
