SECOND FLOOR

Stark Elementary School

Area 8

Figure 3.5

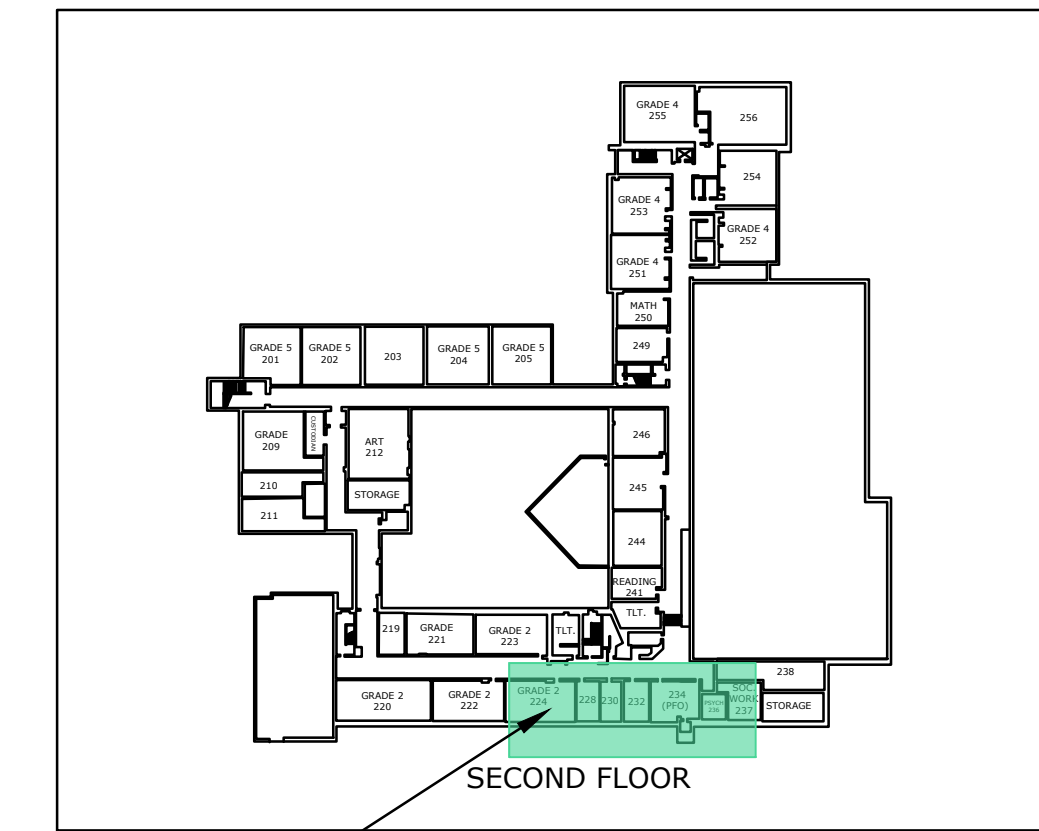
- SET UP EDGE GUARD AT ROOM ENTRANCE,
- SET UP CONTAINMENT AND NEGATIVE AIR MACHINE,
- REMOVE MILLWORK,
- INSPECT ROOF DRAIN AND REPAIR IF NEEDED,
- REMOVE APPROXIMATELY 650 SF OF VINYL WALL PAPER;
- REMOVE APPROXIMATELY 30 SF OF DRYWALL AROUND WINDOW SYSTEM;
- INSTALL INSPECTION HOLES WHERE NEEDED
- CLEAN EXPOSED FIN TUBE,
- CLEAN 1 RETURN AND 1 VENT;
- CLEAN 3 CEILING TILE (REMOVE IF UNABLE TO CLEAN);
- REPAIR HVAC INSULATION

- SET UP EDGE GUARD AT ROOM ENTRANCE,
- SET UP CONTAINMENT AND NEGATIVE AIR MACHINE,
- REMOVE MILLWORK,
- INSPECT ROOF DRAIN AND REPAIR IF NEEDED,
- REMOVE APPROXIMATELY 560 SF OF VINYL WALL PAPER;
- REMOVE APPROXIMATELY 30 SF OF DRYWALL AROUND WINDOW SYSTEM;
- INSTALL INSPECTION HOLES WHERE NEEDED,
- CLEAN EXPOSED FIN TUBE,
- REMOVE 6 CEILING TILE
- CLEAN 4 CEILING TILE (REMOVE IF UNABLE TO CLEAN), CLEAN 1 RETURN AND 1 VENT;
- REPAIR HVAC INSULATION IF NEEDED

- SET UP EDGE GUARD AT ROOM ENTRANCE,
- SET UP CONTAINMENT AND NEGATIVE AIR MACHINE,
- REMOVE MILLWORK,
- INSPECT ROOF DRAIN AND REPAIR IF NEEDED,
- REMOVE APPROXIMATELY 560 SF OF VINYL WALL PAPER;
- REMOVE APPROXIMATELY 30 SF OF DRYWALL AROUND WINDOW SYSTEM;
- INSTALL INSPECTION HOLES WHERE NEEDED
- CLEAN EXPOSED FIN TUBE,
- REMOVE 1 CEILING TILE
- CLEAN 3 CEILING TILE, (REMOVE IF UNABLE TO CLEAN)
- CLEAN 1 RETURN AND 1 VENT;
- REPAIR HVAC INSULATION IF NEEDED

- SET UP EDGE GUARD AT ROOM ENTRANCE,
- SET UP CONTAINMENT AND NEGATIVE AIR MACHINE,
- REMOVE APPROXIMATELY 525 SF OF WALL COVERING;
- REMOVE APPROXIMATELY 30 SF OF DRYWALL AROUND WINDOW SYSTEM;
- INSTALL INSPECTION HOLES WHERE NEEDED,
- CLEAN EXPOSED FIN TUBE,
- CLEAN 1 RETURN AND 1 VENT;
- REMOVE 15 CEILING TILE;
- CLEAN AND VAC 3 CEILING TILE (REMOVE IF UNABLE TO CLEAN)
- REPAIR HVAC INSULATION IF NEEDED

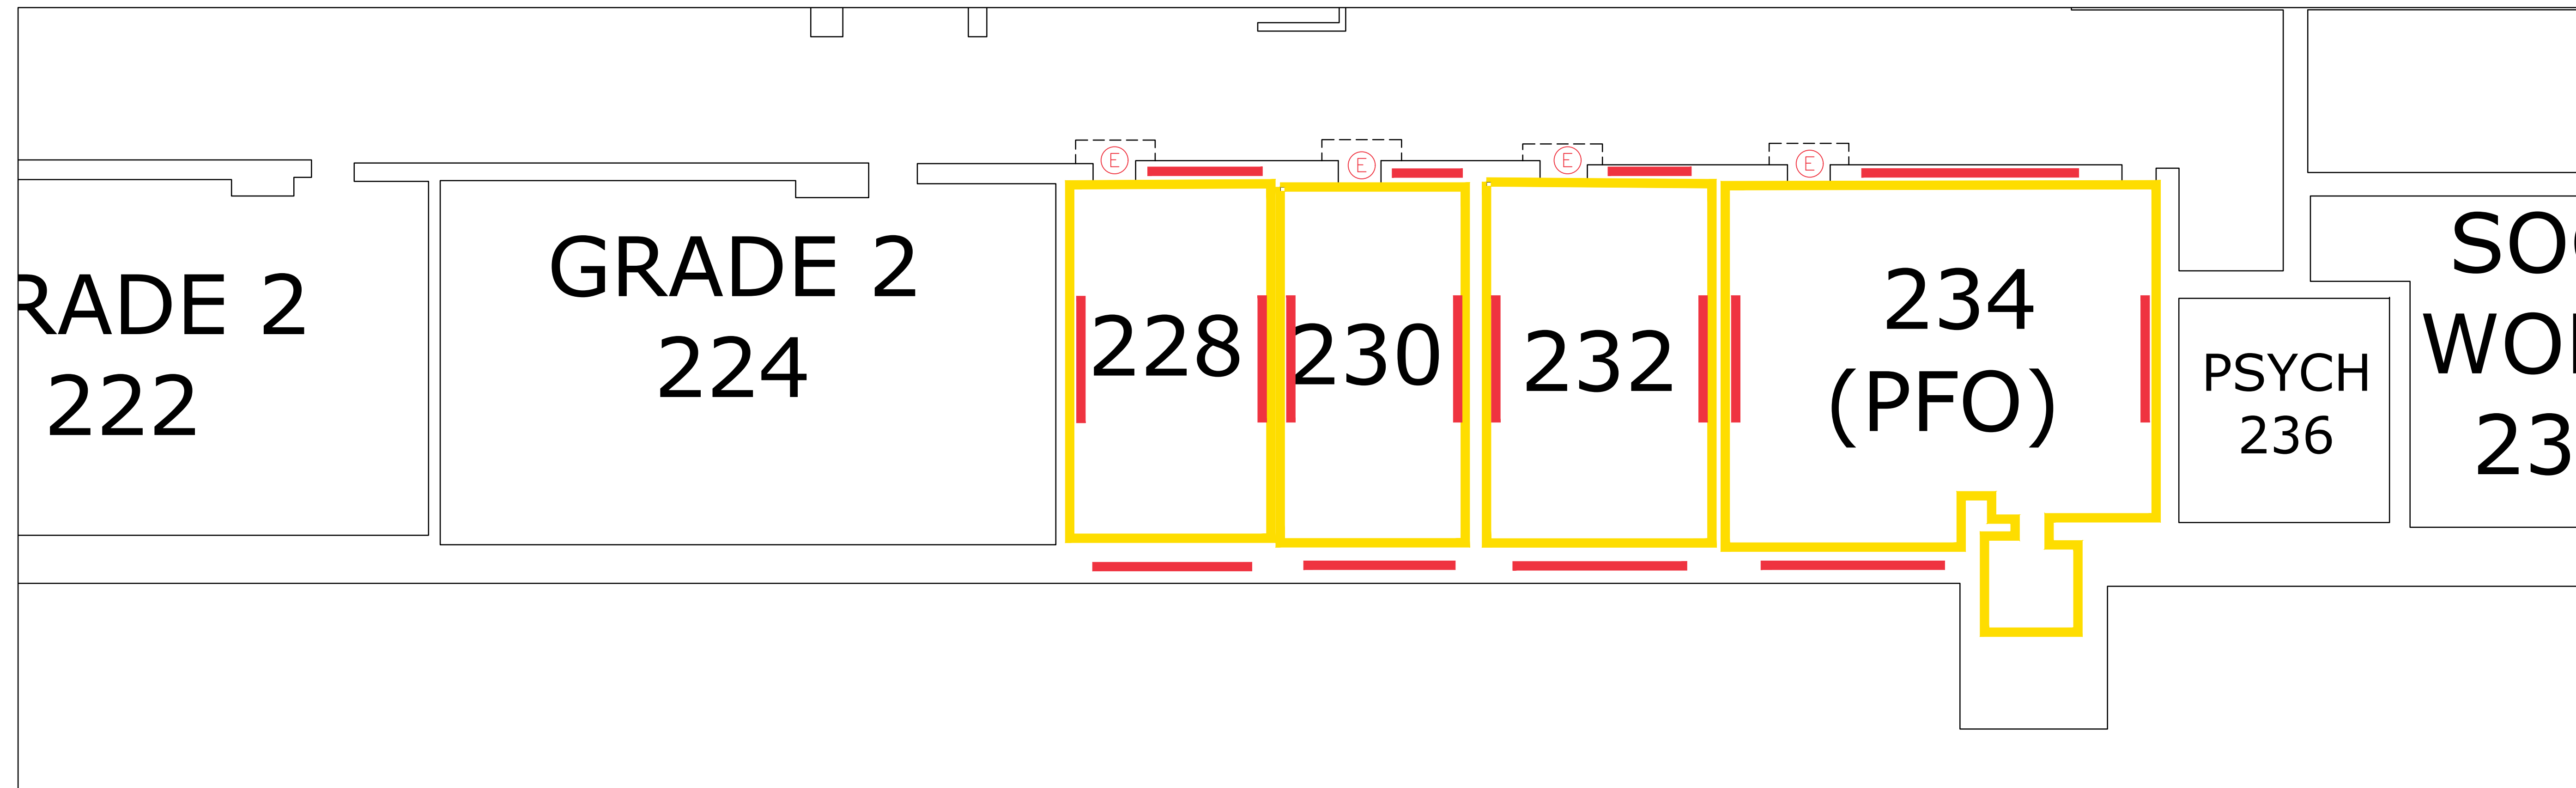
ROOM 228

ROOM 230

ROOM 232

ROOM 234 (PFO)
