INFRA-RED ROOF MOISTURE ANALYSIS

VIKING CONSTRUCTION
 BRIDGEPORT, CT
 JULIA STARK ELEM.
 STAMFORD, CT

SCALE:	3/64"=1'-0"
DATE:	05-08-19
PAGE:	1 OF 1
DRAWN BY:	DMR
JOB#:	19231X08

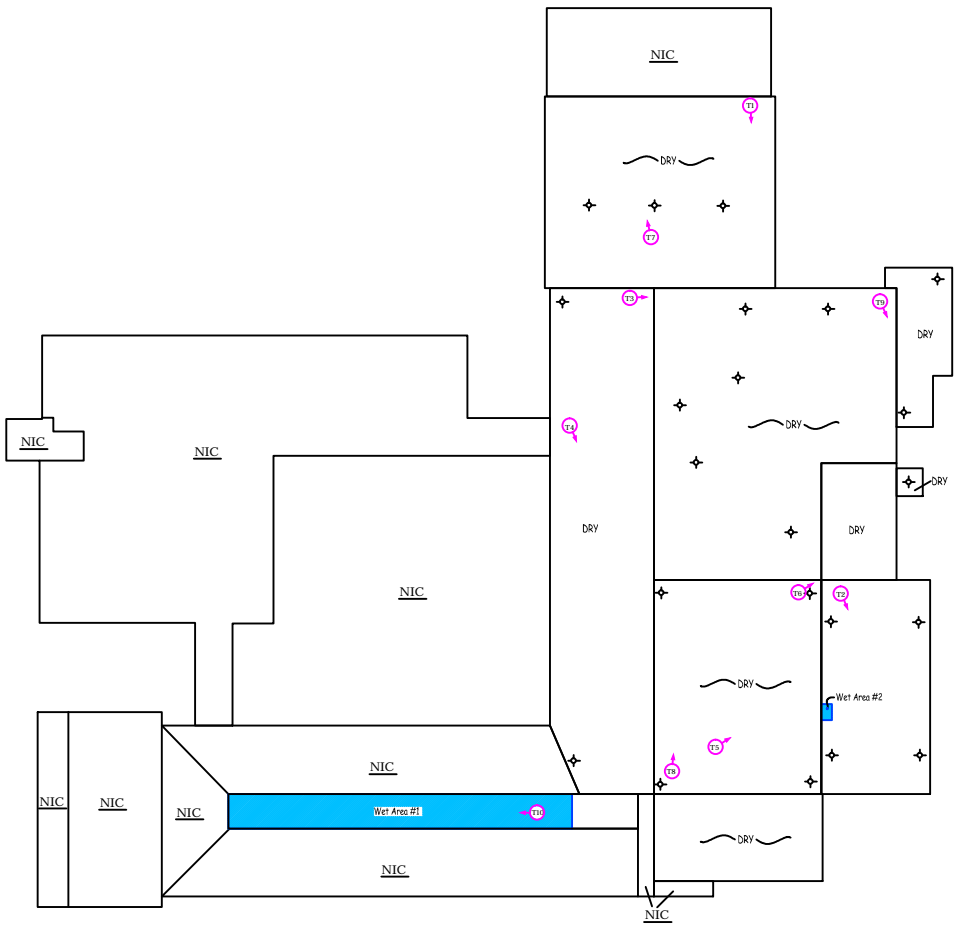
SUSPECTED WET INSULATION

Square Footage of Roof Inspected:	37,744
Square Footage of Suspected Wet Area:	1,731
Percentage of Suspected Wet Area:	4.6%
