**INFRA-RED ROOF MOISTURE ANALYSIS**

**VIKING CONSTRUCTION**  
 BRIDGEPORT, CT  
 NORTHEAST SCHOOL  
 STAMFORD, CT

SCALE: 3/64"=1'-0"  
 DATE: 04-24-19  
 PAGE: 1 OF 1  
 DRAWN BY: DMR  
 JOB#: 19231X03

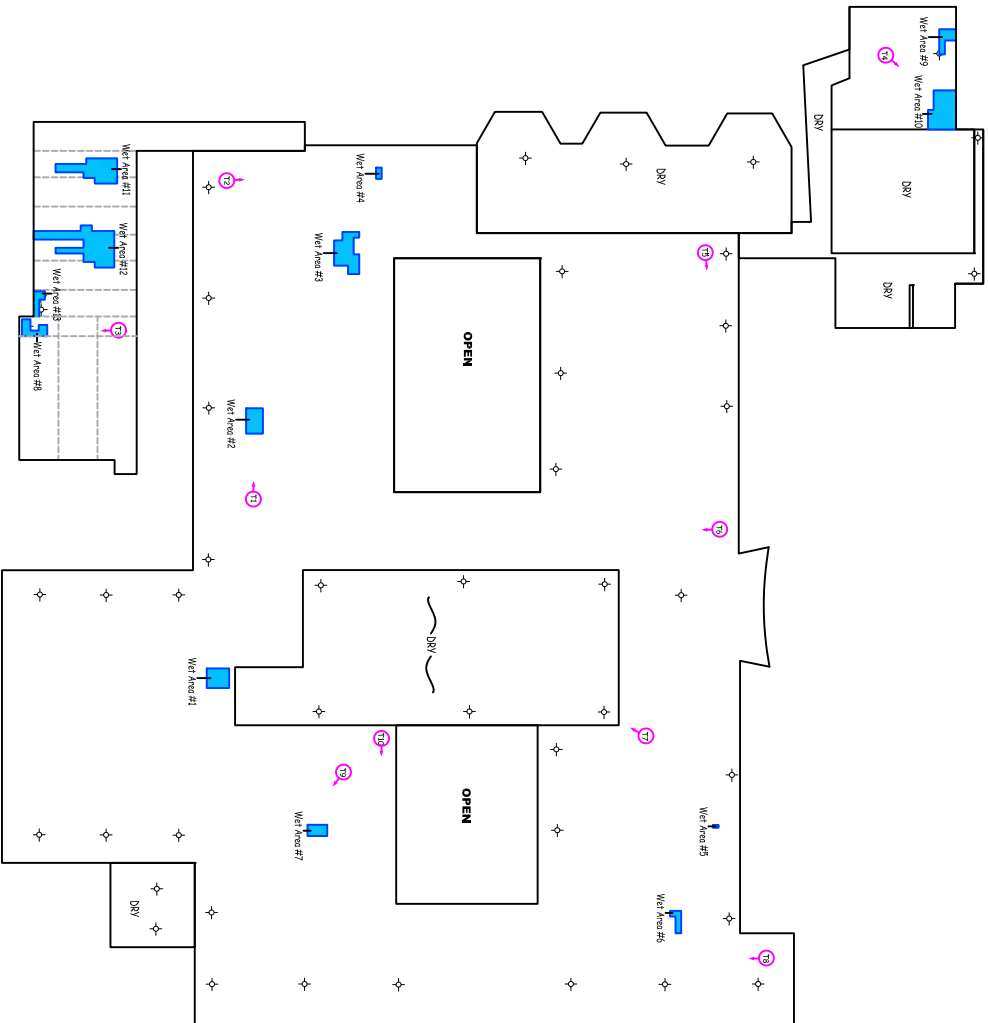
**Arenas Total of All Roofs**  
 (Individual square feet)  
 Square Footage of Roof Inspected: 75,815  
 Square Footage of Suspected Wet Areas: 831  
 Percentage of Suspected Wet Areas: 1.0%
