Toquam Magnet School

City of Stamford

UPPER LEVEL

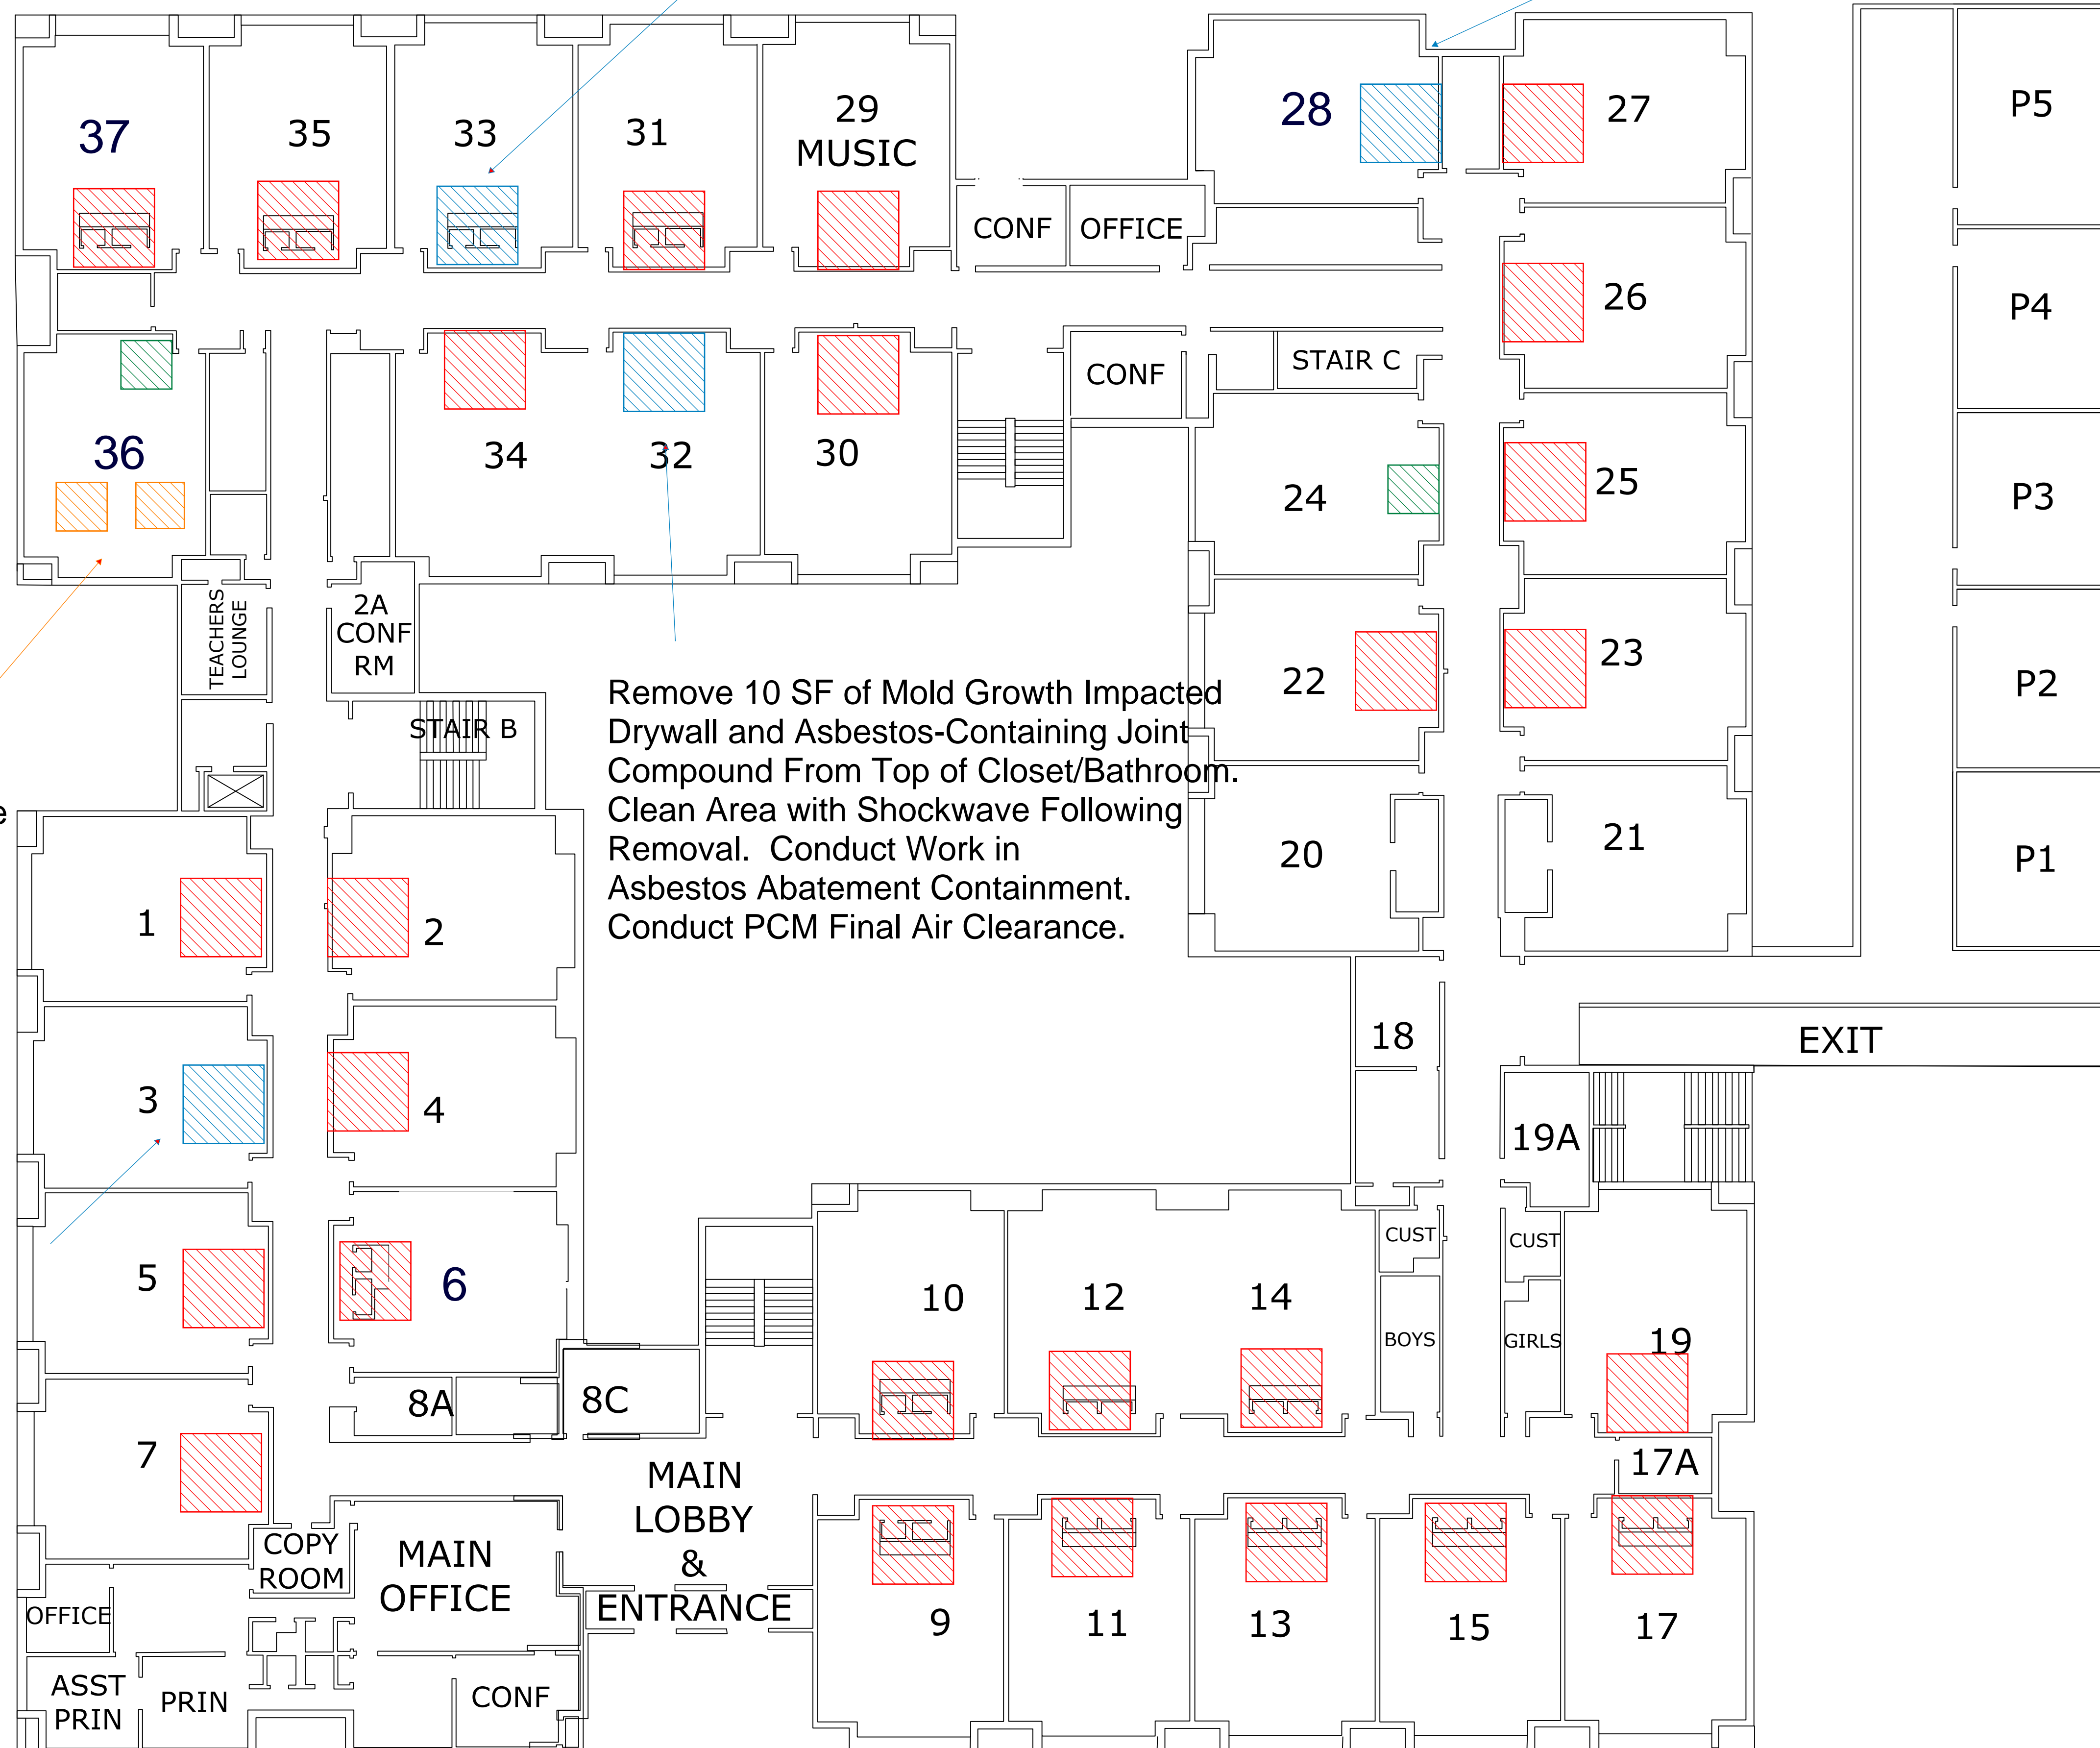
Clean Walls and Top of Closet/Bathroom Drywall, Pipe Fittings, and Air Handler Unit with Shockwave. HEPA Vacuum Roofing Debris and Dust/Debris Prior to Cleaning.

Remove 25 SF of Mold growth Impacted Drywall and Asbestos-Containing Joint Compound From Top of Closet/Bathroom. Clean Area with Shockwave Following Removal. Conduct Work in Asbestos Abatement Containment. Conduct PCM Final Air Clearance.

Remove 50 SF of Water Damaged Drywall and Asbestos -Containing Joint Compound From Top and Bottom of Overhang. Clean Area with Shockwave Following Removal. Conduct Work in Asbestos Abatement Containment. Conduct PCM Final Air Clearance.

Remove 2 SF of Asbestos-Containing Floor Tile/Mastic in 2 Locations Where Holes are. Conduct Work in An Asbestos Abatement Contianment. Conduct PCM Final Air Clearance

Remove 10 SF of Mold Growth Impacted Drywall and Asbestos-Containing Joint Compound From Top of Closet/Bathroom. Clean Area with Shockwave Following Removal. Conduct Work in Asbestos Abatement Containment. Conduct PCM Final Air Clearance.

Remove 25 SF of Mold Growth Impacted Drywall and Asbestos-Containing Joint Compound From Top of Closet and 10 SF of Mold Growth Impacted Drywall and Asbestos-Containing Joint Compound from Closet Ceiling. Clean Area with Shockwave Following Removal. Conduct Work in Asbestos Abatement Containment. Conduct PCM Final Air Clearance.
