**Davenport
Ridge
Elementary
School**

City of Stamford

AREA 1

FIGURE 3.1

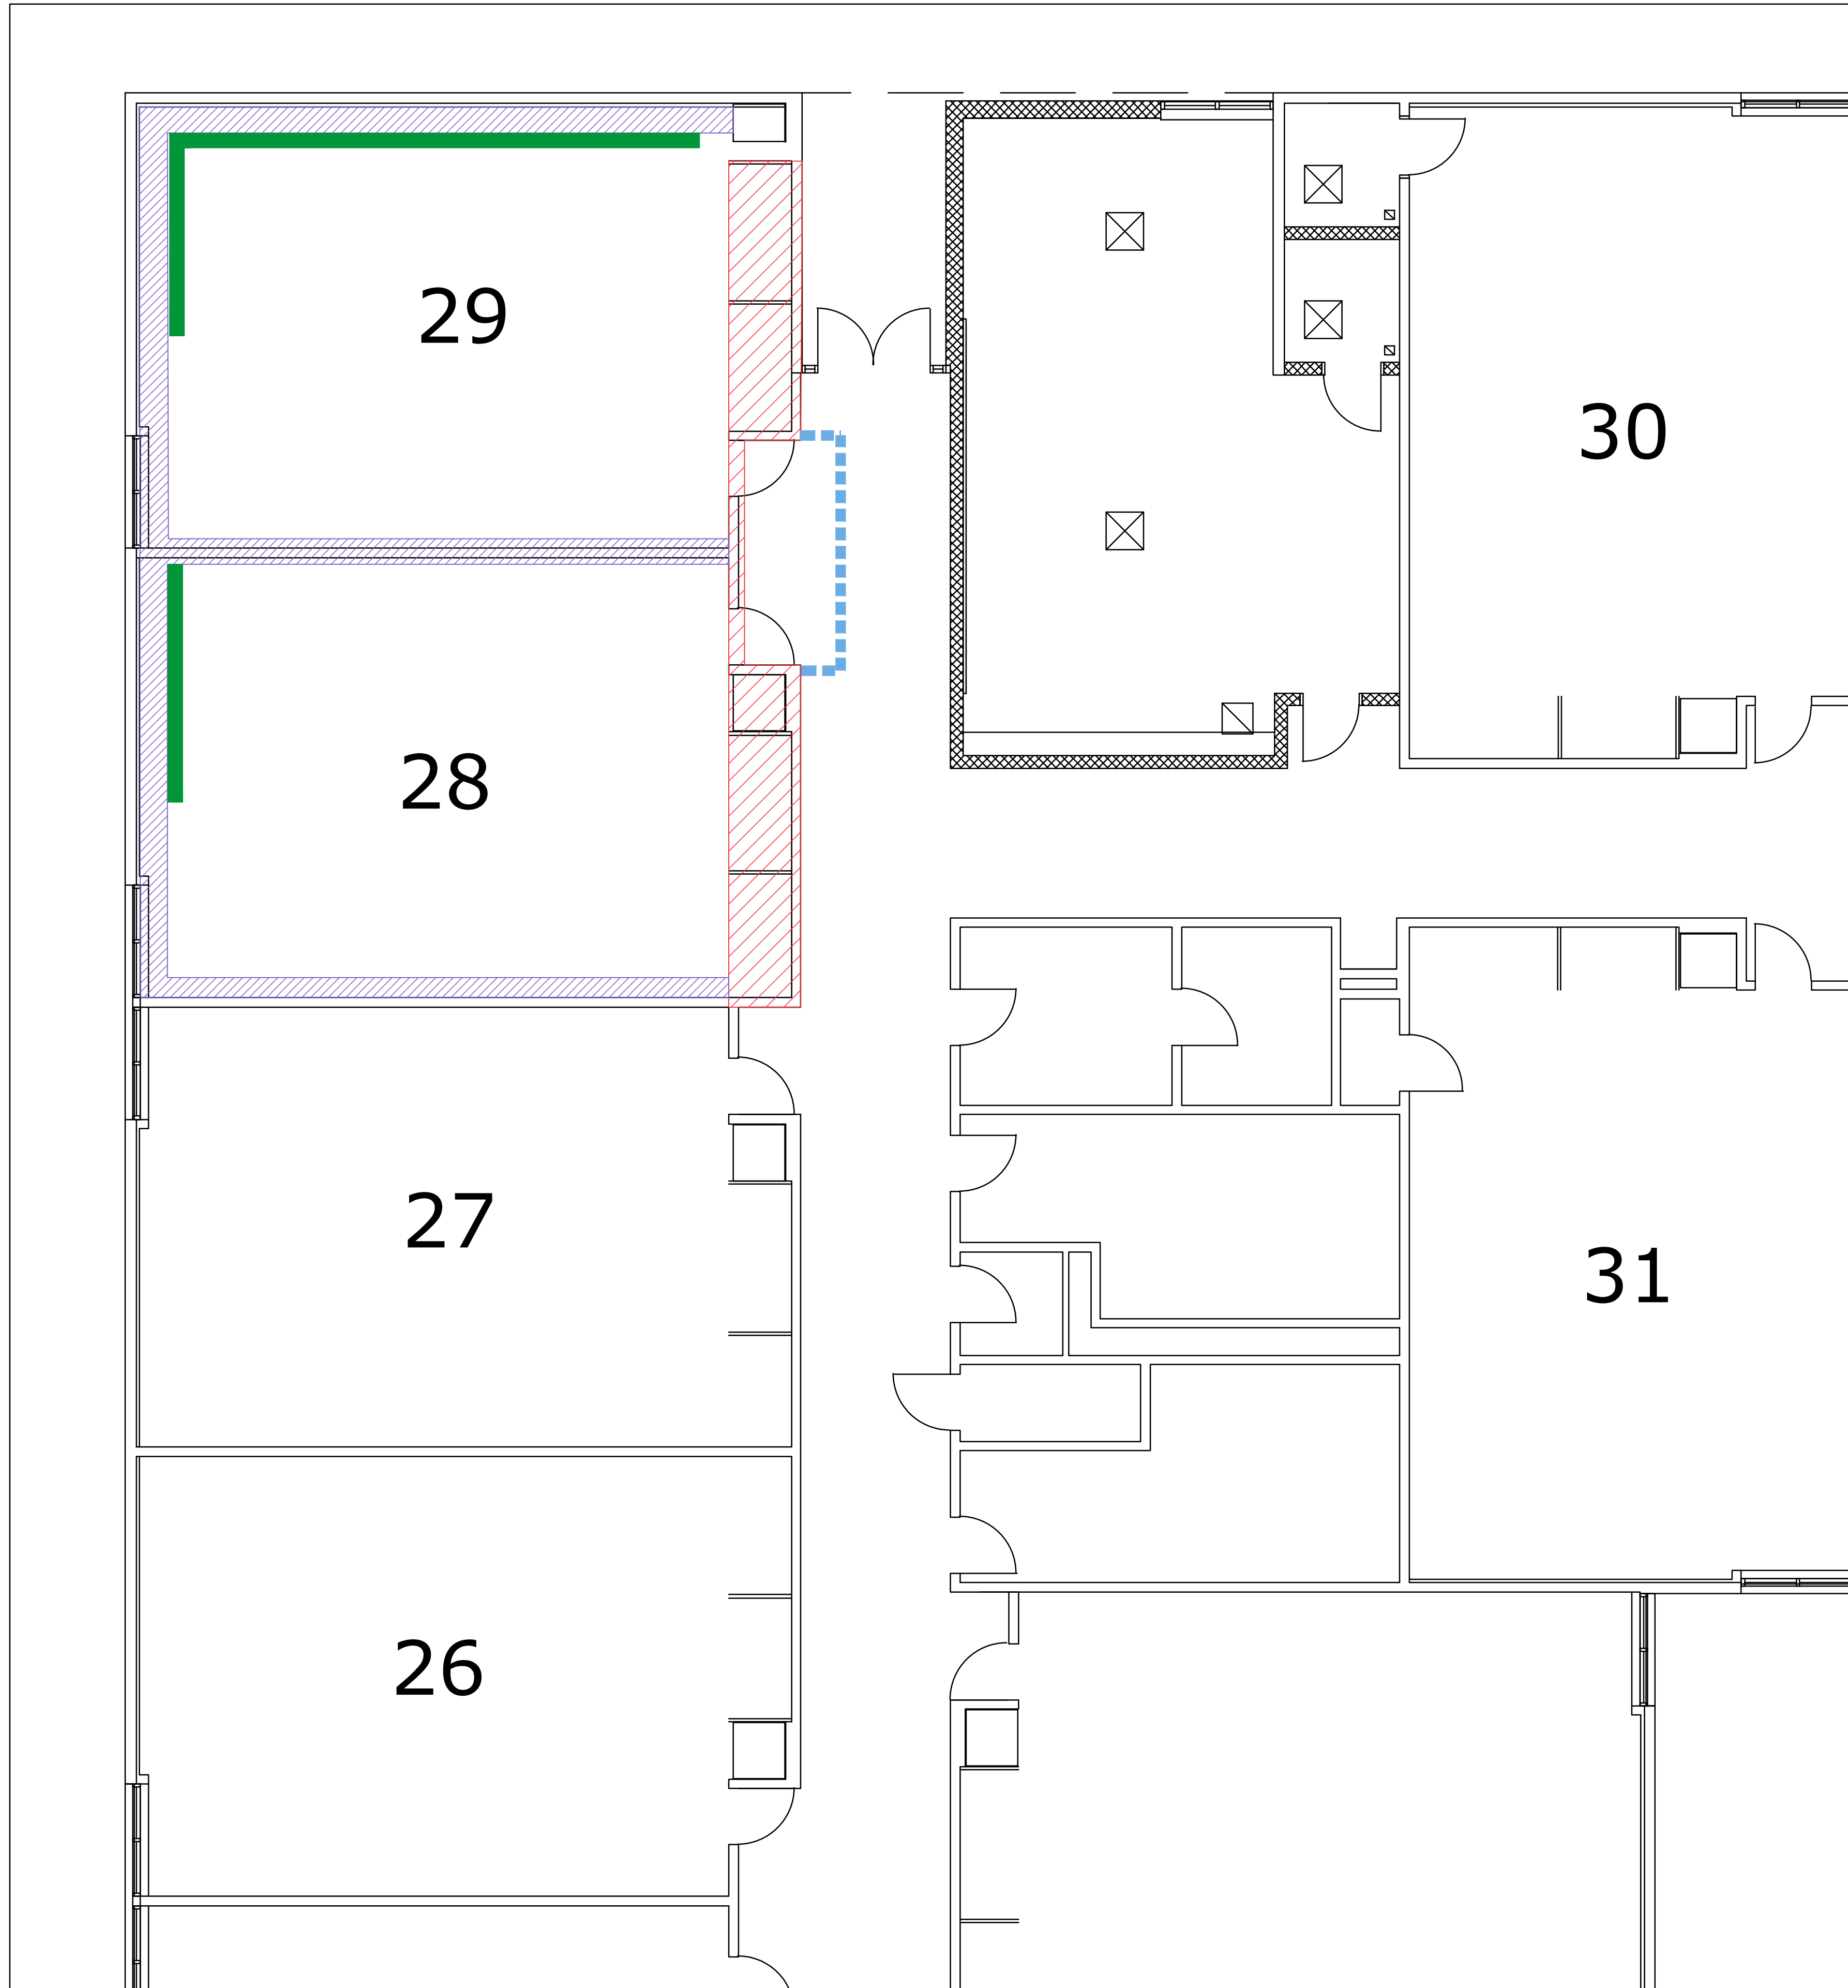
- REMOVE VINYL COVERING AND DRYWALL/ASBESTOS TAPING COMPOUND SOFFIT IN ENTIRETY
REMOVE WATER STAINED AND/OR MOLD GROWTH IMPACTED PIPE INSULATION ABOVE SOFFIT
CLEAN AND DISINFECT AREA
- REMOVE TACKBOARD, ASBESTOS GLUE DAUBS, AND DRYWALL/ASBESTOS TAPING COMPOUND IN ENTIRETY
REMOVE WATER IMPACTED AND/OR MOLD GROWTH IMPACTED RIGID INSULATION
CLEAN AND DISINFECT AREA
- REMOVE ASBESTOS CEMENT RADIATOR BOARDS
- HARD BARRIER
