Julia A. Stark Elementary School

Exterior Façade Investigation

Final Report
September 19, 2019

Prepared by:
SILVER / PETRUCELLI+ASSOCIATES
Architects / Engineers / Interior Designers
3190 Whitney Avenue, Hamden, CT06518-2340
Tel: 203 230 9007 Fax: 203 230 8247
silverpetrucci.com

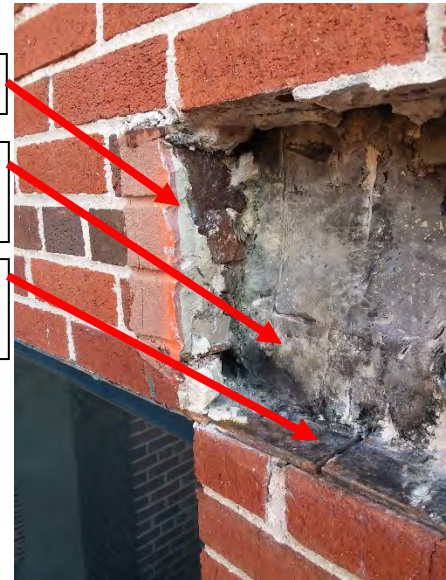
P2-2

WRB continuous over back leg of lintel

Gap between lintels

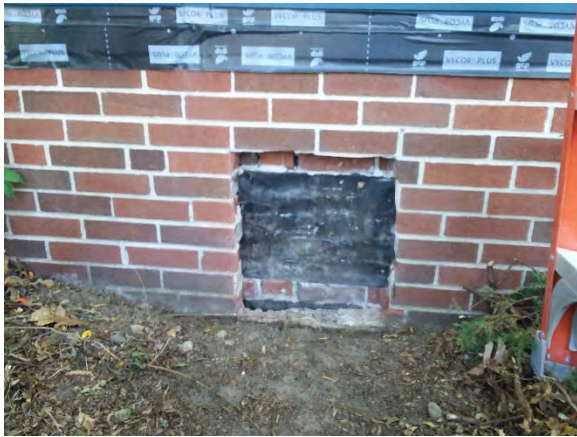
P3-1

The exterior wall construction appears to be at least 2 wythes of solid brick masonry with a three-quarter inch air space between the layers of the brick. There is a weather resistive barrier between the exterior wythe and second wythe of brick. The WRB is interrupted by a header course that is one course below grade. This brick coursing is a variation on the Common Bond where the header and the stretcher alternate at every sixth course of brick. The header brick extends back into the second brick wythe and helps tie the two wythes of brick together. The WRB is tucked into the mortar joint below the header course. The WRB is rigid but appears to be intact. There is an open mortar joint. There are no through wall flashing and no weeps observed at this area of the building. The floor elevation of the classroom is below the finished grade elevation of the planter. Mortar droppings within the air space can prevent proper drainage of water.

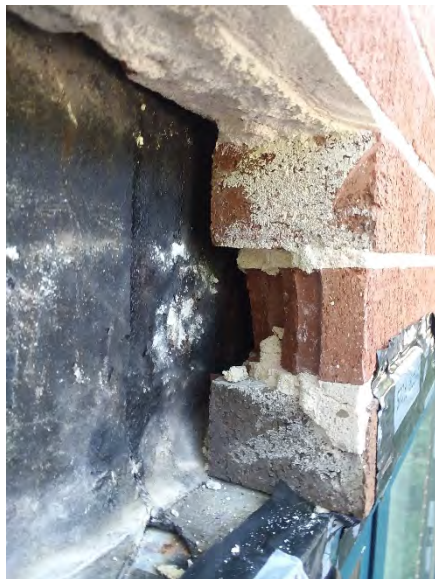
P4-1

Temporary sealing around window openings

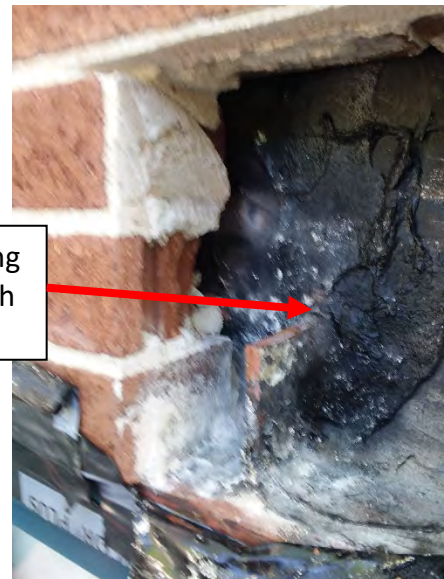
P4-2

Steel penetrating WRB sealed with mastic.

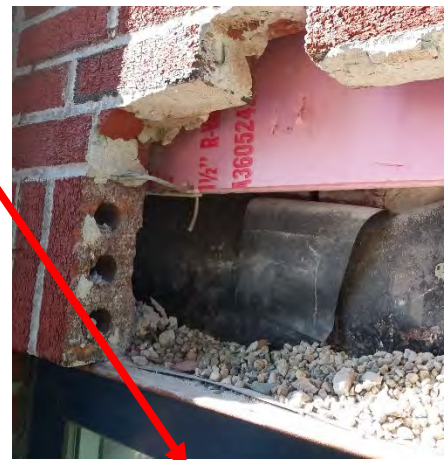
P 6-2

Pea gravel behind weep holes

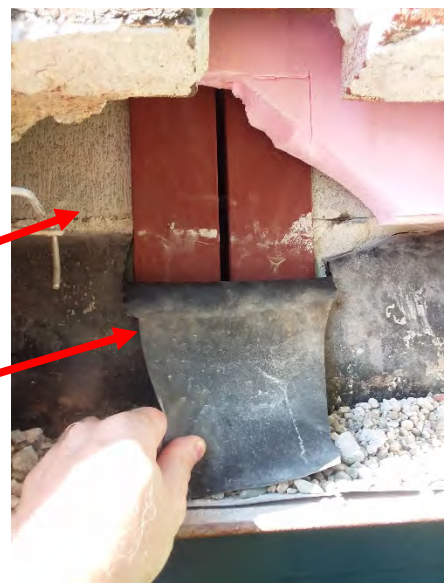
P6-4

WRB tucked into mortar joint

WRB cut at steel angles

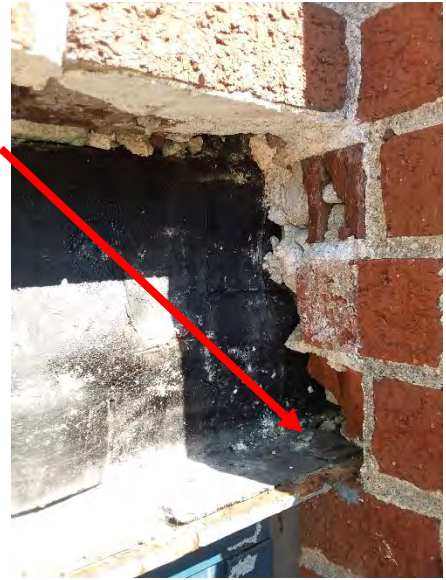
P8-3

No end damn at end of through wall flashing.

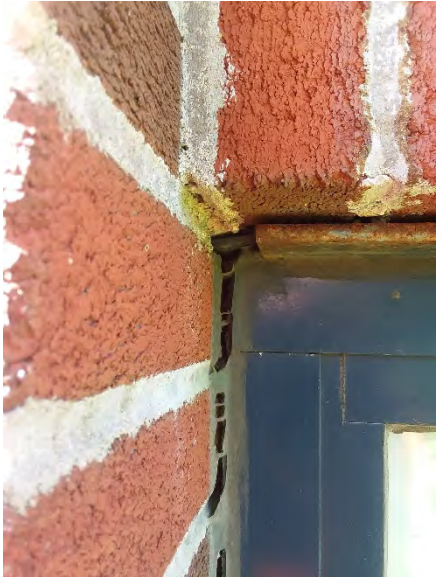
2-1

1. Seals between IG window panes are failing.
2. Sealant around windows openings is cracked and failing.
3. Control/Expansion joints are cracked and failing.

Failing Seals

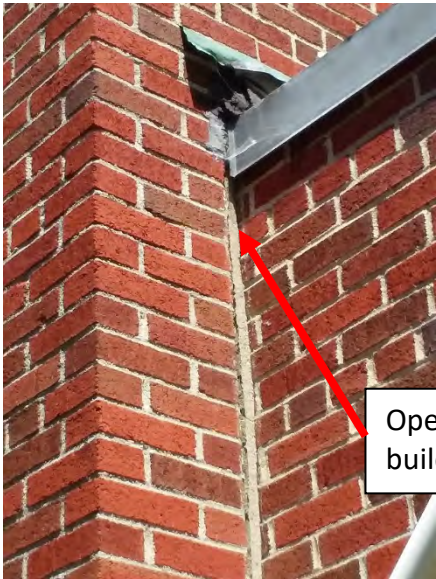
8-1

4. Several head joints around room 104 are missing mortar.
5. Mortar is missing at the head joints and under the stone windowsills at rooms 104 and 105.
6. Mortar is missing from the top corners of window openings at room 104 and 105.
7. At rooms 104 and 105 the precast parapet cap has shifted, and mortar is missing from its head joints and below the cap. Efflorescence on face of brick. Brick at parapet elevation is shifting.
8. Mortar joint at rooms 104 and 105 between 1927 and 1951 addition is open.

Open joint between building additions

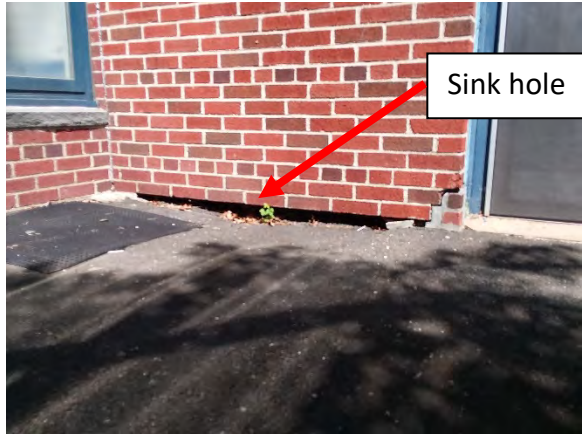
21-1

Sink hole

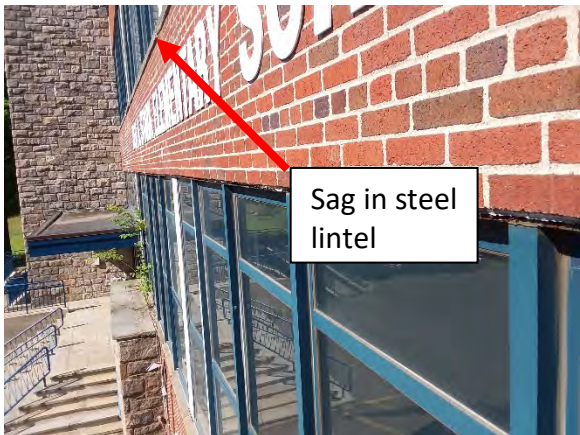
27-2

27. Steel lintels at the head of the first-floor and basement windows on the east elevation have a substantial amount of rust and appear to have the original steel lintel still above a newer one. The original steel lintel is delaminating and may be contributing the large sage observed across the three window openings.

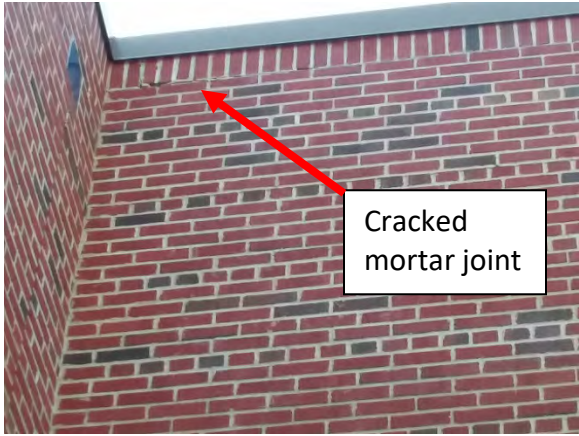
48-1

48. At room 212, masonry at the inside corner, top of wall, is cracked.
49. At room 212, masonry between control joint and inside corner is out of plane with the rest of the wall.
