FACILITIES NEEDS ASSESSMENT

STAMFORD PUBLIC SCHOOLS

Facilities Needs Assessment

K.T. MURPHY ELEMENTARY SCHOOL

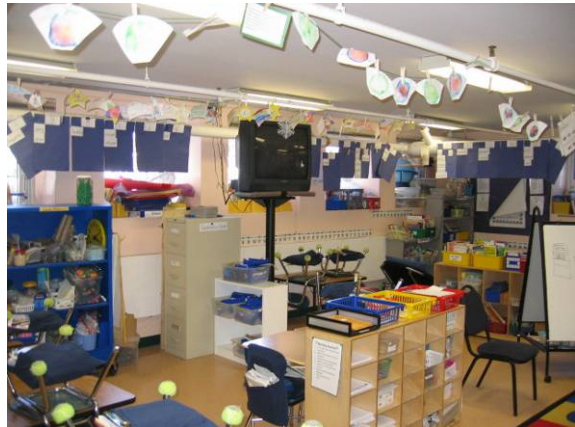
Photo #64: View of a typical first grade classroom

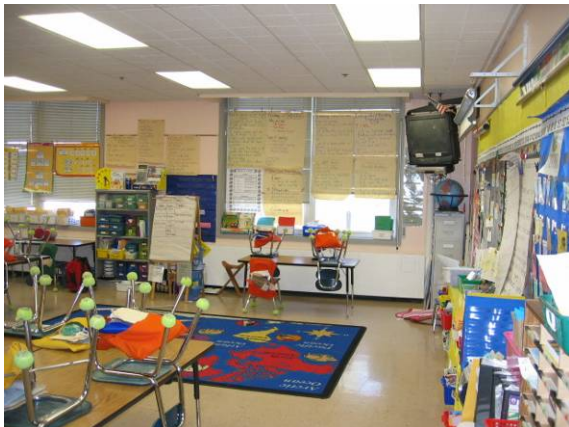
Photo #65: View of a typical kindergarten classroom

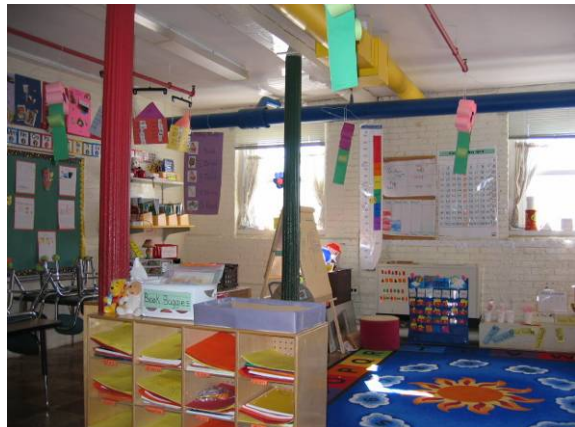
Photo #66: View of a typical 2nd grade classroom

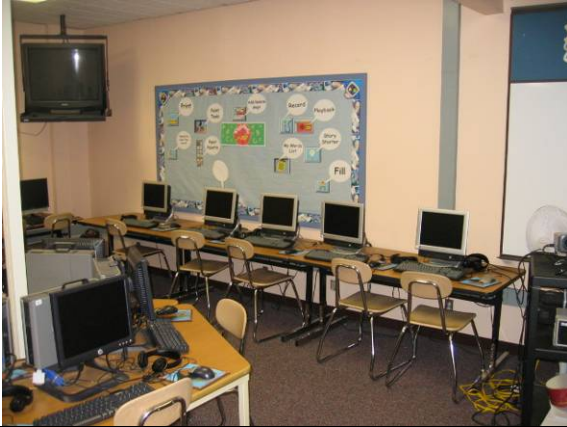
Photo #67: View of the computer lab

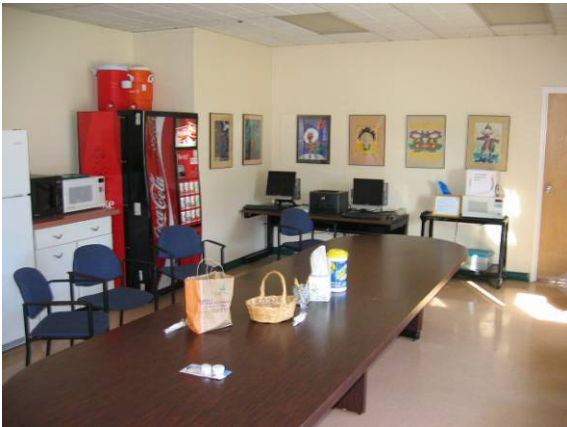
Photo #69: View of the teacher's lounge

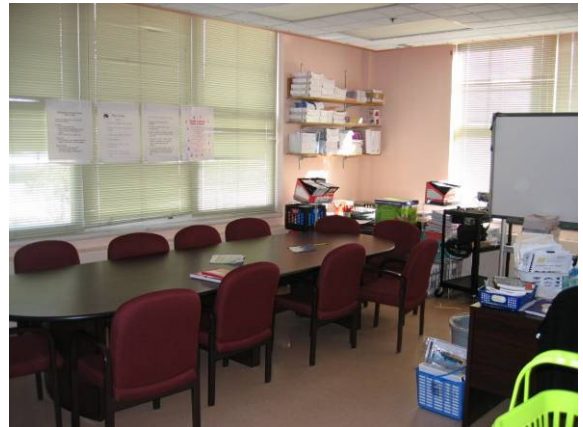
Photo #70: View of the PPT conference room

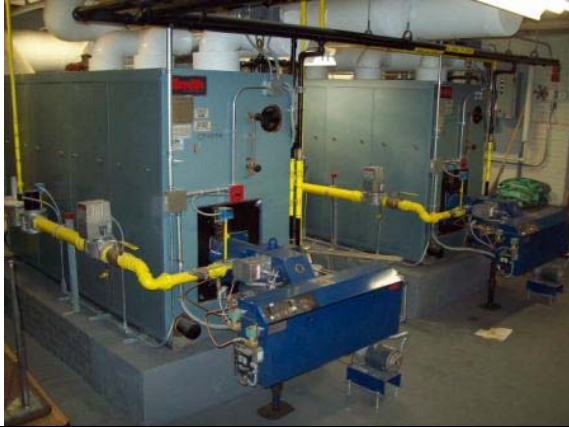
Photo #73: Boilers

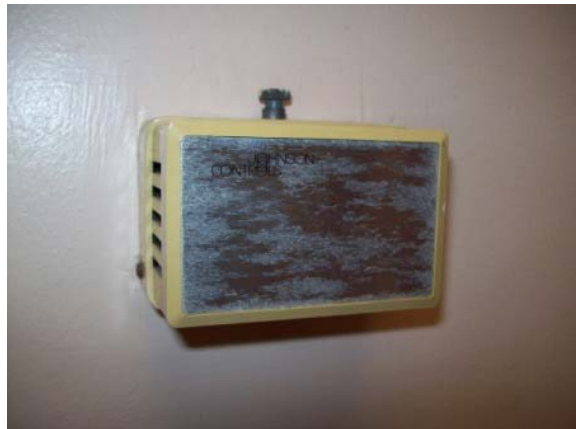
Photo #90: Typical thermostat

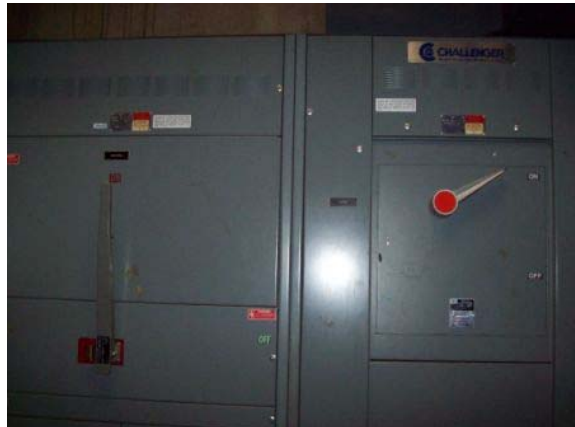
Photo #100: Switchgear

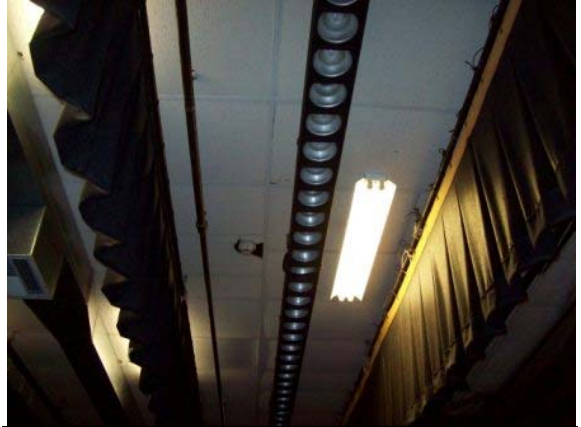
Photo #104: Stage lighting

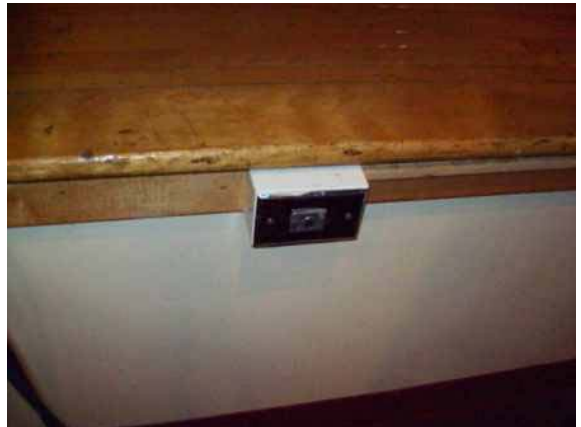
Photo #106: Microphone input jack

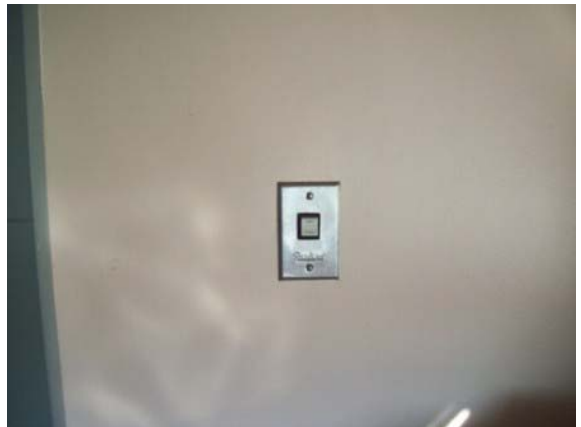
Photo #108: Public address button in classroom

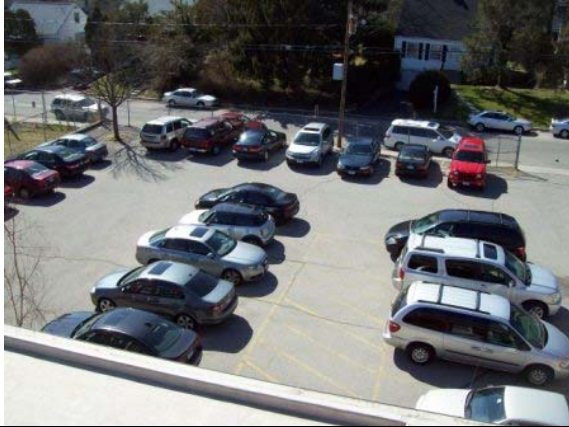
Photo #121: Staff parking lot

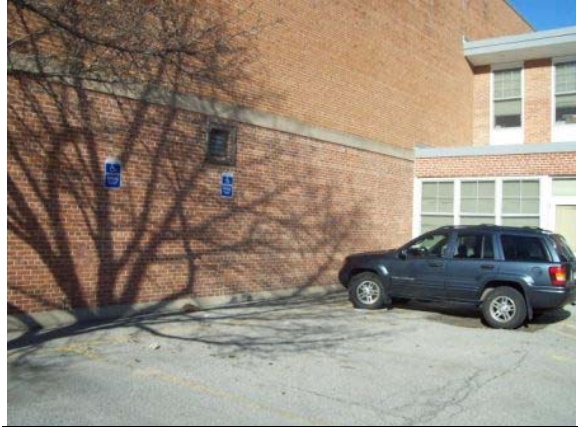
Photo #122: Accessible parking stalls

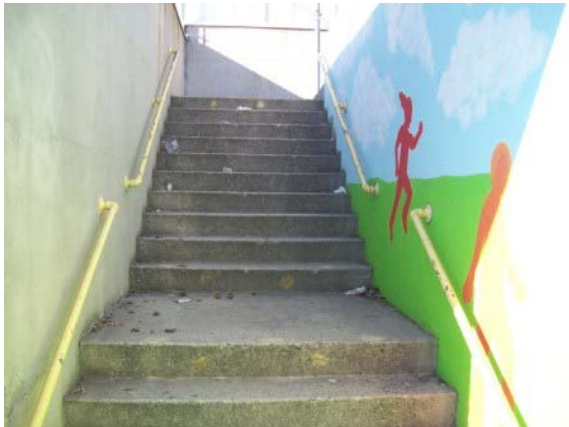
Photo #129: Concrete steps

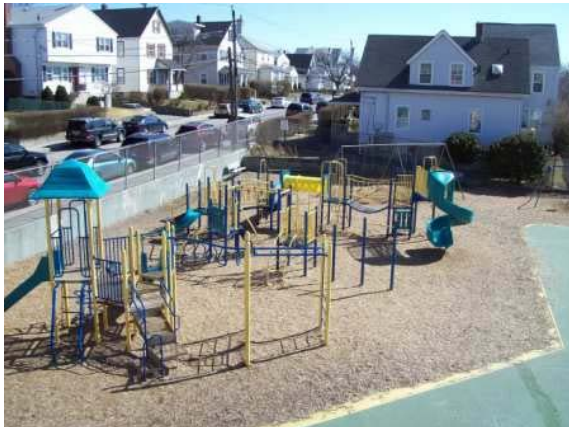
Photo #147: Main playground at southeast corner of property
