FACILITIES NEEDS ASSESSMENT

STAMFORD PUBLIC SCHOOLS

FACILITIES NEEDS ASSESSMENT OF NORTHEAST ELEMENTARY SCHOOL

EMG Project #: 88166.09R-010.017
Date of Report: August 27, 2009
On-site Date: February 17 and 18, 2009

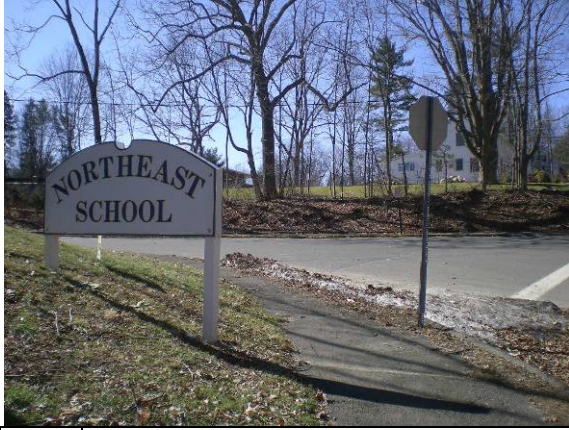
Photo #1: Front entrance signage

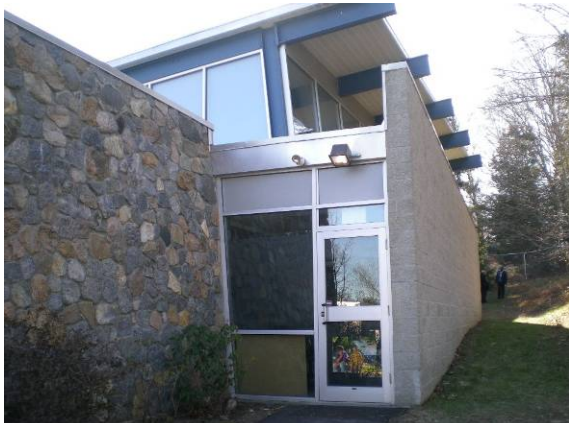
Photo #11: North elevation of Media Center

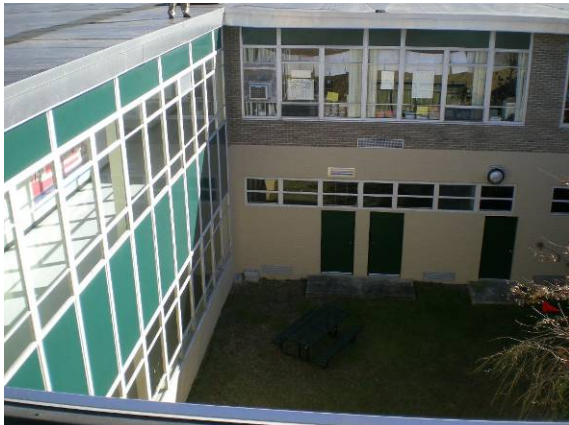
Photo #17: East side courtyard

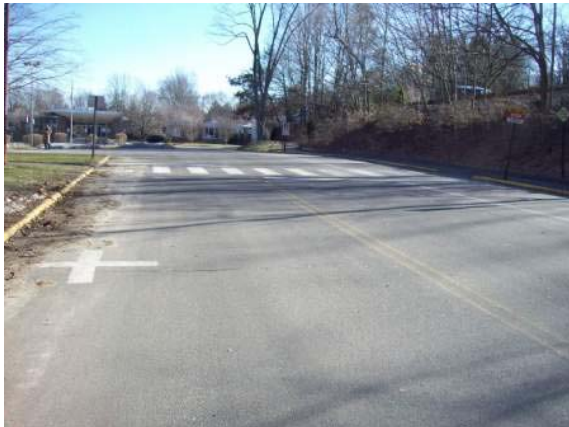
Photo #27: Main entry drive

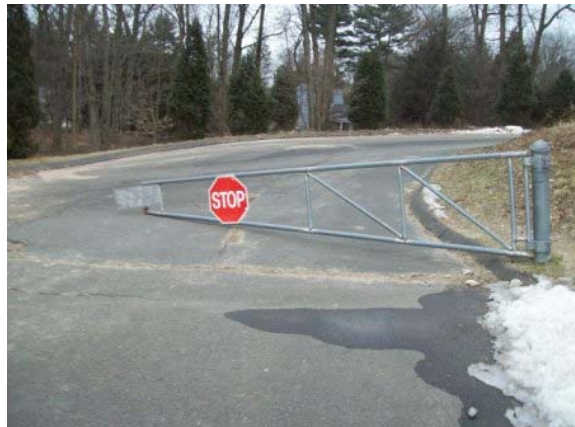
Photo #30: Service drive at south end of property

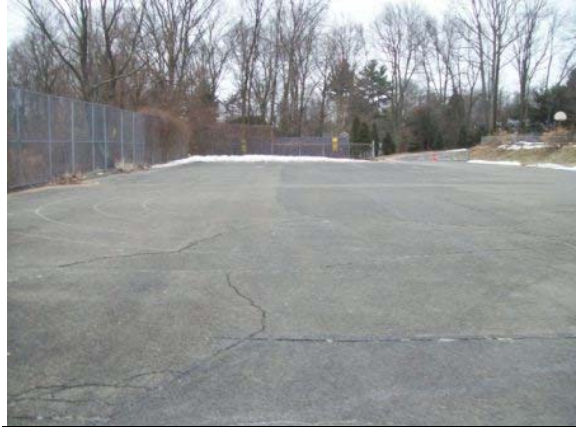
Photo #32:	Paved athletic area
------------	---------------------

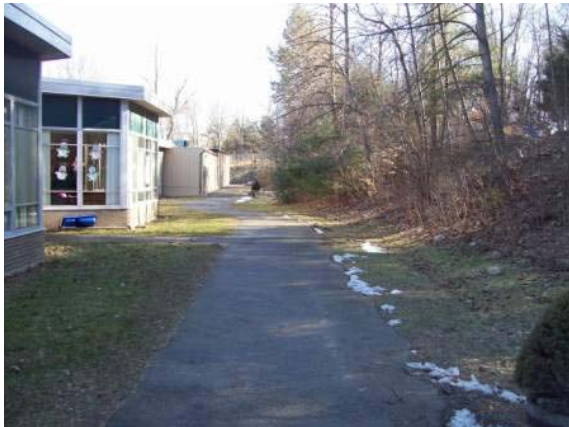
Photo #33:	Asphalt walking path
------------	----------------------

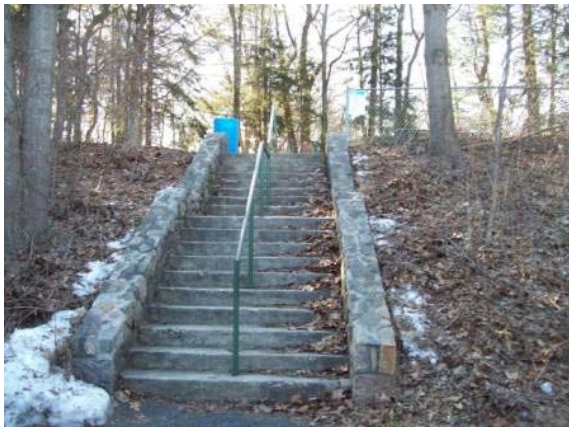
Photo #35:	Typical concrete steps with metal handrail
------------	--

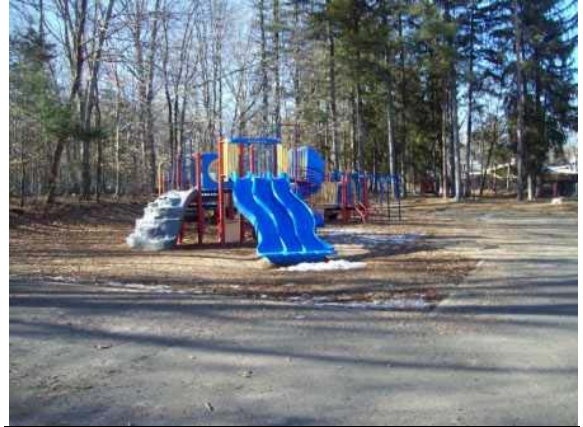
Photo #44:	Jungle gym playground equipment
------------	---------------------------------

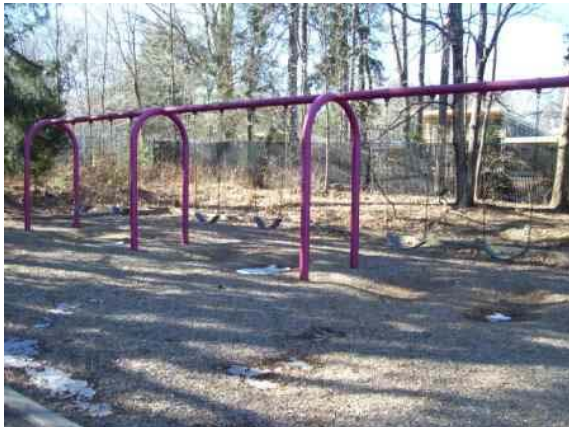
Photo #45:	Swing set playground equipment
------------	--------------------------------

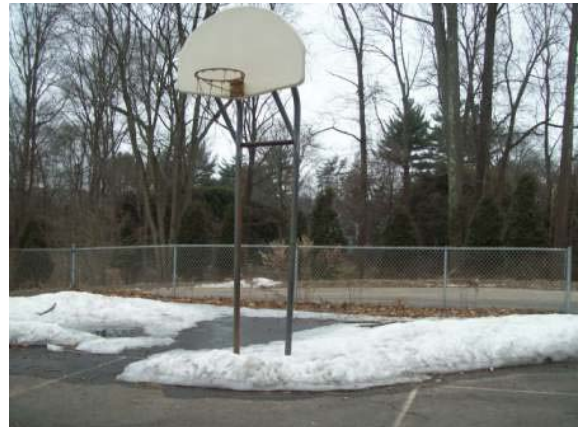
Photo #46:	Basketball goal
------------	-----------------

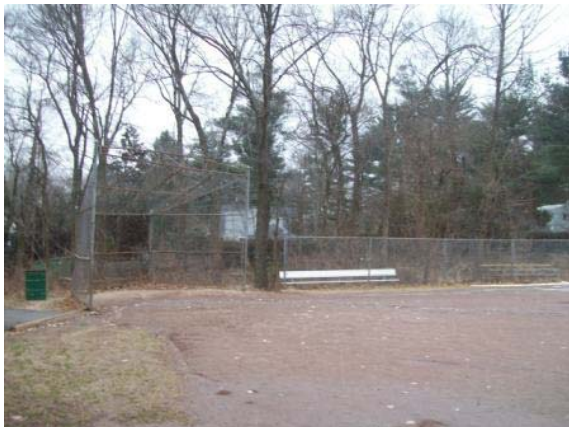
Photo #47:	Baseball field and backstop
------------	-----------------------------

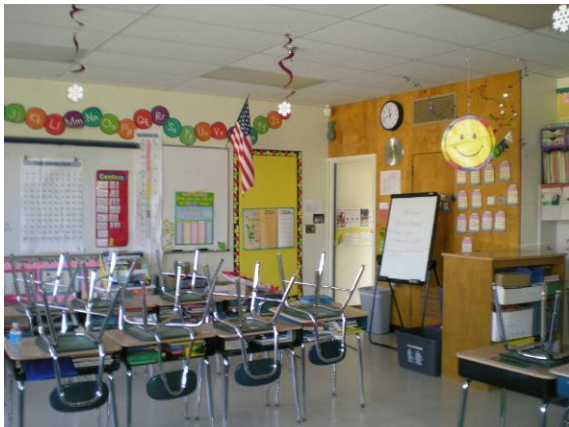
Photo #51: Typical classroom

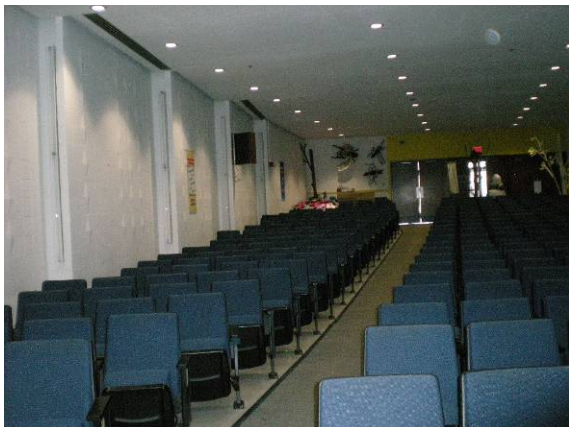
Photo #53: Auditorium

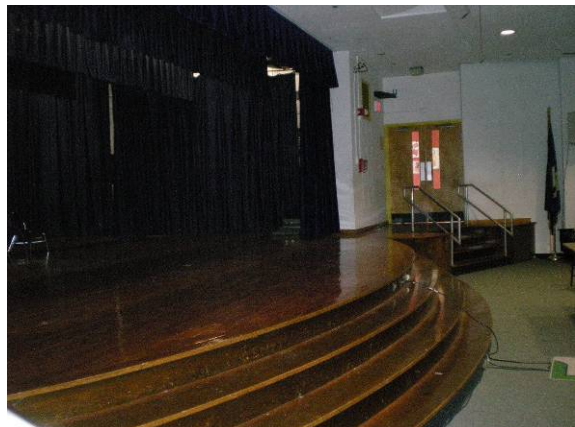
Photo #54: Auditorium stage

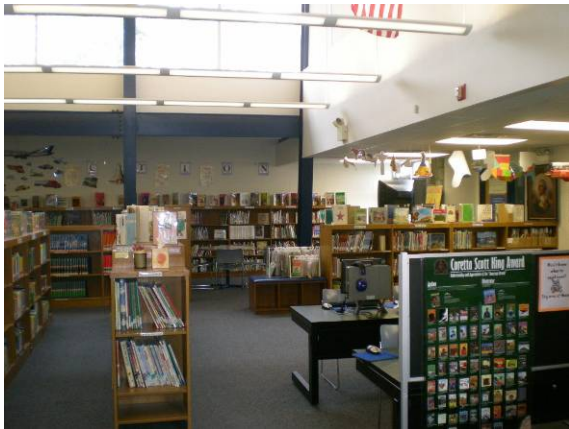
Photo #63: Media Center

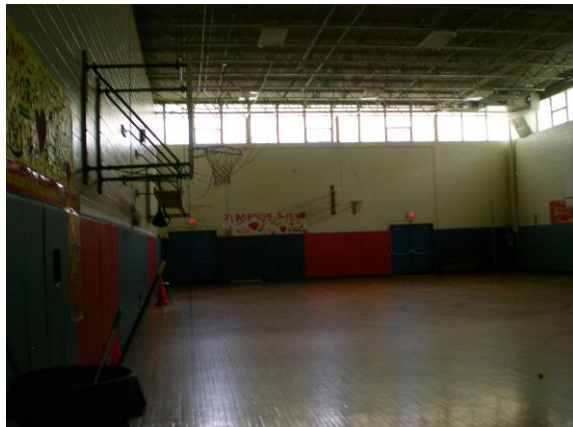
Photo #71: Gymnasium

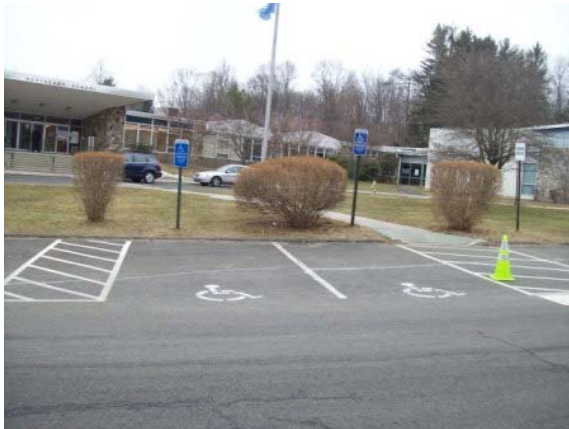
Photo #77: Accessible parking area

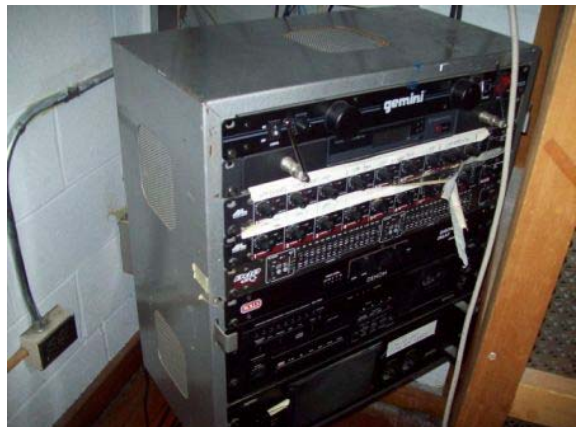
Photo #108: Sound system controls for auditorium

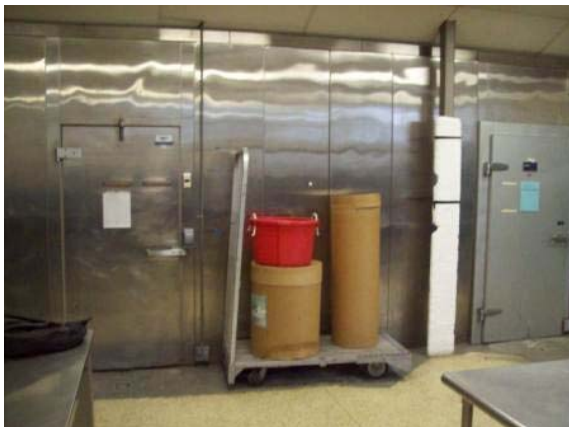
Photo #120: Walk in refrigeration compressor units
