# FACILITIES NEEDS ASSESSMENT

## STAMFORD PUBLIC SCHOOLS

## Facilities Needs Assessment of ROGERS ELEMENTARY SCHOOL

**EMG Project #:** 88166.09R-007.017  
**Date of Report:** August 28, 2009  
**On site Date:** February 19 and 20, 2009

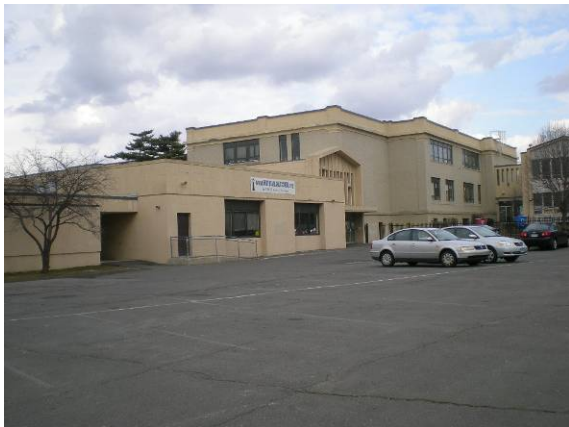
Photo #5: Alternate entrance facing south

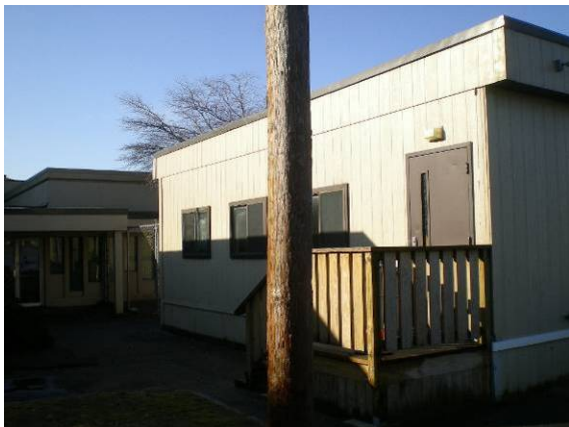
Photo #11: Modular elevation

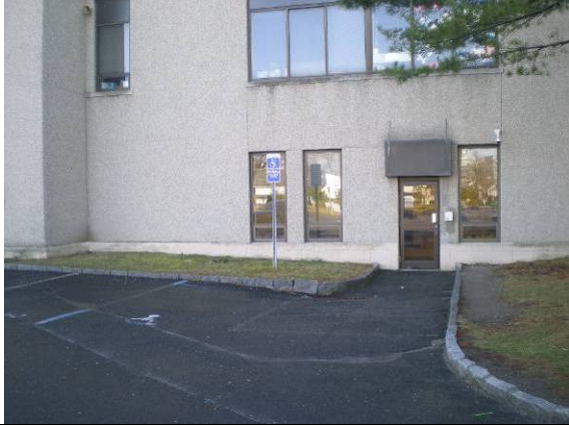
Photo #13: ADA entrance from teachers parking lot

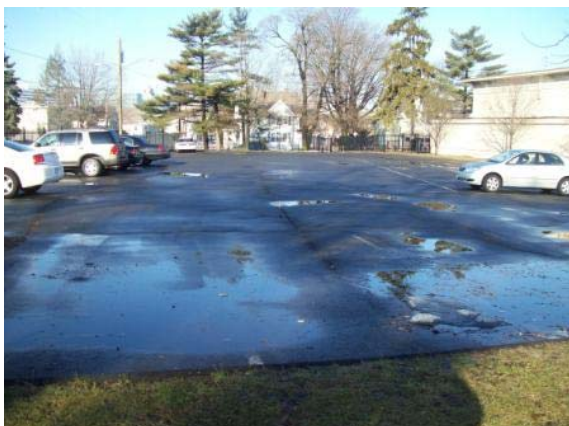
Photo #35:	South parking lot
------------	-------------------

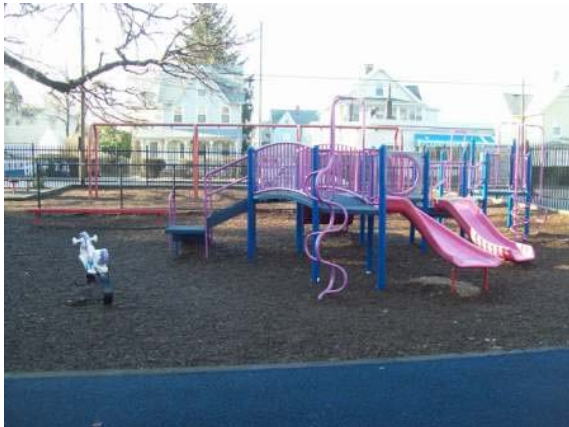
Photo #45: South playground equipment

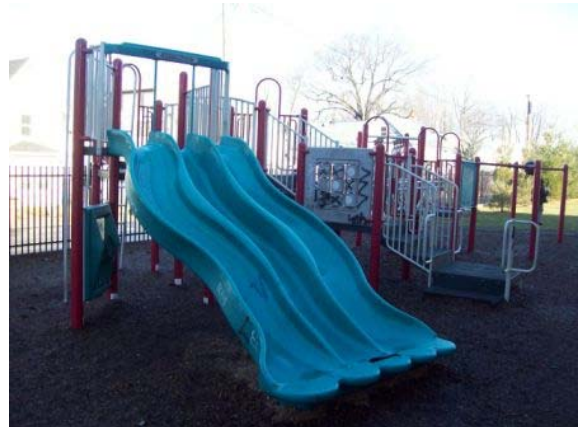
Photo #46: Southwest playground equipment

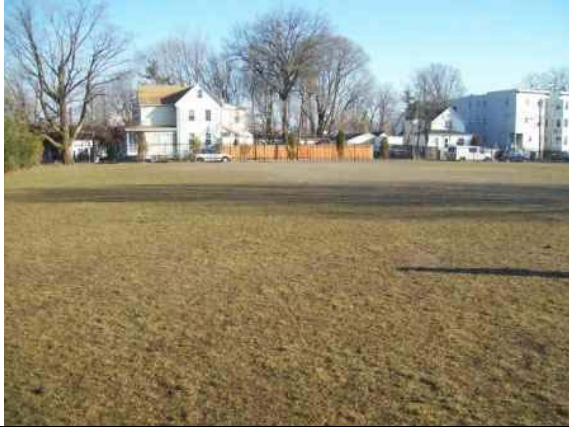
Photo #49: Soccer field
