# FACILITIES NEEDS

### FACILITIES NEEDS ASSESSMENT OF ROXBURY ELEMENTARY SCHOOL

751 West Hill Road  
Stamford, Connecticut 06902

**EMG Project #:** 88166.09R-006.017  
**Date of Report:** August 28, 2009  
**On site Date:** March 25, 2009

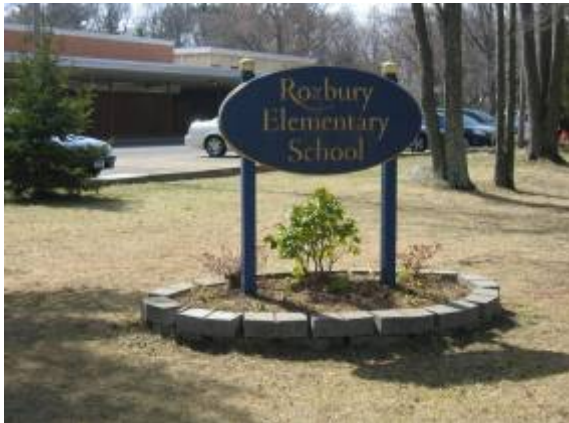
Photo #1:	View of school identification signage.
-----------	--

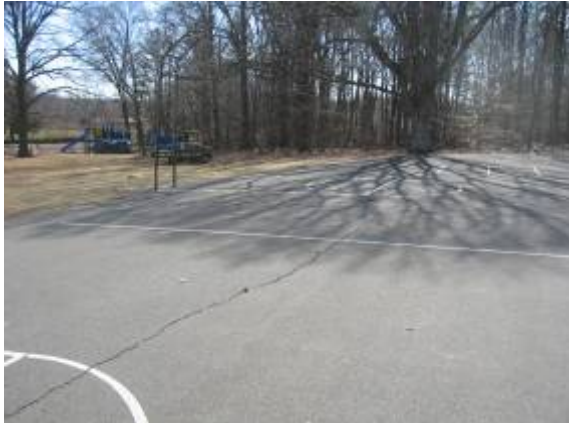
Photo #19: View of asphalt paved basketball court.

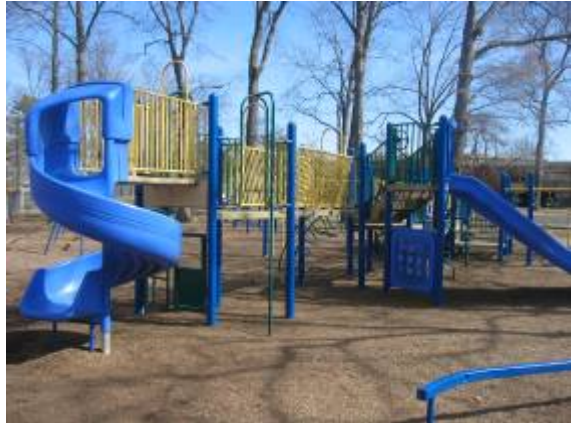
Photo #20: View of playground equipment.

5.5	3193	Replace Play Structure, Large	20	12	8	2	EA	\$52,920.00	\$105,840									\$105,840			\$105,840
5.5	3194	Replace basketball backstop, 3' wide 12' high	25	23	2	6	EA	\$6,122.09	\$36,733			\$36,733									\$36,733

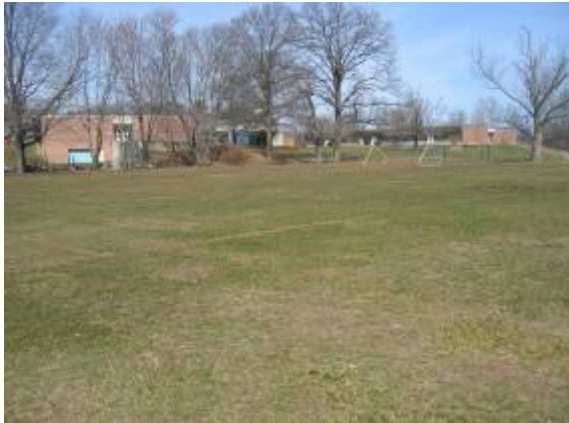
Photo #21: View of soccer field.

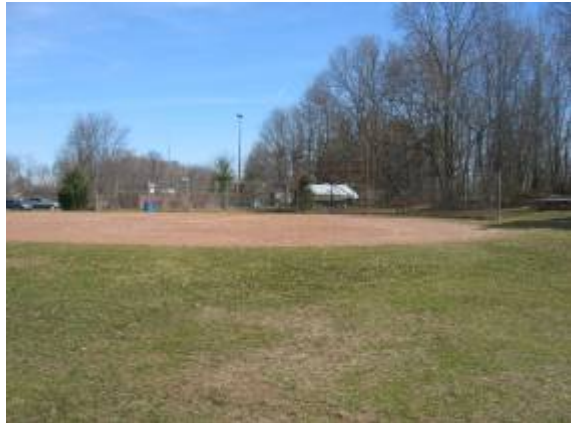
Photo #22: View of baseball field.

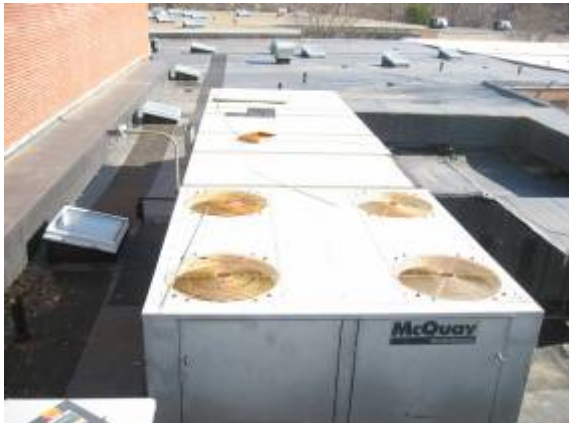
Photo #31: View of ACC-1, which serves the media center.

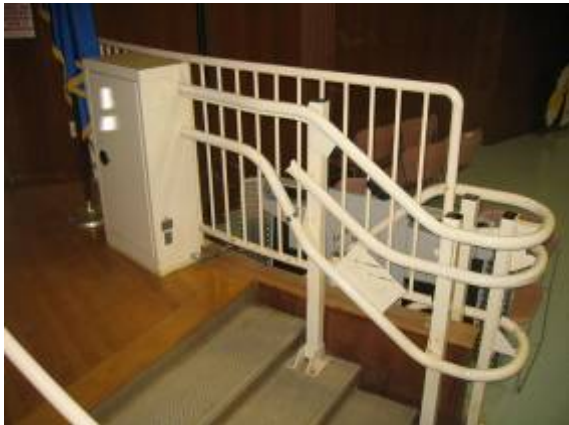
Photo #53: View of wheel chair lift, which is located within auditorium.

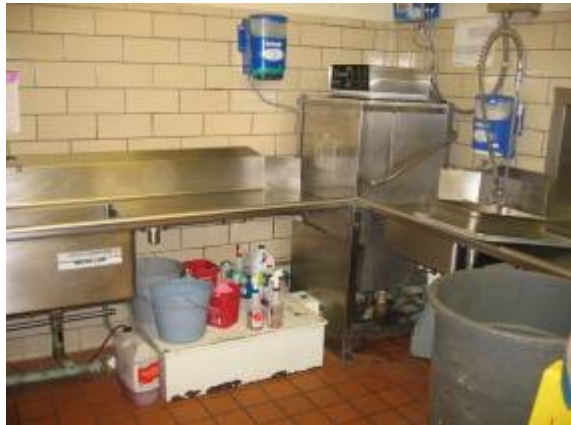
Photo #54: View of dishwashing station.

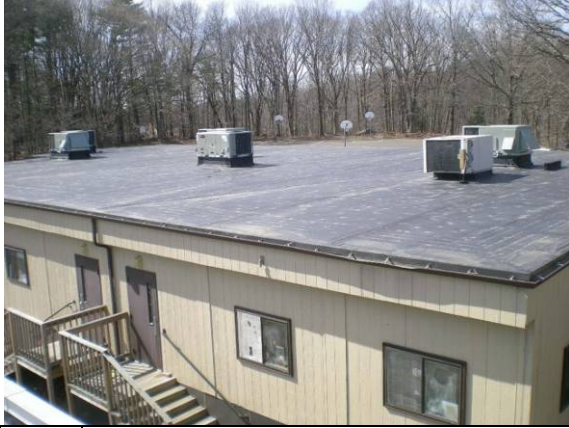
Photo #85: South end modular addition

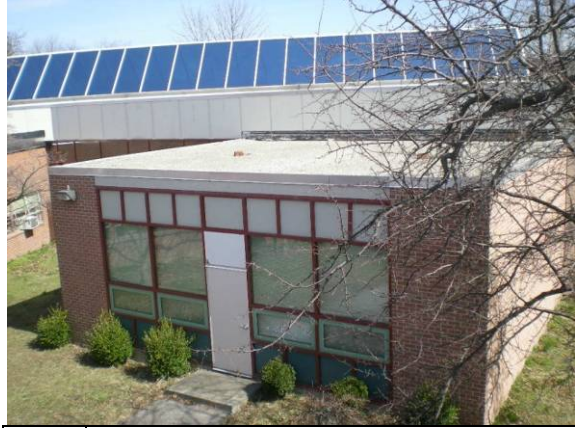
Photo #86: South side of Media Center

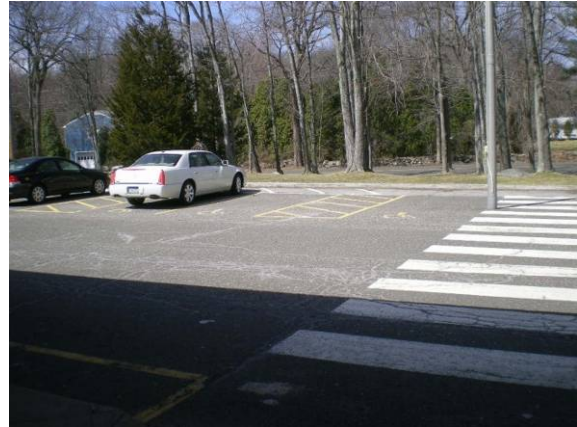
Photo #92:	ADA parking
------------	-------------

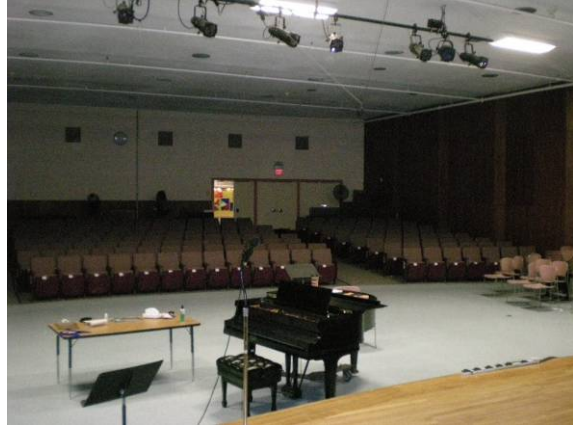
Photo #110: Auditorium

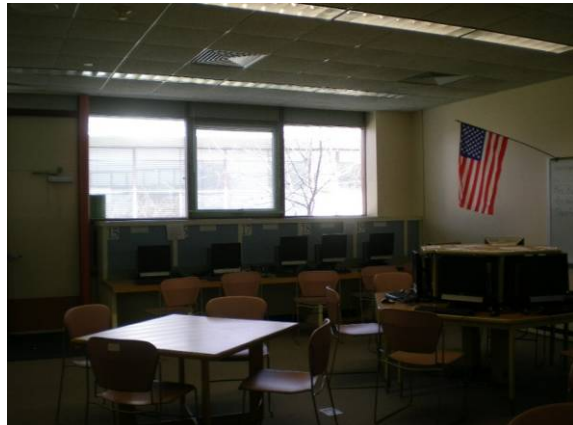
Photo #114: Computer lab off Media Center

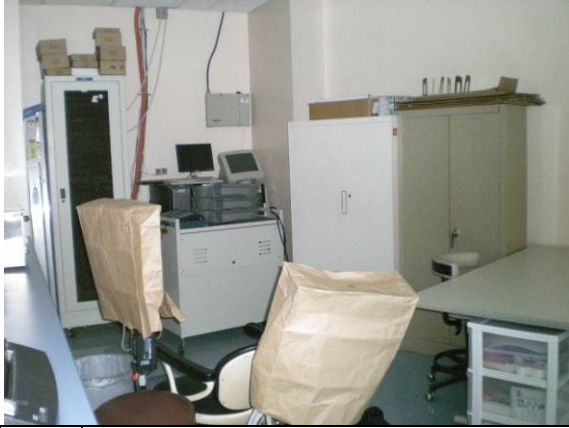
Photo #115: Dentist chair in Media Center server room

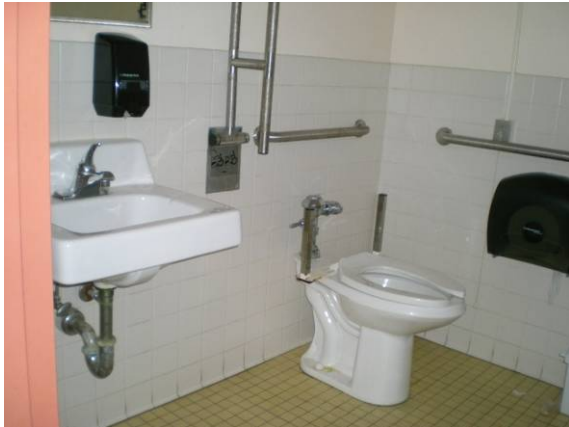
Photo #117: Restroom off of Nurse's office

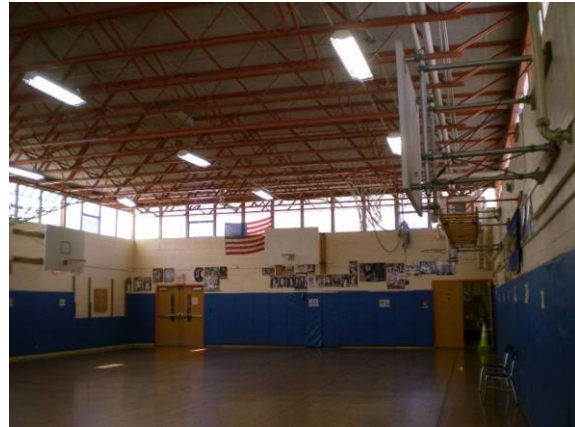
Photo #118: Gymnasium

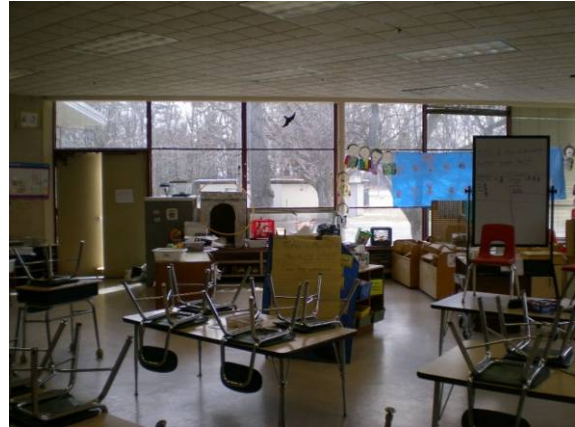
Photo #122: Kindergarten

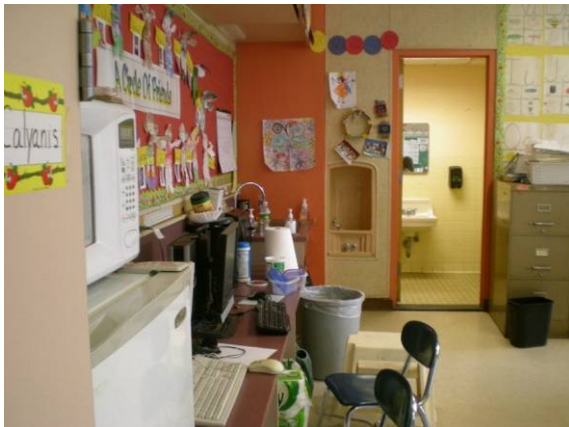
Photo #123: Drinking fountain, restroom and sink in Kindergarten classroom

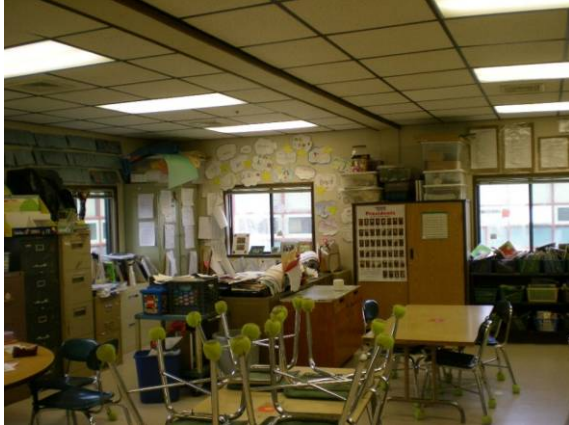
Photo #127: Classroom in south modular wing

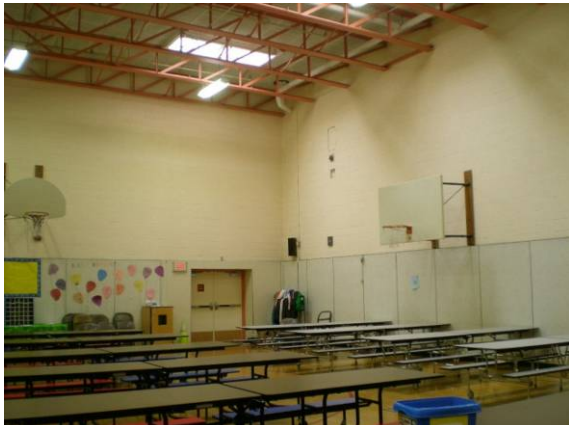
Photo #131: Cafeteria – no longer used as gym

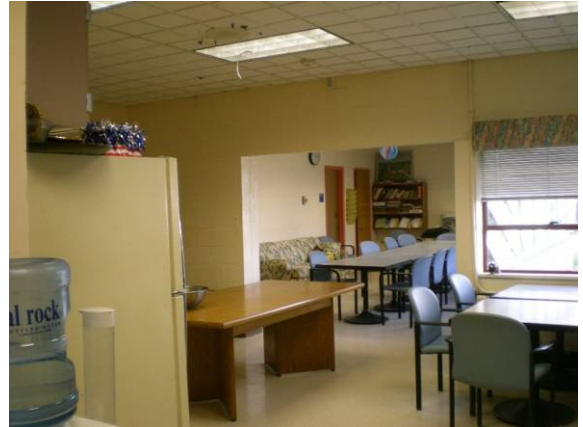
Photo #134: Teachers' lounge
