Toquam Magnet Elementary School

Exterior Façade Investigation

398 Glenbrook Road
Stamford, CT 06906

FINAL Report
November 12, 2019

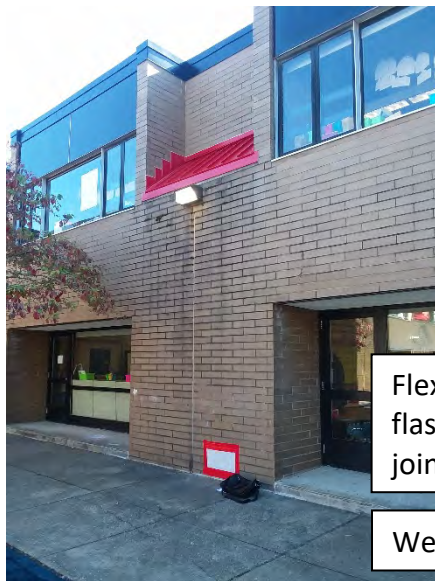
P1-1

Brick weeps at this probe location are one course above where the through wall flashing is tucked into the mortar joint of the exterior brick. At the top of the test probe is a piece of ladder reinforcement which extends into the probe approximately 10 inches from the right and is not continuous across the probe opening. Through wall flashing is tucked into the mortar bed of the exterior wythe of brick, extends into a cavity that extends 2 courses high, runs vertically 8 inches and then into the mortar bed of the brick above. Brick at the base through wall flashing is 4 in thick. Brick above the through wall flashing is approximately 8 in thick. Through wall flashing is brittle and cracked. Mortar is generally in good condition with some small areas not adhered to the head of brick. Sand at the bottom of the brick cavity is damp. Cells of the bottom two courses of 8" thick brick, located just above the through wall flashing, have been grouted. Courses above have not been grouted.

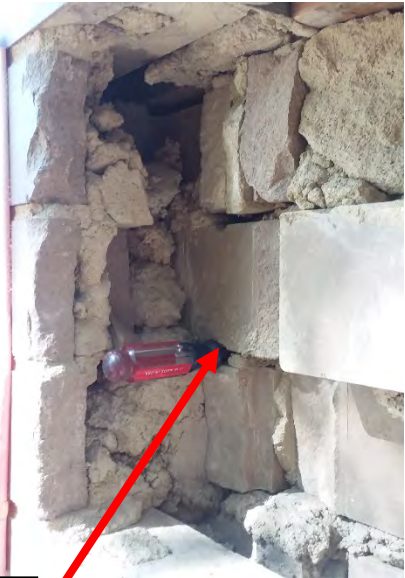
P3-6

Opening into media center

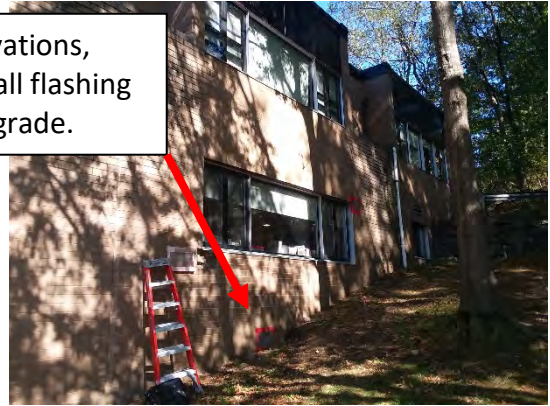
P4-1

Based on building elevations, weeps and through wall flashing bay be further below grade.

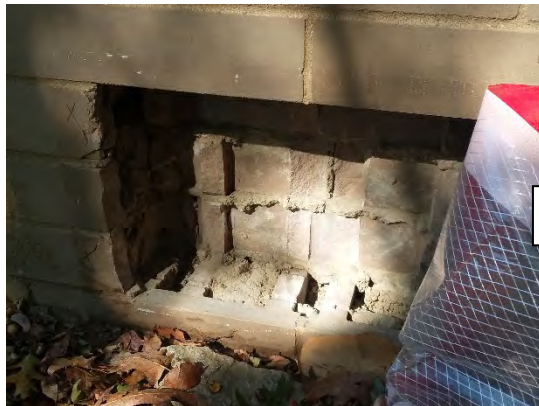
Wire reinforcing

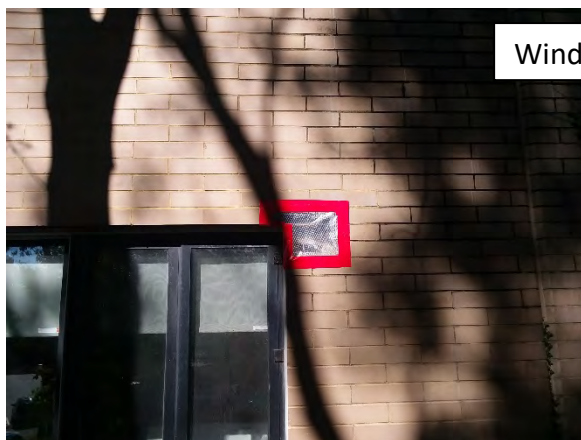
Probe is located at the top right-hand corner of the window to the media center. There is a large steel lintel across the top of the window. Steel lintel appears to consist of a plate with a t or angle welded to the top of it. There is a flexible through wall flashing membrane located above the lintel and turns out across the top of the lintel to the exterior. There is an end dam formed by the through wall flashing at the right side of the probe opening. The top of this flashing extends up the wall cavity two courses and then turns to the exterior at the second grout line above the window. There is a small piece of wire reinforcing located one course above the window lintel and it is not continuous across the grout line. The wire reinforcing is penetrating the flexible through wall flashing membrane. There is pea stone gravel above the window lintel. There are tube weeps a 24-inch on center across the top of the window. The exposed portion of the window lintel has minimal rust on the exposed face and little rust where it was buried into the grout line. Next to this test probe a piece of the wire reinforcing is exposed through the grout line. The through wall flashing at the steel is rigid but is still flexible about 4 in above the steel.

Window lintel

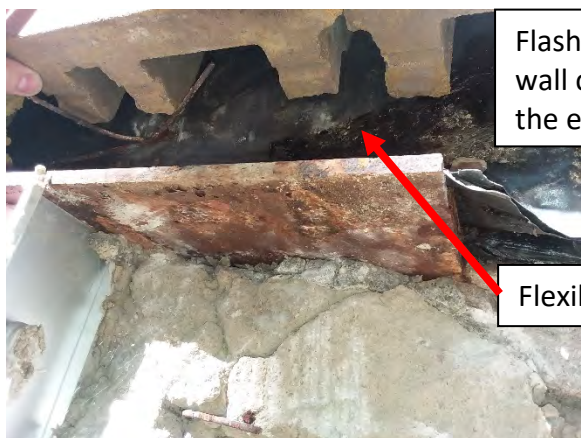
Flashing wrapped up wall cavity and turned to the exterior of the wall

Flexible wall flashing

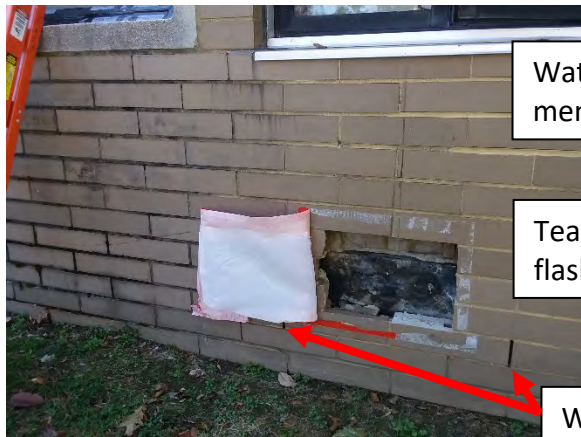
Probe is located on the east elevation below the upper level classroom E304 window, to the right of the main entrance. The probe is located 1 course above the weep holes. The bottom of the flexible through wall flashing cannot be located at this area. The top of the through wall flashing is three courses above the bottom of the weep holes. The through wall flashing is between the exterior 4-inch-thick brick veneer and an inner brick. It turns into the grout line of the inner brick wythe. The flashing is visible from the interior where wall finishes have been removed from the indoor kindergarten play area. The through wall flashing is becoming rigid and there is a large tear in the membrane. There is no reinforcing visible at this area. The flexible through wall flashing has white staining on it. It also appears to be damp. The probe opening was well sealed using red duct tape and plastic sheeting. There are also a large number of small dead ants within the probe opening. There is an abundance of musty, damp air coming out of the probe opening.

Watermarks on membrane flashing

Tear in membrane flashing

Weep holes

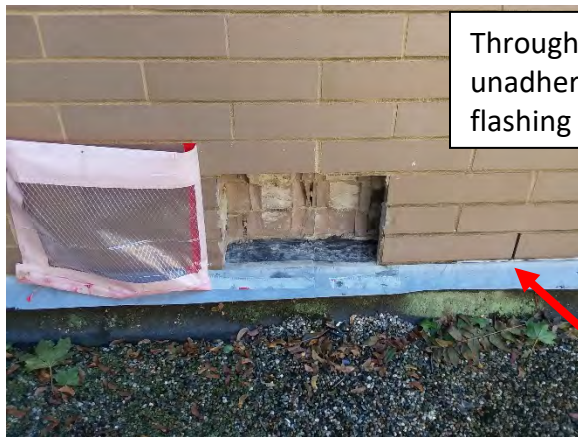
Probe is located above the through wall counter flashing above a roof over room W103. There are weeps at 24 inches on center above the counter flashing. The cells of the brick veneer are grouted solid for the four courses that are visible. There is a flexible through wall flashing located above the counter flashing terminating about 1/2 inch back from the face of the brick veneer. The through wall flashing turns up when it reaches the backside of the 8 inch veneer brick. The through wall flashing is not adhered to the counter flashing below it. The counter flashing seams are not sealed from one piece to another. The flexible through wall flashing is becoming rigid and brittle. There are several penetrations in the through wall flashing which may have been caused by the probe demolition. Behind the brick veneer there is pea gravel. The weeps appear to be blocked by the mortar and do not appear to be continuous all the way back to the pea gravel.

Through wall flashing is unadhered to counter flashing

Weeps

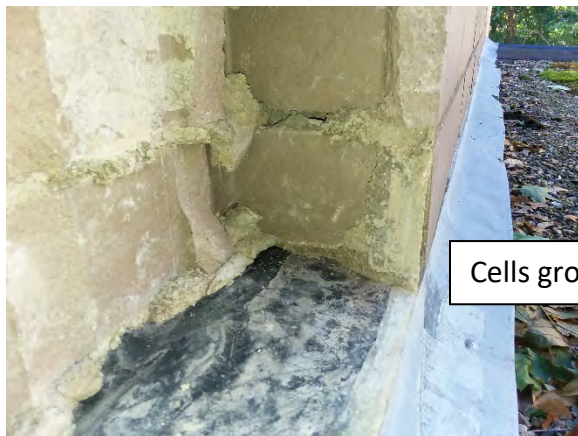
Cells grouted solid

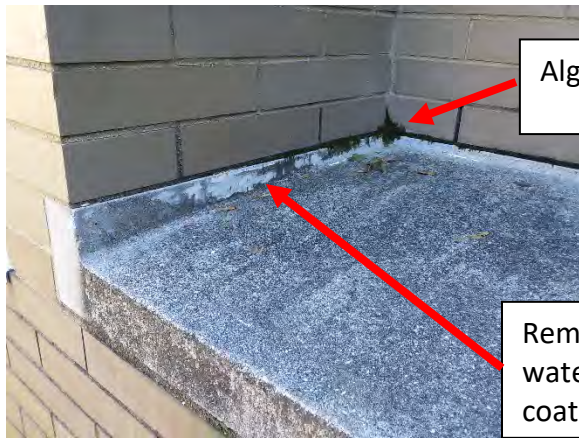
Algae growth

Remnants of water resistive coating

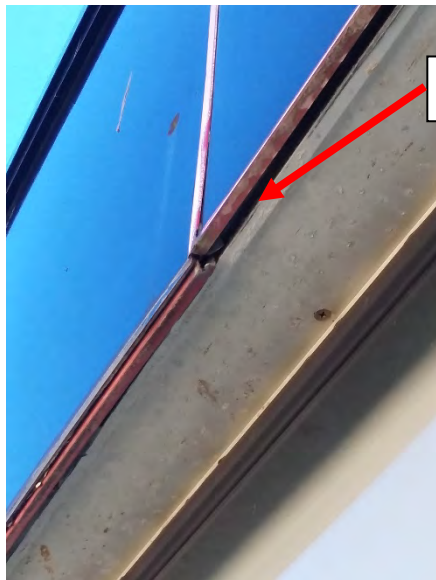
5-3

Sink hole

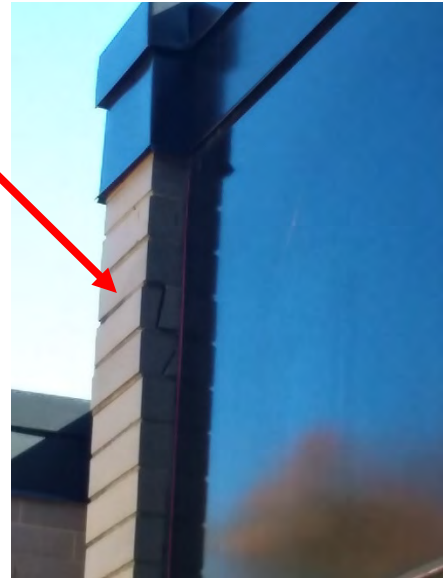
14-3

Bricks out of alignment

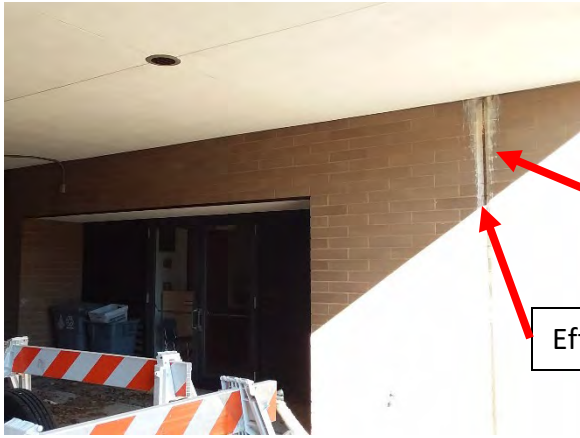
29-1

Control Joint

Efflorescence

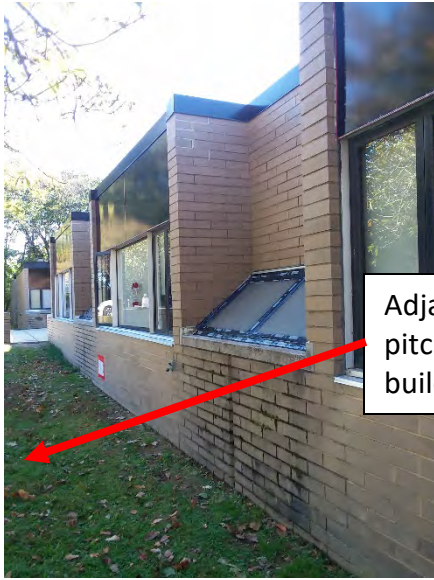
Grade elevated around walkway preventing proper drainage

Adjacent grade pitched toward building

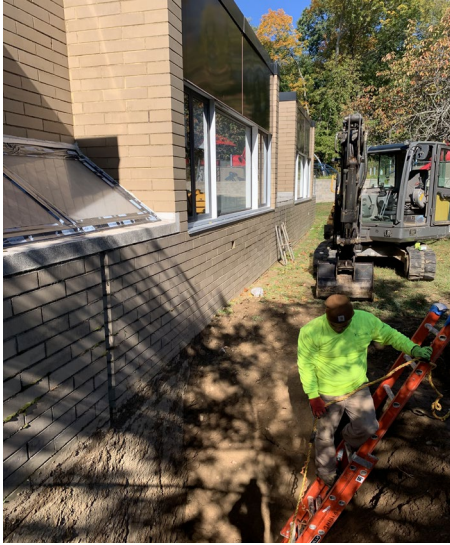
Photo # 1: Location of test pit on eastern side of Toquam School.

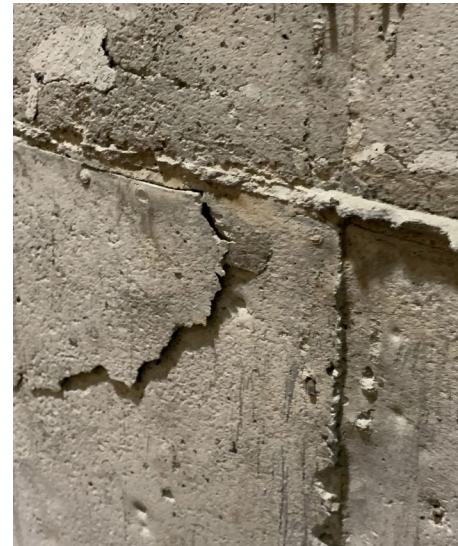
GeoInsight Environmental Strategy & Engineering	Photo # 7: Interior of foundation wall is pitted and stained.
	Photo # 8: Spalling on interior of foundation wall.
