# FACILITIES NEEDS ASSESSMENT

## STAMFORD PUBLIC SCHOOLS

## Facilities Needs Assessment of CLOONAN MIDDLE SCHOOL

**EMG Project #:** 88166.09R-009.017  
**Date of Report:** August 27, 2009  
**On-site Date:** April 1, 2009

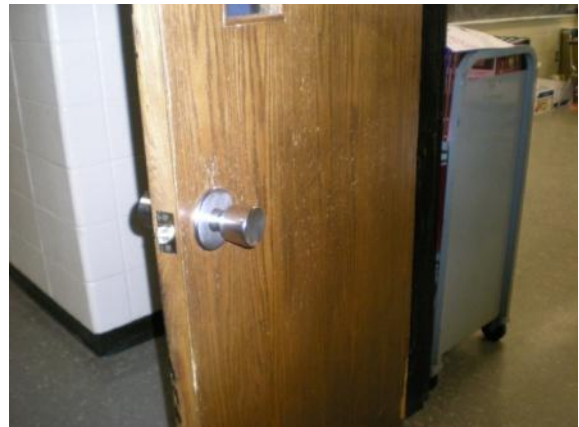
Photo #52: Typical classroom door lockable from outside room only

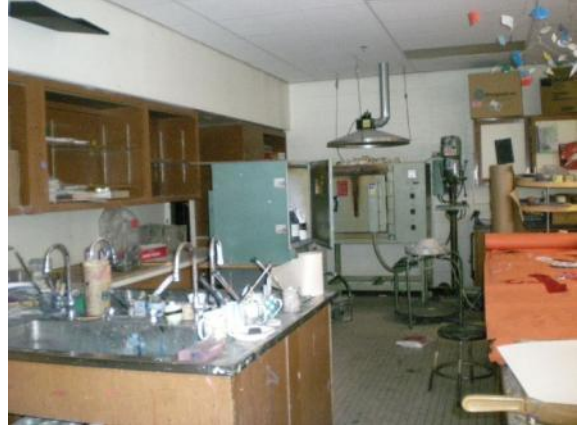
Photo #56: Art room with two kilns - one small one is unused

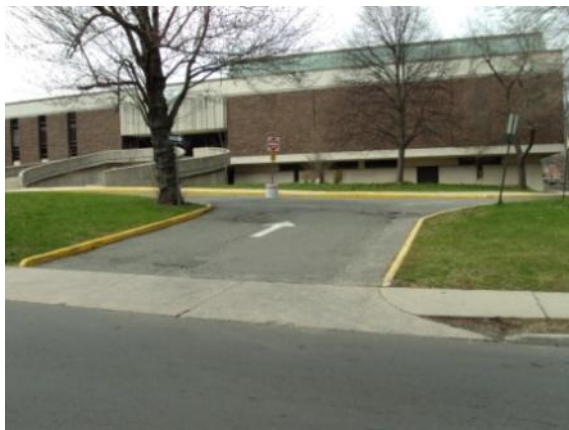
Photo #65: Main property entrance drive off West North Street

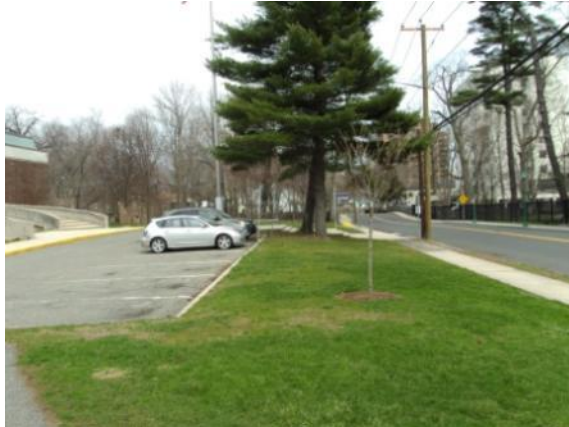
Photo #109: Landscaping at front elevation

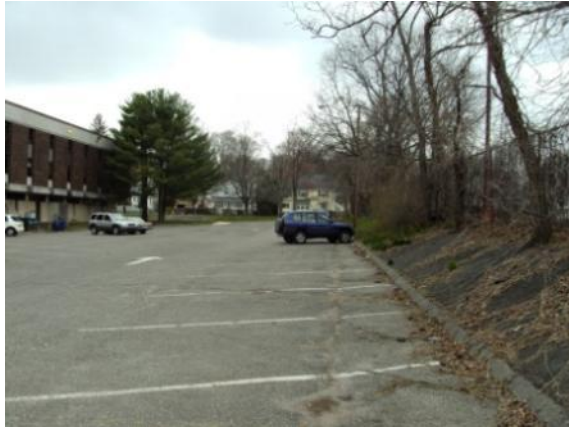
Photo #115: Landscaping and hard surface at front elevation

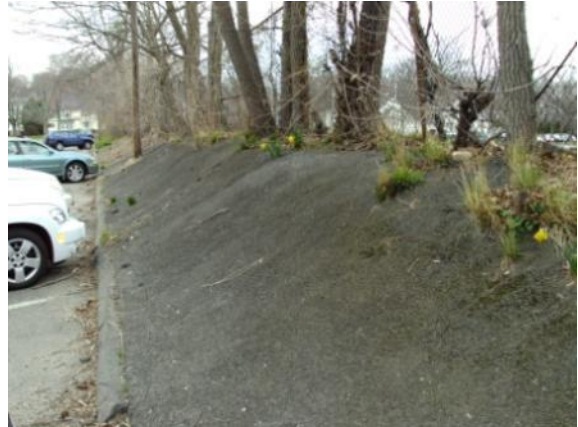
Photo #116: Asphalt overlay on landscape hill at north property line

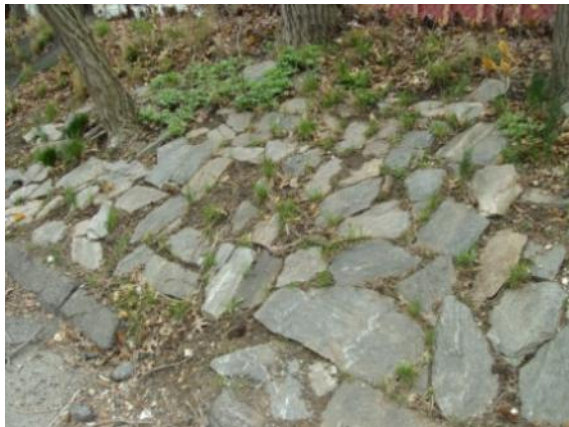
Photo #117: Stone masonry on landscape hill at north property line

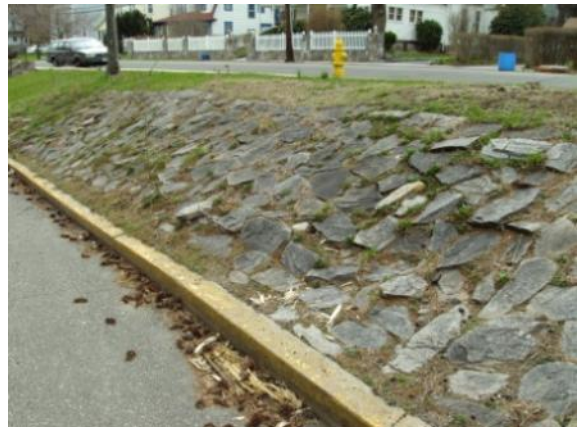
Photo #118: Stone masonry on landscape hill at west elevation

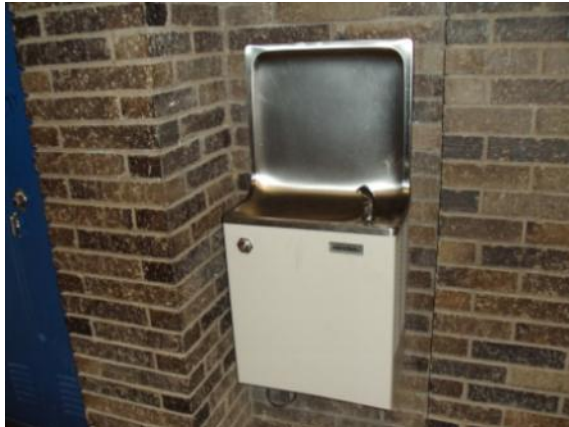
Photo #153: Common area drinking fountain

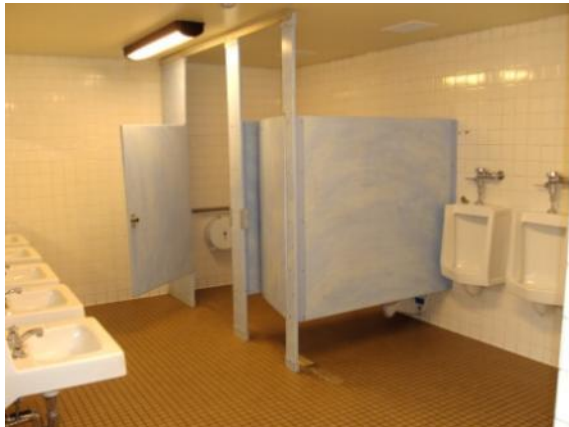
Photo #155: Overview of common area restroom

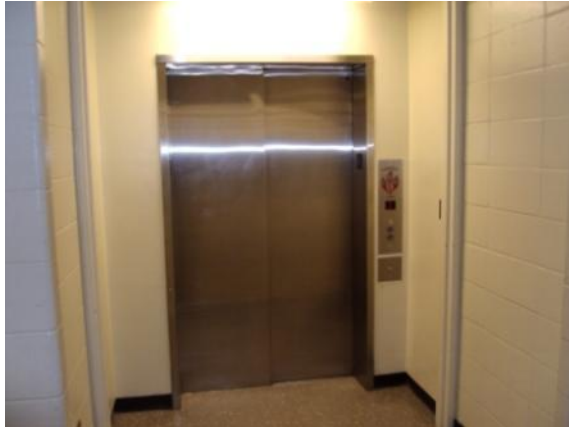
Photo #175: Elevator

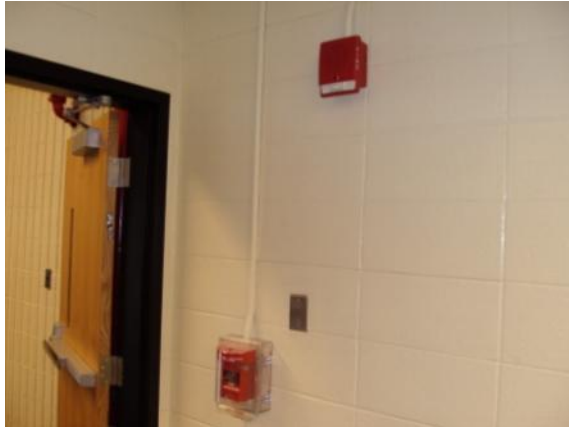
Photo #187: Fire pull station and strobe alarm

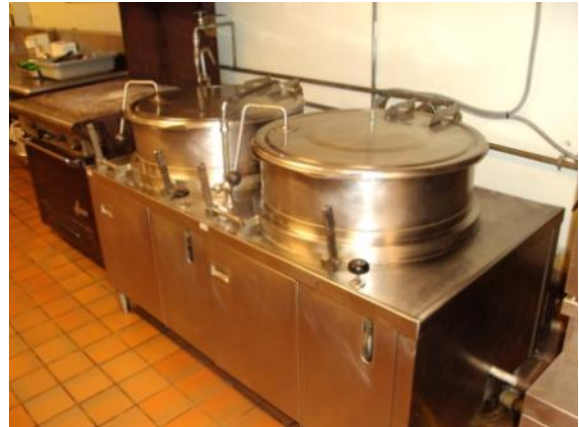
Photo #196: Kitchen steamers

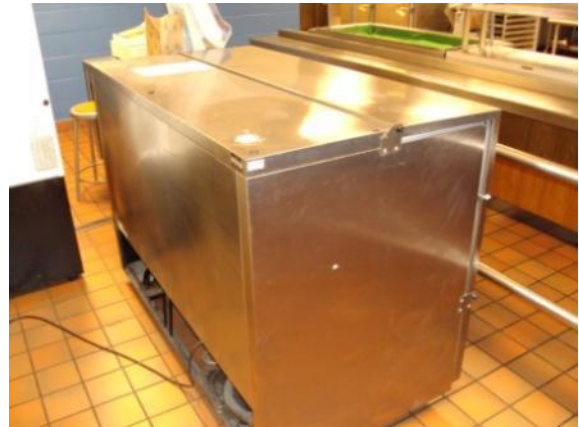
Photo #198: Chest cooler in kitchen

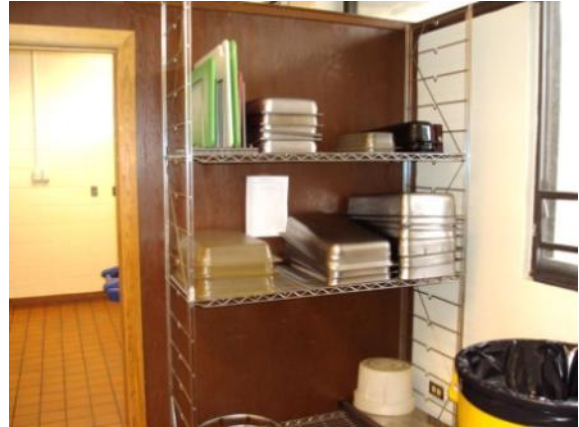
Photo #200:	Kitchen shelving
-------------	------------------
