FACILITIES NEEDS

STAMFORD PUBLIC SCHOOLS

SCOFIELD MAGNET MIDDLE SCHOOL

EMG Project #: 88166.09R-016.017
Date of Report: August 29, 2009
On site Date: April 16, 2009

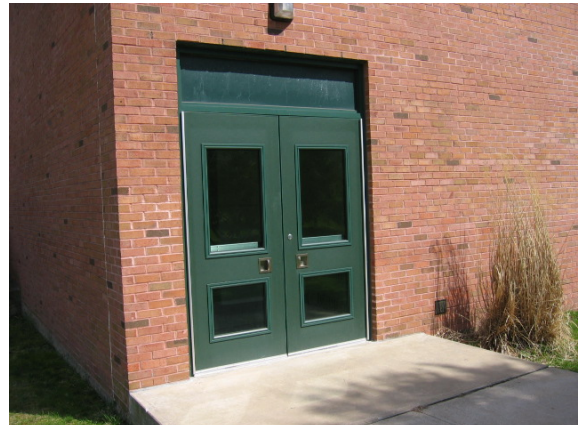
Photo #4:	Typical secondary egress door
-----------	-------------------------------

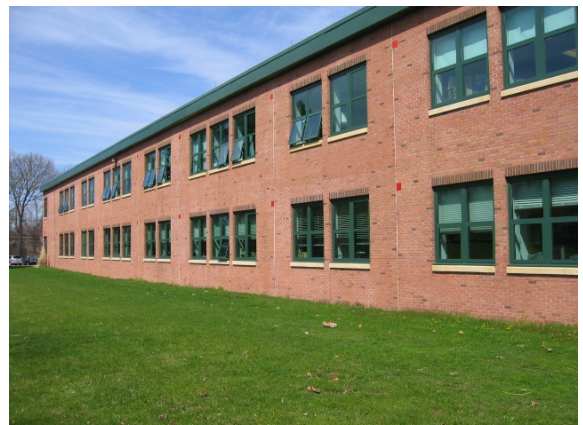
Photo #6:	West side elevation
-----------	---------------------

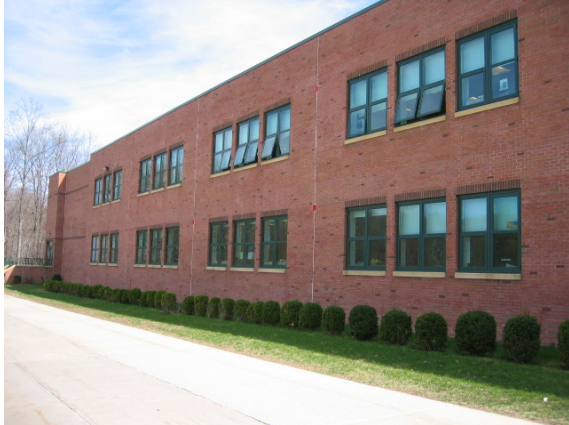
Photo #7: View of the north (rear) elevation

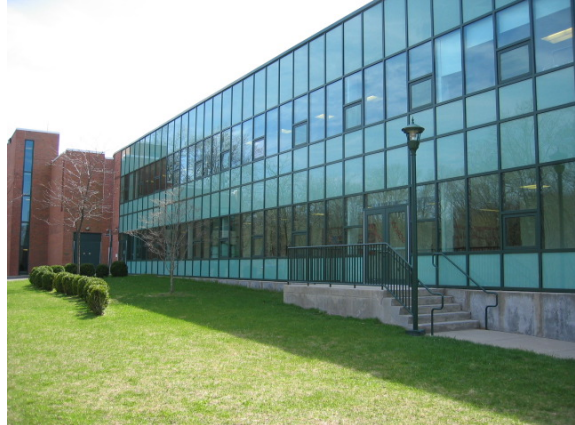
Photo #8: West side elevation

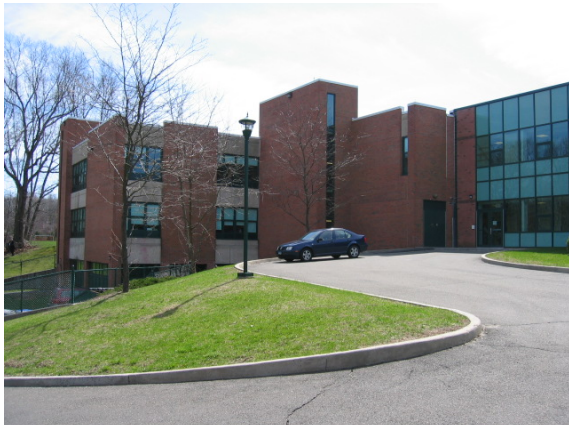
Photo #9: Rear elevation, service area and cafeteria

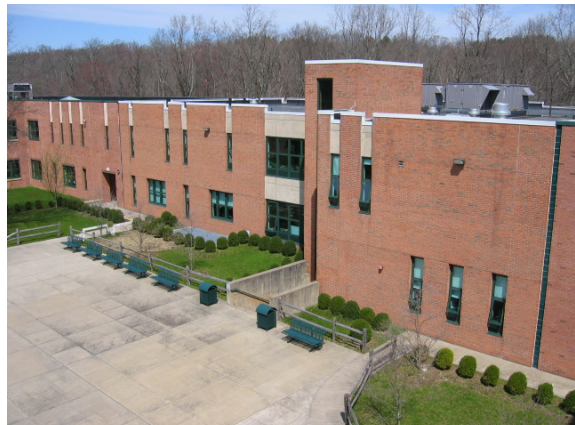
Photo #12: East side of the inner courtyard area

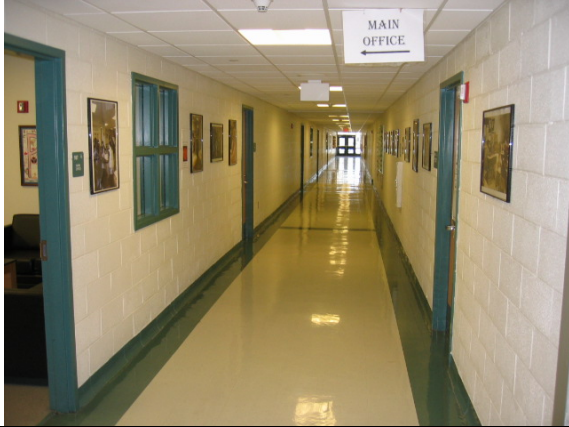
Photo #25: Administrative corridors

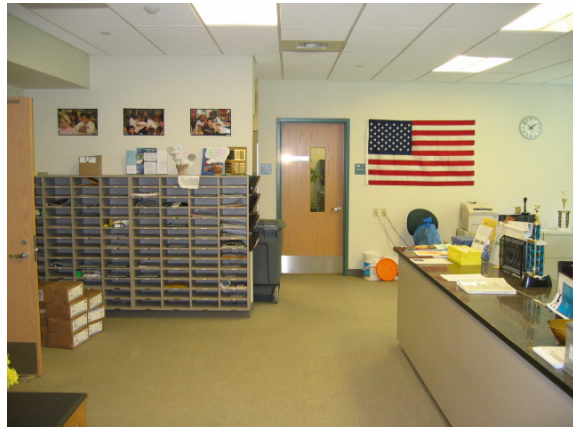
Photo #28: Main office, note teacher mailboxes on public side of counter

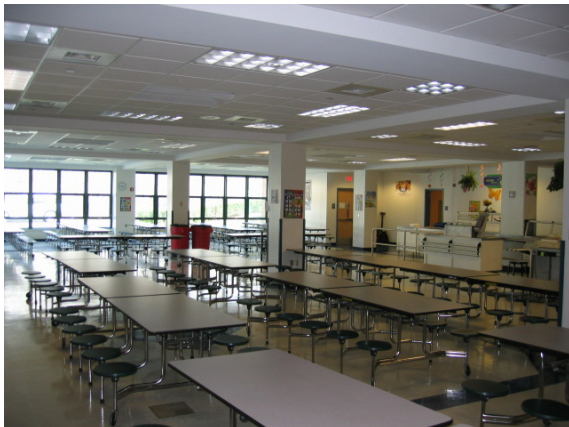
Photo #29: Cafeteria

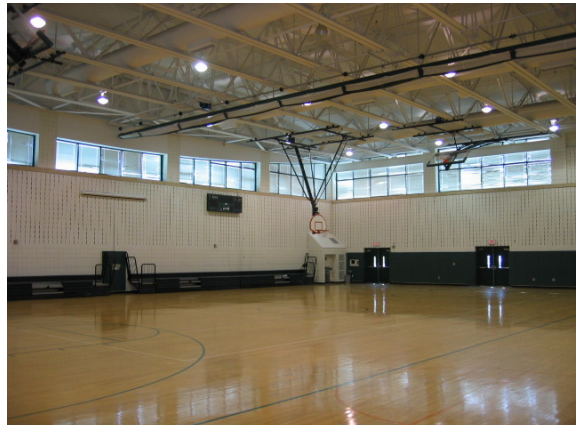
Photo #34: Gymnasium

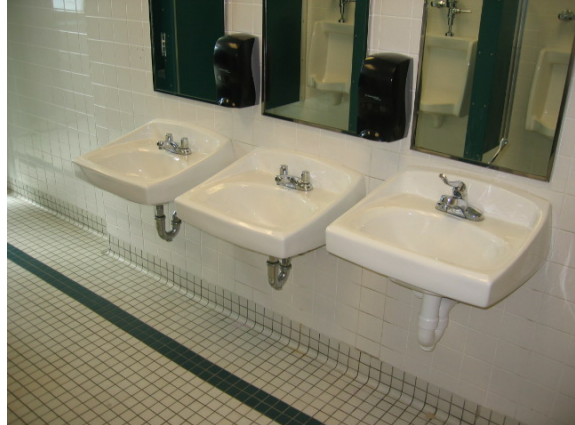
Photo #38: Restroom lavatories

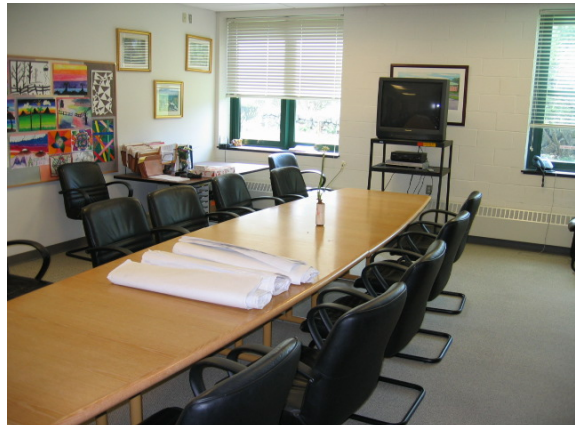
Photo #40: Conference room

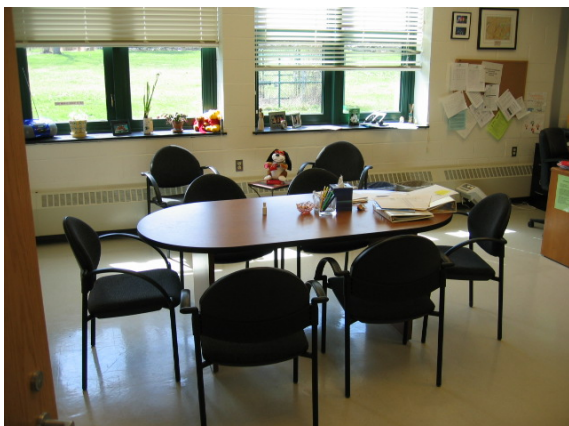
Photo #41: Staff dining room

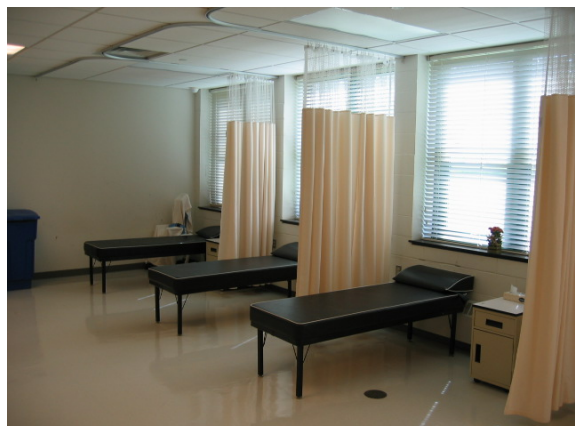
Photo #42: Nurse's office

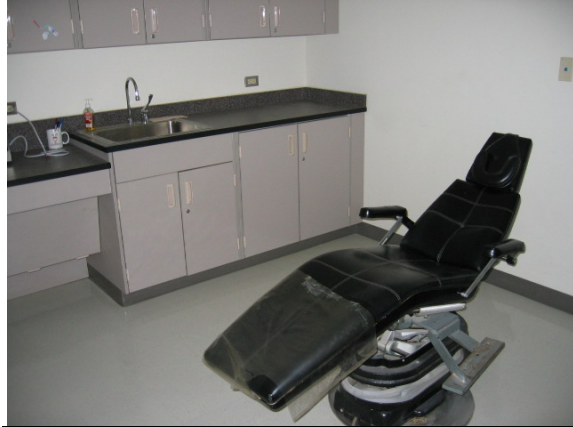
Photo #44: Dental office

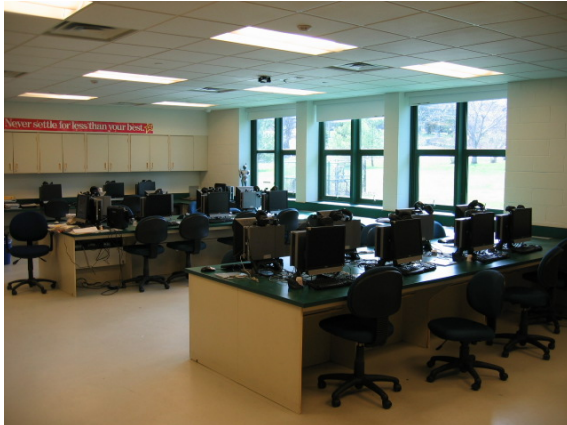
Photo #45: Computer lab

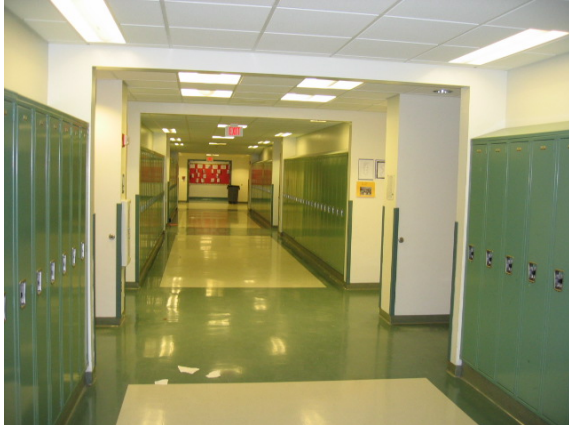
Photo #49: 2nd floor classroom corridor with lockers

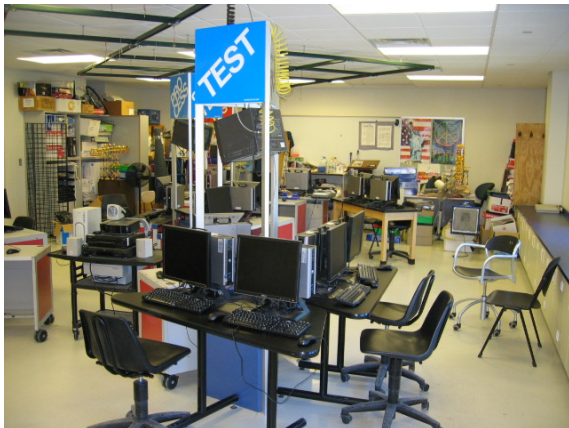
Photo #59: Math lab

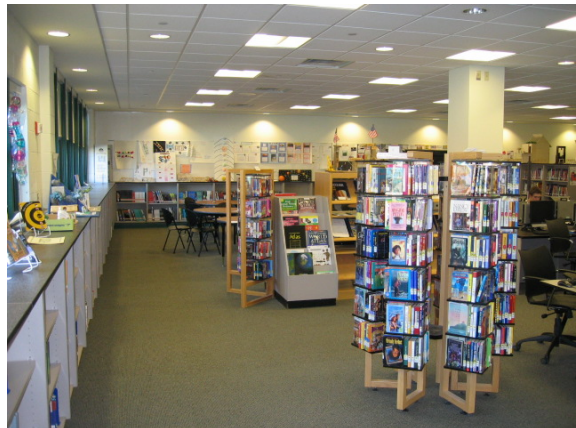
Photo #60: Media center

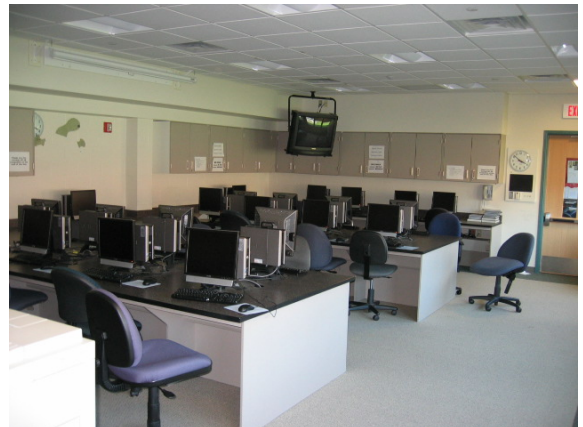
Photo #62: Computer lab within the media center

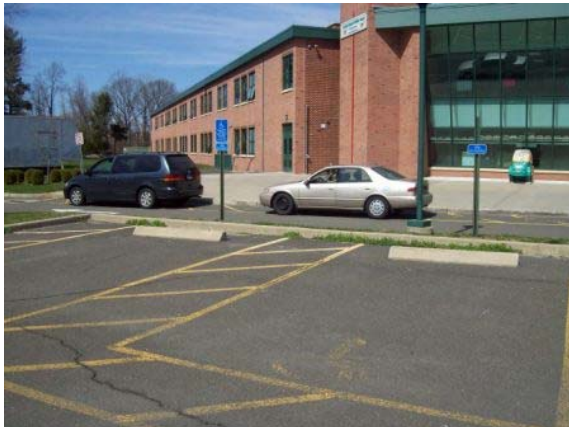
Photo #129: Accessible parking stalls

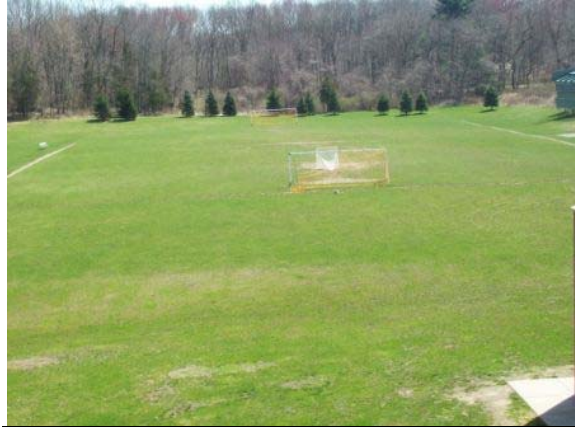
Photo #146: Soccer field
