# FACILITIES NEEDS ASSESSMENT

## STAMFORD PUBLIC SCHOOLS

## FACILITIES NEEDS ASSESSMENT OF TURN OF RIVER MIDDLE SCHOOL

**EMG Project #:** 88166.09R-014.017  
**Date of Report:** August 29, 2009  
**On-Site Date:** April 6 and 7, 2009

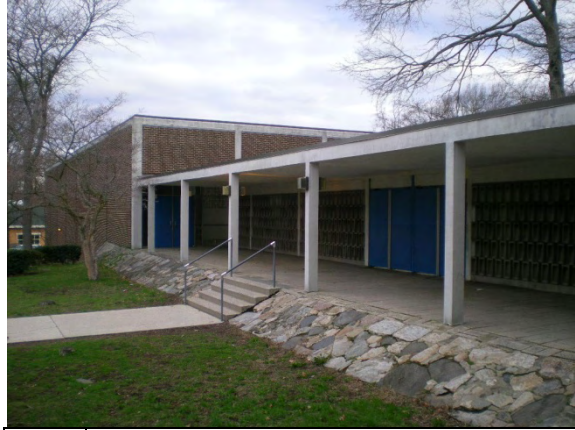
Photo #2:	Side entrance and covered walkway and partial elevation of auditorium
-----------	---

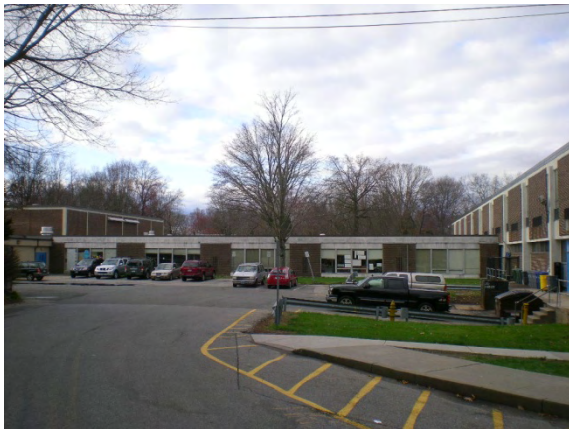
Photo #5:	Service drive area at rear
-----------	----------------------------

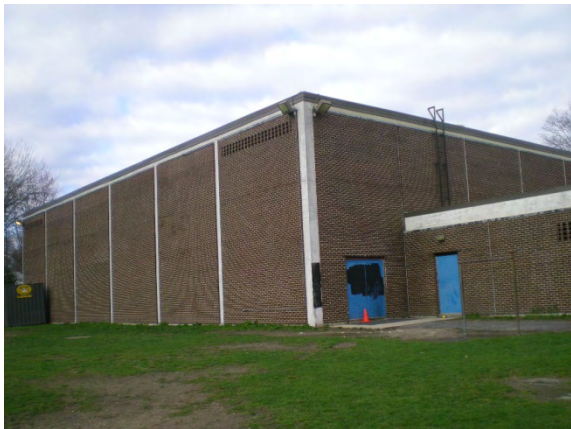
Photo #9: Gymnasium

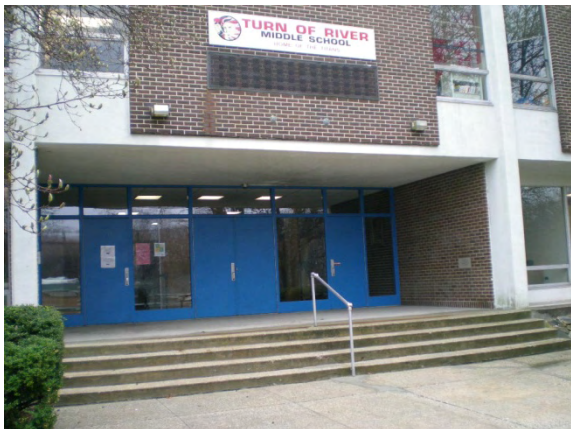
Photo #11: Main entrance

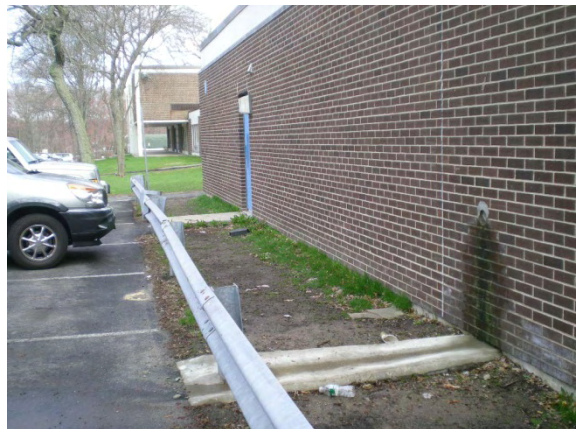
Photo #12: Partial south elevation showing storm water discharge onto parking lot

5.2	3374	Remove & replace 4' wide concrete sidewalk	25	25	0	315	LF	\$40.65	\$12,804	\$12,804										\$12,804	
5.3	3383	Storm drainage improvement allowance to mitigate ponding	0	0	0	1	EA	\$148,207.50	\$148,208	\$148,208											\$148,208

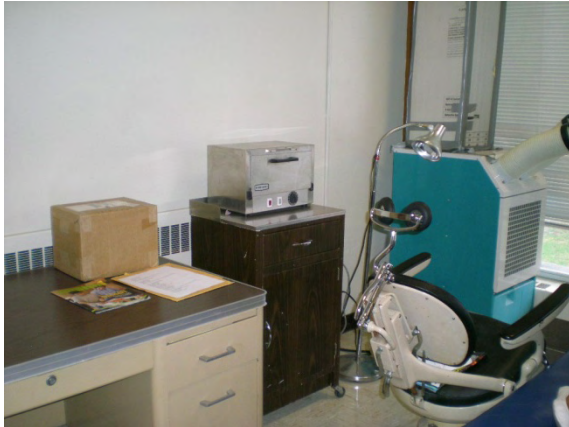
Photo #49: Nurse's bed area with portable air conditioning and dental chair

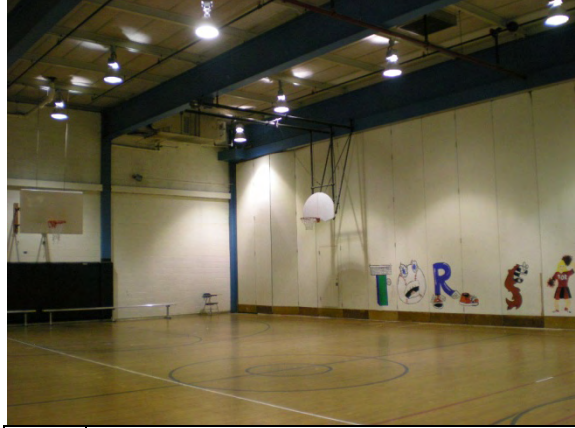
Photo #62: Gymnasium and folding divider wall

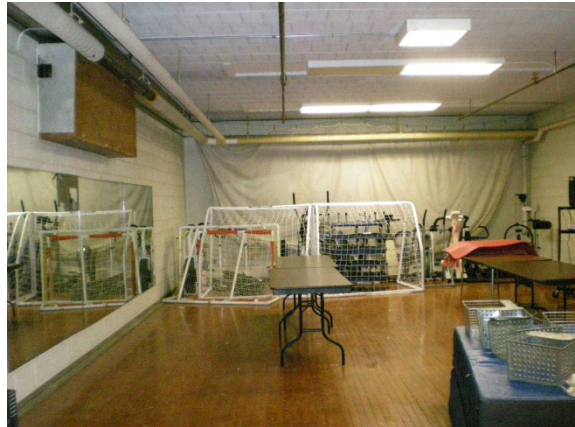
Photo #64: Exercise gym

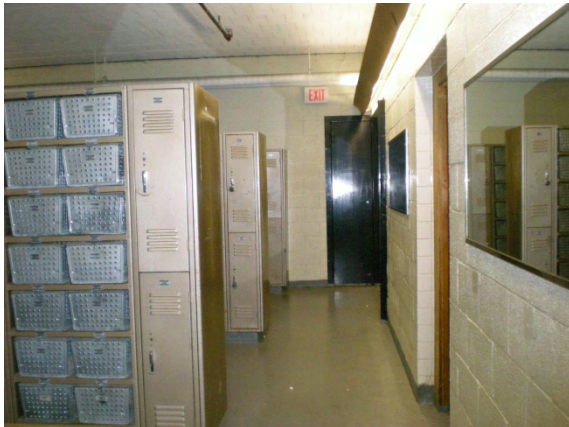
Photo #65: Girl's locker room

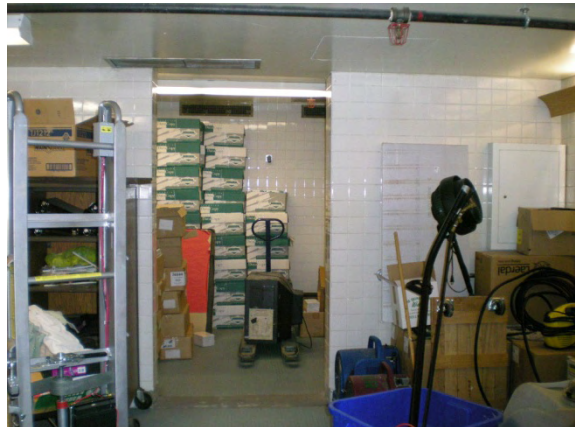
Photo #66: Former shower area now used for bulk paper storage

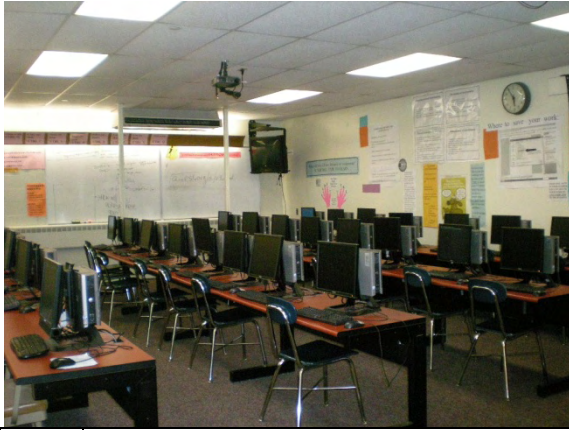
Photo #67: Computer lab

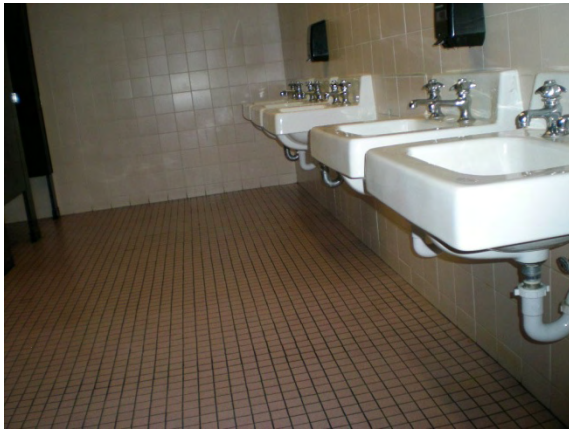
Photo #71: Student restroom

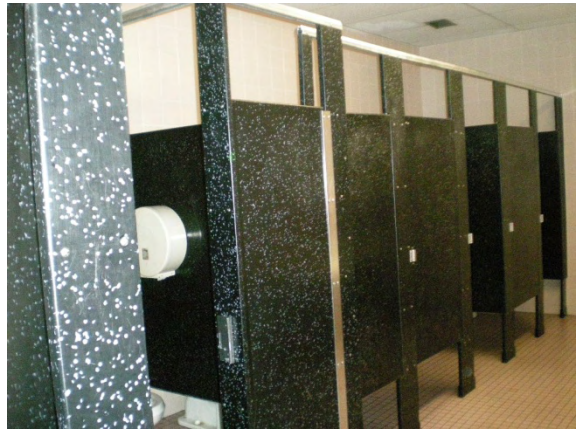
Photo #72: Student restroom

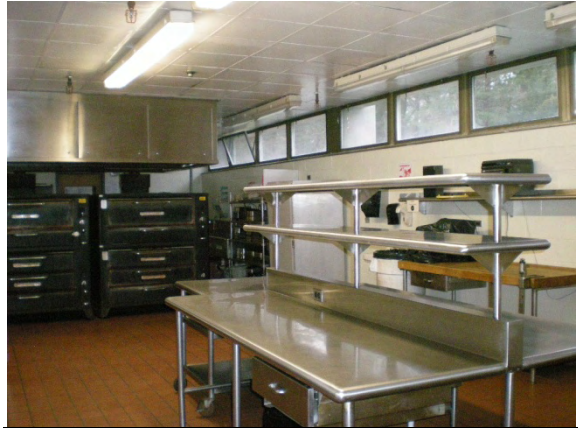
Photo #74: Kitchen finishes

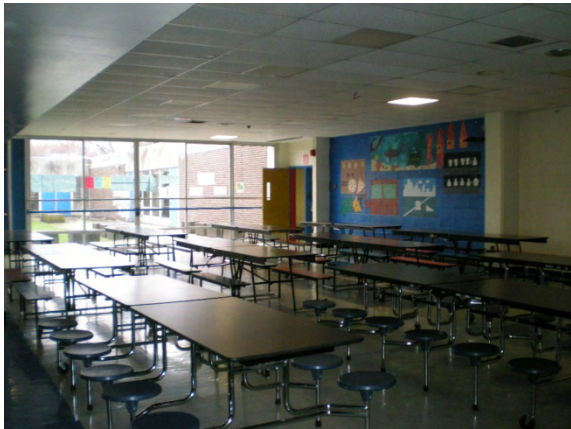
Photo #75: Cafeteria

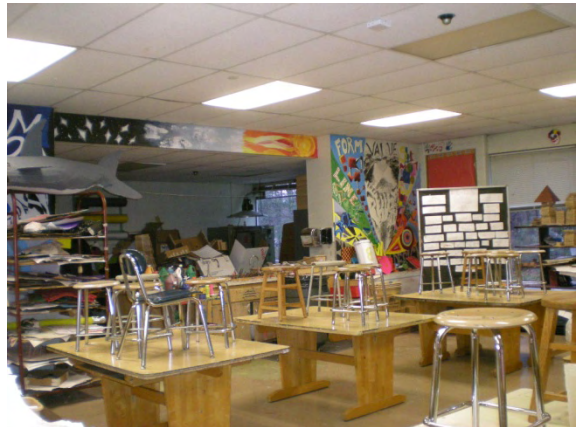
Photo #78: Art room

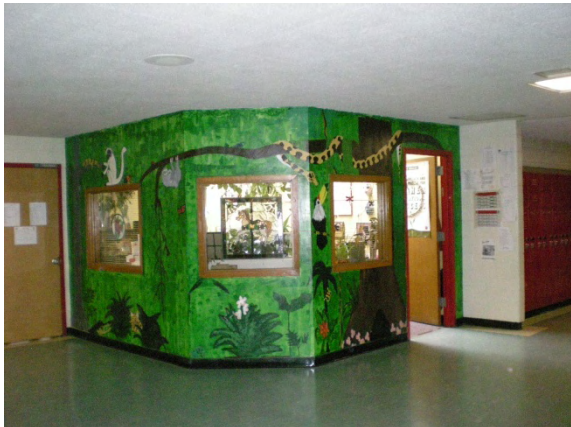
Photo #87: Assistant Principal's office on 2<sup>nd</sup> level

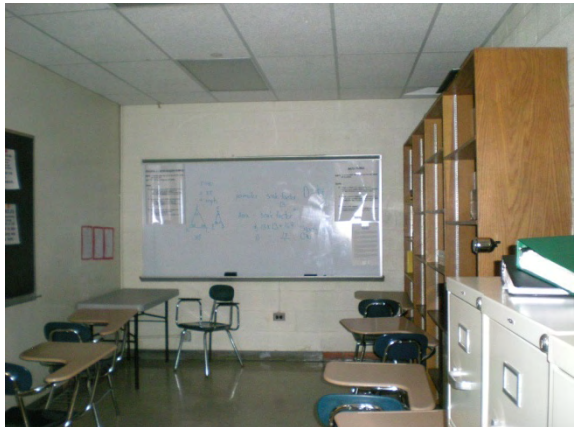
Photo #88: Windowless classroom 204

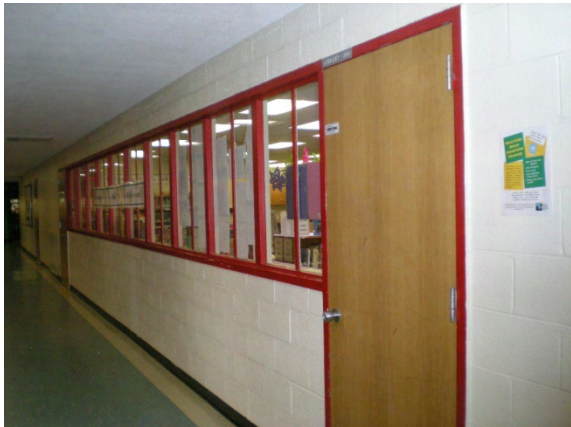
Photo #89: Entrance to Media Center with knob handle hardware

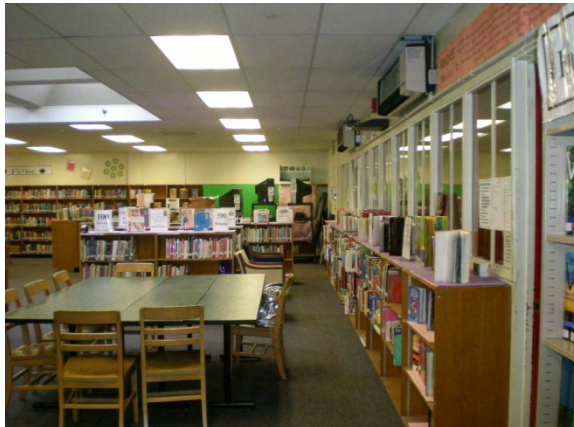
Photo #90: Media Center - 2<sup>nd</sup> level

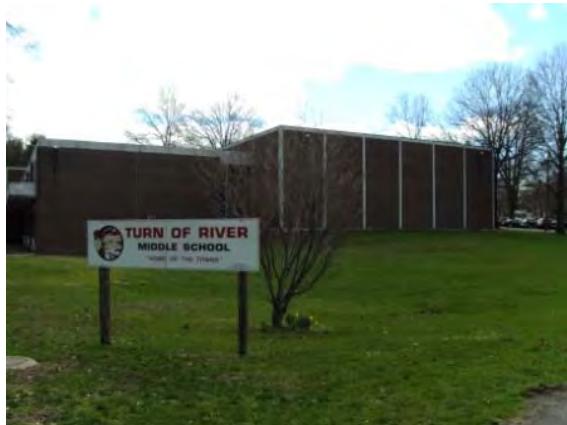
Photo #91: Project site and signage at main entrance

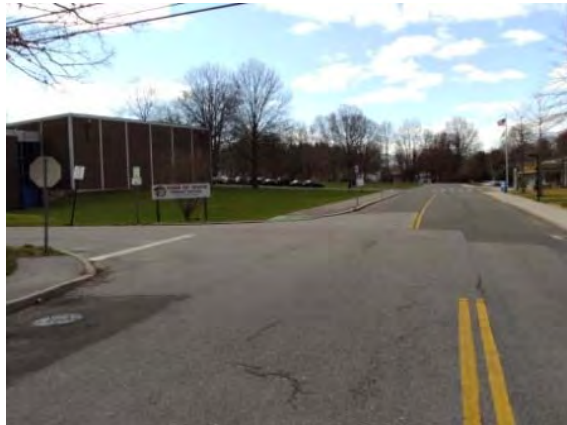
Photo #93: Main property entrance drive off Vine Road

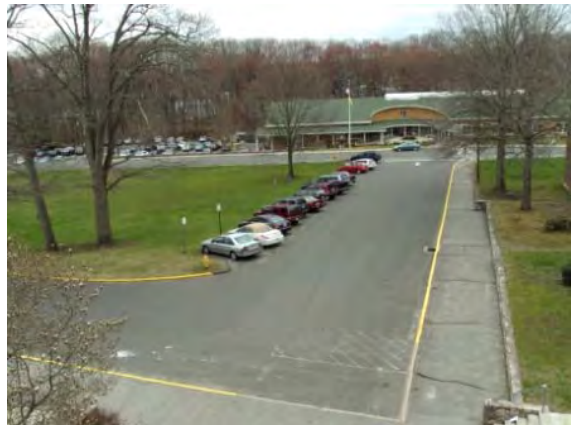
Photo #96: Parking area along front drive lane

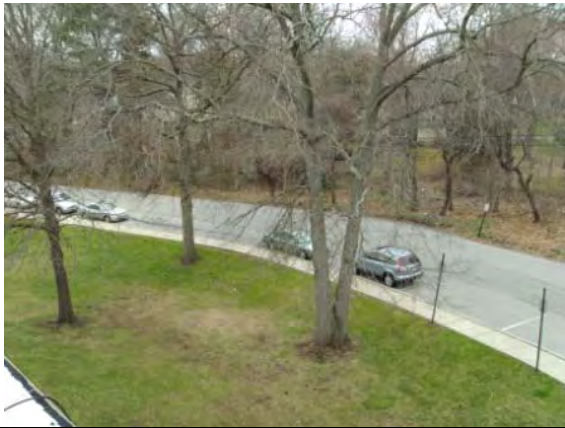
Photo #97:	Parking area along rear drive lane
------------	------------------------------------

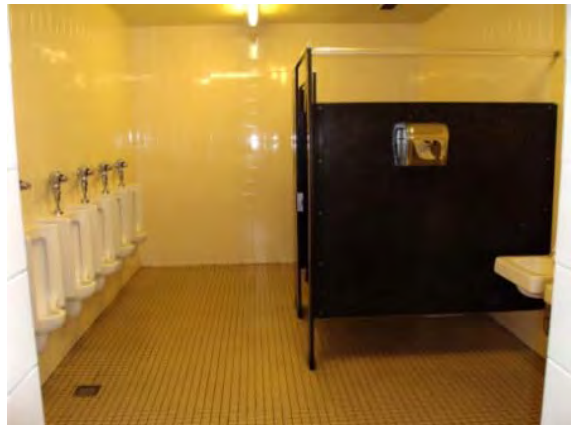
Photo #178: Overview of common area restroom

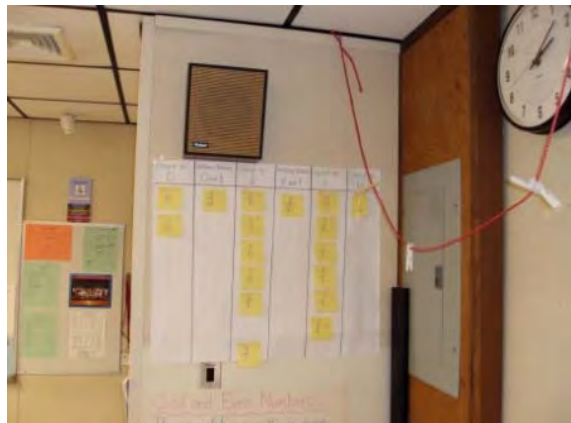
Photo #192: PA system call button and speaker in classroom

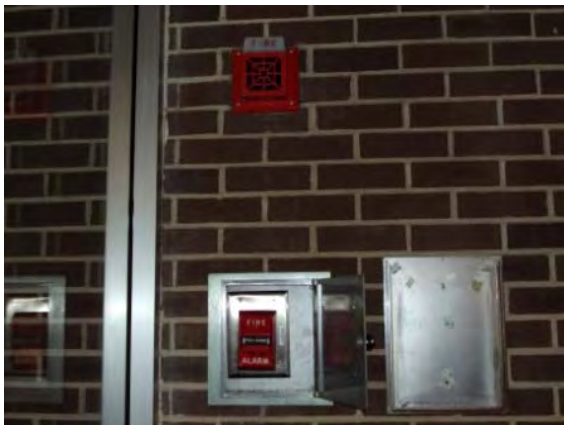
Photo #143: Fire pull station and strobe alarm

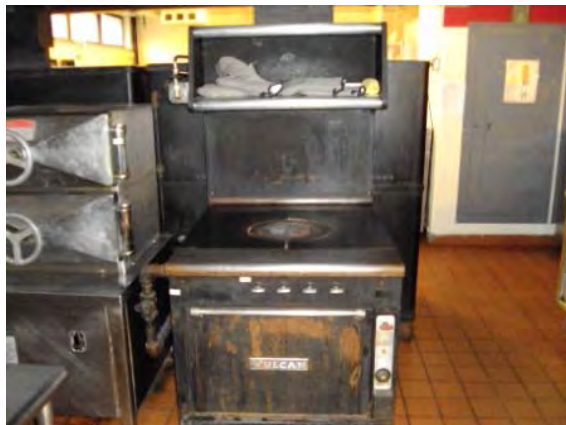
Photo #215: Original kitchen gas range

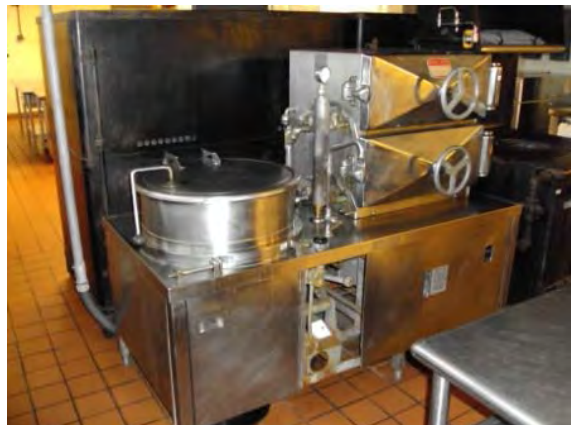
Photo #216: Kitchen steamer

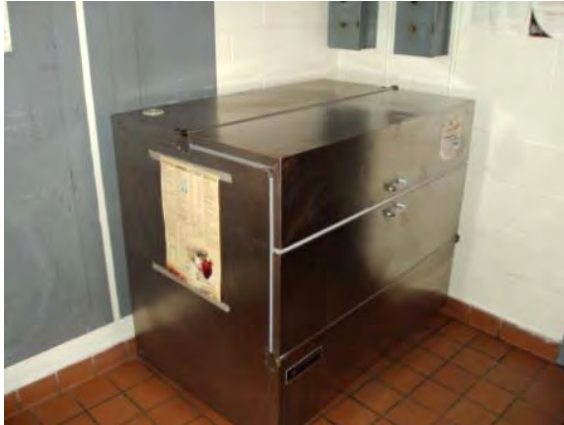
Photo #217:	Chest cooler
-------------	--------------

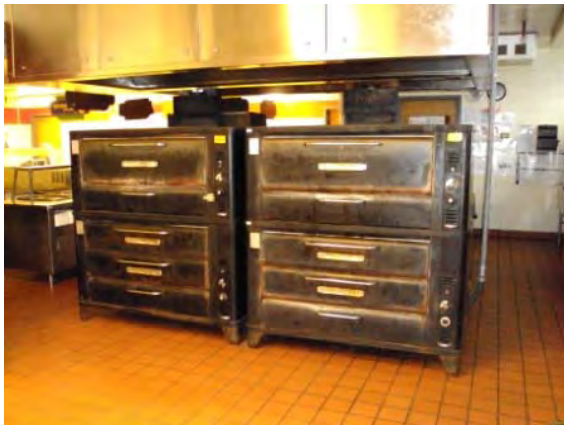
Photo #219:	Original gas ovens
-------------	--------------------
