FACILITIES NEEDS ASSESSMENT

STAMFORD HIGH SCHOOL

55 Strawberry Hill Avenue
Stamford, Connecticut 06902

EMG Project #: 88166.09R-021.017
Date of Report: August 30, 2009
On site Date: April 8 - 10, 13, 2009

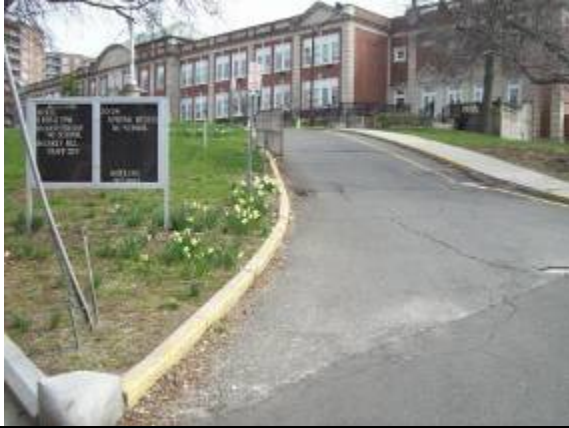
Photo #1:	South entrance to parking lot
-----------	-------------------------------

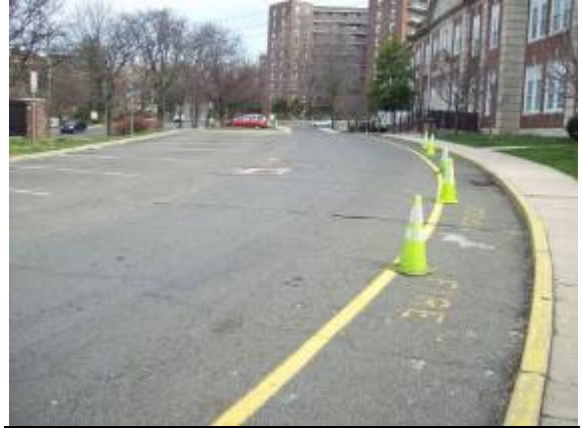
Photo #2:	Front parking lot
-----------	-------------------

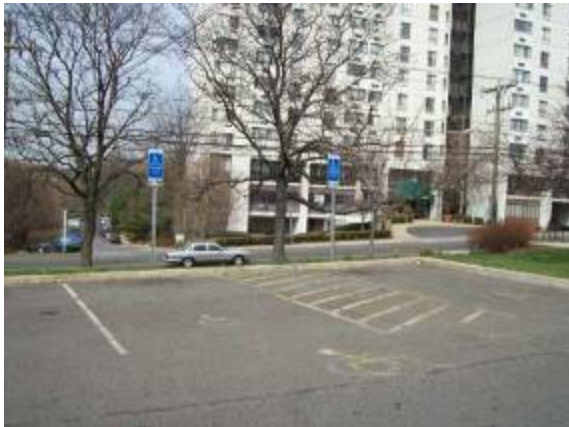
Photo #3:	Accessible parking stalls
-----------	---------------------------

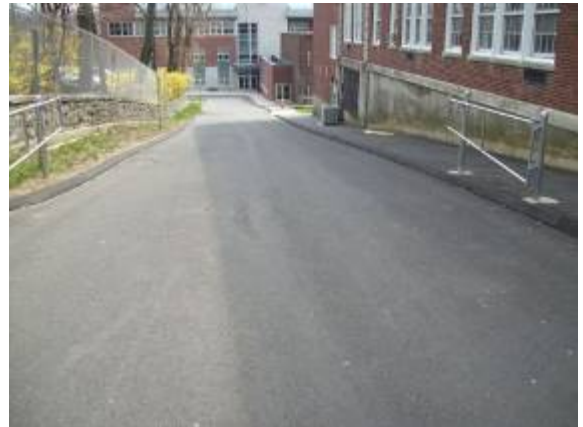
Photo #4:	Drive aisle at north side
-----------	---------------------------

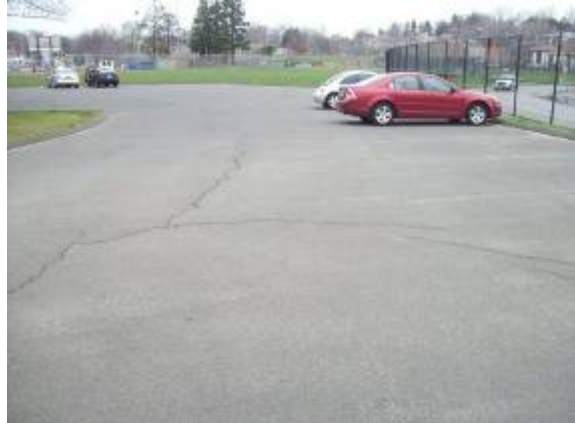
Photo #8: Staff parking lot along Hillandale Avenue

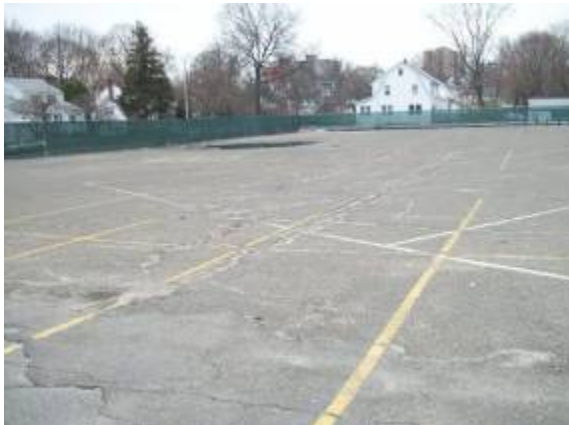
Photo #9: Student parking lot along Hillandale Avenue

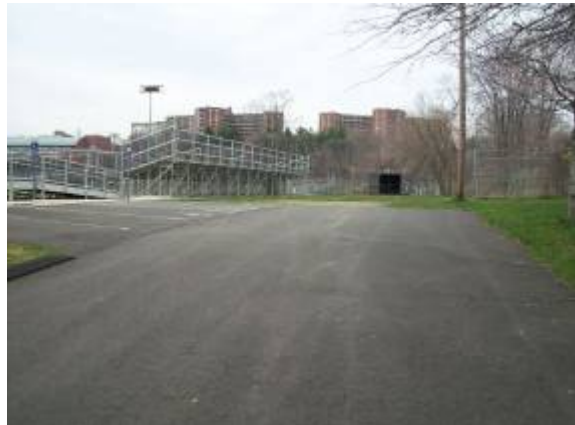
Photo #10: East parking lot near upper playing field

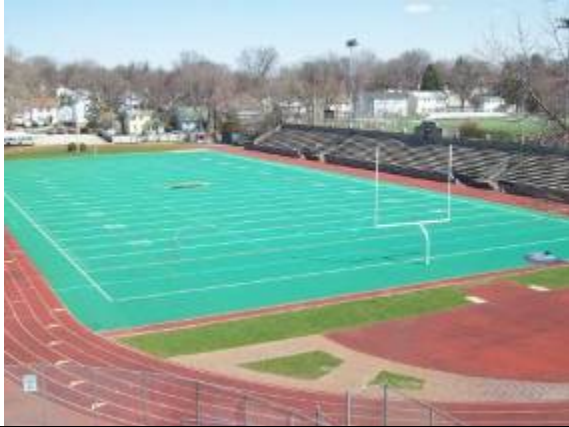
Photo #25: Boyle Stadium

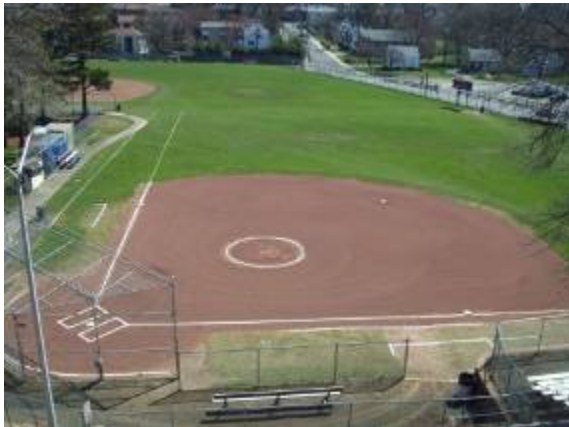
Photo #27: Softball and baseball fields

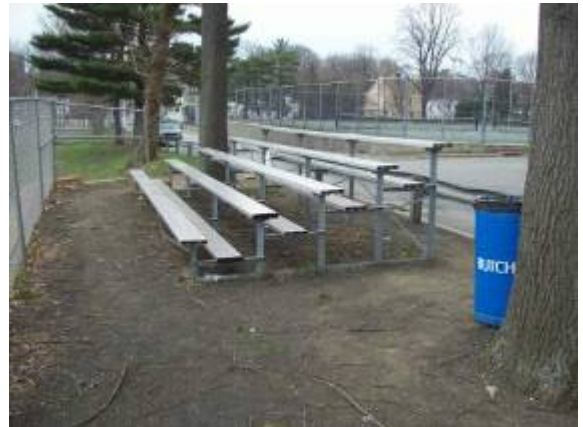
Photo #28: Bleachers at ball fields

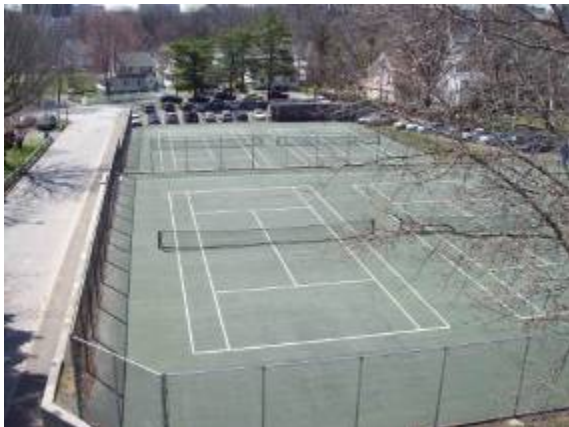
Photo #29: Tennis courts

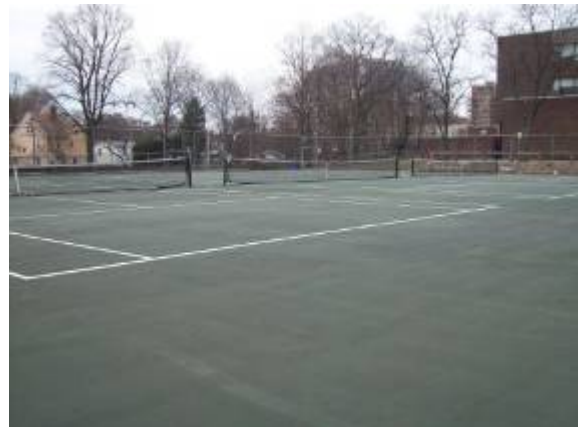
Photo #30: Tennis court surface

5.5	3543	Resurface asphalt tennis court	7	2	5	5	Court	\$8,492.40	\$42,462						\$42,462						\$42,462
5.5	4105	Replace Colored latex track surface	20	13	7	3150	SY	\$32.38	\$102,003							\$102,003					\$102,003

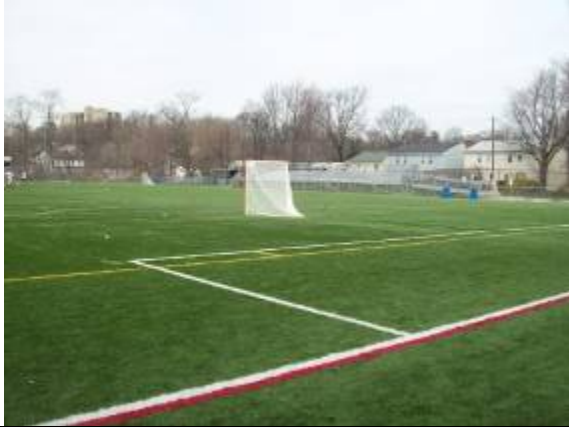
Photo #31: Soccer/lacrosse playing field

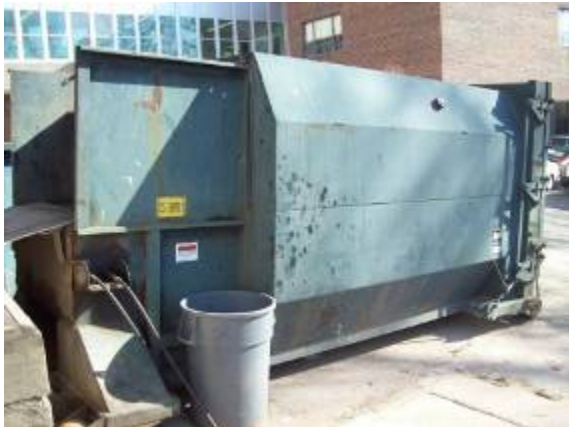
Photo #41:	Trash compactor
------------	-----------------

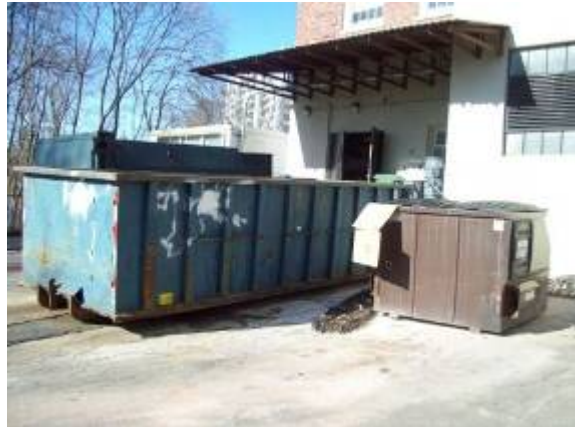
Photo #42:	Dumpsters
------------	-----------

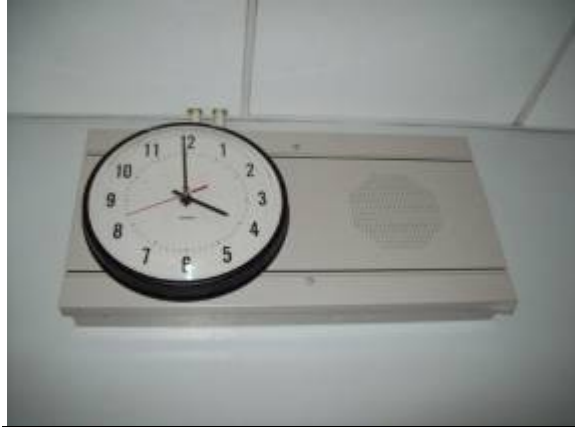
Photo #92: Classroom clock and PA speaker

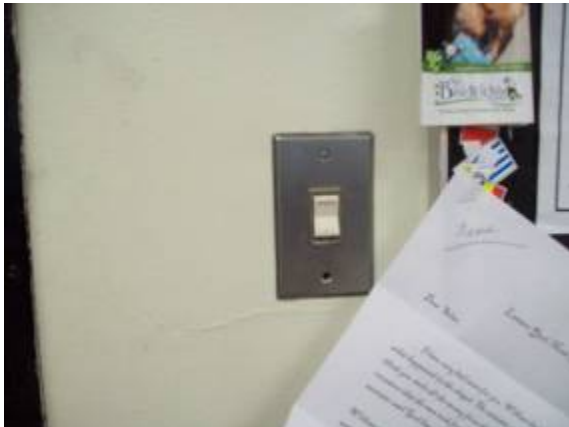
Photo #93: Classroom call button

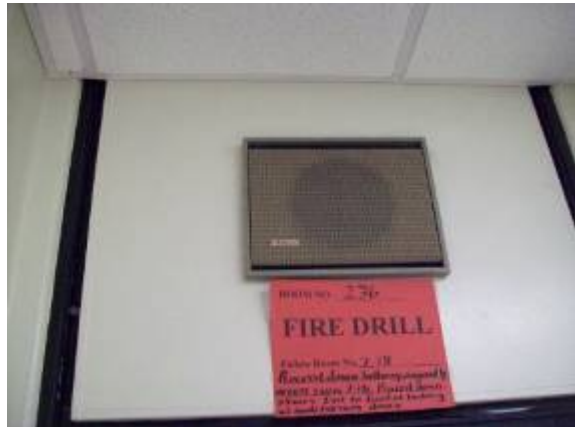
Photo #94: Older PA speaker in classroom

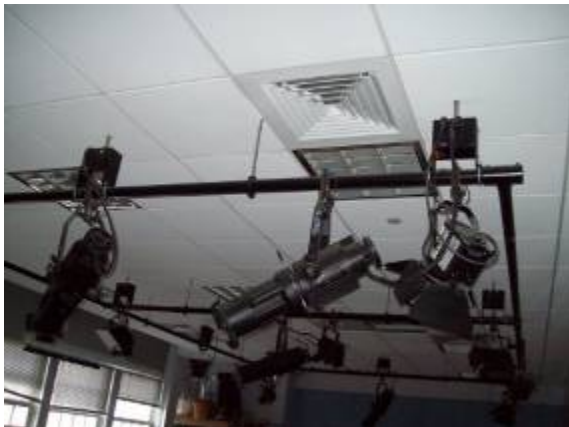
Photo #95: Advanced lighting in art classroom

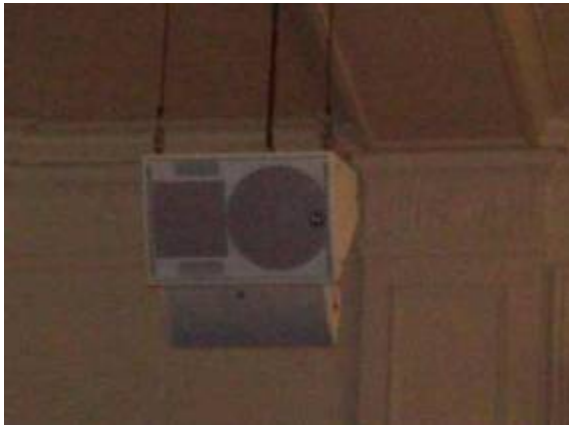
Photo #99: Auditorium speaker

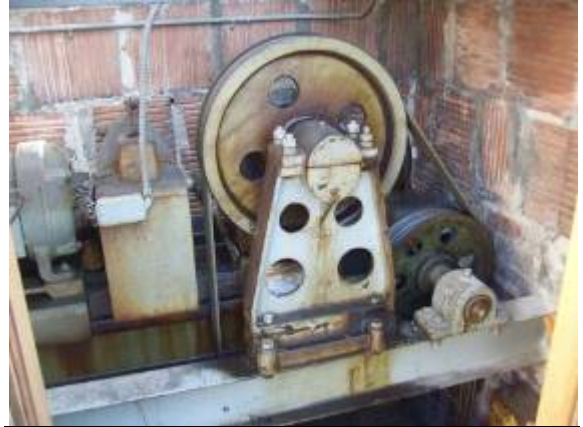
Photo #116: Elevator 4 traction equipment

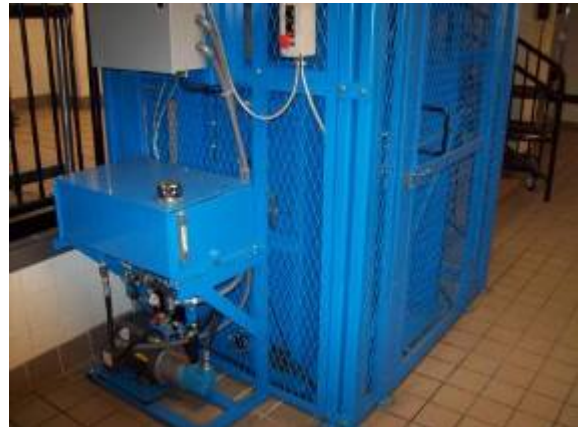
Photo #118: Hydraulic lift in kitchen

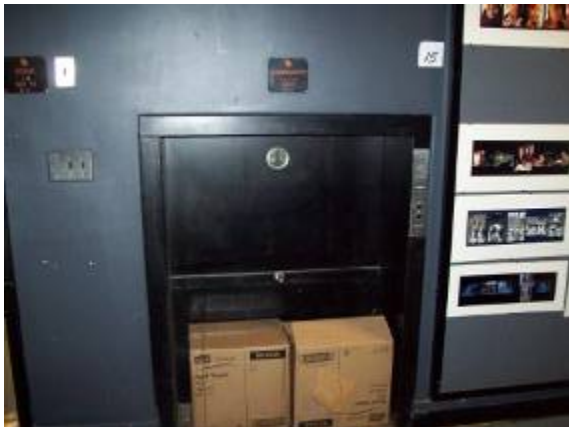
Photo #119: Dumb waiter in Art Corridor

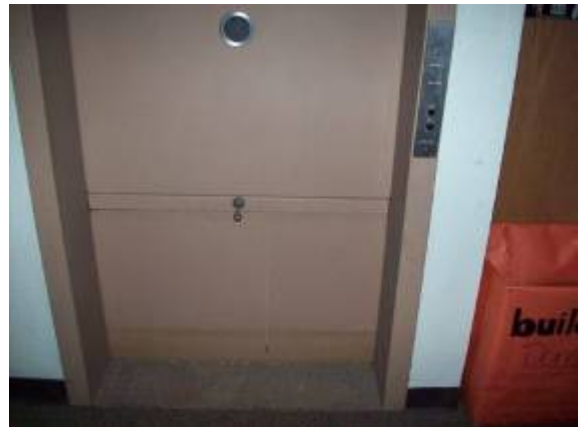
Photo #120: Dumb waiter in Media Center

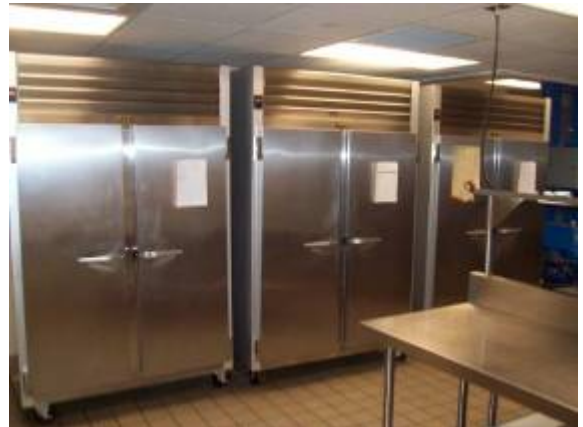
Photo #136: Kitchen equipment – Refrigerators

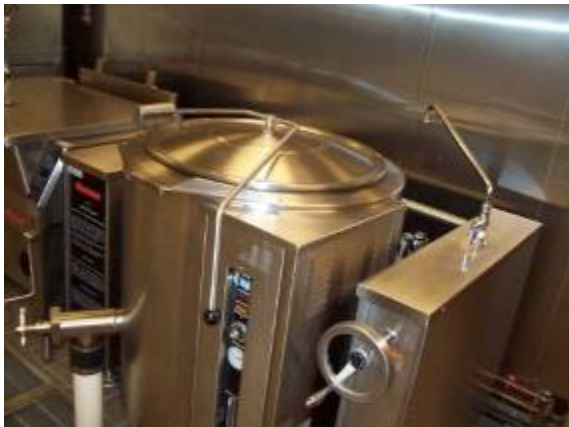
Photo #137: Kitchen equipment – Steamer
