PLAYGROUND SAFETY INSPECTION REPORT

SITE: Davenport Ridge Elementary School
1300 Newfield Avenue
Stamford, CT 06905

DATE OF INSPECTION: April 24, 2019

INSPECTOR: Natale Chionchio
CPSI Certification # 41619-0521
Expiration: 5/1/2021

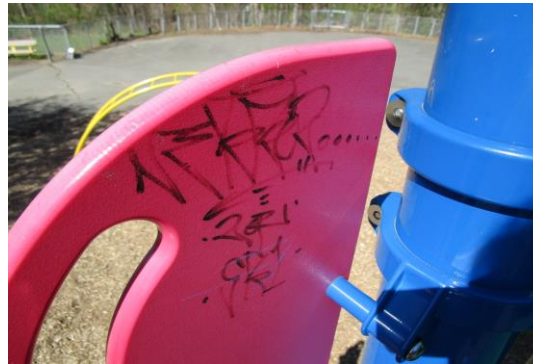
Summit Climber - Graffiti on one handhold - MAINTENANCE

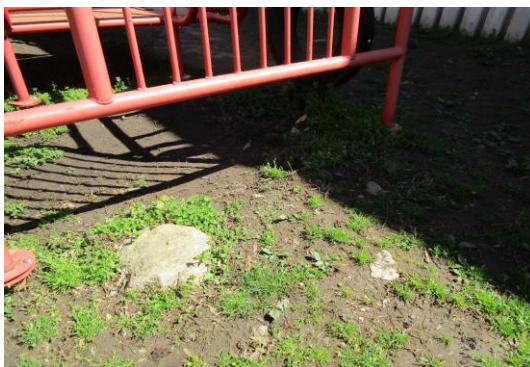
Surfacing - No wear mat at slide exit - CLASS C HAZARD

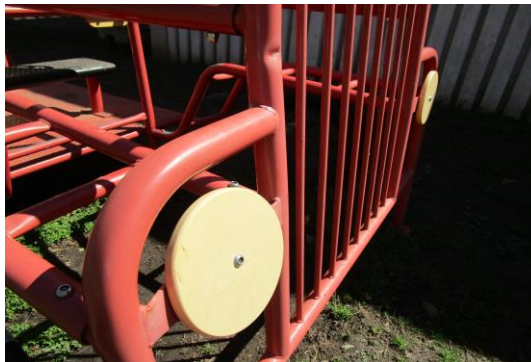
**Structure Stability - Unit leaning slightly & one headlight & support bent -
MAINTENANCE**

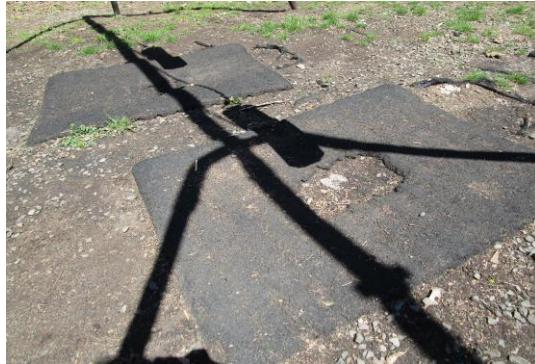
Use Zone - Inadequate, no clear use zone - CLASS A HAZARD

Condition	Hazard Priority	Recommendation
8ft. Swing Set (2Bay/4Belts) (Playworld)			Eight swing hangers worn	A	Replace eight swing hangers
Surface	0"	No surfacing, gravel & rocks below swings	A	Remove rocks & add 9-12" EWF	
		Four wear mats broken, tipping hazard	B	Replace four wear mats	
		Exposed fabric, tripping hazard	B	Cover fabric with EWF	
Use Zone		Inadequate, no clear use zone	A	Create clear use zone and add 9-12" of EWF	
Structural Stability		Good
