**STILLMEADOW ELEMENTARY SCHOOL  
Area #3**

**AREA #3 CONDITION REPORT**

**STILLMEADOW ELEMENTARY SCHOOL  
Area #4**

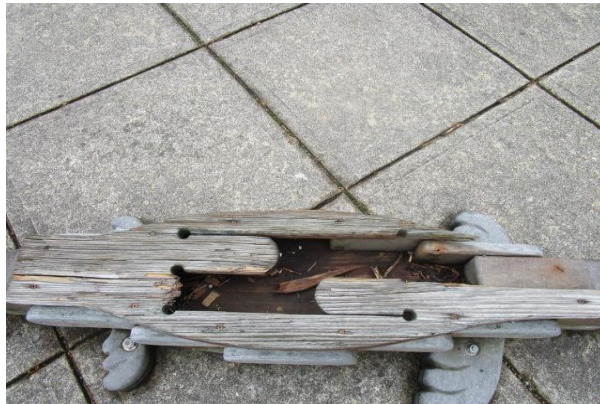
**Alligator (SoundPlay) - Music component is missing - MAINTENANCE**

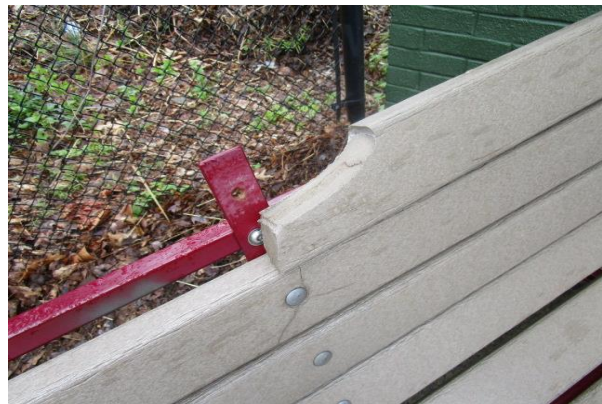
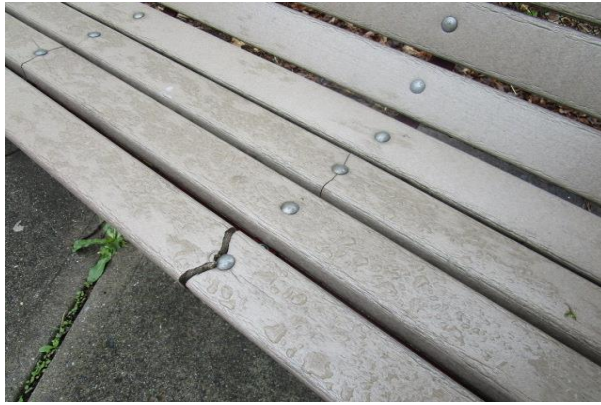
**Site Amenities - One bench damaged - MAINTENANCE**

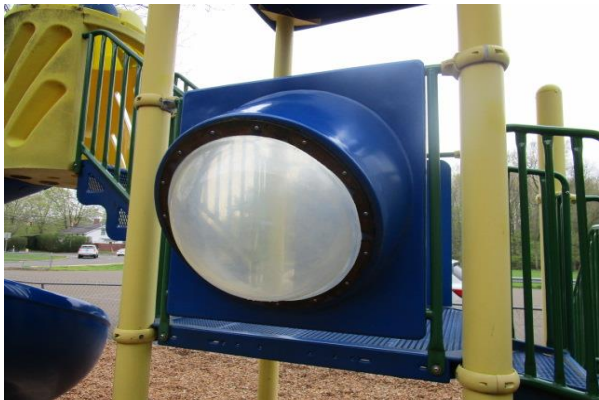
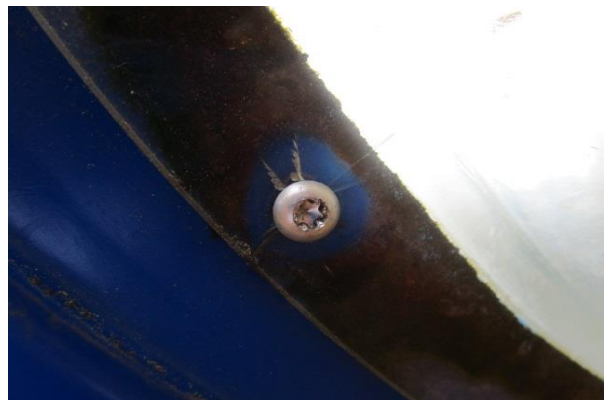
**Look Down Panel - Loose at post bracket, bubble cracked at bolts - MAINTENANCE**

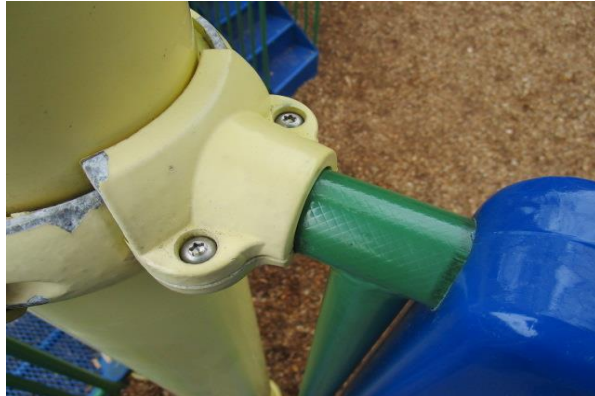
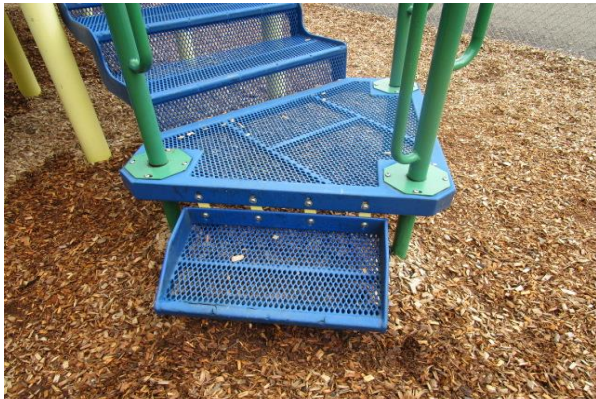
**Transfer Platform - Step loose & plastisol worn - MAINTENANCE**
